Levee Inspection Report

Name of System: Burr Street
 Name of Segment: Griffith
 NLD System ID: 2605000004 NLD Segment ID: 2604000006

Segment Type: USACE Federally constructed, turned over to public sponsor operations and maintenance
 Levee Sponsor (Name and Organization): Little Calumet River Basin Development Commission
 Inspection Report Prepared by: Chris Schaal Date(s) of Inspection: 06/09/2022 - 06/09/2022

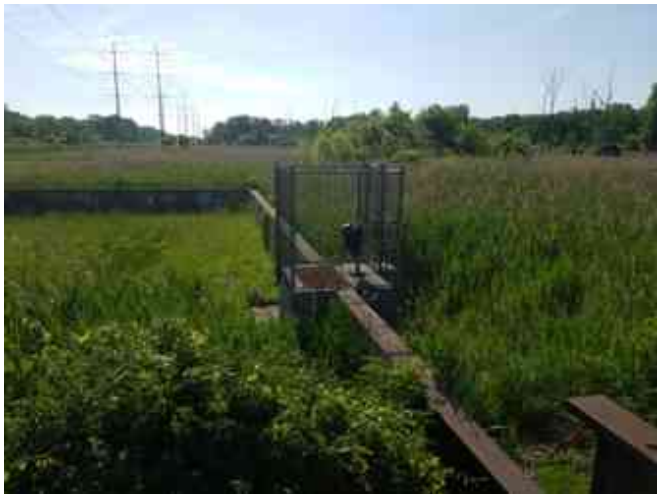
<p>Inspect ID: 2022-0009 Title: 2604000006_CELRC_2022_A_0009_1_20220609T134036.jpg Rated Item: 1. Unwanted Vegetation Growth Caption: Minimally Acceptable - Tall vegetation growth along riverside of sheet pile.</p>

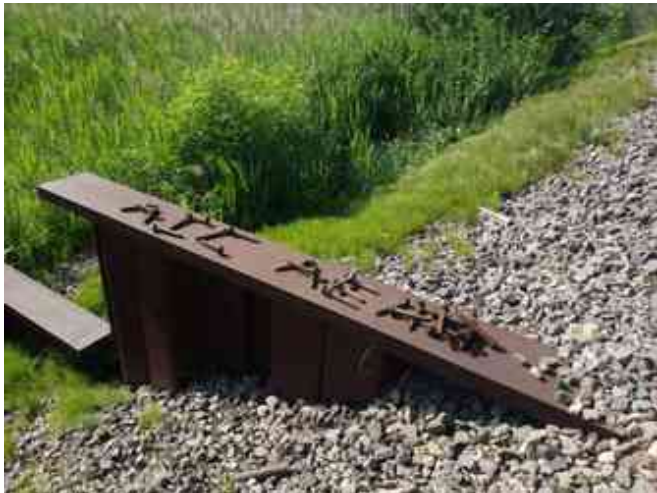
<p>Inspect ID: 2022-0011 Title: 2604000006_CELRC_2022_A_0011_1_20220609T134208.jpg Rated Item: 1. Unwanted Vegetation Growth Caption: Minimally Acceptable - Tall vegetation along landside of sheet pile.</p>

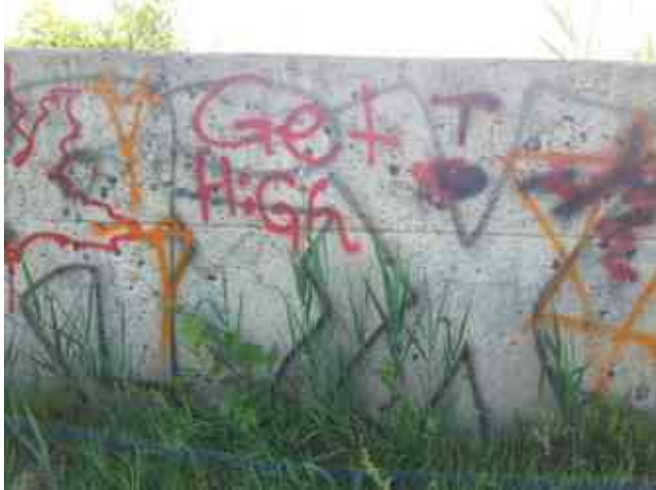
Inspect ID: 2022-0019 **Title:**
2604000006_CELRC_2022_A_0019_1_20220609T135732.jpg
Rated Item: 4. Concrete Surfaces **Caption:** Minimally
Acceptable - Crack on the riverside.

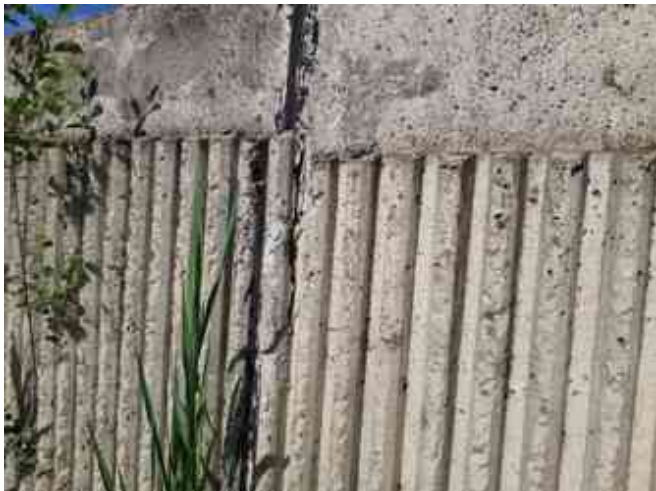
Inspect ID: 2022-0021 **Title:**
2604000006_CELRC_2022_A_0021_1_20220609T135936.jpg
Rated Item: 4. Concrete Surfaces **Caption:** Minimally
Acceptable - Large piece of concrete spalling from floodwall
on the landside.

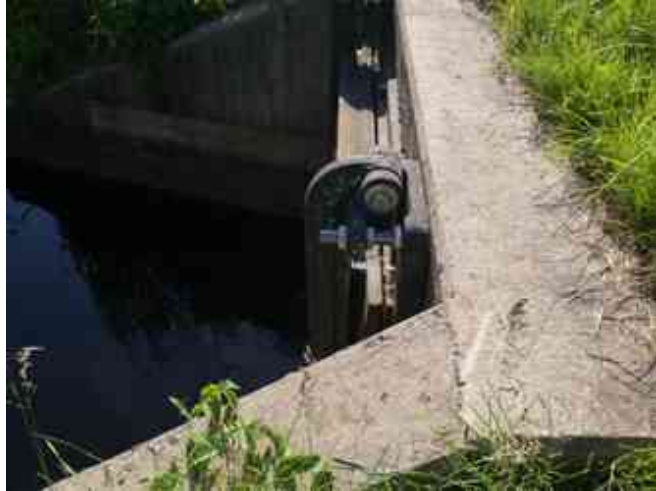
11. Flap Gates/ Flap Valves/ Pinch Valves	M	A	Gates/ valves open and close easily with minimal leakage, have no corrosion damage, and have been exercised and lubricated as required.	2022-0002 : GR-2: Flap gate stuck open. (M) Recommendation: Remove debris from flap gate.
		M	Gates/ valves will not fully open or close because of obstructions that can be easily removed, or have minor corrosion damage that requires maintenance.	
		U	Gates/ valves are missing, have been damaged, or have deteriorated to the point that they need to be replaced.	
		N/A	There are no flap gates.

Inspect ID: 2022-0002 **Title:**
2604000006_CELRC_2022_A_0002_1_20220609T131515.jpg
Rated Item: 11. Flap Gates/ Flap Valves/ Pinch Valves
Caption: Minimally Acceptable - GR-2: Flap gate stuck open.
