Levee Inspection Report

Name of System: Hammond Forest Ave
 Name of Segment: Hammond Forest Ave
 NLD System ID: 2605000010 NLD Segment ID: 2604000010

Segment Type: USACE Federally constructed, turned over to public sponsor for operations and maintenance
 Levee Sponsor (Name and Organization): Little Calumet River Basin Development Commission
 Inspection Report Prepared by: Chris Schaal Date(s) of Inspection: 04/29/2024 - 04/30/2024
 Inspection Report Prepared by: Mike Cook
 Inspection Report Prepared by: Youa Yang

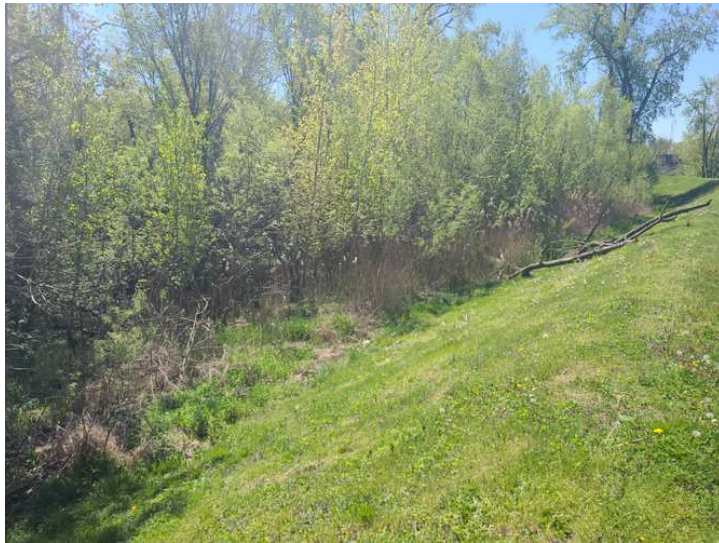
Caption: Minimally Acceptable - Trees within 15 feet of the landside toe

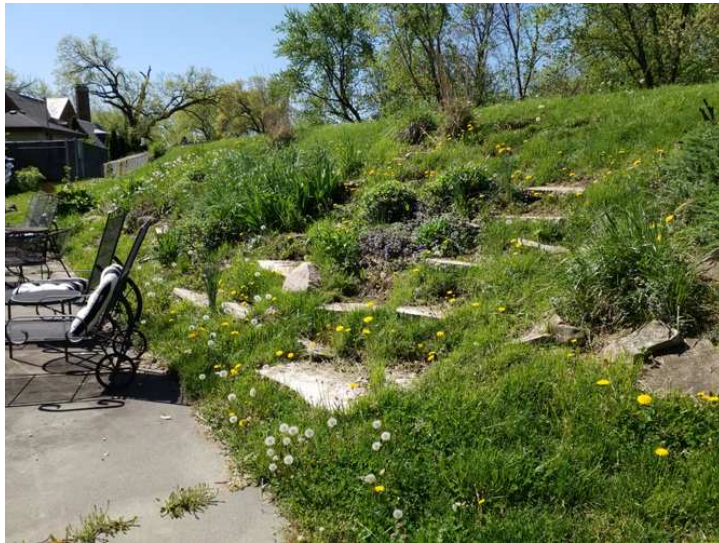
Inspect ID: 2024-0077
Feature Details: Levee Embankments - Unwanted Vegetation Growth - Waterside Toe
Station Start:
Station End:
Caption: Minimally Acceptable - Three large trees within 15 feet of the riverside toe

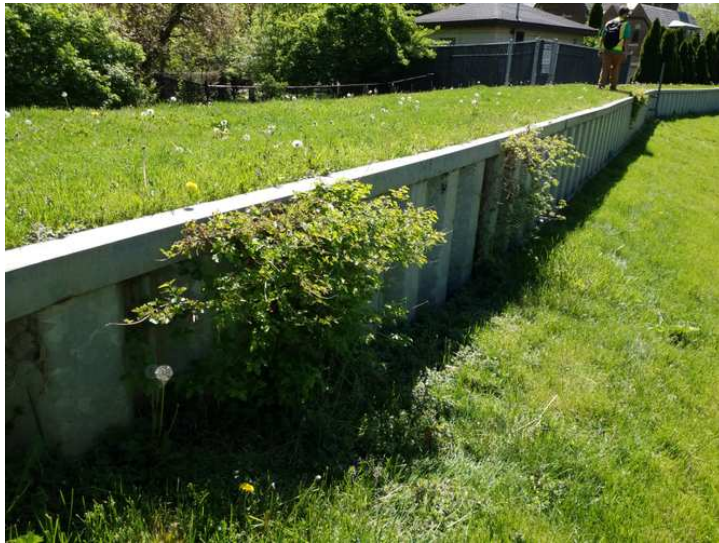
Caption: Minimally Acceptable - Trees on the landside slope

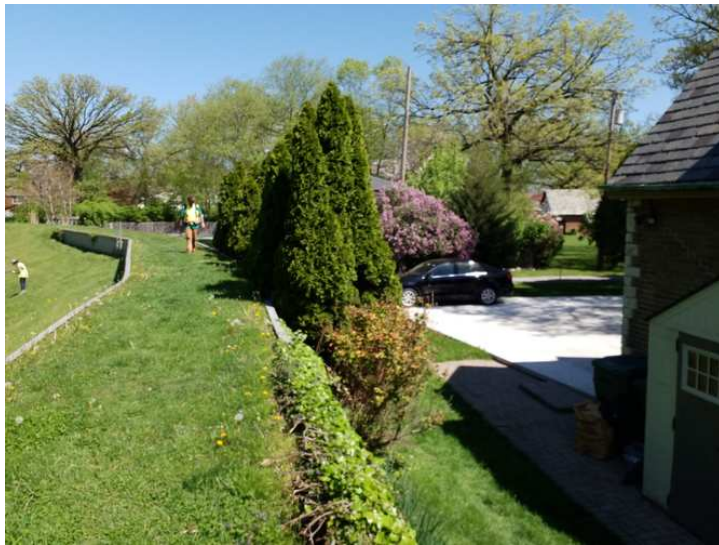
Caption: Minimally Acceptable - Three trees planted in the landside slope since the last inspection

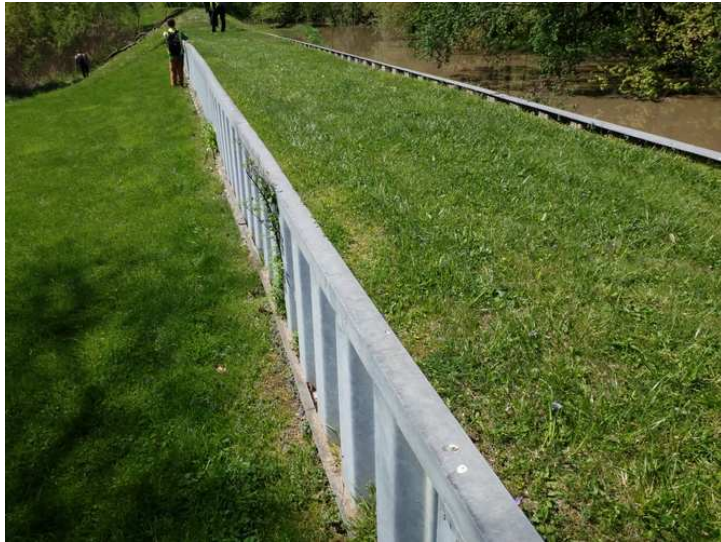
Caption: Minimally Acceptable - Small trees on the riverside of the sheetpile wall

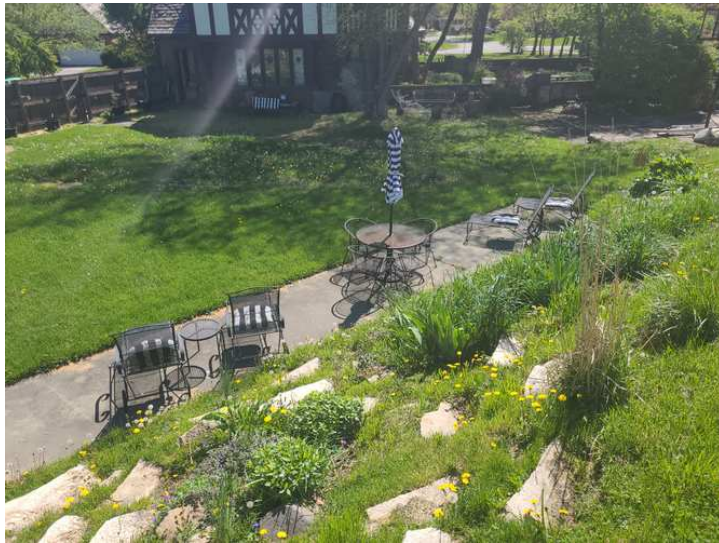
Rated Item	Rating	Rating Guidelines		Observation Locations with Descriptions and Resulting Item Rating Justification
2. Sod Cover	A	A	There is good coverage of sod over the levee.	2024-0139 : Good sod cover(A) Justification: No issues observed.
		M	Approximately 25% of the sod cover is missing or damaged over a significant portion or over significant portions of the levee embankment. This may be the result of over-grazing or feeding on the levee, unauthorized vehicular traffic, chemical or insect problems, or burning during inappropriate seasons.	
		U	Over 50% of the sod cover is missing or damaged over a significant portion or portions of the levee embankment.	
		NA	Surface protection is provided by other means.

Inspect ID: 2024-0139
Feature Details: Levee Embankments - Sod Cover - Slopes and Crown
Station Start:
Station End:
Caption: Acceptable - Good sod cover

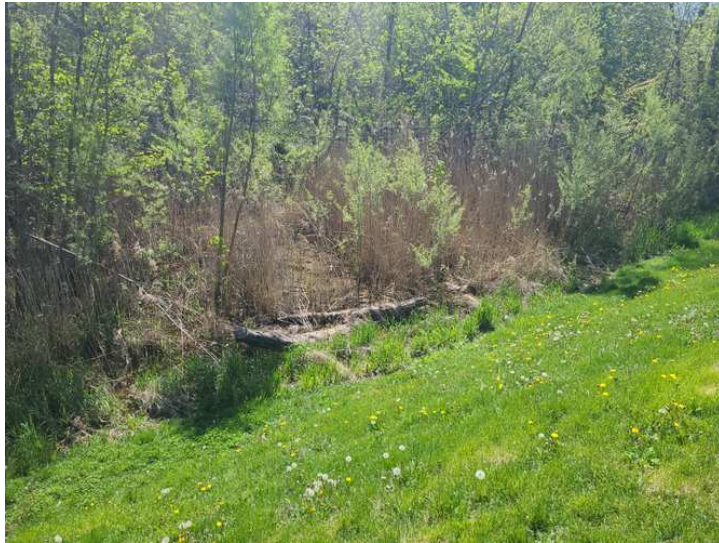
Caption: Minimally Acceptable - Downed branches on the riverside toe

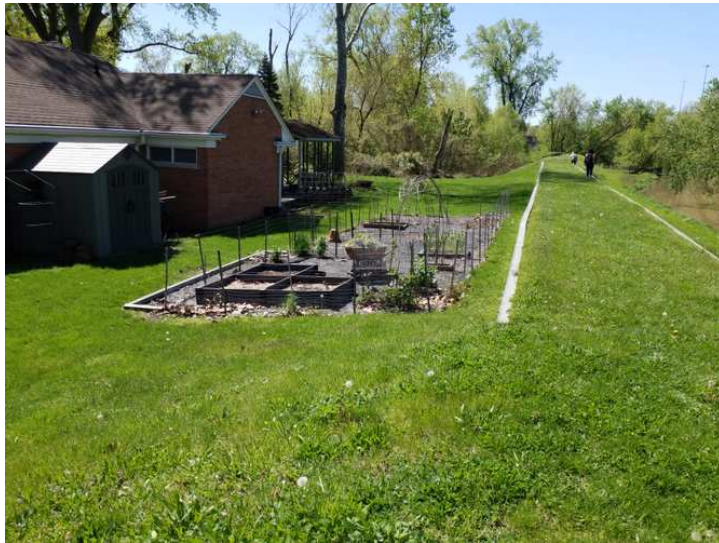
Inspect ID: 2024-0115
Feature Details: Levee Embankments - Encroachments - Landside
Station Start:
Station End:
Caption: Minimally Acceptable - Planter bin within the landside toe easement

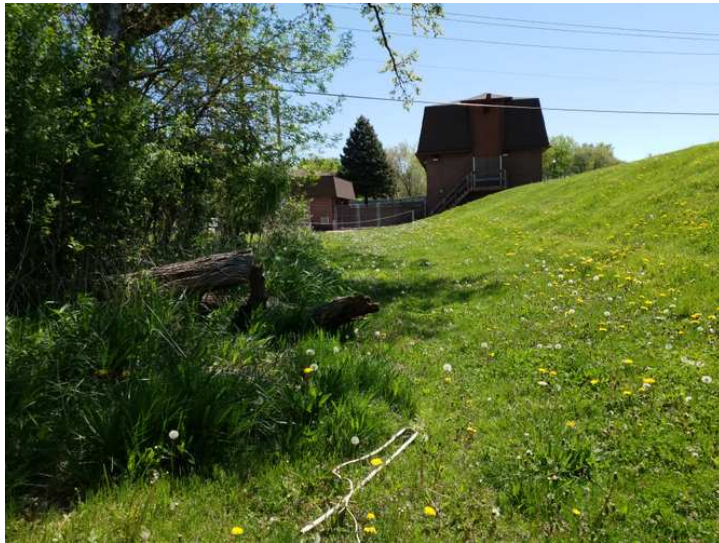
Inspect ID: 2024-0147
Feature Details: Levee Embankments - Encroachments - Landside Toe
Station Start:
Station End:
Caption: Minimally Acceptable - Tree debris on the landside toe

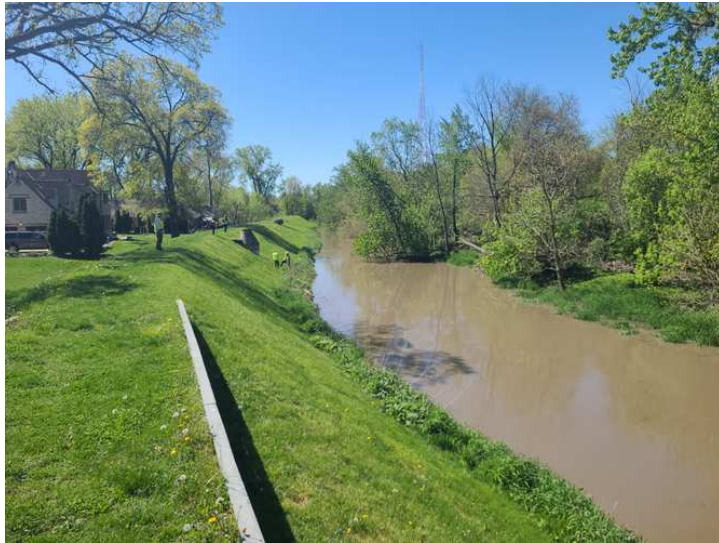
Inspect ID: 2024-0017
Feature Details: Levee Embankments - Erosion/ Bank Caving - Waterside
Station Start:
Station End:
Caption: Minimally Acceptable - Riverside bank caving

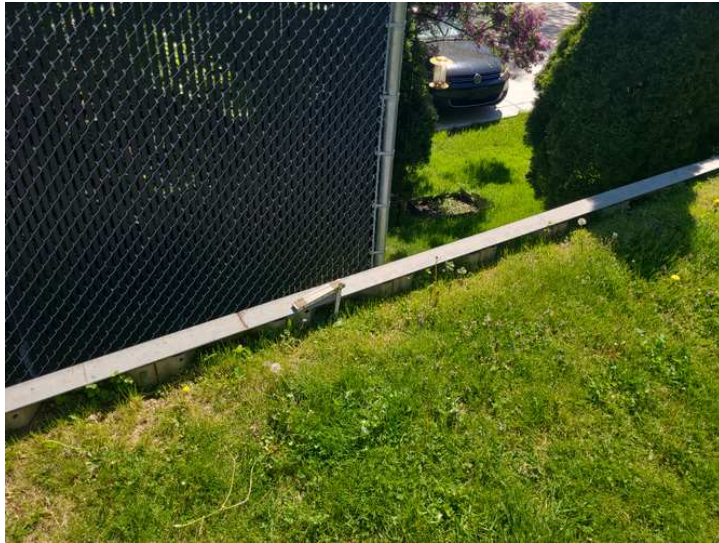
Inspect ID: 2024-0091
Feature Details: Levee Embankments - Erosion/ Bank Caving - Waterside Toe
Station Start:
Station End:
Caption: Minimally Acceptable - Erosion along the riverside toe.

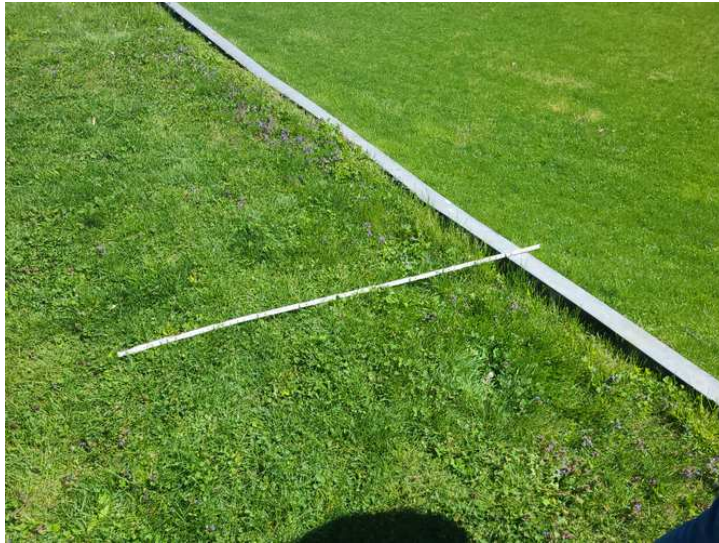
Caption: Minimally Acceptable - Since the last inspection at the sheetpile wall - Along the center of the crest and on the slope, there is approximately 2 and 3 additional inches of settlement, respectively

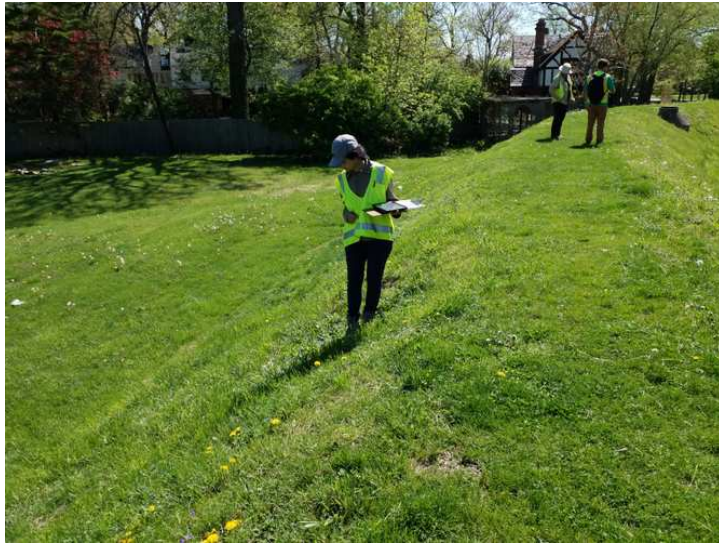
Inspect ID: 2024-0074
Feature Details: Levee Embankments - Depressions/ Rutting - Waterside Slope
Station Start:
Station End:
Caption: Minimally Acceptable - Rutting due to animal tracks on the riverside slope

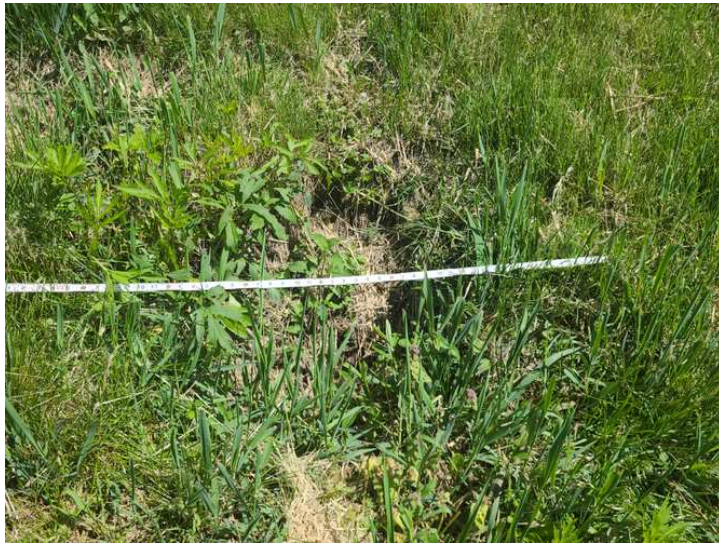
Inspect ID: 2024-0083
Feature Details: Levee Embankments - Depressions/ Rutting - Crown
Station Start:
Station End:
Caption: Minimally Acceptable - Depression in the levee crown

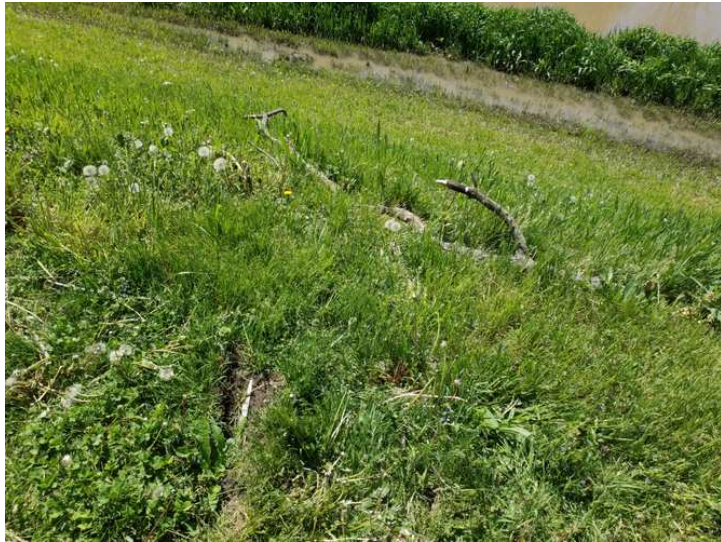
Inspect ID: 2024-0089
Feature Details: Levee Embankments - Depressions/ Rutting - Landside
Station Start:
Station End:
Caption: Minimally Acceptable - Rutting and loss of sod cover on the landside crest

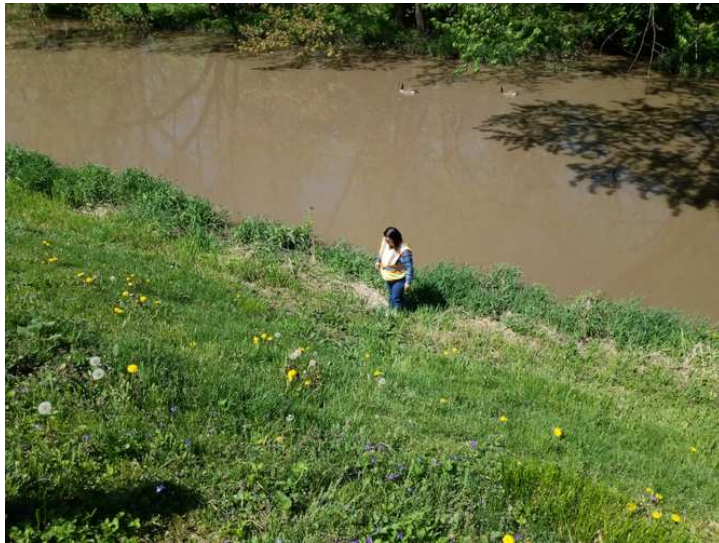
Inspect ID: 2024-0102
Feature Details: Levee Embankments - Depressions/ Rutting - Crown
Station Start:
Station End:
Caption: Minimally Acceptable - Depression on the levee crest

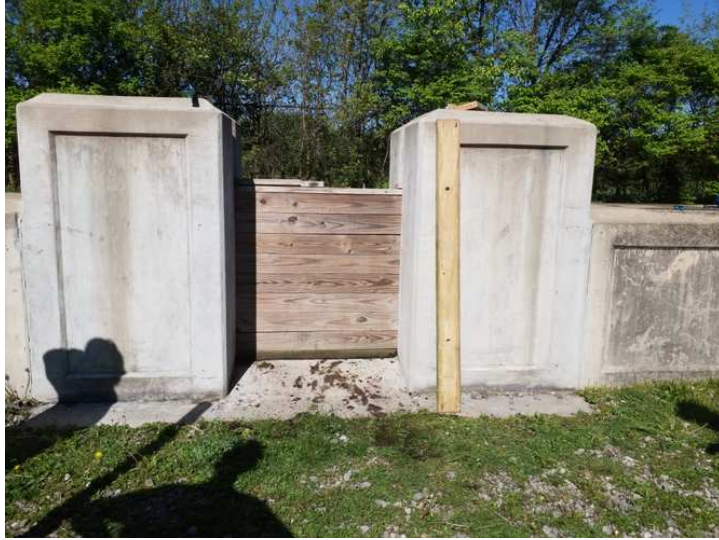
Inspect ID: 2024-0003
Feature Details: Floodwalls - Closure Structures (Stop Log Closures and Gates) (A or U only) - Landside Face
Station Start:
Station End:
Caption: Acceptable - South closure: Top piece broke during exercise and a few logs are deformed, leaving gaps

NA	There are no closure structures along this component of the levee segment / system.	2024-0031 : The sandbag closure base is in good condition(A) Recommendation: Replace broken or deformed stop logs

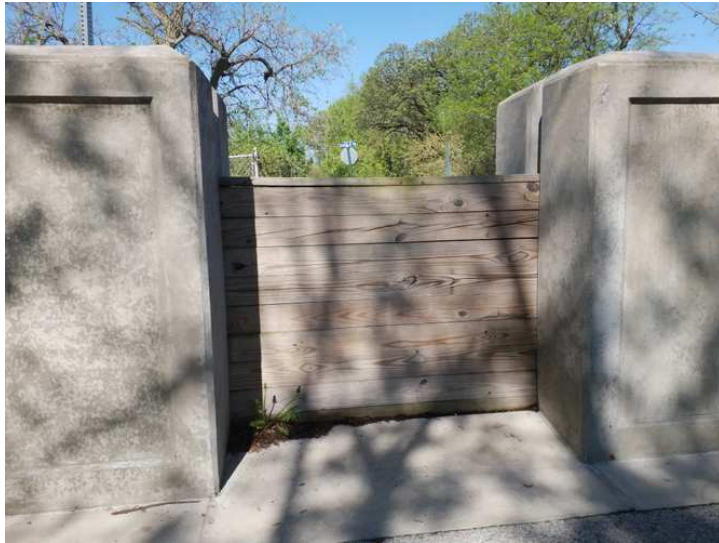
Rated Item	Rating	Rating Guidelines		Observation Locations with Descriptions and Resulting Item Rating Justification
3. Closure Structures (Stop Log Closures and Gates) (A or U only)	A	A	Closure structure in good repair. Placing equipment, stoplogs, and other materials are readily available at all times. Components are clearly marked and installation instructions/ procedures readily available. Trial erections have been accomplished in accordance with the O&M Manual.	2024-0001 : Tested opening and closing the closure structure. No issues noted. Two people took 7 minutes to completely install the closure(A)
		U	Any of the following issues is cause for this rating: Closure structure in poor condition. Parts missing or corroded. Placing equipment may not be available within the anticipated warning time. The storage vaults cannot be opened during the time of inspection. Components of closure are not clearly marked and installation instructions/ procedures are not readily available. Trial erections have not been accomplished in accordance with the O&M Manual.	2024-0003 : South closure: Top piece broke during exercise and a few logs are deformed, leaving gaps(A) 2024-0015 : North closure: There are small gaps between the stop logs(A)

Inspect ID: 2024-0015
Feature Details: Floodwalls - Closure Structures (Stop Log Closures and Gates) (A or U only) - Landside
Station Start:
Station End:
Caption: Acceptable - North closure: There are small gaps between the stop logs

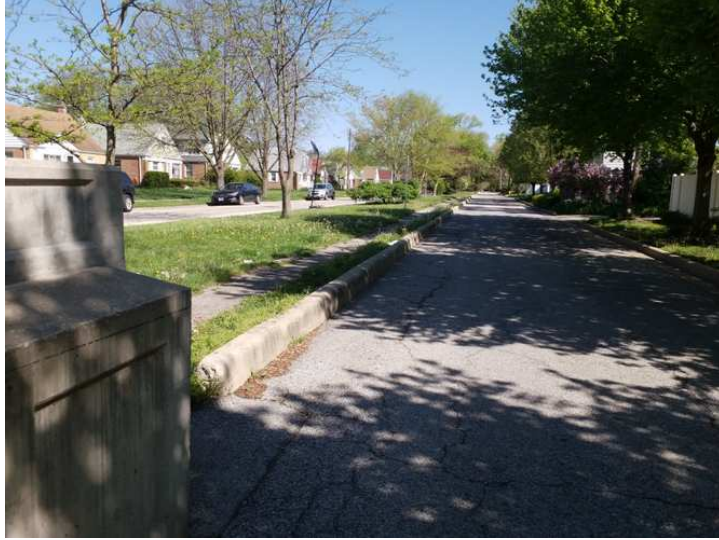
Inspect ID: 2024-0031
Feature Details: Floodwalls - Closure Structures (Stop Log Closures and Gates) (A or U only) - Other
Station Start:
Station End:
Caption: Acceptable - The sandbag closure base is in good condition

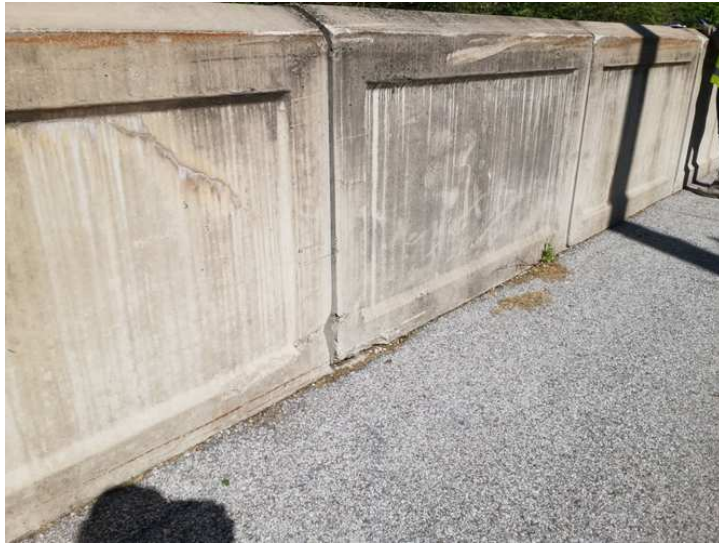
Inspect ID: 2024-0007
Feature Details: Floodwalls - Concrete Surfaces - Landside
Station Start:
Station End:
Caption: Minimally Acceptable - Typical example of minor spalling on the landside of the floodwall

Rated Item	Rating	Rating Guidelines		Observation Locations with Descriptions and Resulting Item Rating Justification
				Recommendation: Grind down any major spalled areas and patch. Patch any cracks that are wider than hairline width.

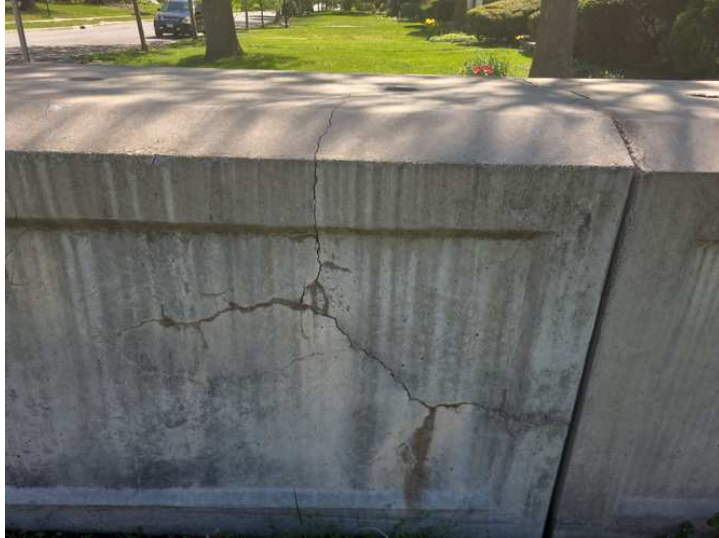
Inspect ID: 2024-0009
Feature Details: Floodwalls - Concrete Surfaces - Waterside
Station Start:
Station End:
Caption: Minimally Acceptable - Crack on the riverside of the floodwall

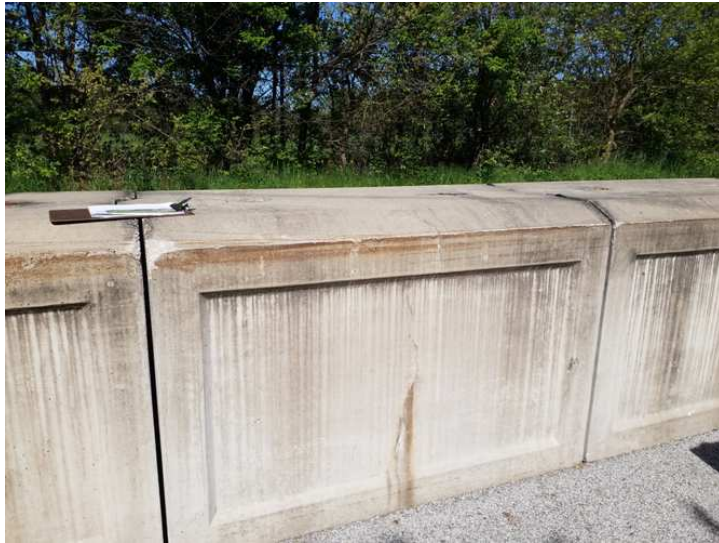
Inspect ID: 2024-0010
Feature Details: Floodwalls - Concrete Surfaces - Landside
Station Start:
Station End:
Caption: Minimally Acceptable - Typical cracking on the landside of the floodwall

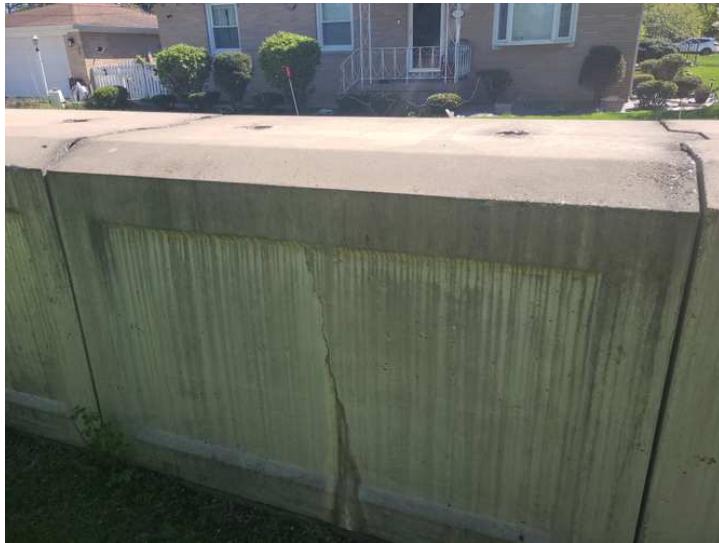
Caption: Minimally Acceptable - Minor spalling on the landside of the floodwall

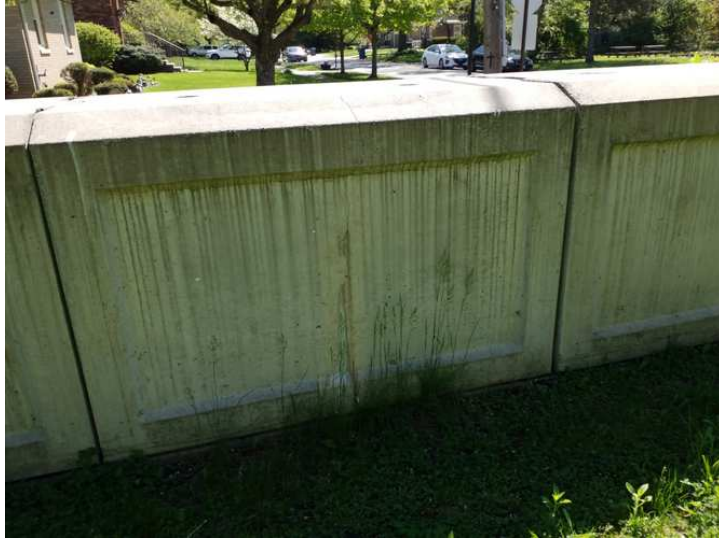
Inspect ID: 2024-0058
Feature Details: Floodwalls - Concrete Surfaces - Waterside
Station Start:
Station End:
Caption: Minimally Acceptable - Cracking on the riverside of the floodwall

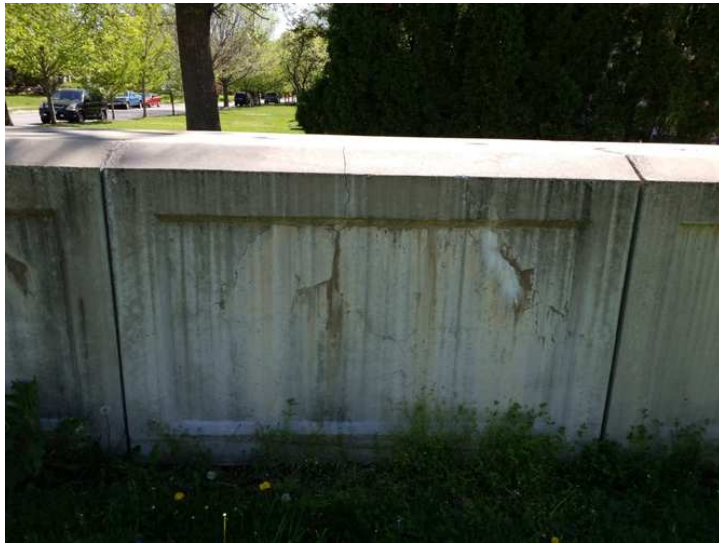
Inspect ID: 2024-0059
Feature Details: Floodwalls - Concrete Surfaces - Waterside
Station Start:
Station End:
Caption: Minimally Acceptable - Crack on the riverside of the floodwall

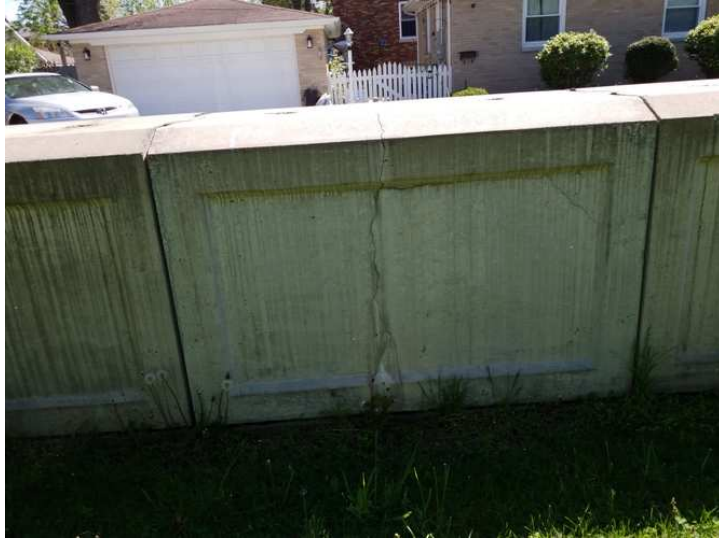
Rated Item	Rating	Rating Guidelines		Observation Locations with Descriptions and Resulting Item Rating Justification
4. Concrete Surfaces	M	A	Negligible spalling, scaling or cracking. If the concrete surface is weathered or holds moisture, it is still satisfactory but should be seal coated to prevent freeze/ thaw damage.	2024-0007 : Typical example of minor spalling on the landside of the floodwall(M)
		M	Spalling, scaling, and open cracking present, but the immediate integrity or performance of the structure is not threatened. Reinforcing steel may be exposed. Repairs/ sealing is necessary to prevent additional damage during periods of thawing and freezing.	2024-0009 : Crack on the riverside of the floodwall(M) 2024-0010 : Typical cracking on the landside of the floodwall(M)
		U	Surface deterioration or deep cracks present that may result in an unreliable structure. Any surface deterioration that exposes the sheet piling or lies adjacent to monolith joints may indicate underlying reinforcement corrosion and is unacceptable.	2024-0011 : Minor spalling on the landside of the floodwall(M) 2024-0013 : Crack maintenance on the riverside of the floodwall(M) 2024-0018 : Cracking that is slightly larger (not typical) on the landside of the floodwall(M) 2024-0026 : Broken concrete on the landside of the floodwall(M) 2024-0038 : Separation between the top and bottom portions of the riverside of the floodwall(M) 2024-0051 : Deteriorating concrete at the base of the riverside of the floodwall(M) 2024-0058 : Cracking on the riverside of the floodwall(M) 2024-0059 : Crack on the riverside of the floodwall(M) 2024-0063 : Cracking on the riverside of the floodwall(M)

Inspect ID: 2024-0063
Feature Details: Floodwalls - Concrete Surfaces - Waterside
Station Start:
Station End:
Caption: Minimally Acceptable - Cracking on the riverside of the floodwall

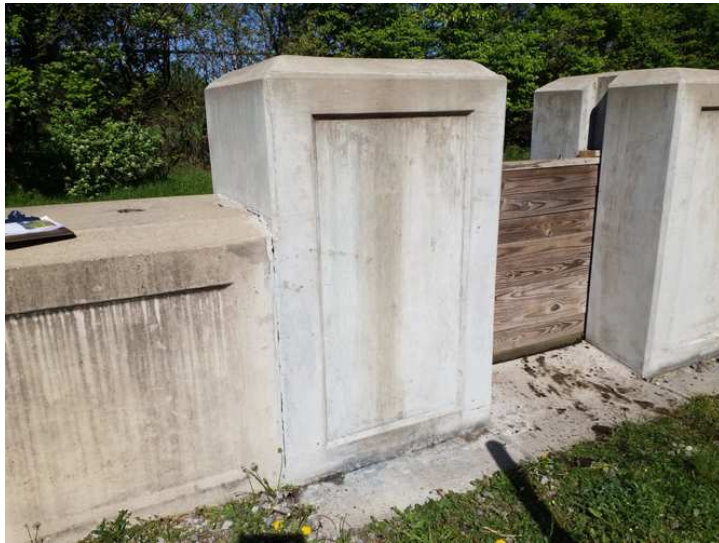
Inspect ID: 2024-0002
Feature Details: Floodwalls - Monolith Joints - Landside Joint
Station Start:
Station End:
Caption: Minimally Acceptable - Typical example of joint sealant shrinking while drying on the landside of the floodwall

NA	There are no monolith joints in the floodwall.	2024-0023 : Exposed backer rod at the top of the floodwall(M) 2024-0027 : Degraded sealant on the landside of the floodwall(M) 2024-0039 : Typical sealant cracking on the riverside of the floodwall(M) 2024-0043 : Sealant is saturated and deteriorating and the backer rod is exposed due to a concrete spill on the riverside of the floodwall(M) Recommendation: Restore any exposed/displaced backer rod to its original position. Remove any degraded sealant and replace in kind.

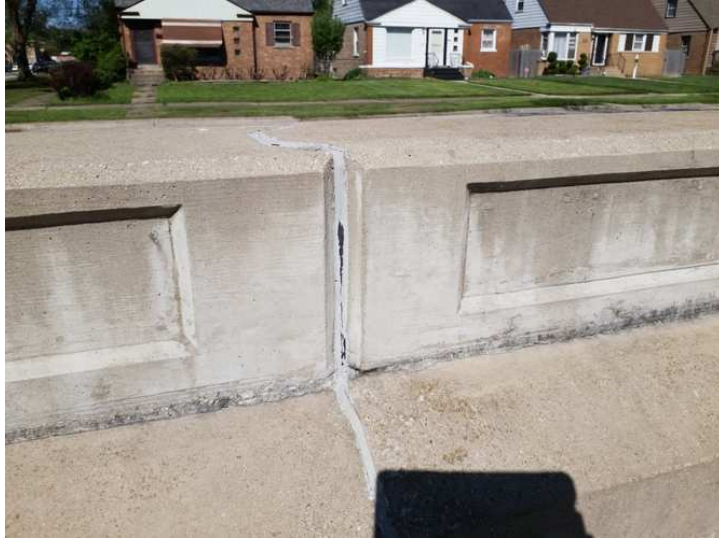
Rated Item	Rating	Rating Guidelines		Observation Locations with Descriptions and Resulting Item Rating Justification
7. Monolith Joints	M	A	The joint material is in good condition. The exterior joint sealant is intact and cracking/ desiccation is minimal. Joint filler material and/or waterstop is not visible at any point.	2024-0002 : Typical example of joint sealant shrinking while drying on the landside of the floodwall(M)
		M	The joint material has appreciable deterioration to the point where joint filler material and/or waterstop is visible in some locations. This needs to be repaired or replaced to prevent spalling and cracking during freeze/ thaw cycles, and to ensure water tightness of the joint.	2024-0014 : Typical example of the backer rod exposed at the top of the floodwall through the sealant(M)
		U	The joint material is severely deteriorated or the concrete adjacent to the monolith joints has spalled and cracked, damaging the waterstop; in either case damage has occurred to the point where it is apparent that the joint is no longer watertight and will not provide the intended level of protection during a flood.	2024-0019 : Cracked sealant on the landside of the floodwall(M) 2024-0022 : Typical exposed backer rod on the landside of the floodwall(M)

Inspect ID: 2024-0022
Feature Details: Floodwalls - Monolith Joints - Landside
Station Start:
Station End:
Caption: Minimally Acceptable - Typical exposed backer rod on the landside of the floodwall

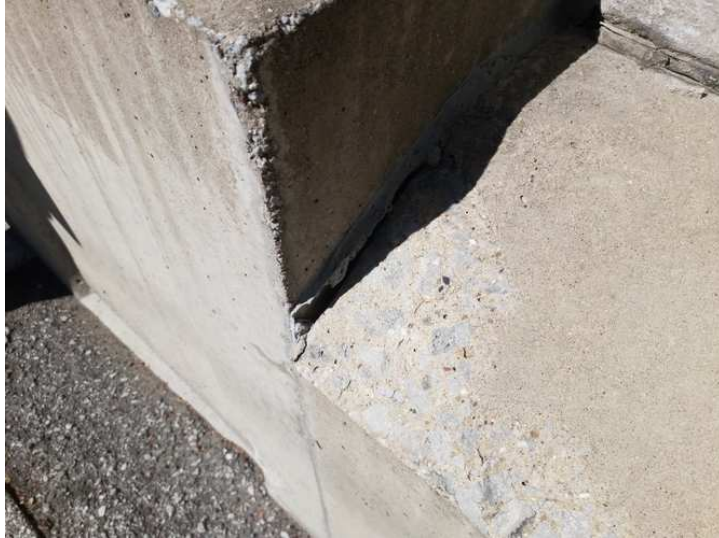
Inspect ID: 2024-0027
Feature Details: Floodwalls - Monolith Joints - Joints
Station Start:
Station End:
Caption: Minimally Acceptable - Degraded sealant on the landside of the floodwall

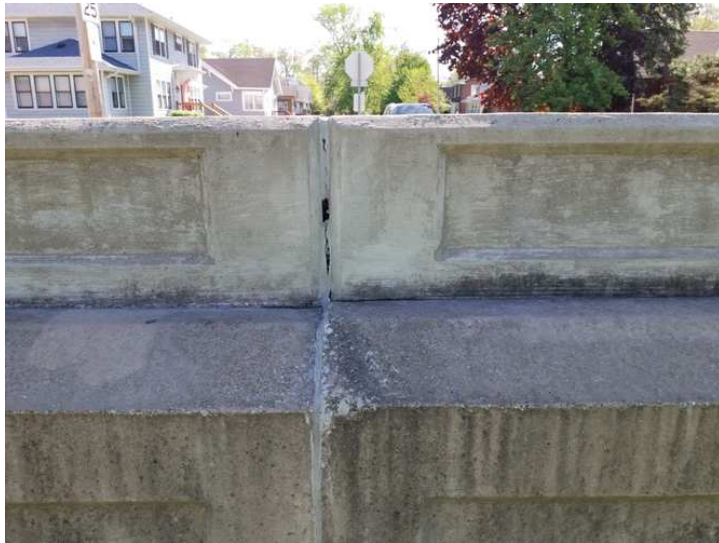
Inspect ID: 2024-0039
Feature Details: Floodwalls - Monolith Joints - Joints
Station Start:
Station End:
Caption: Minimally Acceptable - Typical sealant cracking on the riverside of the floodwall

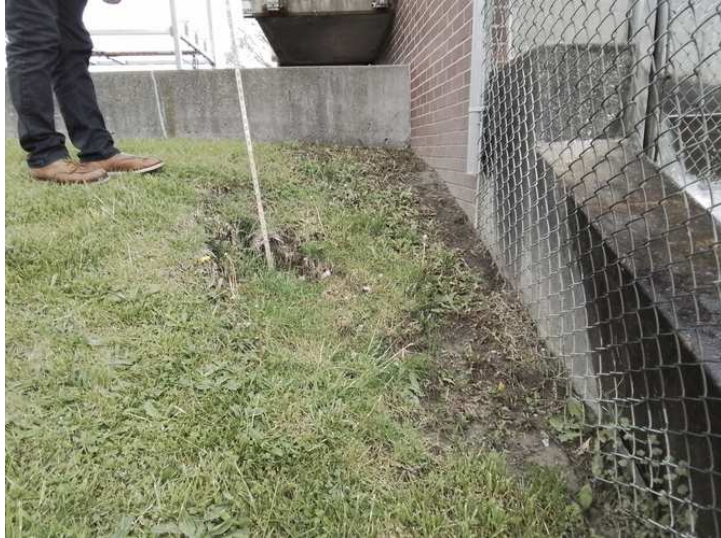
Inspect ID: 2024-0036
Feature Details: Pump Stations - Plant Building - Exterior
Station Start:
Station End:
Caption: Minimally Acceptable - PS-SH: Depression near sluiceway, approximately 4" deep - noted during last inspection.

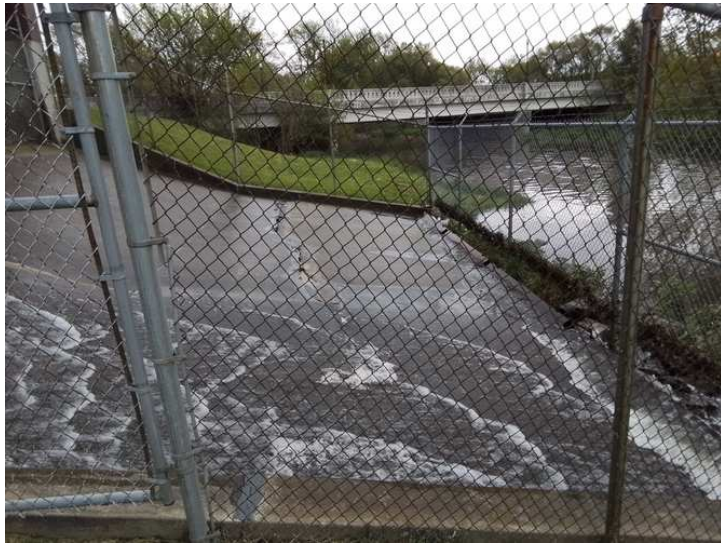
Inspect ID: 2024-0040
Feature Details: Pump Stations - Plant Building - Exterior
Station Start:
Station End:
Caption: Minimally Acceptable - PS-SH: Cracks in sluiceway. Repair attempts have been made in the past.

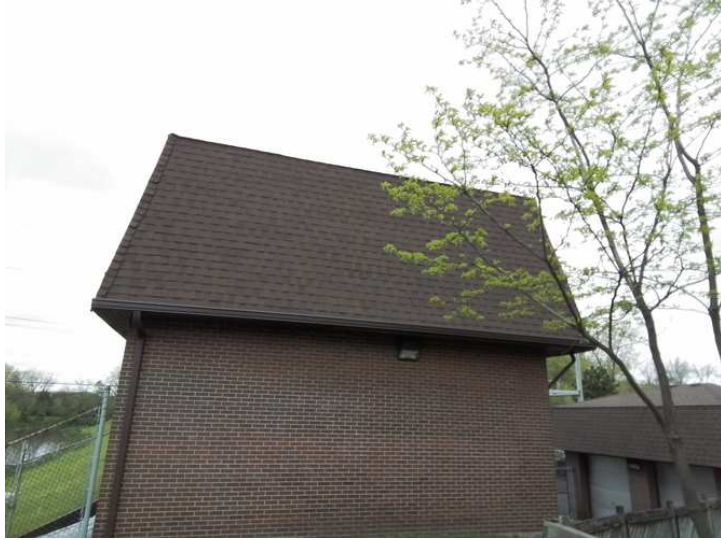
Inspect ID: 2024-0044
Feature Details: Pump Stations - Plant Building - Exterior
Station Start:
Station End:
Caption: Acceptable - PS-SH: Missing roof shingles have been replaced since the last inspection

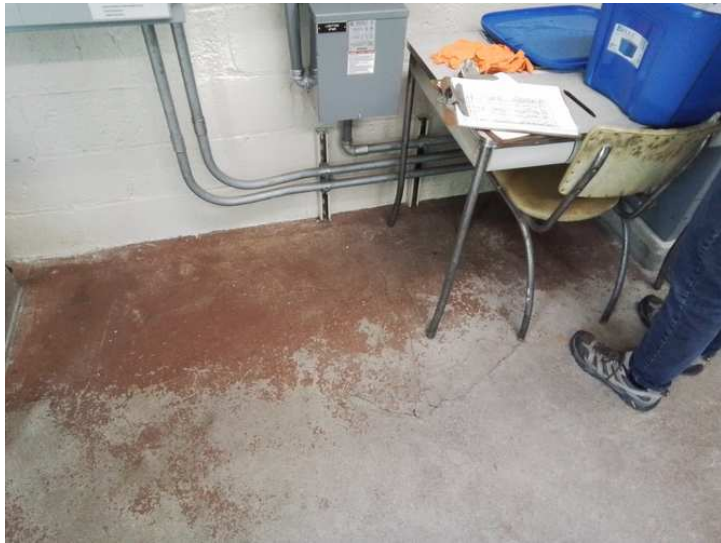
Inspect ID: 2024-0068
Feature Details: Pump Stations - Plant Building - Interior
Station Start:
Station End:
Caption: Minimally Acceptable - PS-FA: Hollow sounding floor at the location pictured / possible delamination.

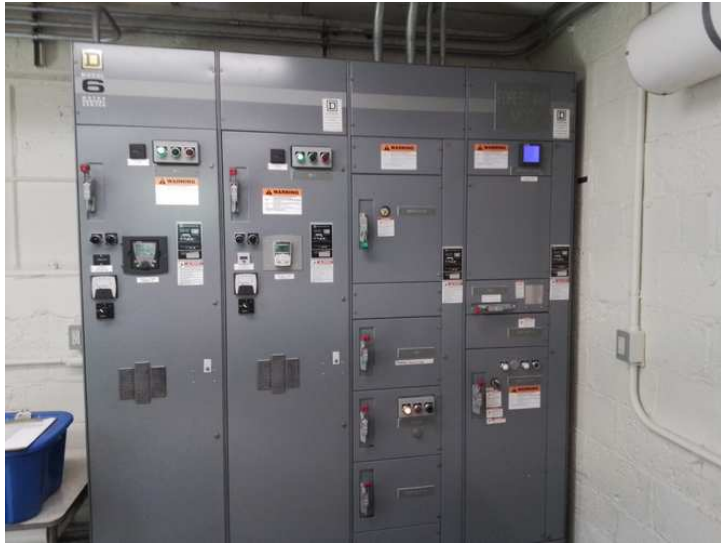
Inspect ID: 2024-0056
Feature Details: Pump Stations - Electrical Systems - Interior
Station Start:
Station End:
Caption: Minimally Acceptable - PS-FA: Outdated arc flash warning labels.
