**US Army Corps
of Engineers ®**

Site Visit Summary

Name of Segment: Gary Ironwood

NLD System ID: 2605000003 NLD Segment ID: 2604000039

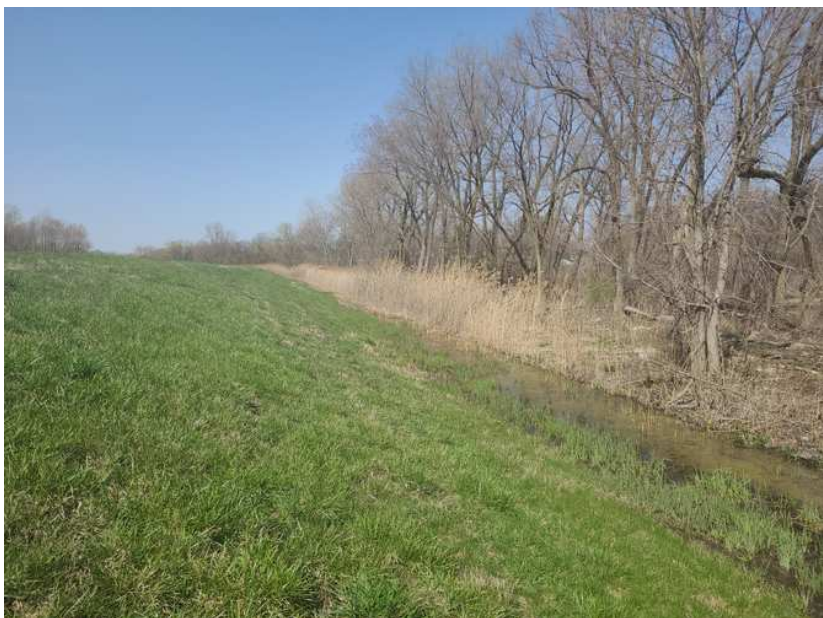
Inspect ID: 2024-0001

No User Rating (Site Visit) - Vegetation along landside toe

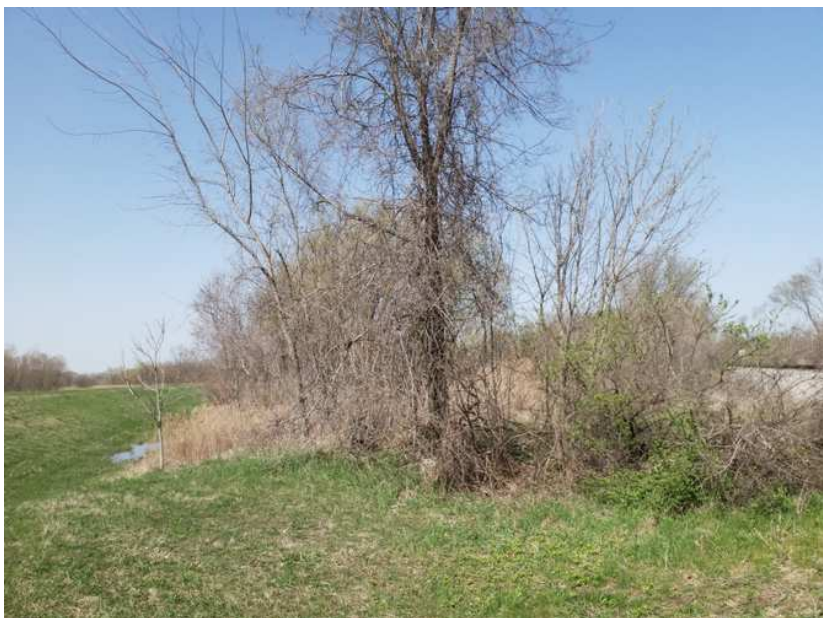
Inspect ID: 2024-0003

No User Rating (Site Visit) - Trees on the landside berm

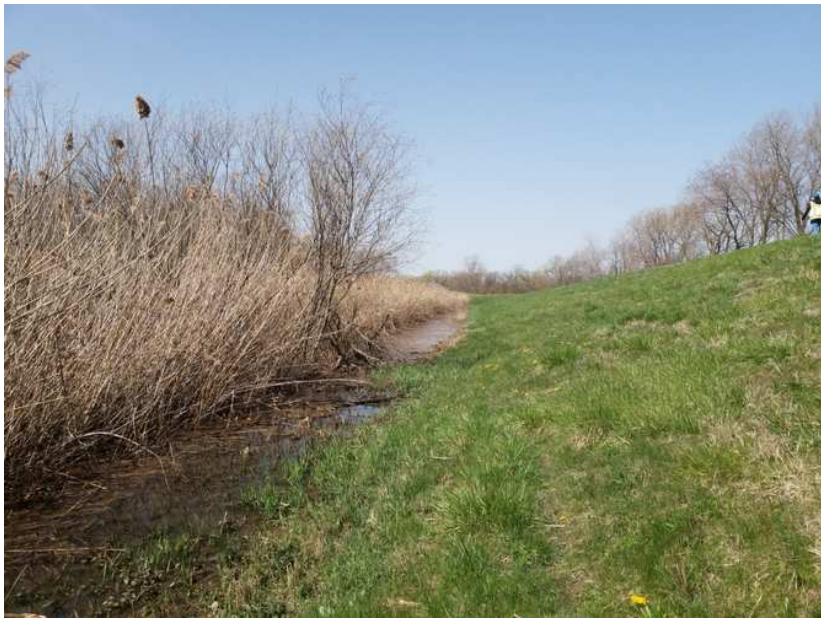
Inspect ID: 2024-0007

No User Rating (Site Visit) - Tree and vegetation on riverside toe

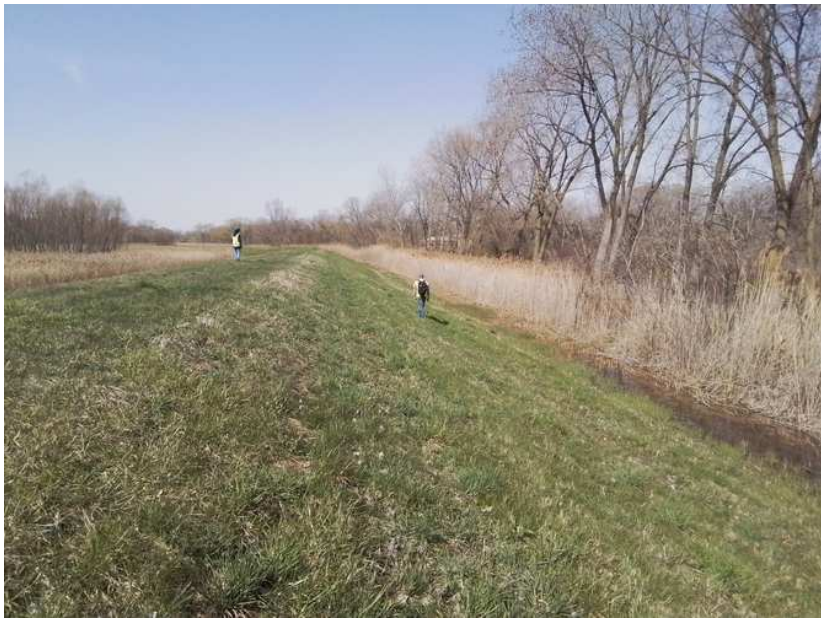
Inspect ID: 2024-0008

No User Rating (Site Visit) - Vegetation close to landside toe

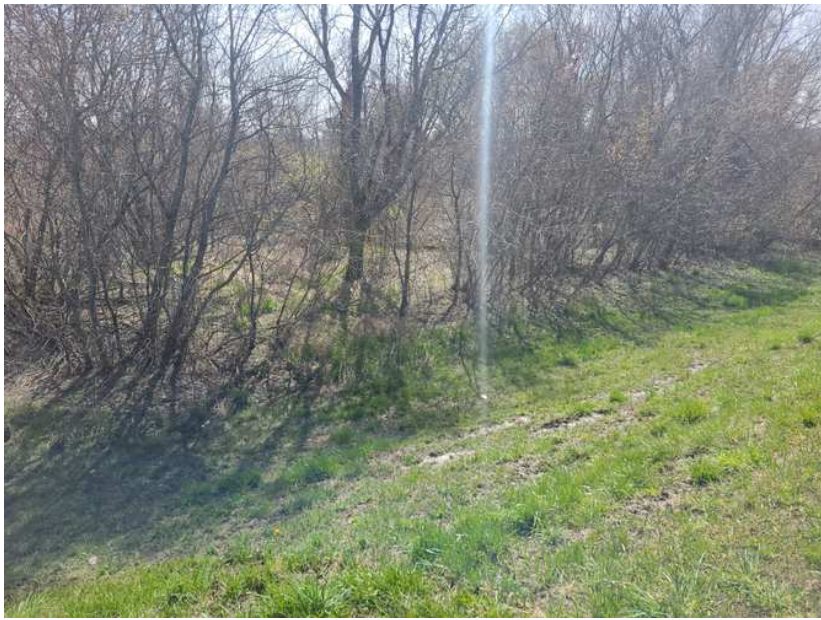
Inspect ID: 2024-0017

No User Rating (Site Visit) - Vegetation encroaching on riverside toe

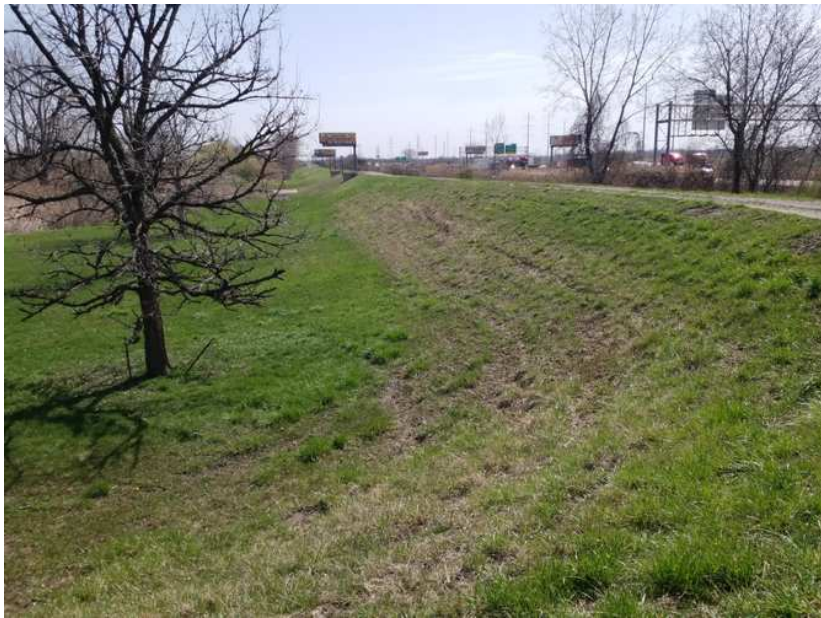
Inspect ID: 2024-0019

No User Rating (Site Visit) - Tree within the vegetation free zone on the riverside toe

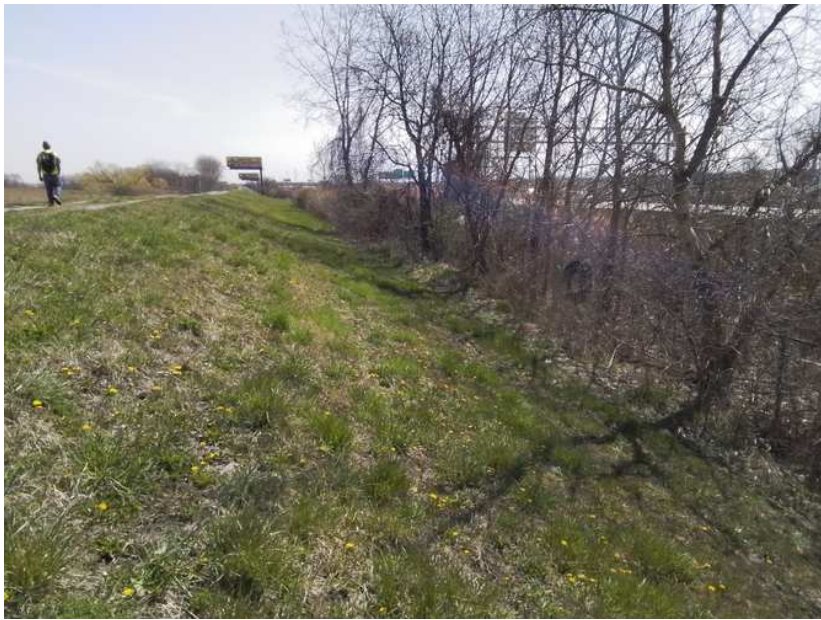
Inspect ID: 2024-0036

No User Rating (Site Visit) - Vegetation along landside toe against the fence barrier

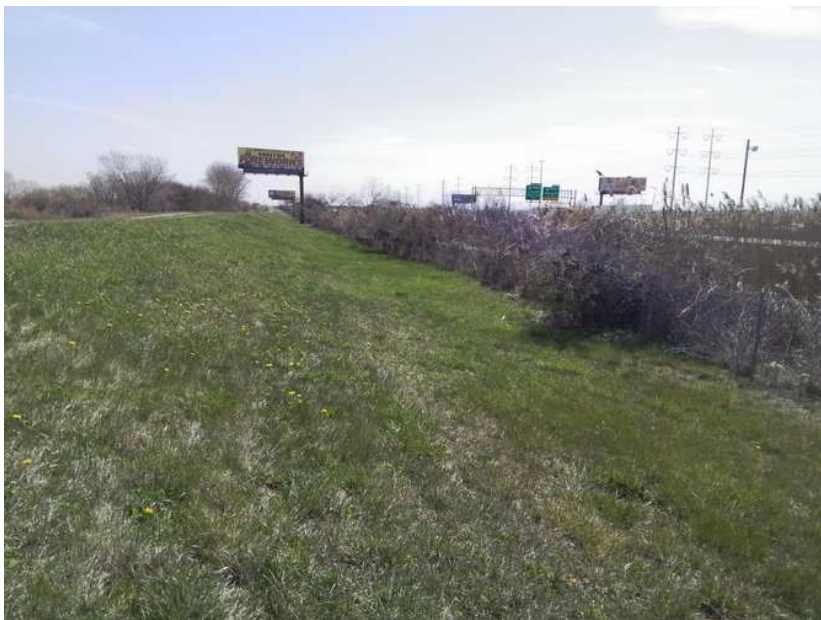
Inspect ID: 2024-0040

No User Rating (Site Visit) - Vegetation along landside toe against the fence barrier

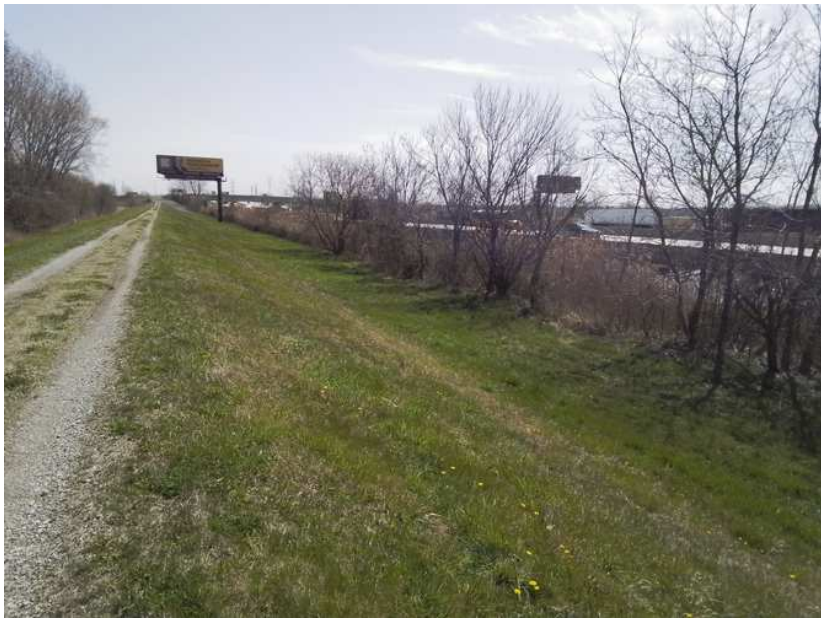
Inspect ID: 2024-0044

No User Rating (Site Visit) - Tree growth along landside toe against the fence barrier

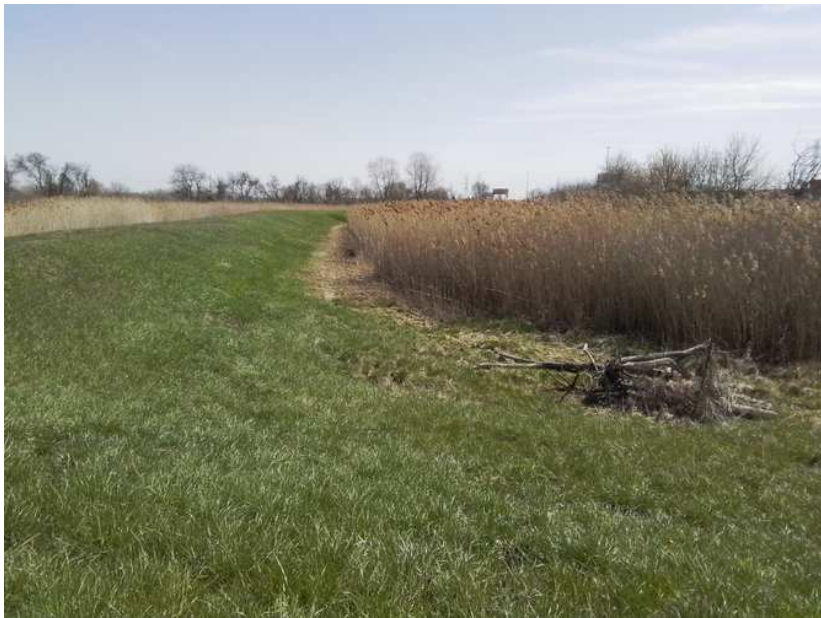
Inspect ID: 2024-0056

No User Rating (Site Visit) - Tree on landside toe

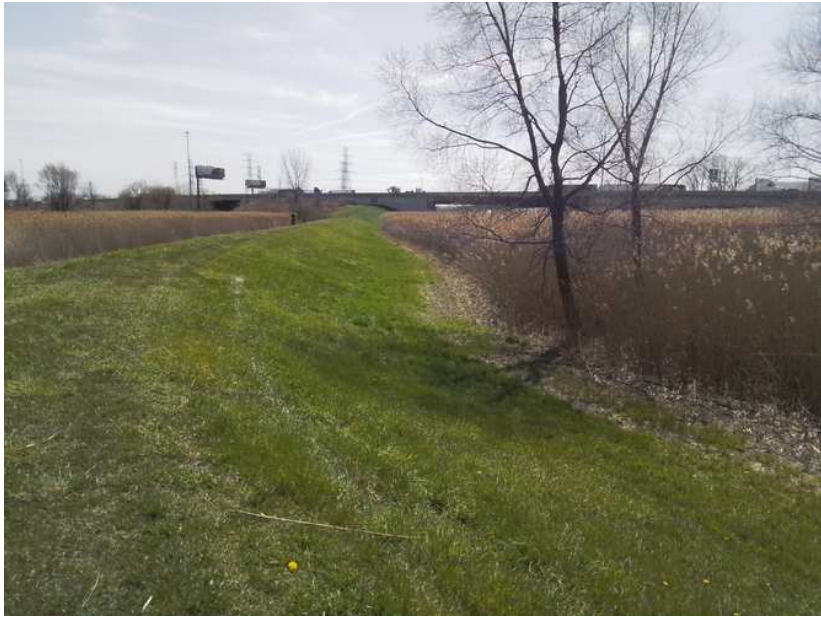
Inspect ID: 2024-0068

No User Rating (Site Visit) - Tree on riverside toe

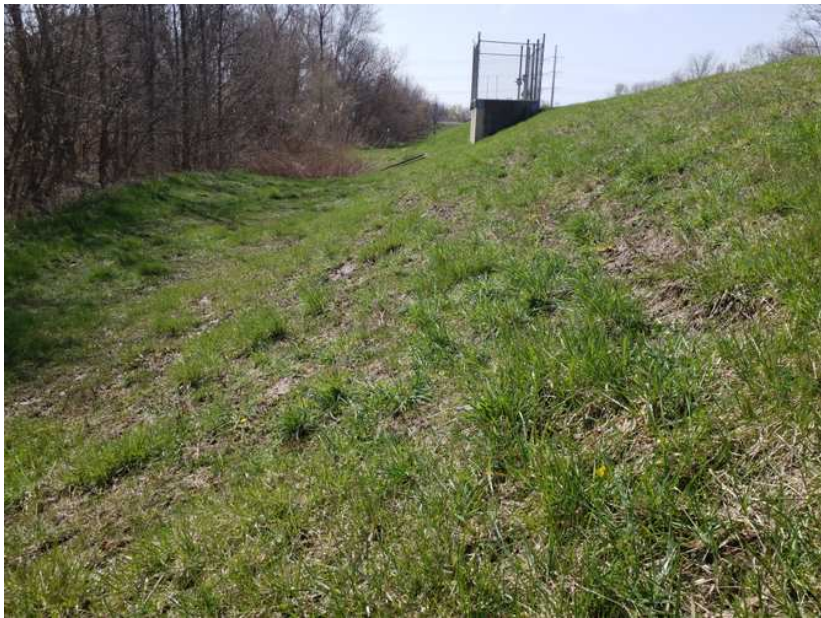
Inspect ID: 2024-0015

No User Rating (Site Visit) - Poor sod cover on riverside slope

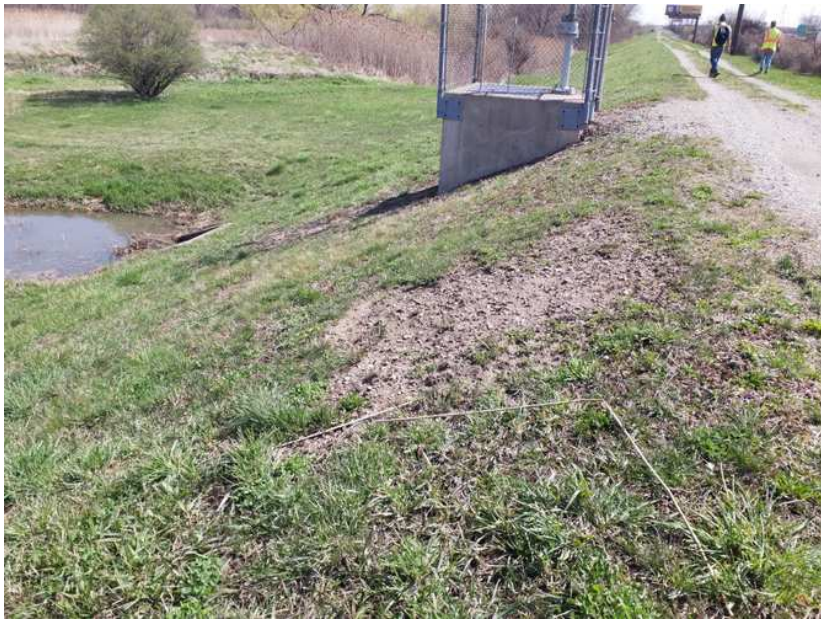
Inspect ID: 2024-0027

No User Rating (Site Visit) - Poor sod cover on riverside slope

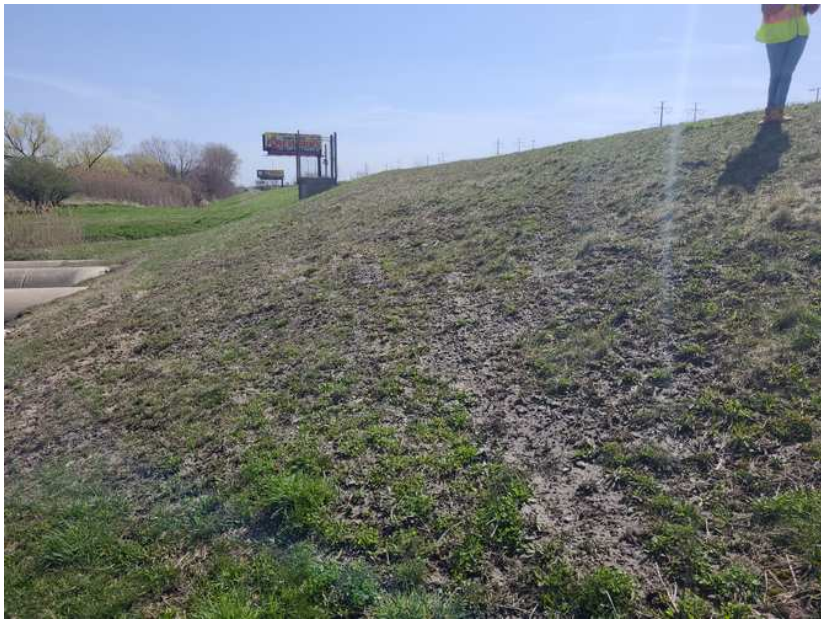
Inspect ID: 2024-0029

No User Rating (Site Visit) - Poor sod cover on riverside slope

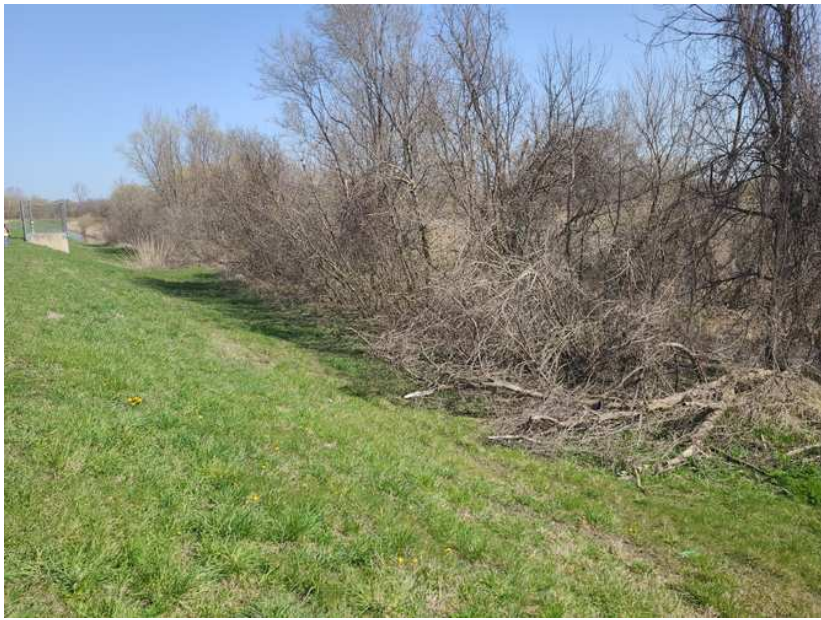
Inspect ID: 2024-0021

No User Rating (Site Visit) - Downed tree on riverside toe

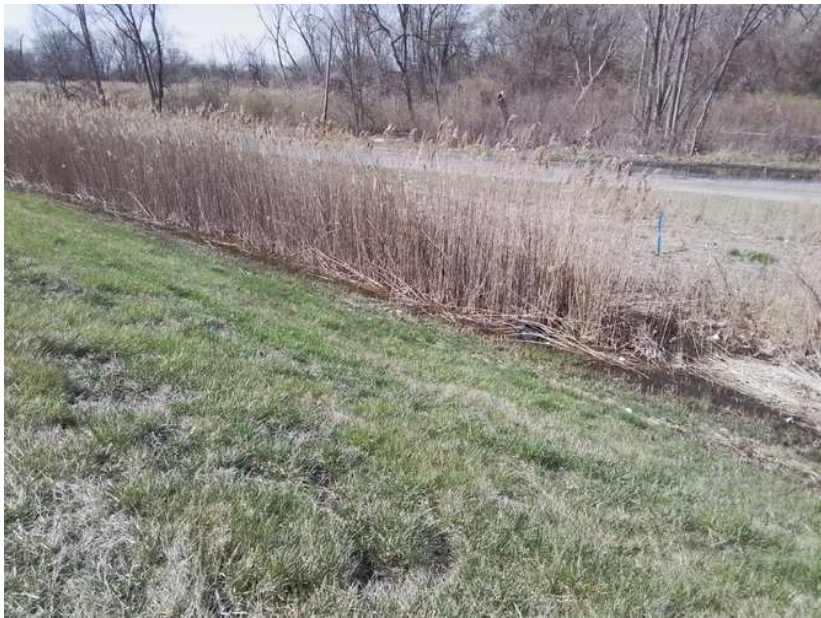
Inspect ID: 2024-0024

No User Rating (Site Visit) - Tire on landside toe

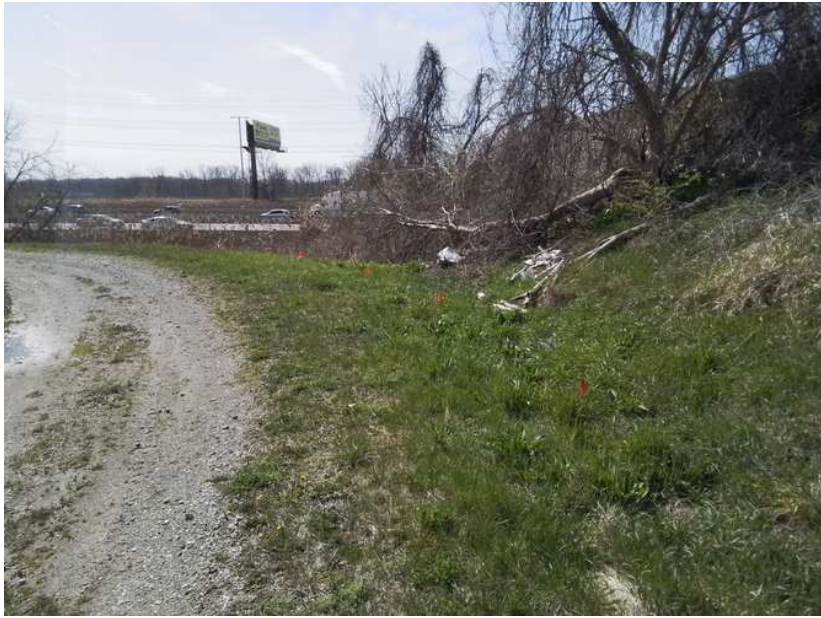
Inspect ID: 2024-0032

No User Rating (Site Visit) - Debris and tree branches along landside slope

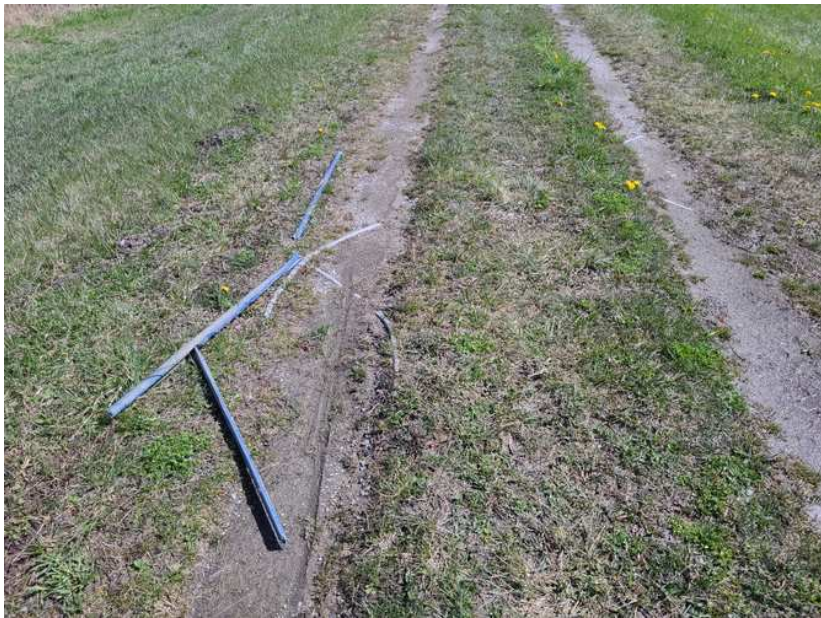
Inspect ID: 2024-0041

No User Rating (Site Visit) - Debris on crown

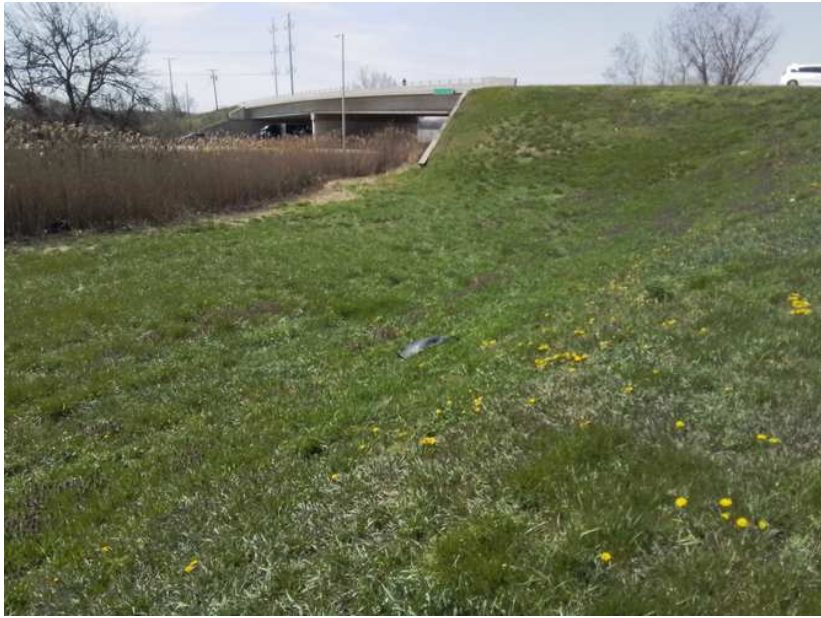
Inspect ID: 2024-0048

No User Rating (Site Visit) - Debris encroaching on riverside slope

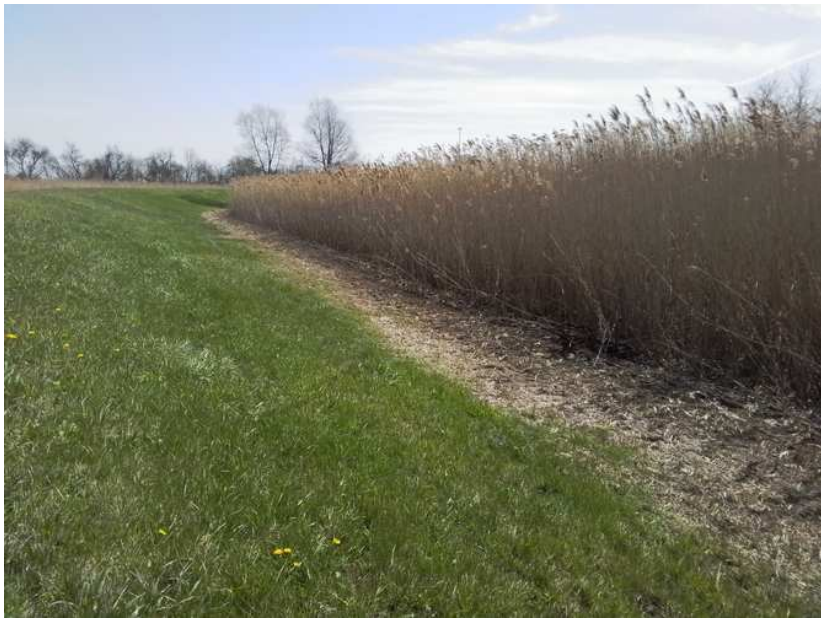
Inspect ID: 2024-0060

No User Rating (Site Visit) - Metal debris encroaching on riverside toe

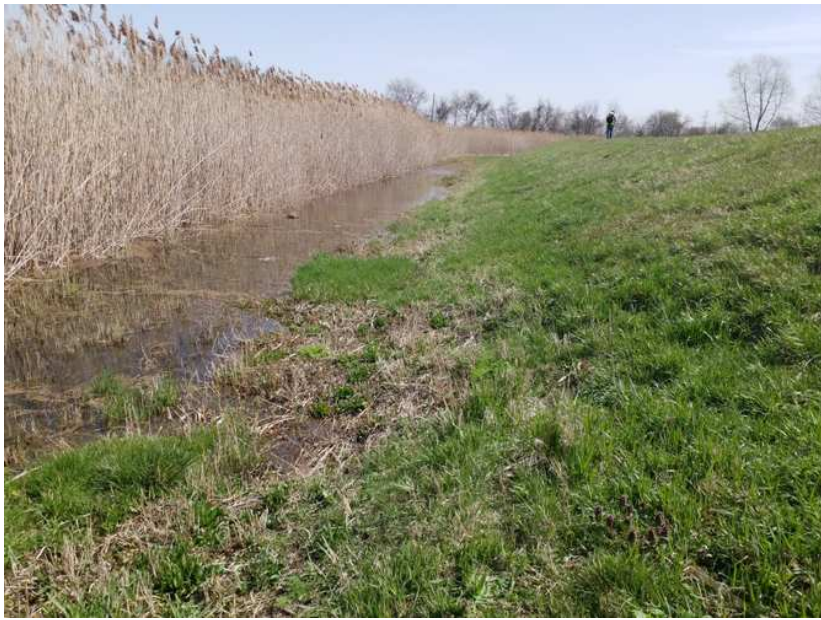
Inspect ID: 2024-0035

No User Rating (Site Visit) - Settlement of riverside toe and slope - likely due to collapsed animal burrows

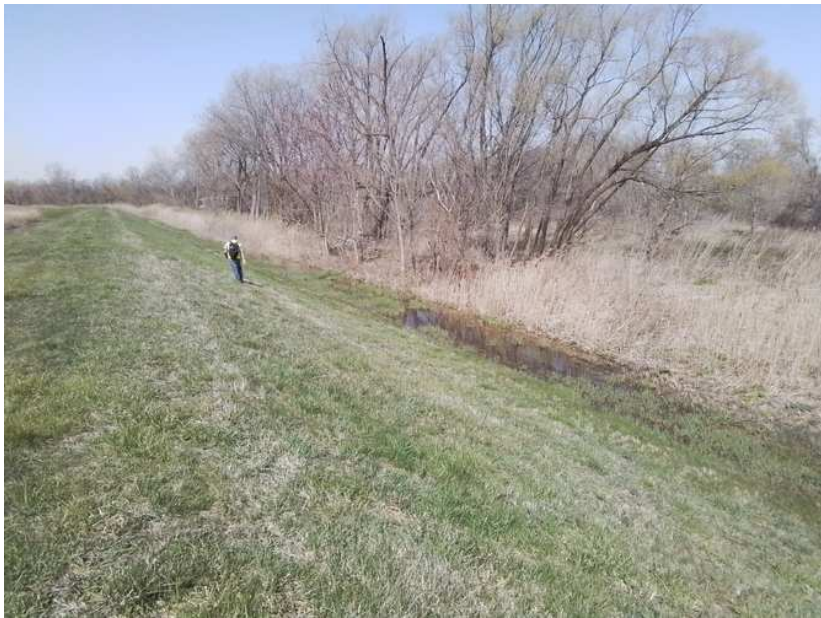
Inspect ID: 2024-0004

No User Rating (Site Visit) - Ponding along landside toe

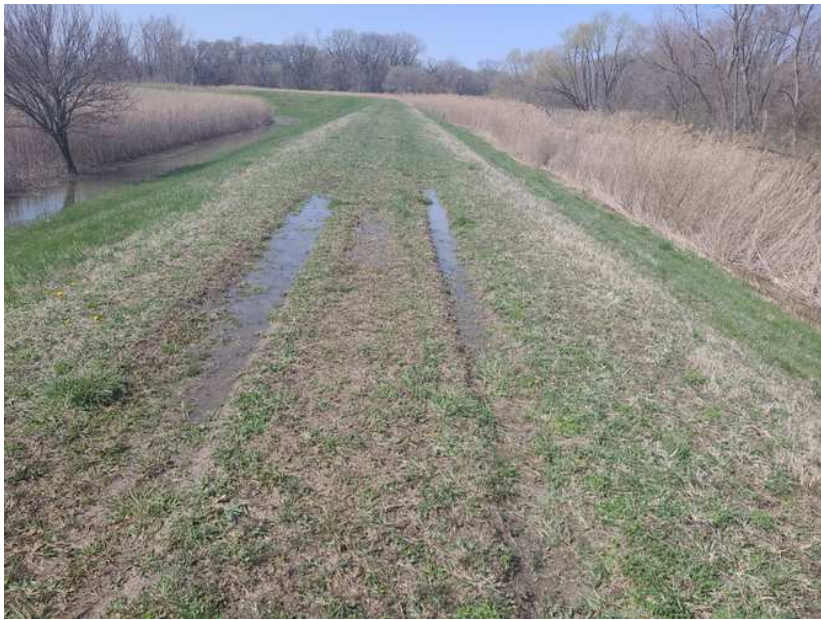
Inspect ID: 2024-0009

No User Rating (Site Visit) - Depression and rutting in crown

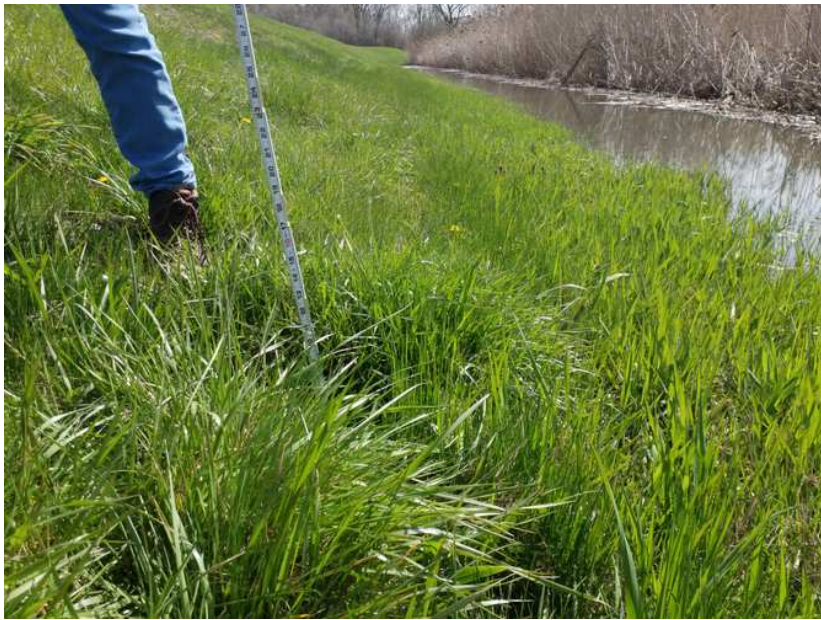
Inspect ID: 2024-0011

No User Rating (Site Visit) - Five-inch deep depression on riverside toe and slope - likely from erosion

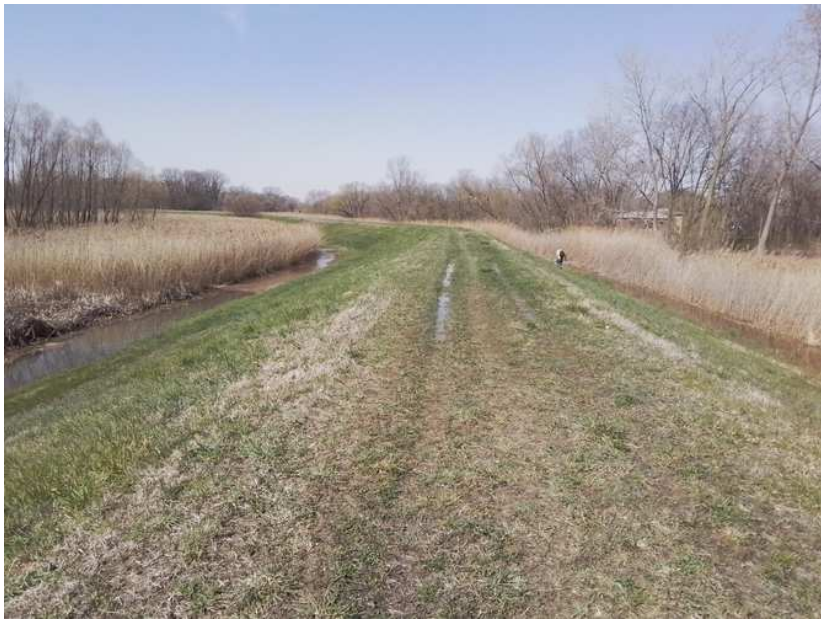
Inspect ID: 2024-0012

No User Rating (Site Visit) - Rutting and ponded water along the levee crown

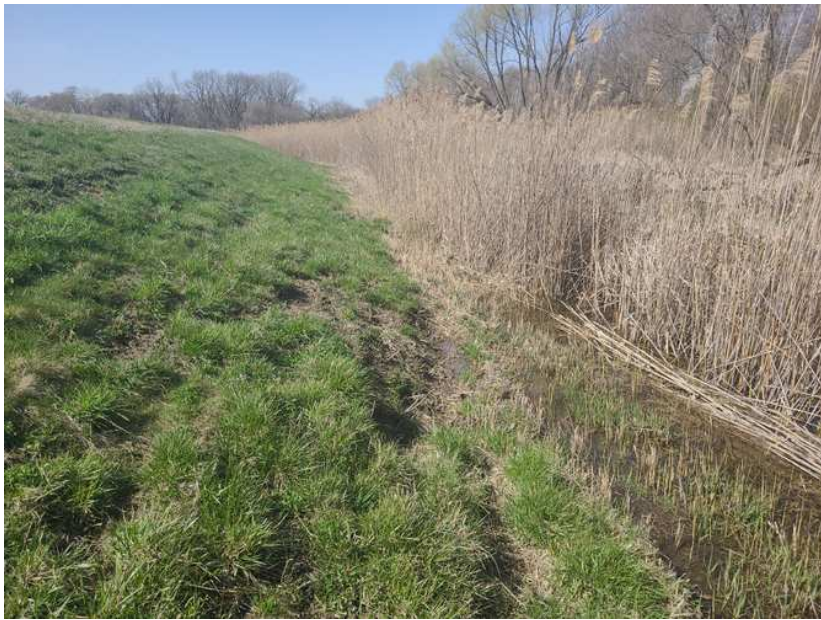
Inspect ID: 2024-0013

No User Rating (Site Visit) - Rutting along landside toe

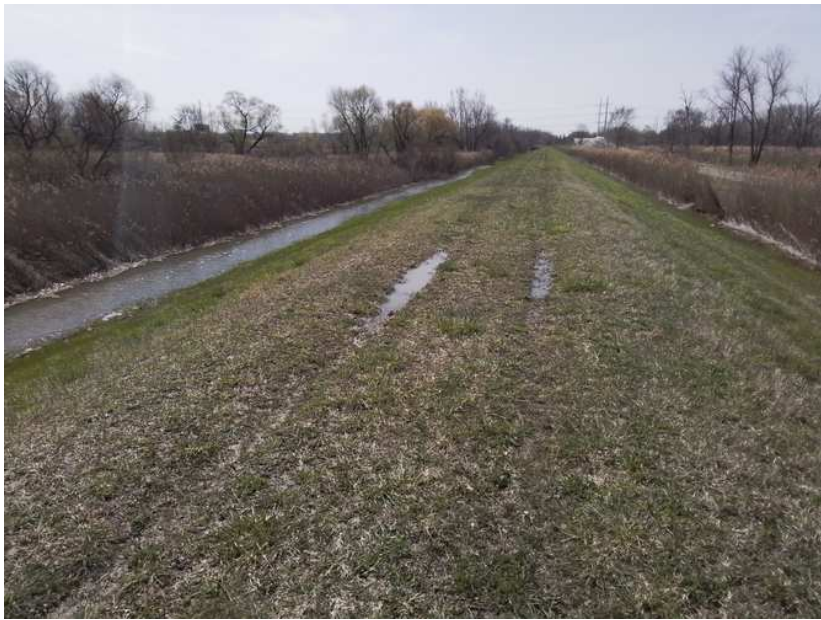
Inspect ID: 2024-0020

No User Rating (Site Visit) - Ponding and rutting along levee crown

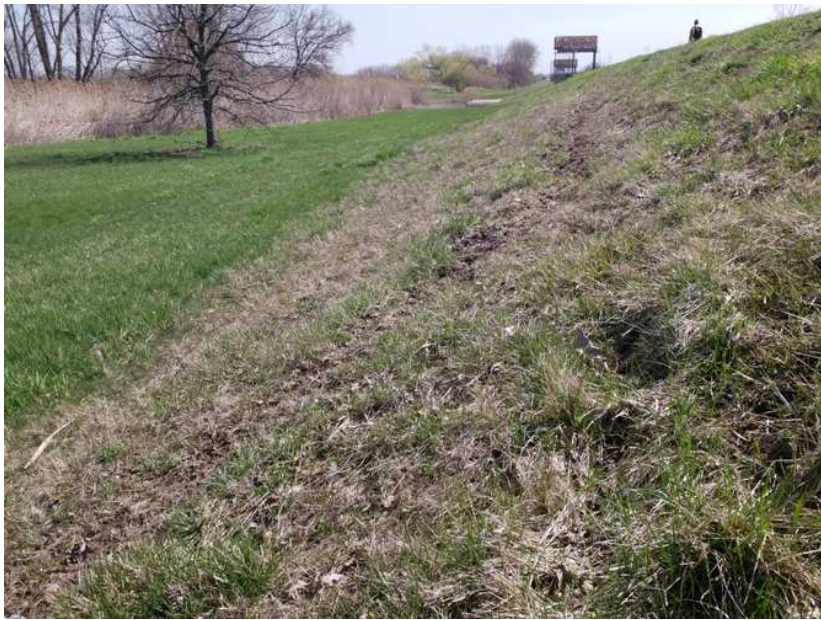
Inspect ID: 2024-0023

No User Rating (Site Visit) - Rutting from vehicle tires along riverside slope

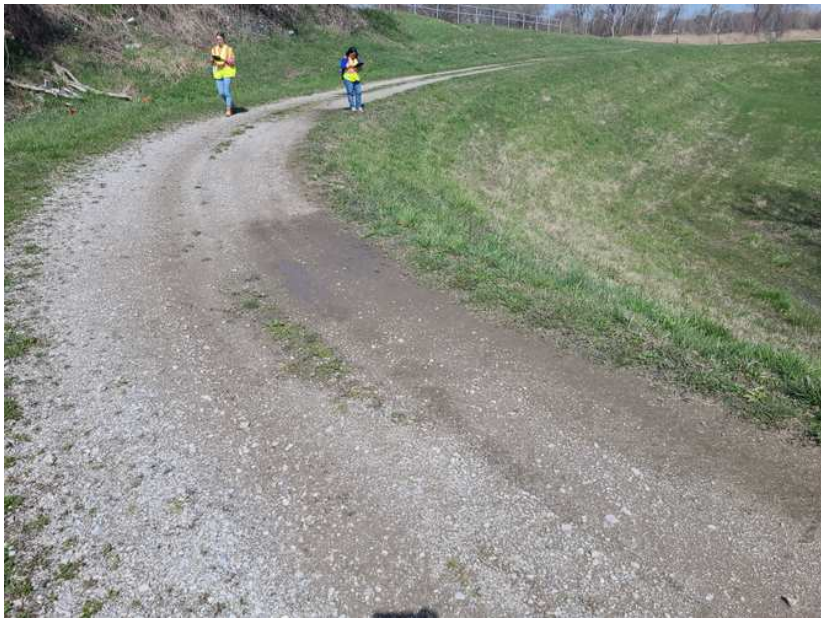
Inspect ID: 2024-0025

No User Rating (Site Visit) - Minor depression in crown

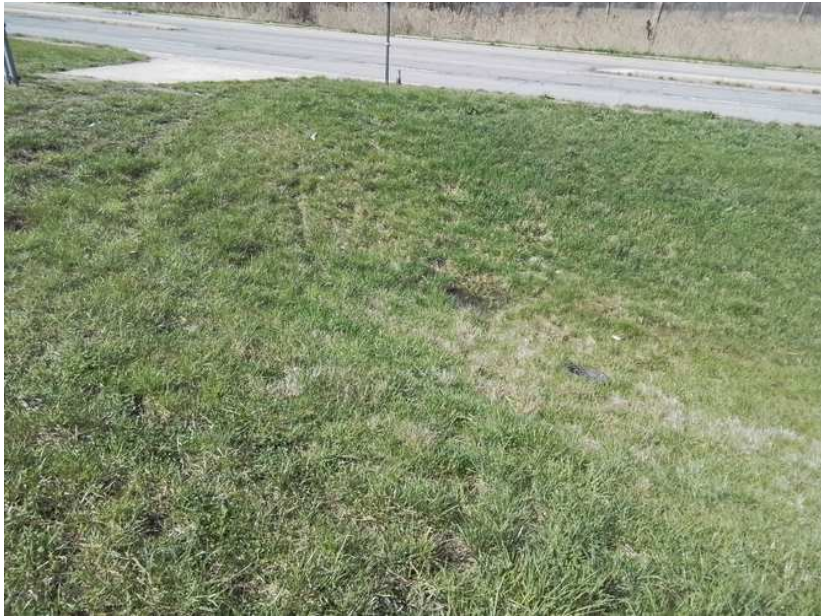
Inspect ID: 2024-0028

No User Rating (Site Visit) - Ponding/depression at culvert inlet along landside toe

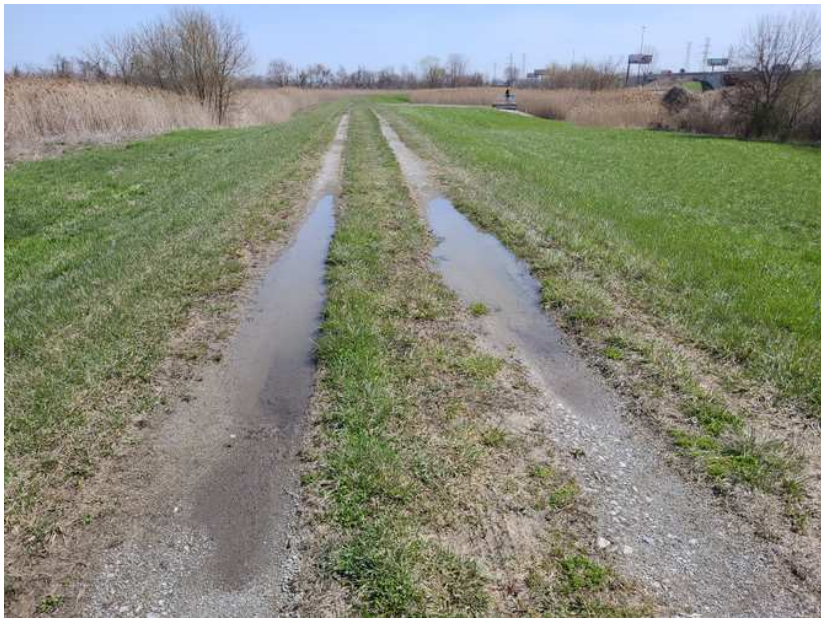
Inspect ID: 2024-0037

No User Rating (Site Visit) - Moderate rutting and depressions with ponding in crown

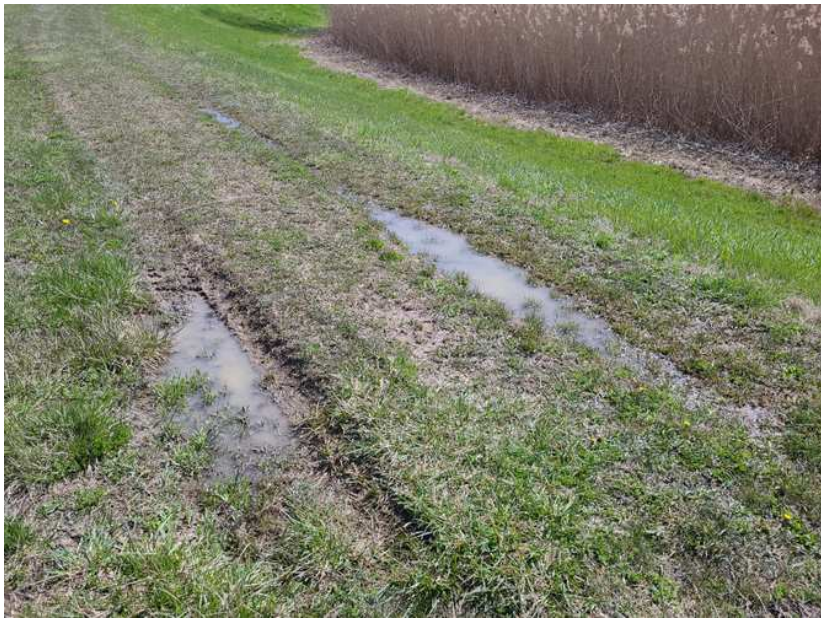
Inspect ID: 2024-0049

No User Rating (Site Visit) - Rutting and ponding in crown

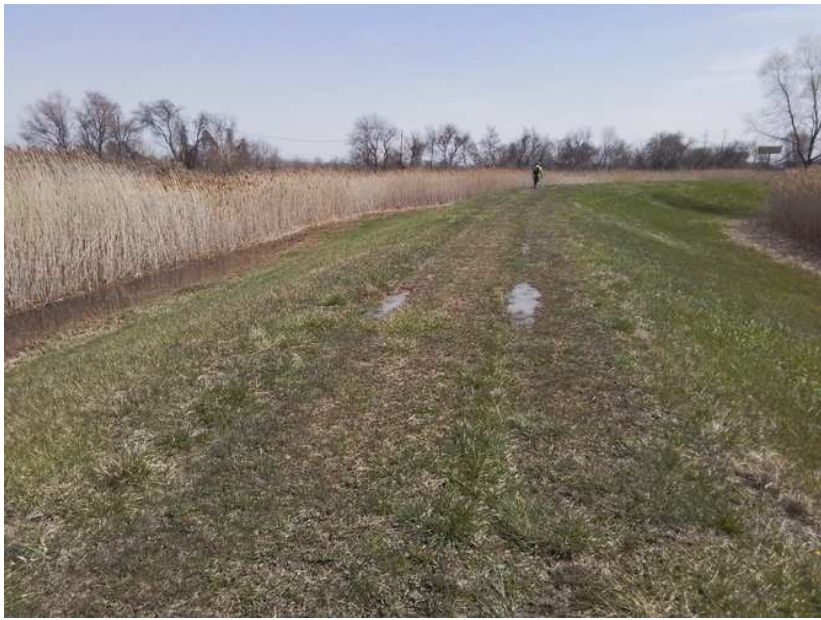
Inspect ID: 2024-0064

No User Rating (Site Visit) - Rutting and ponding along levee crown

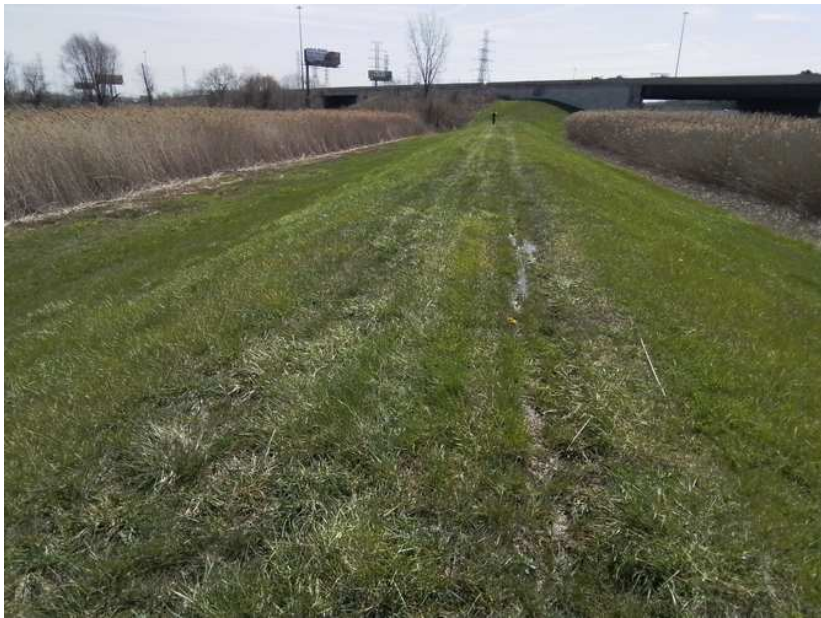
Inspect ID: 2024-0072

No User Rating (Site Visit) - Rutting and ponding along levee crown

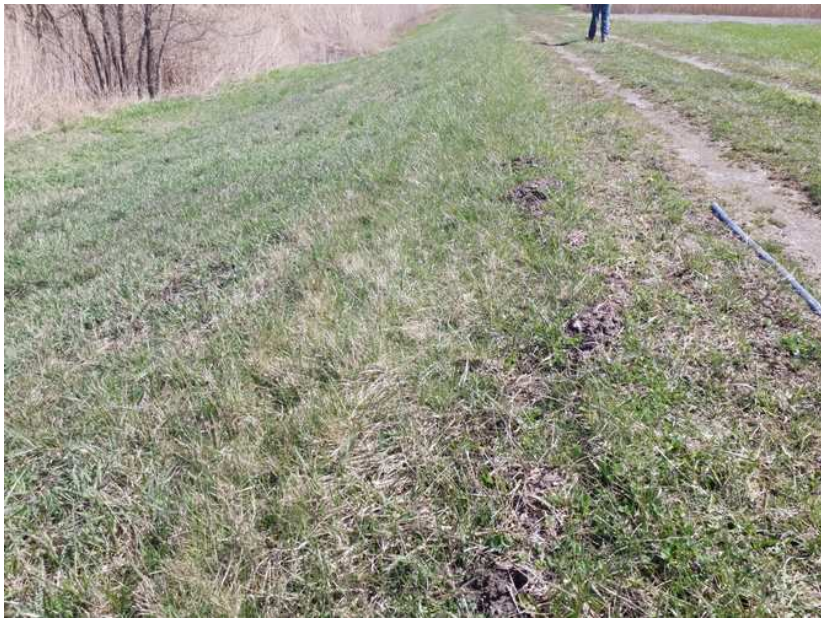
Inspect ID: 2024-0031

No User Rating (Site Visit) - Animal burrows along riverside slope (typical)

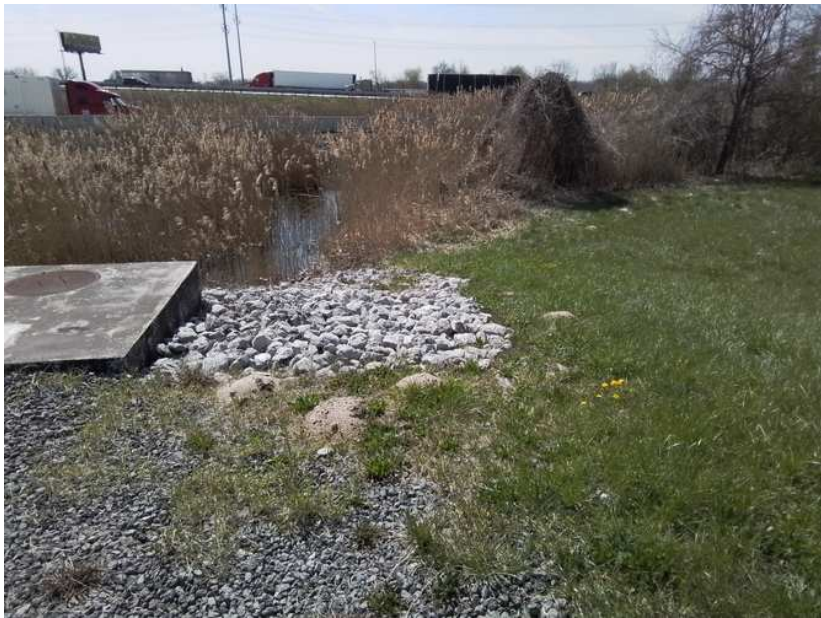
Inspect ID: 2024-0052

No User Rating (Site Visit) - Animal burrow activity along landside toe and slope

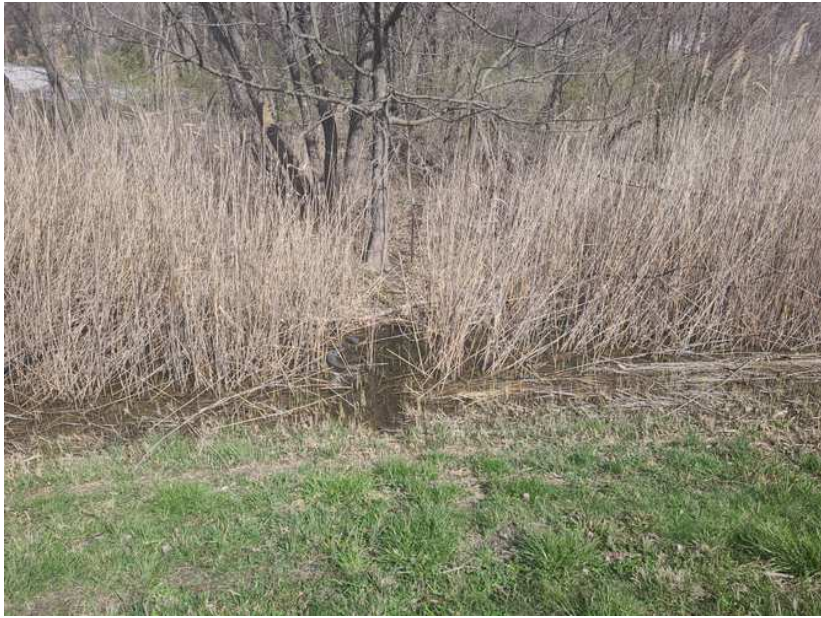
Inspect ID: 2024-0005

No User Rating (Site Visit) - Tires in landside ditch

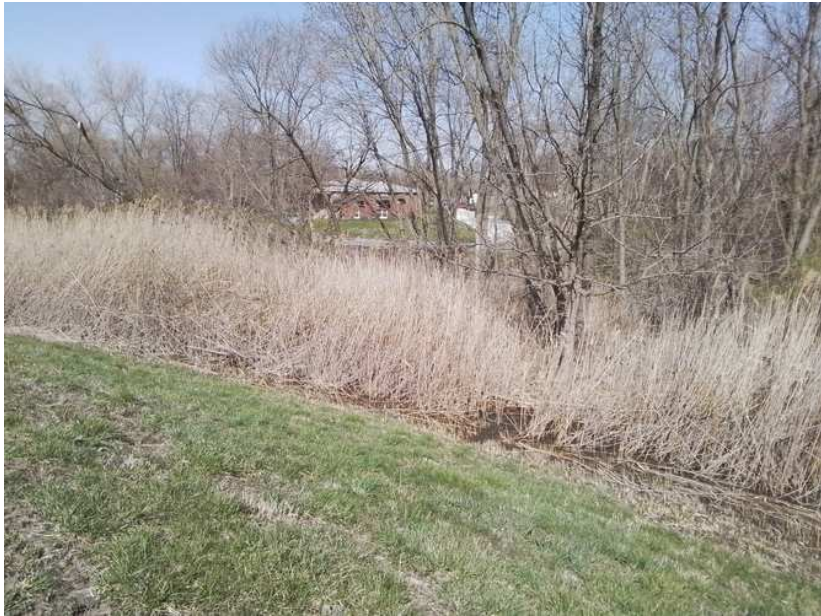
Inspect ID: 2024-0016

No User Rating (Site Visit) - Trees and tires in landside ditch

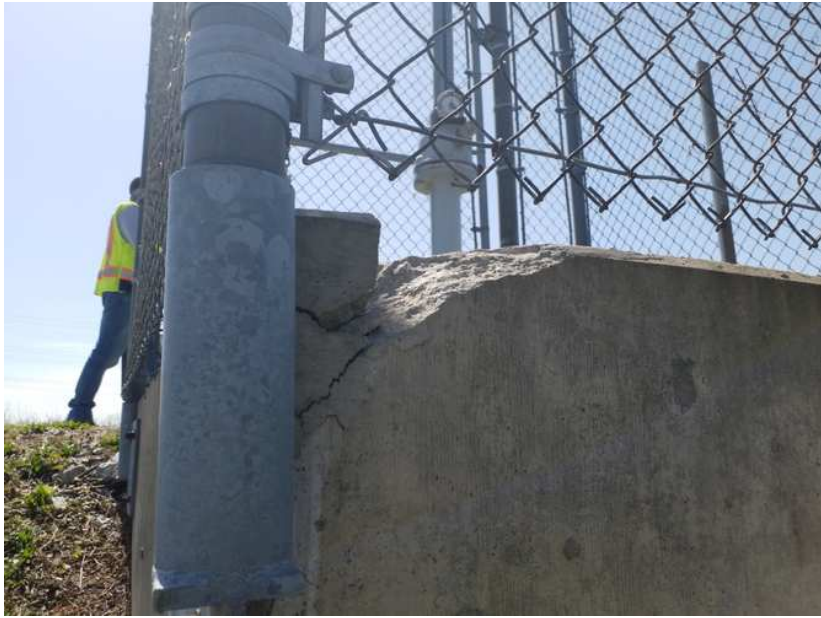
Inspect ID: 2024-0006

No User Rating (Site Visit) - IW-04: Spalling on corner of inlet structure

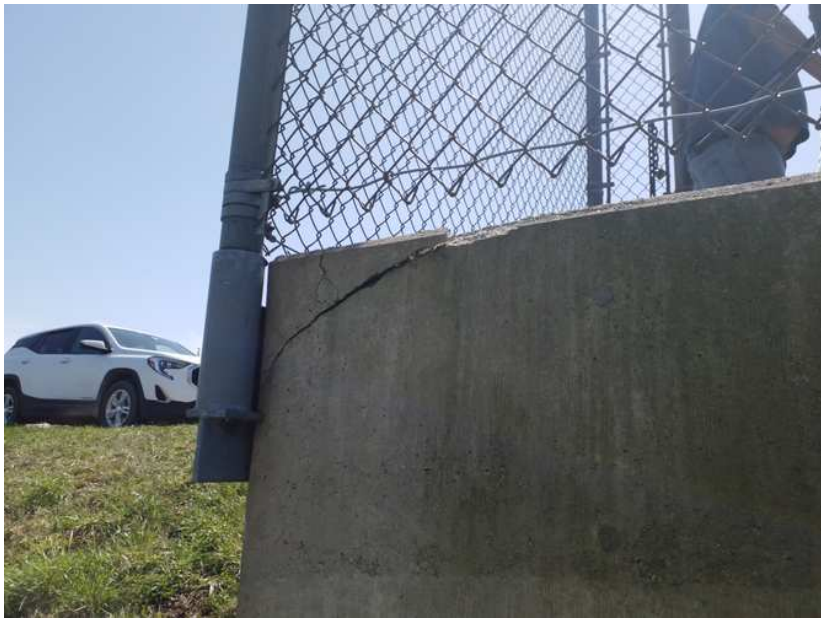
Inspect ID: 2024-0081

0081 - No User Rating (Site Visit) - IW05: Damage to concrete.

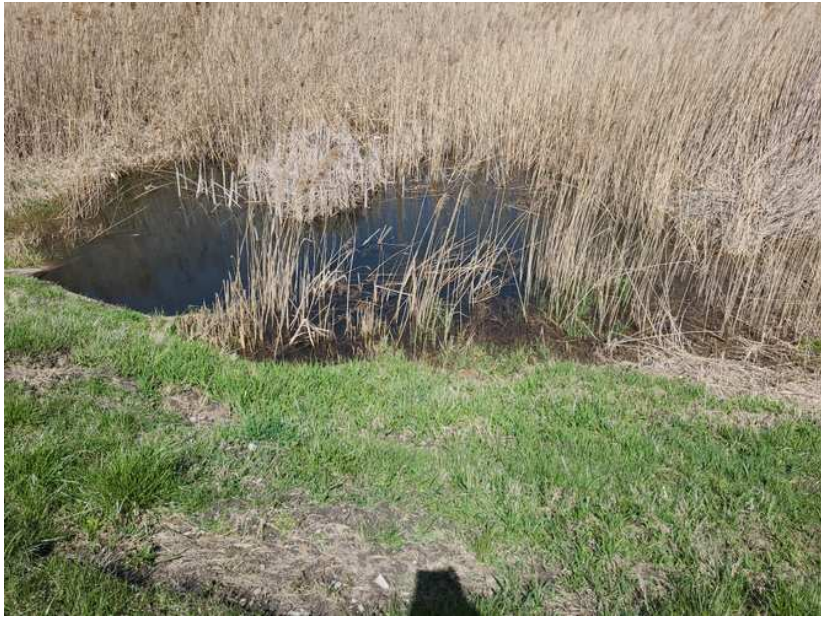
Inspect ID: 2024-0045

No User Rating (Site Visit) - IW-06: Erosion around gate wingwall

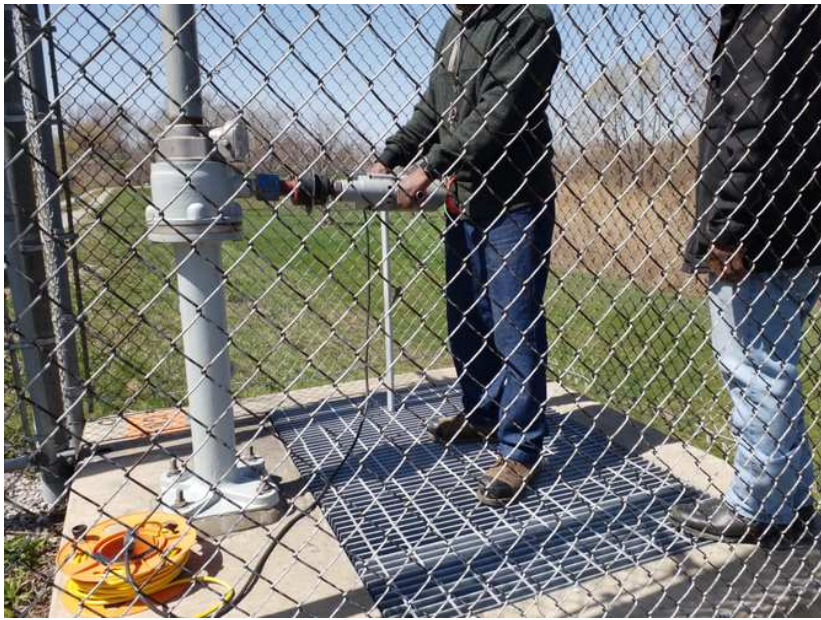
Inspect ID: 2024-0002

No User Rating (Site Visit) - IW-04: Operated successfully

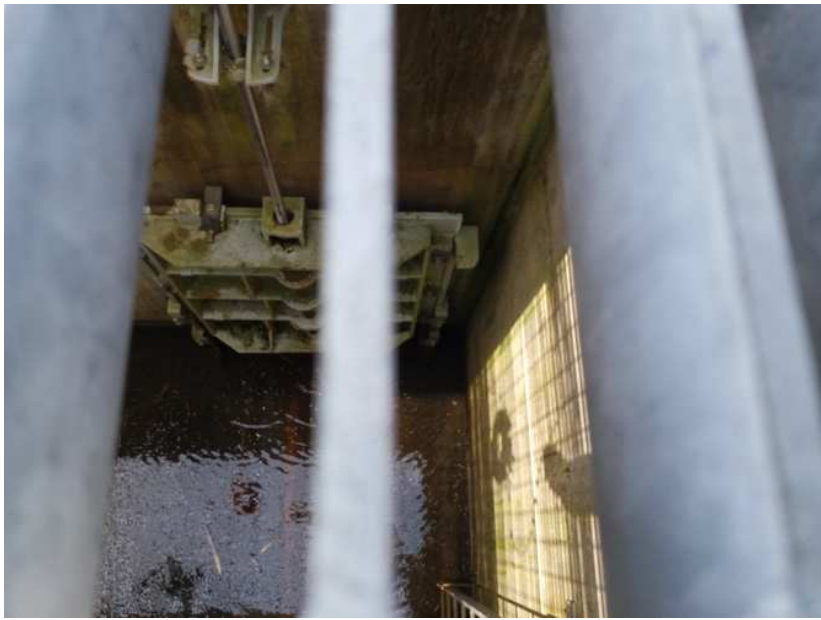
Inspect ID: 2024-0014

No User Rating (Site Visit) - IW-03: Operated successfully
