**US Army Corps
of Engineers ®**

Site Visit Summary

Name of Segment: Gary Ironwood

NLD System ID: 2605000003 NLD Segment ID: 2604000039

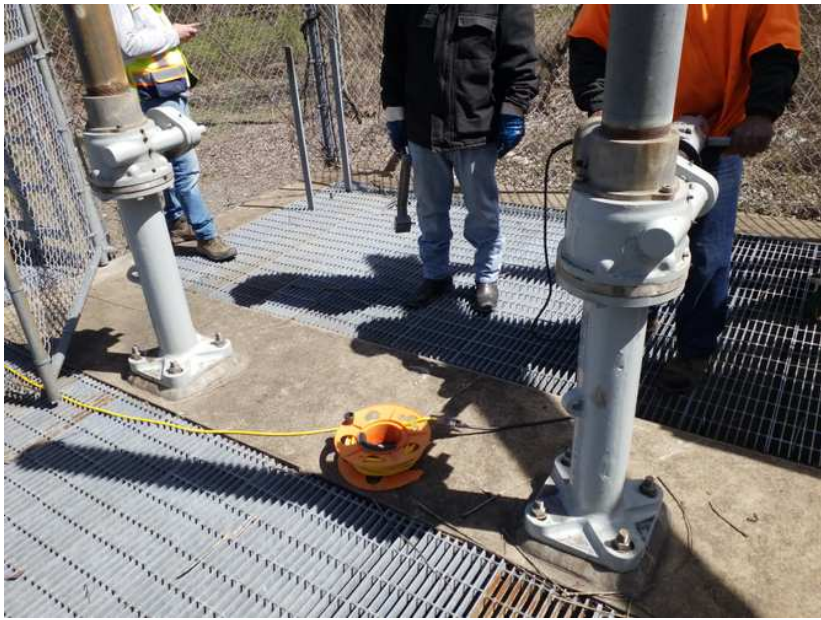
Inspect ID: 2024-0074

0074 - No User Rating (Site Visit) IW-01: operated successfully.

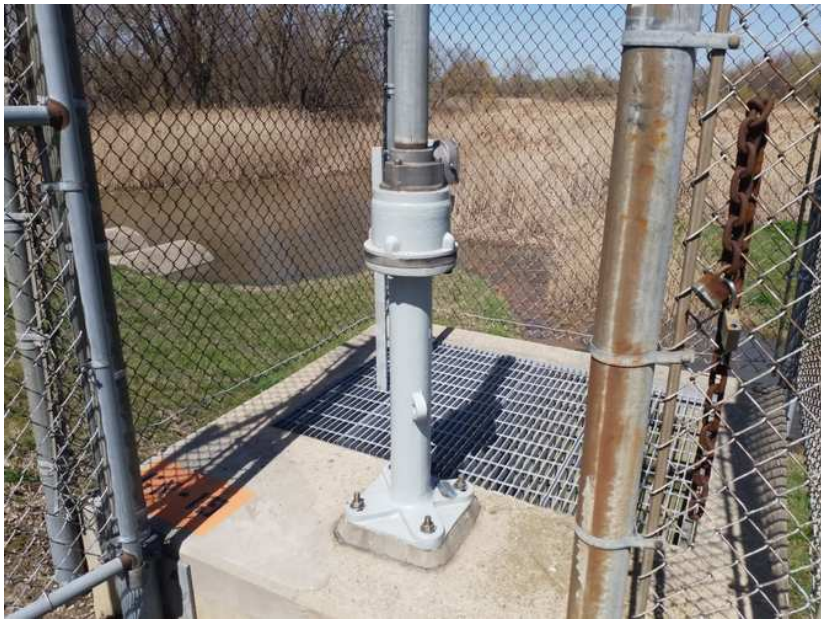
Inspect ID: 2024-0075

0075 - No User Rating (Site Visit) IW-05: operated successfully.

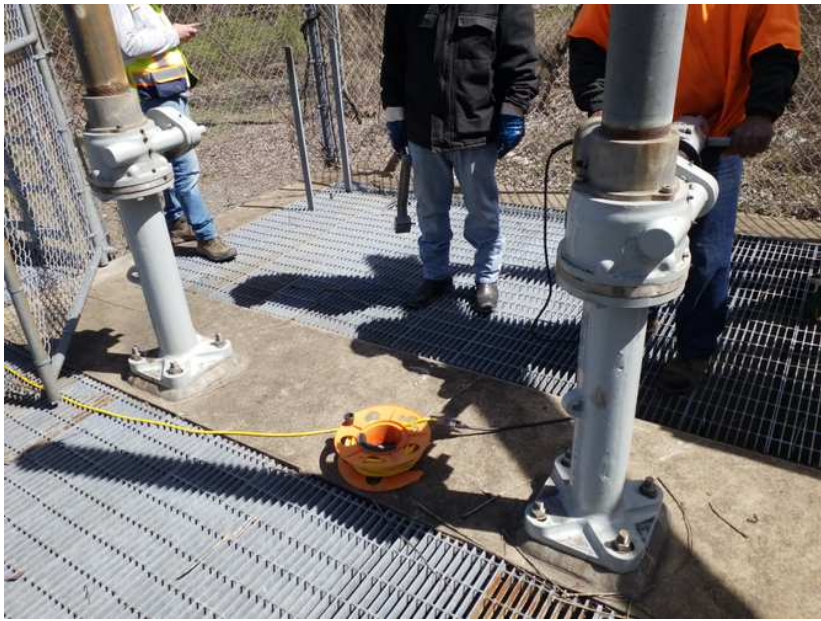
Inspect ID: 2024-0078

0078 - No User Rating (Site Visit) - IW-01: operated successfully.

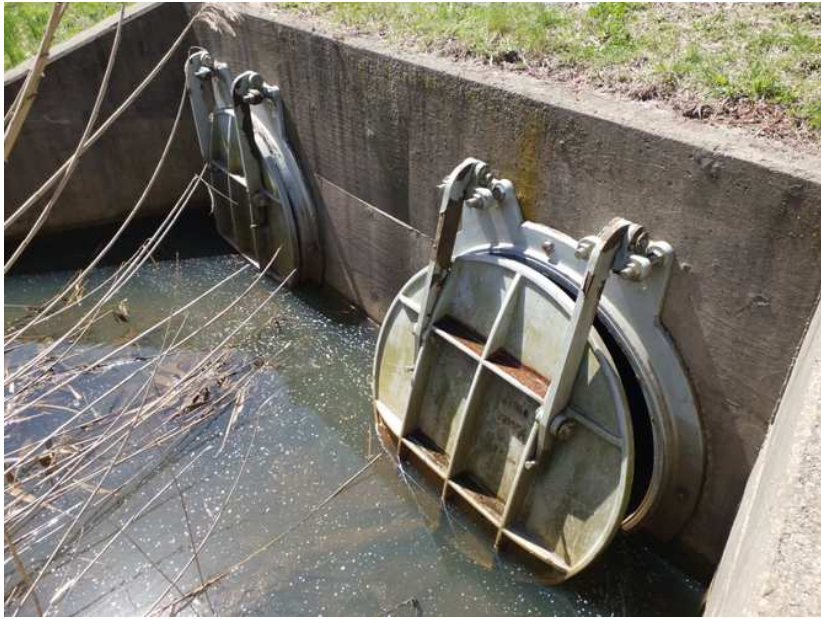
Inspect ID: 2024-0010

No User Rating (Site Visit) - IW-03: Flap gate not sealing

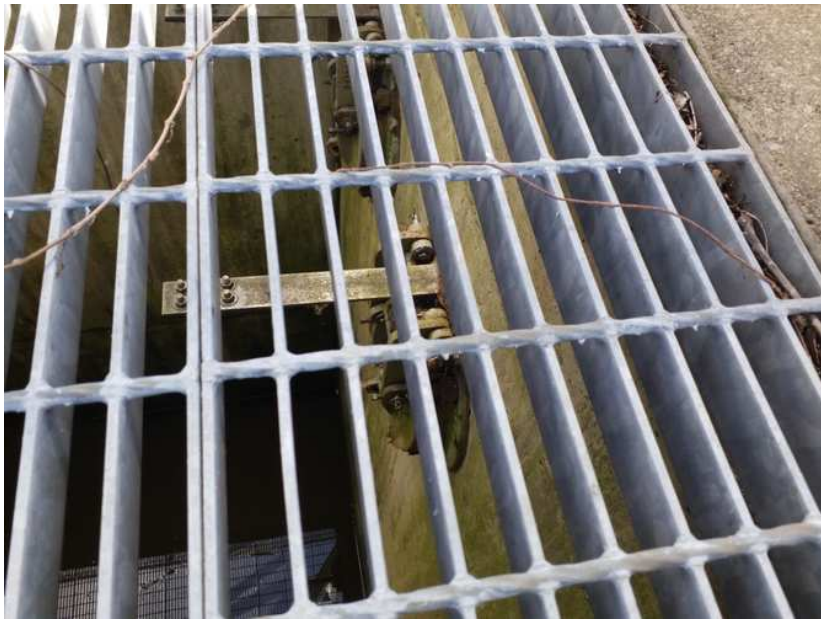
Inspect ID: 2024-0076

0076 - No User Rating (Site Visit) IW-02: flap gates sealing well.

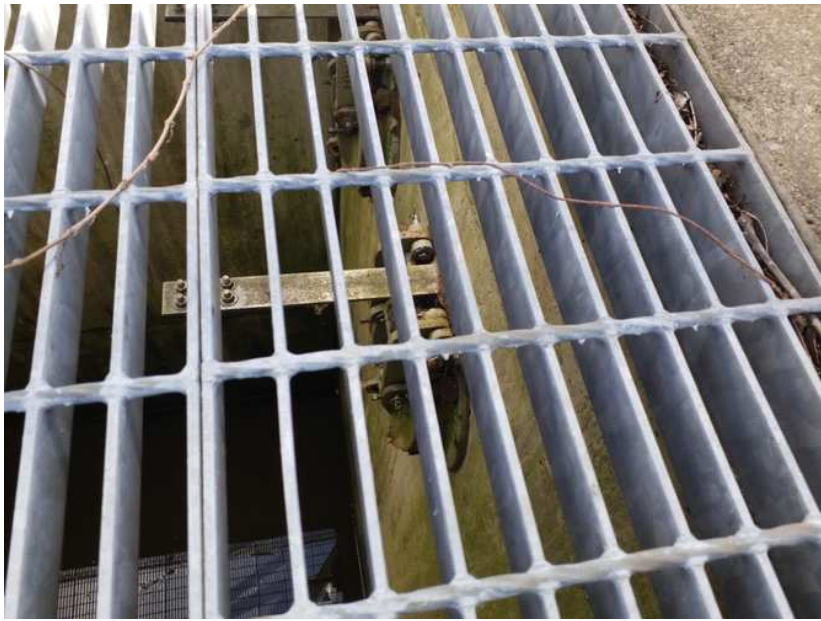
Inspect ID: 2024-0080

0080 - No User Rating (Site Visit) - IW-02: flap gates sealing well

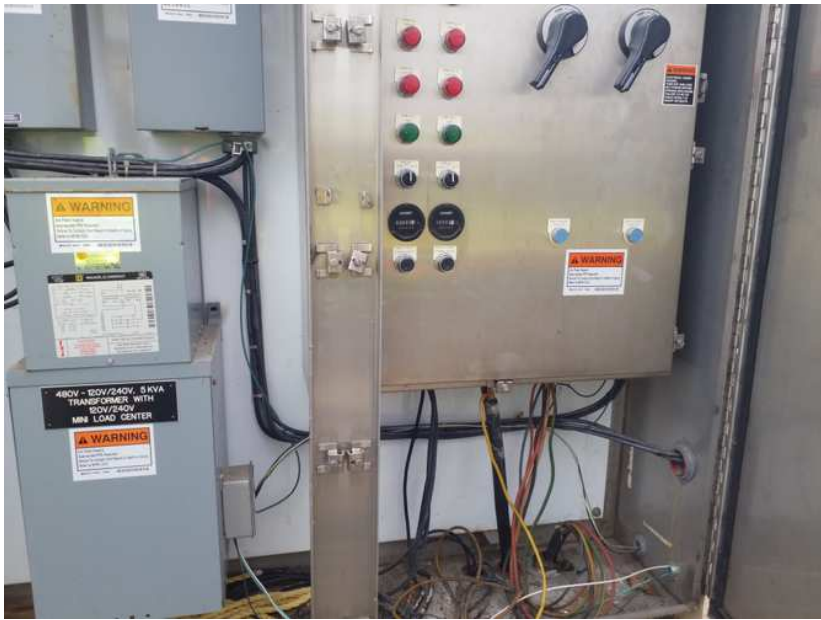
Inspect ID: 2024-0030

No User Rating (Site Visit) - PS-IW: No operations manuals on site. Kept in central location

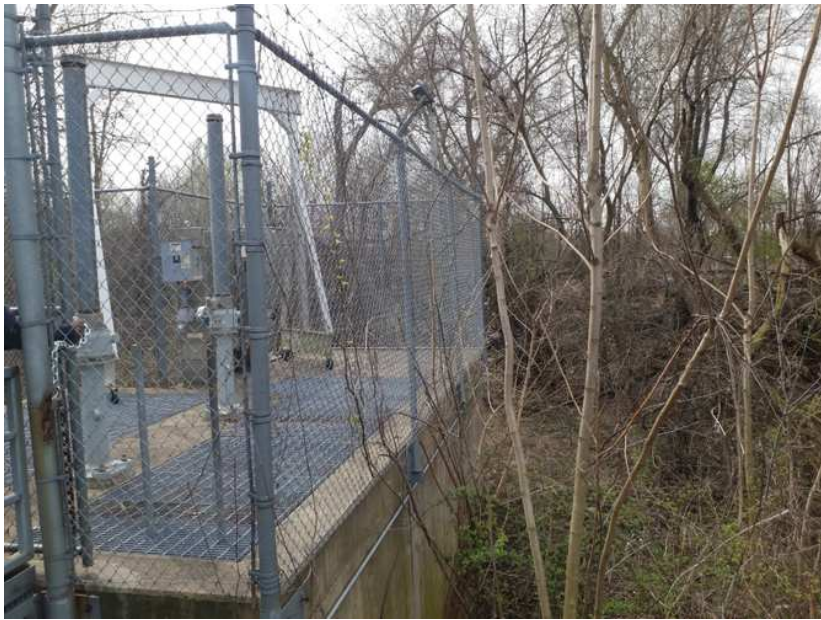
Inspect ID: 2024-0034

No User Rating (Site Visit) - PS-IW: Vegetation in fence - less than previous years

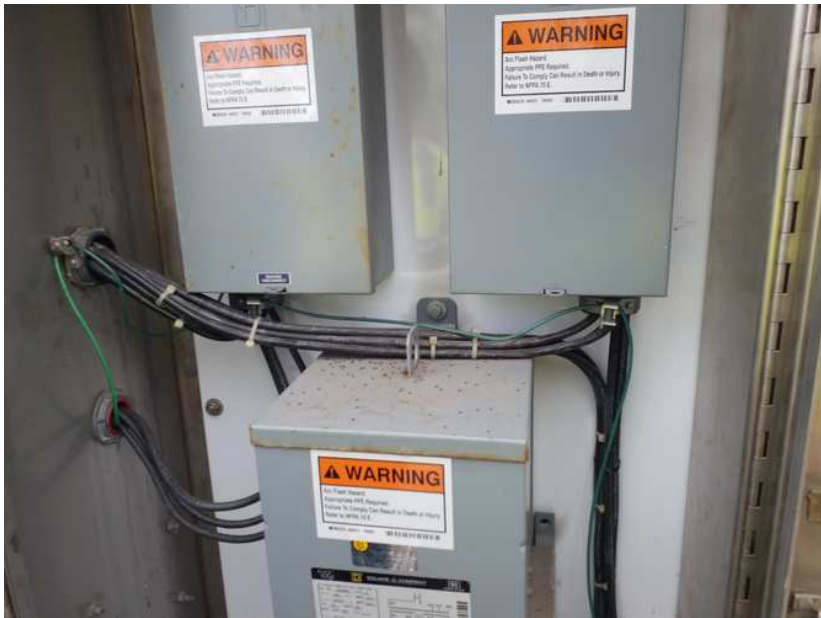
Inspect ID: 2024-0018

No User Rating (Site Visit) - PS-IW: Cables should not be routed on top of hot transformer

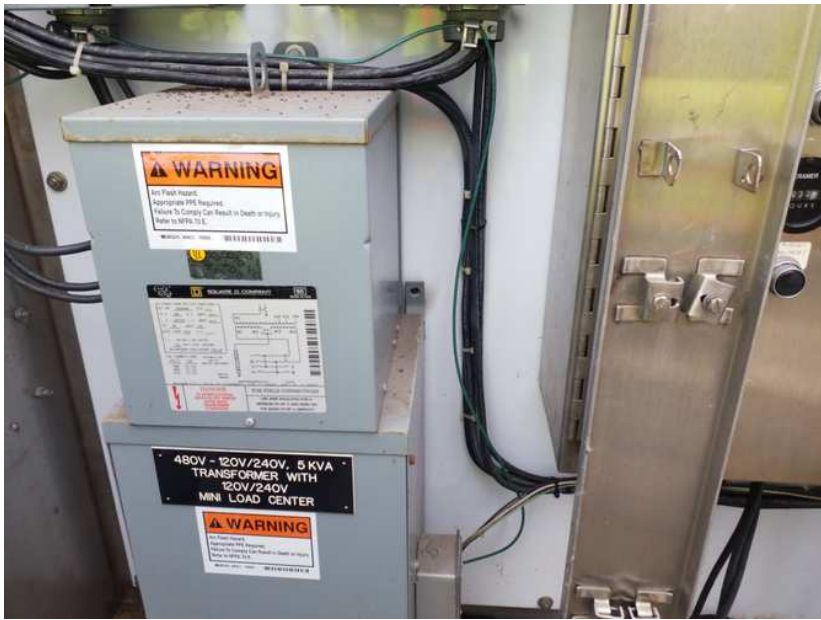
Inspect ID: 2024-0022

No User Rating (Site Visit) - PS-IW: Missing bolt on transformer

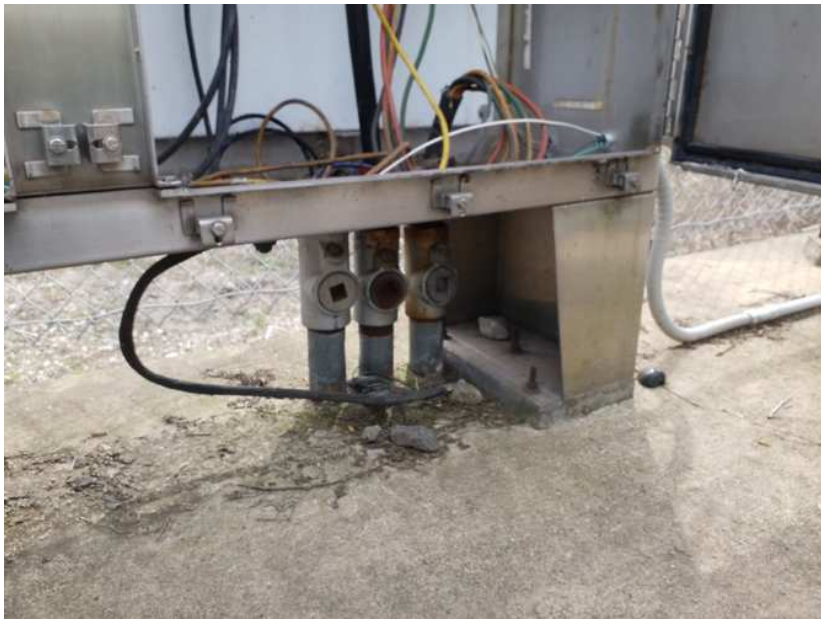
Inspect ID: 2024-0026

No User Rating (Site Visit) - PS-IW: Ground conductor is starting to fray
