Site Visit Summary

Name of System: Gary

Name of Segment: Gary Burr St

Field Trip Report Prepared by: Chris Schaal Date of Site Visit: 04/08/2024 - 04/10/2024

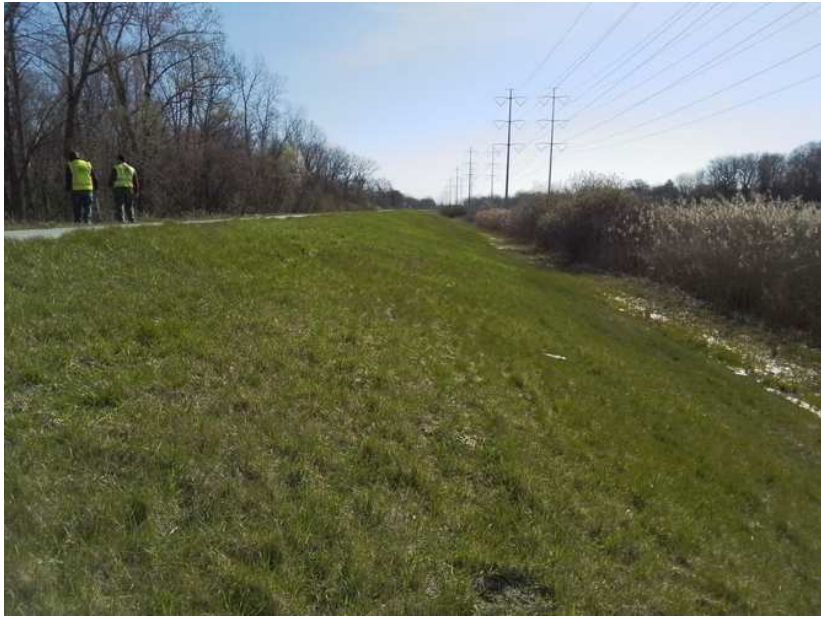
Inspect ID: 2024-0008

No User Rating (Site Visit) - Small tree growth observed along landside toe/ditch. Looking east.

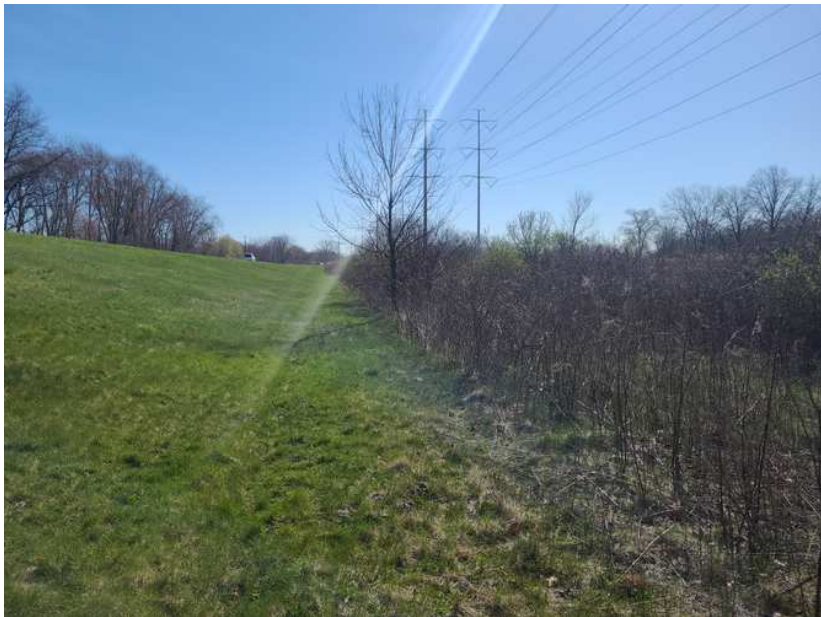
Inspect ID: 2024-0013

No User Rating (Site Visit) -Encroaching trees and brush on landside toe.

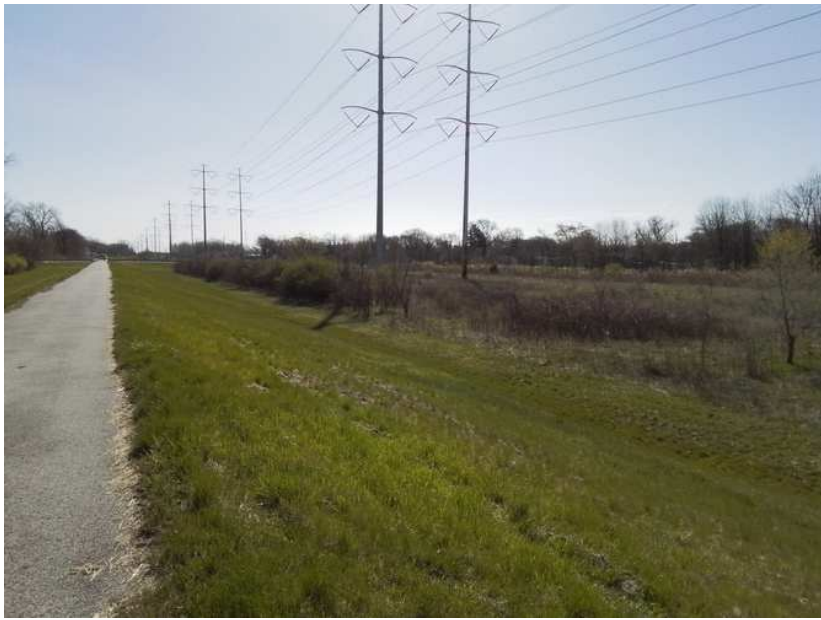
Inspect ID: 2024-0020

No User Rating (Site Visit) - Trees and bushes observed along landside toe.

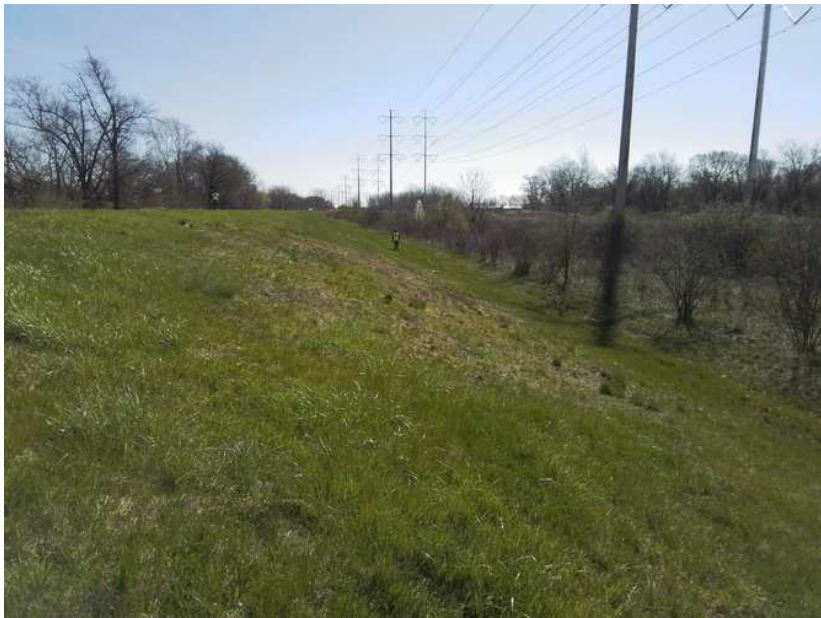
Inspect ID: 2024-0032

No User Rating (Site Visit) - Vegetation close to toe of landside slope.

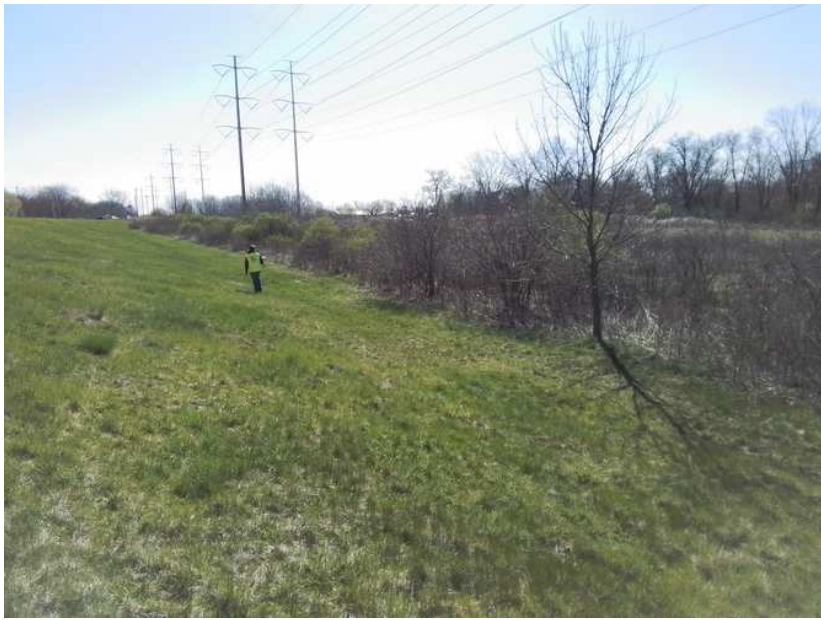
Inspect ID: 2024-0036

No User Rating (Site Visit) - Larger tree observed close to landside levee toe (looking east).

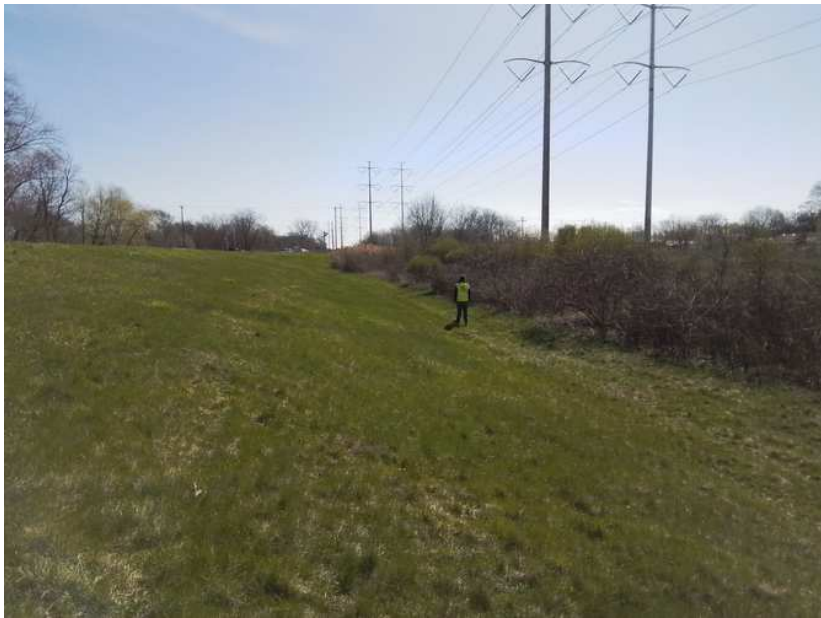
Inspect ID: 2024-0040

No User Rating (Site Visit) - Vegetation observed along landside levee toe (looking east).

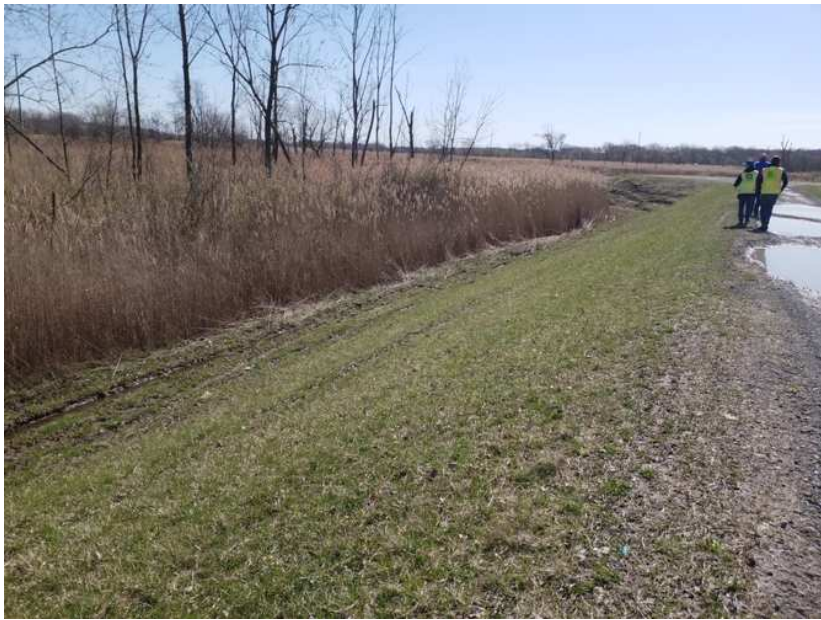
Inspect ID: 2024-0059

No User Rating (Site Visit) - Vegetation on riverside toe.

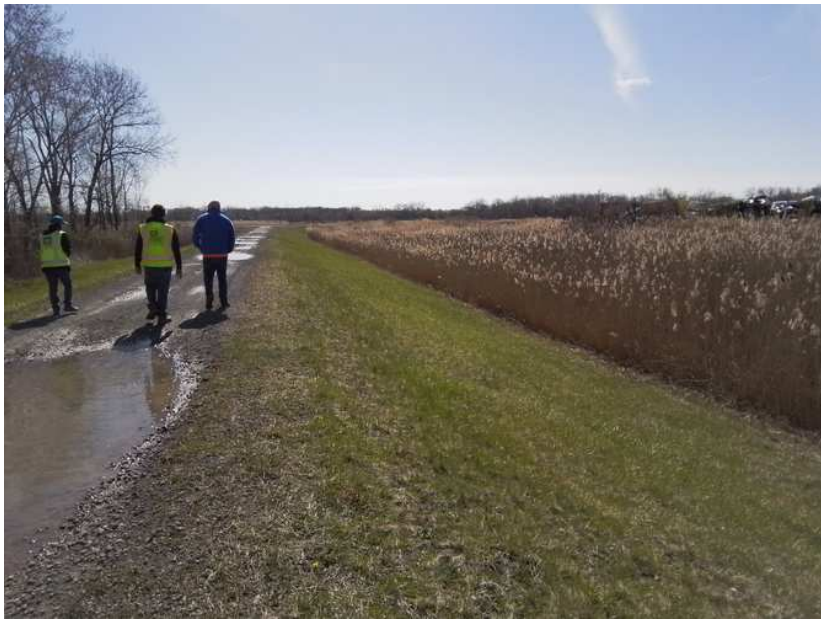
Inspect ID: 2024-0076

No User Rating (Site Visit) - Vegetation observed along landside toe

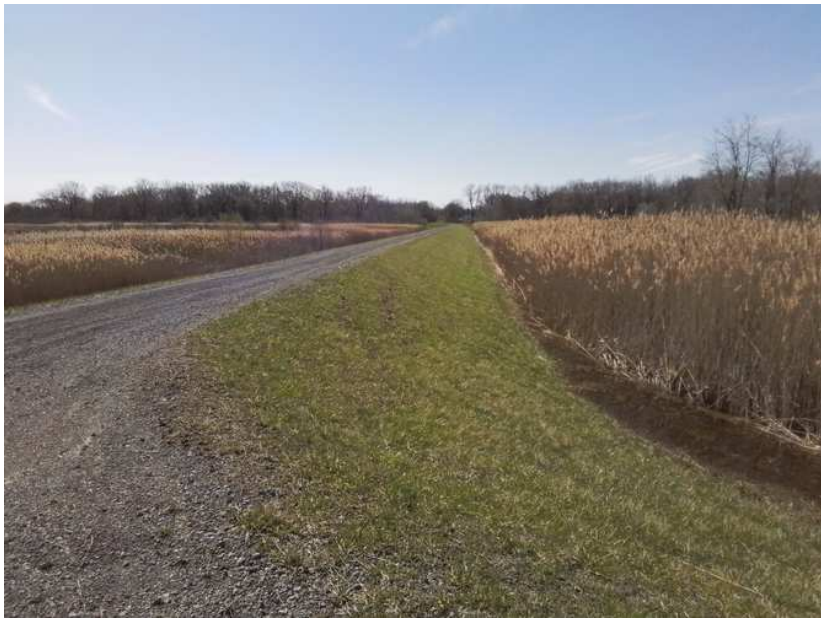
Inspect ID: 2024-0100

No User Rating (Site Visit) - Vegetation observed along landside toe of levee.

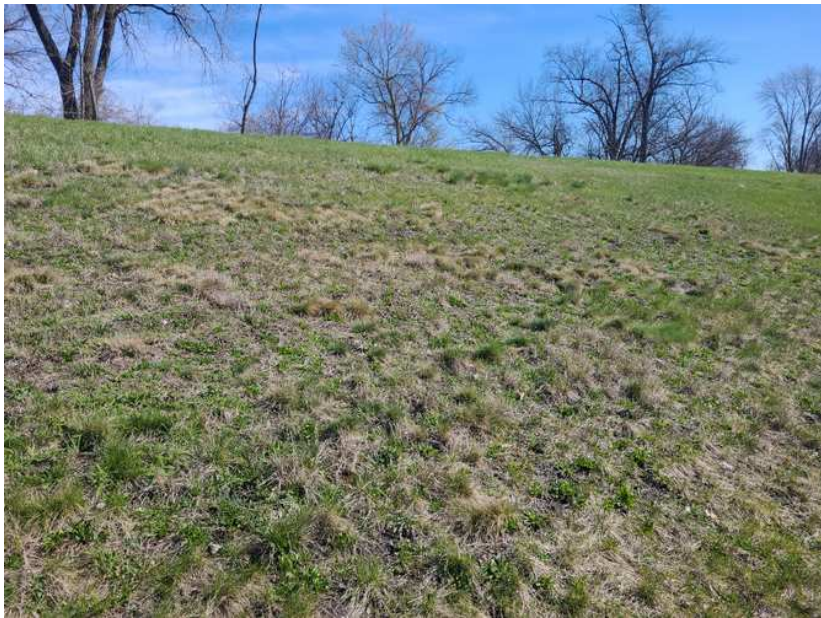
Inspect ID: 2024-0009

No User Rating (Site Visit) - Poor sod cover on landside slope and crown.

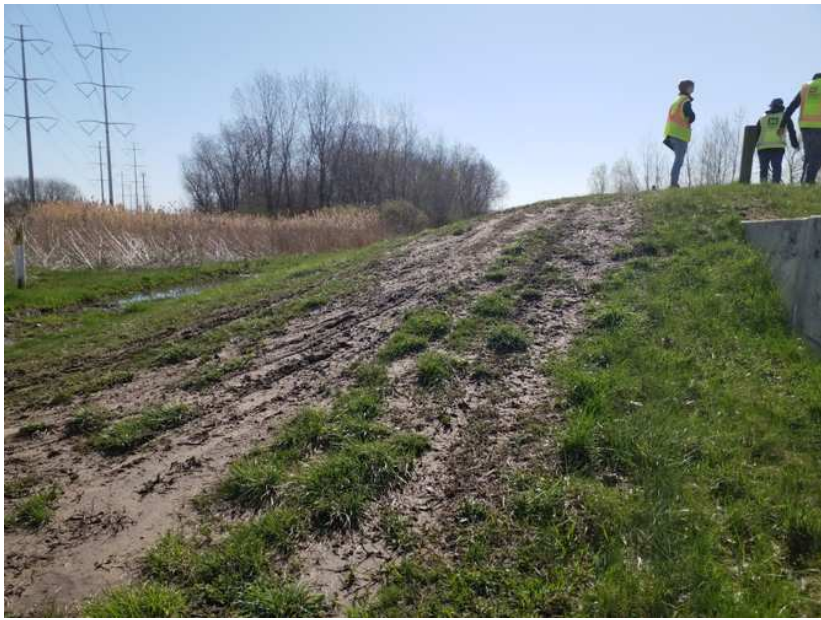
Inspect ID: 2024-0043

No User Rating (Site Visit) - Poor sod cover on riverside slope.

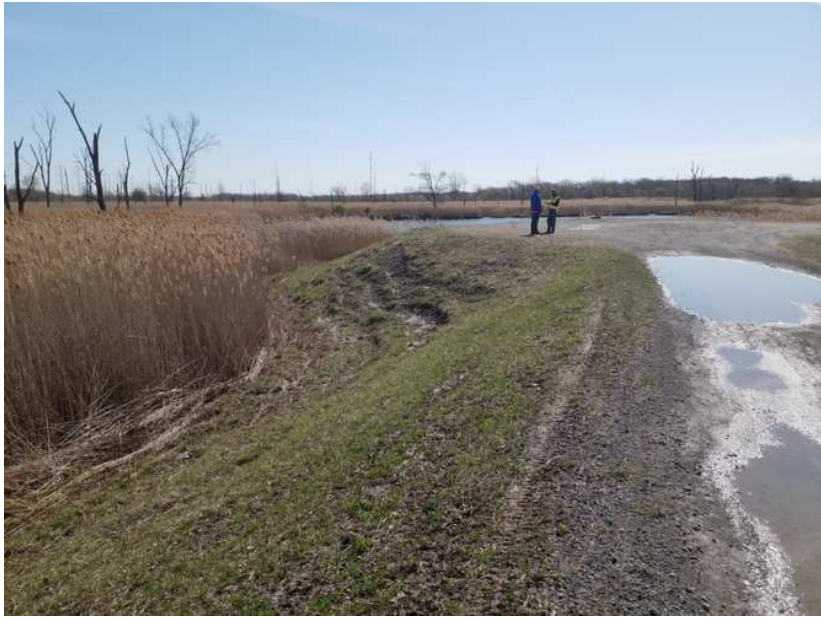
Inspect ID: 2024-0063

No User Rating (Site Visit) - Poor sod cover on riverside slope.

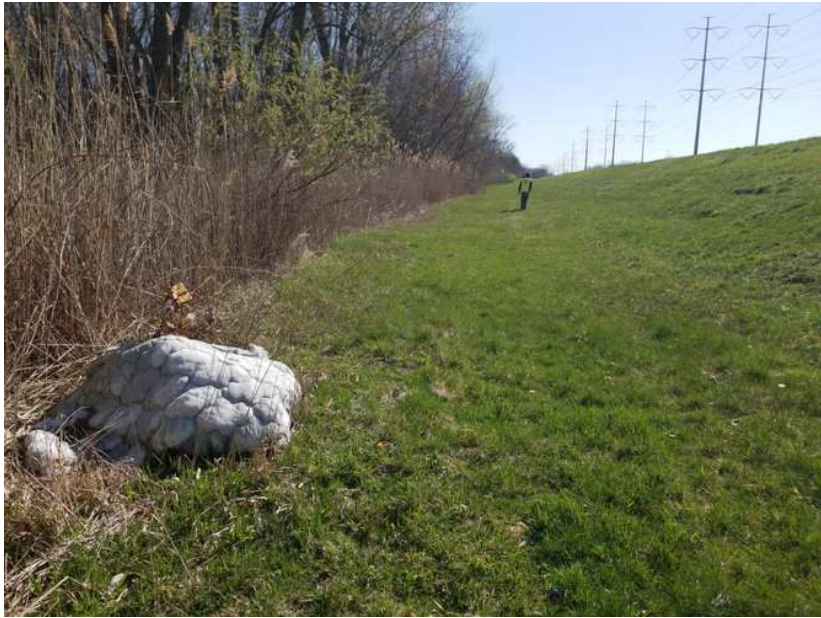
Inspect ID: 2024-0003

No User Rating (Site Visit) - Discarded mattress on riverside toe.

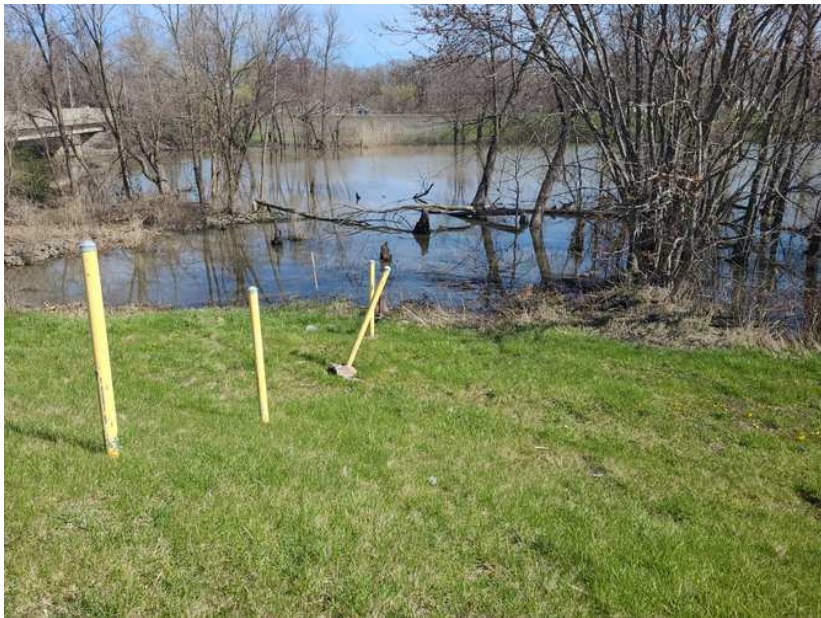
Inspect ID: 2024-0025

No User Rating (Site Visit) - Damaged bollard on riverside crest.

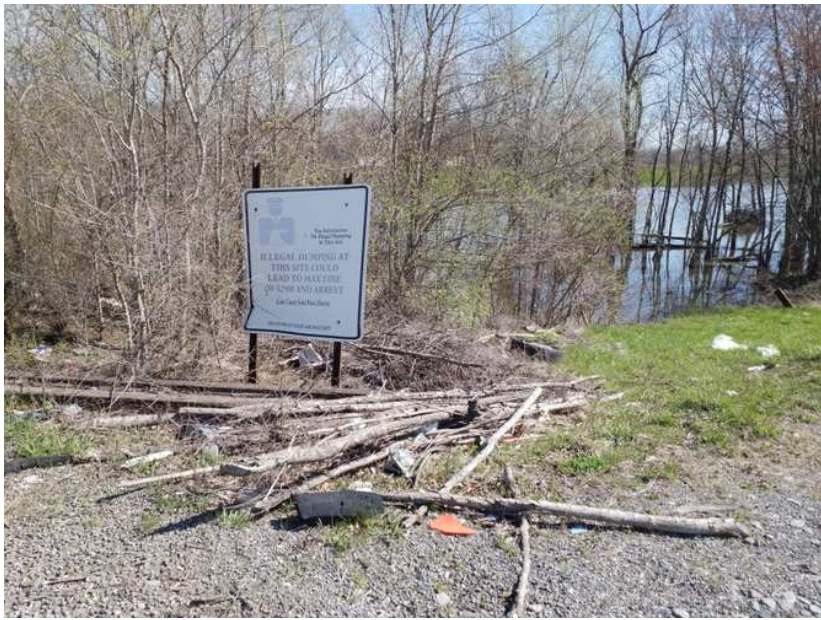
Inspect ID: 2024-0027

No User Rating (Site Visit) - Garbage and debris on riverside.

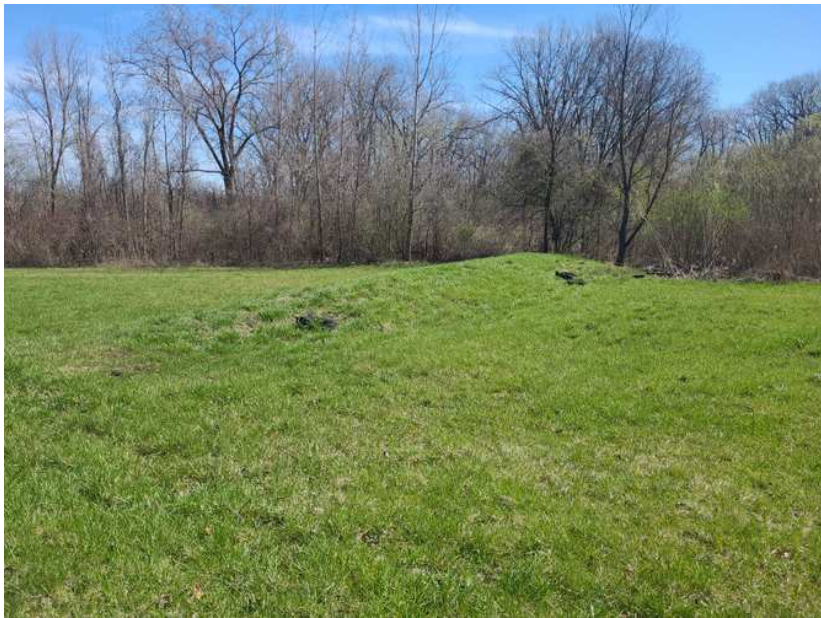
Inspect ID: 2024-0069

No User Rating (Site Visit) - Debris on berms at end of levee.

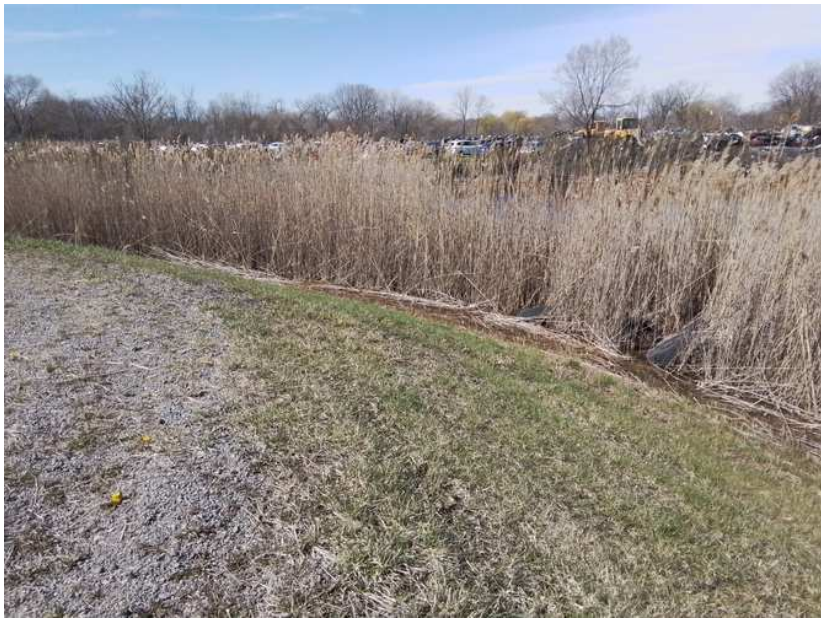
Inspect ID: 2024-0096

No User Rating (Site Visit) - Tires, debris observed on landside toe..

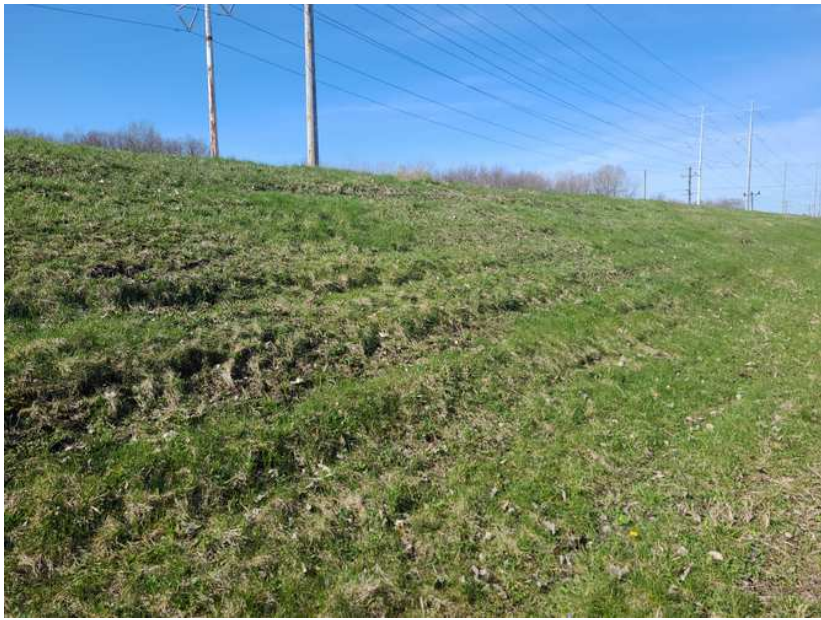
Inspect ID: 2024-0001

No User Rating (Site Visit) - Rutting over time leading to erosion of the cross section.

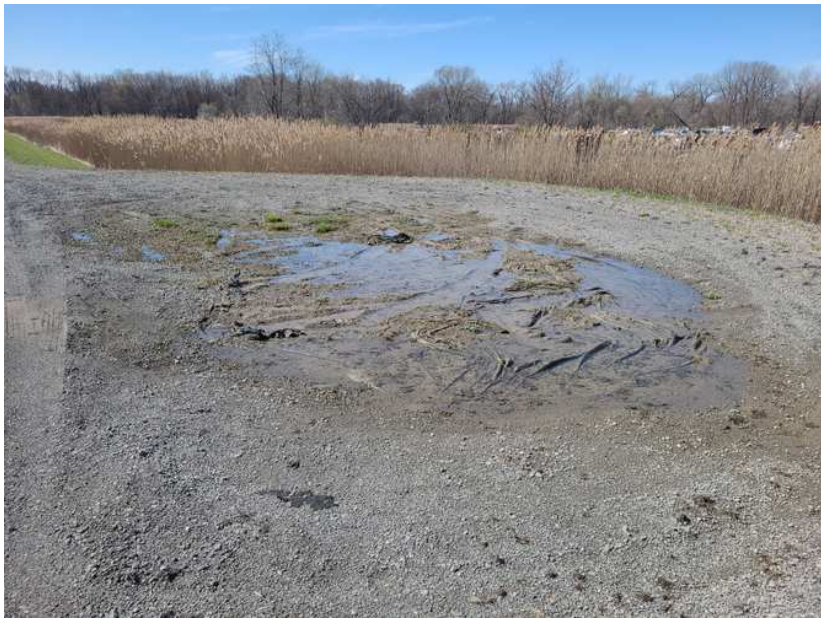
Inspect ID: 2024-0057

No User Rating (Site Visit) - Ponding on crest.

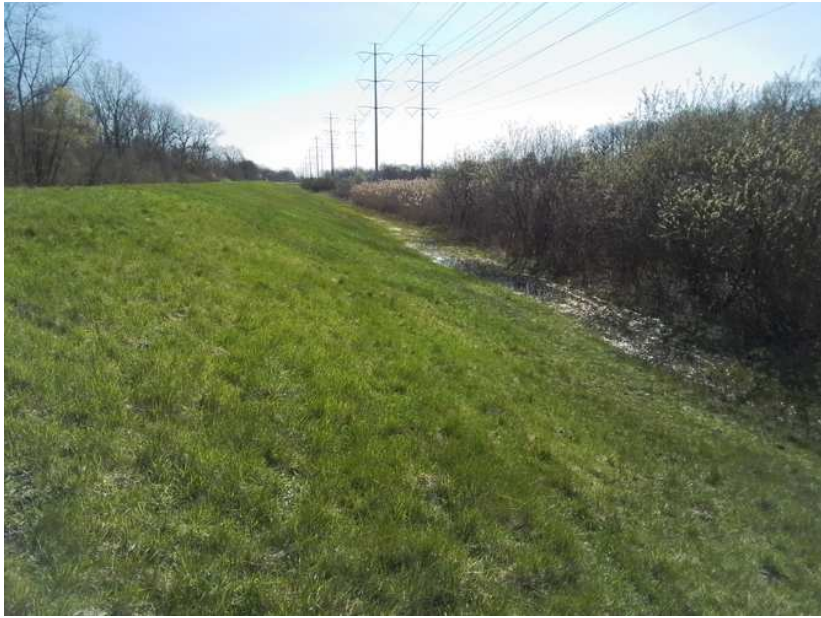
Inspect ID: 2024-0012

No User Rating (Site Visit) - Ponding in ruts observed along landside toe.

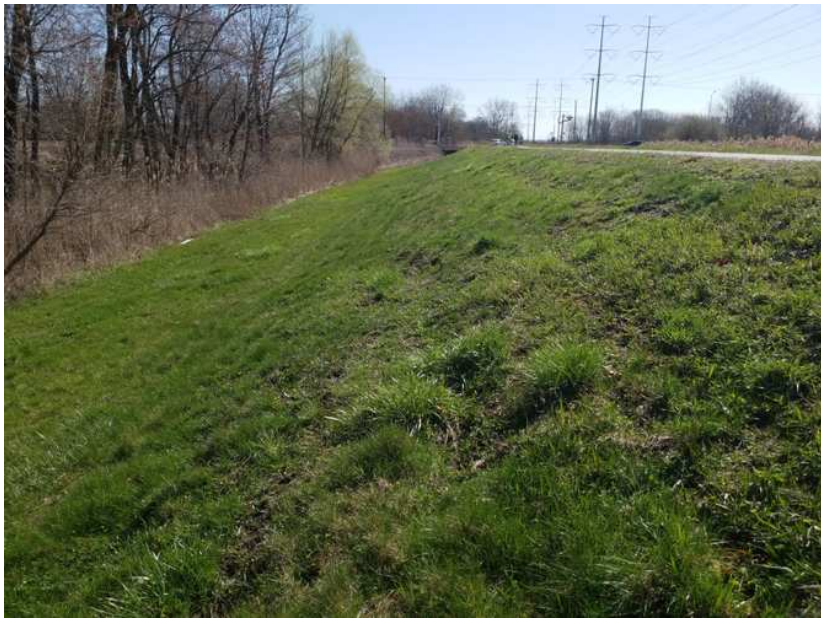
Inspect ID: 2024-0015

No User Rating (Site Visit) - Typical rutting from mowing on riverside slope.

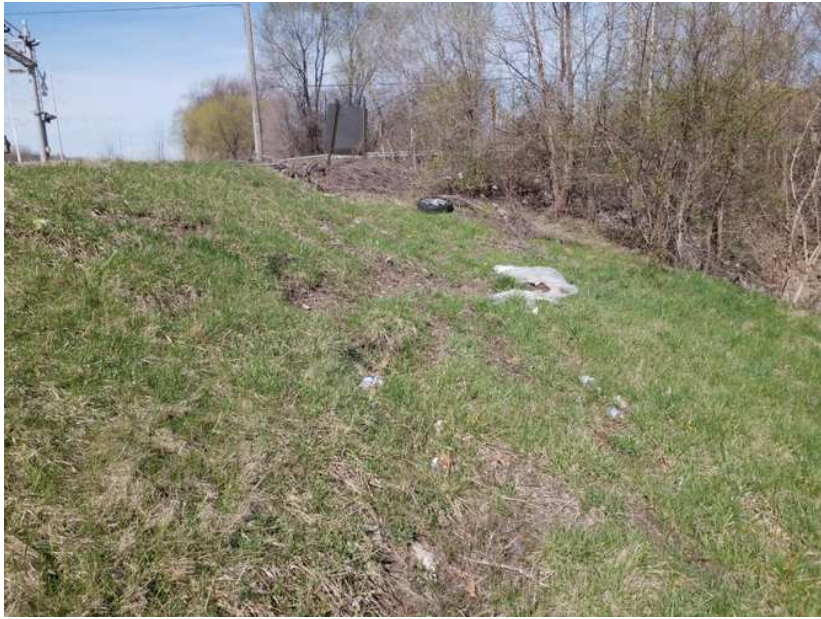
Inspect ID: 2024-0031

No User Rating (Site Visit) - Large ruts on riverside slope.

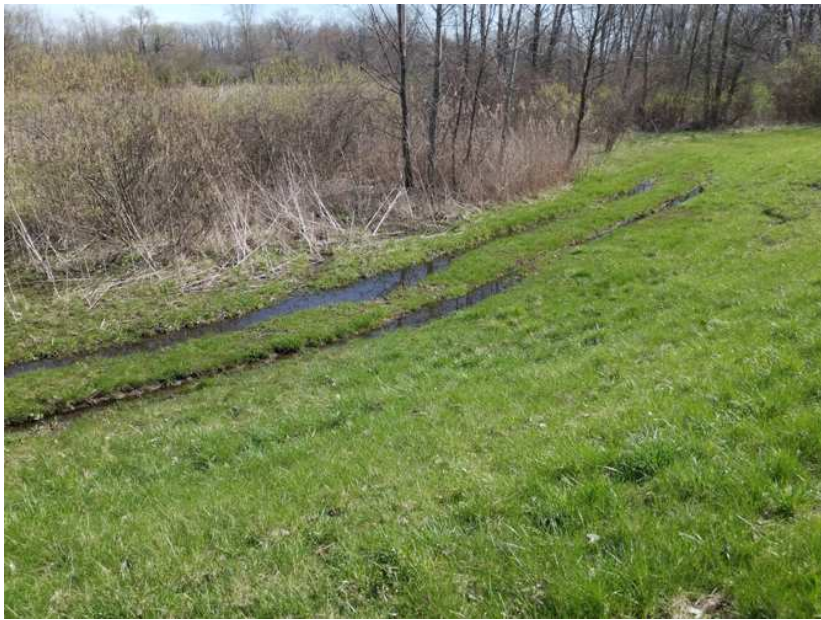
Inspect ID: 2024-0047

No User Rating (Site Visit) - Rutting on riverside toe.

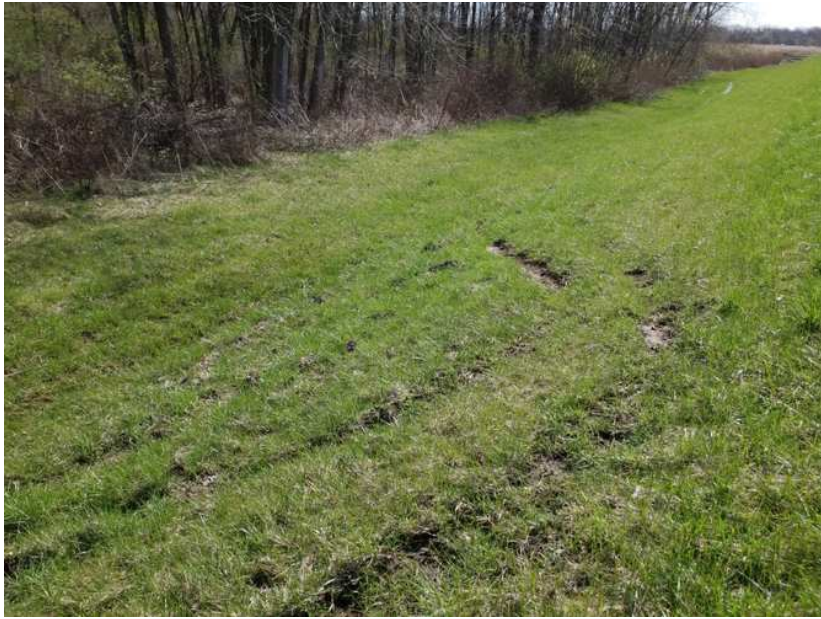
Inspect ID: 2024-0051

No User Rating (Site Visit) - Ruts on riverside slope.

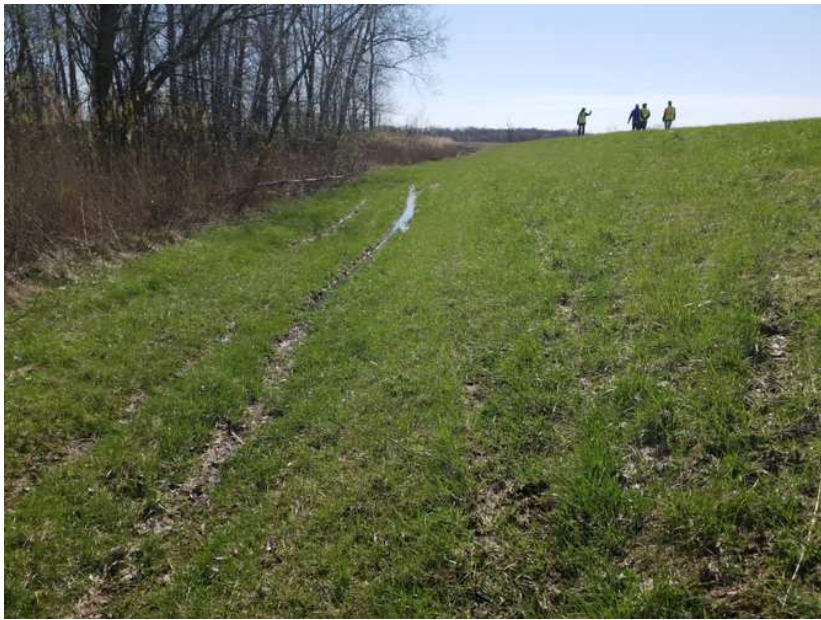
Inspect ID: 2024-0055

No User Rating (Site Visit) - Riverside toe and slope rutting.

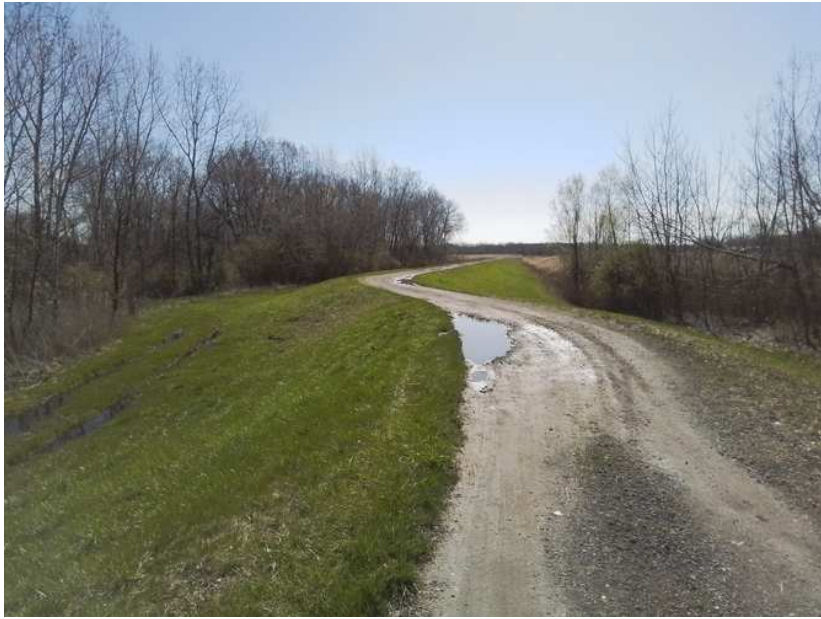
Inspect ID: 2024-0068

No User Rating (Site Visit) - Potholes and ponding observed along gravel road. This is typical of this road (looking east).

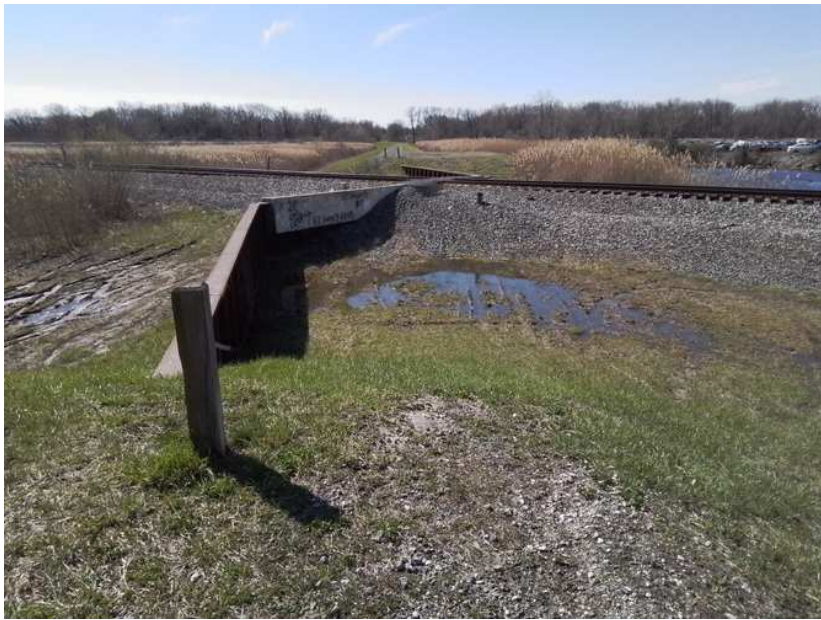
Inspect ID: 2024-0080

No User Rating (Site Visit) - Rutting and ponded water observed along levee and floodwall on landside.

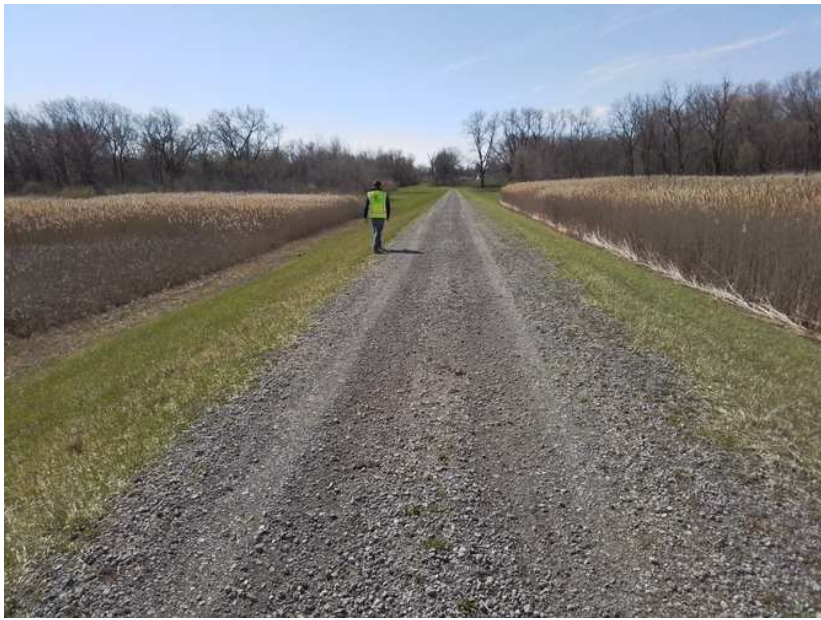
Inspect ID: 2024-0104

No User Rating (Site Visit) - Typical depressions along gravel levee crown.

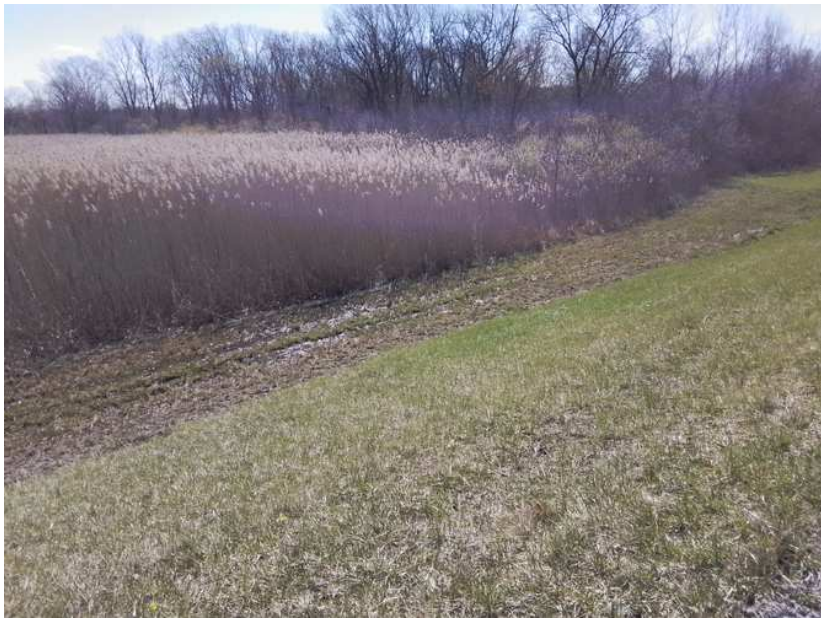
Inspect ID: 2024-0108

No User Rating (Site Visit) - Rutting and ponding observed on waterside toe.

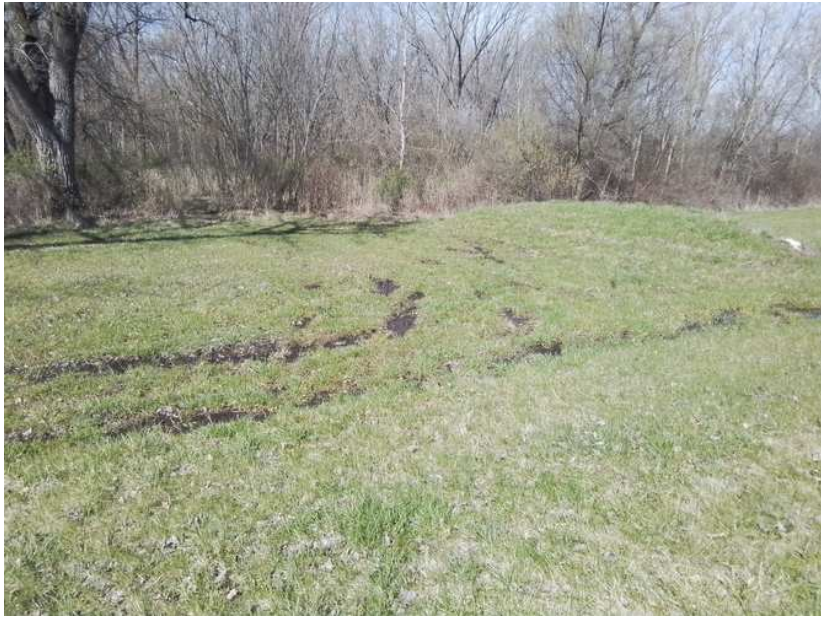
Inspect ID: 2024-0112

No User Rating (Site Visit) - Rutting and debris on landside toe.

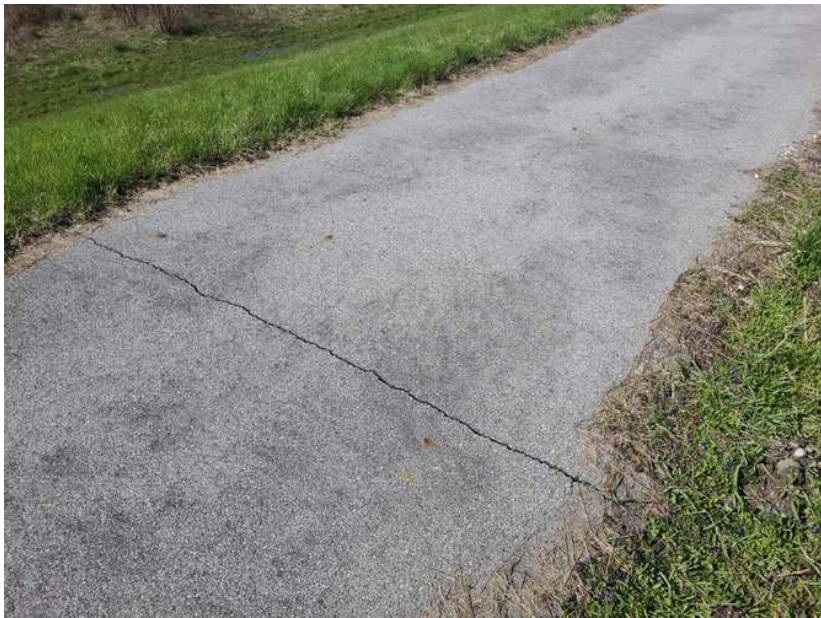
Inspect ID: 2024-0005

No User Rating (Site Visit) - Cracking on asphalt crest, typical for segment about every 150 feet.

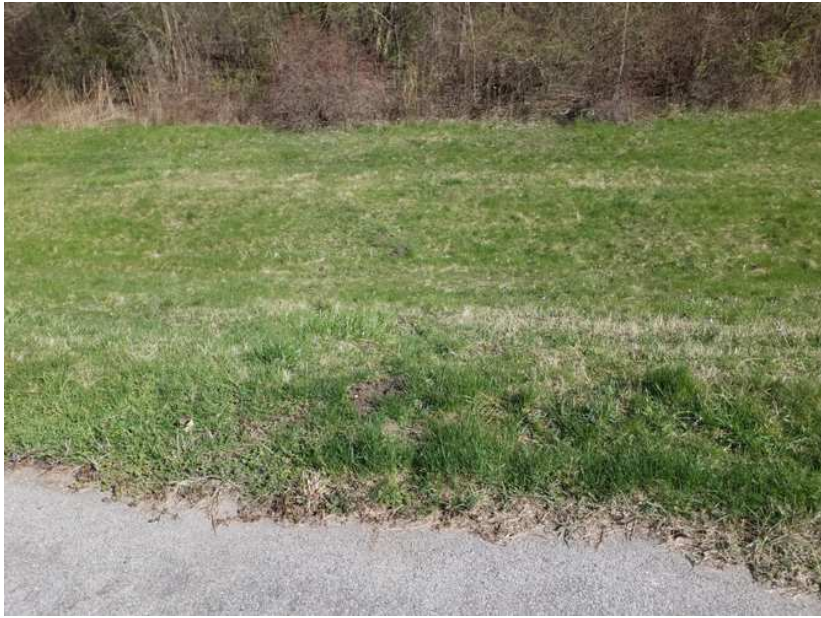
Inspect ID: 2024-0007

No User Rating (Site Visit) - Typical animal burrow on riverside slope.

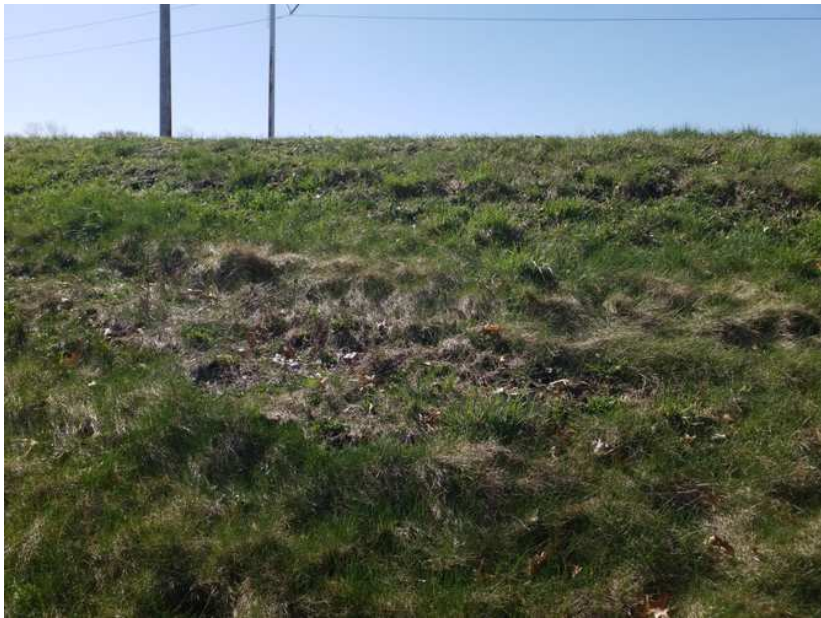
Inspect ID: 2024-0011

No User Rating (Site Visit) - Typical collapsed animal burrow/ tunnel on riverside slope.

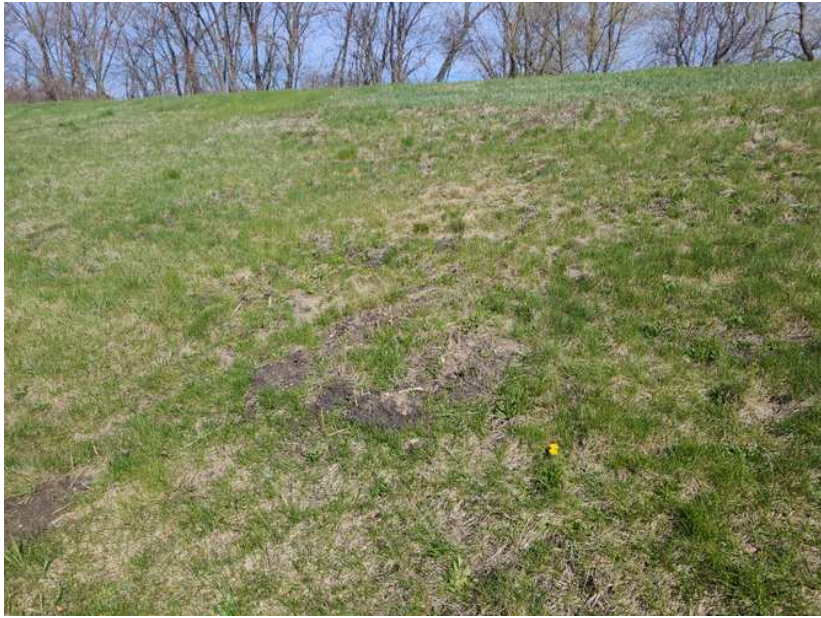
Inspect ID: 2024-0017

No User Rating (Site Visit) - Typical animal burrows on landside slope.

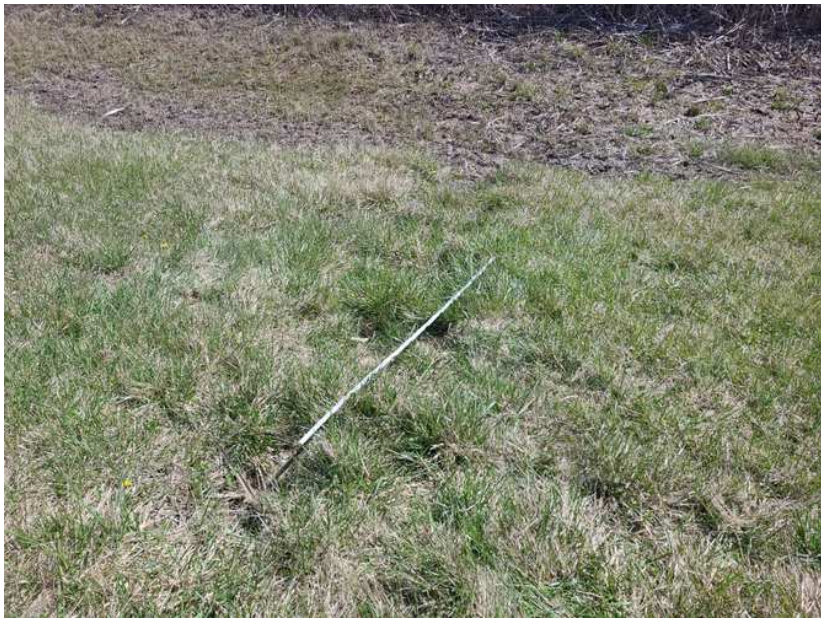
Inspect ID: 2024-0061

No User Rating (Site Visit) - Collapsed animal burrow on riverside slope.

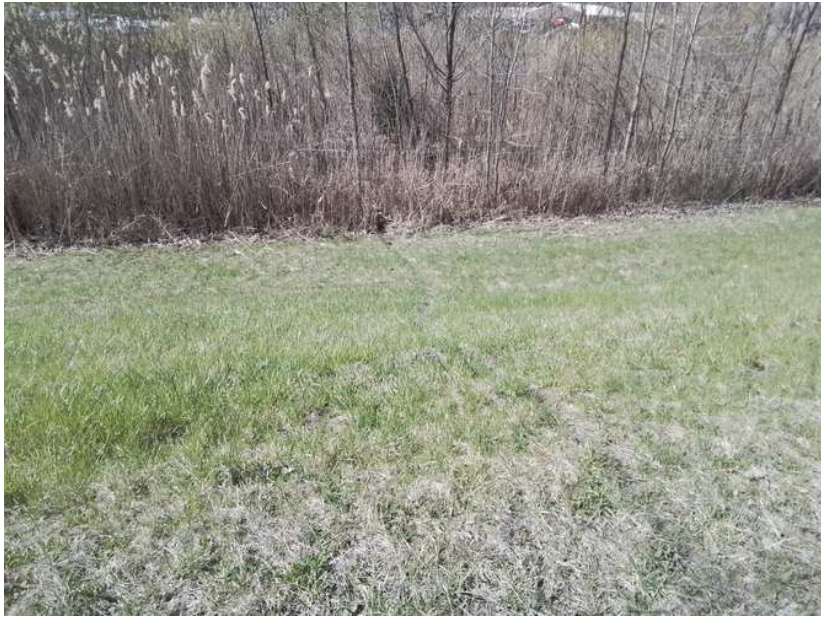
Inspect ID: 2024-0072

No User Rating (Site Visit) - Animal path observed on landside slope.

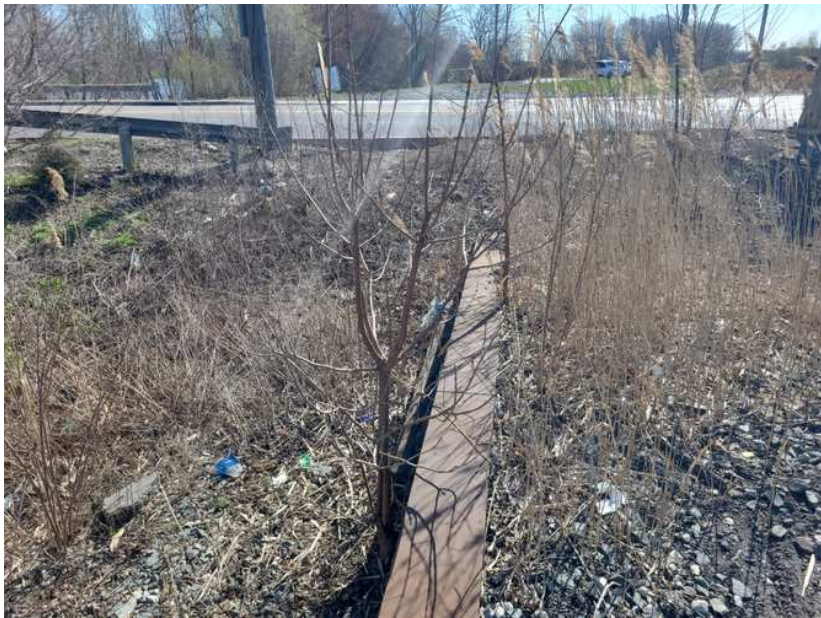
Inspect ID: 2024-0021

No User Rating (Site Visit) - Vegetation on landside and riverside.

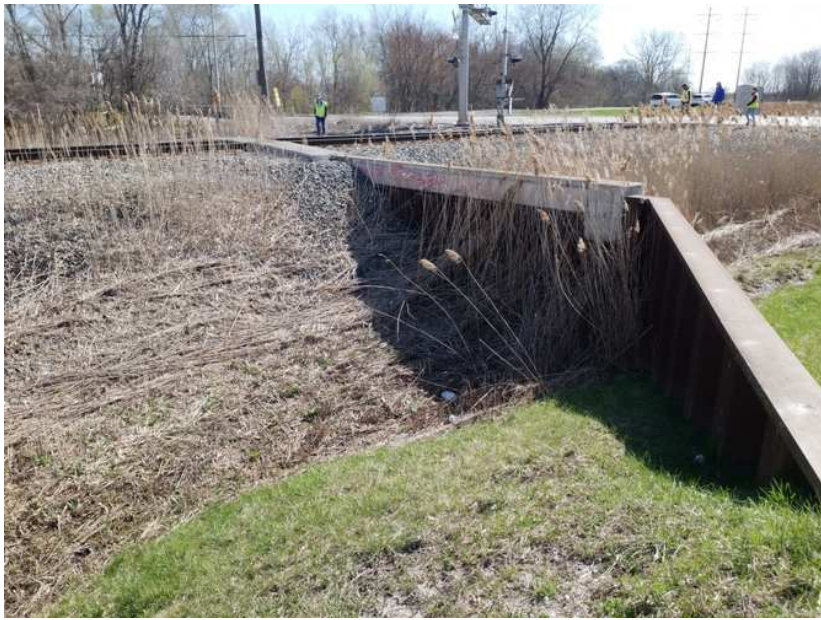
Inspect ID: 2024-0023

No User Rating (Site Visit) - Vegetation along riverside face.

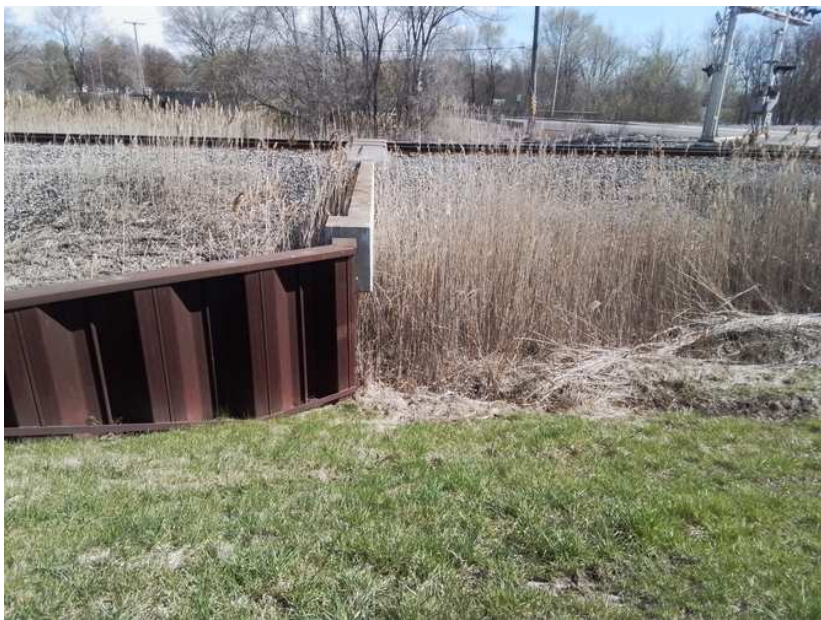
Inspect ID: 2024-0044

No User Rating (Site Visit) - Vegetation observed along landside of floodwall.

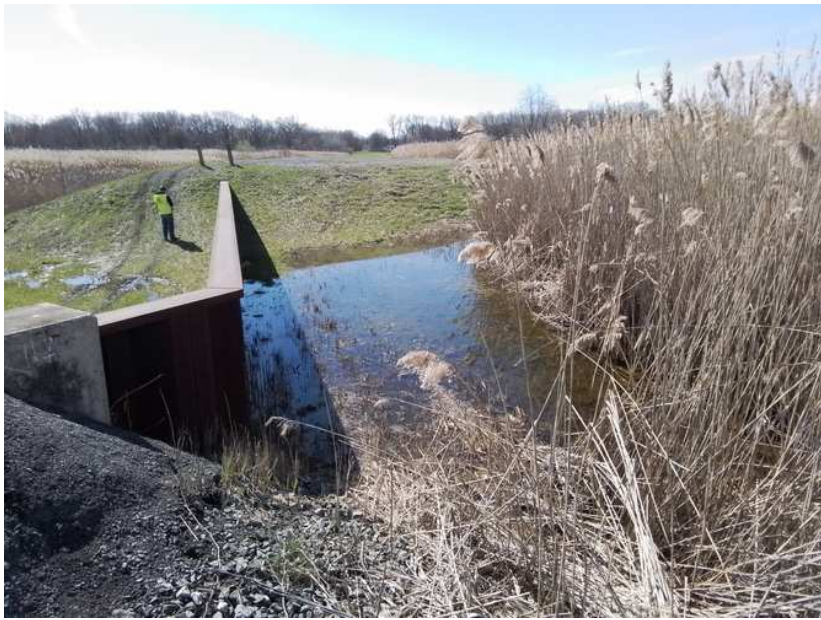
Inspect ID: 2024-0092

No User Rating (Site Visit) - Vegetation along landside of floodwall.

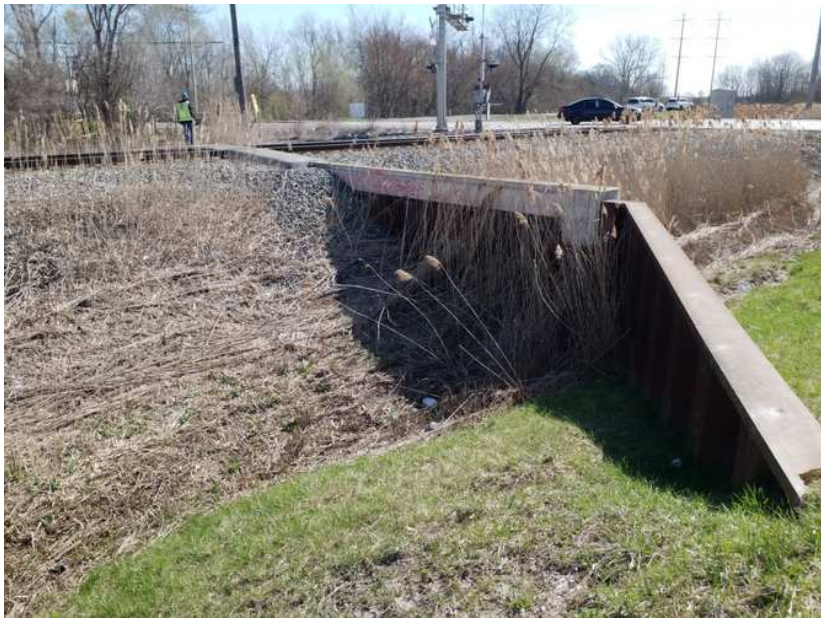
Inspect ID: 2024-0019

No User Rating (Site Visit) - Graffiti on riverside face.

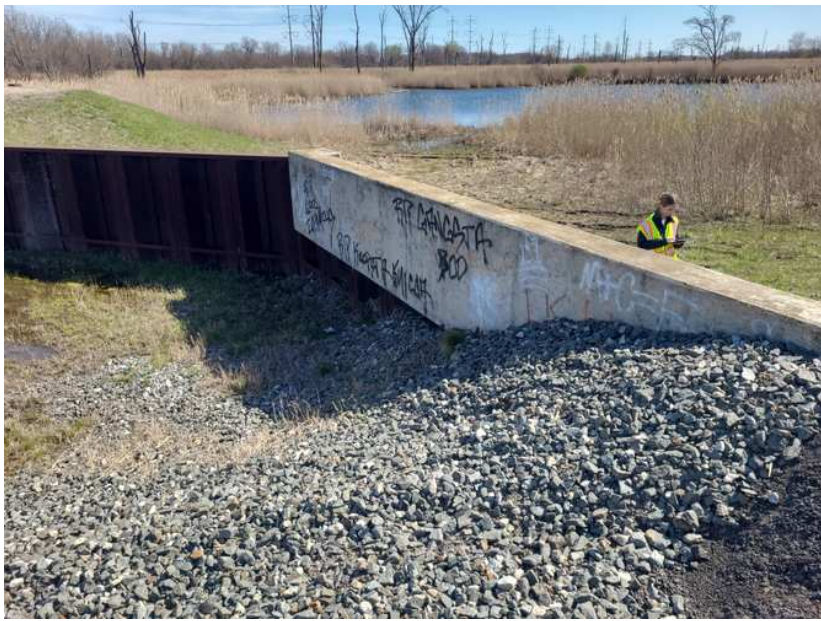
Inspect ID: 2024-0049

No User Rating (Site Visit) - Typical graffiti on landside floodwall.

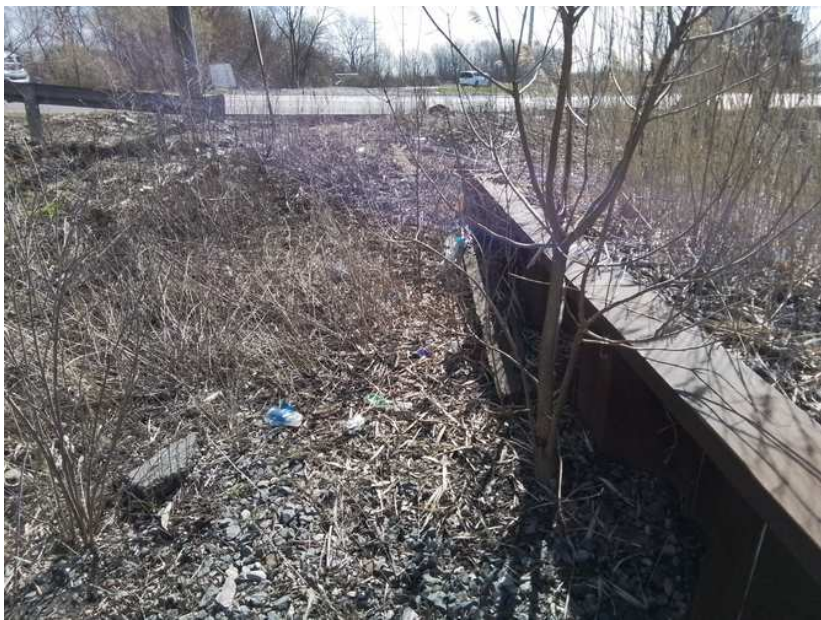
Inspect ID: 2024-0052

No User Rating (Site Visit) - Old railroad tie observed on riverside of floodwall.
