Site Visit Summary

Name of System: Gary

Name of Segment: Gary Burr St

Field Trip Report Prepared by: Chris Schaal Date of Site Visit: 04/08/2024 - 04/10/2024

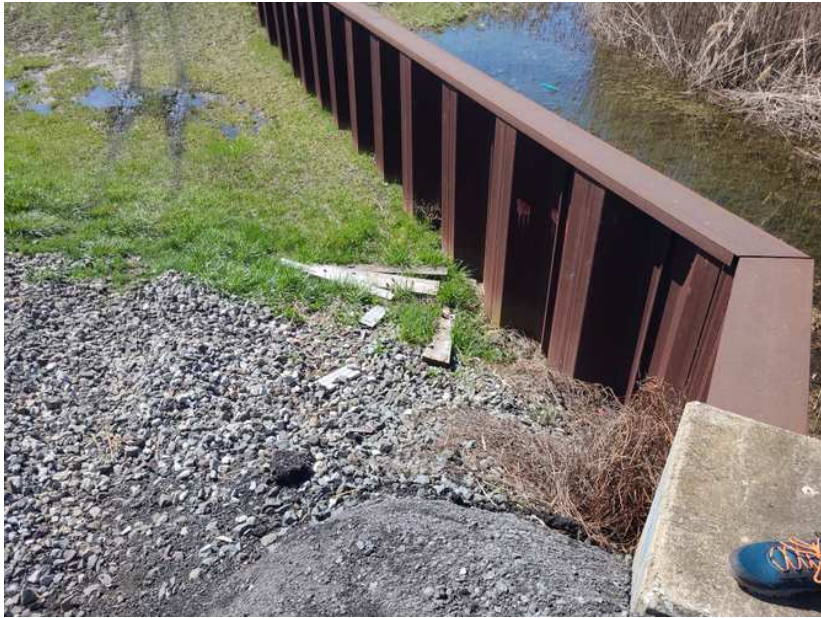
Inspect ID: 2024-0053

No User Rating (Site Visit) - Debris near riverside of floodwall.

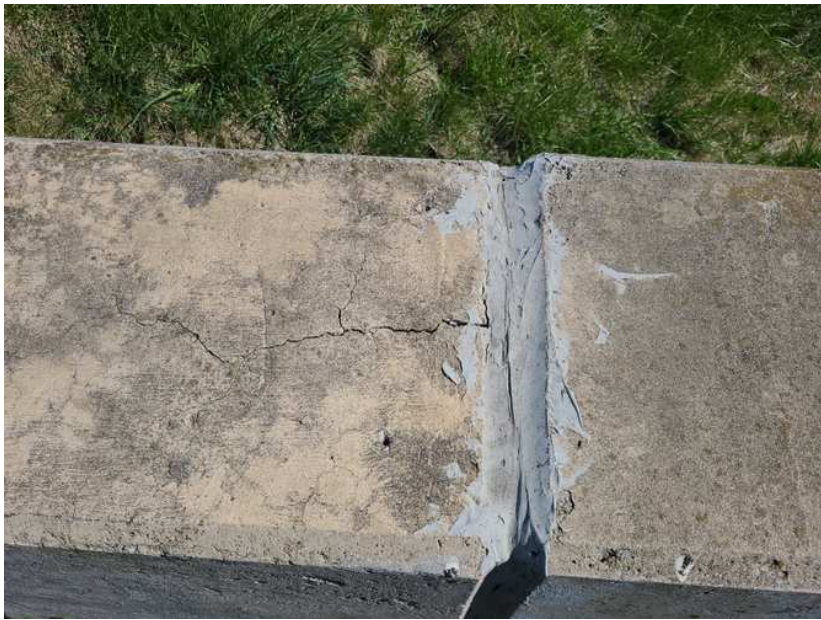
Inspect ID: 2024-0029

No User Rating (Site Visit) - Cracked concrete on top of flood wall.

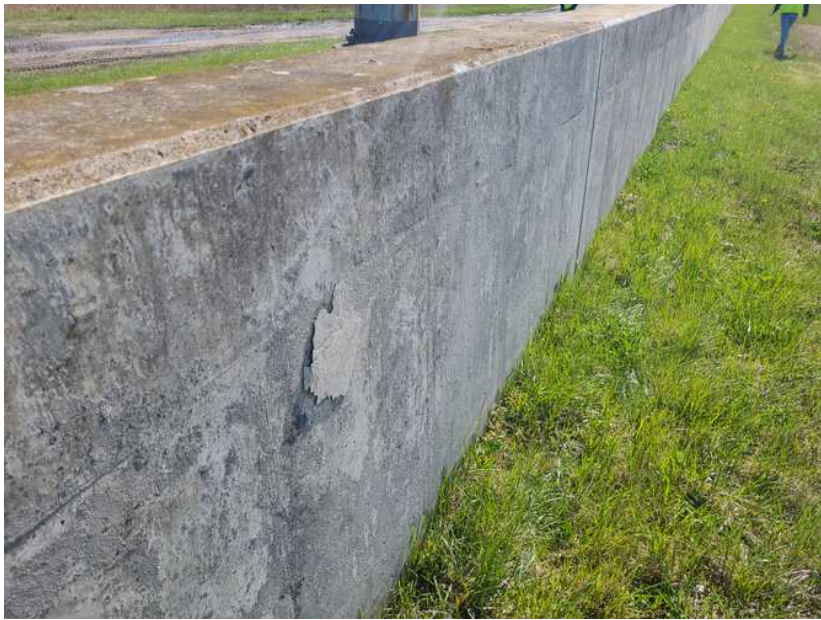
Inspect ID: 2024-0033

No User Rating (Site Visit) - Spalling on land side face.

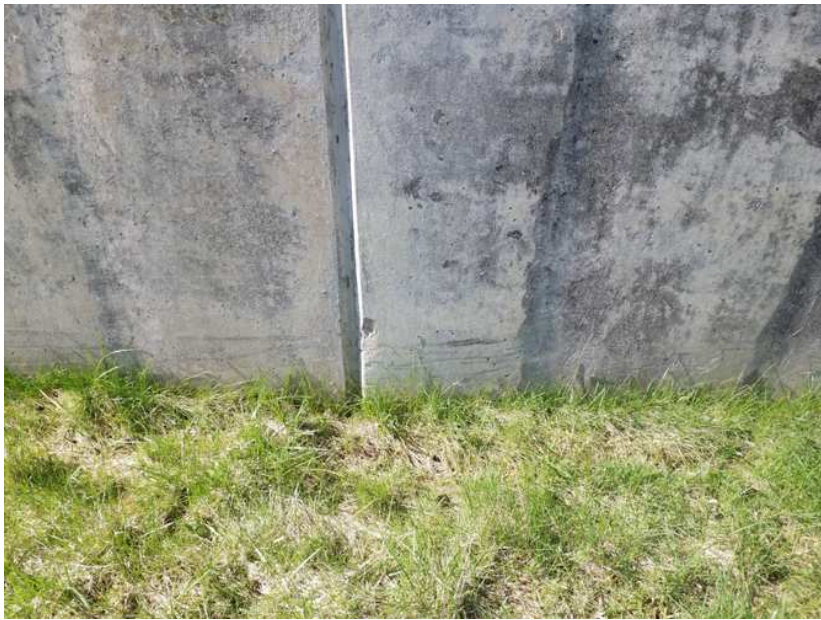
Inspect ID: 2024-0035

No User Rating (Site Visit) - Riverside superficial spalling.

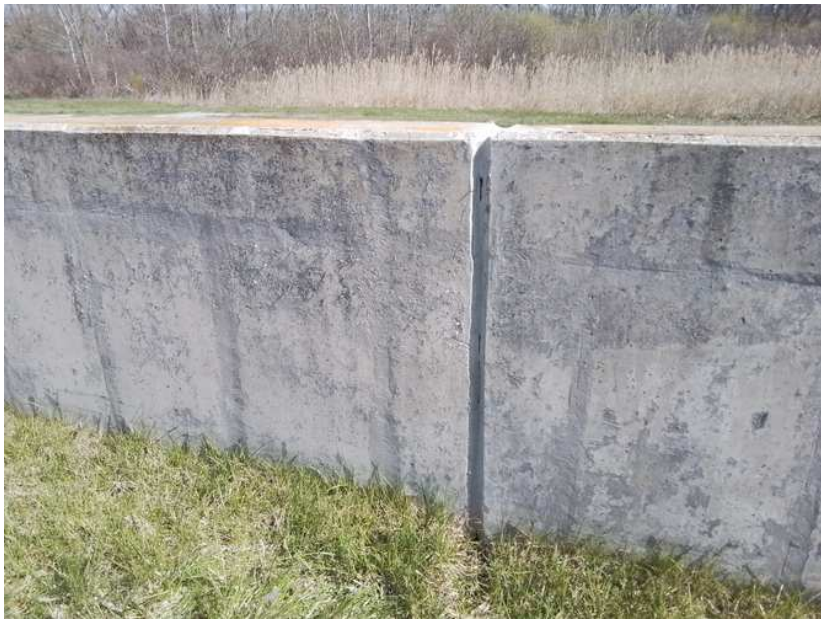
Inspect ID: 2024-0064

No User Rating (Site Visit) - Caulking deteriorating at floodwall joint on landside (typical).

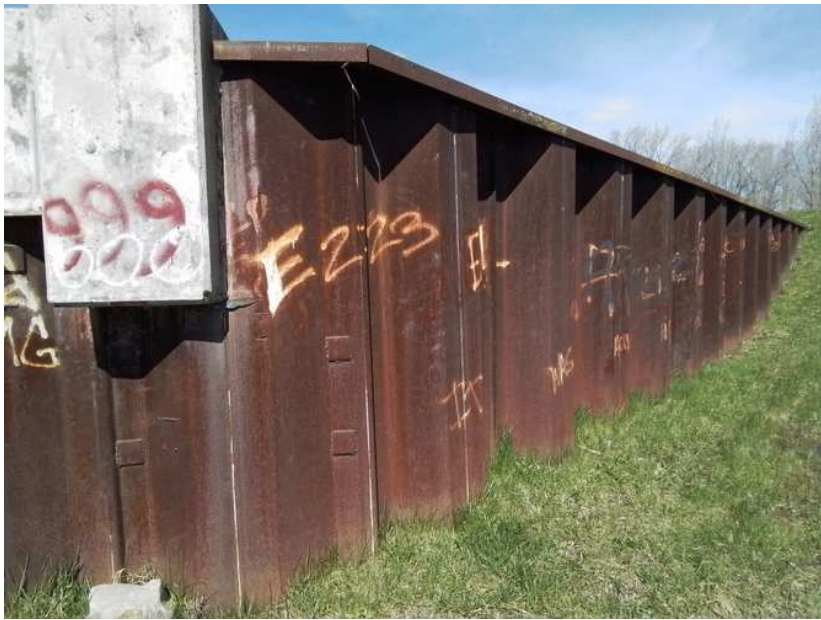
Inspect ID: 2024-0088

No User Rating (Site Visit) - Sealant coming off of floodwall joints on riverside. (typical)

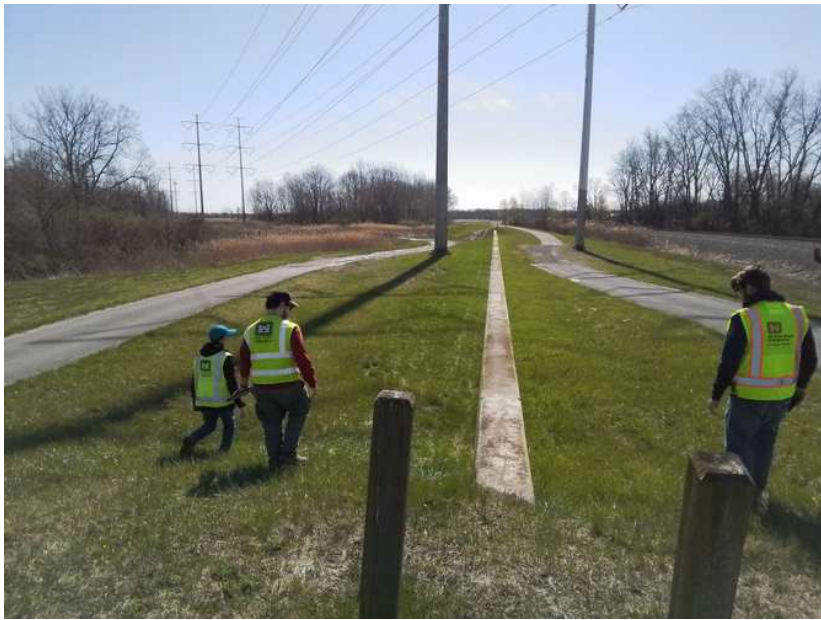
Inspect ID: 2024-0060

No User Rating (Site Visit) - Western end of floodwall tilting slightly to the North (looking east).

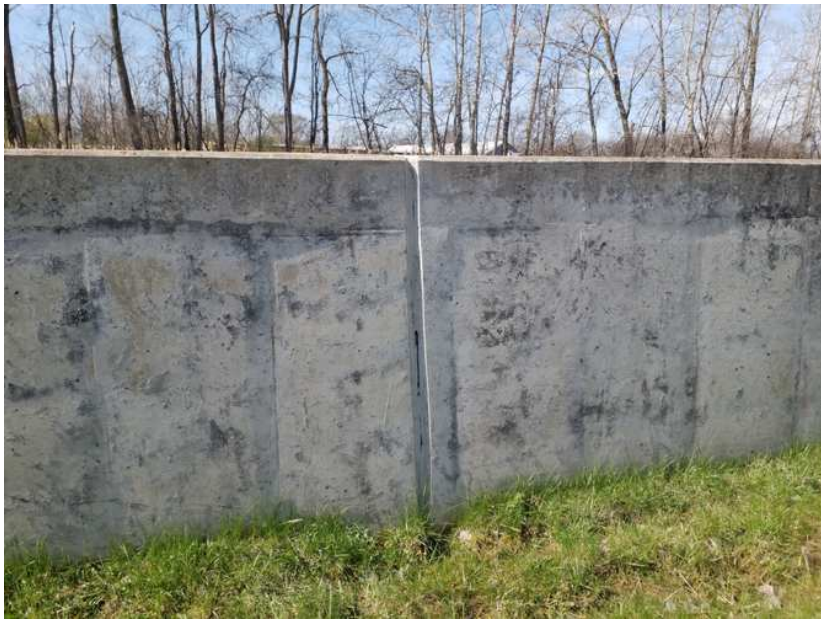
Inspect ID: 2024-0039

No User Rating (Site Visit) - Riverside joint with foam exposed and degraded.

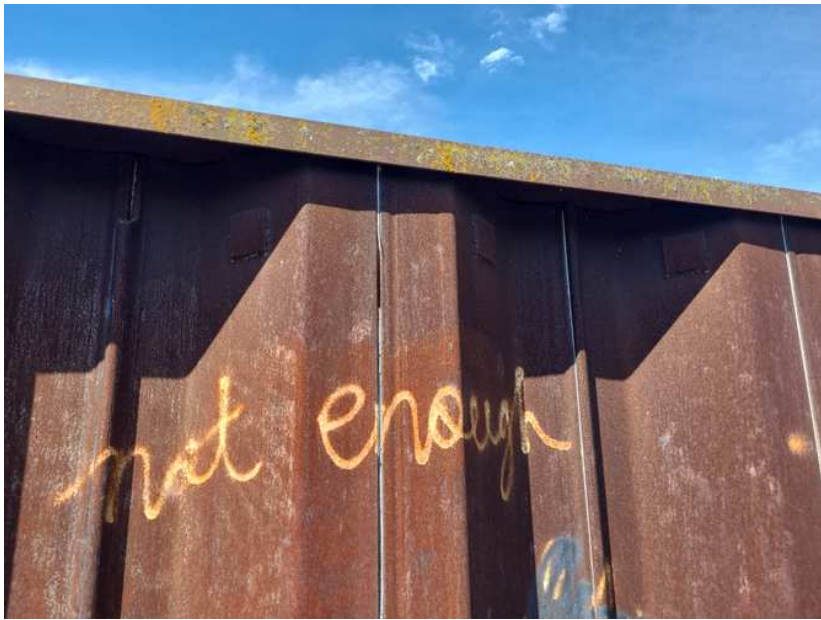
Inspect ID: 2024-0045

No User Rating (Site Visit) - Joint sealant peeling on riverside floodwall.

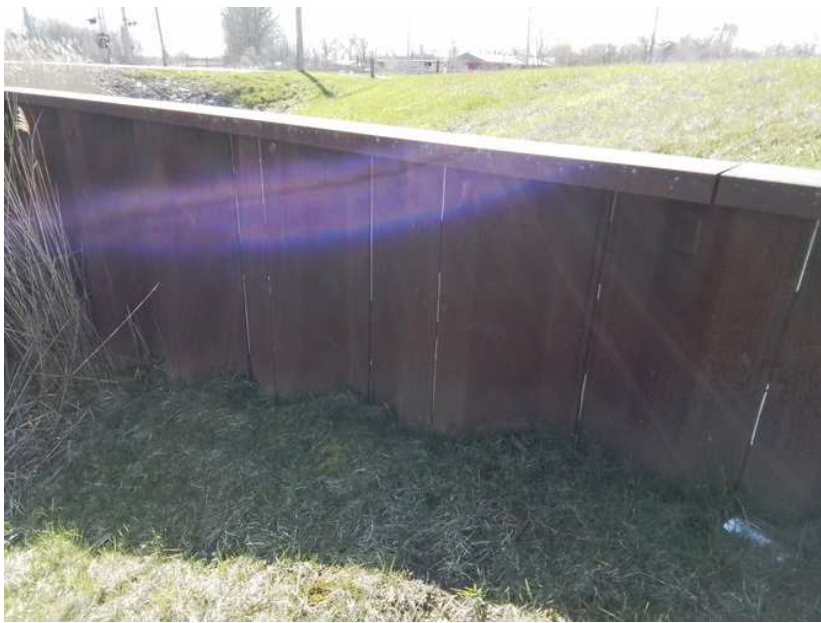
Inspect ID: 2024-0048

No User Rating (Site Visit) - Caulking deteriorated on riverside face.

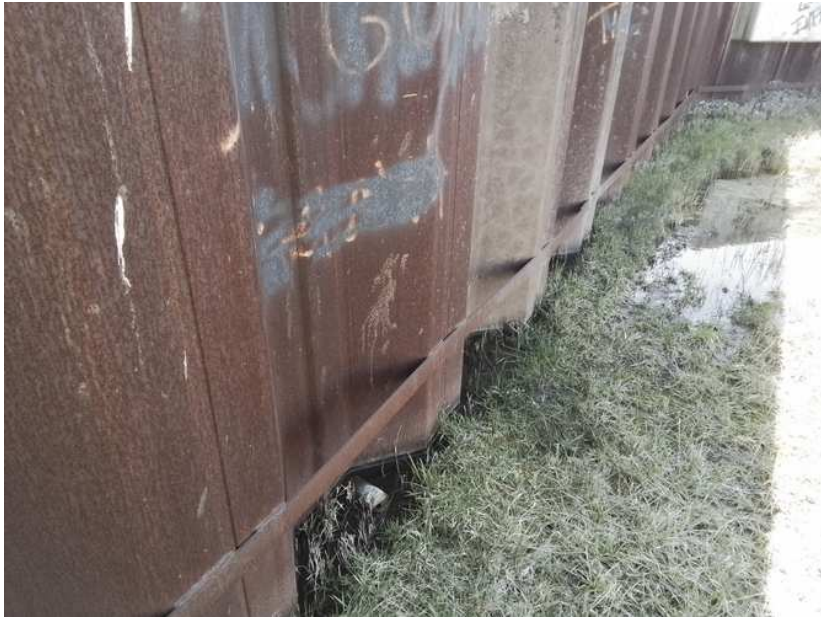
Inspect ID: 2024-0084

No User Rating (Site Visit) - Water ponding observed along landside floodwall toe.

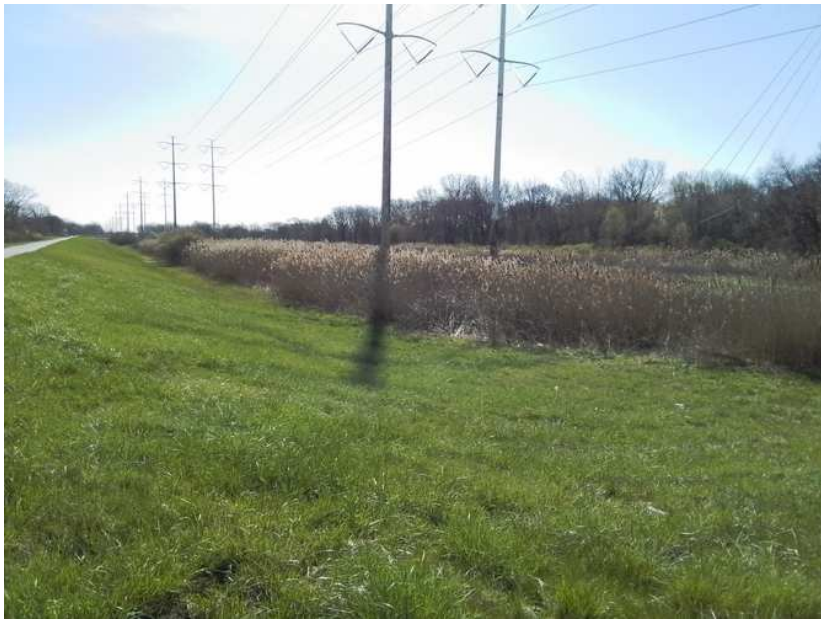
Inspect ID: 2024-0004

No User Rating (Site Visit) - Vegetation observed in both ditches (looking SE).

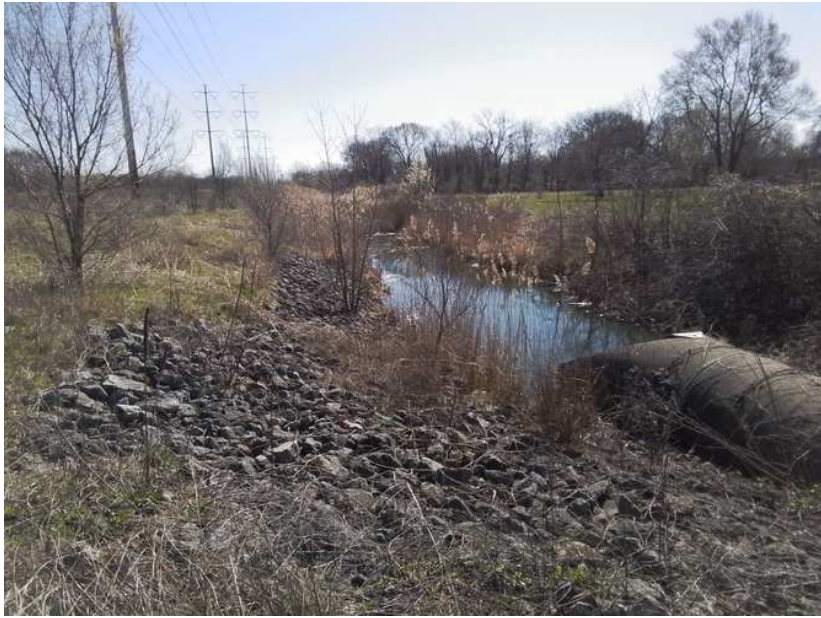
Inspect ID: 2024-0028

No User Rating (Site Visit) - Some vegetation observed in southern ditch (looking east).

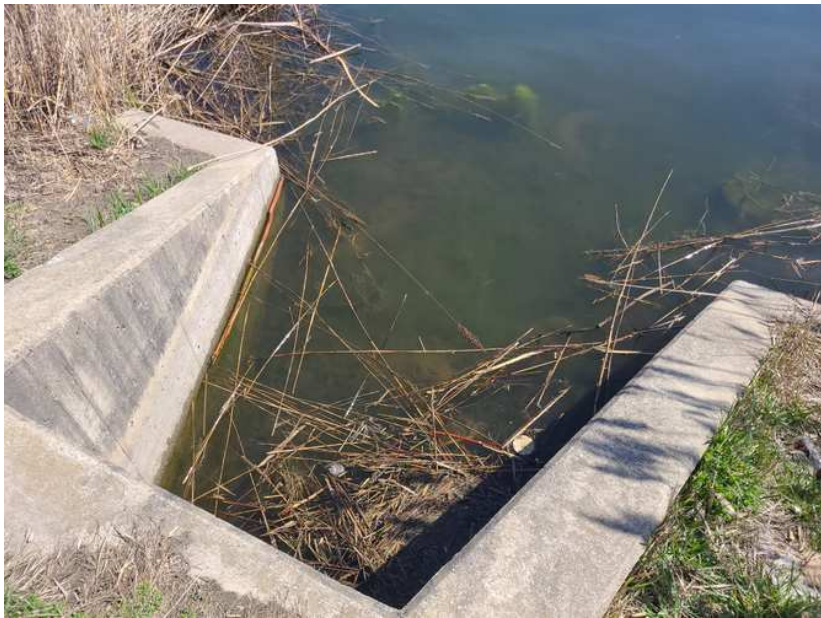
Inspect ID: 2024-0037

No User Rating (Site Visit) - GB-02: Sedimentation and vegetation near flap gate.

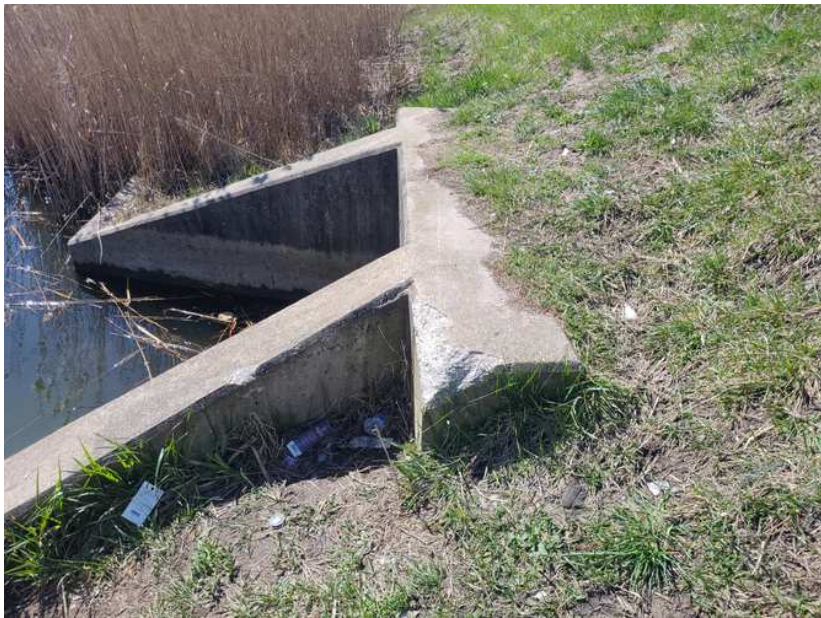
Inspect ID: 2024-0041

No User Rating (Site Visit) - GB-02: Spalling on wingwall.

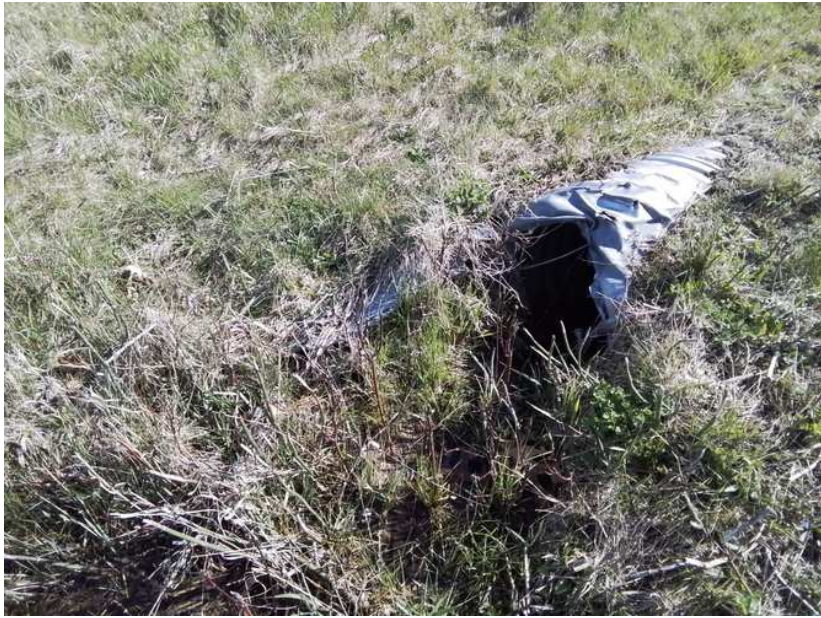
Inspect ID: 2024-0024

No User Rating (Site Visit) - Culvert under Calhoun St. appears to be crushed partially on end.

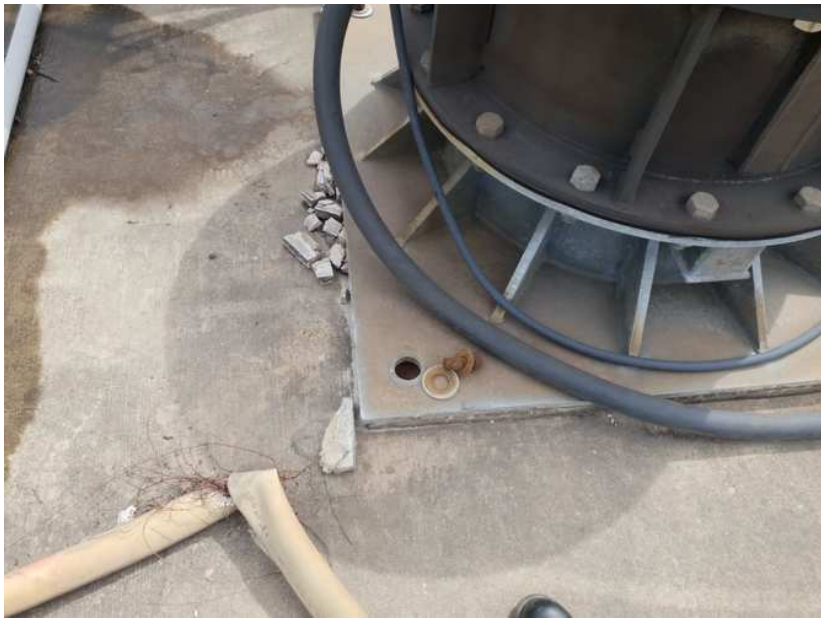
No User Rating (Site Visit) - PS-BS: nut and bolt broken off on pump base plate.

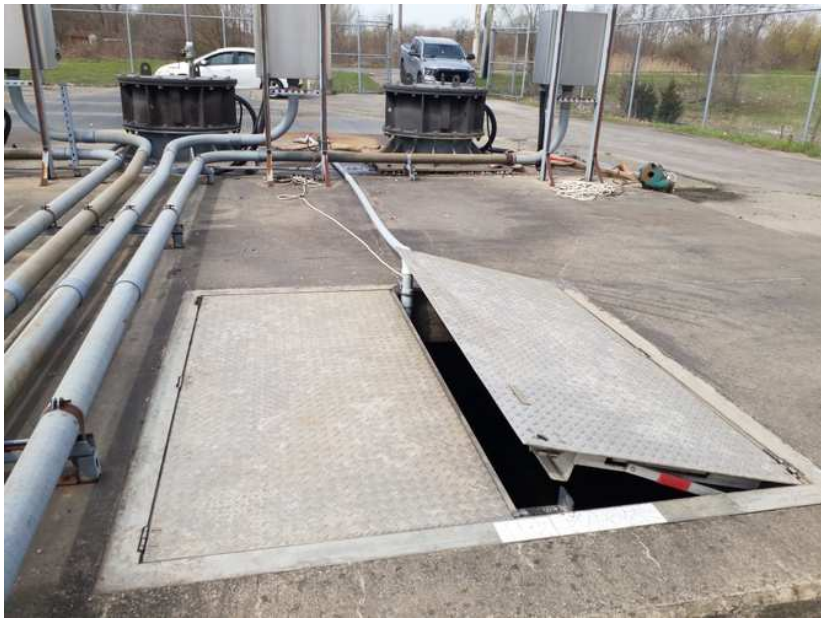
No User Rating (Site Visit) - PS-BS: temporary discharge pipe has been here for many years.

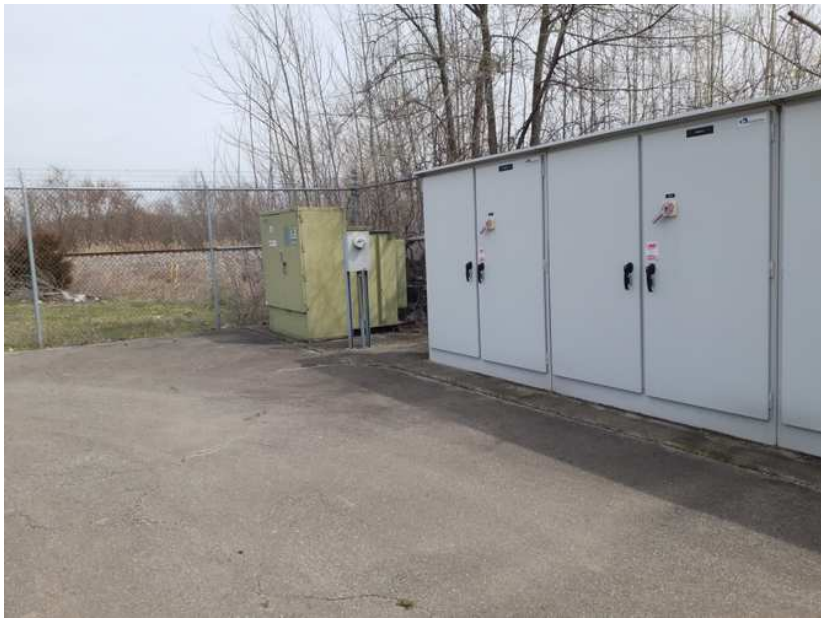
Inspect ID: 2024-0022

No User Rating (Site Visit) - PS-BS: no generator or backup power plug location on site.

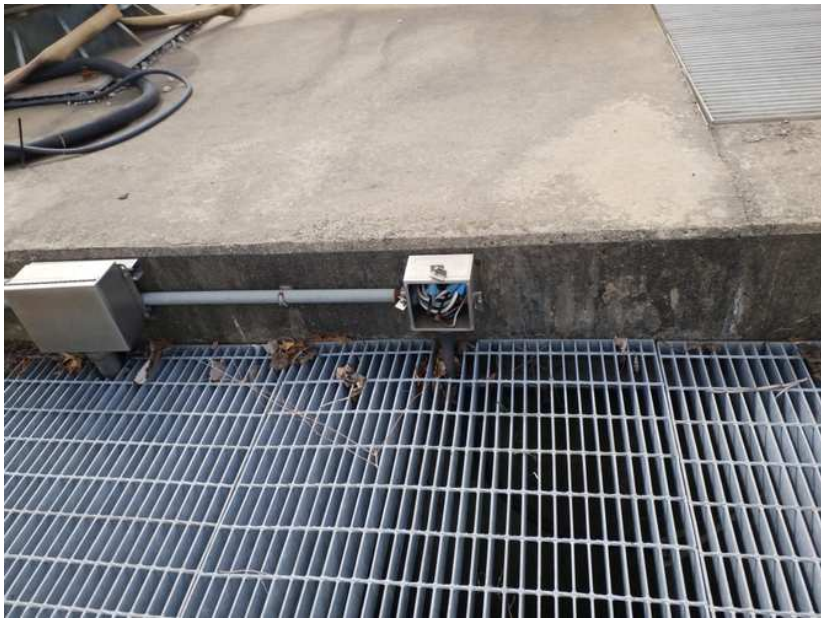
Inspect ID: 2024-0006

No User Rating (Site Visit) - PS-BS: missing cover on electrical box.
