**US Army Corps
of Engineers ®**

Site Visit Summary

Name of System: Gary

Name of Segment: Gary North

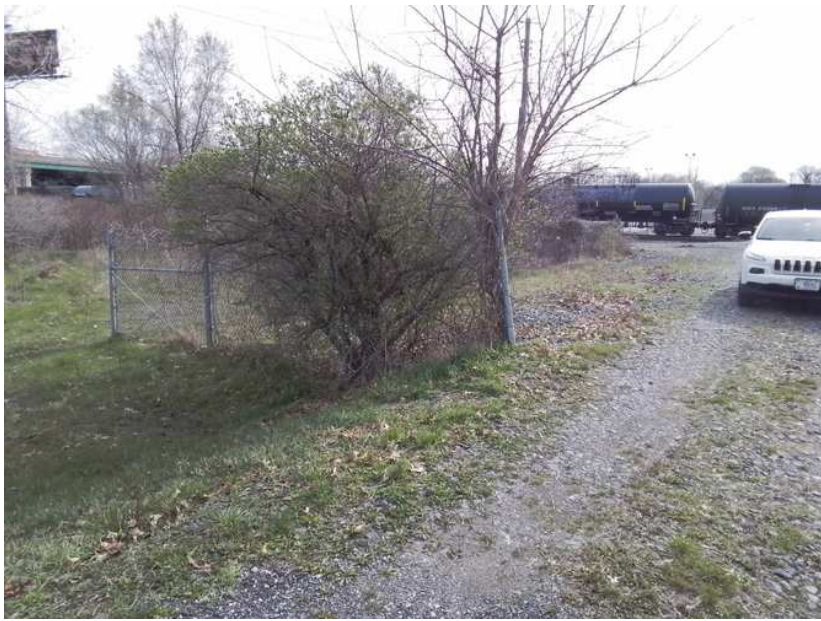
Inspect ID: 2024-0084

No User Rating (Site Visit) - Vegetation on landside slope

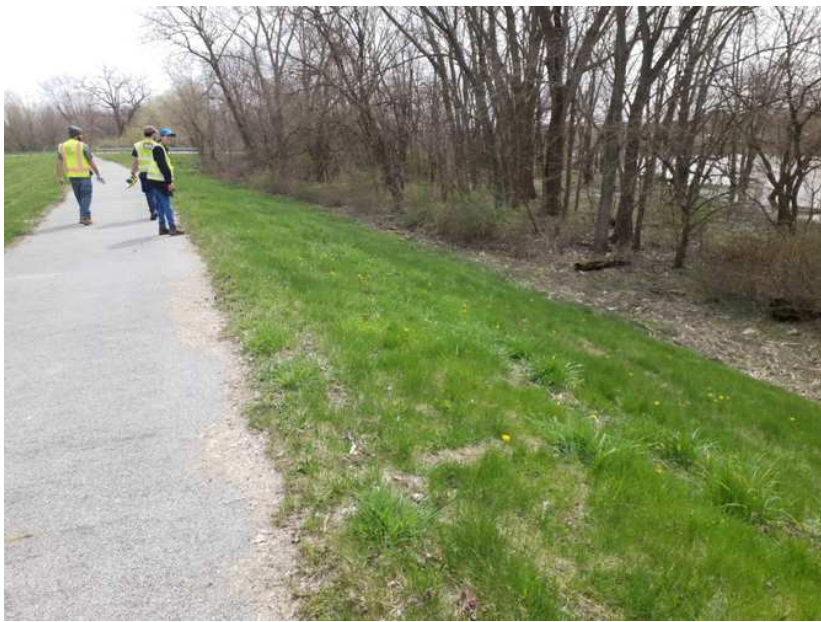
Inspect ID: 2024-0263

No User Rating (Site Visit) - Trees on riverside toe

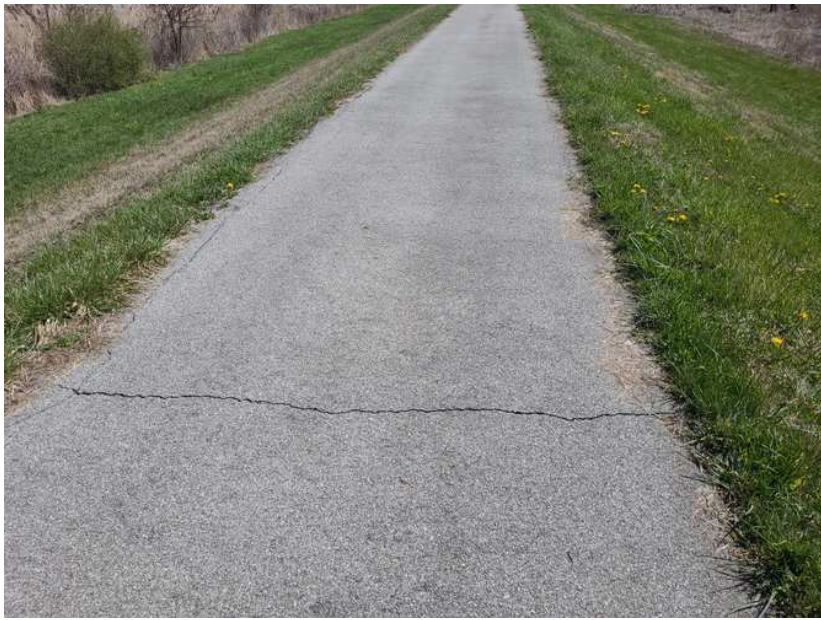
Inspect ID: 2024-0013

No User Rating (Site Visit) - Crack in asphalt on crest

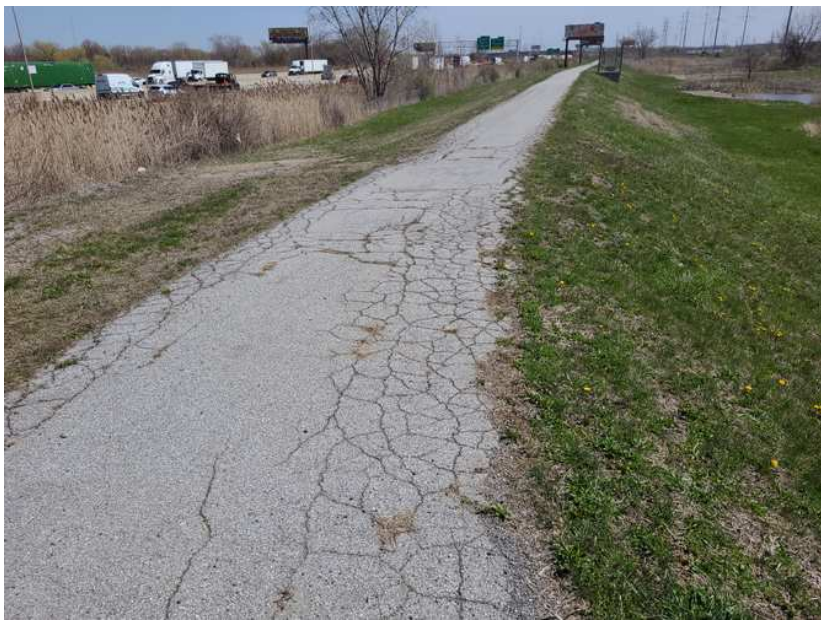
Inspect ID: 2024-0037

No User Rating (Site Visit) - Crack in asphalt on crest

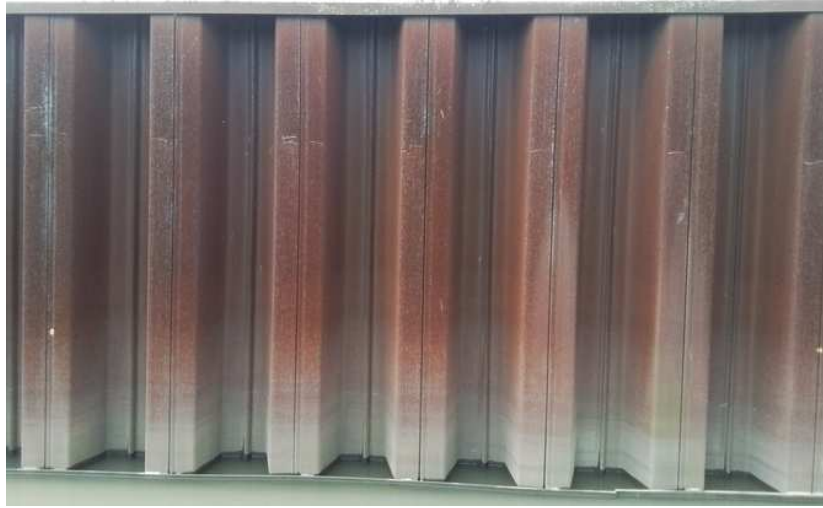
Inspect ID: 2024-0176

No User Rating (Site Visit) - Four bolts missing on floodwall joint.

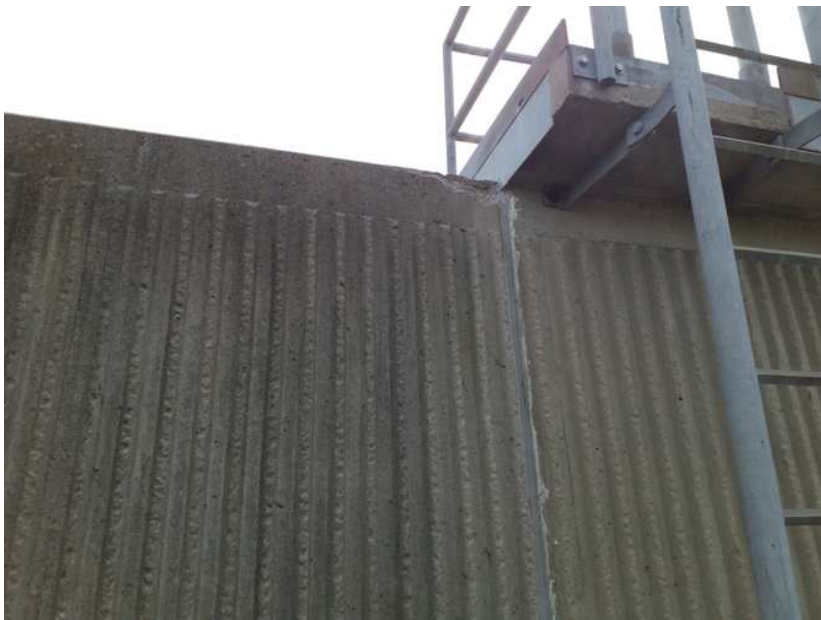
Inspect ID: 2024-0367

No User Rating (Site Visit) - Spalling on floodwall top

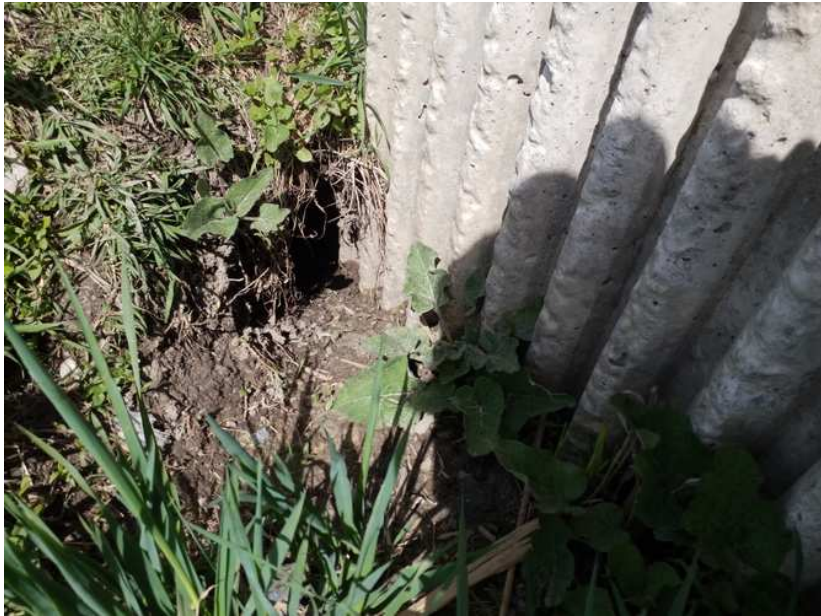
Inspect ID: 2024-0086

No User Rating (Site Visit) - 10 inch deep animal burrow at riverside base.

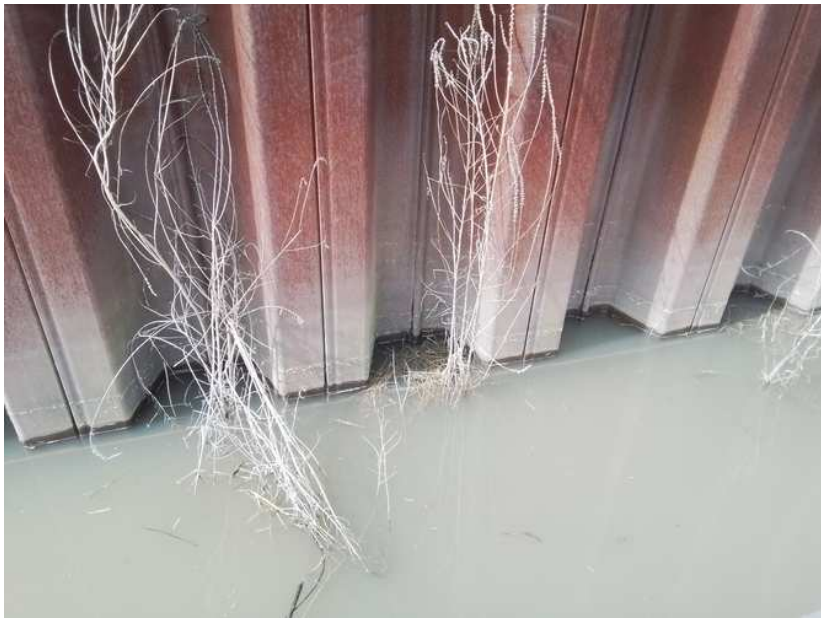
Inspect ID: 2024-0184

No User Rating (Site Visit) - Typical missing sealant on floodwall joints, landside.

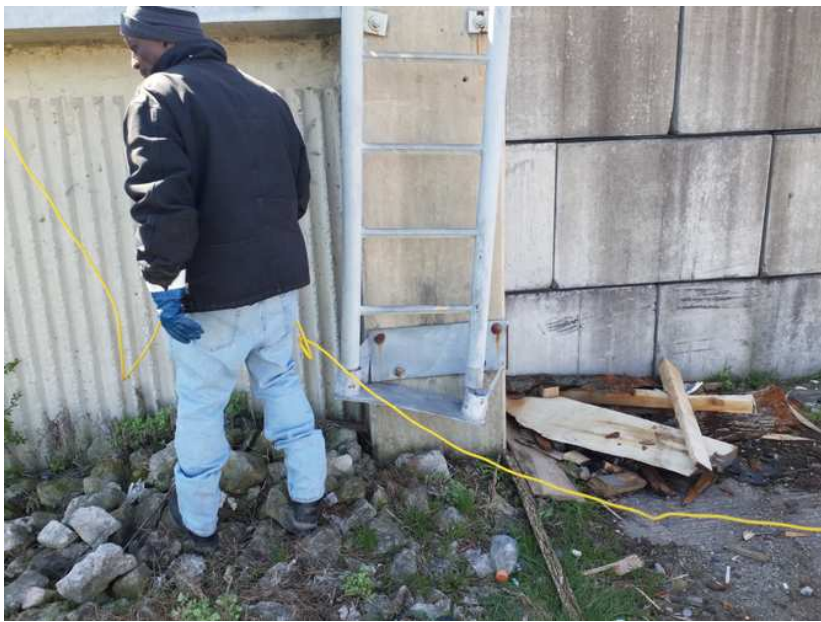
Inspect ID: 2024-0050

No User Rating (Site Visit) - Crack in concrete and missing chunk of concrete in headwall

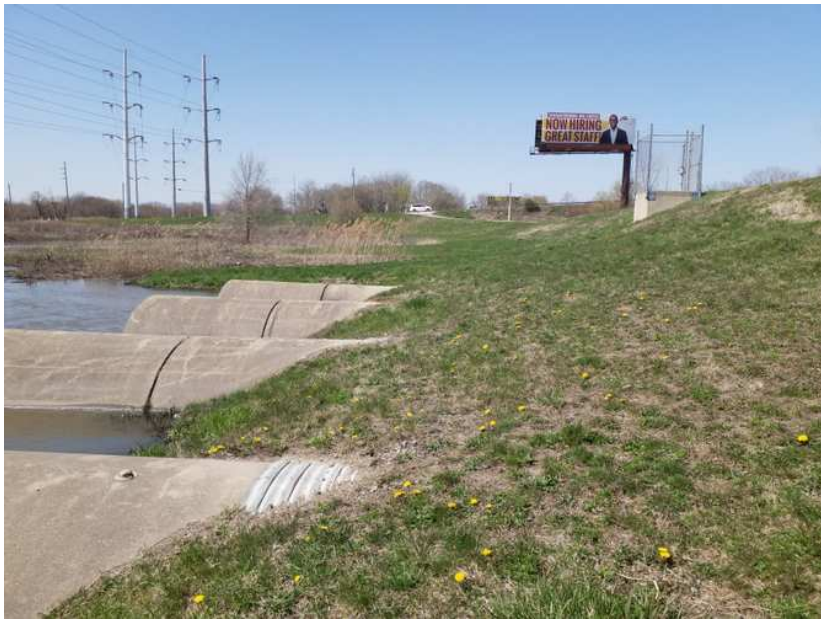
Inspect ID: 2024-0011

No User Rating (Site Visit) - GN-02: Spalling on landside wing wall

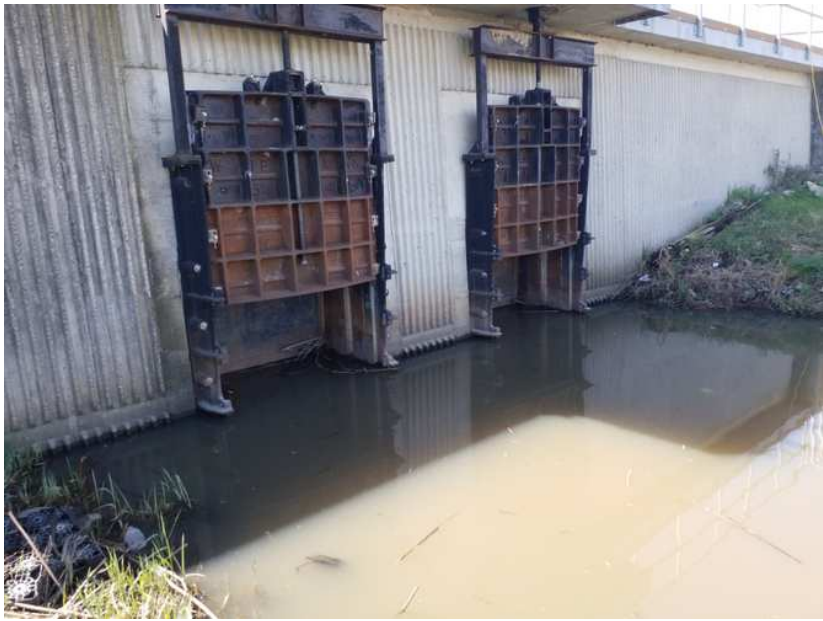
Inspect ID: 2024-0054

No User Rating (Site Visit) - GN-08: All gauges (A, B, and C) were not working - unchanged since last inspection. Closure was verified using screw shaft

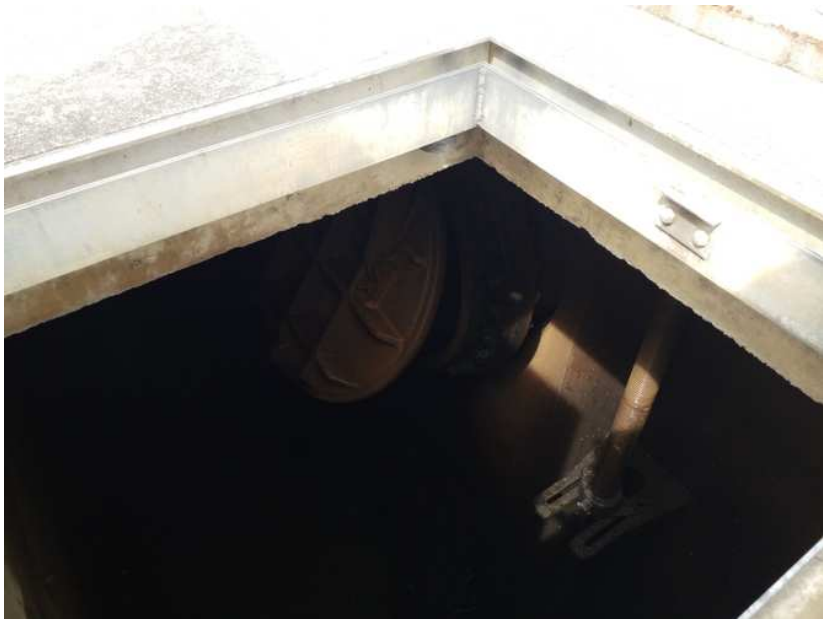
Inspect ID: 2024-0130

No User Rating (Site Visit) - PS-BR: Pump 1 is out for service.
