US Army Corps
of Engineers ®

Site Visit Summary

Name of System: Gary

Name of Segment: Gary South

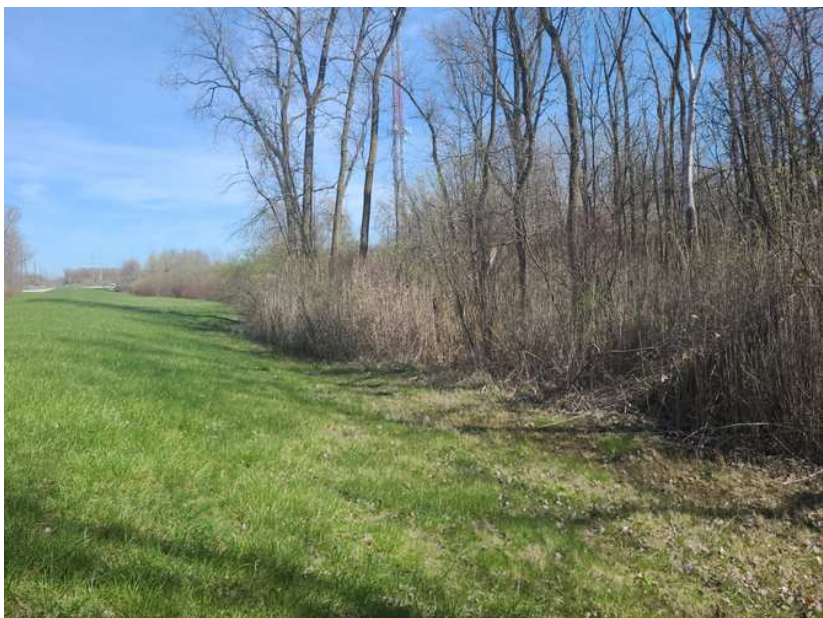
Inspect ID: 2024-0005

No User Rating (Site Visit) - Trees and vegetation within 15 feet of landside toe.

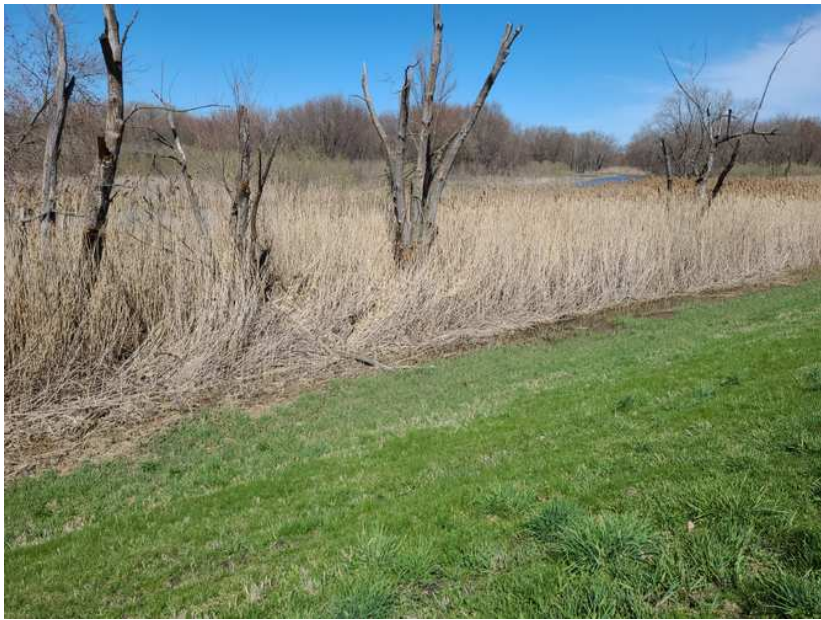
Inspect ID: 2024-0121

No User Rating (Site Visit) - Several dead trees near riverside toe and one downed tree on the riverside toe.

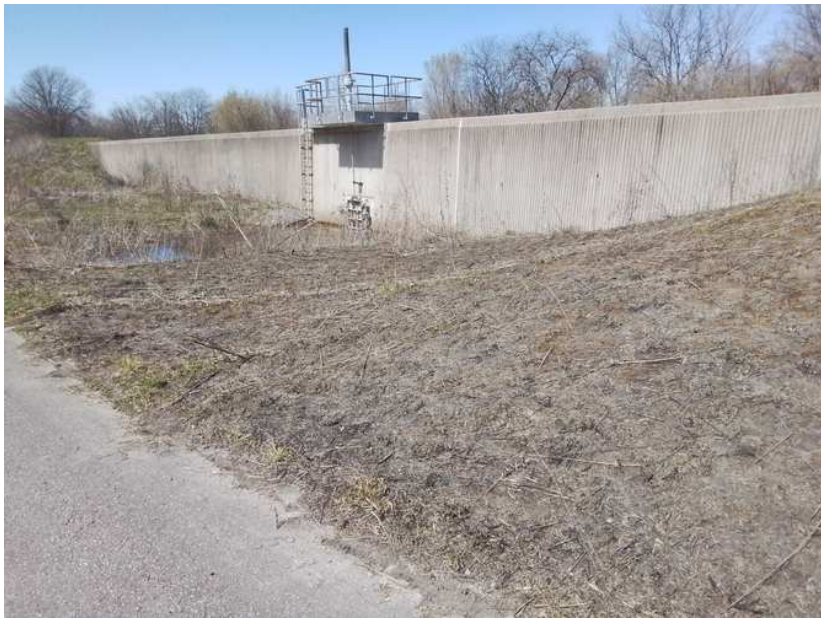
Inspect ID: 2024-0132
Rated Item: 2. Sod Cover
Lat/Long: 41.56056/-87.34379
Caption:

No User Rating (Site Visit) - Poor grass coverage on landside slope due to recent burn.

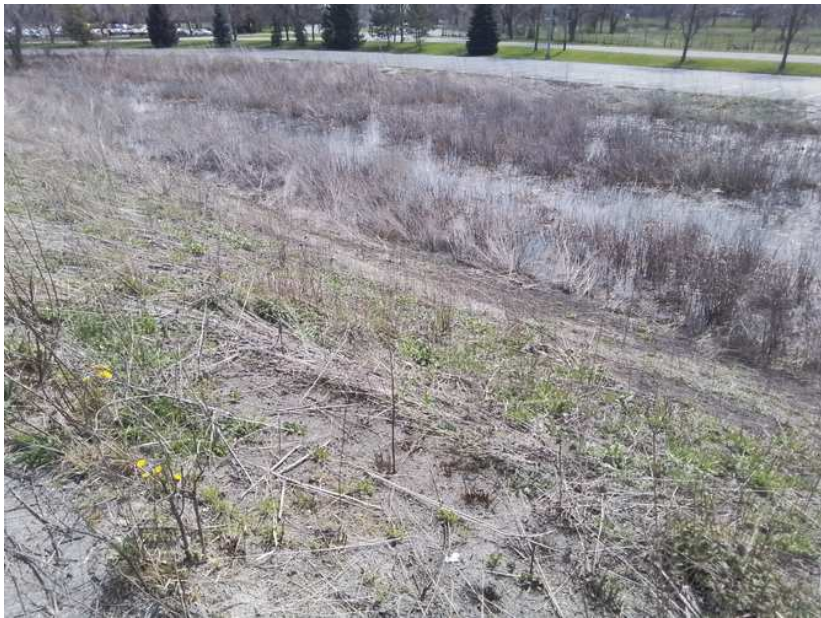
Inspect ID: 2024-0140
Rated Item: 2. Sod Cover
Lat/Long: 41.55946/-87.34106
Caption:

No User Rating (Site Visit) - Area of poor grass coverage on landside slope and toe after recent burn.

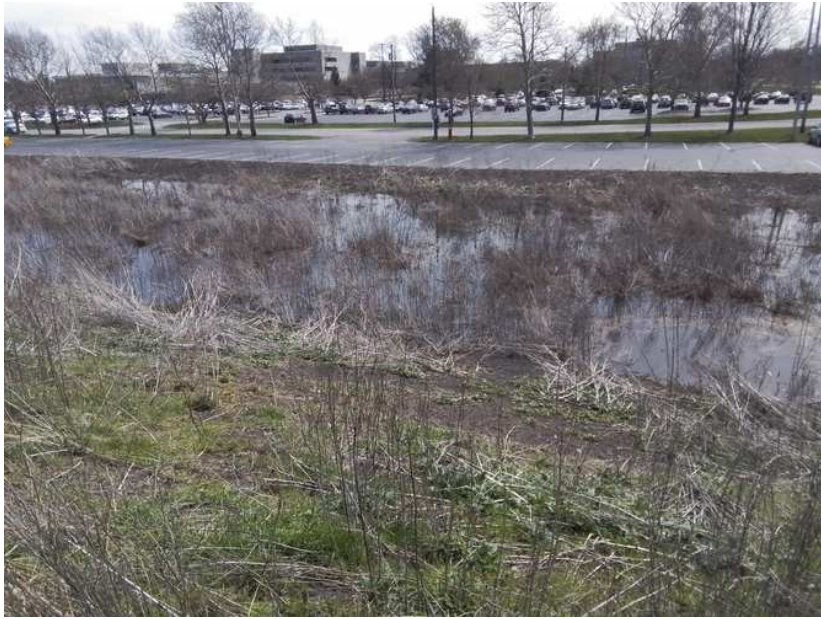
Inspect ID: 2024-0144

No User Rating (Site Visit) - Area of poor grass coverage on landside slope and toe after recent burn.

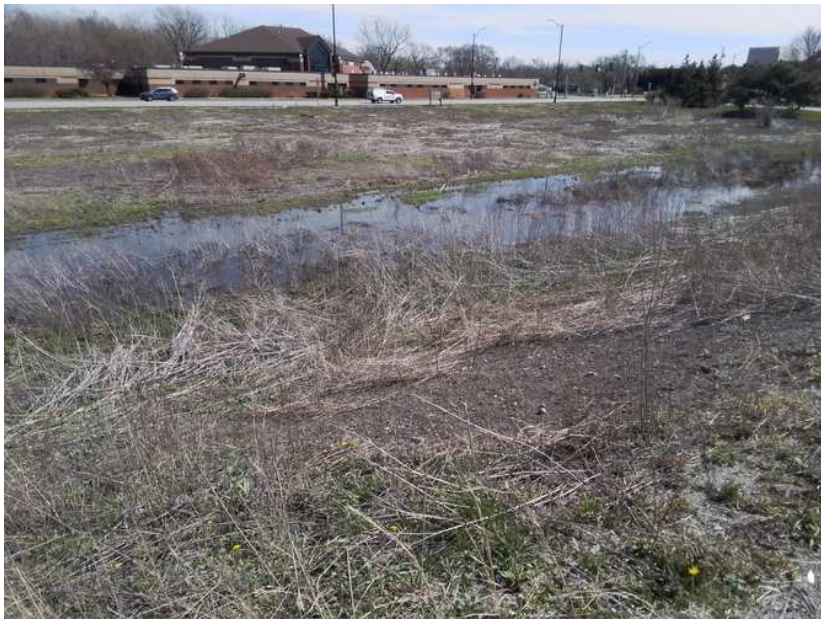
Inspect ID: 2024-0152

No User Rating (Site Visit) - Area of poor sod coverage on landside slope after recent burn.

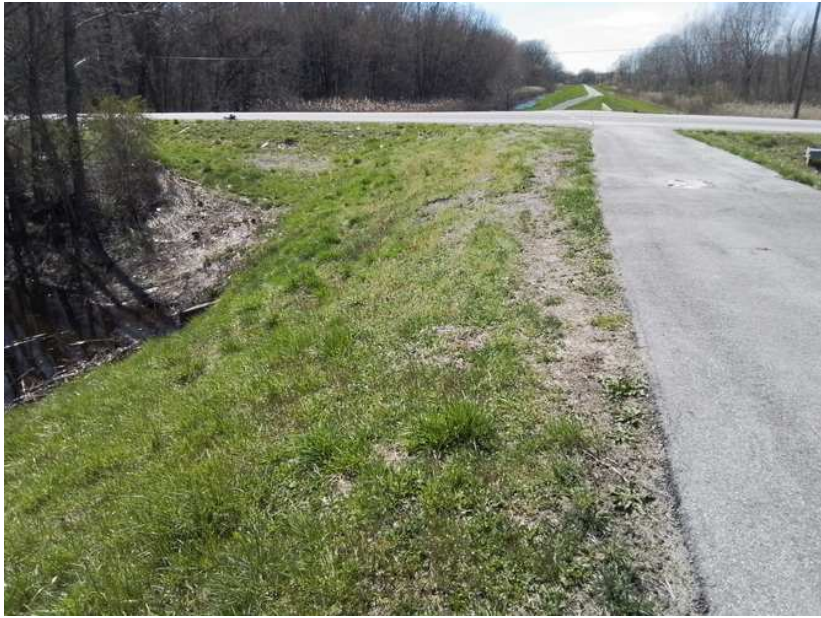
Inspect ID: 2024-0192

No User Rating (Site Visit) - Minimal sod cover observed on landside slope

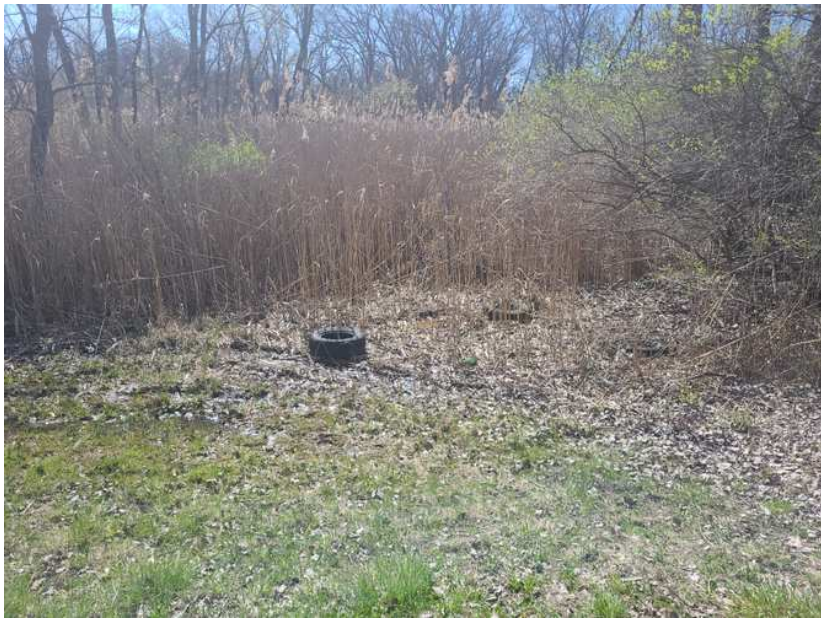
Inspect ID: 2024-0001

No User Rating (Site Visit) - Tire observed on landside toe.

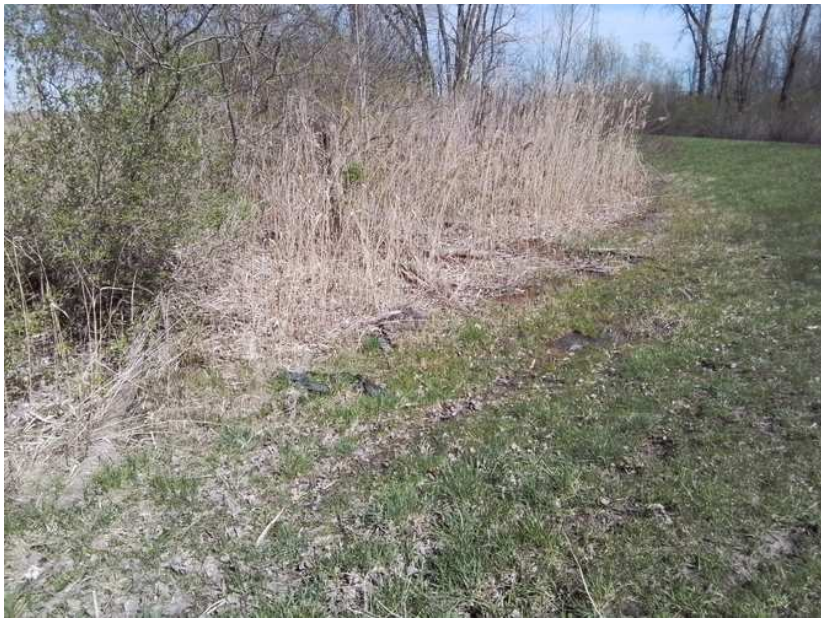
Inspect ID: 2024-0004

No User Rating (Site Visit) - Fallen logs and other debris observed on riverside toe

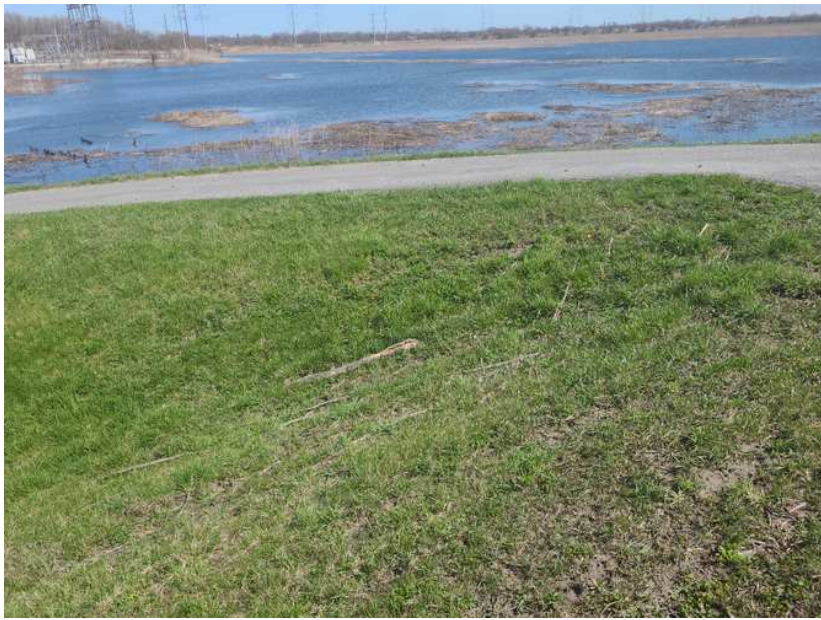
Inspect ID: 2024-0021

No User Rating (Site Visit) - Fallen logs washed up on riverside toe.

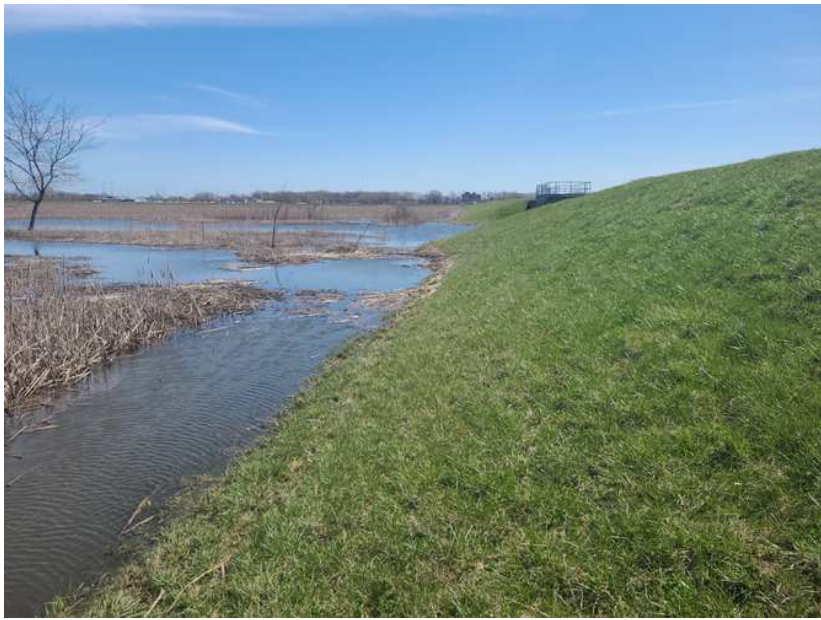
Inspect ID: 2024-0033

No User Rating (Site Visit) - Erosion and bank caving on the riverside toe

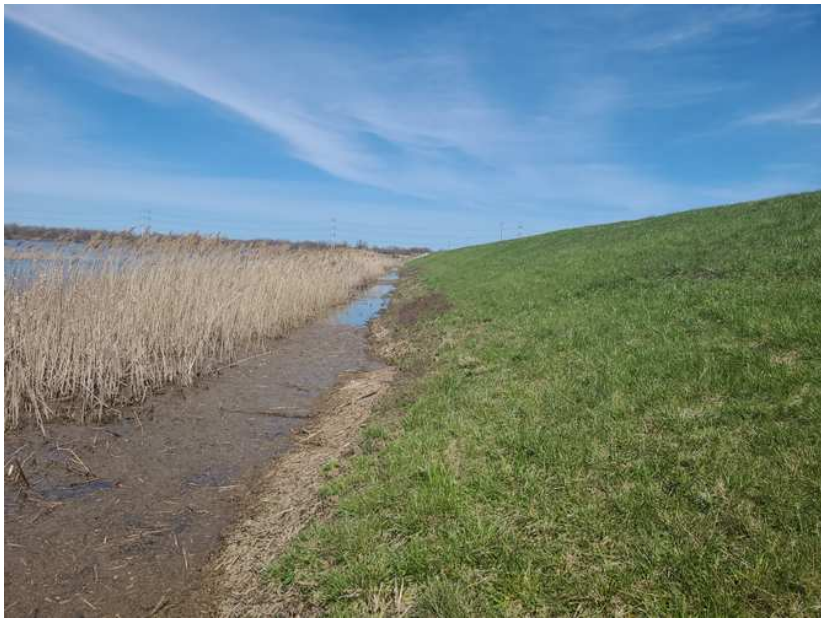
Inspect ID: 2024-0045

No User Rating (Site Visit) - Typical erosion and bank caving. Wave action causing bank caving line on riverside slope

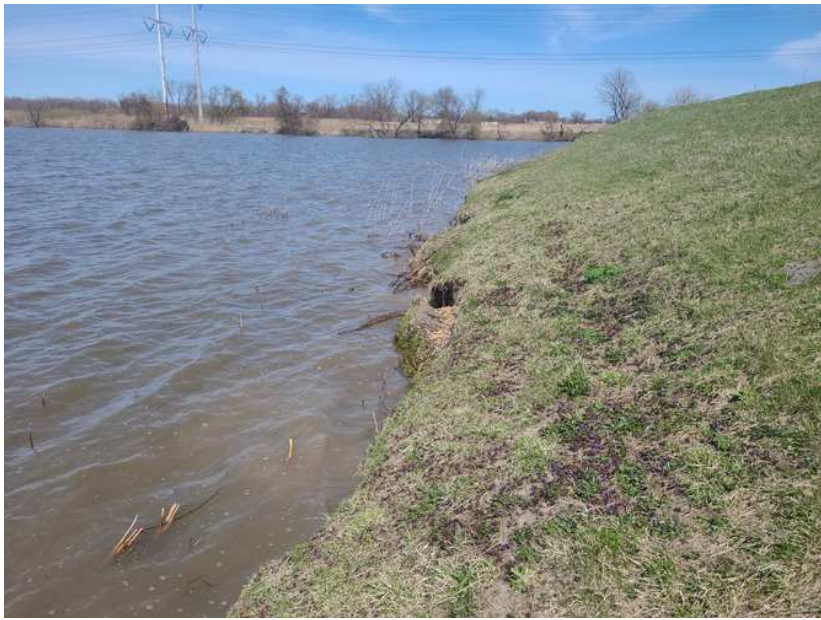
Inspect ID: 2024-0057

No User Rating (Site Visit) - Active bank caving on riverside toe

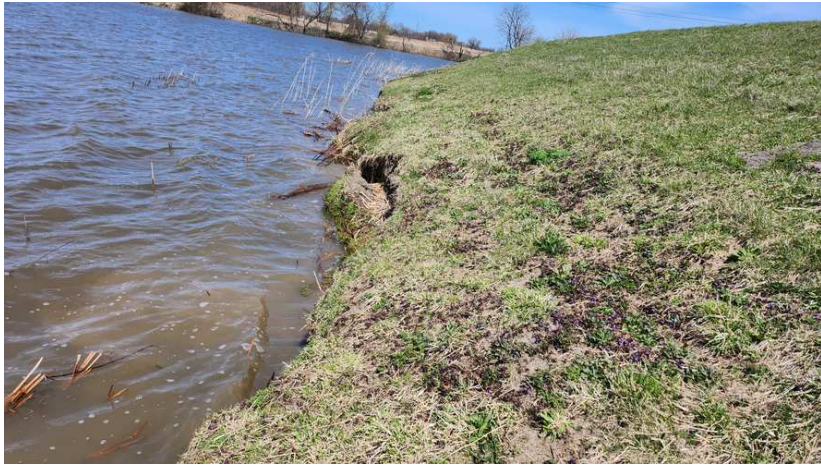
Inspect ID: 2024-0221

0221 - No User Rating (Site Visit) - Bank caving on riverside toe

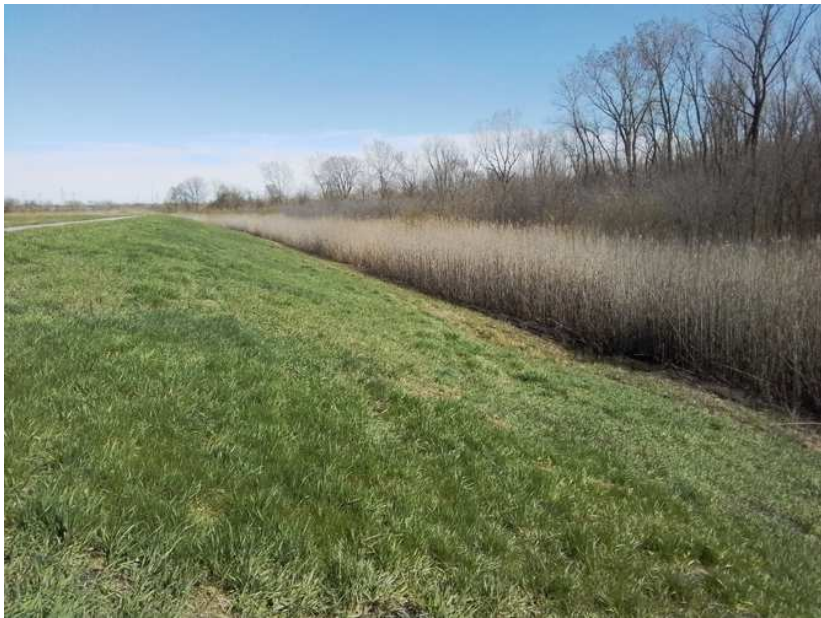
Inspect ID: 2024-0212

No User Rating (Site Visit) - Depression on landside toe.

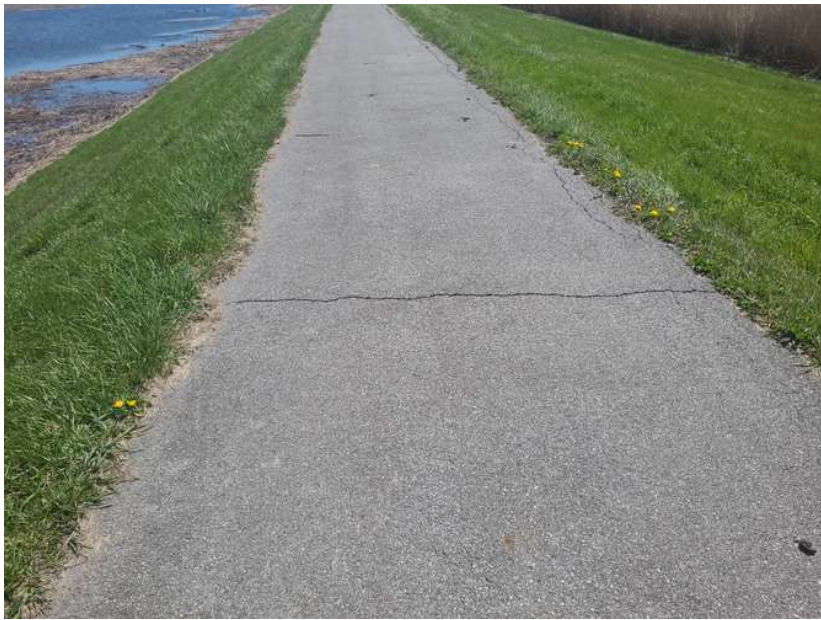
Inspect ID: 2024-0025

No User Rating (Site Visit) - Small crack in the asphalt on crown of levee

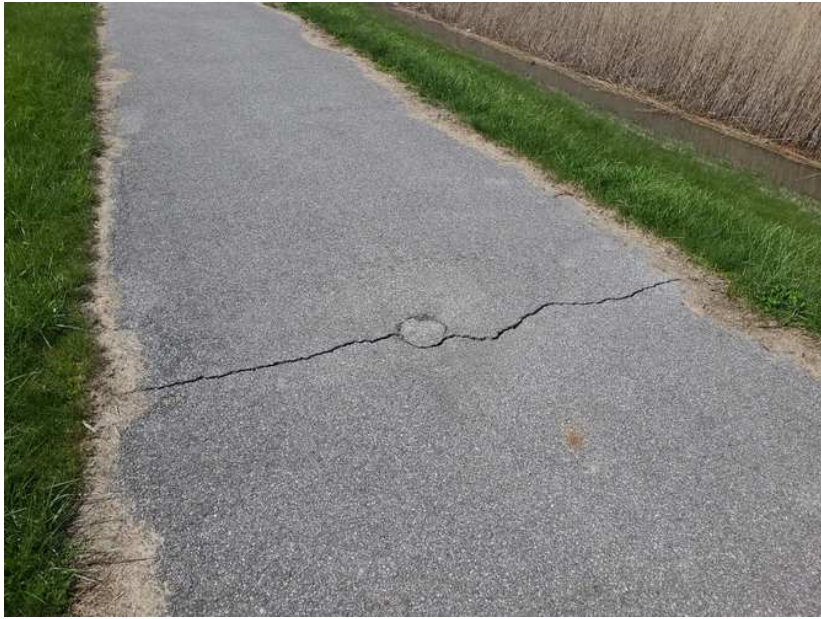
Inspect ID: 2024-0081

No User Rating (Site Visit) - Typical cracking along asphalt on crown

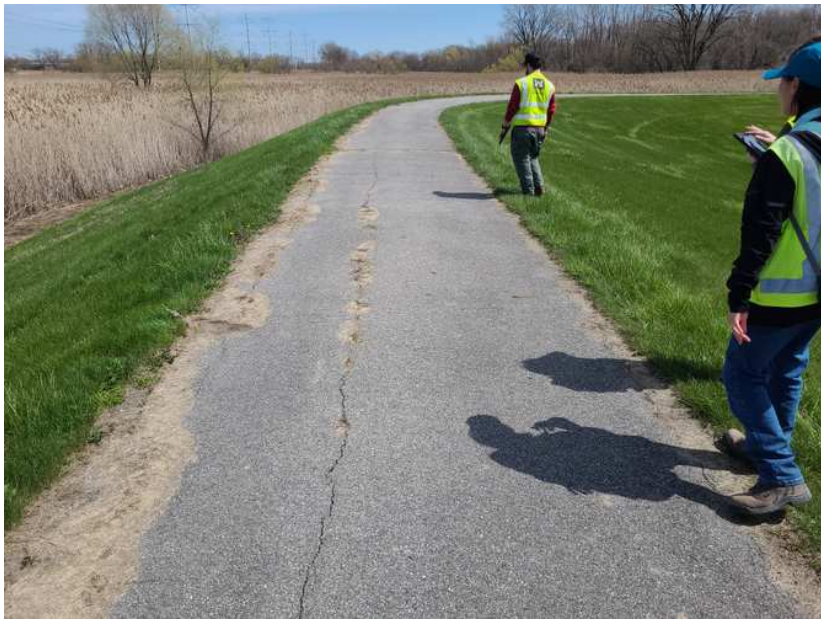
Inspect ID: 2024-0085

No User Rating (Site Visit) - Crack in asphalt running parallel to levee alignment

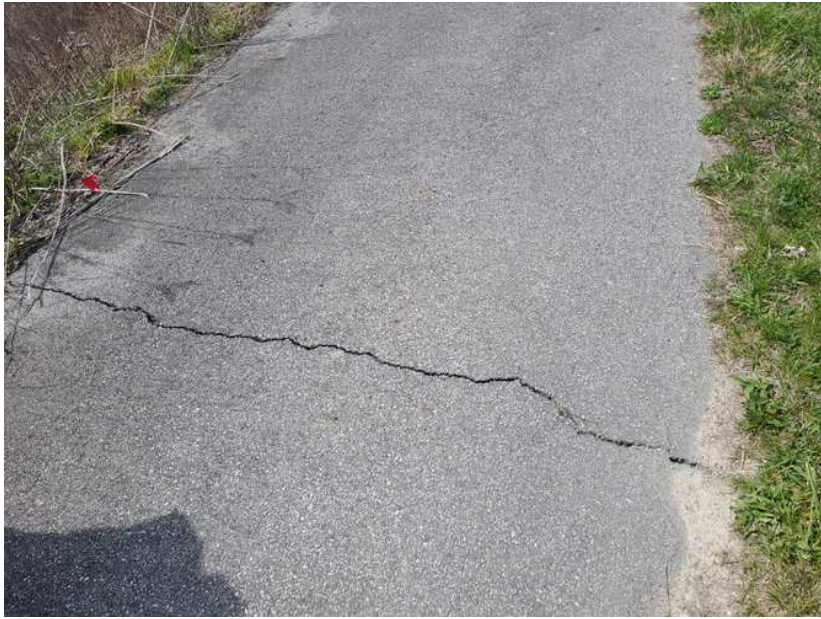
Inspect ID: 2024-0105
Rated Item: 9. Cracking
Lat/Long: 41.55971/-87.34173
Caption:

No User Rating (Site Visit) - Typical asphalt cracking in crown

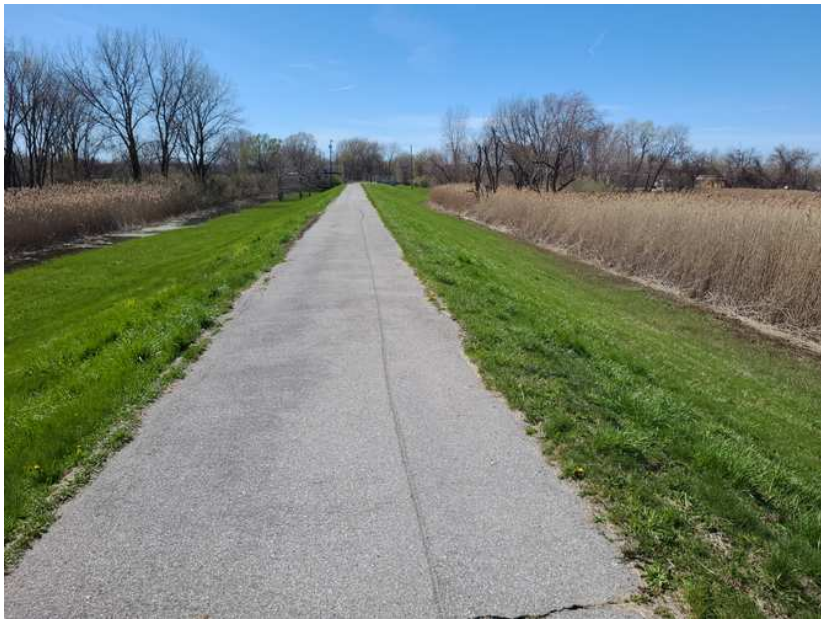
Inspect ID: 2024-0125
Rated Item: 9. Cracking
Lat/Long: 41.56067/-87.33371
Caption:

No User Rating (Site Visit) - Groove in asphalt running parallel to levee alignment

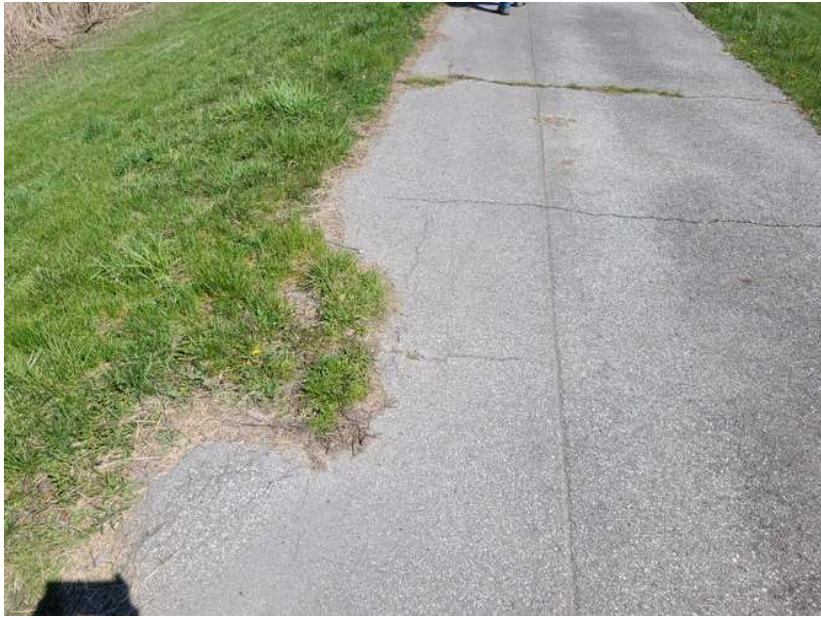
Inspect ID: 2024-0129

No User Rating (Site Visit) - Cracked and separated asphalt

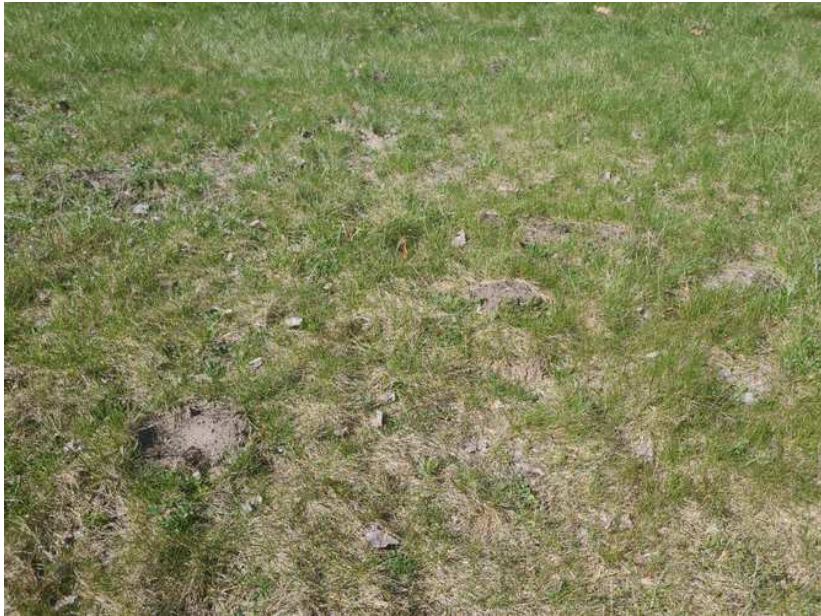
Inspect ID: 2024-0009

No User Rating (Site Visit) - Animal burrows are typical along landside toe

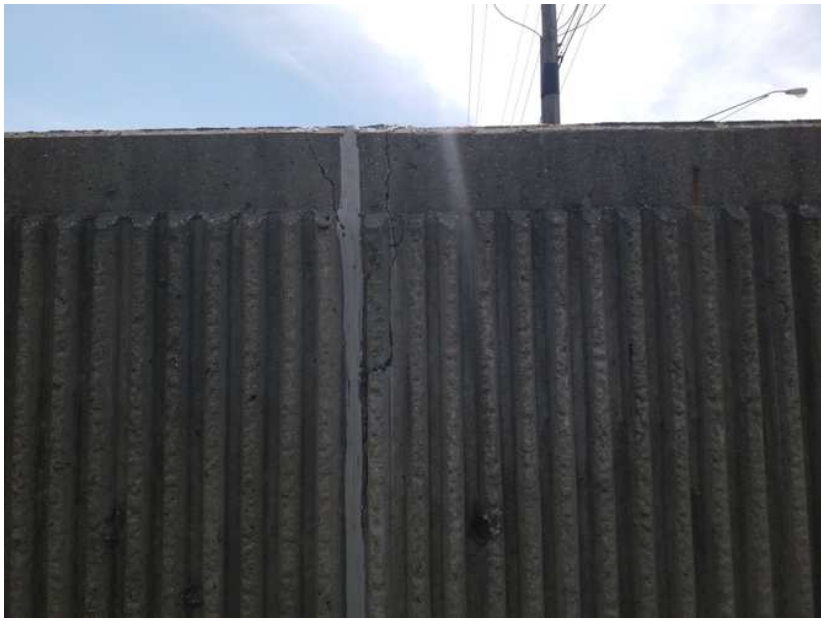
Inspect ID: 2024-0035

No User Rating (Site Visit) - Riverside cracks in wall near joint

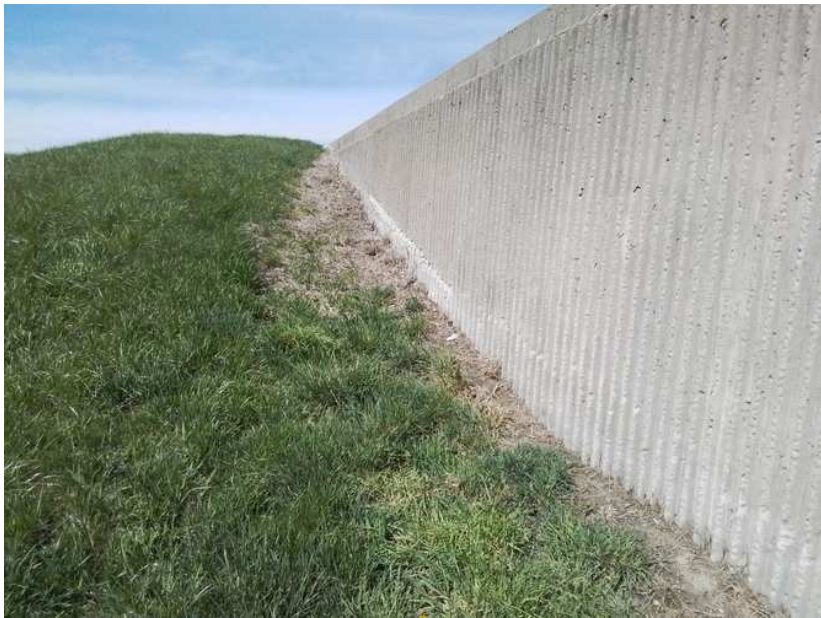
Inspect ID: 2024-0044

No User Rating (Site Visit) - Rutting along concrete on landside of floodwall.

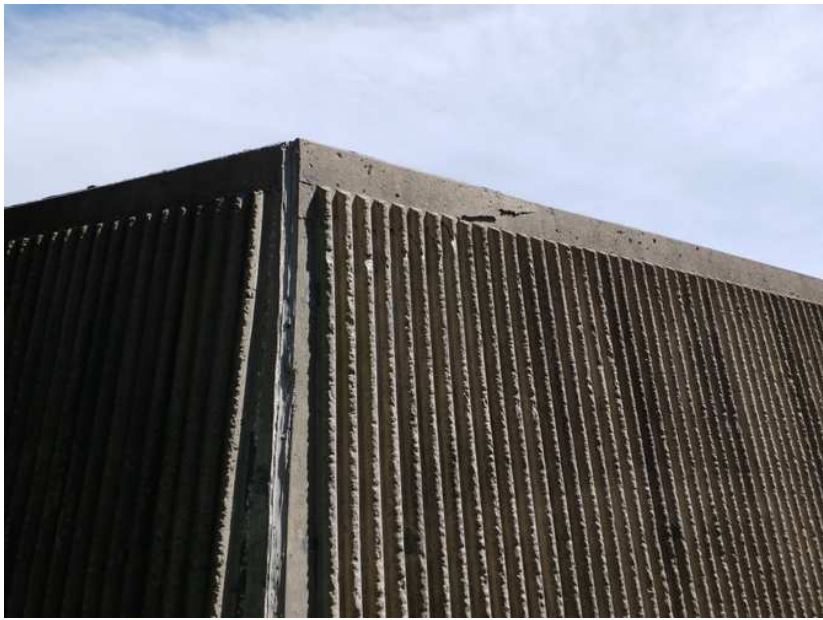
Inspect ID: 2024-0067

No User Rating (Site Visit) - Crack at the top corner on the riverside

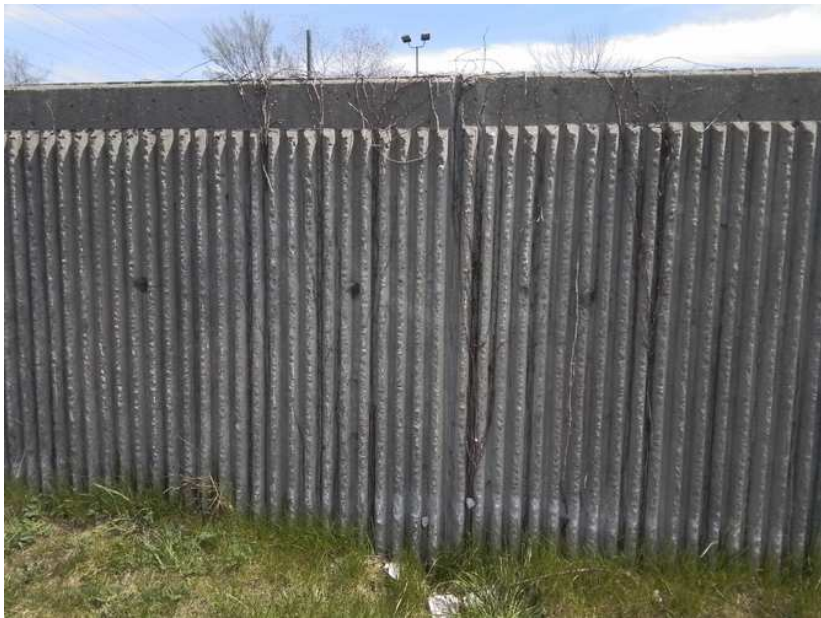
Inspect ID: 2024-0096

No User Rating (Site Visit) - Two long cracks observed on landside floodwall

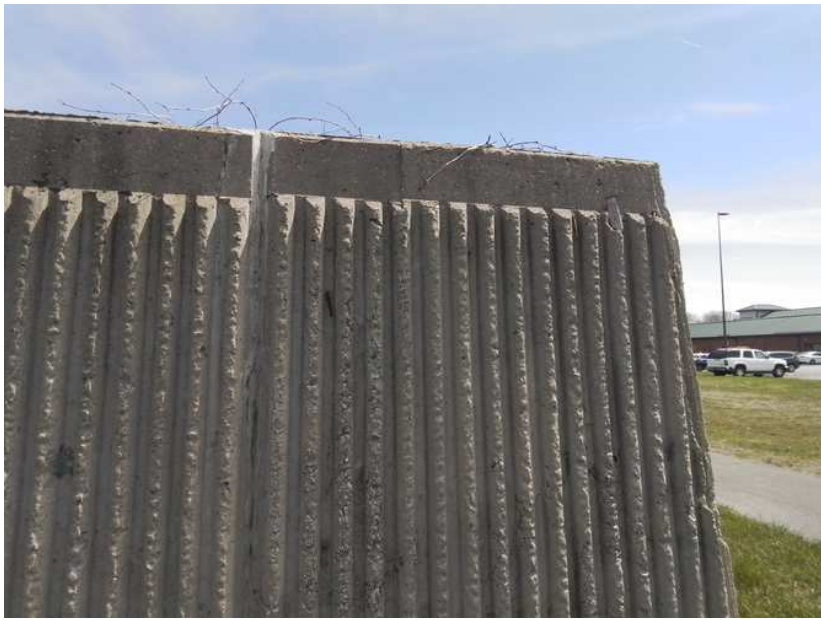
Inspect ID: 2024-0100

No User Rating (Site Visit) - Rebar sticking out of landside floodwall

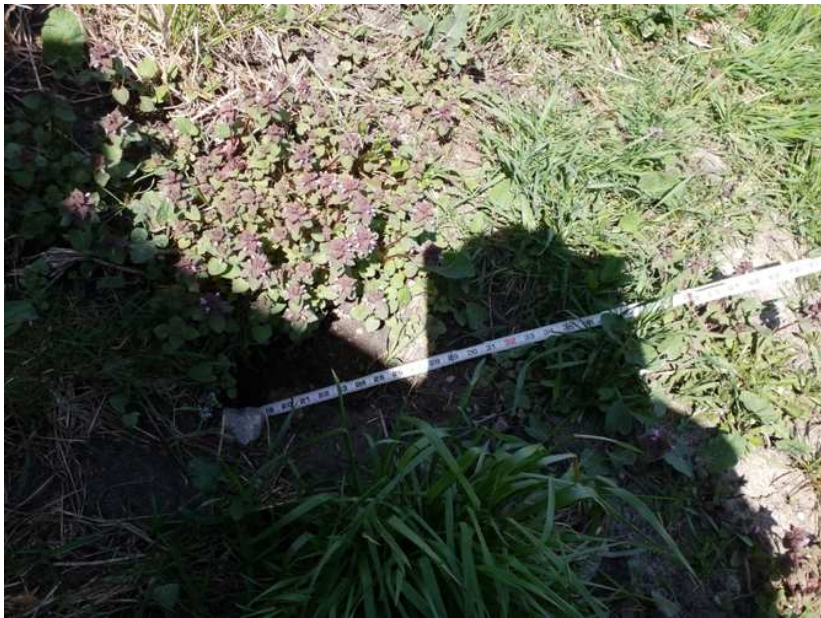
Inspect ID: 2024-0027

No User Rating (Site Visit) - Animal burrow on riverside of floodwall

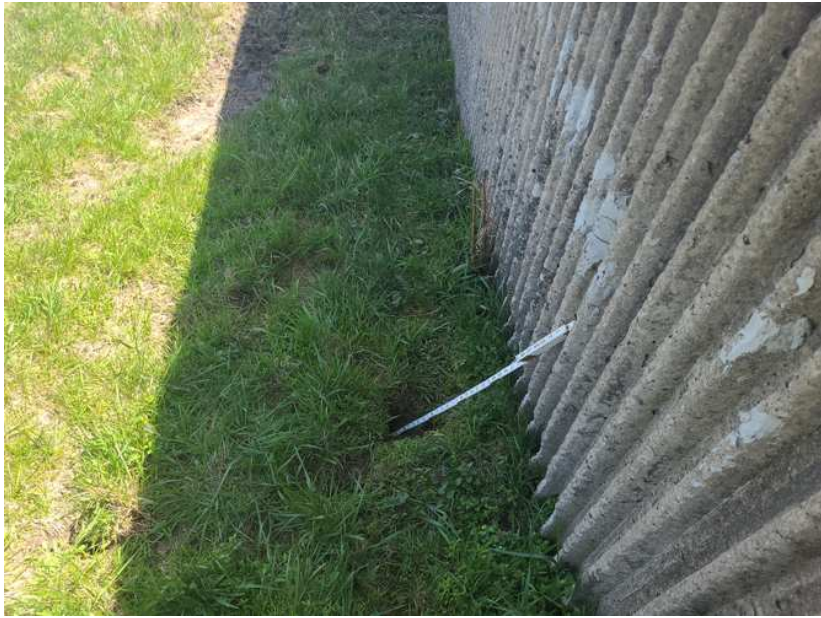
Inspect ID: 2024-0037

No User Rating (Site Visit) - Animal burrows on riverside toe.

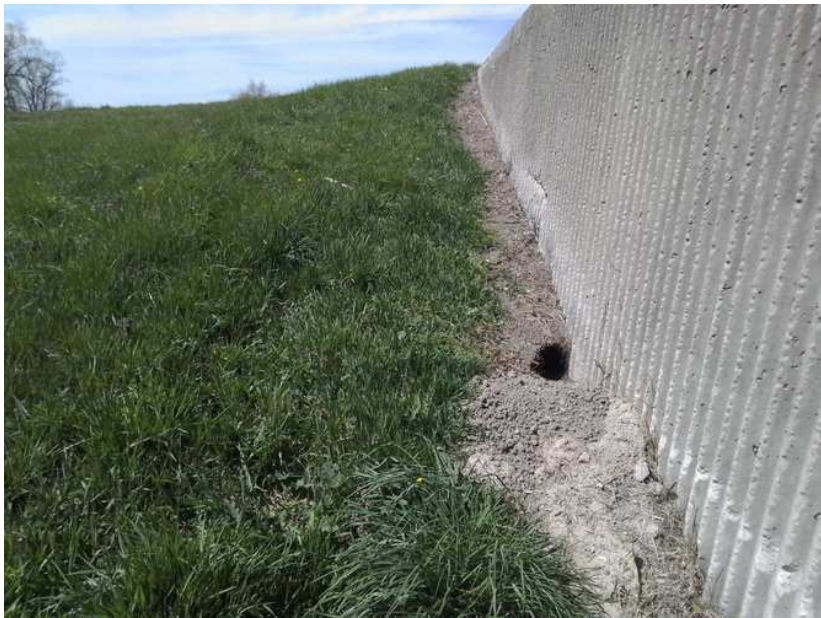
Inspect ID: 2024-0080

No User Rating (Site Visit) - Animal burrow (approximately 8 inch) along landside of floodwall

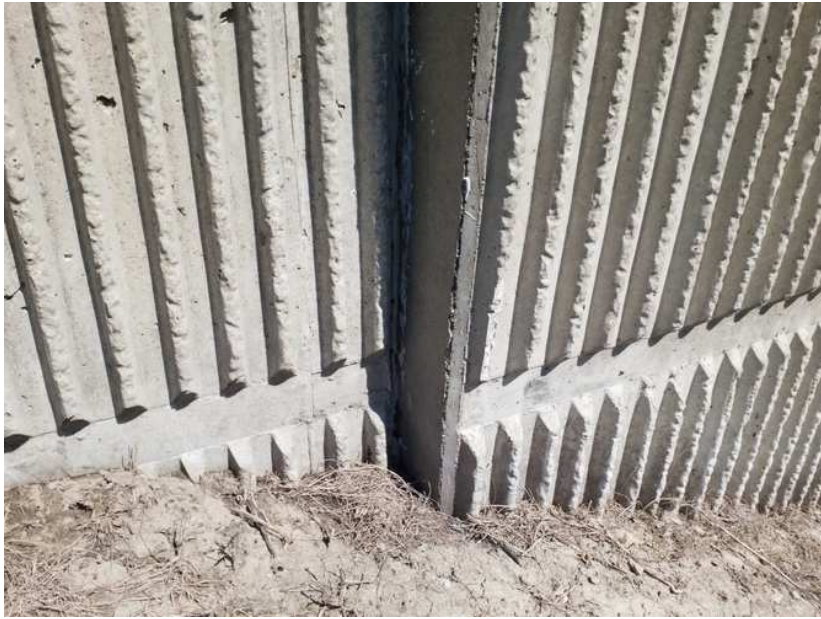
Inspect ID: 2024-0011

No User Rating (Site Visit) - Cracking sealant in landside joint

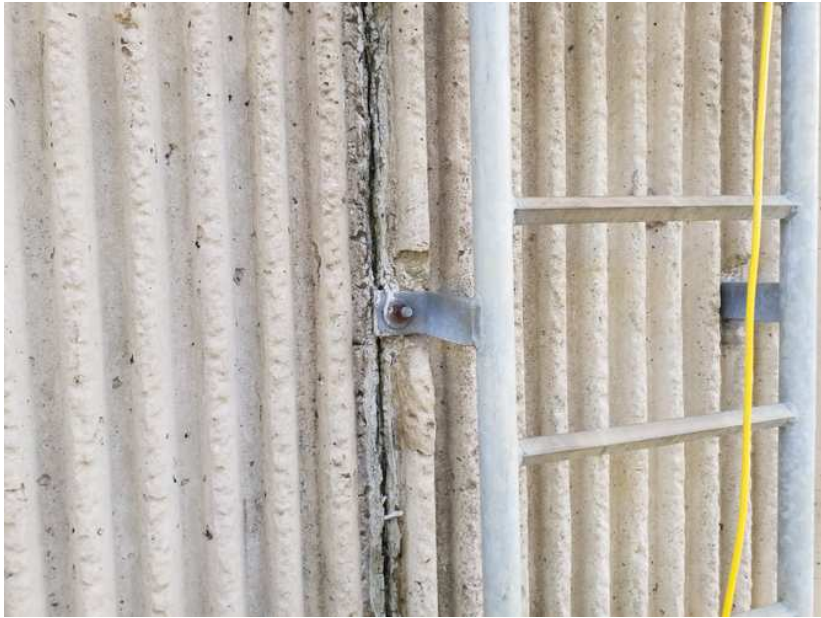
Inspect ID: 2024-0018

No User Rating (Site Visit) - Degradation of seal on riverside near GS-10

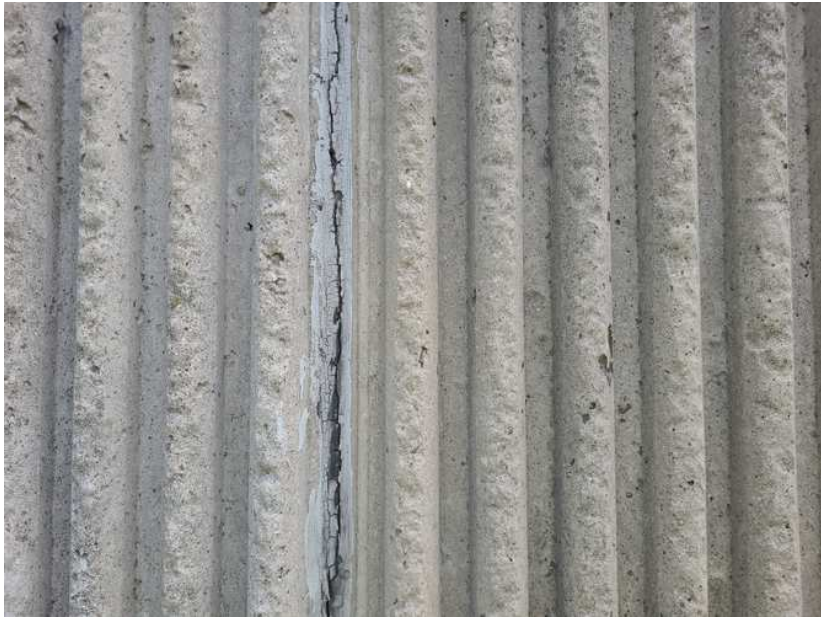
Inspect ID: 2024-0073

No User Rating (Site Visit) - Typical riverside flood wall sealant cracking

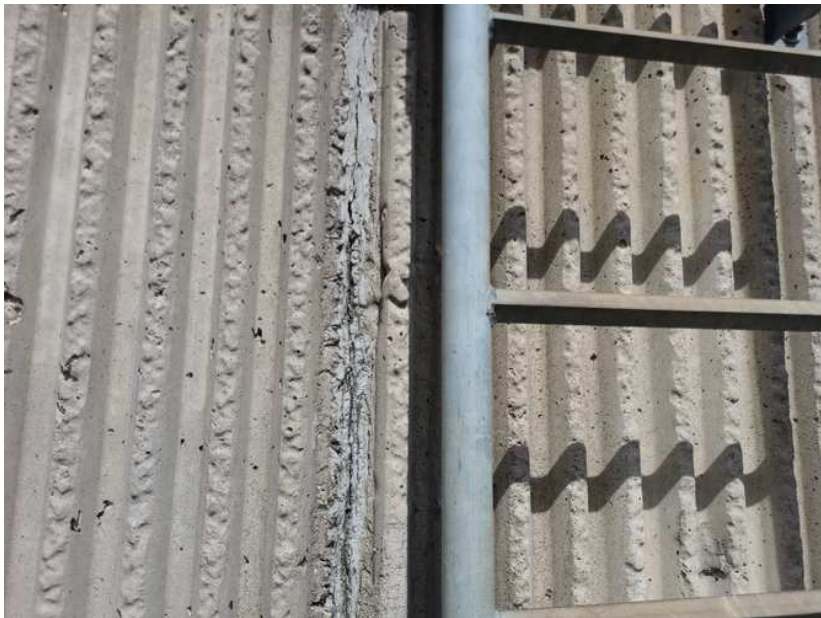
Inspect ID: 2024-0101

No User Rating (Site Visit) - Small sealant cracks on landside floodwall

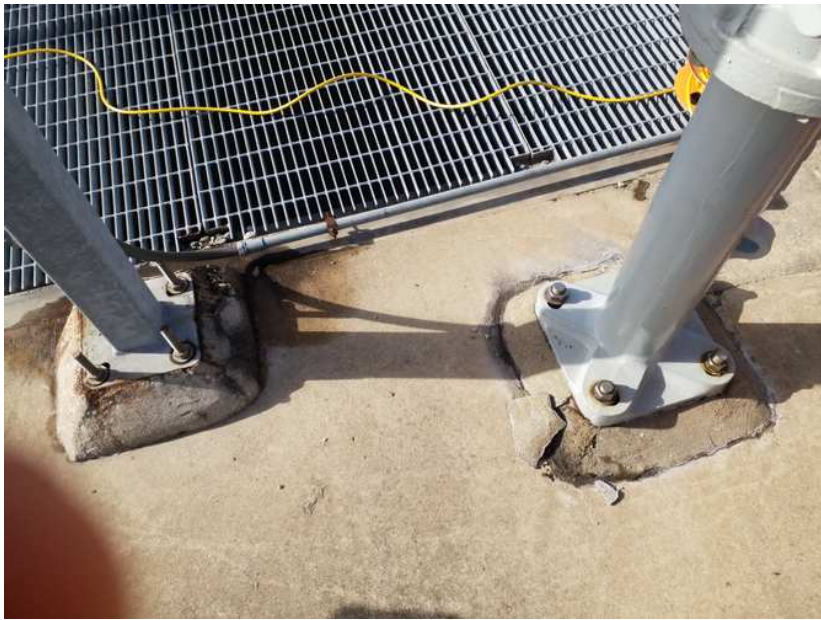
Inspect ID: 2024-0006

No User Rating (Site Visit) - GS-8: Some spalling on pedestals.

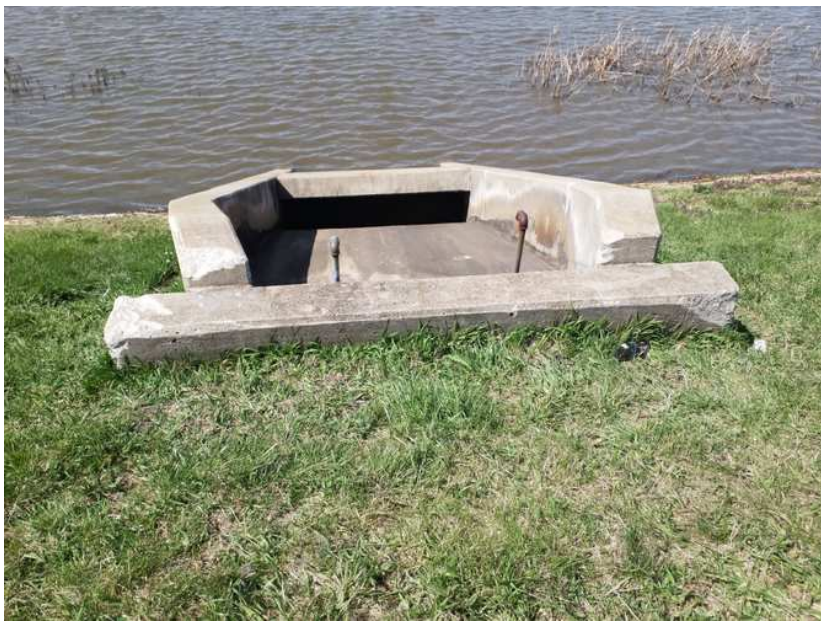
Inspect ID: 2024-0019

No User Rating (Site Visit) - GS-04: Spalling on river side wingwall.

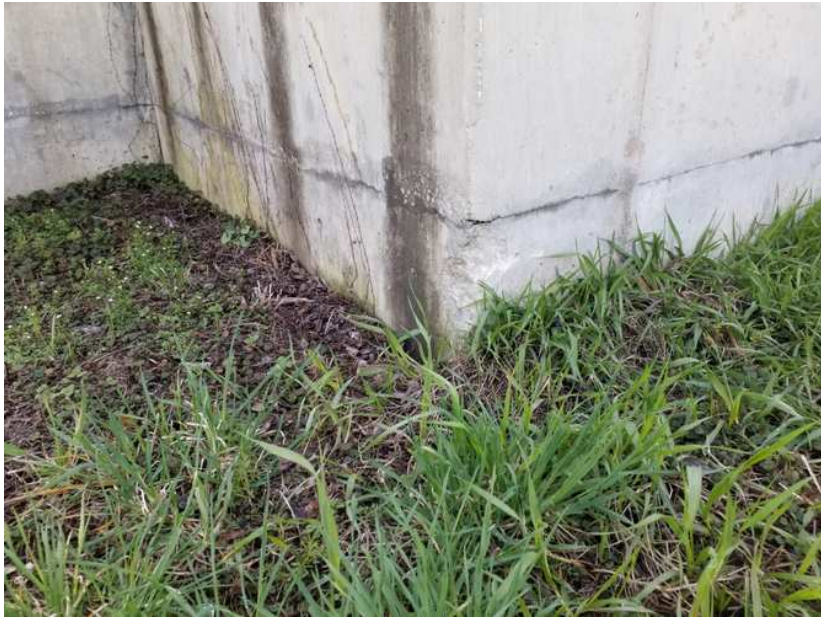
Inspect ID: 2024-0042

No User Rating (Site Visit) - GS-12: Typical spalling on corners of structure

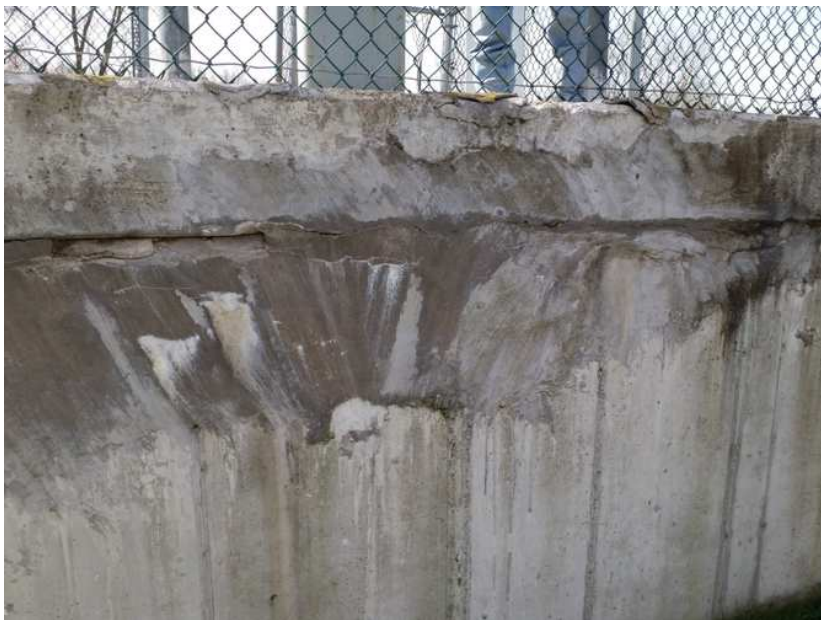
Inspect ID: 2024-0050

No User Rating (Site Visit) - GS-14: Delamination and spalling at patch similar to last year

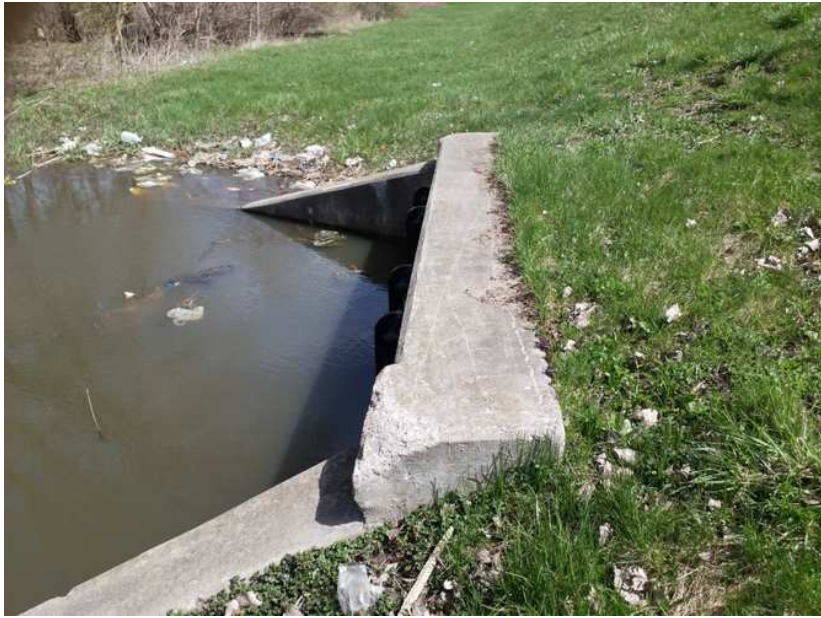
Inspect ID: 2024-0051

No User Rating (Site Visit) - GS-09: Spalling on concrete at outfall riverside

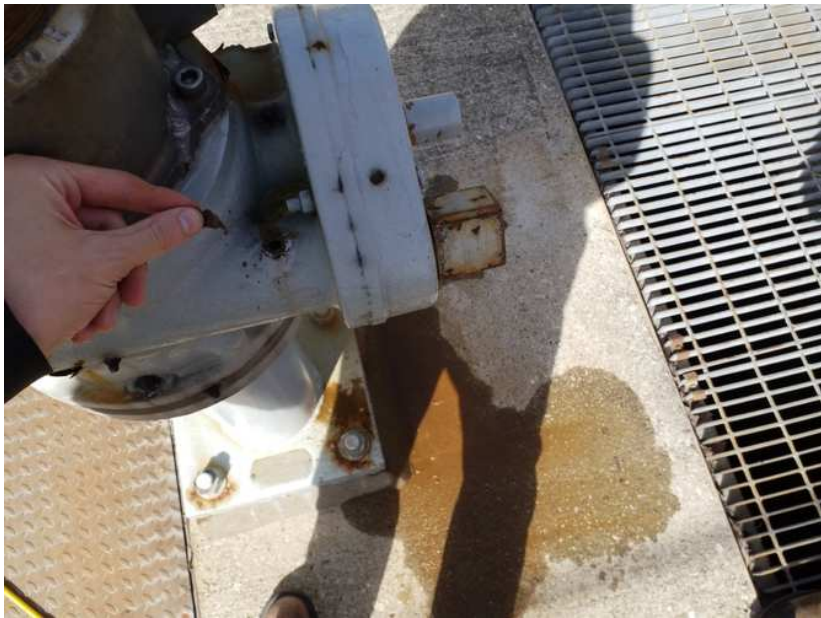
Inspect ID: 2024-0034

No User Rating (Site Visit) - GS-12A: Water is getting into gate mechanism. Seems seal is broken.

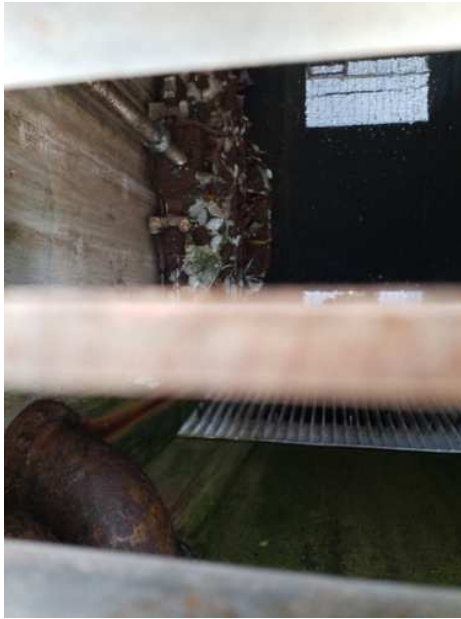
Inspect ID: 2024-0038

No User Rating (Site Visit) - GS-12A: Operated successfully. Can't tell if gate is leaking still. Paint peeling on gate.

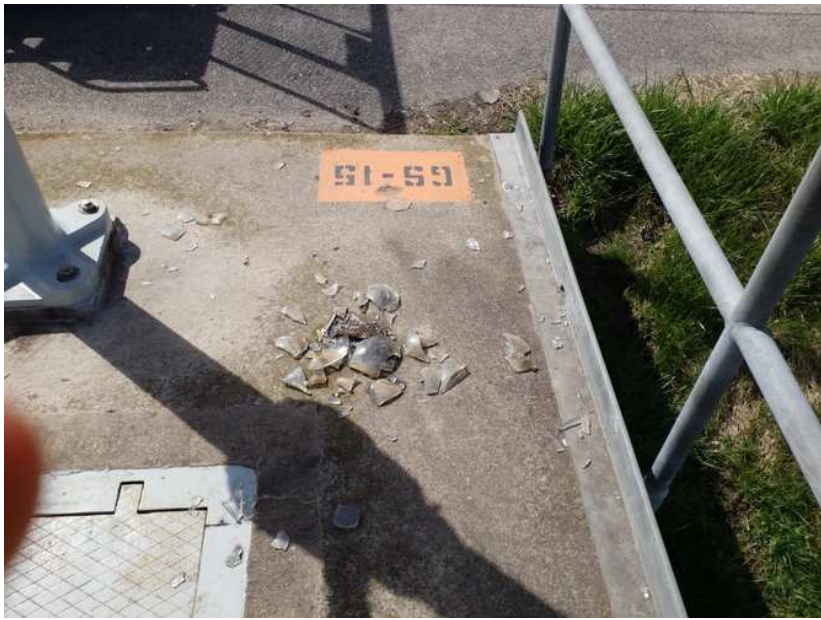
Inspect ID: 2024-0066

No User Rating (Site Visit) - GS-15: Broken glass on gate structure

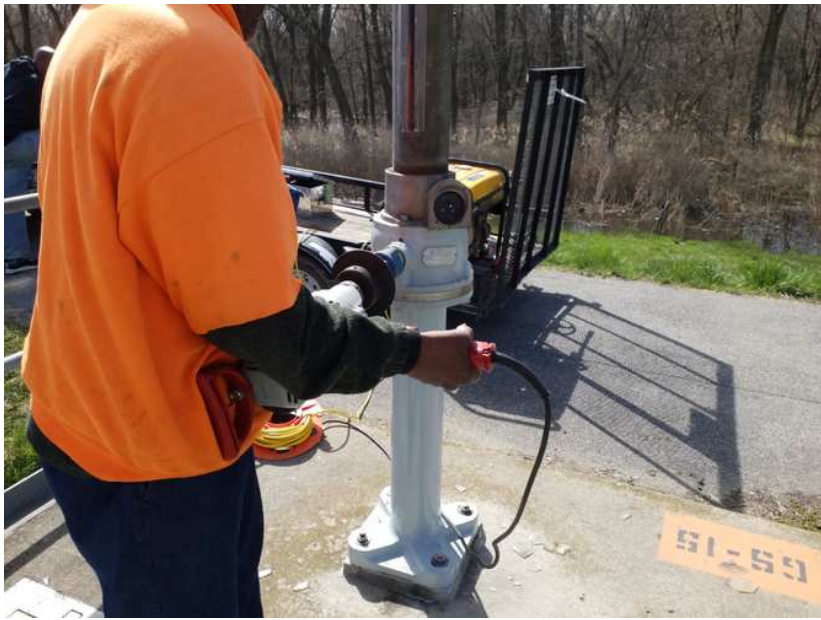
Inspect ID: 2024-0070

No User Rating (Site Visit) - GS-15: Gate operated successfully. Could not verify seal due to missing gauge. Gate goes up and down smoothly
