US Army Corps
of Engineers ®

Site Visit Summary

Name of System: Gary

Name of Segment: Gary South

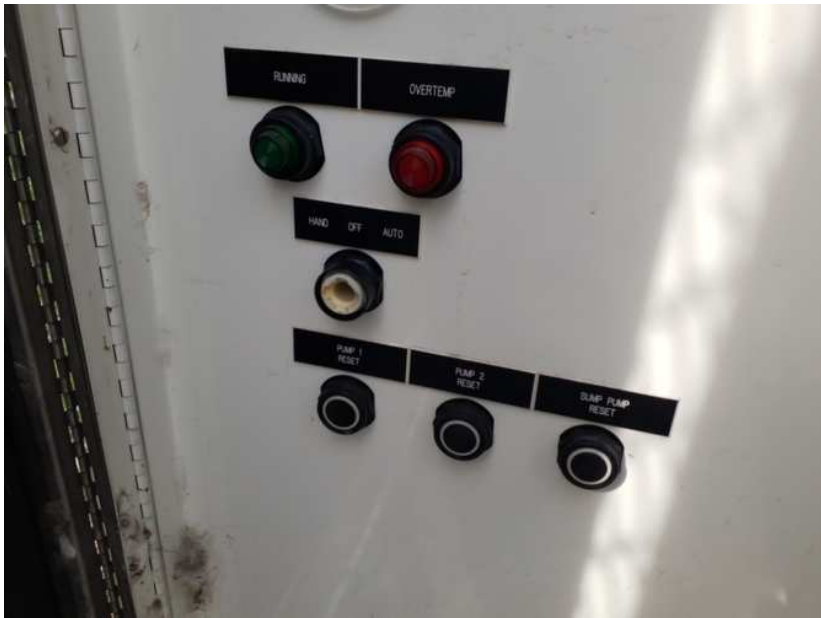
Inspect ID: 2024-0190

No User Rating (Site Visit) - PS-CL: Missing hand off auto switch for sump pump

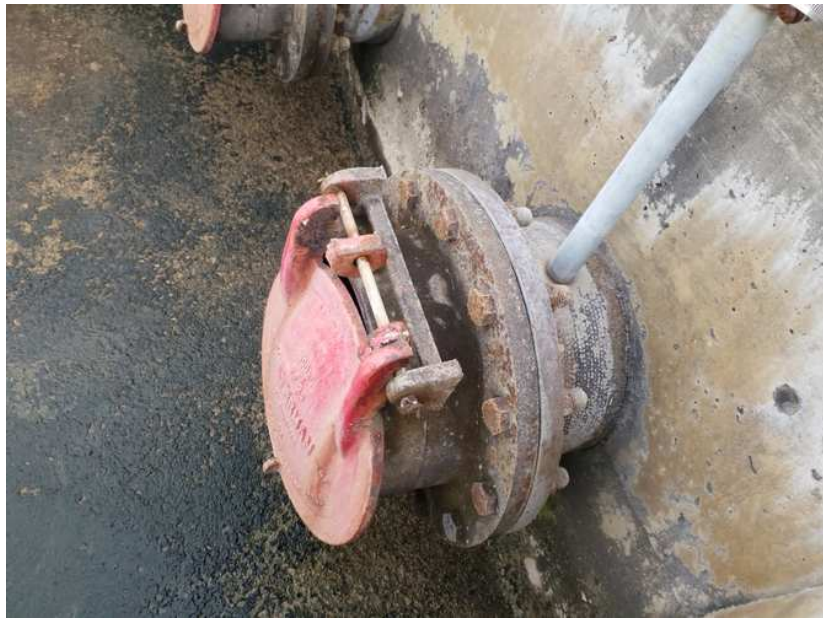
Inspect ID: 2024-0198

No User Rating (Site Visit) - PS-CL: Flap gate broken.
