## Site Visit Summary

Name of System: Burr Street

Name of Segment: Griffith

NLD System ID: 2605000004 NLD Segment ID: 2604000006

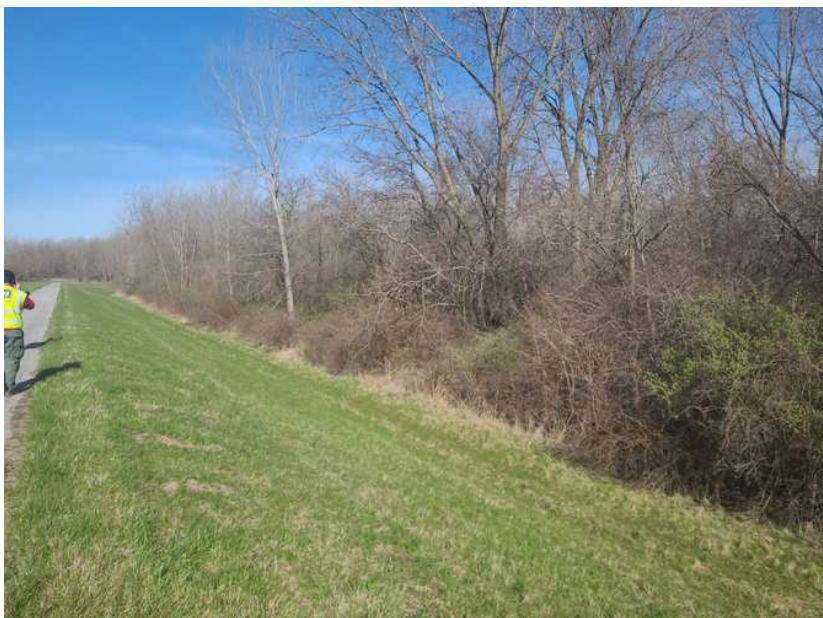
**Inspect ID:** 2024-0001

No User Rating (Site Visit) - Vegetation on riverside toe.

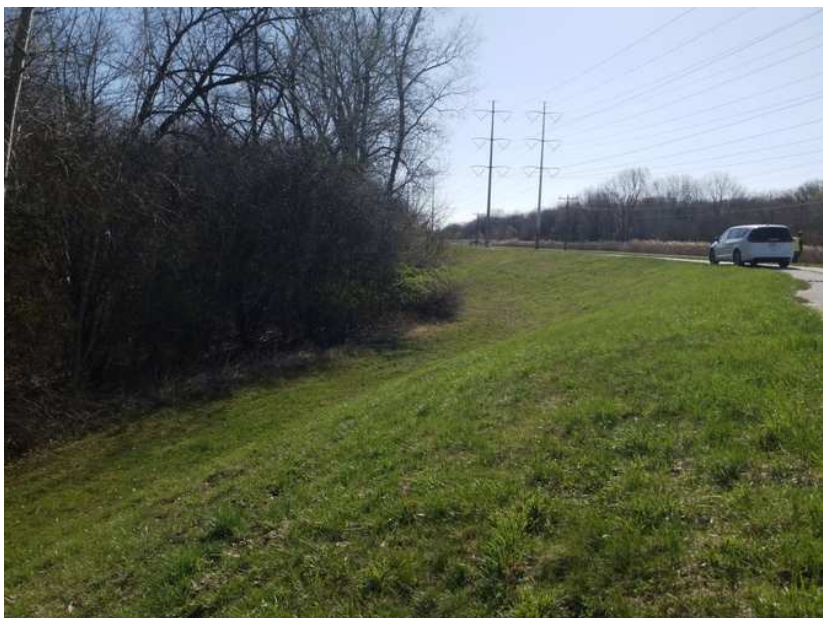
**Inspect ID:** 2024-0019

No User Rating (Site Visit) - Typical vegetation on riverside toe.

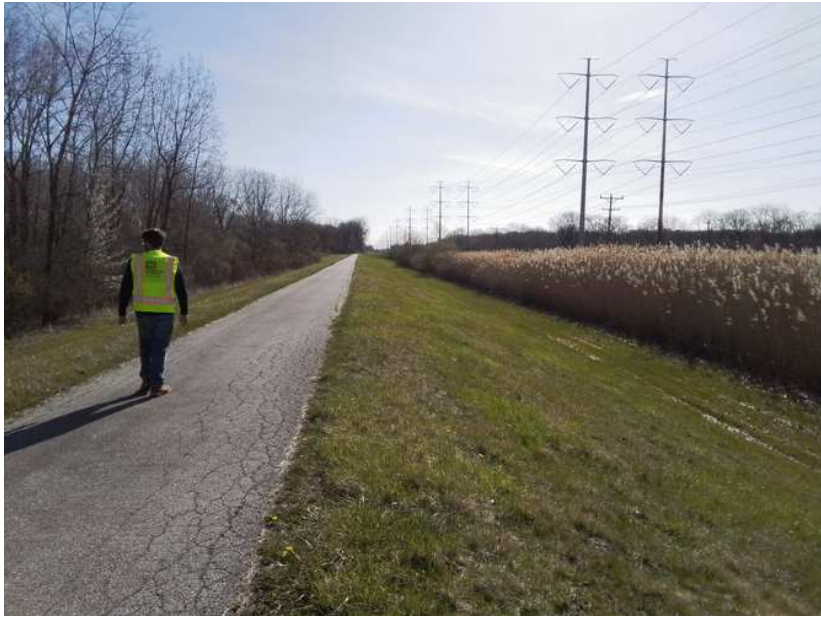
**Inspect ID:** 2024-0020

No User Rating (Site Visit) - Vegetation observed along landside toe of levee in ditch. Trees observed within 15' of levee landside toe (looking east).

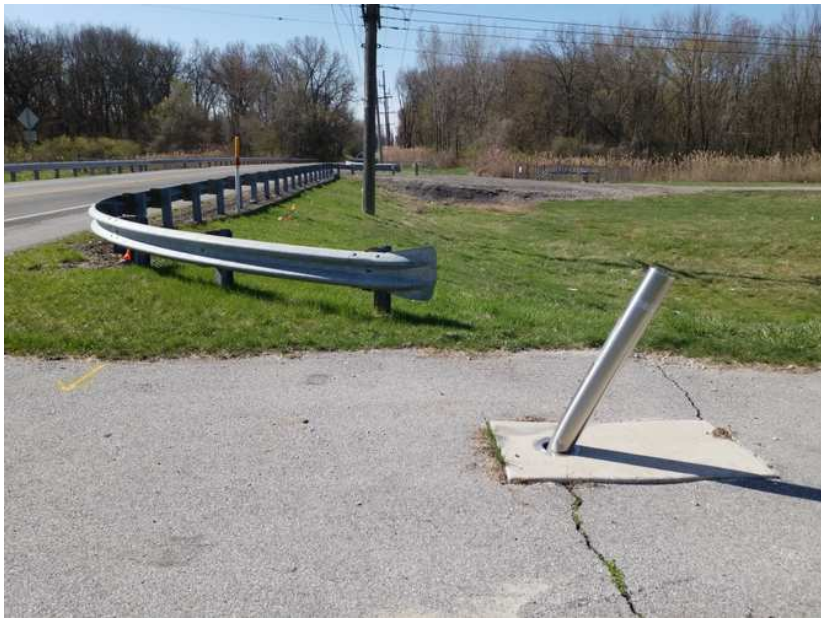
**Inspect ID:** 2024-0023

No User Rating (Site Visit) - Damaged bollard on crown of levee.

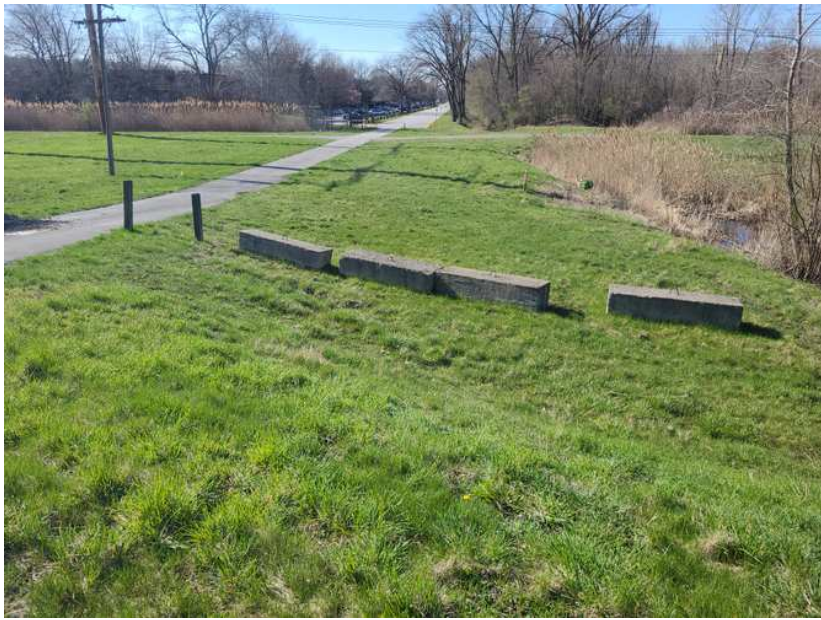
**Inspect ID:** 2024-0029

No User Rating (Site Visit) - Concrete blocks on landside.

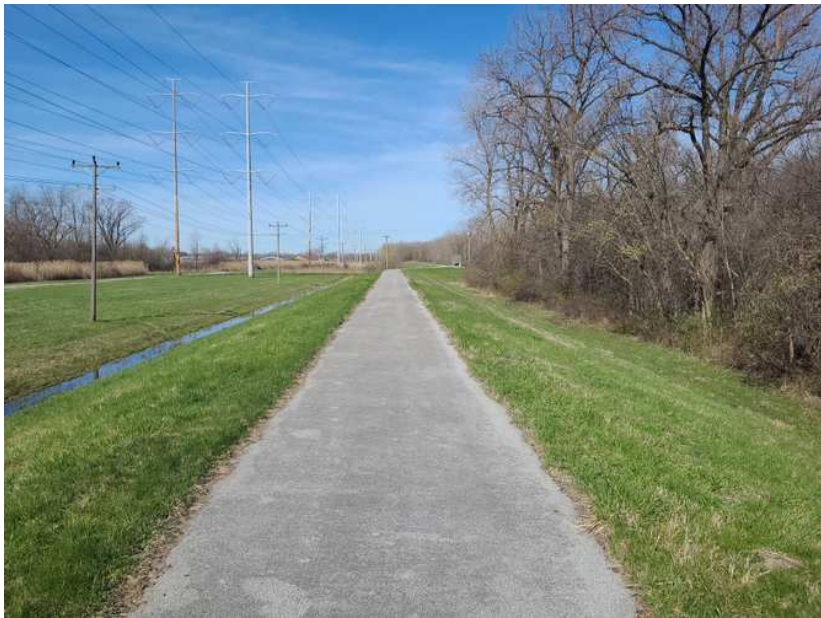
**Inspect ID:** 2024-0041

No User Rating (Site Visit) - Typical slope cross section, in good condition.

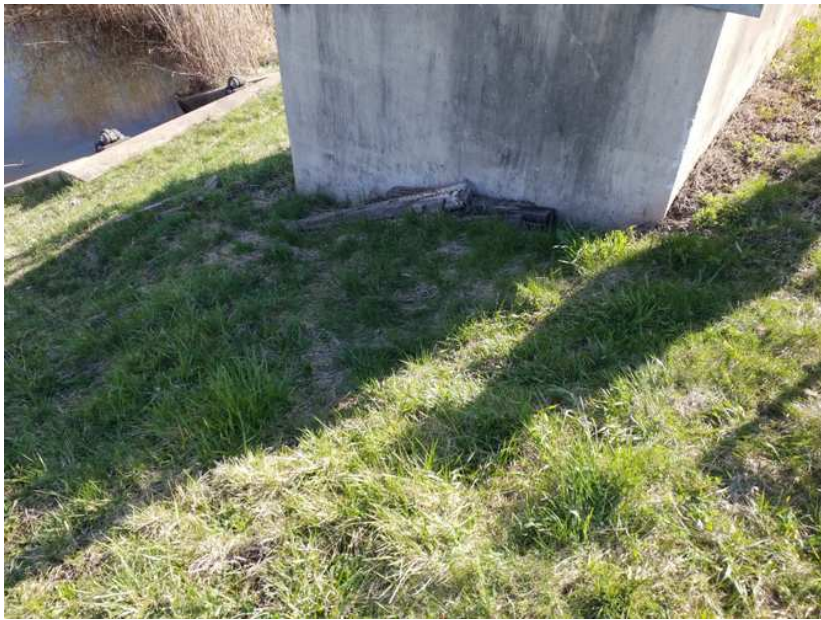
**Inspect ID:** 2024-0014

No User Rating (Site Visit) - GR-02: Erosion and debris around gate structure.

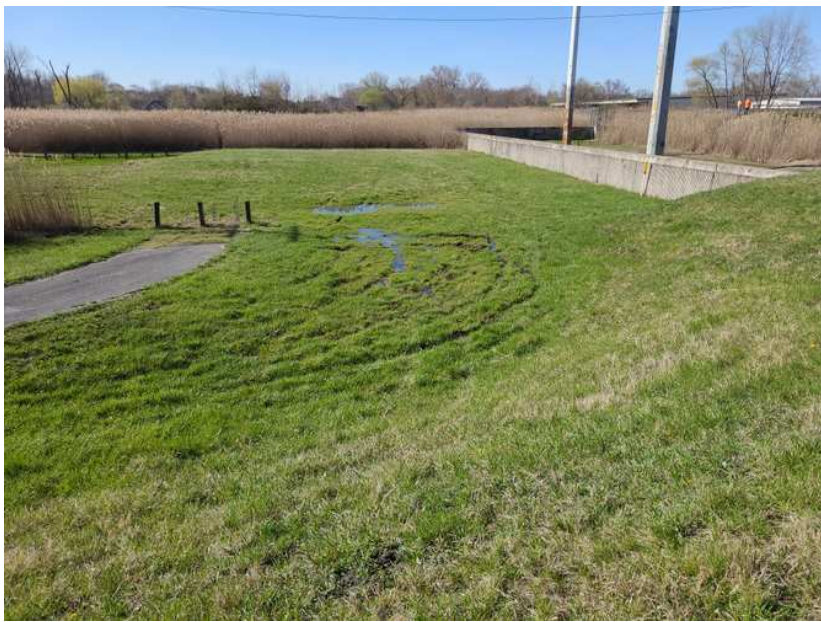
**Inspect ID:** 2024-0017

No User Rating (Site Visit) - Deep ruts on landside toe.

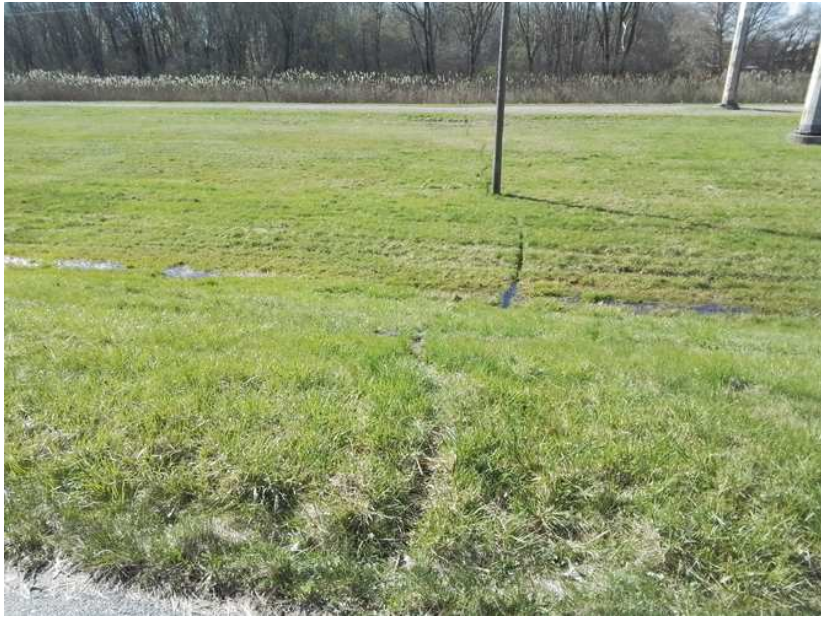
**Inspect ID:** 2024-0036

No User Rating (Site Visit) - Animal path/rut on landside (looking south).

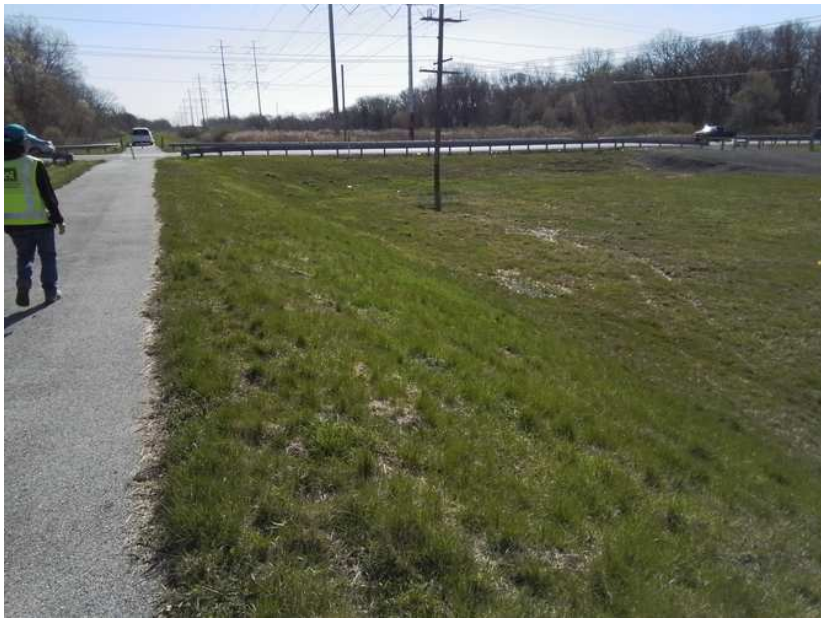
**Inspect ID:** 2024-0040

No User Rating (Site Visit) - Rutting and ponding observed along landside.

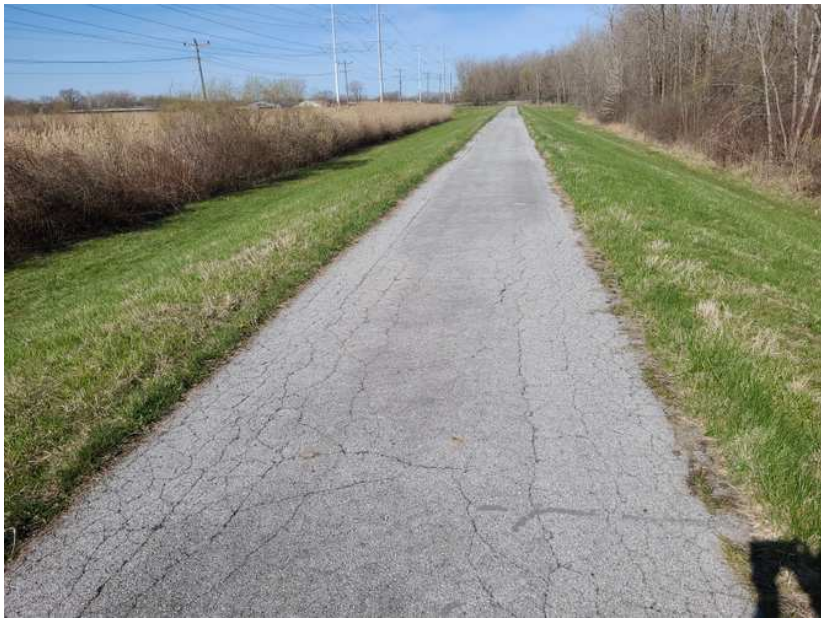
No User Rating (Site Visit) - Typical asphalt cracking on levee crown.

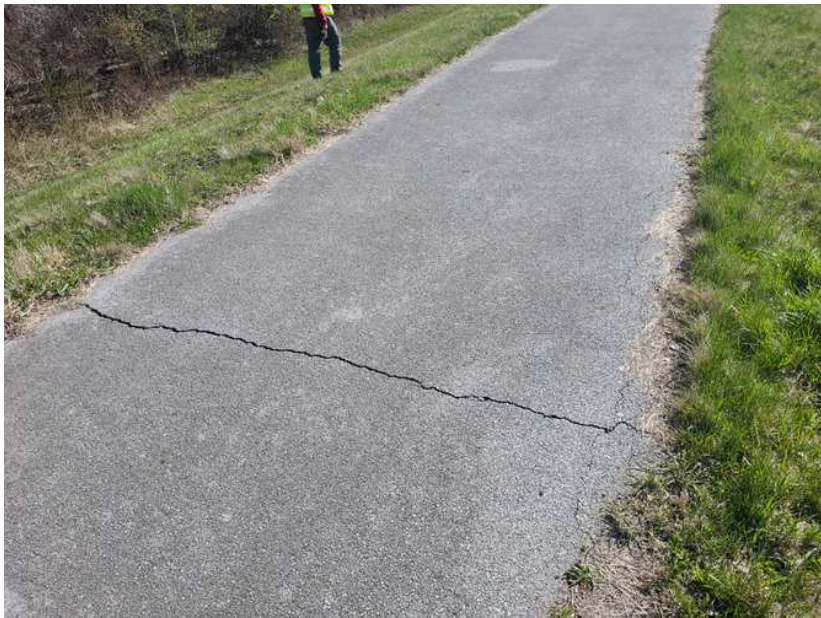
No User Rating (Site Visit) - Cracking on crown.

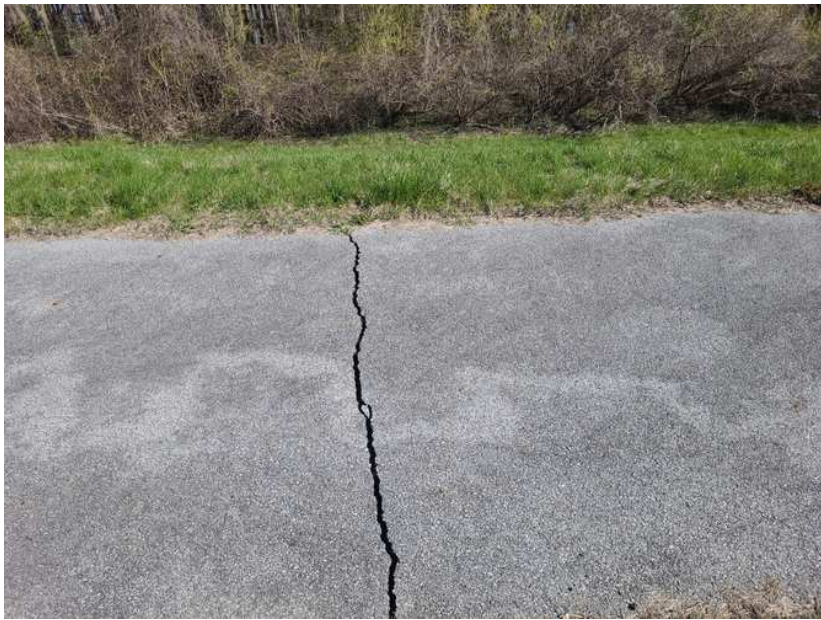
**Inspect ID:** 2024-0045

No User Rating (Site Visit) - Deep cracking in asphalt on crown.

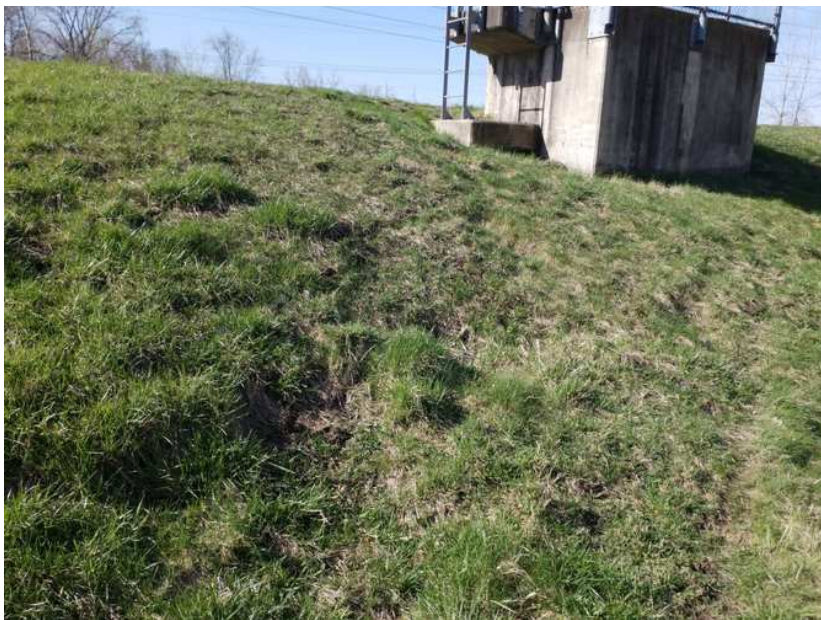
**Inspect ID:** 2024-0015

No User Rating (Site Visit) - Typical collapsed animal burrows on riverside slopes.

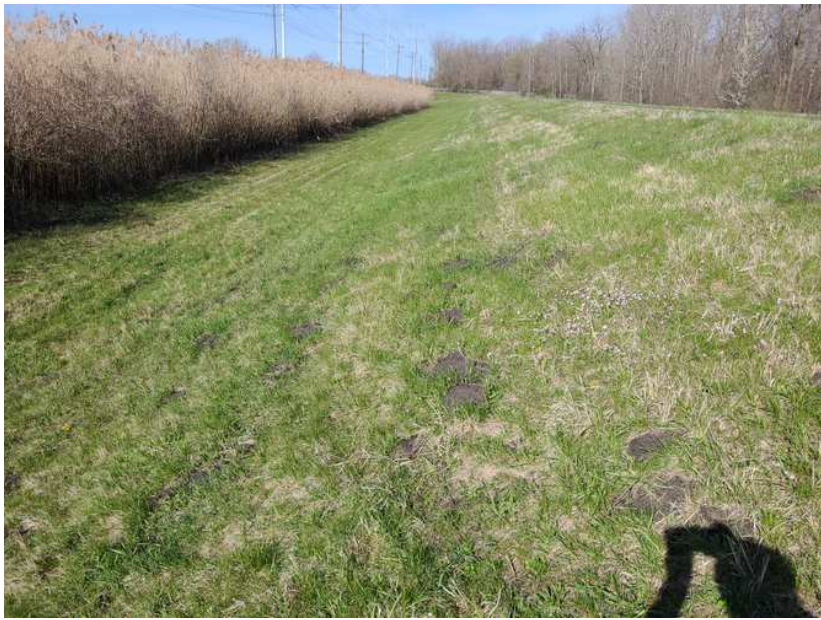
**Inspect ID:** 2024-0021

No User Rating (Site Visit) - Animal burrows typical on both sides of levee in this area.

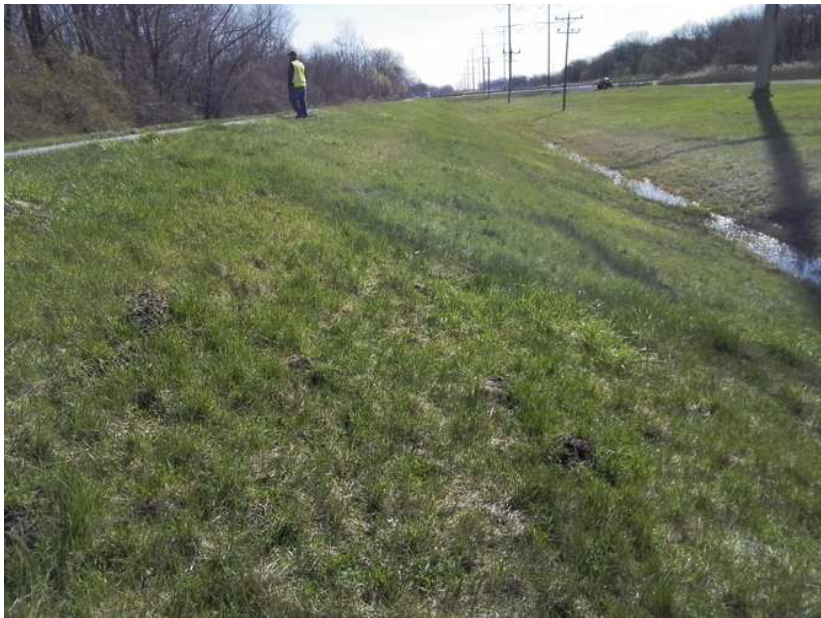
**Inspect ID:** 2024-0032

No User Rating (Site Visit) - Animal burrows observed along landside slope.

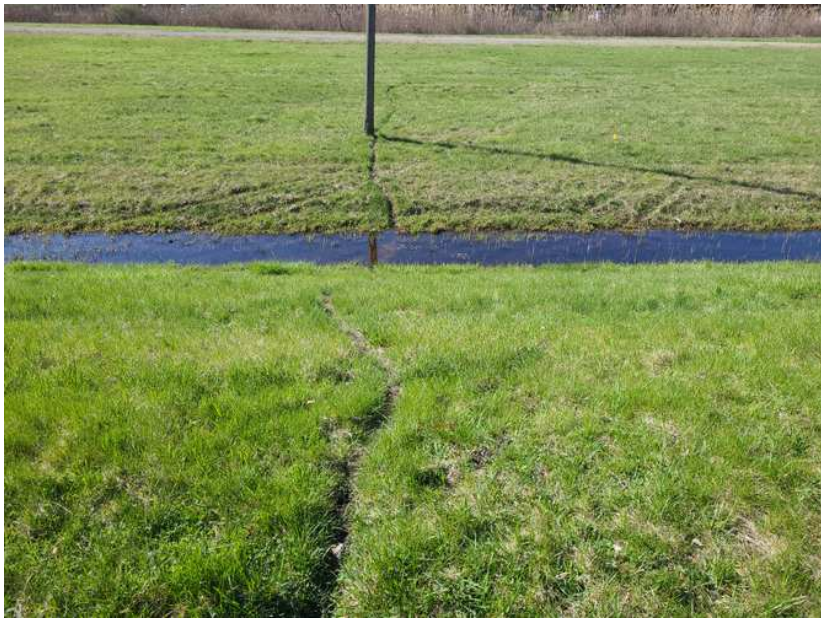
**Inspect ID:** 2024-0037

No User Rating (Site Visit) - Animal trail landside and riverside.

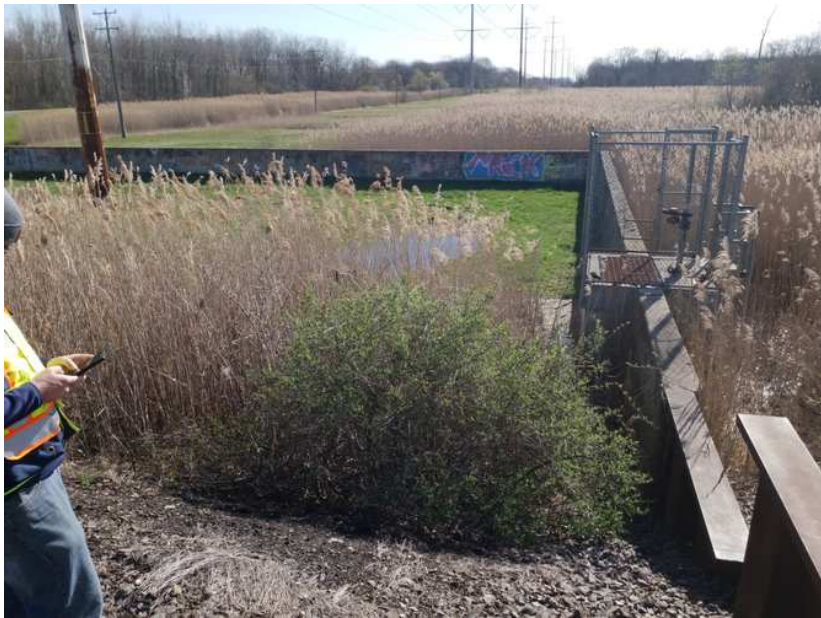
**Inspect ID:** 2024-0003

No User Rating (Site Visit) - Typical vegetation on riverside.

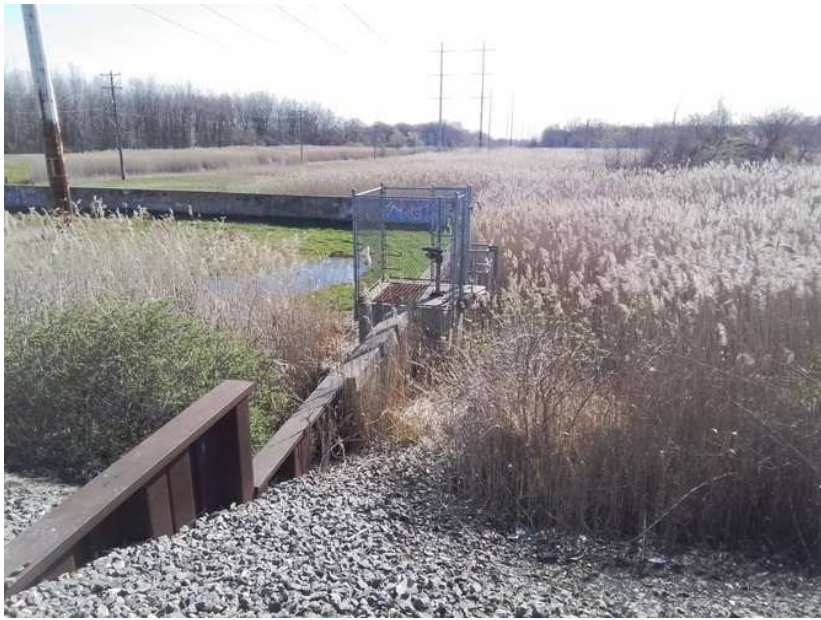
**Inspect ID:** 2024-0004

No User Rating (Site Visit) - Vegetation observed along floodwall on landside (looking East).

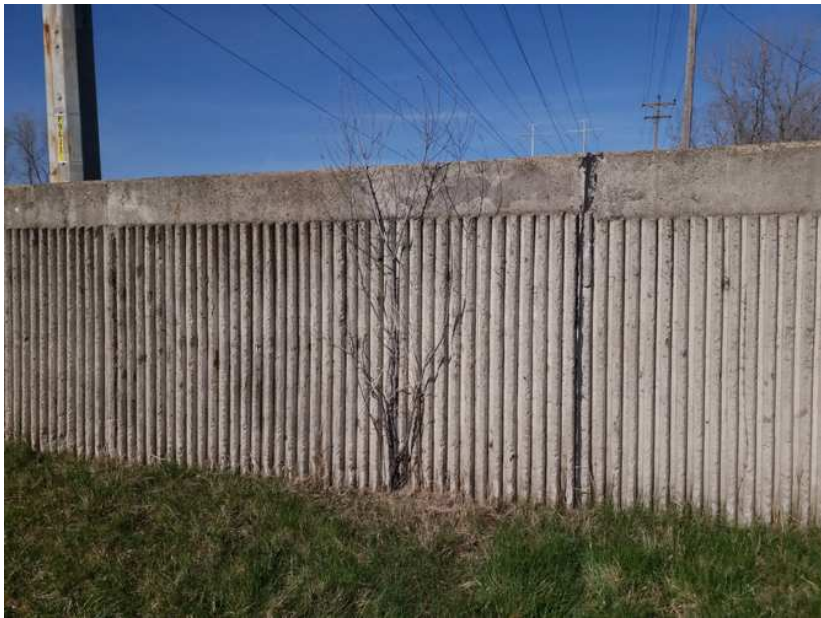
**Inspect ID:** 2024-0011

No User Rating (Site Visit) - Tree growing at floodwall's landside base.

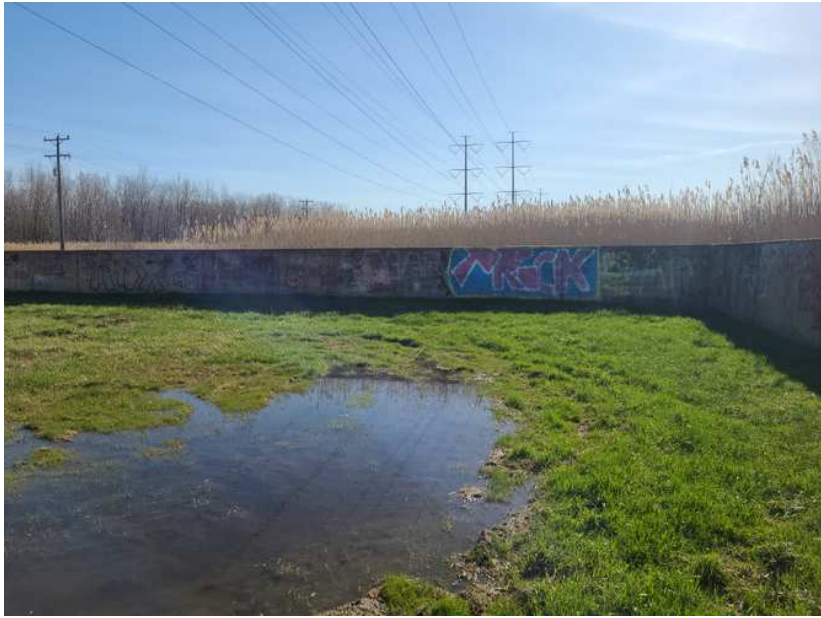
**Inspect ID:** 2024-0005

No User Rating (Site Visit) - Graffiti on riverside of floodwall.

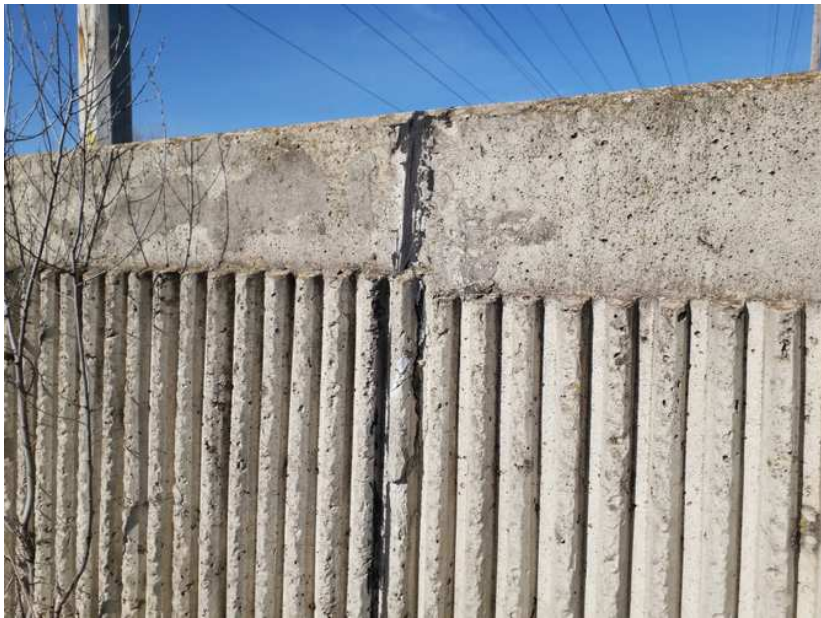
**Inspect ID:** 2024-0007

No User Rating (Site Visit) - Typical superficial crack in floodwall concrete.

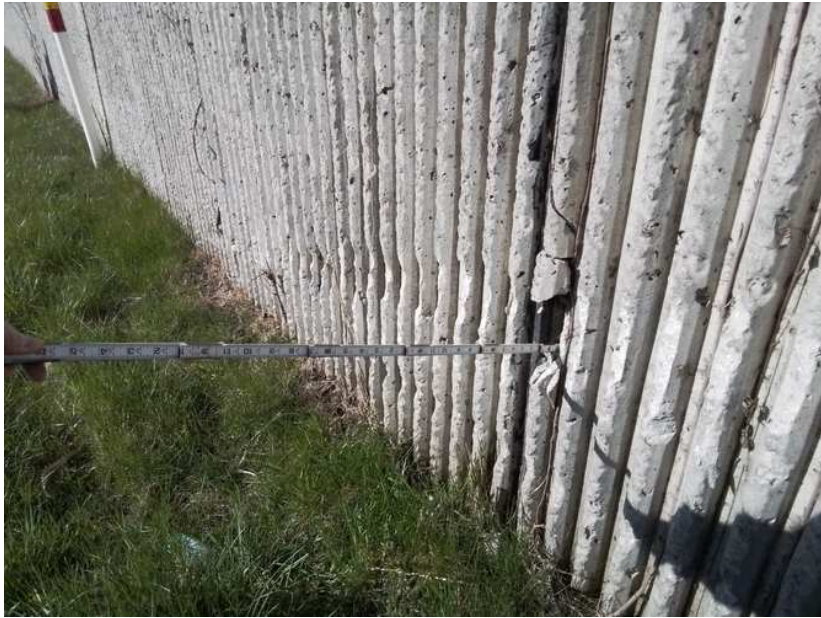
**Inspect ID:** 2024-0008

No User Rating (Site Visit) - Concrete spalling along landside floodwall joint. Hole observed 1/2 inch wide, 1 ft deep.

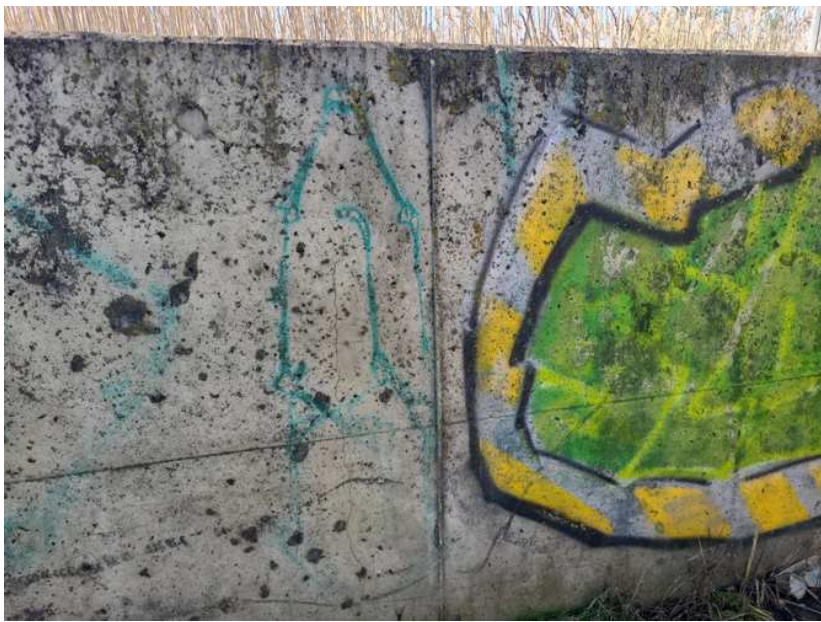
**Inspect ID:** 2024-0009

No User Rating (Site Visit) - Cracking on riverside flood wall.

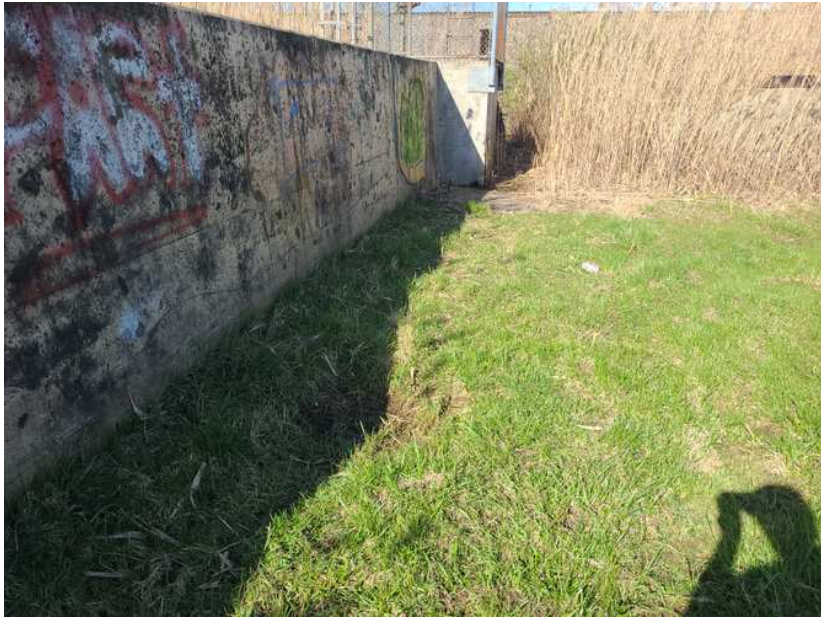
**Inspect ID:** 2024-0013

No User Rating (Site Visit) - Small depression near riverside flood wall. Monitor for further settlement.

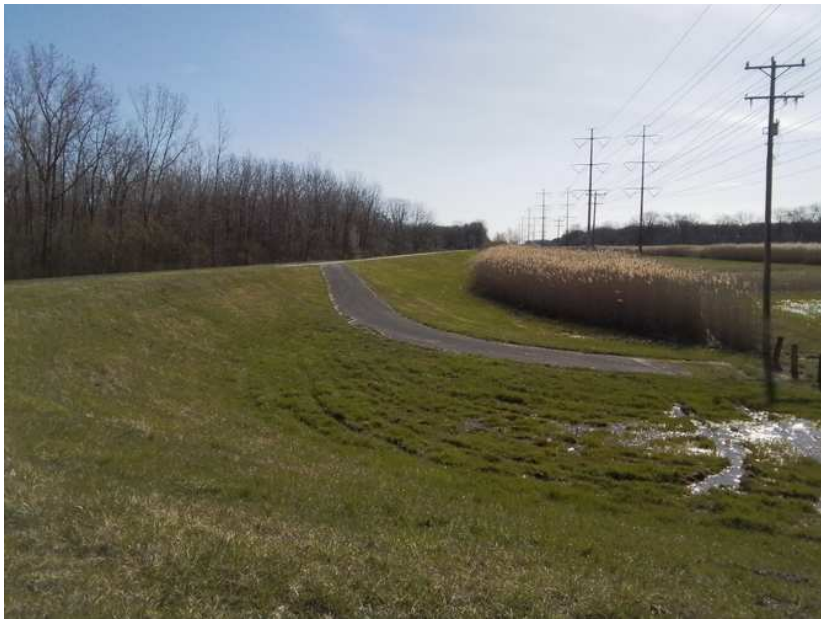
**Inspect ID:** 2024-0012

No User Rating (Site Visit) - Vegetation observed in northern landside ditch (looking east).

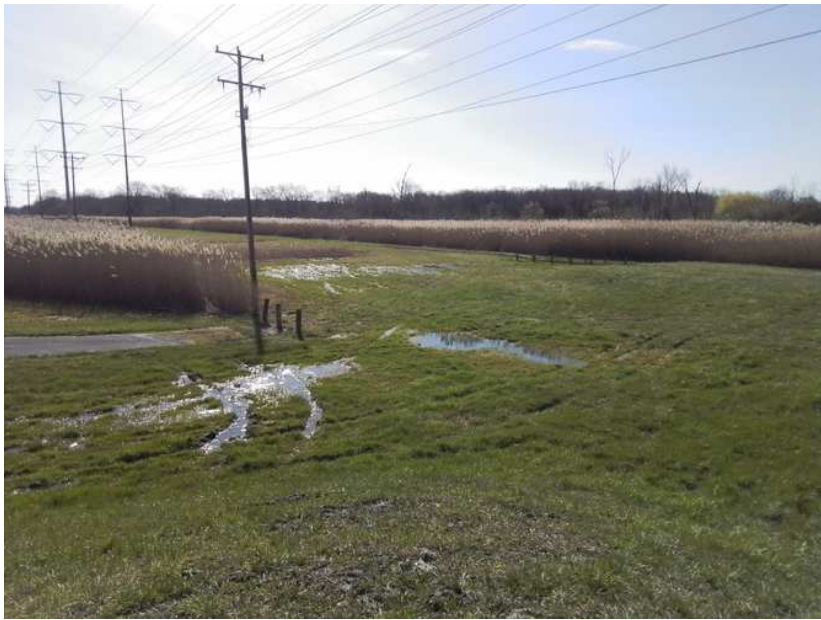
**Inspect ID:** 2024-0016

No User Rating (Site Visit) - Vegetation observed in southern landside ditch(looking east).

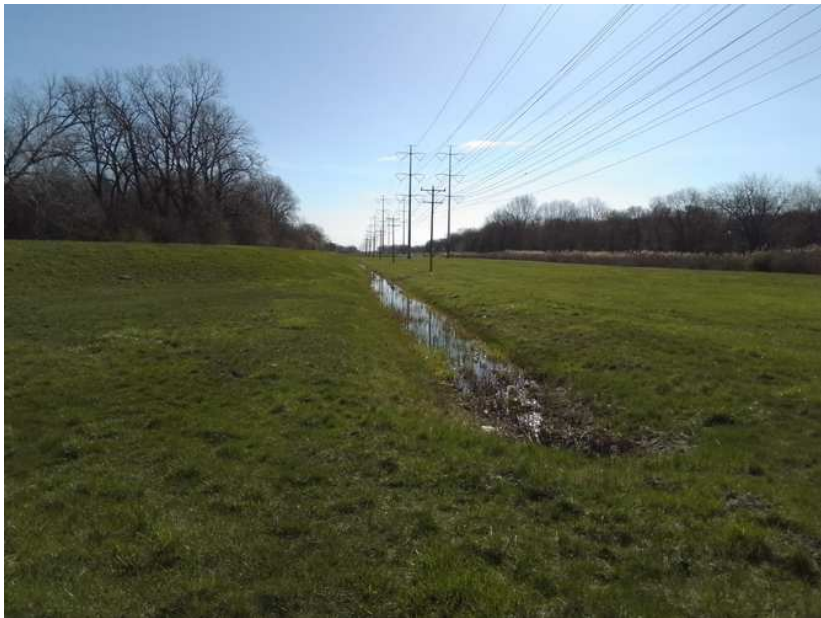
**Inspect ID:** 2024-0028

No User Rating (Site Visit) - Typical view of landside ditches looking east. Southern ditch has vegetation growth. Northern ditch is clear.

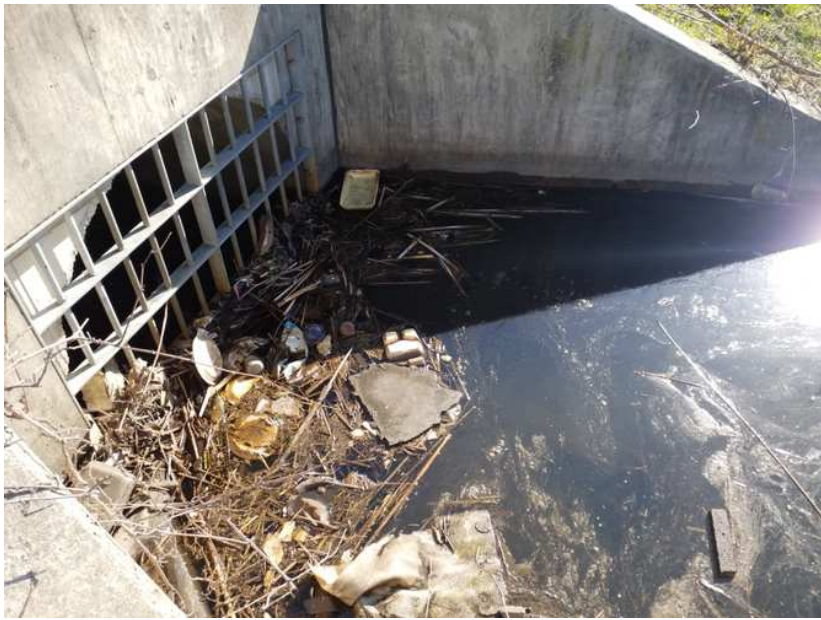
**Inspect ID:** 2024-0006

No User Rating (Site Visit) - GR-02: Debris at inlet.

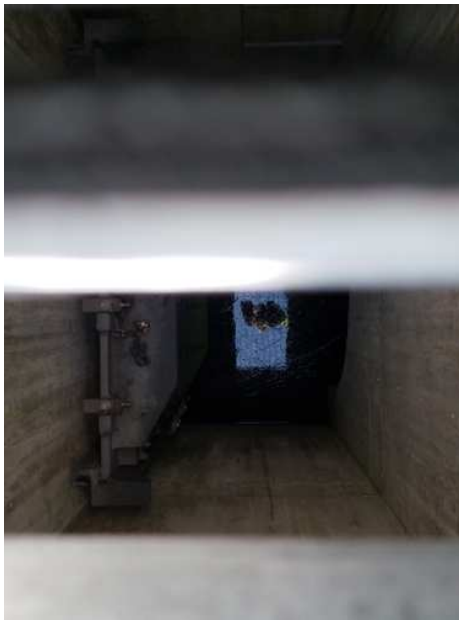
**Inspect ID:** 2024-0010

No User Rating (Site Visit) - GR-02: Fully closed.

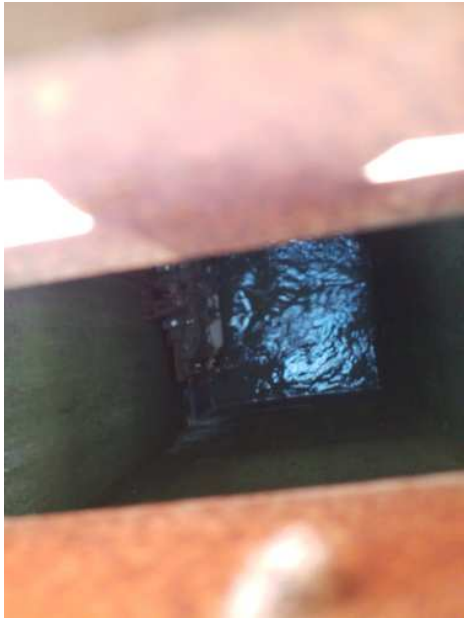
**Inspect ID:** 2024-0018

No User Rating (Site Visit) - GR-01: Open. Can only be partially closed due to connection to sanitary sewer. Mechanism works smoothly and is in good condition.

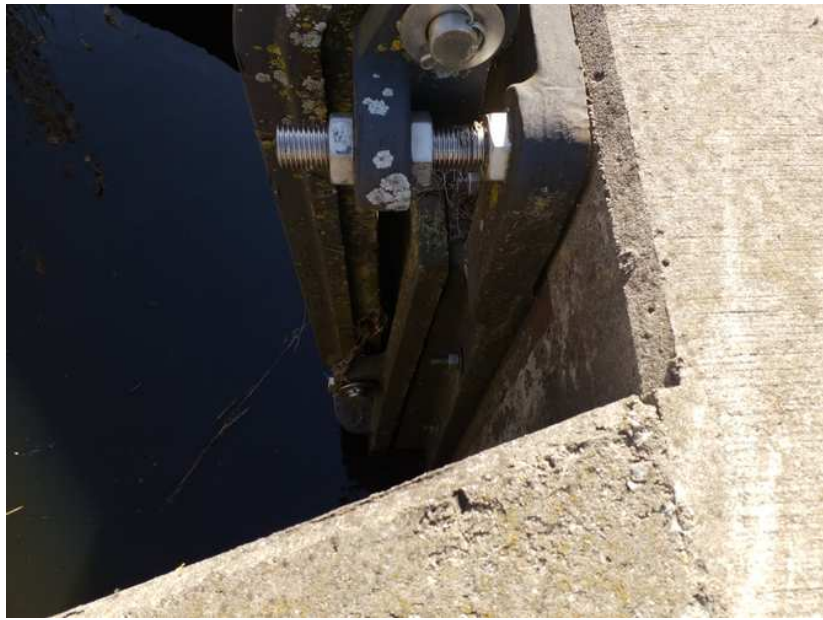
**Inspect ID:** 2024-0002

No User Rating (Site Visit) - GR-02: Flap gate leaking. Not fully closed.

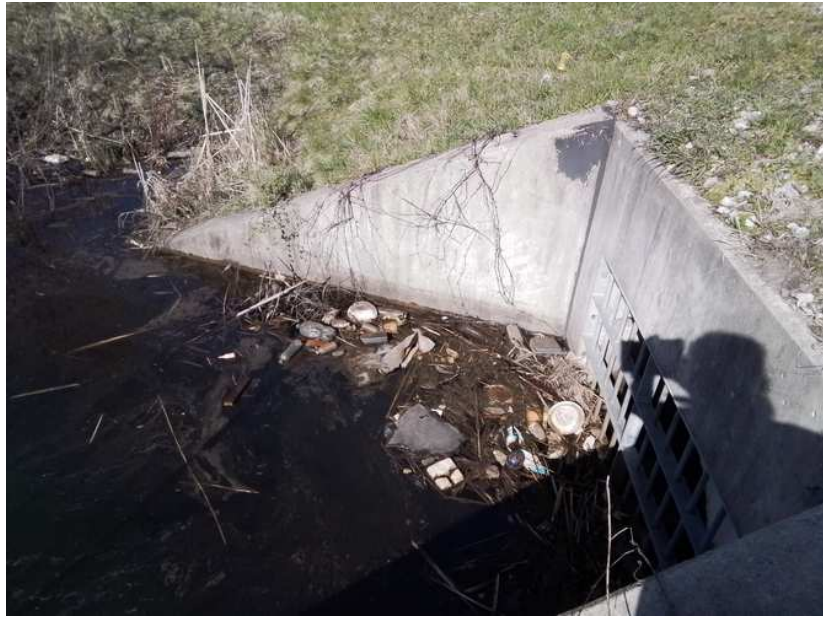
**Inspect ID:** 2024-0024

No User Rating (Site Visit) - Debris buildup on landside trash rack.
