US Army Corps of Engineers ®

## Site Visit Summary

Name of System: Highland

NLD System ID: 2605000005 NLD Segment ID: 2604000007

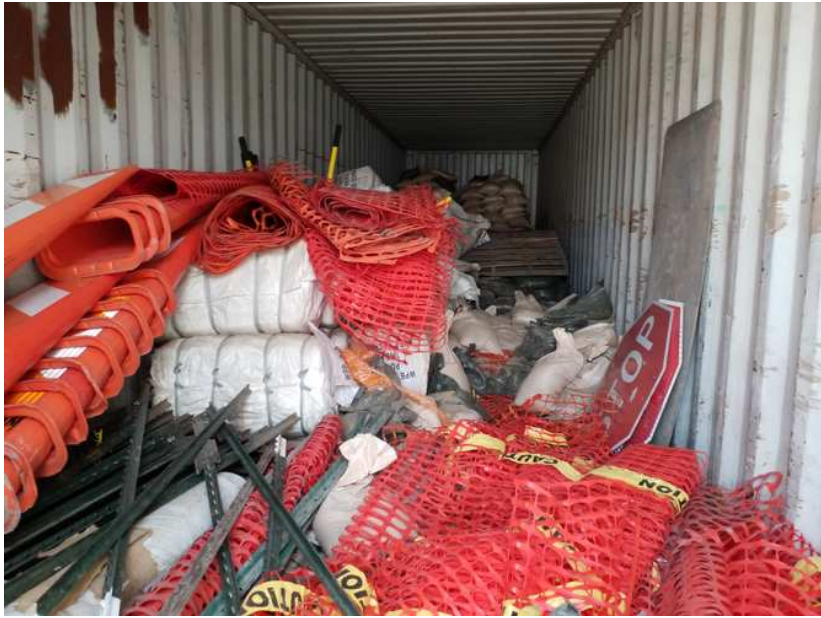
**Inspect ID:** 2024-0110

No User Rating (Site Visit) - Flood fighting supplies at the Public Works Facility at 8001 Kennedy Avenue. Highland Public Works has 14-16 pellets of sandbags, approximately 1000 pieces of sandbags.

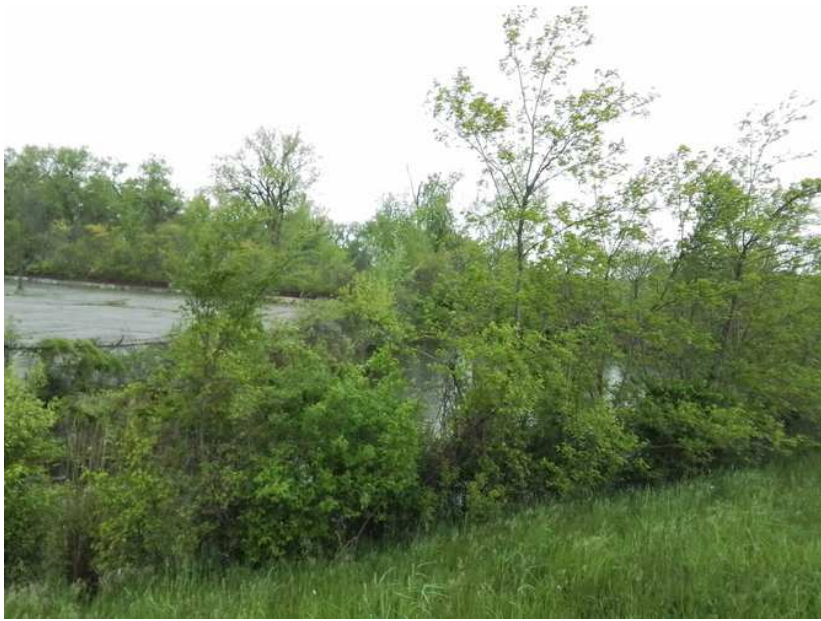
**Inspect ID:** 2024-0045

No User Rating (Site Visit) - Tree on landside toe

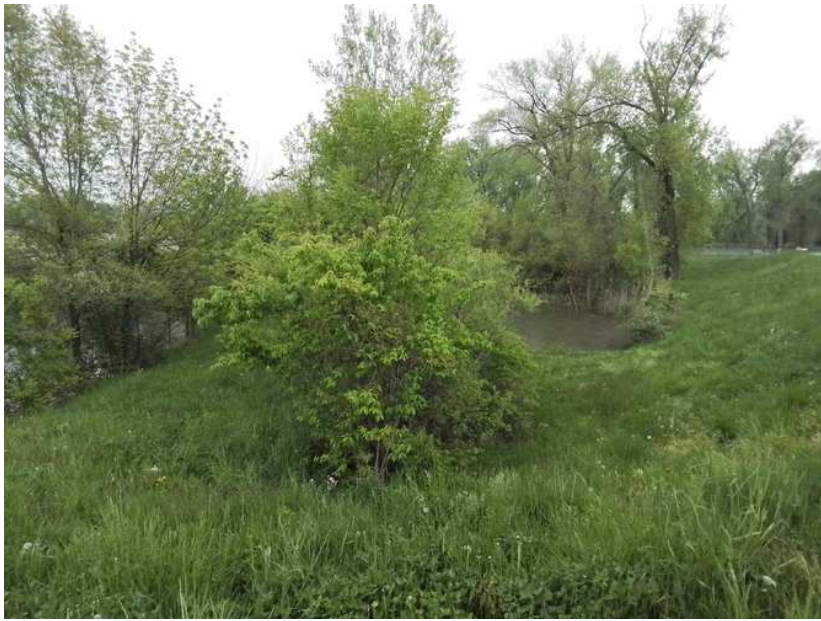
**Inspect ID:** 2024-0049

No User Rating (Site Visit) - Tree on landside toe

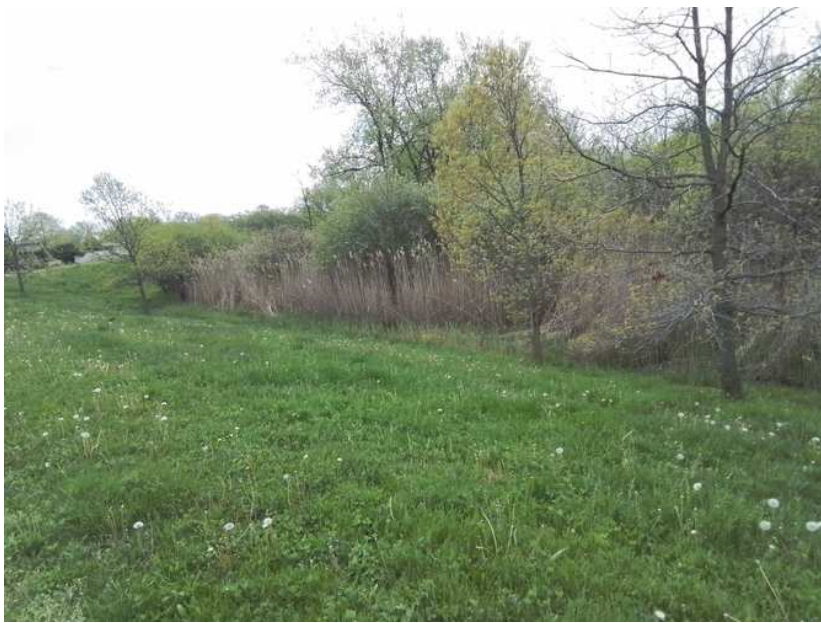
**Inspect ID:** 2024-0252

No User Rating (Site Visit) - Trees on riverside toe

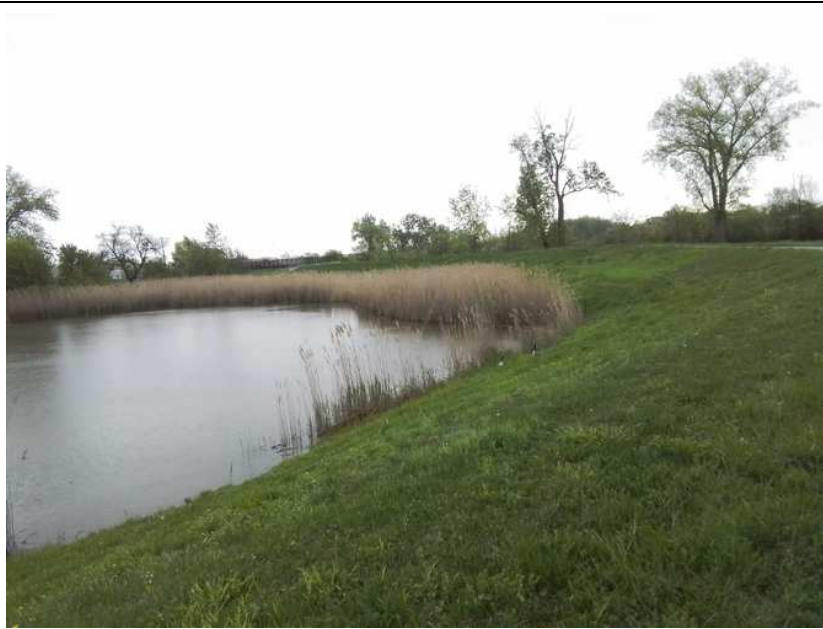
**Inspect ID:** 2024-0036

No User Rating (Site Visit) - Erosion at riverside toe.

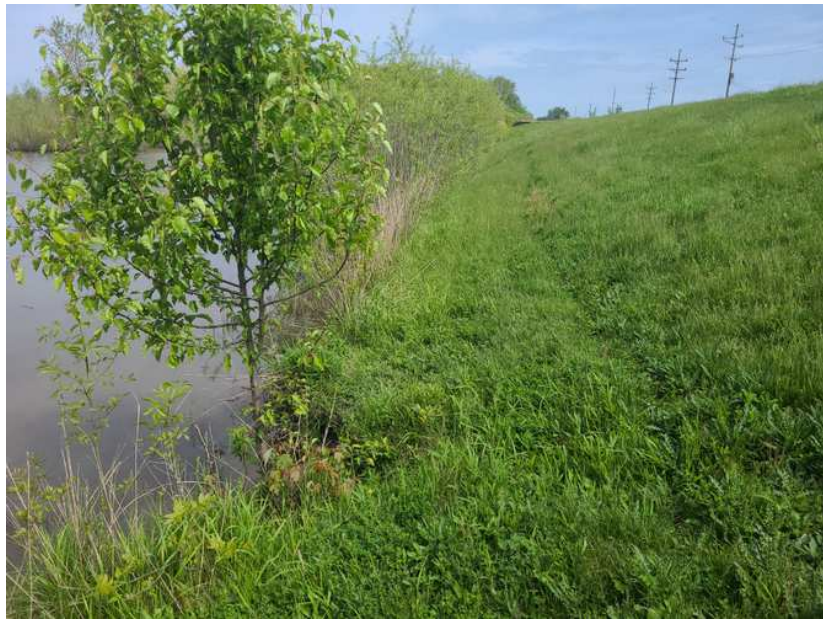
**Inspect ID:** 2024-0040

No User Rating (Site Visit) - Erosion at riverside toe.

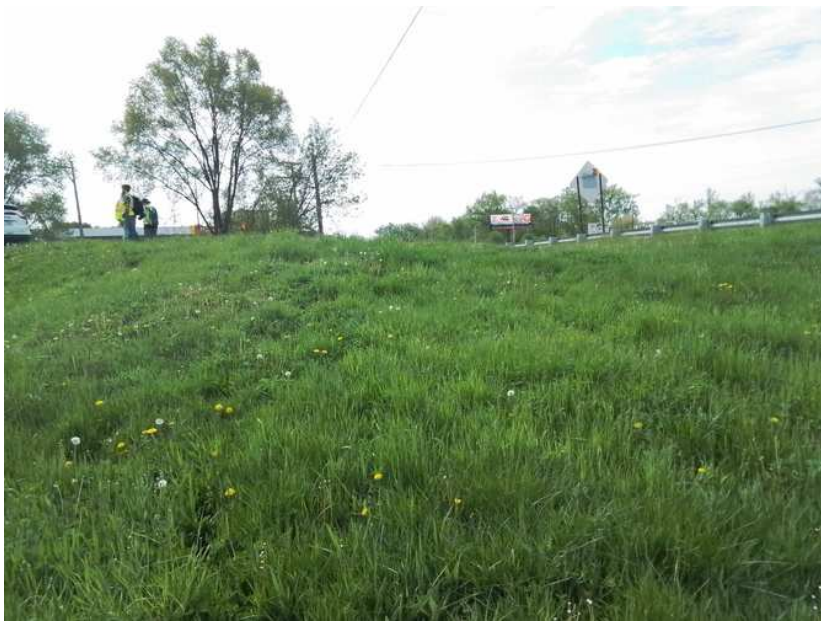
**Inspect ID:** 2024-0133

No User Rating (Site Visit) - Erosion near wingwall on riverside slope.

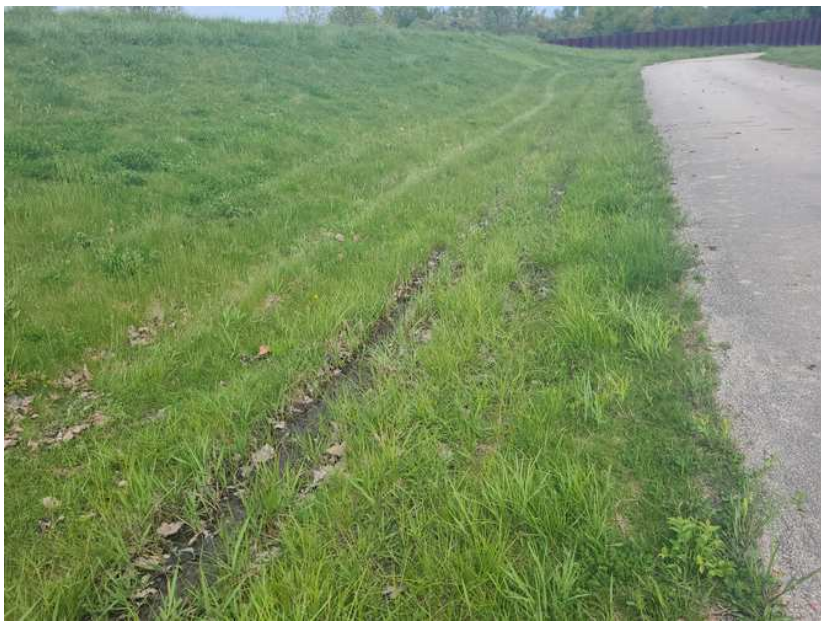
**Inspect ID:** 2024-0064

No User Rating (Site Visit) - Depression in crown of levee around the bend.

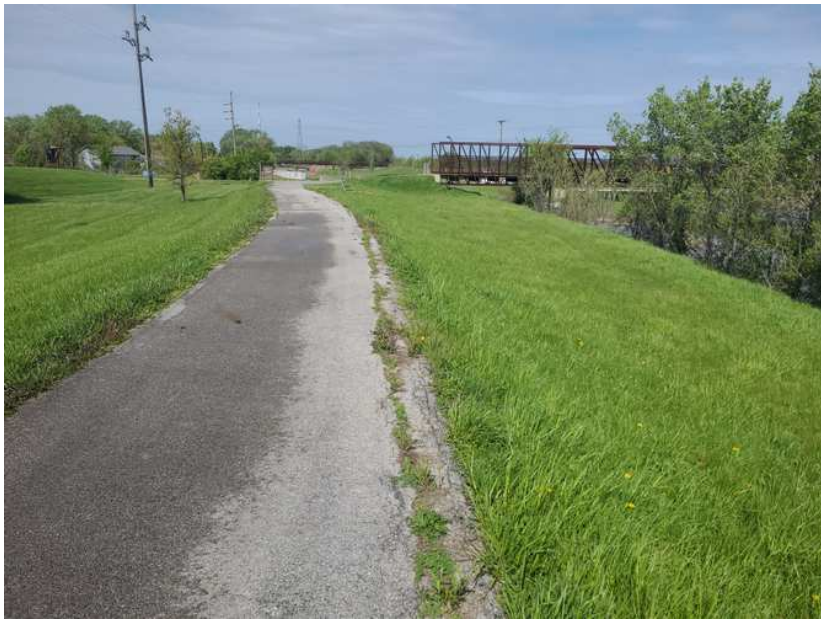
No User Rating (Site Visit) - Rutting in riverside slope

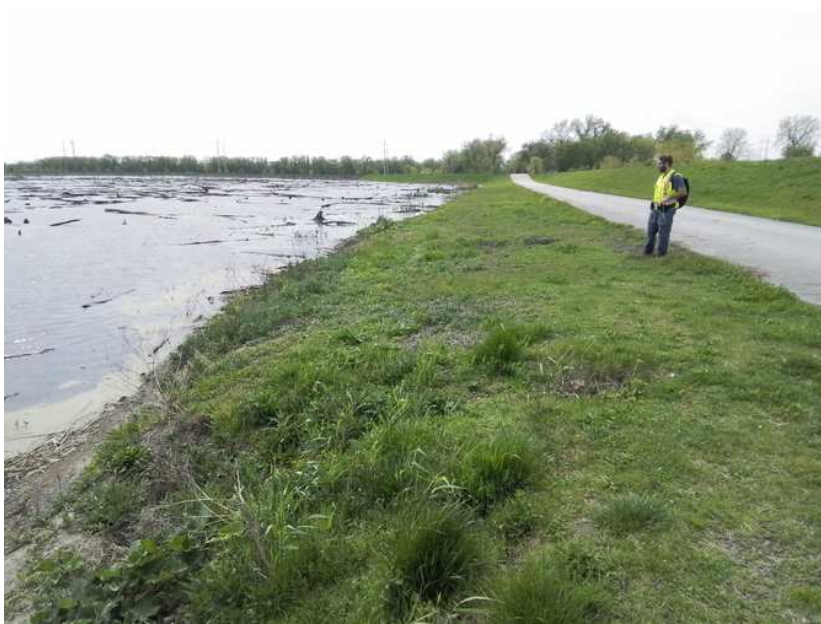
**Inspect ID:** 2024-0185

No User Rating (Site Visit) - Collapsed animal burrow on riverside toe.

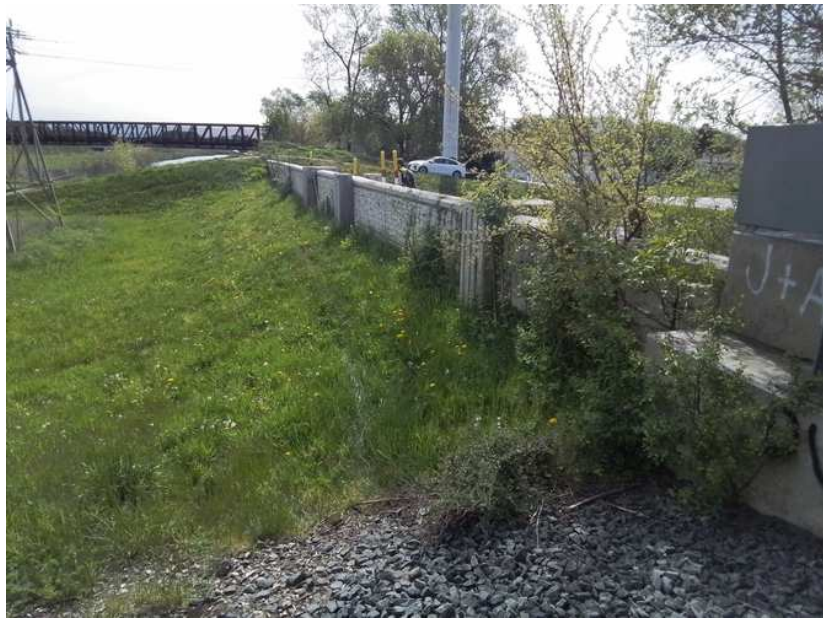
No User Rating (Site Visit) - Vegetation on landside of floodwall

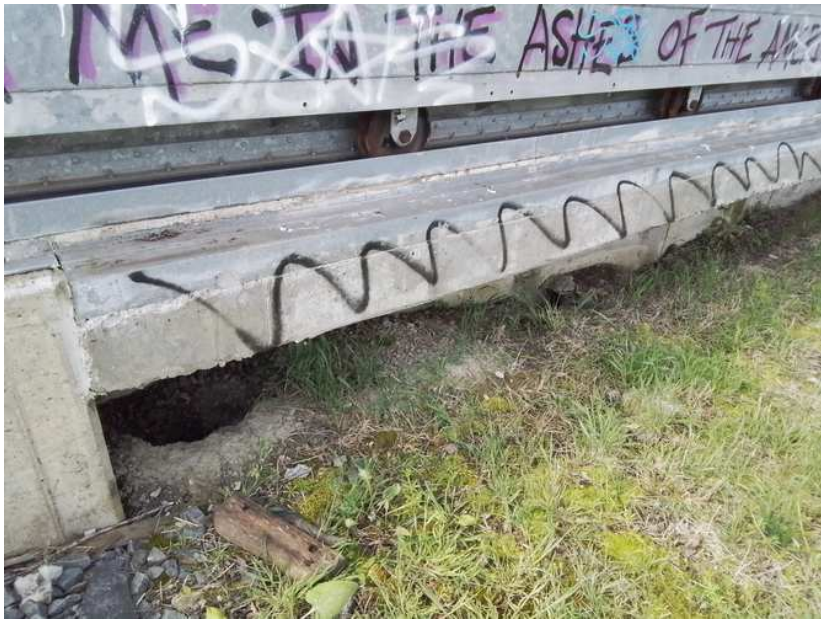
No User Rating (Site Visit) - Missing seal on railroad closure.

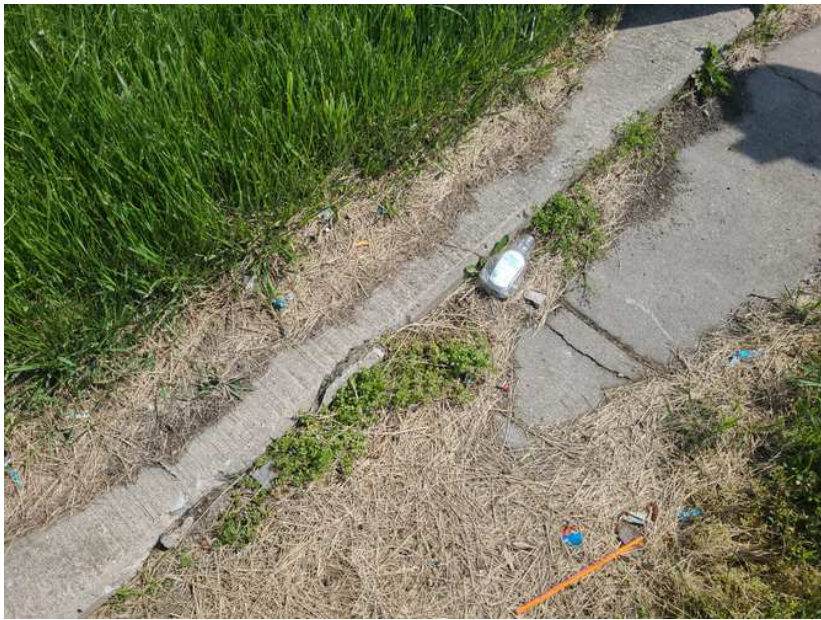
**Inspect ID:** 2024-0100

No User Rating (Site Visit) - Crack in concrete and asphalt at closure structure on the top of the floodwall.

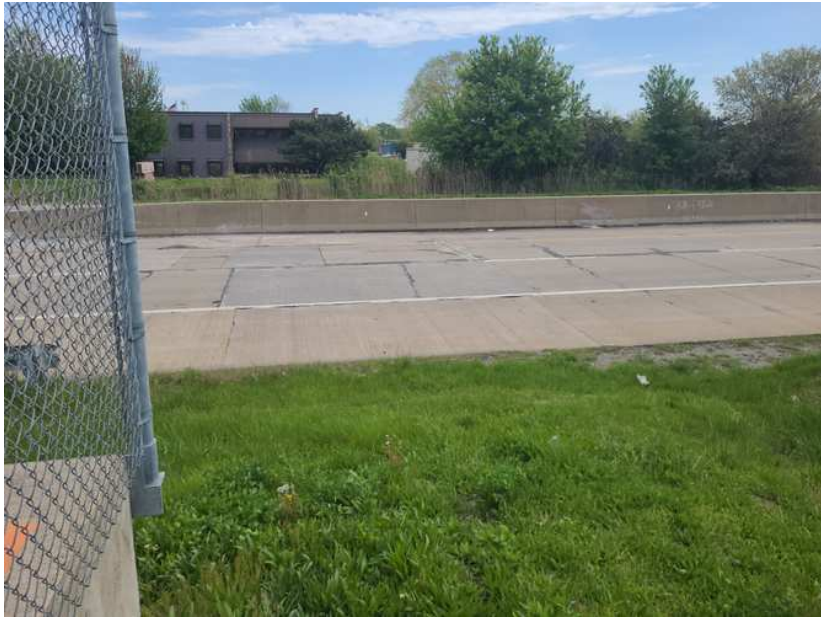
**Inspect ID:** 2024-0105

No User Rating (Site Visit) - Spalling on eastern closure structure

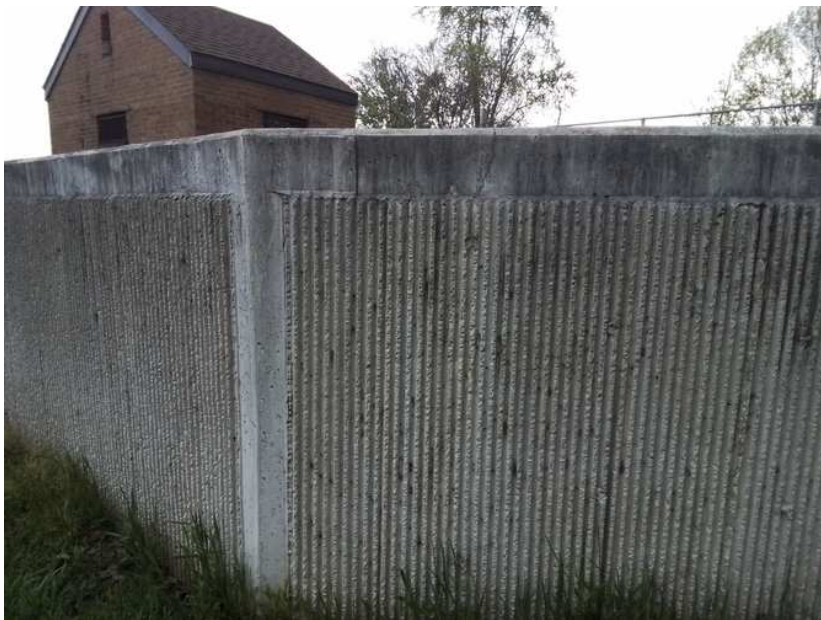
**Inspect ID:** 2024-0016

No User Rating (Site Visit) - Typical joint deterioration on floodwall on riverside.

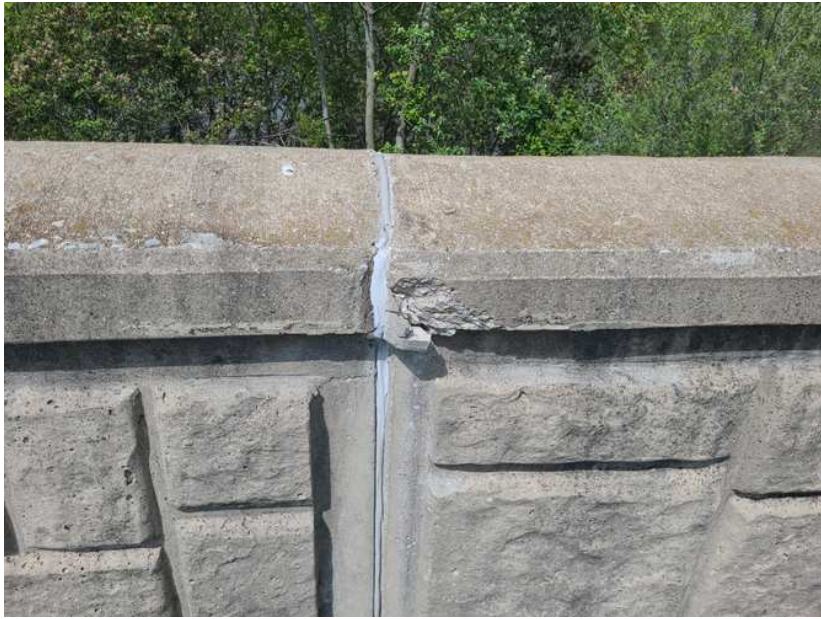
**Inspect ID:** 2024-0020

No User Rating (Site Visit) - Small crack in riverside of floodwall.

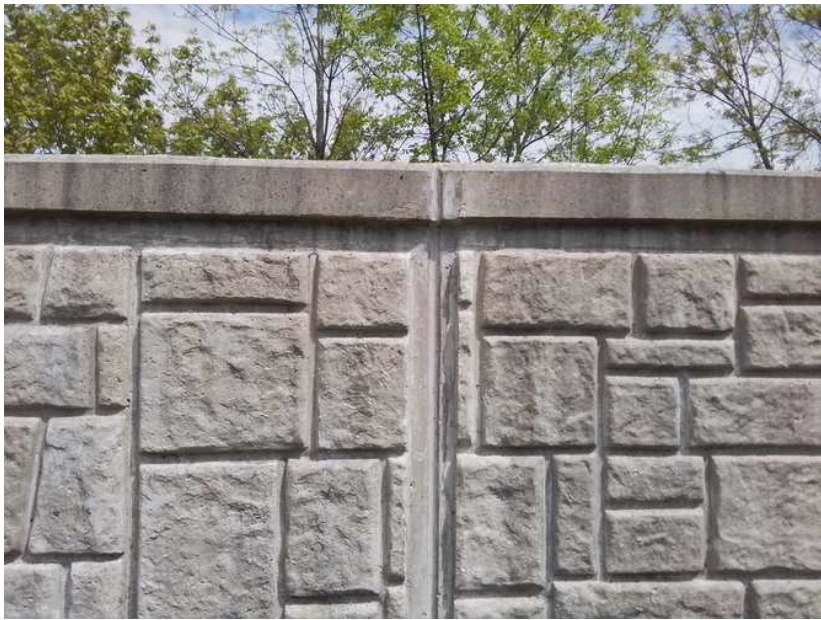
**Inspect ID:** 2024-0141

No User Rating (Site Visit) - Spalling concrete on landside

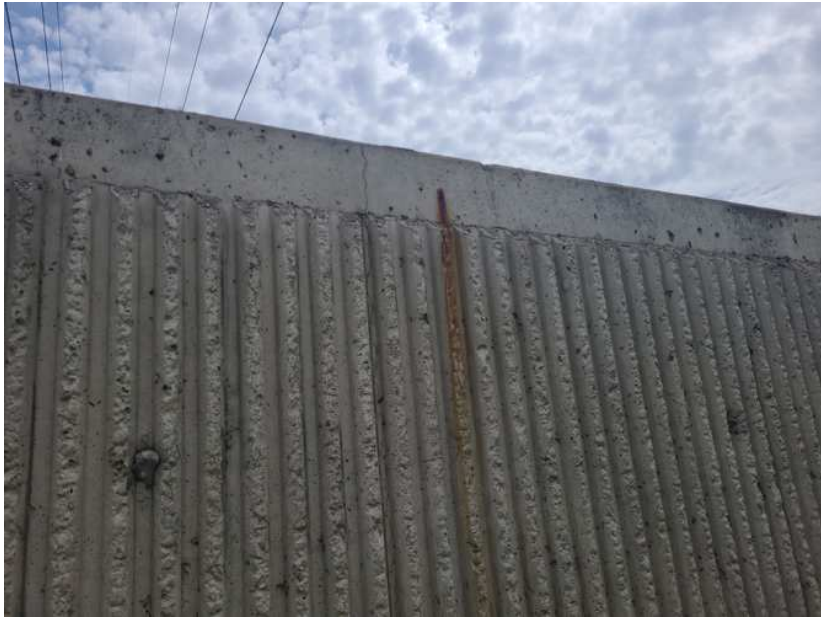
**Inspect ID:** 2024-0200

No User Rating (Site Visit) - Crack on landside of floodwall.

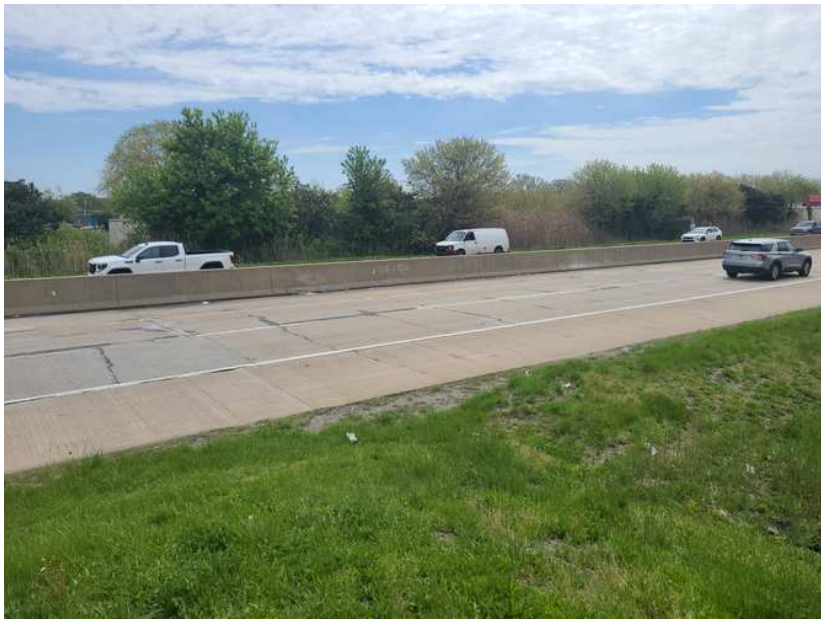
**Inspect ID:** 2024-0217

No User Rating (Site Visit) - Crack over top of floodwall

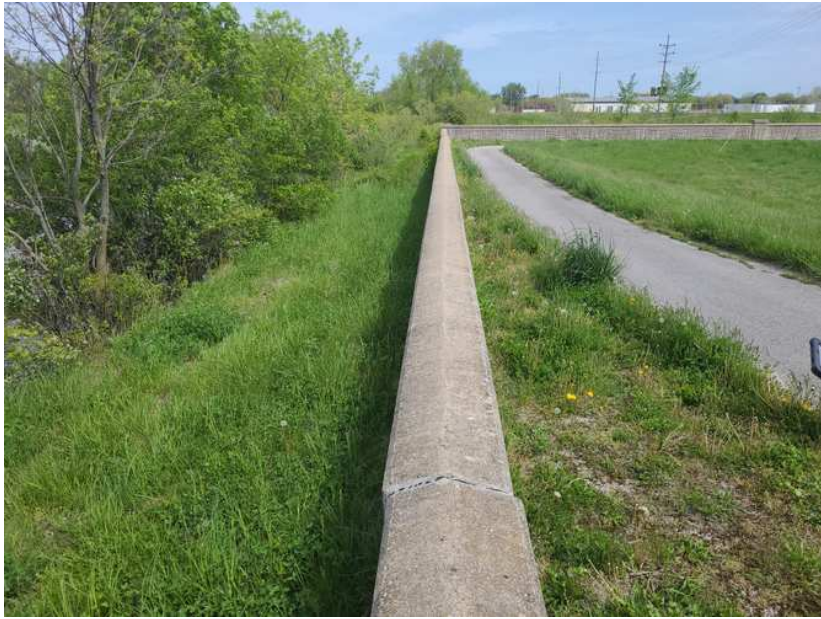
**Inspect ID:** 2024-0233

No User Rating (Site Visit) - Spalling on concrete wall

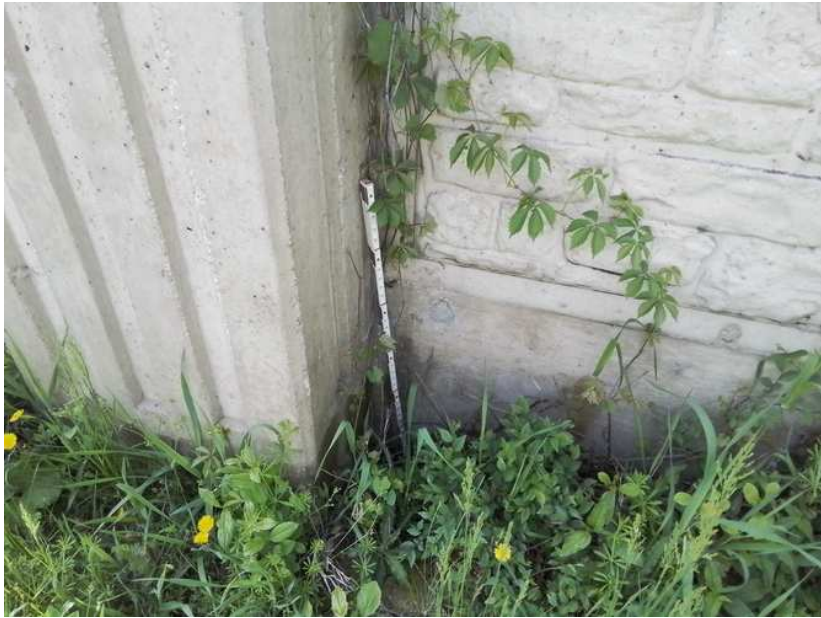
**Inspect ID:** 2024-0137

No User Rating (Site Visit) - Misalignment of I wall

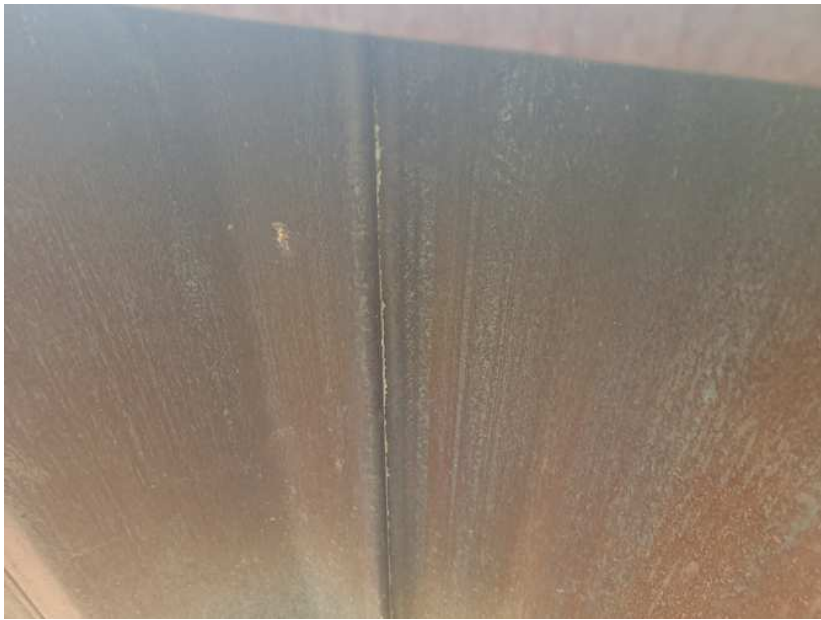
No User Rating (Site Visit) - Cracks in sealant, typical observations on landside.

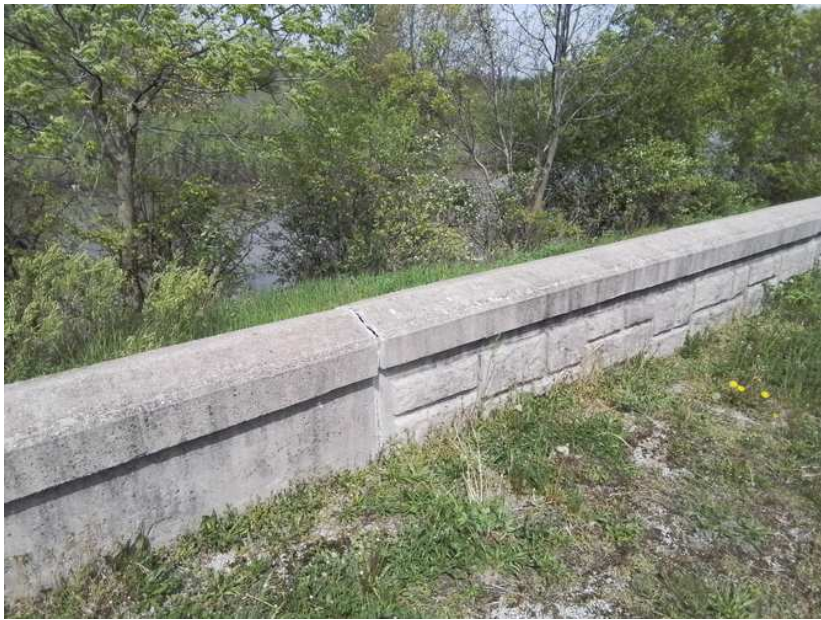
No User Rating (Site Visit) - Sealant cracking on landside of floodwall.

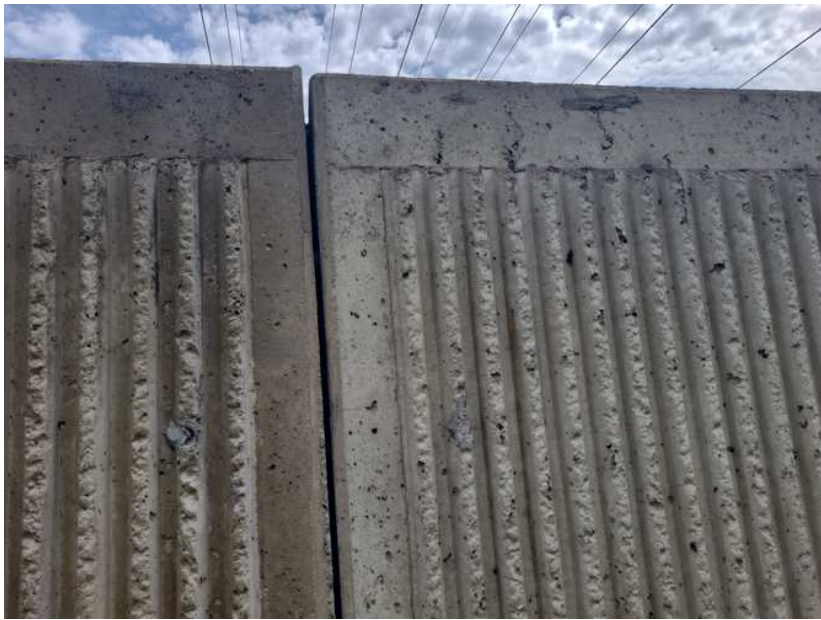
**Inspect ID:** 2024-0188

No User Rating (Site Visit) - Sealant cracking in joints.

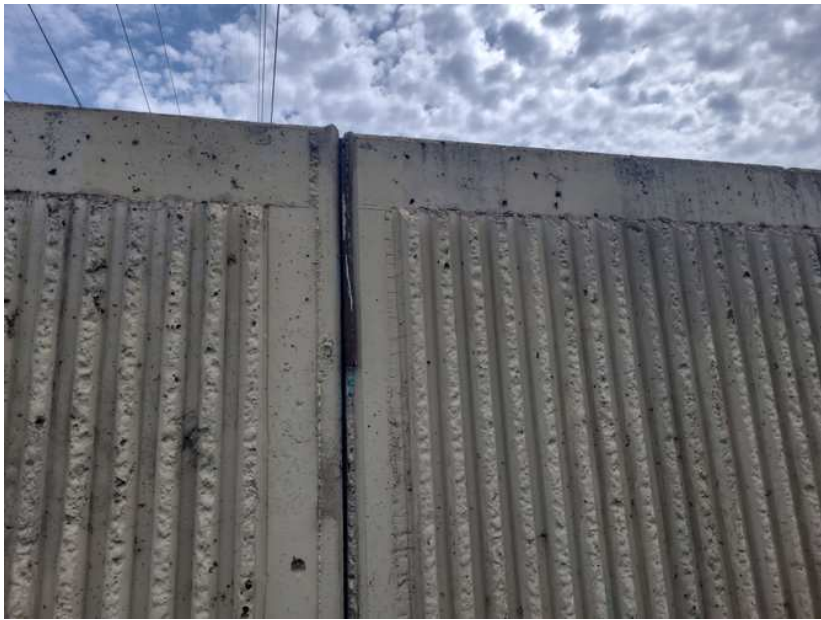
**Inspect ID:** 2024-0213

No User Rating (Site Visit) - Sealant and backer rod completely missing on the landside.

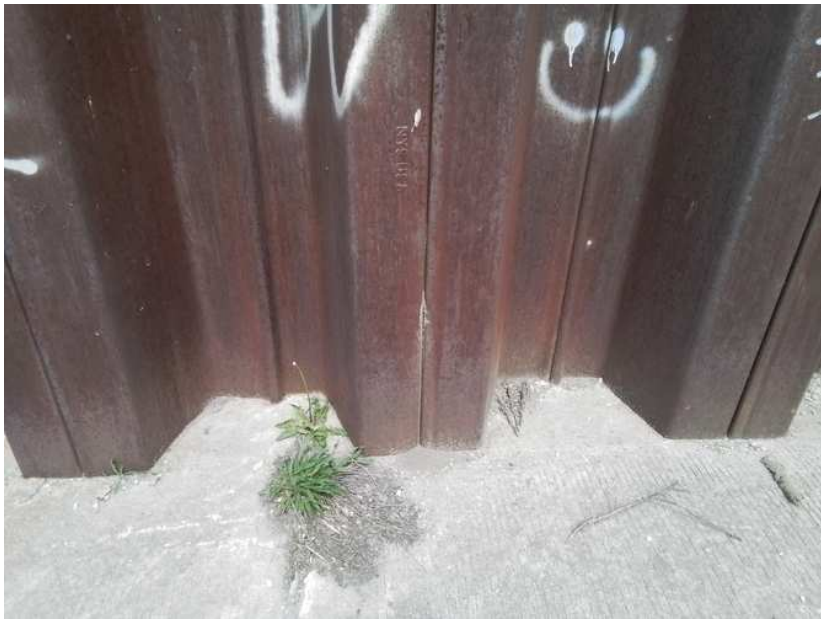
**Inspect ID:** 2024-0221

No User Rating (Site Visit) - Sealant missing and water stop shifting from original location on the landside.

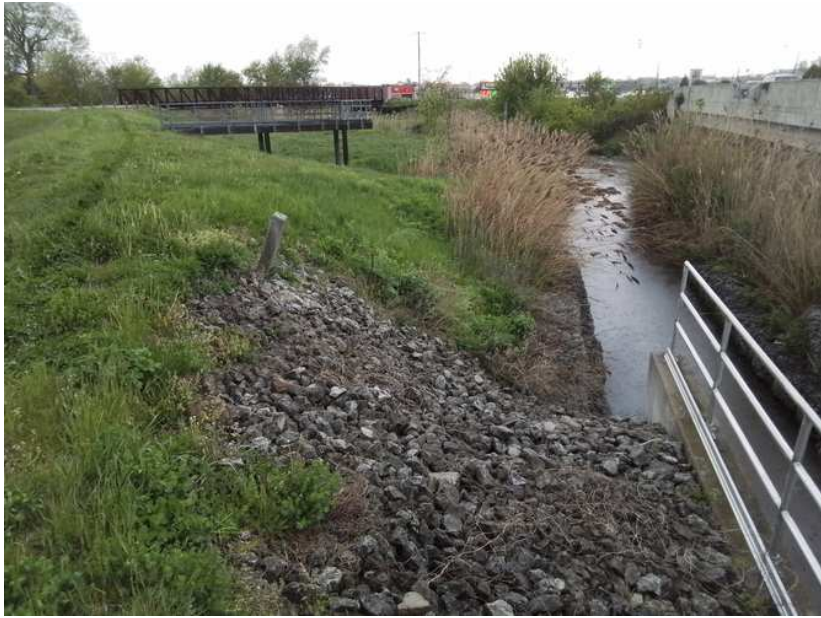
**Inspect ID:** 2024-0042

No User Rating (Site Visit) - HI-07: Scouring around gate well structure

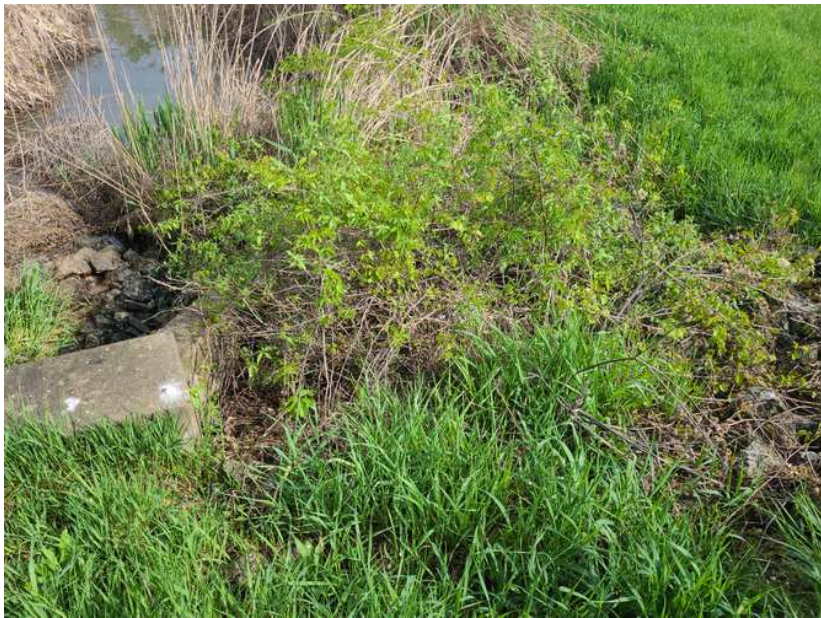
**Inspect ID:** 2024-0044

No User Rating (Site Visit) - INDOT: gabion baskets damaged on West side of outlet structure

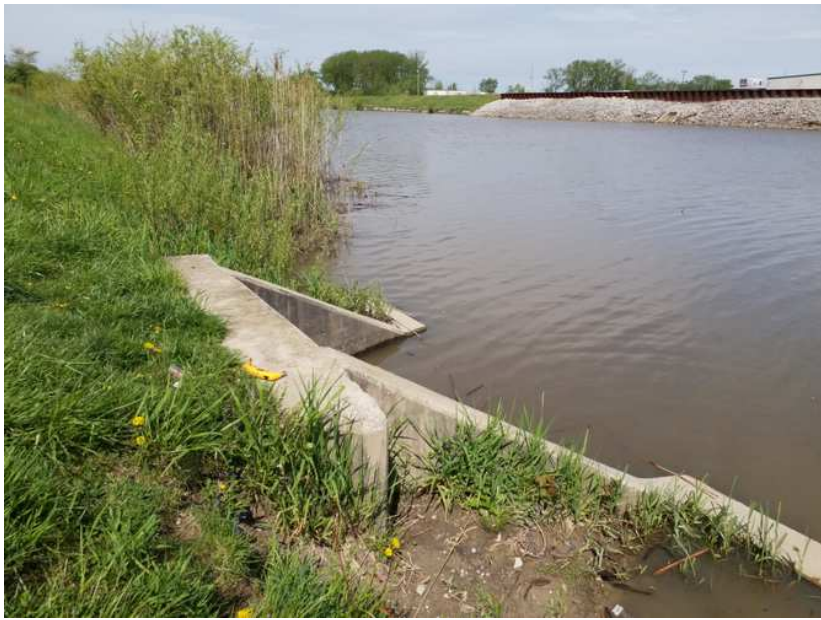
**Inspect ID:** 2024-0053

No User Rating (Site Visit) - Erosion around outlet structure

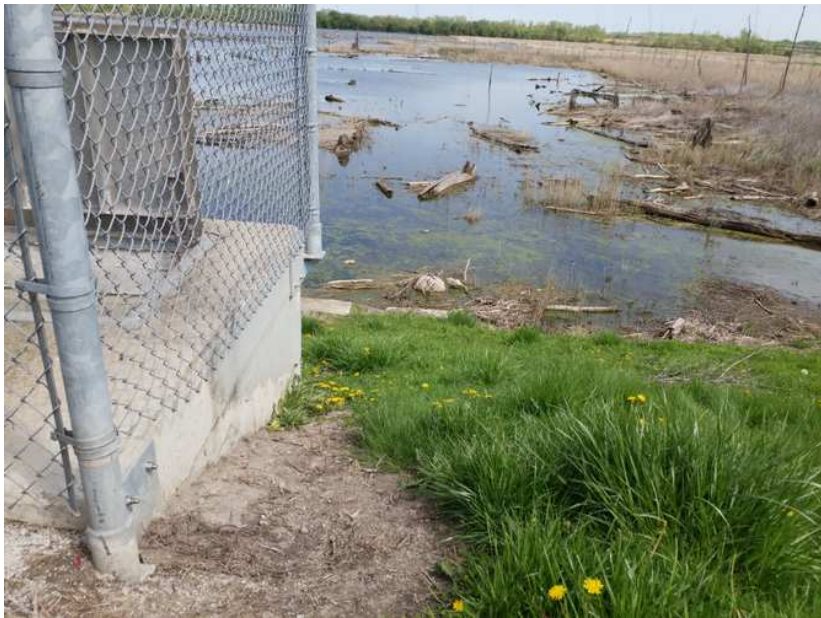
**Inspect ID:** 2024-0066

No User Rating (Site Visit) - HI-10: Scouring around wingwall and debris at outlet

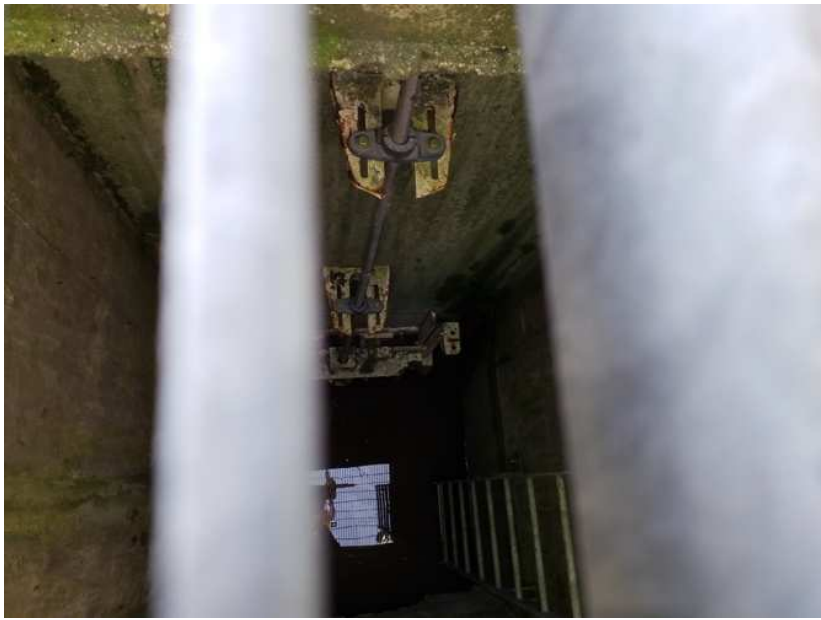
No User Rating (Site Visit) - HI-07: Fully closed, noisy when closing with minor rust on the gate

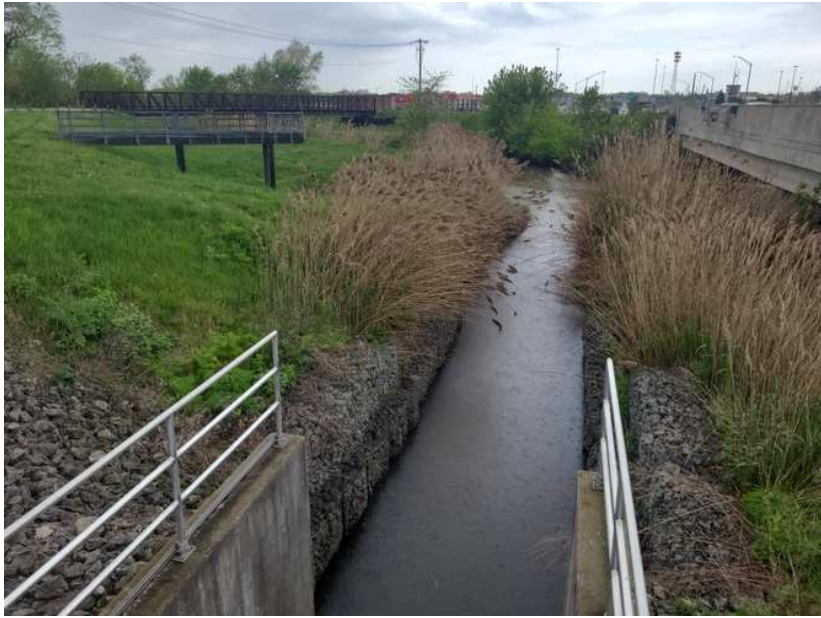
**Inspect ID:** 2024-0117

No User Rating (Site Visit) - HI-08: Outfall gate is bent and damaged.

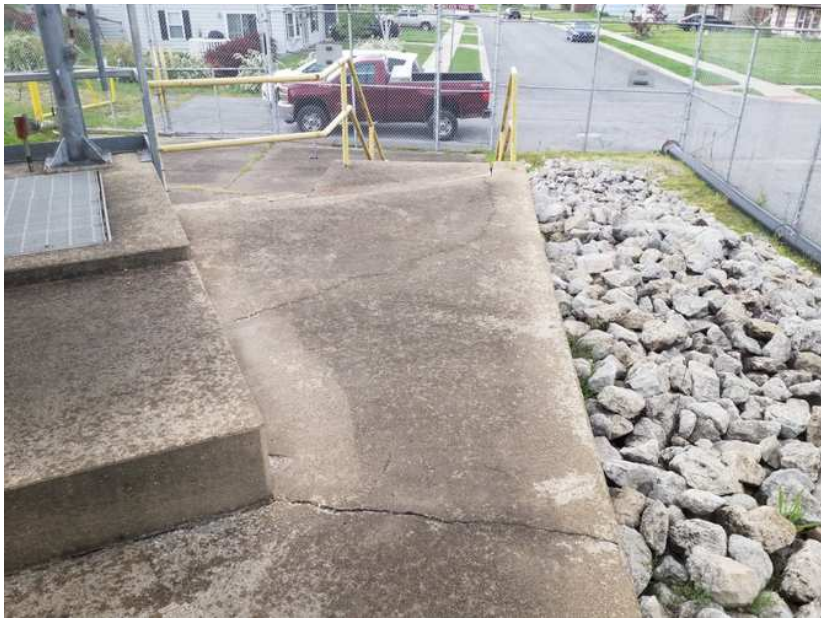
No User Rating (Site Visit) - PS-N5: Guardrails are wobbly - noted during last inspection

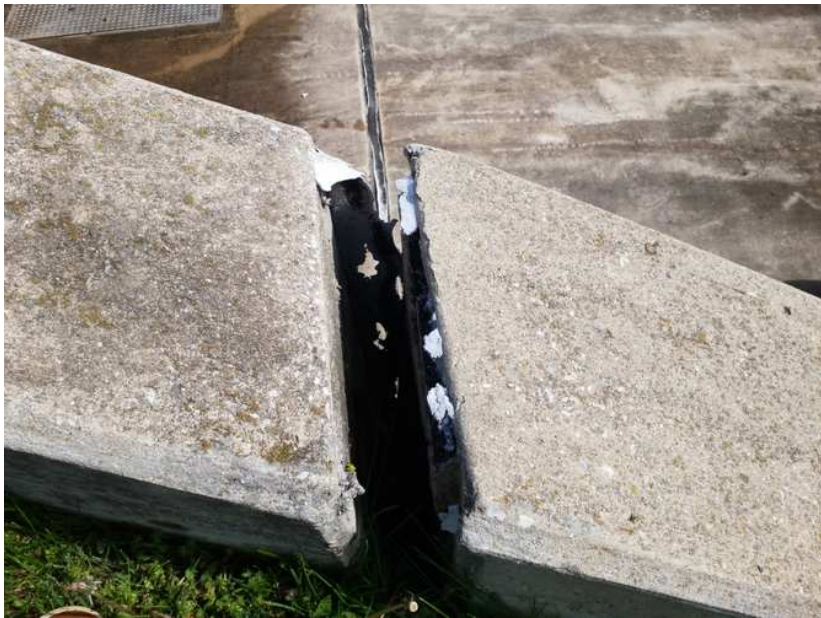
No User Rating (Site Visit) - PS-N5: Erosion in danger of undercutting sidewalk - noted during last inspection

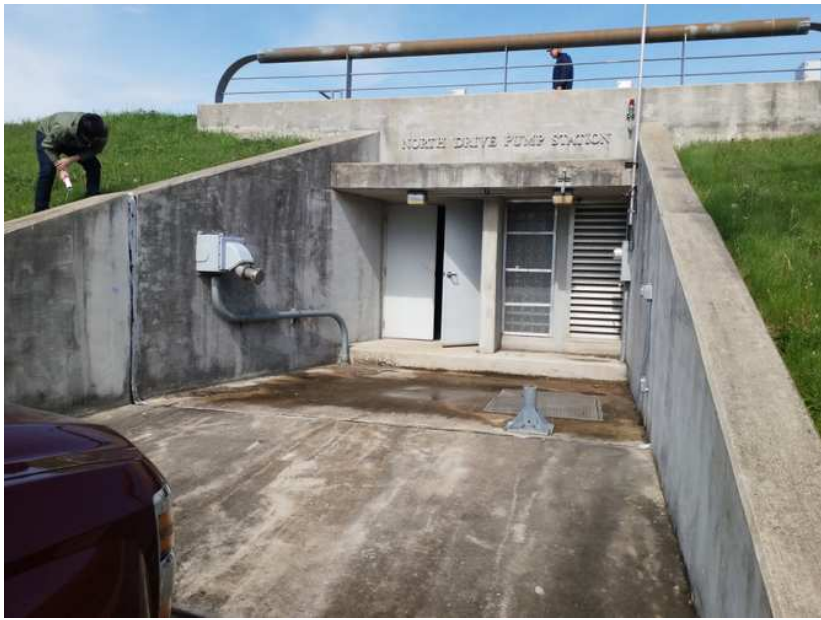
**Inspect ID:** 2024-0087

No User Rating (Site Visit) - PS-ND: Sealant between retaining wall and floor sections is badly deteriorated - noted during previous inspections, may be getting worse

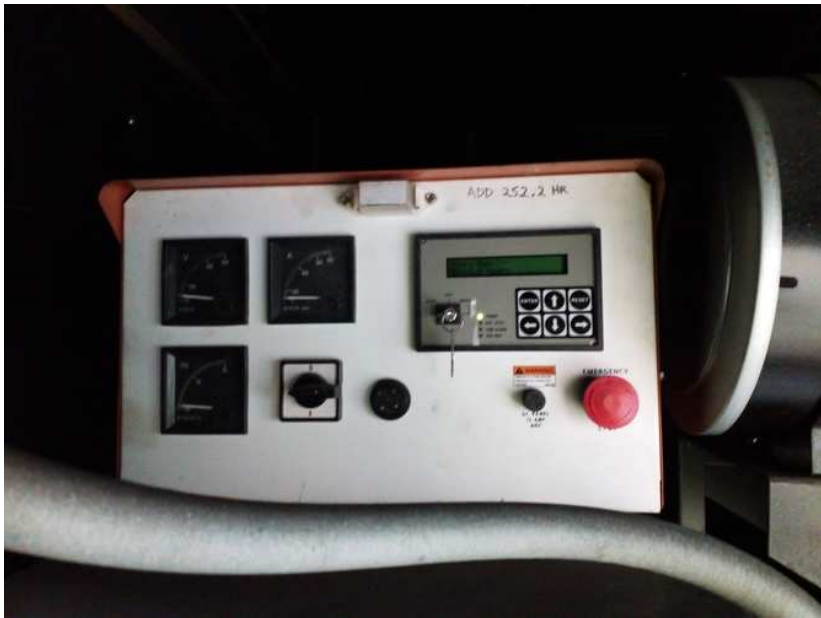
**Inspect ID:** 2024-0079

No User Rating (Site Visit) - PS-N5: Exhaust fan EF-3 is inoperable, no ETA on repair - noted during last inspection

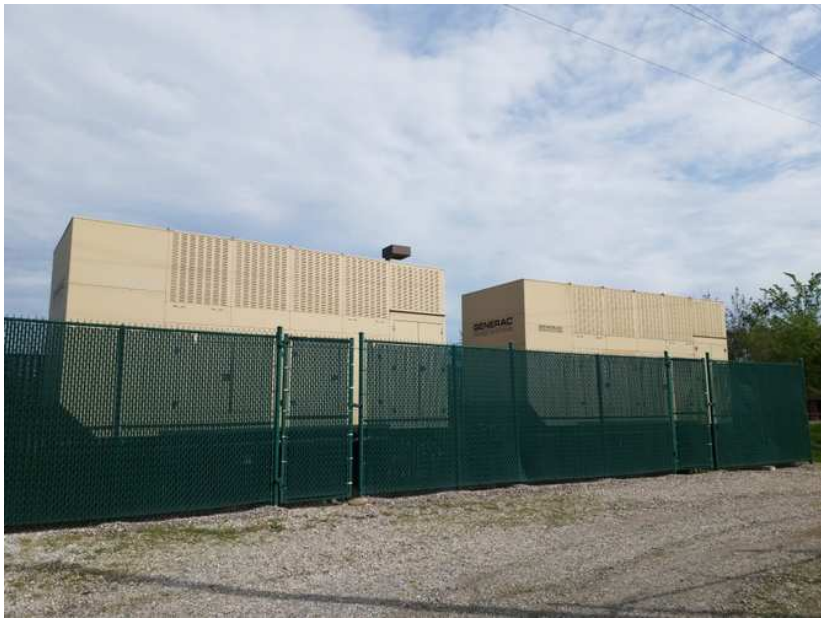
**Inspect ID:** 2024-0023

No User Rating (Site Visit) - PS-81: Generator hours are 920.6 (hours during last inspection were 885.4). Generator was supposed to be replaced last December but the replacement unit had issues so they are waiting on a different replacement, no ETA. Current generator is operational in the meantime with some issues

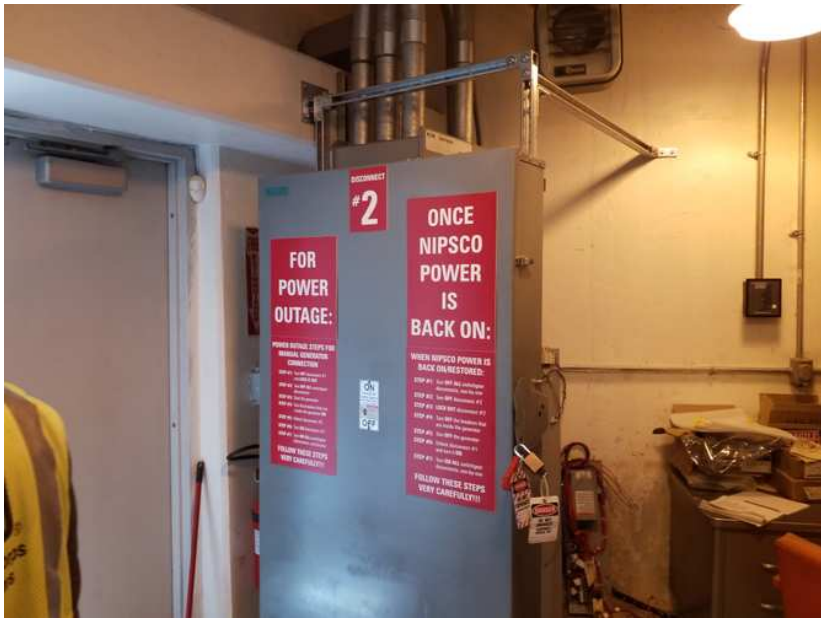
**Inspect ID:** 2024-0075  
**Rated Item:** 13. Power Source  
**Lat/Long:** 41.56971/-87.45674  
**Caption:**  
No User Rating (Site Visit) - PS-N5: Generator 1 through 4 hrs are 417.7, 386.5, 396.4, and 391.9, respectively. Hours during last inspection were 402, 371.2, 380.7, and 376.1, respectively

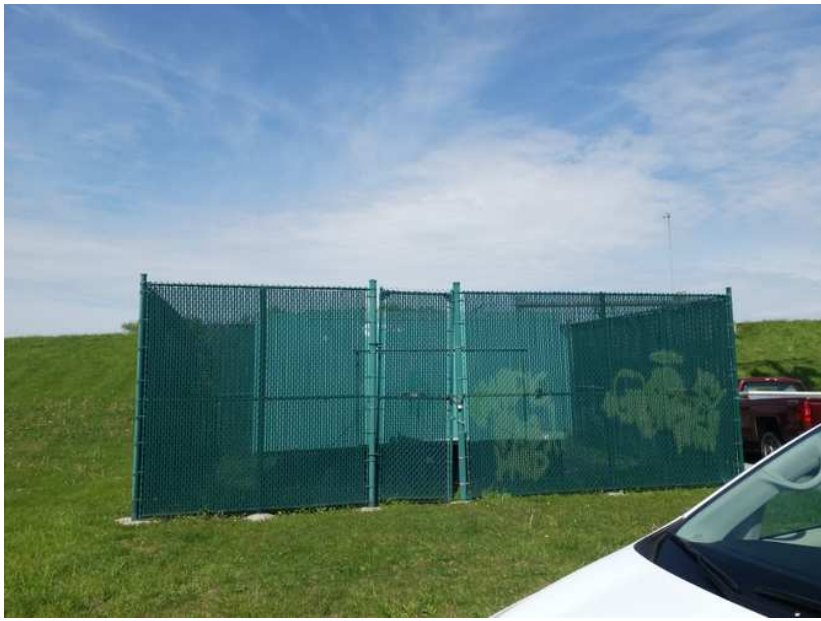
**Inspect ID:** 2024-0099  
**Rated Item:** 13. Power Source  
**Lat/Long:** 41.56788/-87.44797  
**Caption:**  
No User Rating (Site Visit) - PS-ND: Waiting on transfer switch for generator, expected by July 2024 - last inspection noted same issue

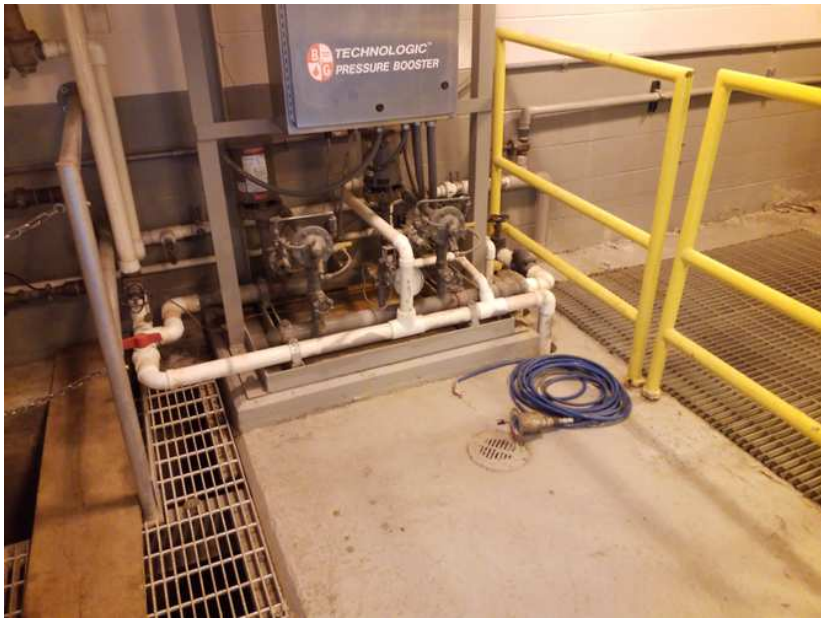
No User Rating (Site Visit) - PS-81: Missing arc flash warning labels

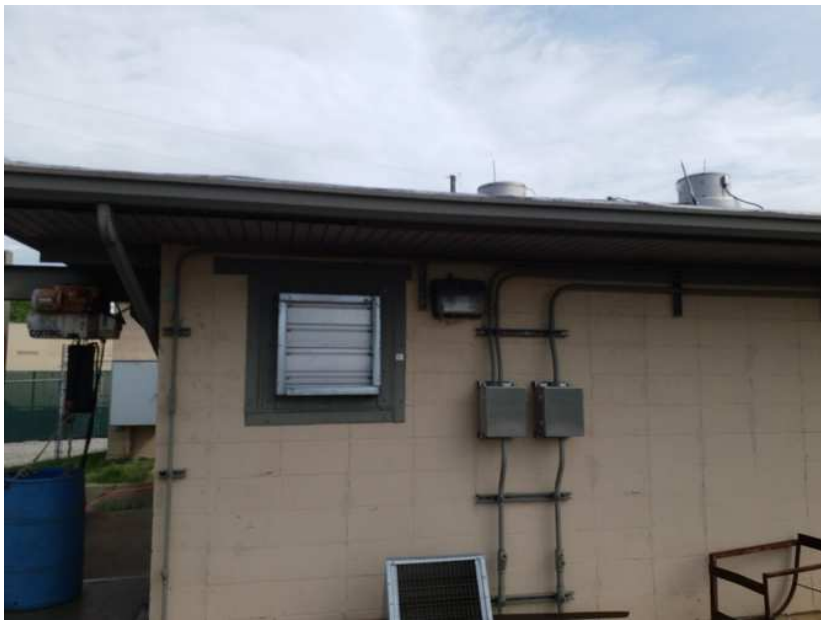
**Inspect ID:** 2024-0047

No User Rating (Site Visit) - PS-N5: Missing arc flash warning labels

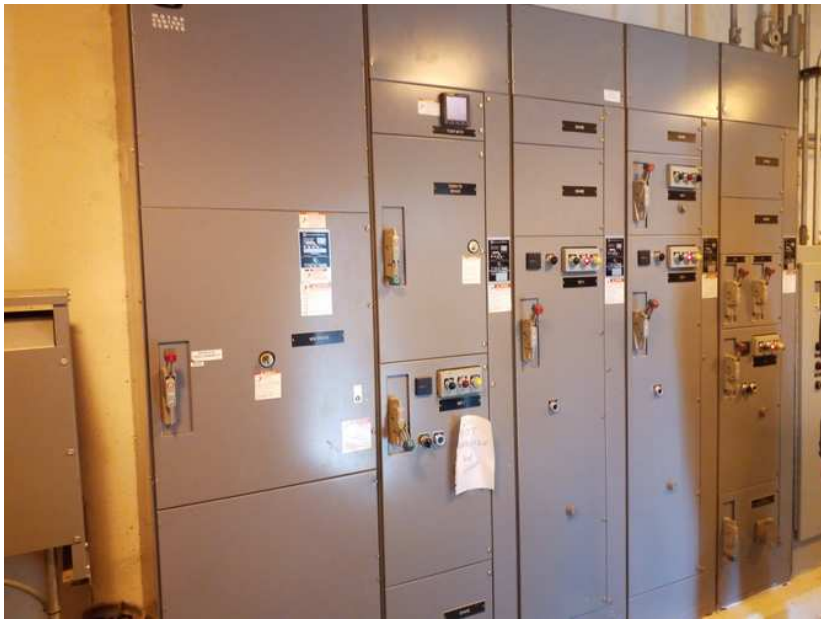
No User Rating (Site Visit) - PS-ND: Missing arc flash warning labels

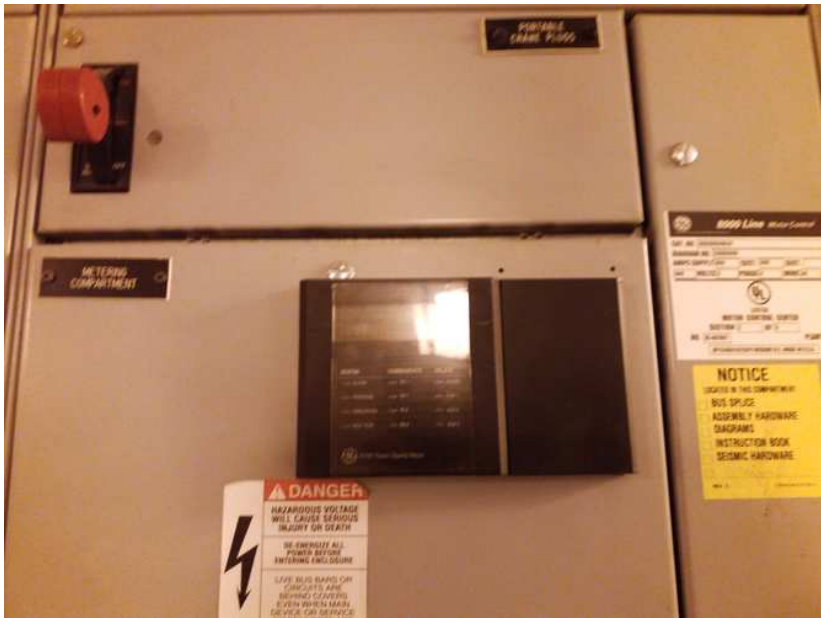
**Inspect ID:** 2024-0107

No User Rating (Site Visit) - PS-ND: Missing arc flash warning labels
