US Army Corps of Engineers ®

## Site Visit Summary

Name of System: Highland

NLD System ID: 2605000005 NLD Segment ID: 2604000007

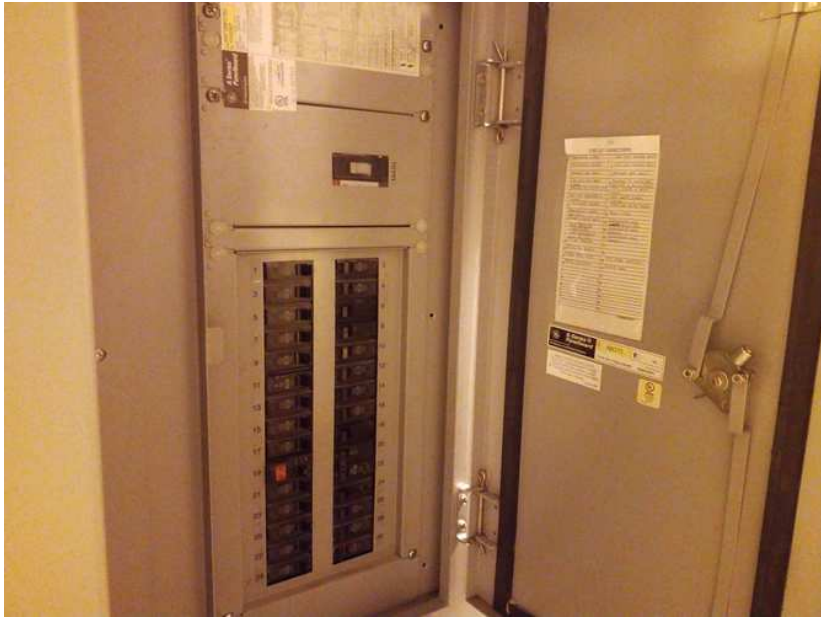
**Inspect ID:** 2024-0011

No User Rating (Site Visit) - PS-81: Power quality meter is out of service, no ETA on repair - noted during last inspection

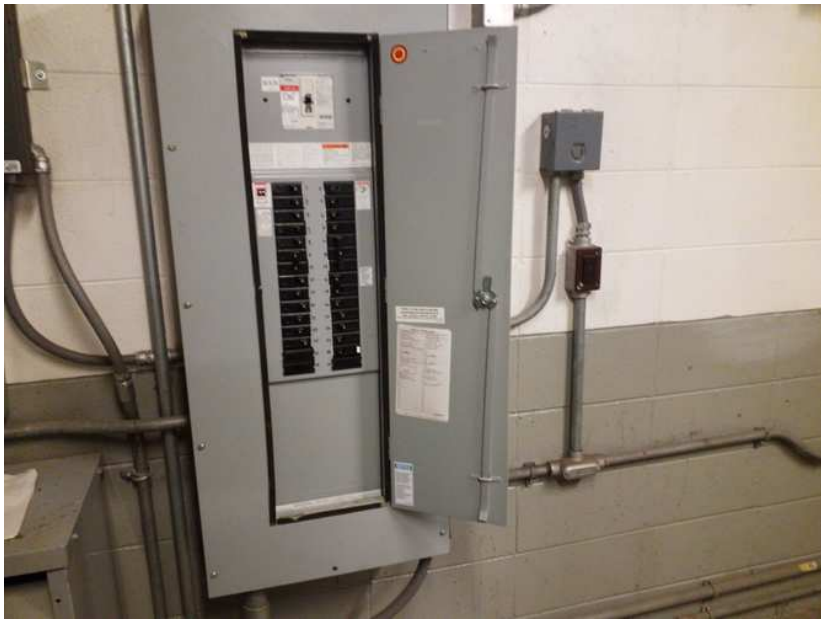
**Inspect ID:** 2024-0031

No User Rating (Site Visit) - PS-81: Breakers 24 and 26 are missing labels - plant personnel don't know what these breakers operate
