US Army Corps of Engineers ®

Levee Inspection Report

Name of System: Munster
 Name of Segment: Munster
 NLD System ID: 2605000006 NLD Segment ID: 2604000009

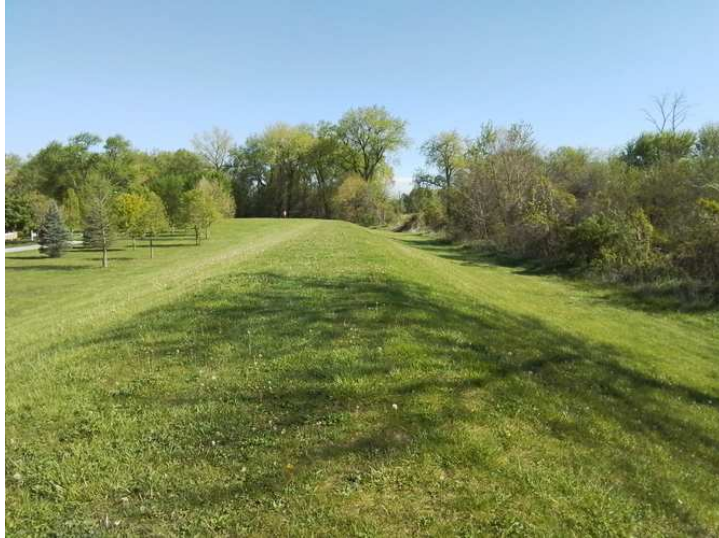
Inspect ID: 2024-0228
Feature Details: Levee Embankments - Slope Stability - Slopes and Crown
Station Start:
Station End:
Caption: Acceptable - Slopes are in good condition.

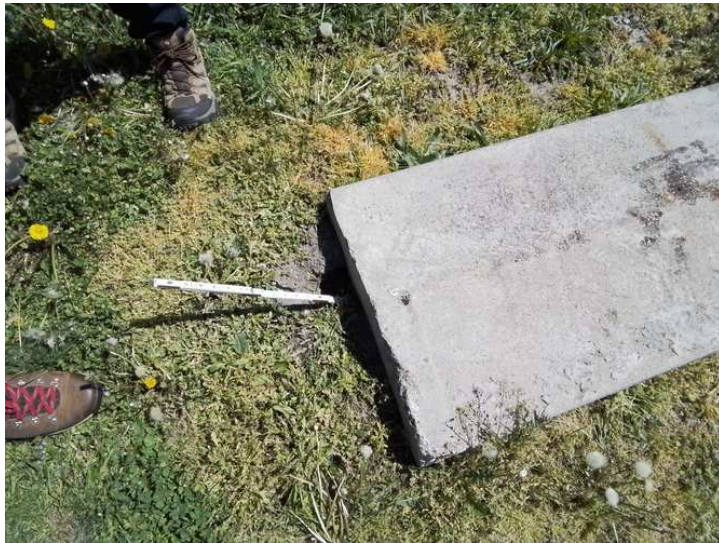
Inspect ID: 2024-0364
Feature Details: Levee Embankments - Settlement
Station Start:
Station End:
Caption: Minimally Acceptable - Hole extending under the floodwall cap at the levee tie-in.

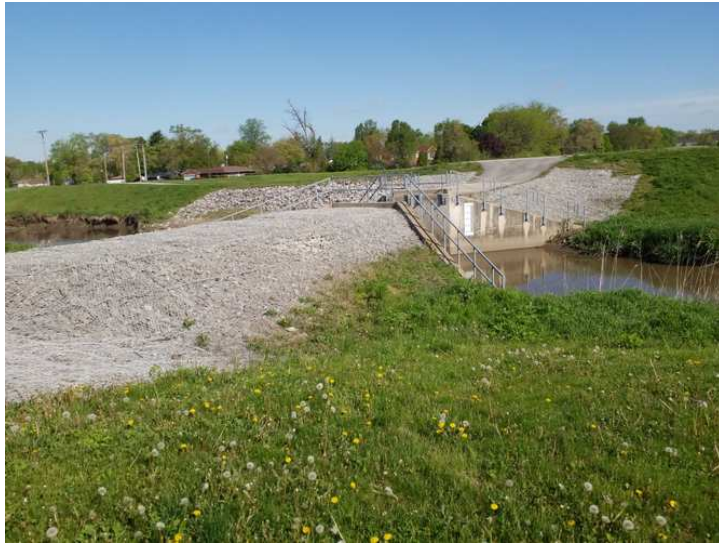
Inspect ID: 2024-0022
Feature Details: Levee Embankments - Revetments other than Riprap - Waterside Slope
Station Start:
Station End:
Caption: Minimally Acceptable - Damaged gabion baskets on the riverside slope.

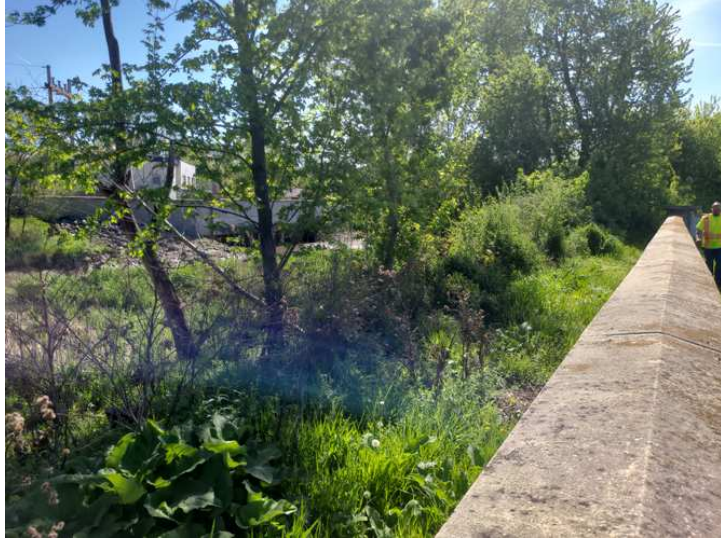
Inspect ID: 2024-0017
Feature Details: Floodwalls - Unwanted Vegetation Growth - Waterside
Station Start:
Station End:
Caption: Minimally Acceptable -Vegetation within 15-ft of the riverside floodwall.

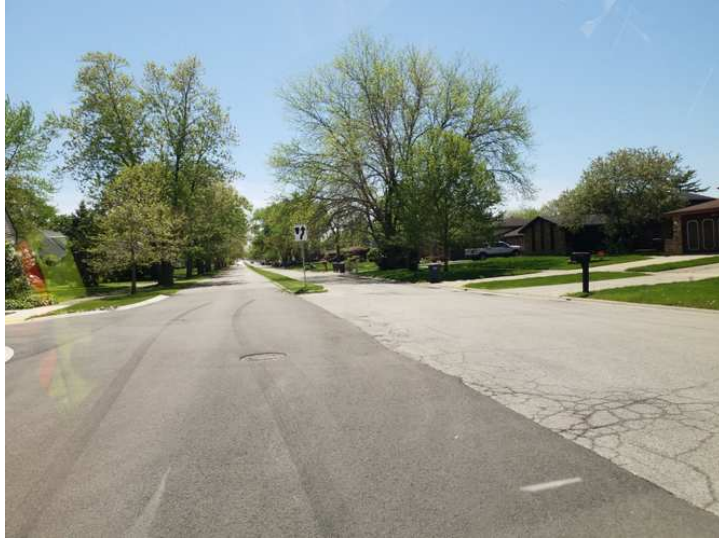
Inspect ID: 2024-0154
Feature Details: Floodwalls - Closure Structures (Stop Log Closures and Gates) (A or U only) - Other
Station Start:
Station End:
Caption: Acceptable - Typical condition of closure structure

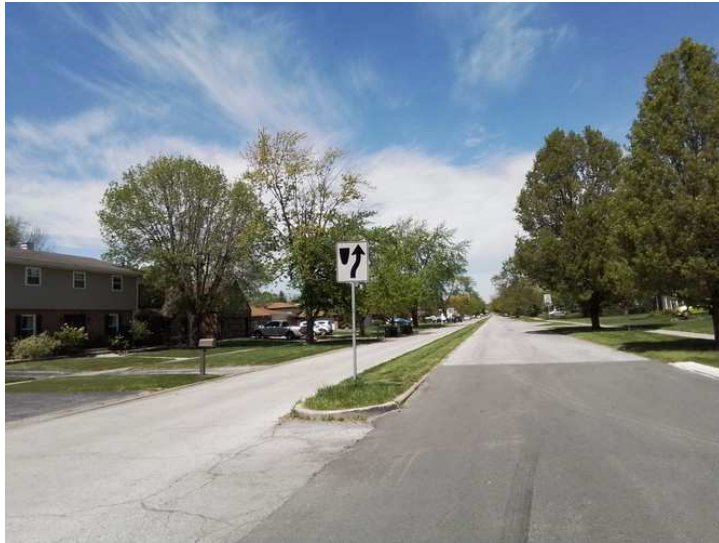
Inspect ID: 2024-0436
Feature Details: Floodwalls - Closure Structures (Stop Log Closures and Gates) (A or U only)
Station Start:
Station End:
Caption: Acceptable - Typical view of the State Line Road closure.

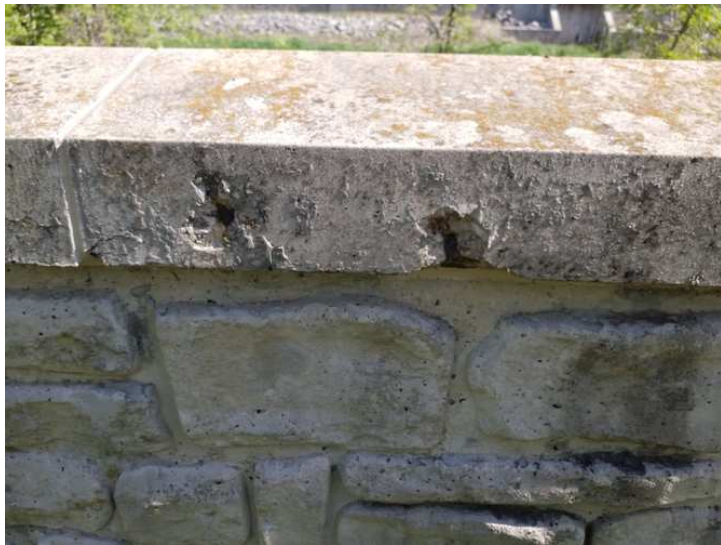
Inspect ID: 2024-0042

Caption: Minimally Acceptable - Minor cracks in the landside floodwall.

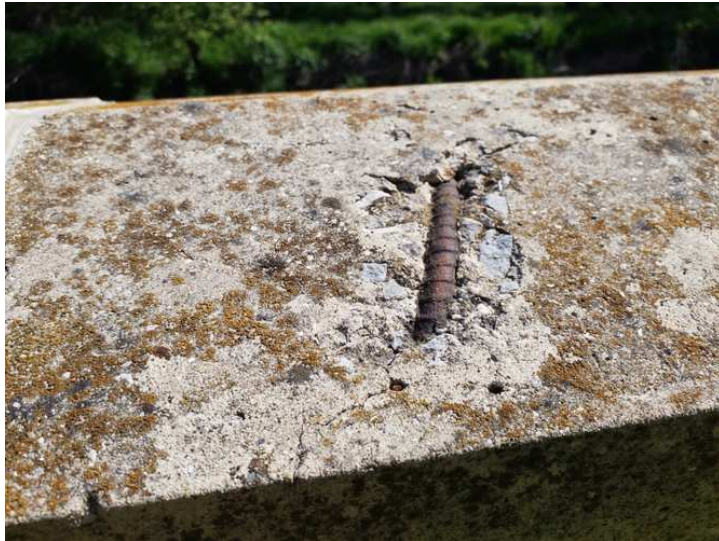
Inspect ID: 2024-0054
Feature Details: Floodwalls - Concrete Surfaces - Top of Floodwall
Station Start:
Station End:
Caption: Minimally Acceptable - Exposed rebar due to spalling on top of the floodwall.

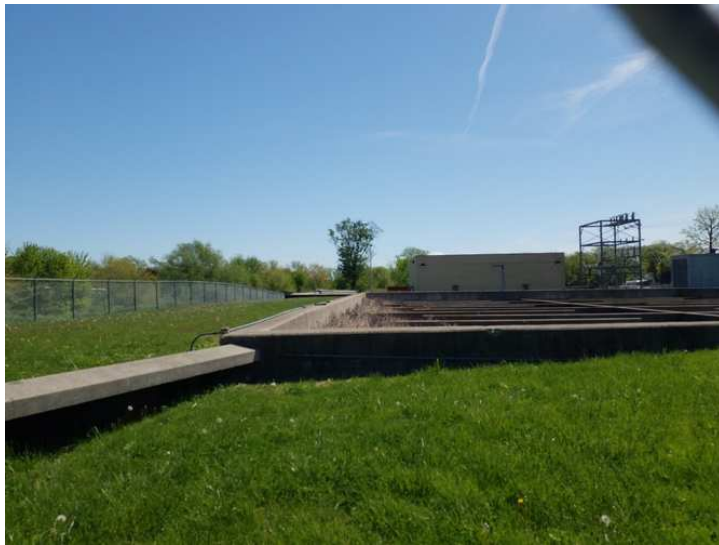
Inspect ID: 2024-0082
Feature Details: Floodwalls - Concrete Surfaces - Top of Floodwall
Station Start:
Station End:
Caption: Minimally Acceptable - Spalling on top of the floodwall.

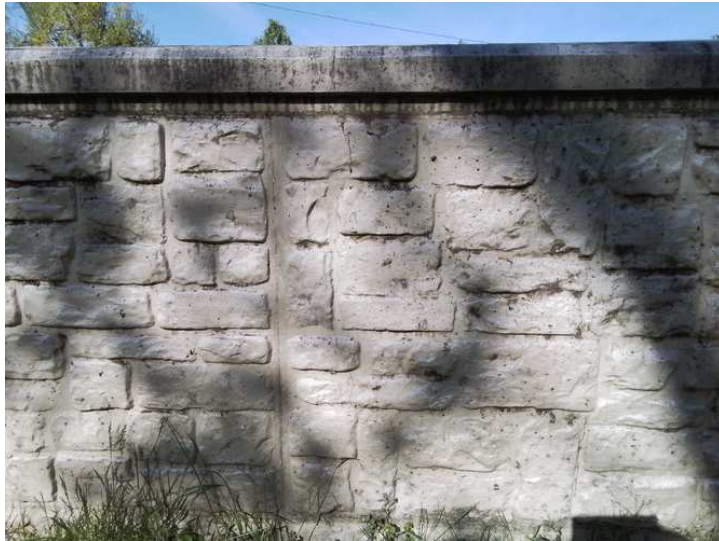
Inspect ID: 2024-0212
Feature Details: Floodwalls - Concrete Surfaces - Landside and Waterside
Station Start:
Station End:
Caption: Minimally Acceptable - Minor crack on both sides of the wall.

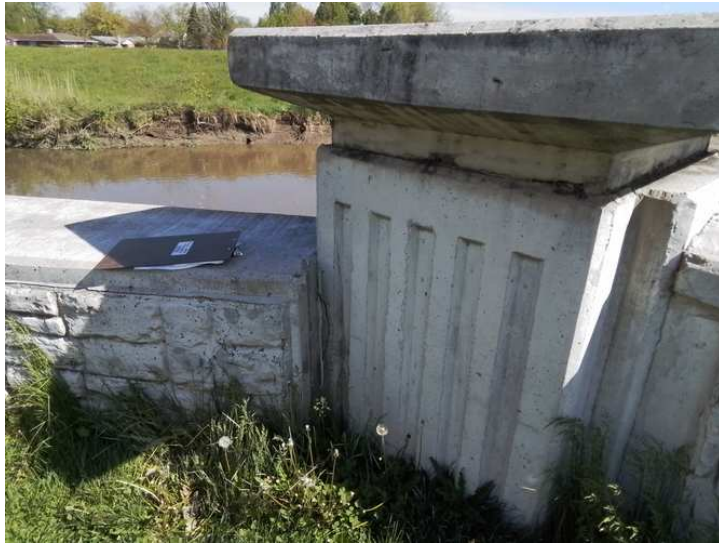
Inspect ID: 2024-0248
Feature Details: Floodwalls - Concrete Surfaces - Landside
Station Start:
Station End:
Caption: Minimally Acceptable - Minor cracks on the landside floodwall.

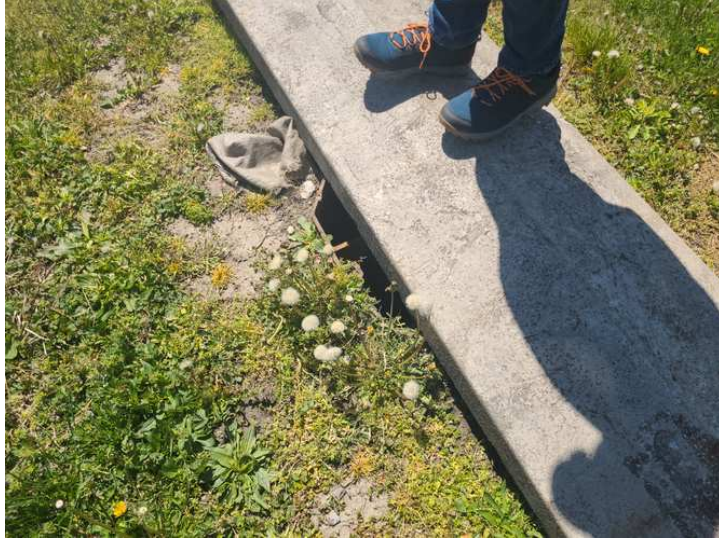
Inspect ID: 2024-0105
Feature Details: Floodwalls - Tilting, Sliding or Settlement of Concrete Structures
Station Start:
Station End:
Caption: Minimally Acceptable - Cap has shifted at tie-in.

Rated Item	Rating	Rating Guidelines		Observation Locations with Descriptions and Resulting Item Rating Justification
5. Tilting, Sliding or Settlement of Concrete Structures	M	A	There are no significant areas of tilting, sliding, or settlement that would endanger the integrity of the structure.	2024-0105 : Cap has shifted at tie-in.(M)
		M	There are areas of tilting, sliding, or settlement (either active or inactive) that need to be repaired. The maximum offset, either laterally or vertically, does not exceed 2 inches unless the movement can be shown to be no longer actively occurring. The integrity of the structure is not in danger.	2024-0117 : Cap has shifted at tie-in.(M)
		U	There are areas of tilting, sliding, or settlement (either active or inactive) that threaten the structure's integrity and performance. Any movement that has resulted in failure of the waterstop (possibly identified by daylight visible through the joint) is unacceptable. Differential movement of greater than 2 inches between any two adjacent monoliths, either laterally or vertically, is unacceptable unless it can be shown that the movement is no longer active. Also, if the floodwall is of I-wall construction, then any visible or measurable tilting of the wall toward the protected side that has created an open horizontal crack on the riverside base of a monolith is unacceptable.	Recommendation: Monitor caps for further shifting at tie-ins.

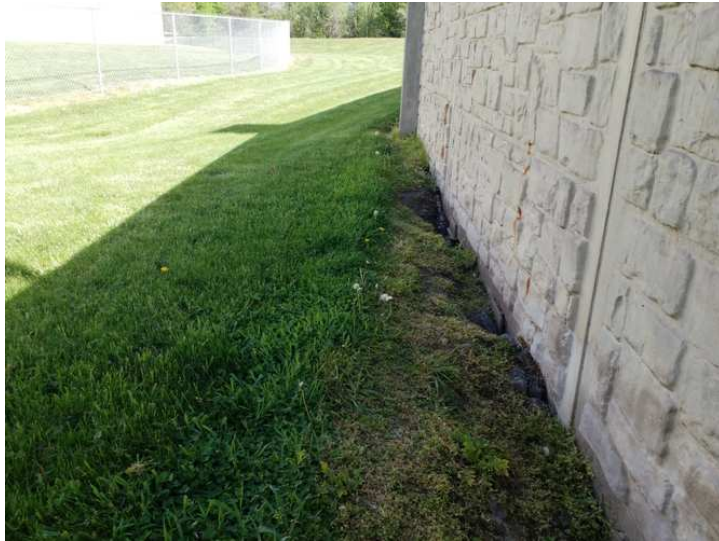
Inspect ID: 2024-0019
Feature Details: Floodwalls - Foundation of Concrete Structures - Landside
Station Start:
Station End:
Caption: Minimally Acceptable - Erosion on the landside of the floodwall.

Rated Item	Rating	Rating Guidelines		Observation Locations with Descriptions and Resulting Item Rating Justification
				<p>Recommendation: Fill in depressions and burrows next to the floodwall. Erosion areas should be regraded and covered with sod to prevent further issues.</p>

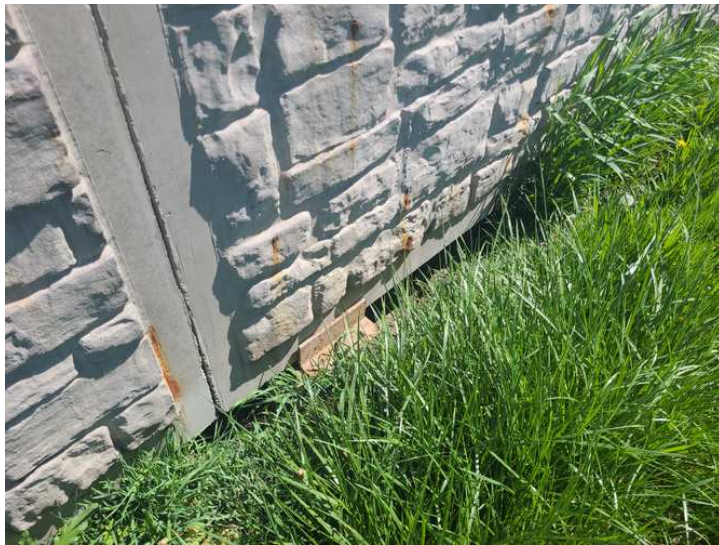
Inspect ID: 2024-0033
Feature Details: Floodwalls - Foundation of Concrete Structures
Station Start:
Station End:
Caption: Minimally Acceptable - Approximately 2-ft of soil settlement along the base of the floodwall.

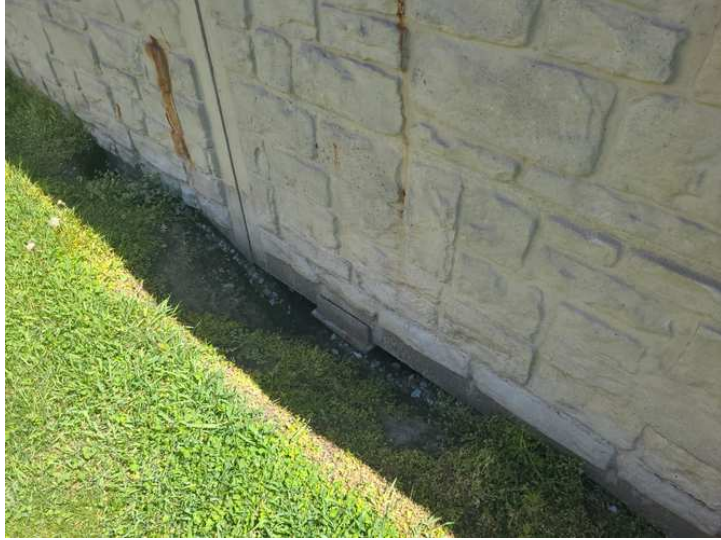
Inspect ID: 2024-0101
Feature Details: Floodwalls - Foundation of Concrete Structures - Landside
Station Start:
Station End:
Caption: Minimally Acceptable - Soil settling under the floodwall panels on the landside.

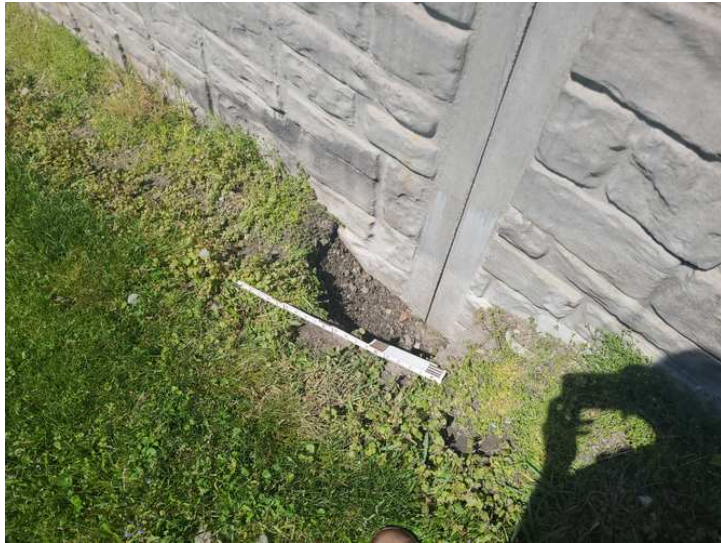
Rated Item	Rating	Rating Guidelines		Observation Locations with Descriptions and Resulting Item Rating Justification
6. Foundation of Concrete Structures	M	A	No active erosion, scouring, or bank caving that might endanger the structure's stability.	2024-0019 : Erosion on the landside of the floodwall.(M)
		M	There are areas where the ground is eroding towards the base of the structure. Efforts need to be taken to slow and repair this erosion, but it is not judged to be close enough to the structure or to be progressing rapidly enough to affect structural stability before the next inspection. For the purposes of inspection, the erosion or scour is not closer to the riverside face of the wall than twice the floodwall's underground base width if the wall is of L-wall or T-wall construction; or if the wall is of sheetpile or I-wall construction, the erosion is not closer than twice the wall's visible height. Additionally, rate of erosion is such that the wall is expected to remain stable until the next inspection.	2024-0033 : Approximately 2-ft of soil settlement along the base of the floodwall.(M) 2024-0101 : Soil settling under the floodwall panels on the landside.(M) 2024-0109 : Animal burrow on the landside of the wall.(M)

Inspect ID: 2024-0109
Feature Details: Floodwalls - Foundation of Concrete Structures - Landside
Station Start:
Station End:
Caption: Minimally Acceptable - Animal burrow on the landside of the wall.

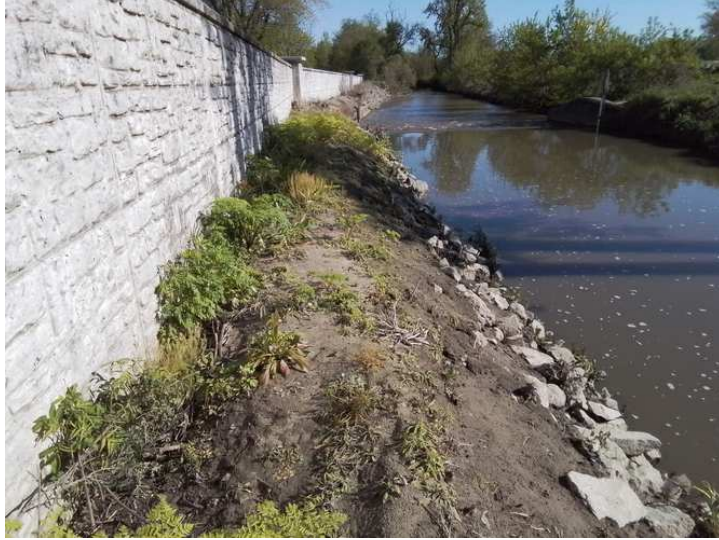
Inspect ID: 2024-0192
Feature Details: Floodwalls - Foundation of Concrete Structures - Waterside
Station Start:
Station End:
Caption: Acceptable - Riprap covered with silt on riverside.

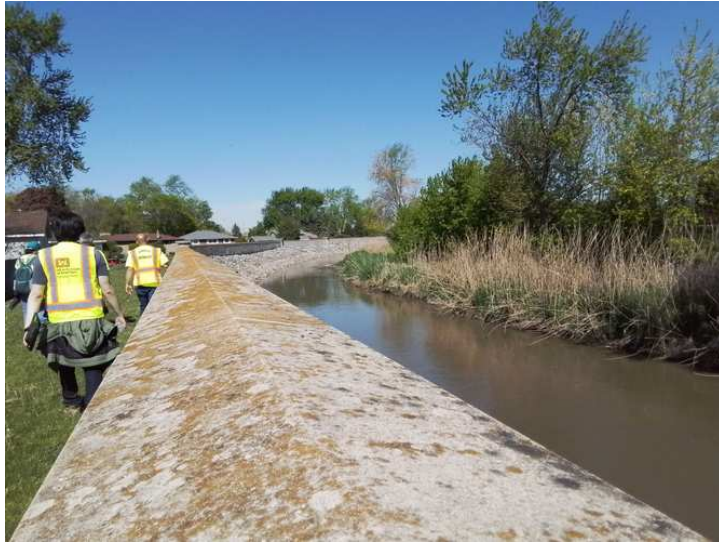
Inspect ID: 2024-0276
Feature Details: Floodwalls - Foundation of Concrete Structures - Waterside
Station Start:
Station End:
Caption: Minimally Acceptable - Displacement of riverside riprap.

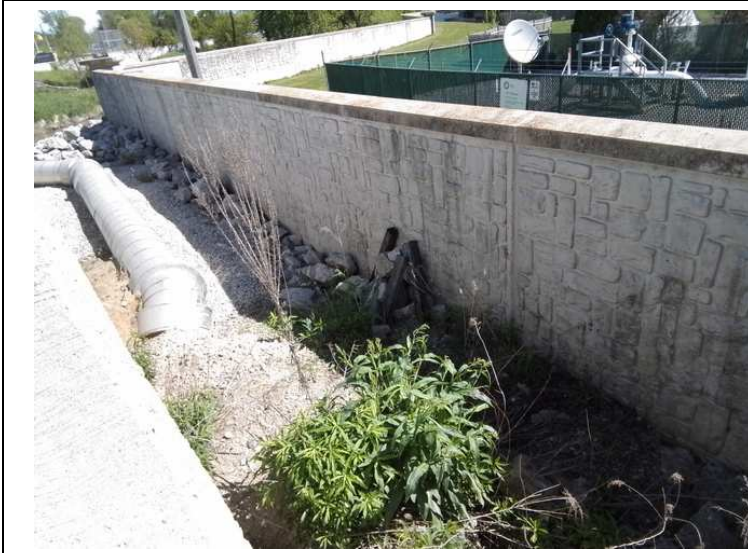
Inspect ID: 2024-0288
Feature Details: Floodwalls - Foundation of Concrete Structures
Station Start:
Station End:
Caption: Minimally Acceptable - Riprap has been displaced.

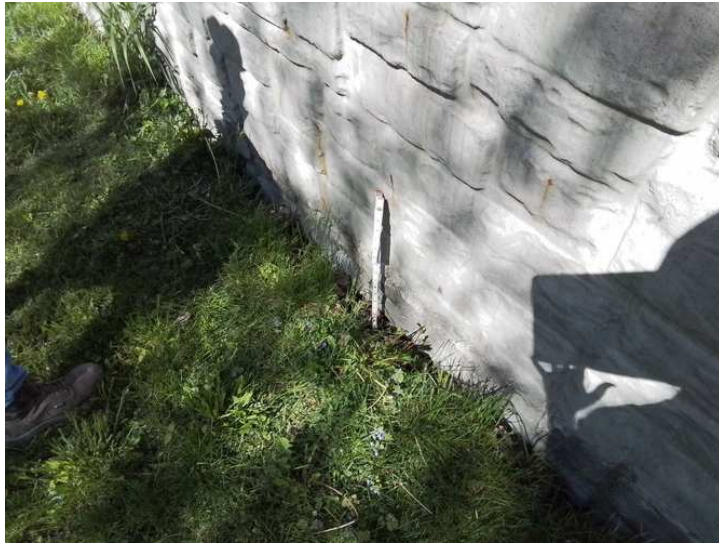
Inspect ID: 2024-0296
Feature Details: Floodwalls - Foundation of Concrete Structures - Landside
Station Start:
Station End:
Caption: Minimally Acceptable - Typical hole/depression on the landside of the wall.

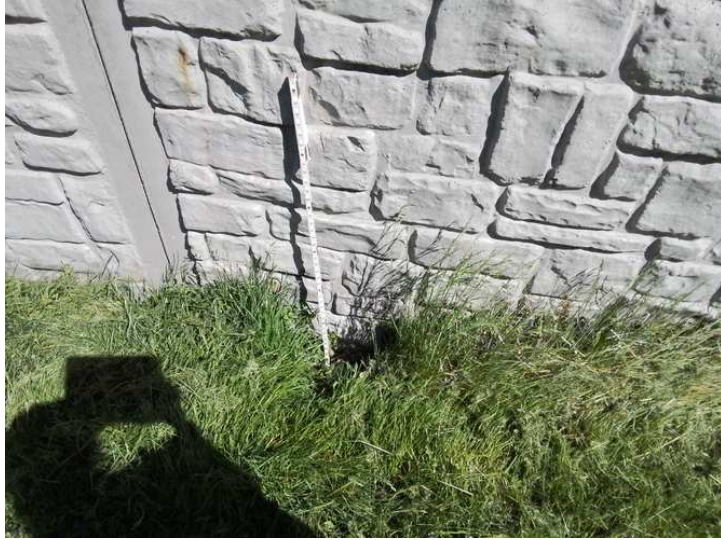
Inspect ID: 2024-0300
Feature Details: Floodwalls - Foundation of Concrete Structures - Landside
Station Start:
Station End:
Caption: Minimally Acceptable - Depression about 1-ft deep on the landside of the wall.

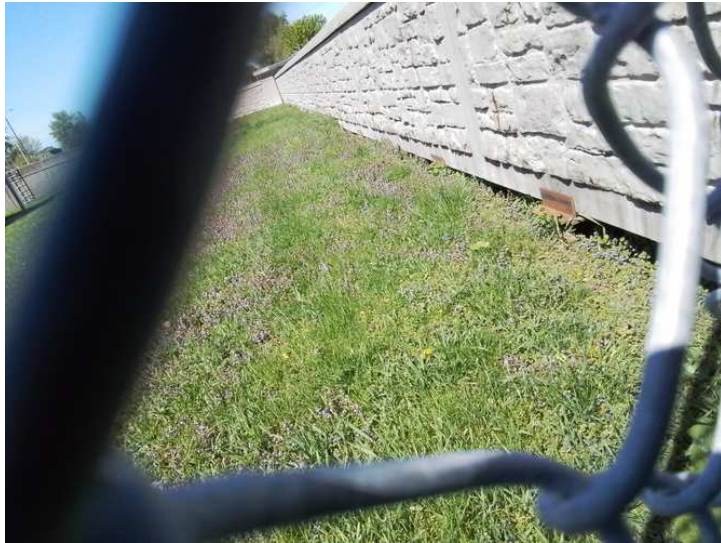
Inspect ID: 2024-0316
Feature Details: Floodwalls - Foundation of Concrete Structures - Landside
Station Start:
Station End:
Caption: Minimally Acceptable - Soil settling under the floodwall panels on the landside.

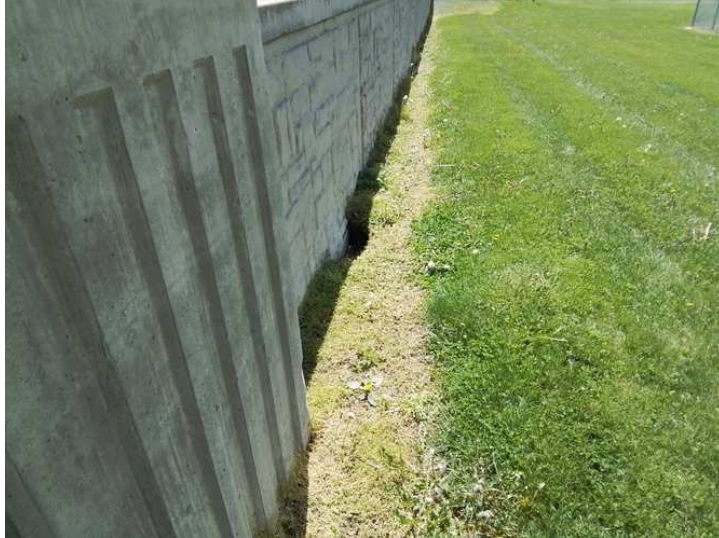
Inspect ID: 2024-0360
Feature Details: Floodwalls - Foundation of Concrete Structures - Landside
Station Start:
Station End:
Caption: Minimally Acceptable - Animal burrow on the landside of the wall.

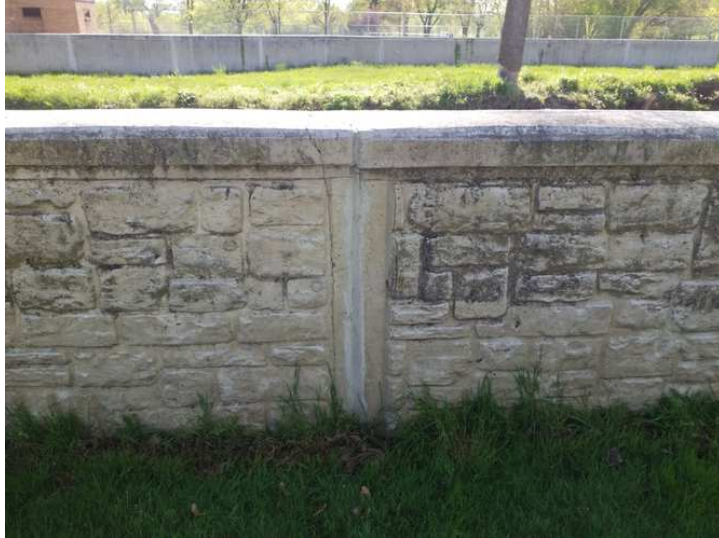
Inspect ID: 2024-0002
Feature Details: Floodwalls - Monolith Joints - Landside Joint
Station Start:
Station End:
Caption: Minimally Acceptable - Cracking in joint sealant.

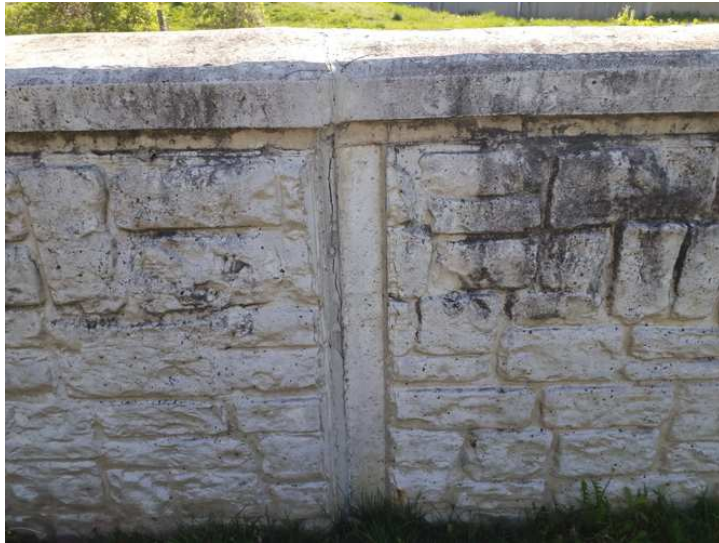
Inspect ID: 2024-0006
Feature Details: Floodwalls - Monolith Joints - Landside Joint
Station Start:
Station End:
Caption: Minimally Acceptable - Cracking in joint sealant.

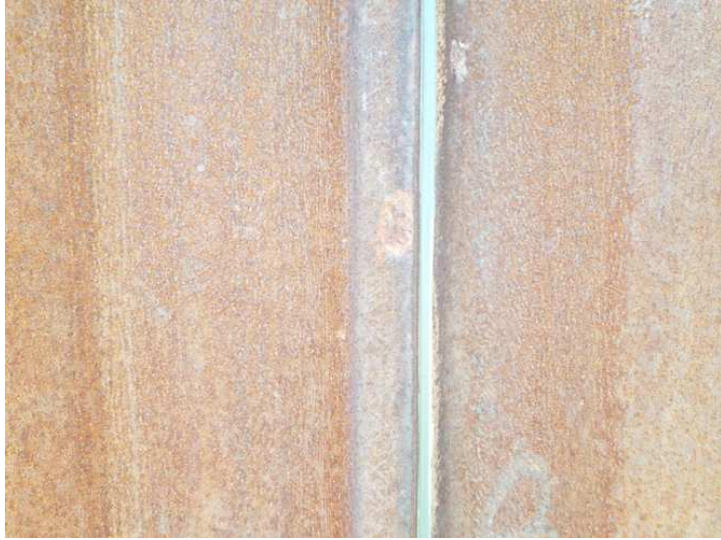
Inspect ID: 2024-0078
Feature Details: Floodwalls - Monolith Joints - Waterside
Station Start:
Station End:
Caption: Minimally Acceptable - Repaired sheetpile joint interlock on riverside.

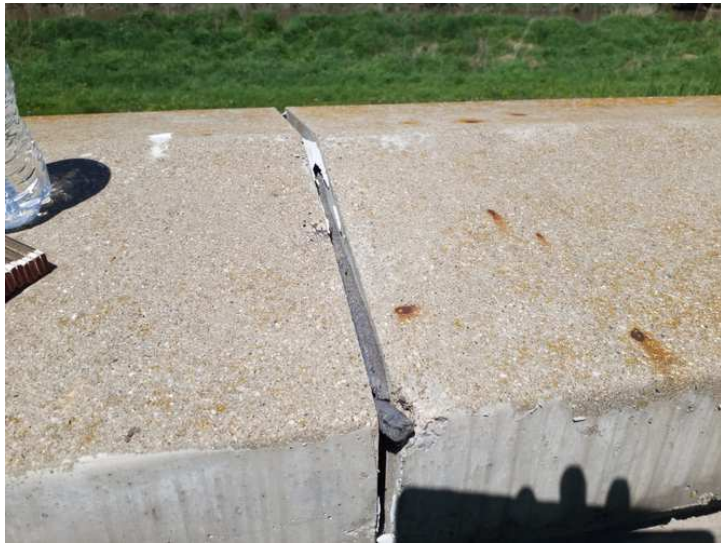
Inspect ID: 2024-0110
Feature Details: Floodwalls - Monolith Joints - Top of Floodwall
Station Start:
Station End:
Caption: Minimally Acceptable - Degraded expansion foam in joint.

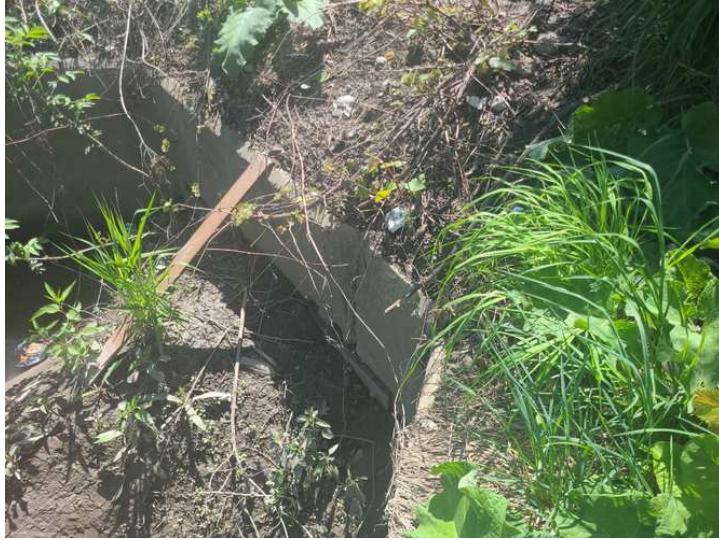
Inspect ID: 2024-0049
Feature Details: Interior Drainage System - Concrete Surfaces (Such as gatewells, outfalls, intakes, or culverts)
Station Start:
Station End:
Caption: Minimally Acceptable - MU-09: Spalling on the outlet headwall.

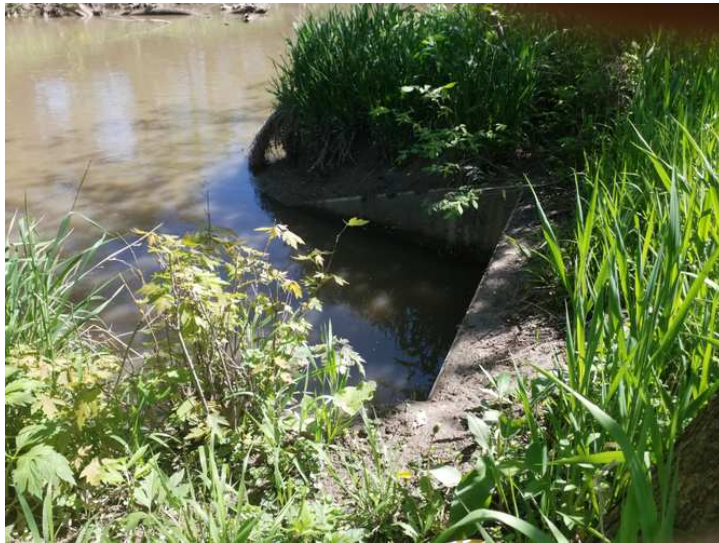
Inspect ID: 2024-0079
Feature Details: Interior Drainage System - Concrete Surfaces (Such as gatewells, outfalls, intakes, or culverts) - Outlet Structure
Station Start:
Station End:
Caption: Acceptable - MU-02: The wingwalls and headwall are in good condition.

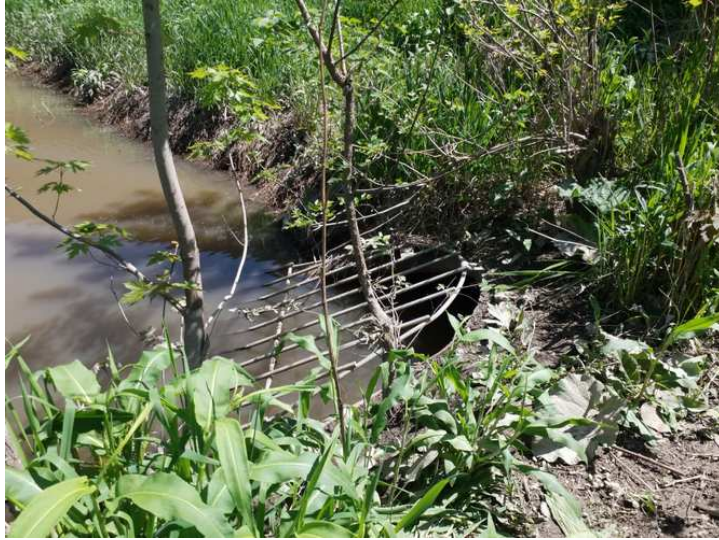
Inspect ID: 2024-0099
Feature Details: Interior Drainage System - Concrete Surfaces (Such as gatewells, outfalls, intakes, or culverts) - Inlet Structure
Station Start:
Station End:
Caption: Acceptable - MU-01: The water level is too high to see below the structure.

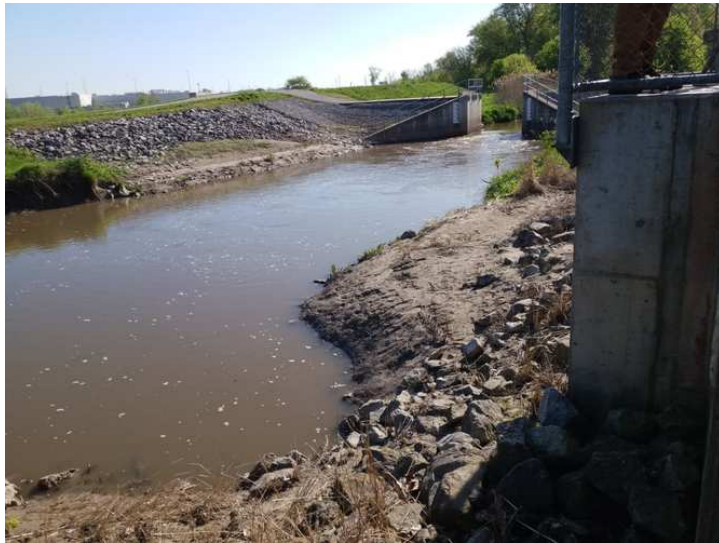
Inspect ID: 2024-0003
Feature Details: Interior Drainage System - Foundation of Concrete Structures (Such as culverts, inlet and discharge structures, or gatewells.) - Outlet Structure
Station Start:
Station End:
Caption: Minimally Acceptable - MU-11: Scour around the outlet structure. The wingwalls were not observed - under riprap.

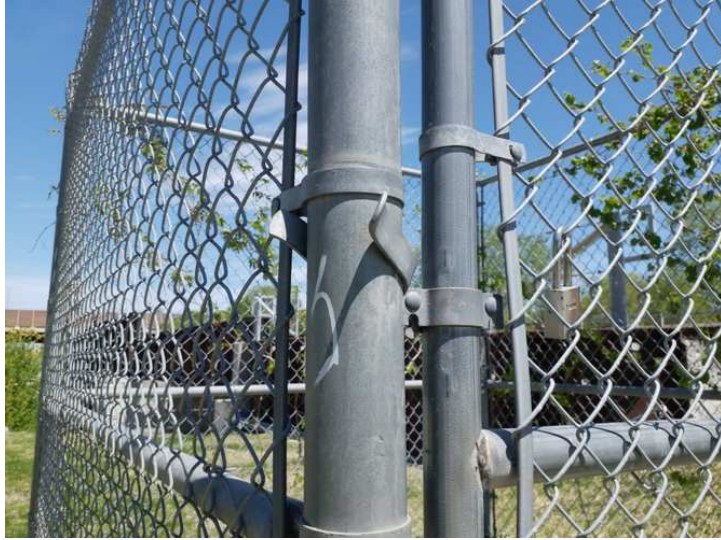
Inspect ID: 2024-0119
Feature Details: Interior Drainage System - Flap Gates/ Flap Valves/ Pinch Valves - Gatewell
Station Start:
Station End:
Caption: Minimally Acceptable - MU-05: Cannot open the chain link gate to observe the gatewell structure.

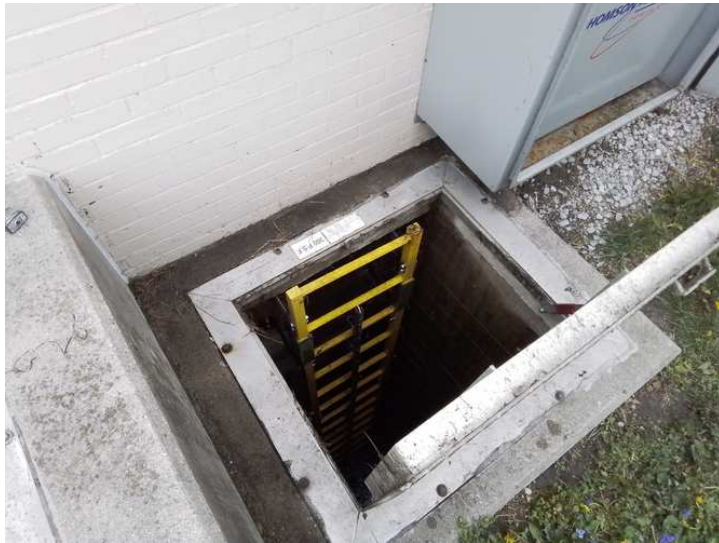
Inspect ID: 2024-0004
Feature Details: Pump Stations - Safety Compliance - Exterior
Station Start:
Station End:
Caption: Minimally Acceptable - PS-BA: Missing confined space label - noted during previous inspections. Recommend adding confined space label.

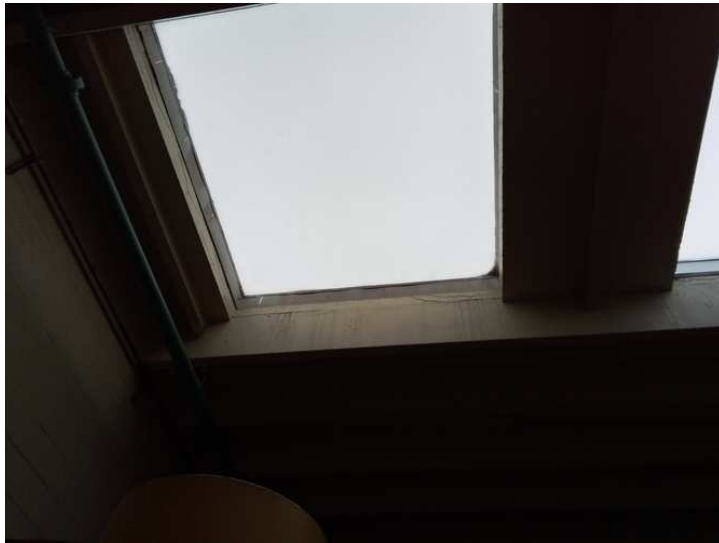
Inspect ID: 2024-0036
Feature Details: Pump Stations - Plant Building - Interior
Station Start:
Station End:
Caption: Minimally Acceptable - PS-CA: Typical example of cracks around skylights - evidence of leaking (staining). Recommend sealing cracks to prevent leaking.

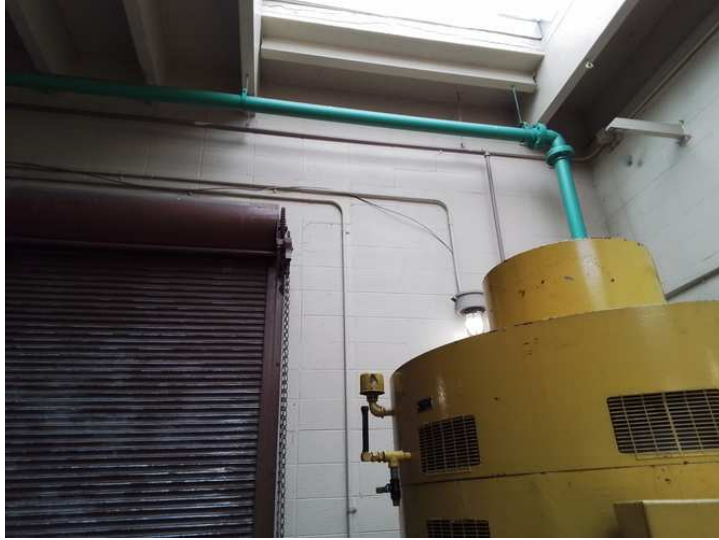
Inspect ID: 2024-0040
Feature Details: Pump Stations - Plant Building - Interior
Station Start:
Station End:
Caption: Minimally Acceptable - PS-CA: Typical example of wall cracks in the building. Recommend continuing to monitor minor cracks and filling in/sealing more significant ones.

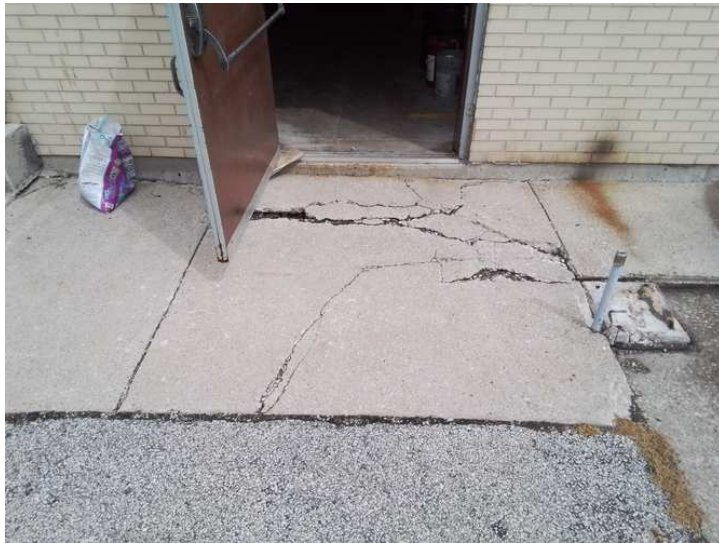
Inspect ID: 2024-0044
Feature Details: Pump Stations - Plant Building - Exterior
Station Start:
Station End:
Caption: Minimally Acceptable - PS-CA: Cracks in concrete pad indicating settlement. Recommend replacing this section of concrete to prevent a possible trip hazard.

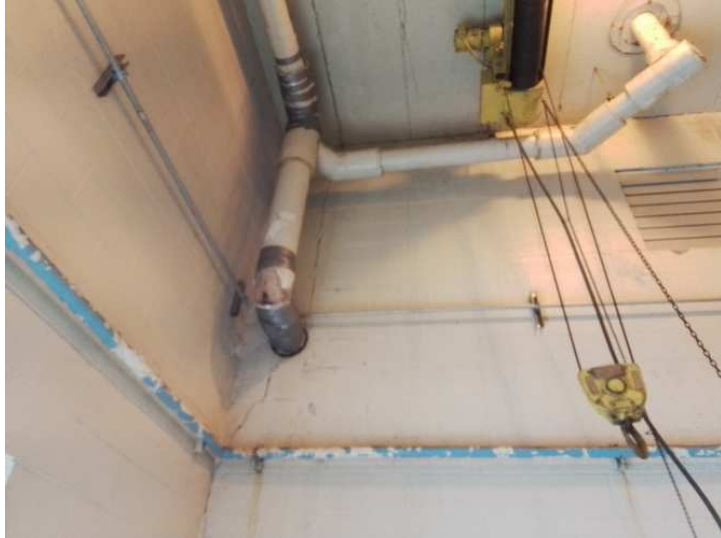
Inspect ID: 2024-0112
Feature Details: Pump Stations - Plant Building - Interior
Station Start:
Station End:
Caption: Minimally Acceptable - PS-OA: Corroded pipe - noted during previous inspections. This pipe is part of the roof drainage, recommend repairing the pipe so that water doesn't leak into the building during/after rain events.

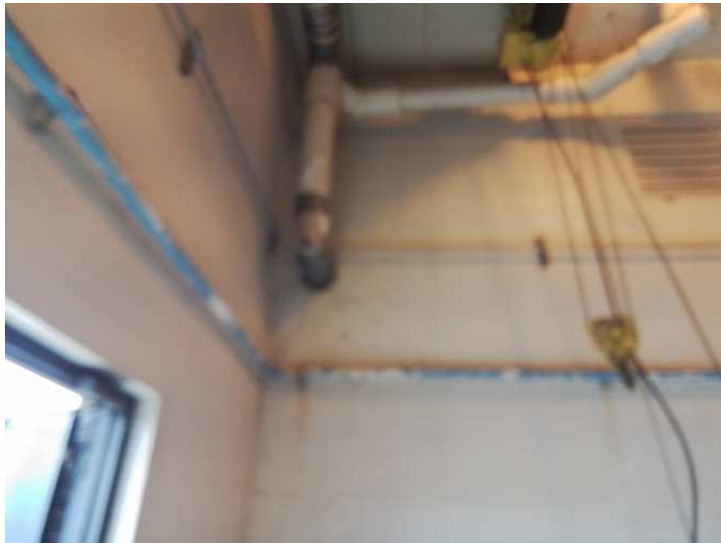
Inspect ID: 2024-0116
Feature Details: Pump Stations - Plant Building - Interior
Station Start:
Station End:
Caption: Minimally Acceptable - PS-OA: Typical example of wall cracks in the building. Recommend continuing to monitor minor cracks and filling in/sealing more significant ones.

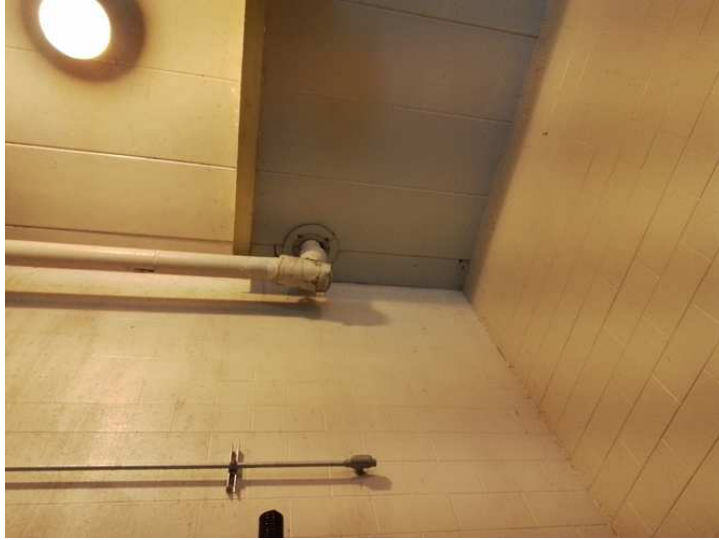
Inspect ID: 2024-0120
Feature Details: Pump Stations - Plant Building - Interior
Station Start:
Station End:
Caption: Minimally Acceptable - PS-OA: Active leak at the roof drain. Recommend repairing to prevent further leaks during/after rain events.

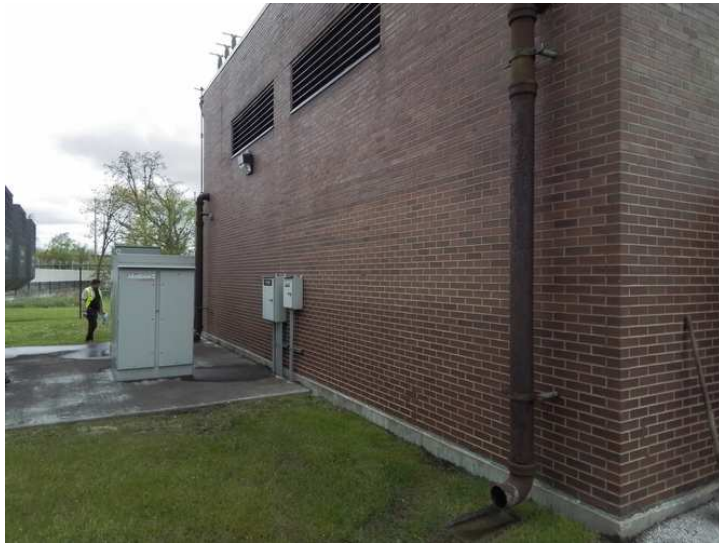
Inspect ID: 2024-0124
Feature Details: Pump Stations - Plant Building - Exterior
Station Start:
Station End:
Caption: Minimally Acceptable - PS-OA: Severe corrosion on the exterior roof drain piping. Recommend repair.

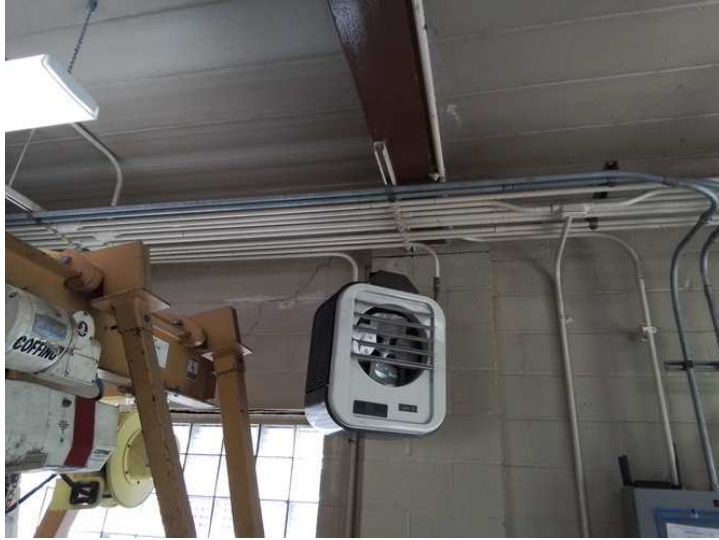
Inspect ID: 2024-0148
Feature Details: Pump Stations - Plant Building - Interior
Station Start:
Station End:
Caption: Minimally Acceptable - PS-HM: Wall cracks in building wall. Recommend monitoring for worsening behavior.

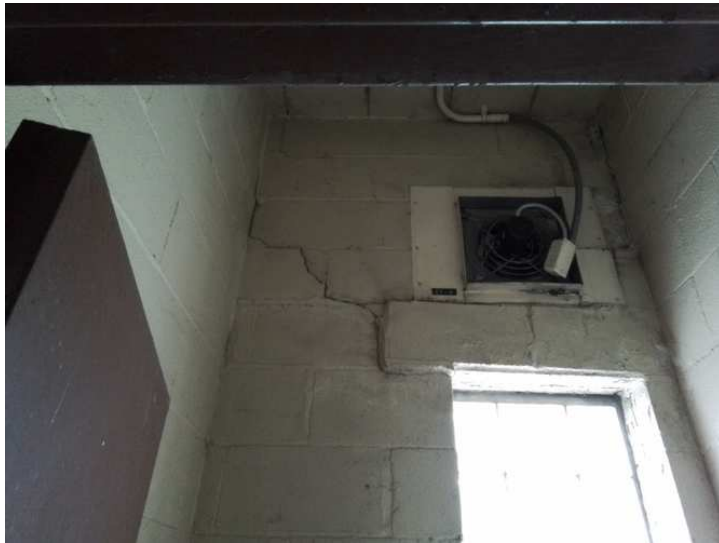
Inspect ID: 2024-0164
Feature Details: Pump Stations - Plant Building - Interior
Station Start:
Station End:
Caption: Minimally Acceptable - PS-HM: Cracks and shifted CMU in the bathroom wall. Recommend repairing cracks and installing a crack gauge to monitor for further wall movement.

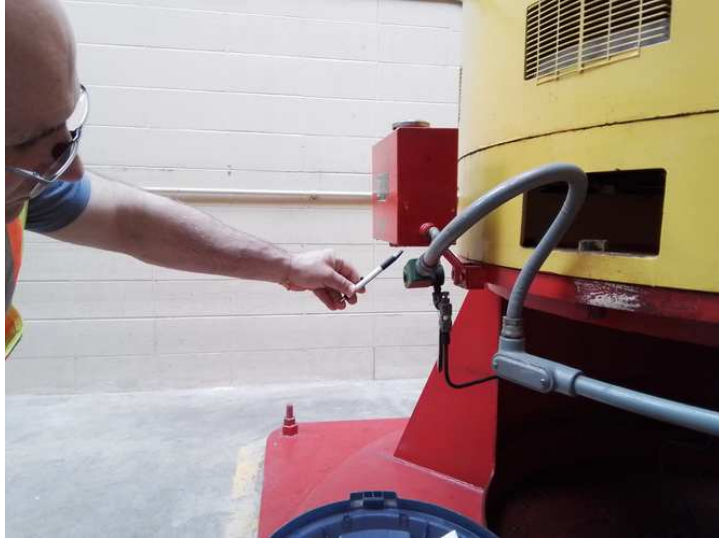
Inspect ID: 2024-0068
Feature Details: Pump Stations - Pumps - Interior
Station Start:
Station End:
Caption: Minimally Acceptable - PS-CA: Active leak at the pump 2 reservoir. Recommend repairing the leak.

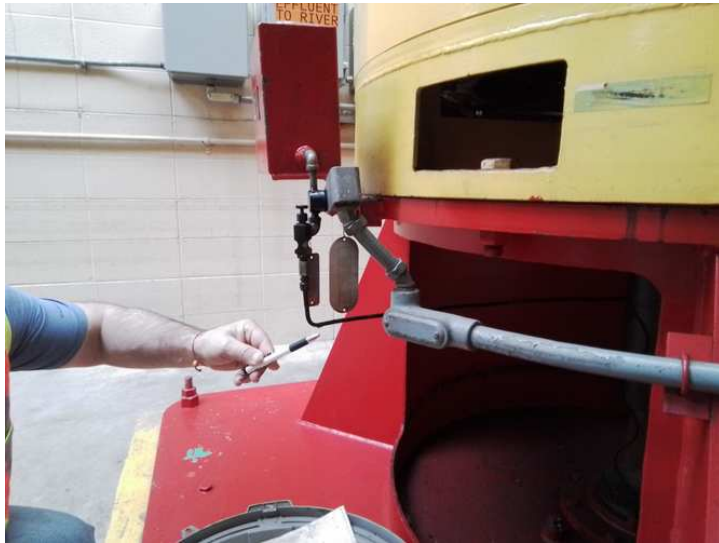
Inspect ID: 2024-0072
Feature Details: Pump Stations - Pumps - Interior
Station Start:
Station End:
Caption: Minimally Acceptable - PS-CA: Active leak at the pump 1 supply line 90-degree bend. Recommend repairing the leak.

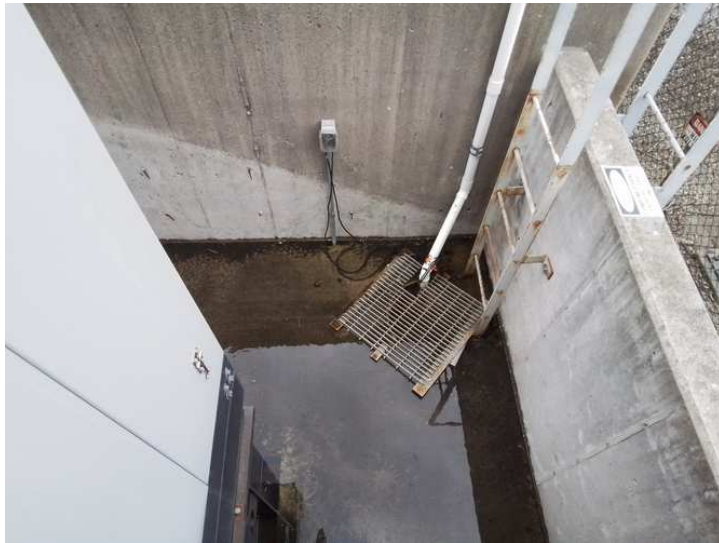
There were a few significant comments that identified inoperable louvre fans while sump pumps were running and one where a sump pump at a pump station generator was inoperable. The Unacceptable items do not affect the overall system rating but should be remedied as soon as possible.

Inspect ID: 2024-0104
Feature Details: Pump Stations - Pumps - Exterior
Station Start:
Station End:
Caption: PS-CA: Sump pump at generator is not operational.

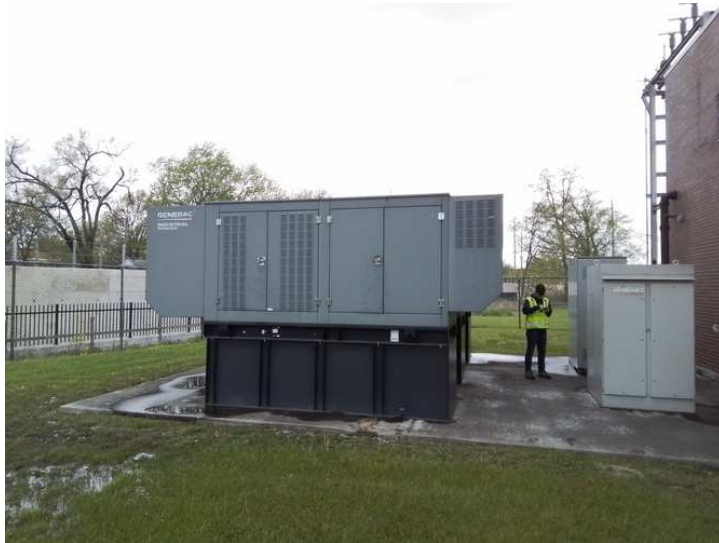
Inspect ID: 2024-0128
Feature Details: Pump Stations - Power Source - Exterior
Station Start:
Station End:
Caption: Acceptable - PS-OA: Generator hours: North - 183.3 (167.4 hrs during last inspection). Center - 188.5 (172 hrs during last inspection). South - 157.6 (141.1 hrs during last inspection).

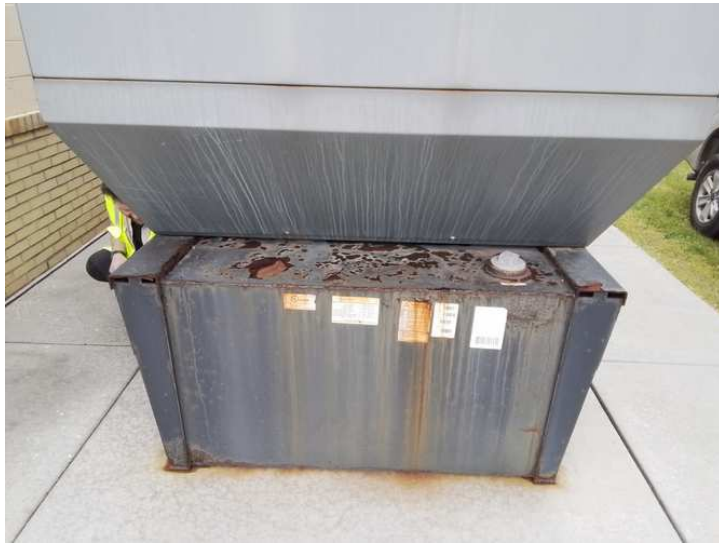
Inspect ID: 2024-0180
Feature Details: Pump Stations - Power Source - Exterior
Station Start:
Station End:
Caption: Minimally Acceptable - PS-HM: There is surficial corrosion on the generator at the fuel tank. Recommend removing the corrosion and repainting.

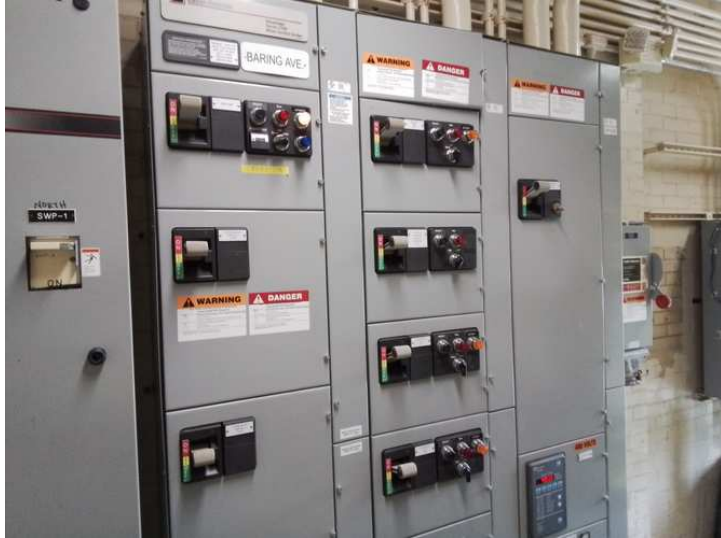
Inspect ID: 2024-0016
Feature Details: Pump Stations - Electrical Systems - Interior
Station Start:
Station End:
Caption: Minimally Acceptable - PS-BA: Outdated arc flash labels. Recommend funding a study to update the arc flash labels.
