US Army Corps of Engineers ®

Levee Inspection Report

Name of System: Munster
 Name of Segment: Munster
 NLD System ID: 2605000006 NLD Segment ID: 2604000009

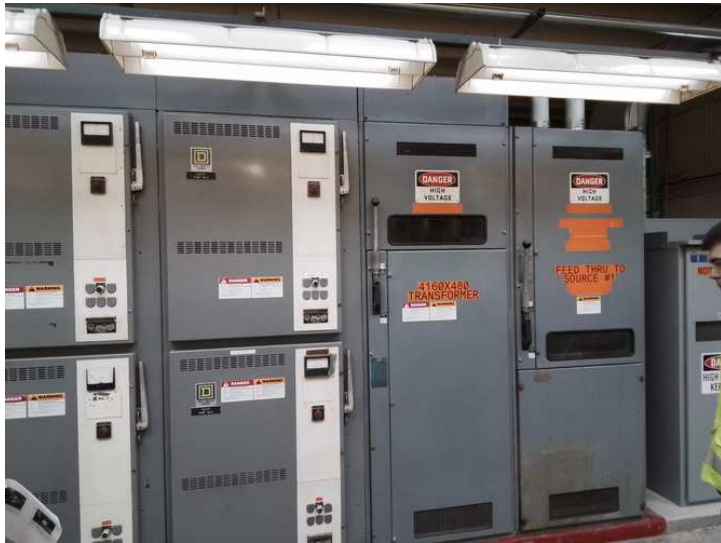
Inspect ID: 2024-0032
Feature Details: Pump Stations - Electrical Systems - Interior
Station Start:
Station End:
Caption: Minimally Acceptable - PS-CA: Outdated arc flash labels on all electrical enclosures. Recommend funding a study to update the arc flash labels.
