Levee Inspection Report

Name of System: Hammond Forest Ave
 Name of Segment: Hammond Forest Ave
 NLD System ID: 2605000010 NLD Segment ID: 2604000010

Segment Type: USACE Federally constructed, turned over to public sponsor for operations and maintenance
 Levee Sponsor (Name and Organization): Little Calumet River Basin Development Commission
 Inspection Report Prepared by: Chris Schaal Date(s) of Inspection: 04/29/2024 - 04/30/2024
 Inspection Report Prepared by: Mike Cook
 Inspection Report Prepared by: Youa Yang

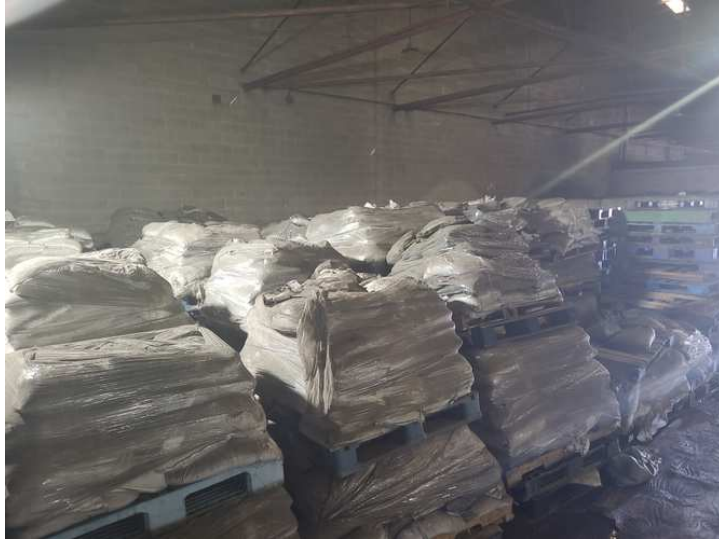
Inspect ID: 2024-0005

Caption: 0005 - Acceptable - Over 4,000 sandbags are available. Pallets and bags are in acceptable condition, stored away from the elements, and located at the Conkey Ave public works department.

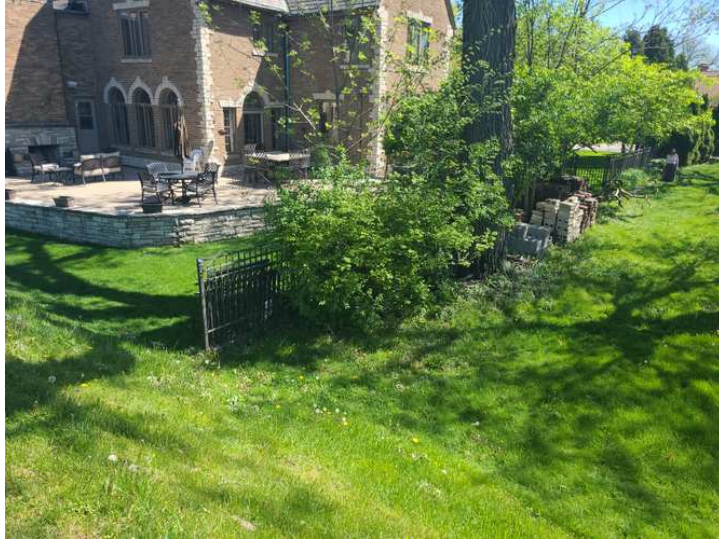
Inspect ID: 2024-0049

Feature Details: Levee Embankments - Unwanted Vegetation Growth - Landside Toe

Caption: Minimally Acceptable - Vegetation along the landside toe

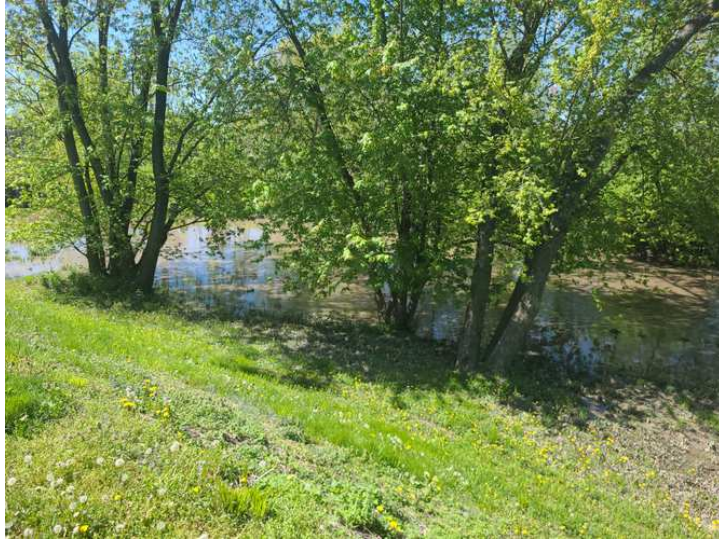
Inspect ID: 2024-0077
Feature Details: Levee Embankments - Unwanted Vegetation Growth - Waterside Toe
Station Start:
Station End:
Caption: Minimally Acceptable - Three large trees within 15 feet of the riverside toe

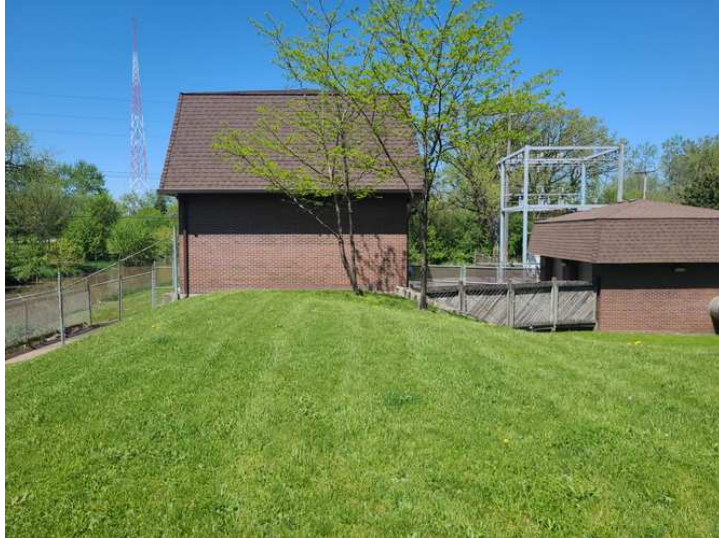
Inspect ID: 2024-0093

Feature Details: Levee Embankments - Unwanted Vegetation Growth - Landside Slope

Caption: Minimally Acceptable - Small trees on the riverside of the sheetpile wall

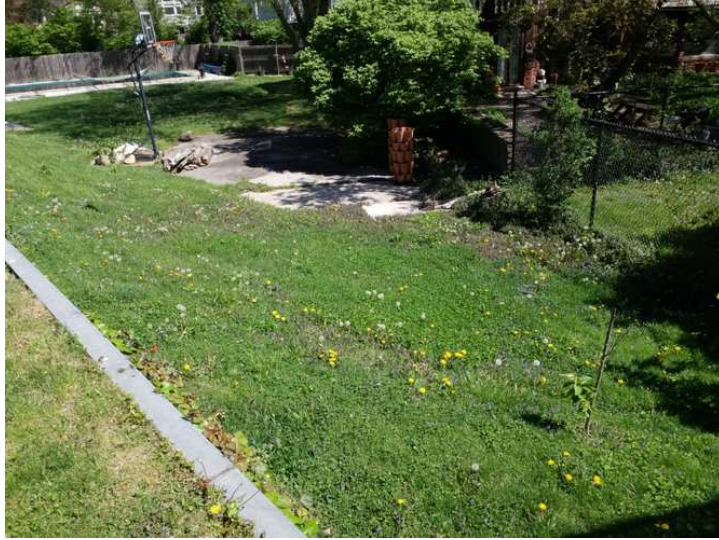
Inspect ID: 2024-0099

Feature Details: Levee Embankments - Unwanted Vegetation Growth - Landside Slope

Caption: Minimally Acceptable - Ornamental trees and a bush on the landside of the retaining wall

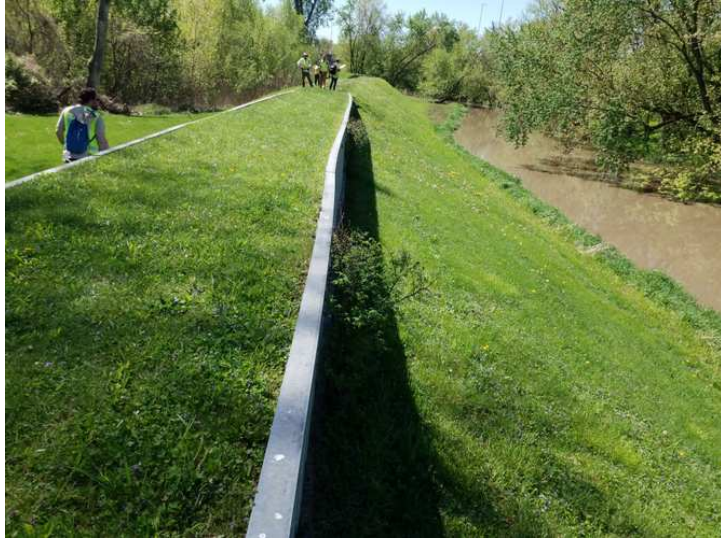
Inspect ID: 2024-0127

Feature Details: Levee Embankments - Unwanted Vegetation Growth - Waterside

Caption: Minimally Acceptable - Small tree on the landside of the sheetpile wall

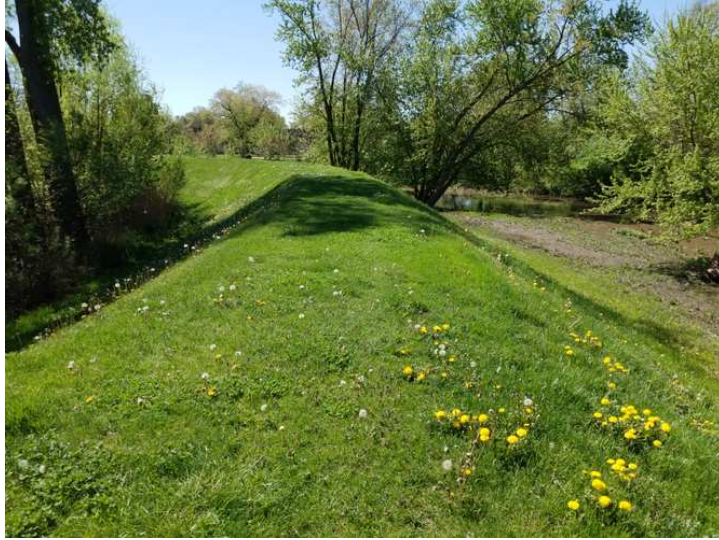
Inspect ID: 2024-0139
Feature Details: Levee Embankments - Sod Cover - Slopes and Crown
Station Start:
Station End:
Caption: Acceptable - Good sod cover

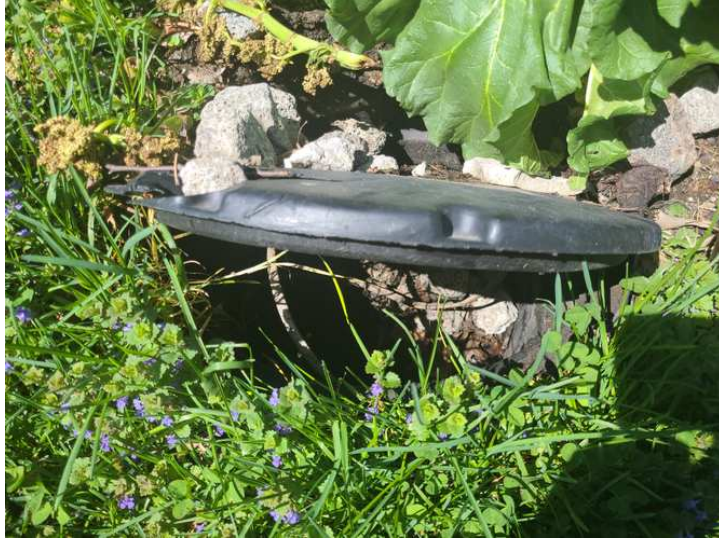
Inspect ID: 2024-0033

Feature Details: Levee Embankments - Encroachments - Landside Toe

Caption: Minimally Acceptable - Junction box embedded in the landside toe

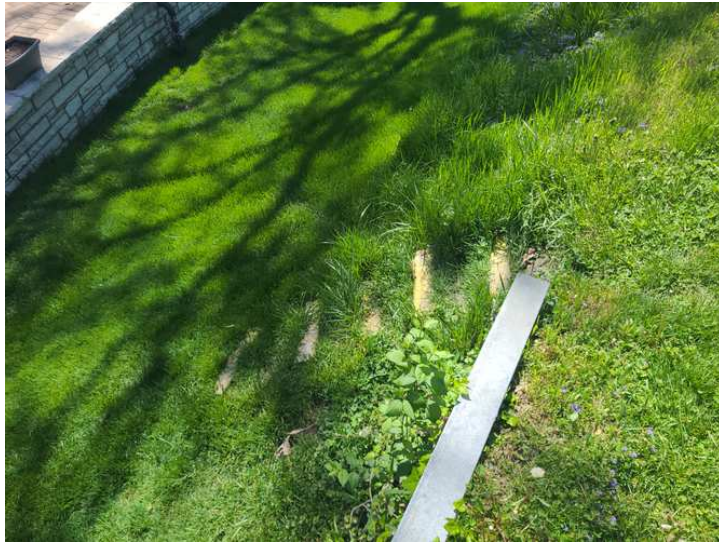
Inspect ID: 2024-0045

Feature Details: Levee Embankments - Encroachments - Landside Slope

Caption: Minimally Acceptable - Steps embedded in the landside slope

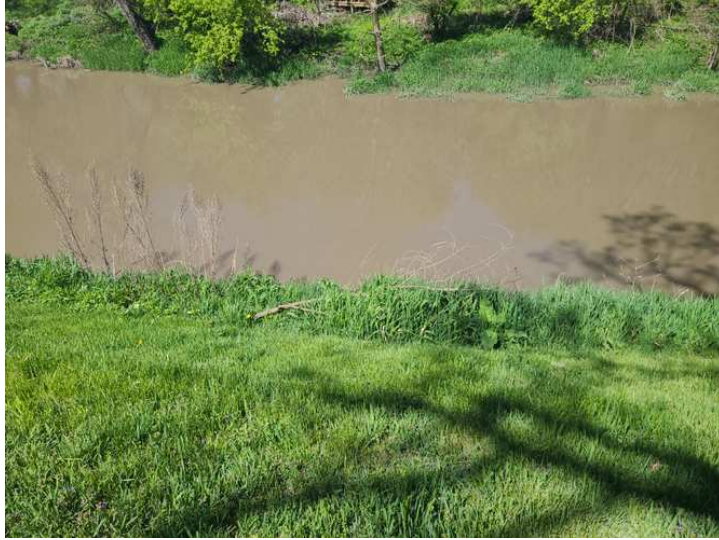
Inspect ID: 2024-0053

Feature Details: Levee Embankments - Encroachments - Waterside Toe

Caption: Minimally Acceptable - Downed logs on the landside toe

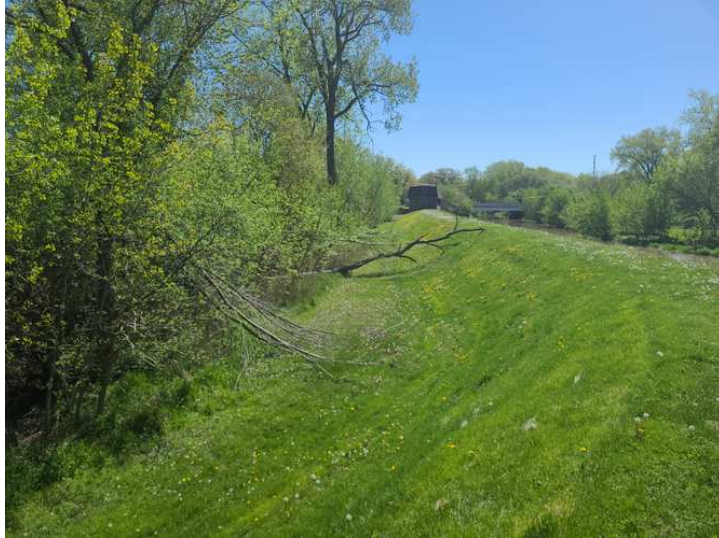
Inspect ID: 2024-0081
Feature Details: Levee Embankments - Encroachments - Landside Toe
Station Start:
Station End:
Caption: Minimally Acceptable - Downed trees on the landside toe

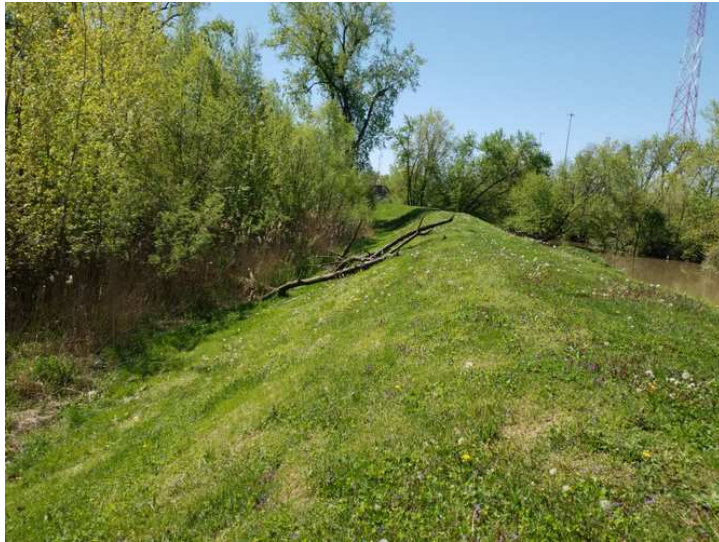
Inspect ID: 2024-0094
Feature Details: Levee Embankments - Encroachments - Landside Slope
Station Start:
Station End:
Caption: Minimally Acceptable - Fallen tree on the landside slope

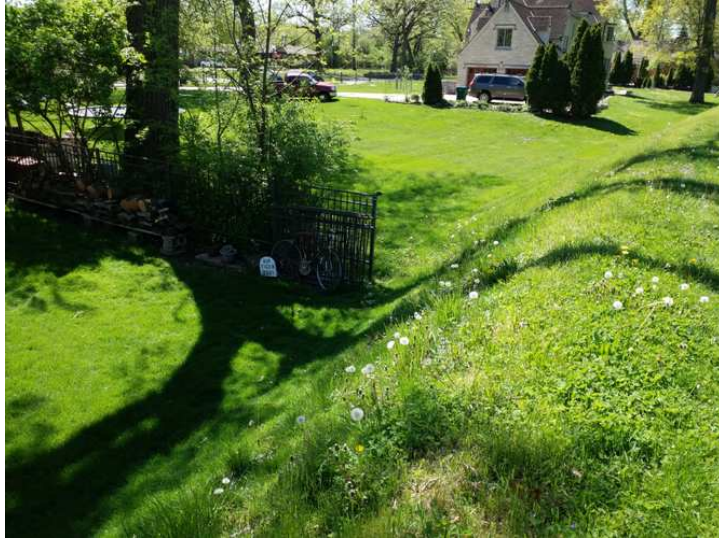
Inspect ID: 2024-0107

Feature Details: Levee Embankments - Encroachments - Landside Toe

Caption: Minimally Acceptable - Fence and other objects within the landside toe easement

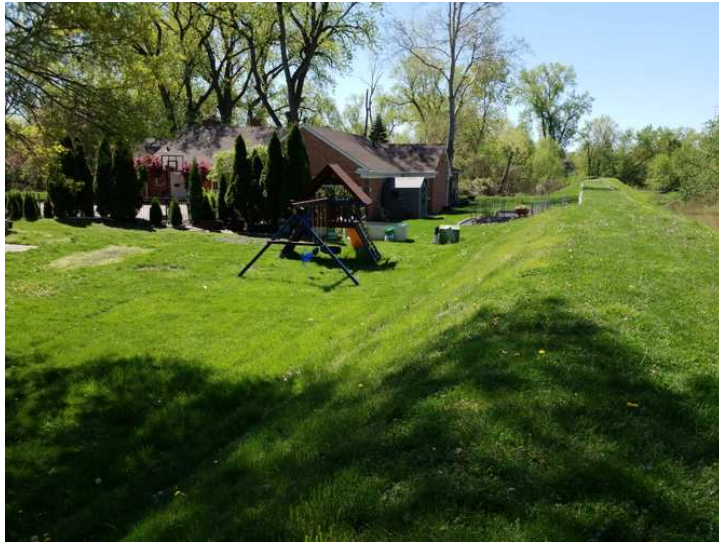
Inspect ID: 2024-0111

Feature Details: Levee Embankments - Encroachments - Landside Toe

Caption: Minimally Acceptable - Playground within the landside toe easement

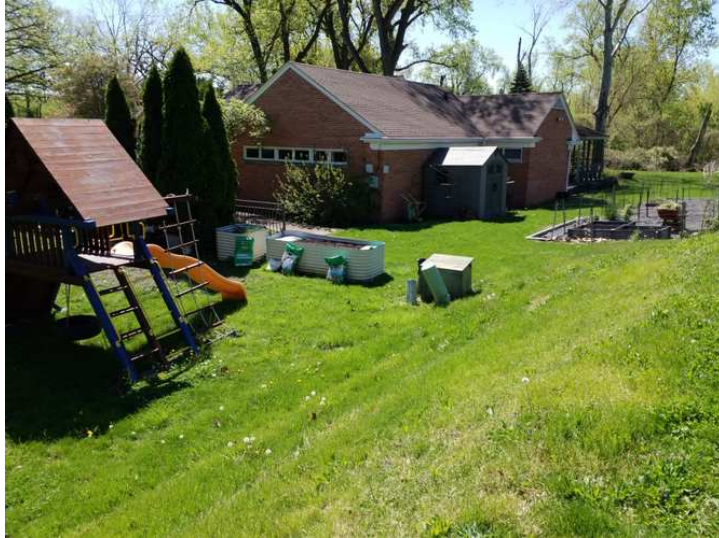
Inspect ID: 2024-0115
Feature Details: Levee Embankments - Encroachments - Landside
Station Start:
Station End:
Caption: Minimally Acceptable - Planter bin within the landside toe easement

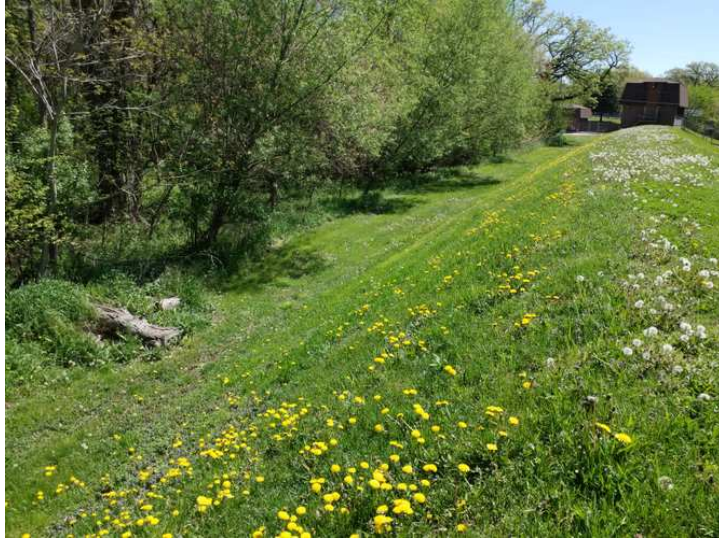
Inspect ID: 2024-0147
Feature Details: Levee Embankments - Encroachments - Landside Toe
Station Start:
Station End:
Caption: Minimally Acceptable - Tree debris on the landside toe

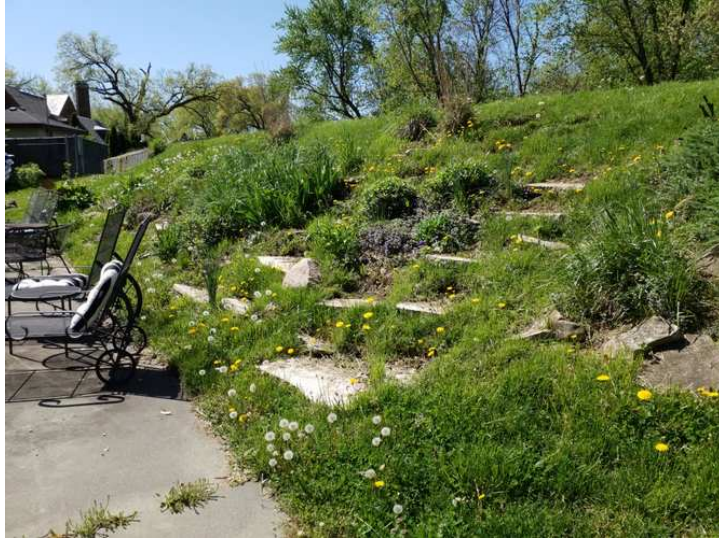
Inspect ID: 2024-0154
Feature Details: Levee Embankments - Encroachments - Landside Slope
Station Start:
Station End:
Caption: Unacceptable - Steps/landscaping rocks in the landside levee slope. Appears to have been embedded into the slope more since the last inspection

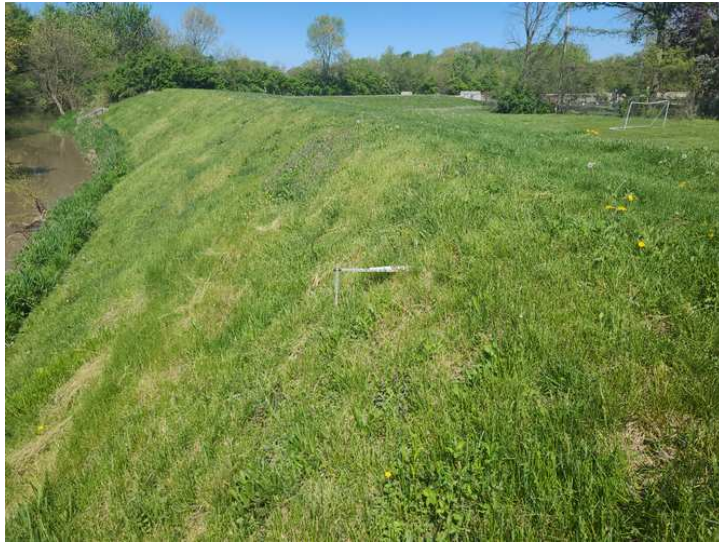
Inspect ID: 2024-0021
Feature Details: Levee Embankments - Slope Stability - Waterside Slope
Station Start:
Station End:
Caption: Minimally Acceptable - 1.5 to 1 slope on the riverside slope

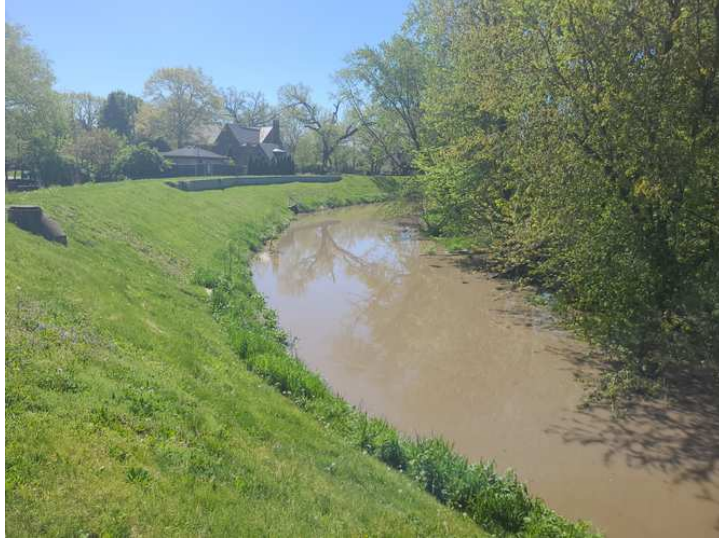
Inspect ID: 2024-0017
Feature Details: Levee Embankments - Erosion/ Bank Caving - Waterside
Station Start:
Station End:
Caption: Minimally Acceptable - Riverside bank caving

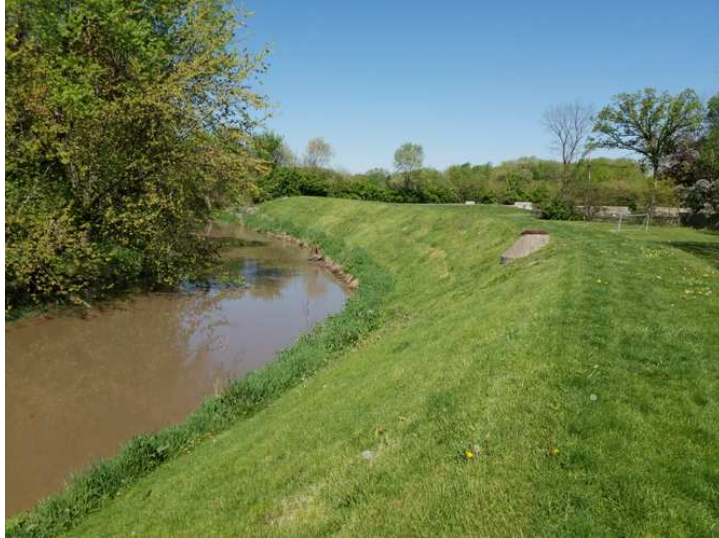
Inspect ID: 2024-0091
Feature Details: Levee Embankments - Erosion/ Bank Caving - Waterside Toe
Station Start:
Station End:
Caption: Minimally Acceptable - Erosion along the riverside toe.

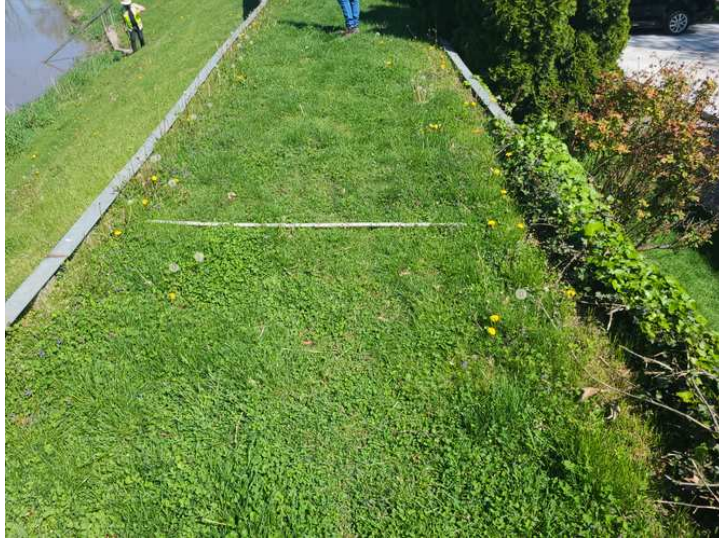
Inspect ID: 2024-0041

Feature Details: Levee Embankments - Settlement - Landside Slope and Crown

Caption: Minimally Acceptable - 2 to 3 inches of settlement on the landside of the sheetpile wall

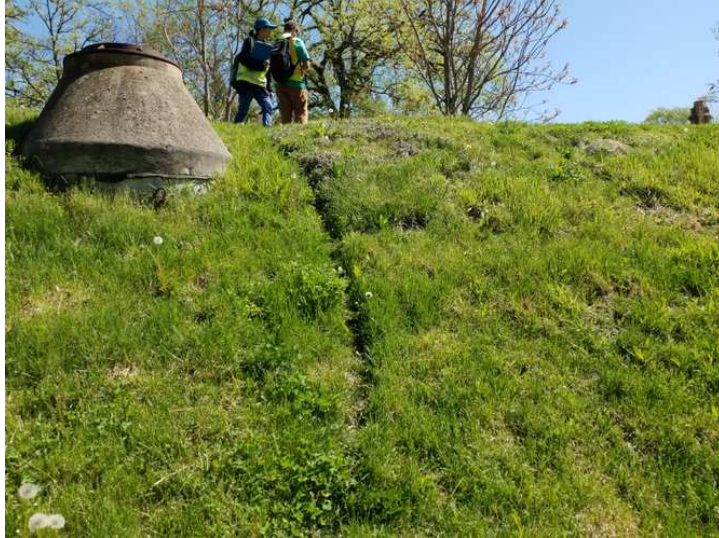
Inspect ID: 2024-0074
Feature Details: Levee Embankments - Depressions/ Rutting - Waterside Slope
Station Start:
Station End:
Caption: Minimally Acceptable - Rutting due to animal tracks on the riverside slope

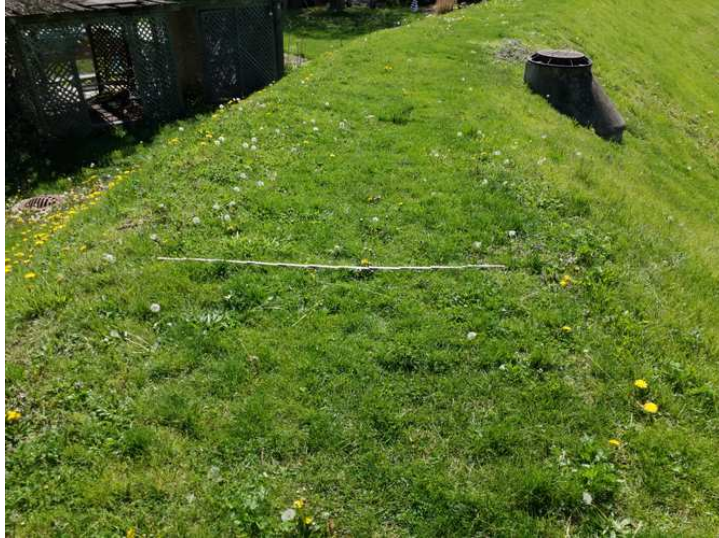
Inspect ID: 2024-0083
Feature Details: Levee Embankments - Depressions/ Rutting - Crown
Station Start:
Station End:
Caption: Minimally Acceptable - Depression in the levee crown

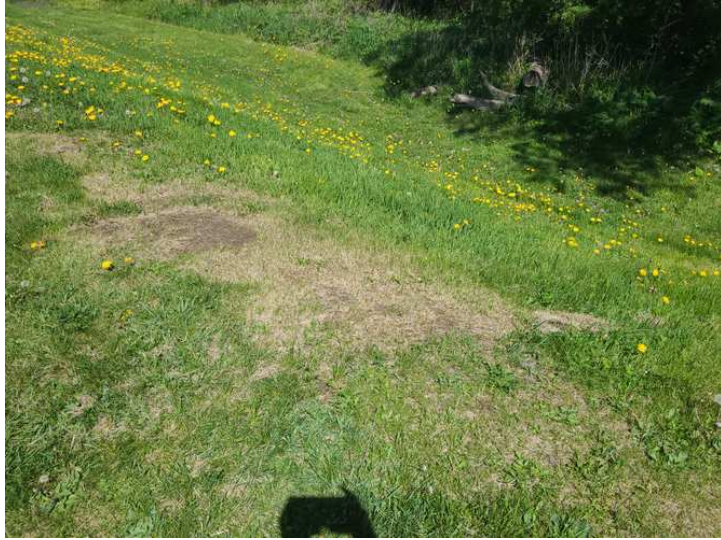
Inspect ID: 2024-0089
Feature Details: Levee Embankments - Depressions/ Rutting - Landside
Station Start:
Station End:
Caption: Minimally Acceptable - Rutting and loss of sod cover on the landside crest

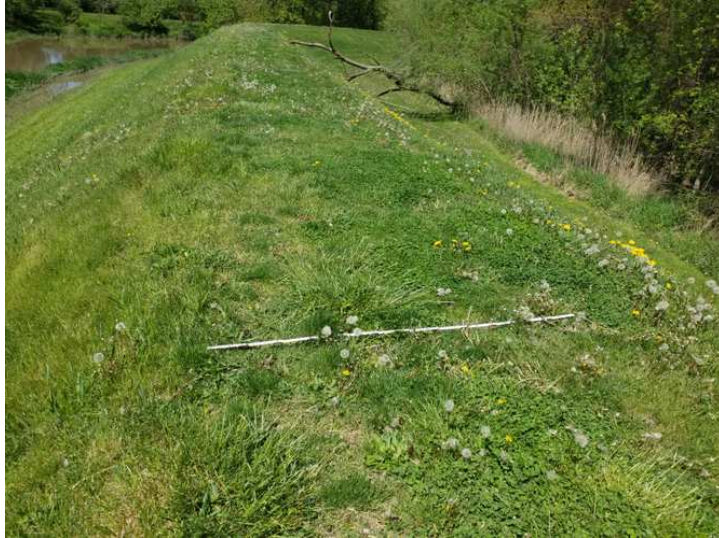
Inspect ID: 2024-0102
Feature Details: Levee Embankments - Depressions/ Rutting - Crown
Station Start:
Station End:
Caption: Minimally Acceptable - Depression on the levee crest

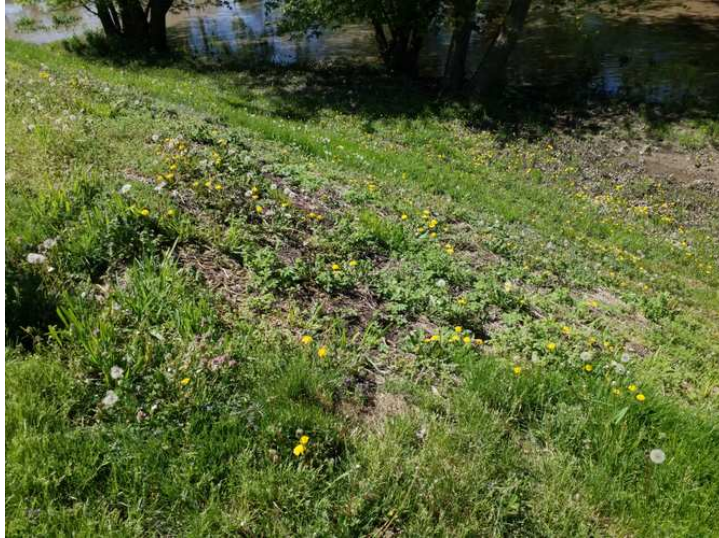
Inspect ID: 2024-0143
Feature Details: Levee Embankments - Depressions/ Rutting - Waterside Slope
Station Start:
Station End:
Caption: Minimally Acceptable - Minor depressions on the riverside slope

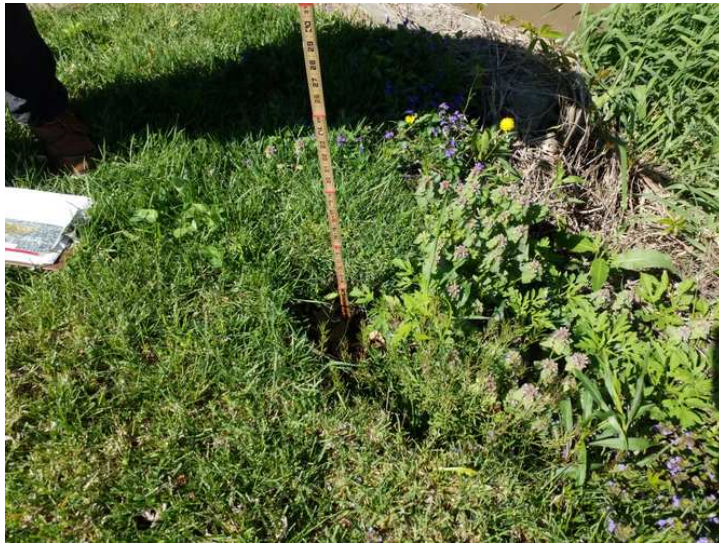
Inspect ID: 2024-0082
Feature Details: Levee Embankments - Animal Control - Waterside Slope
Station Start:
Station End:
Caption: Minimally Acceptable - 7-inch-deep animal burrow in the riverside slope

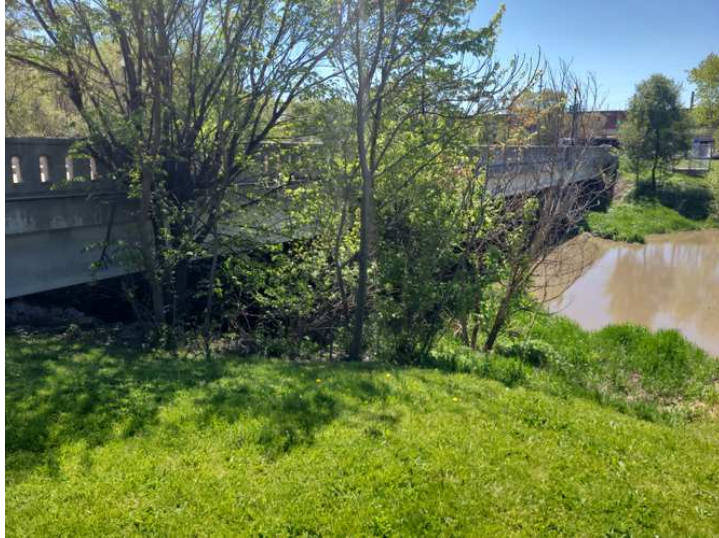
Inspect ID: 2024-0097
Feature Details: Levee Embankments - Riprap Revetments & Bank Protection - Waterside Slope
Station Start:
Station End:
Caption: Minimally Acceptable - Trees in the riprap of the riverside slope

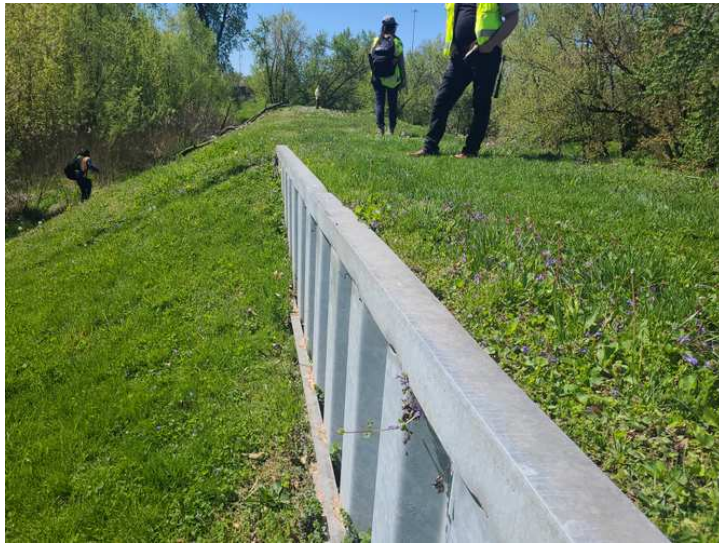
Inspect ID: 2024-0061
Feature Details: Levee Embankments - Revetments other than Riprap - Landside and Waterside
Station Start:
Station End:
Caption: Minimally Acceptable - Sheetpile walls on the landside and riverside are tilting out away from the center

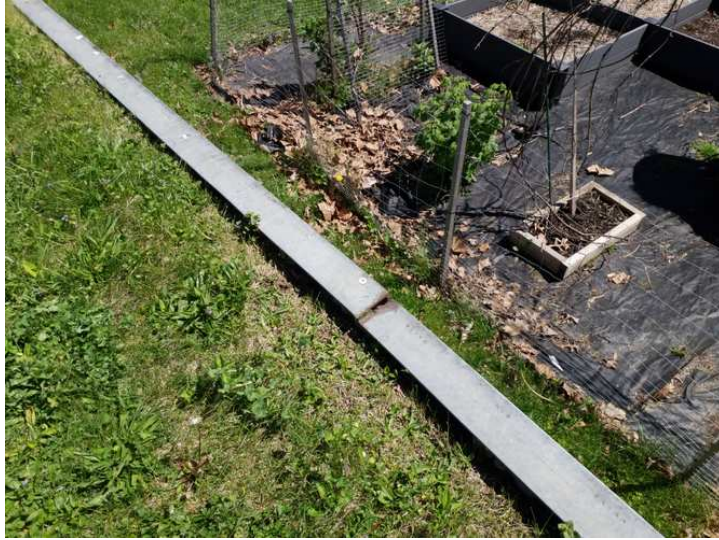
Inspect ID: 2024-0123

Feature Details: Levee Embankments - Revetments other than Riprap - Other

Caption: Minimally Acceptable - Broken weld on the landside of the sheetpile wall

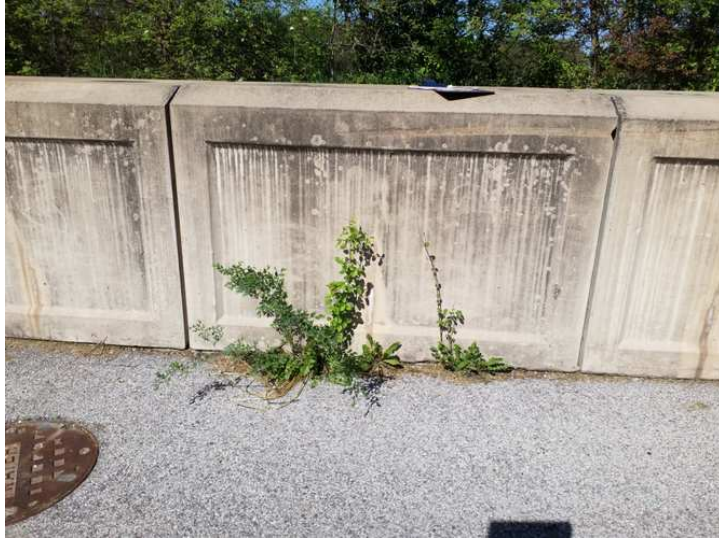
Inspect ID: 2024-0006

Feature Details: Floodwalls - Unwanted Vegetation Growth - Landside

Caption: Minimally Acceptable - Vegetation on the landside of the floodwall

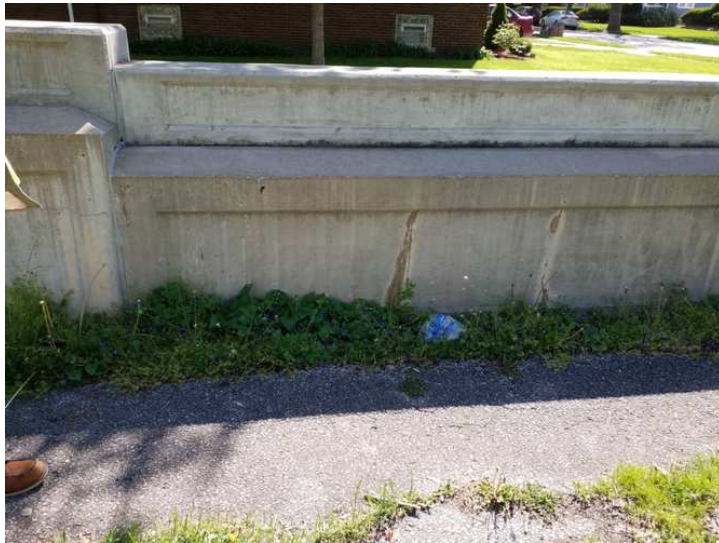
Inspect ID: 2024-0030

Feature Details: Floodwalls - Unwanted Vegetation Growth - Waterside

Caption: Minimally Acceptable - Typical vegetation along the floodwall on the riverside

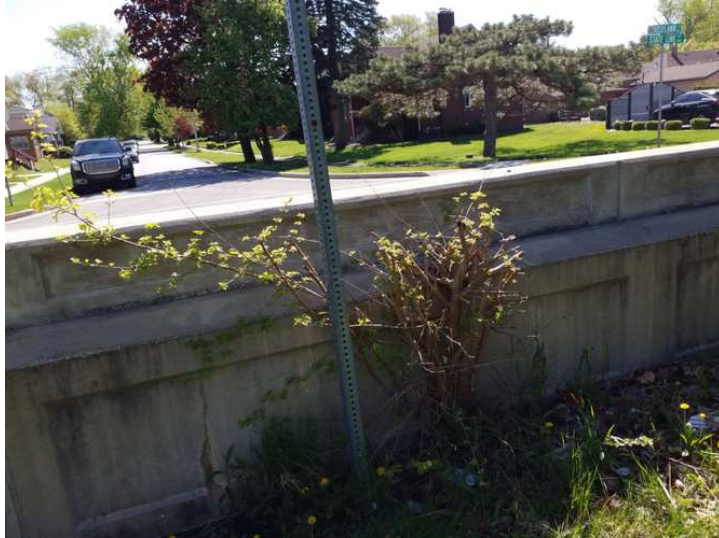
Inspect ID: 2024-0034
Feature Details: Floodwalls - Unwanted Vegetation Growth - Waterside
Station Start:
Station End:
Caption: Minimally Acceptable - Small tree on the riverside of the floodwall

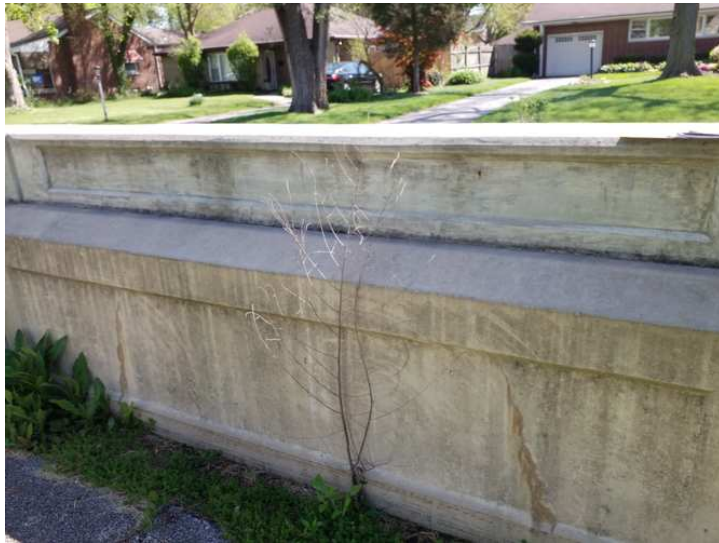
Inspect ID: 2024-0046
Feature Details: Floodwalls - Unwanted Vegetation Growth - Waterside
Station Start:
Station End:
Caption: Minimally Acceptable - Small tree on the riverside of the floodwall

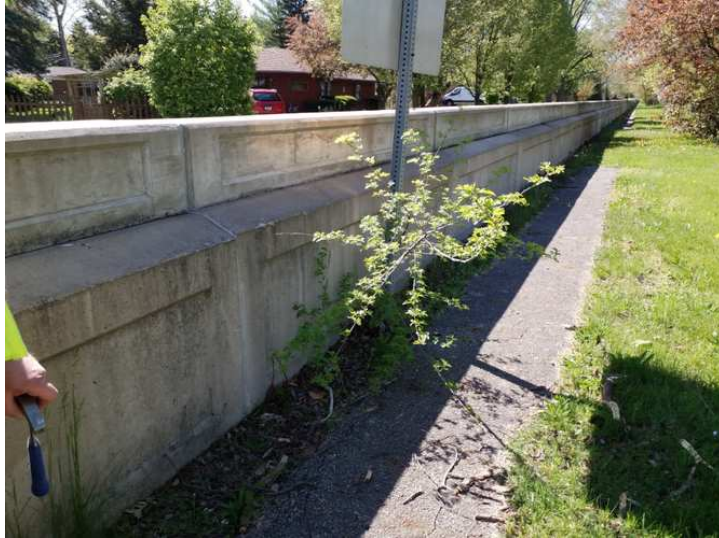
Inspect ID: 2024-0047
Feature Details: Floodwalls - Unwanted Vegetation Growth - Waterside
Station Start:
Station End:
Caption: Minimally Acceptable - Small tree on the riverside of the floodwall

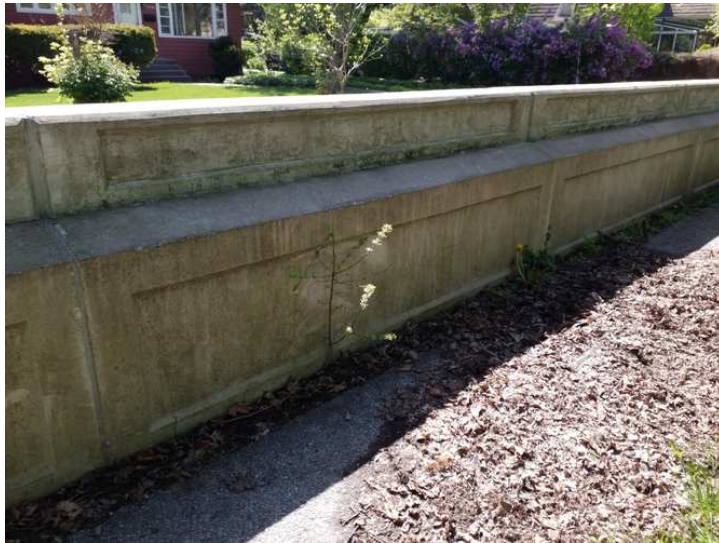
Inspect ID: 2024-0050
Feature Details: Floodwalls - Unwanted Vegetation Growth - Waterside
Station Start:
Station End:
Caption: Minimally Acceptable - Small tree on the riverside of the floodwall

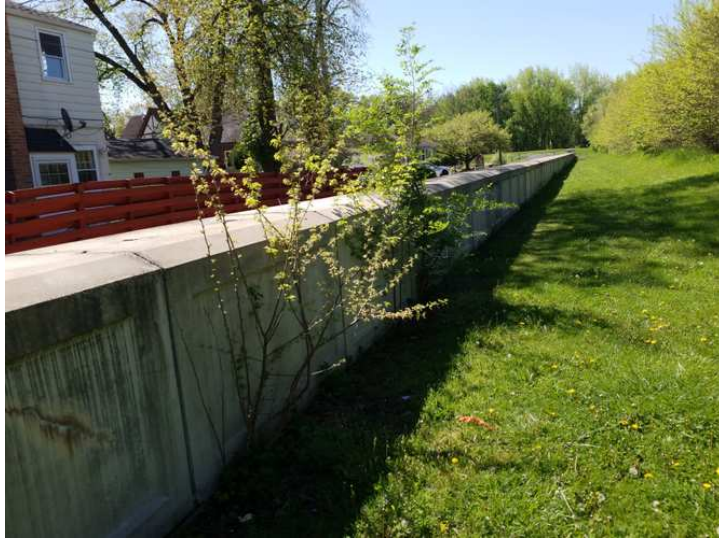
Inspect ID: 2024-0054
Feature Details: Floodwalls - Unwanted Vegetation Growth - Waterside
Station Start:
Station End:
Caption: Minimally Acceptable - Small trees on the riverside of the floodwall

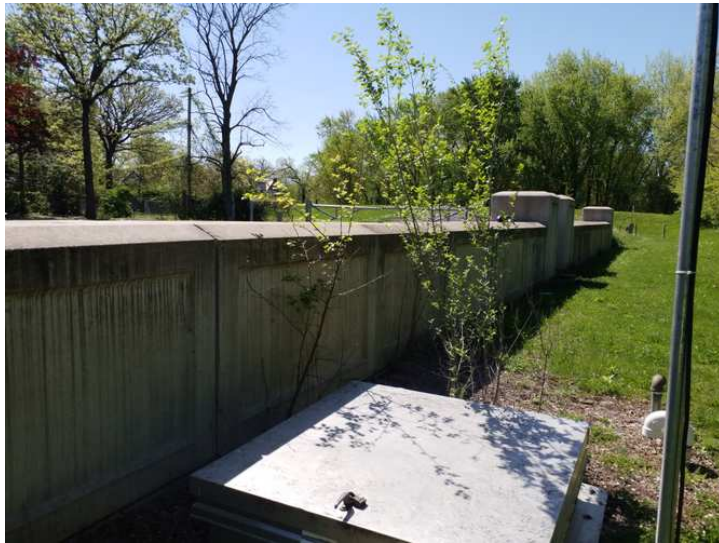
Inspect ID: 2024-0067
Feature Details: Floodwalls - Unwanted Vegetation Growth - Waterside
Station Start:
Station End:
Caption: Minimally Acceptable - Small trees on the riverside of the floodwall

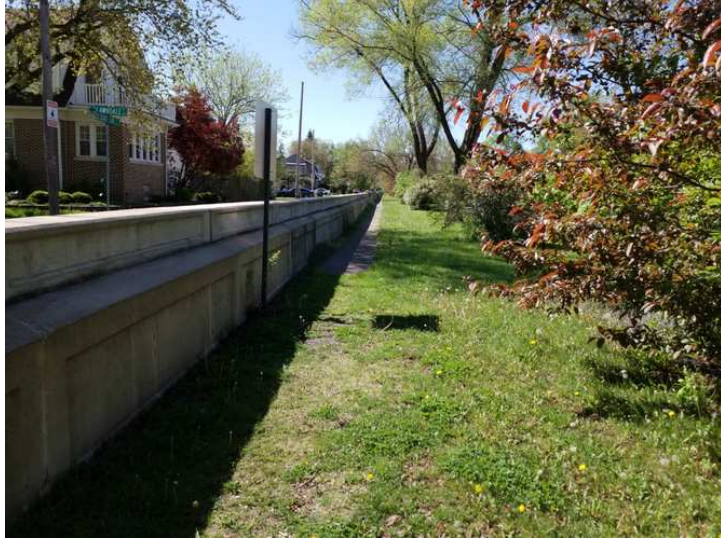
Inspect ID: 2024-0035
Feature Details: Floodwalls - Encroachments - Waterside
Station Start:
Station End:
Caption: Minimally Acceptable - Sign post on the riverside of the floodwall

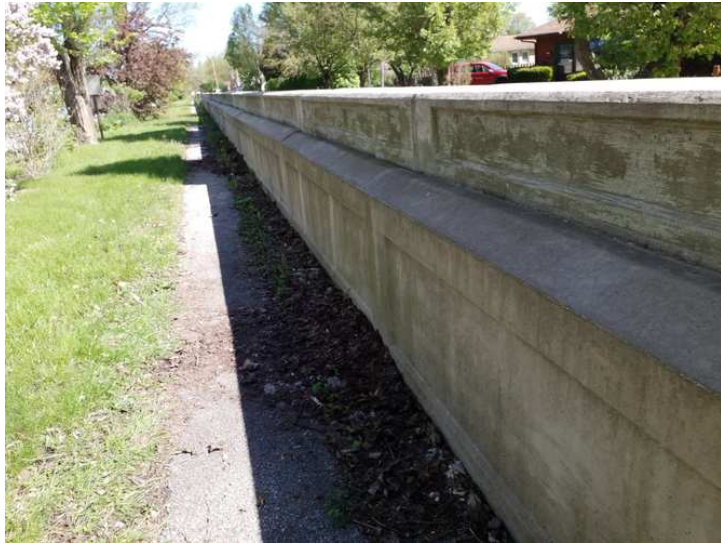
Inspect ID: 2024-0042
Feature Details: Floodwalls - Encroachments - Waterside
Station Start:
Station End:
Caption: Minimally Acceptable - Leafy debris attracting water that could lead to freeze thaw on the riverside of the floodwall

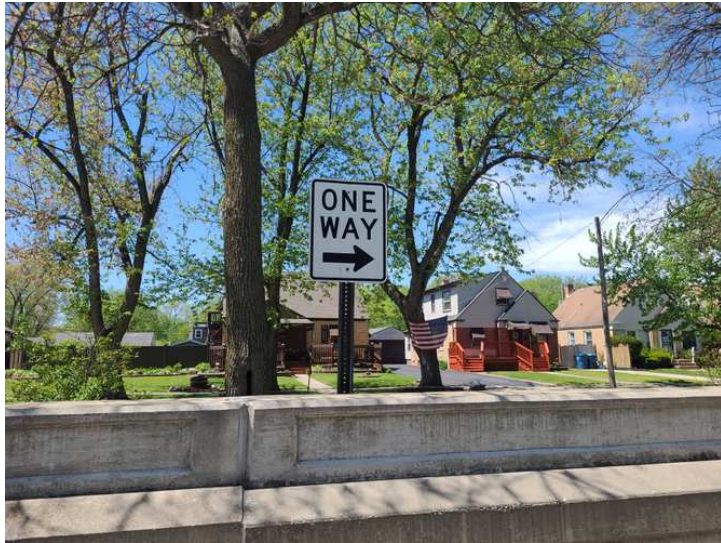
Inspect ID: 2024-0055
Feature Details: Floodwalls - Encroachments - Waterside
Station Start:
Station End:
Caption: Minimally Acceptable - Sign on the riverside of the floodwall

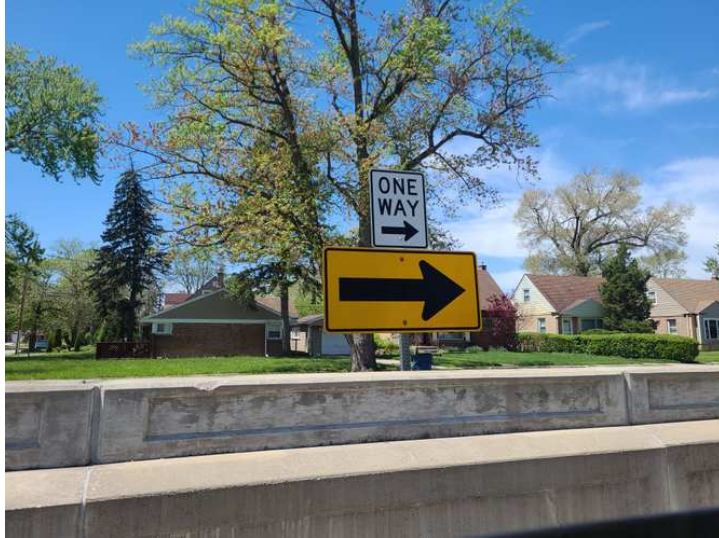
Inspect ID: 2024-0101
Feature Details: Floodwalls - Encroachments - Waterside
Station Start:
Station End:
Caption: Minimally Acceptable - Sign on the riverside of the floodwall

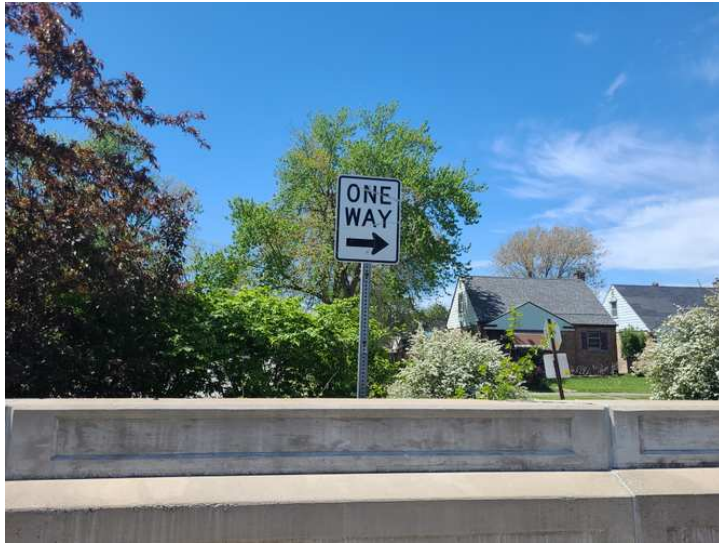
Inspect ID: 2024-0105
Feature Details: Floodwalls - Encroachments - Waterside
Station Start:
Station End:
Caption: Minimally Acceptable - Signs on the riverside of the floodwall

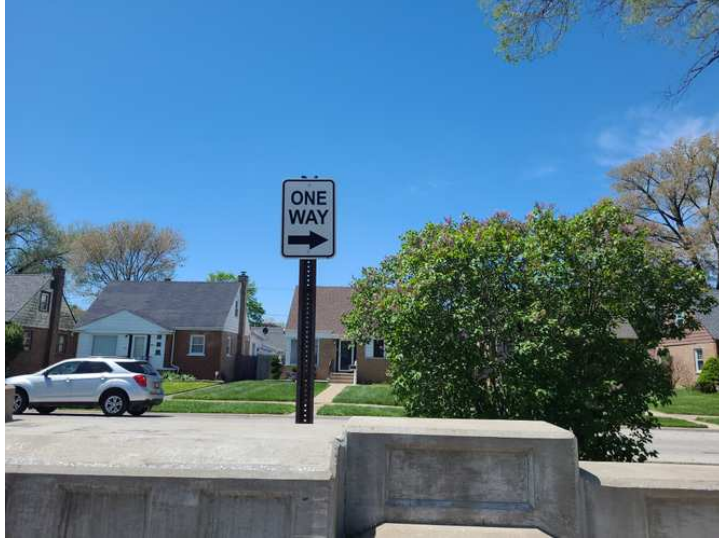
Inspect ID: 2024-0109
Feature Details: Floodwalls - Encroachments - Waterside
Station Start:
Station End:
Caption: Minimally Acceptable - Sign on the riverside of the floodwall

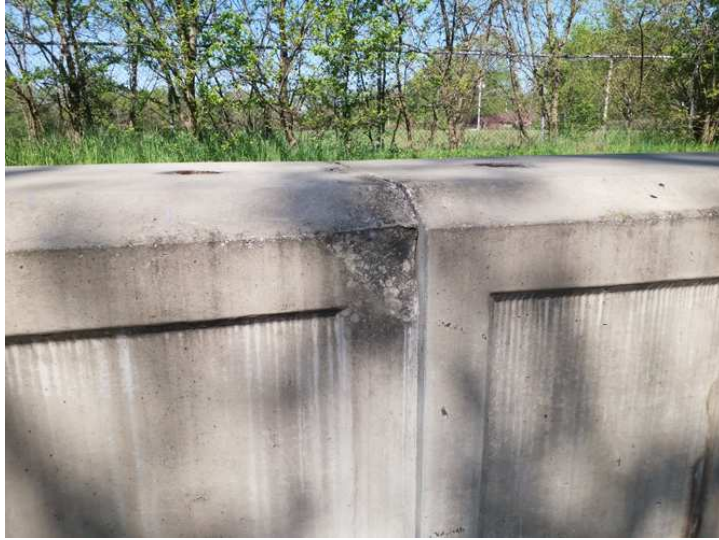
Inspect ID: 2024-0010
Feature Details: Floodwalls - Concrete Surfaces - Landside
Station Start:
Station End:
Caption: Minimally Acceptable - Typical cracking on the landside of the floodwall

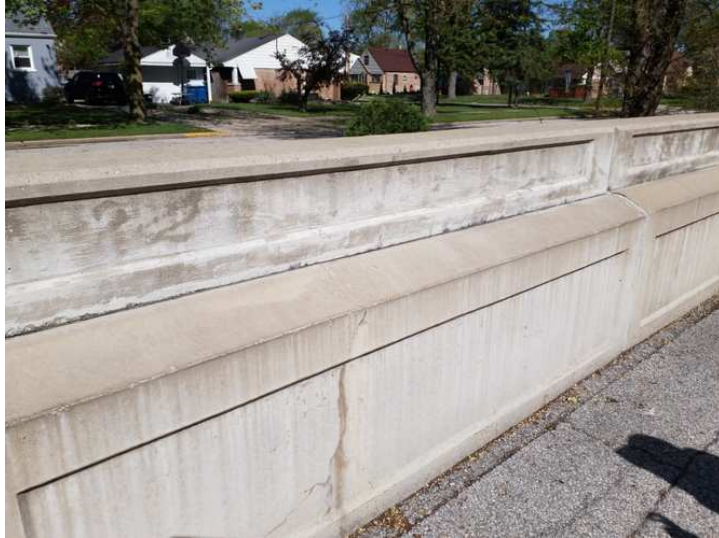
Caption: Minimally Acceptable - Crack maintenance on the riverside of the floodwall

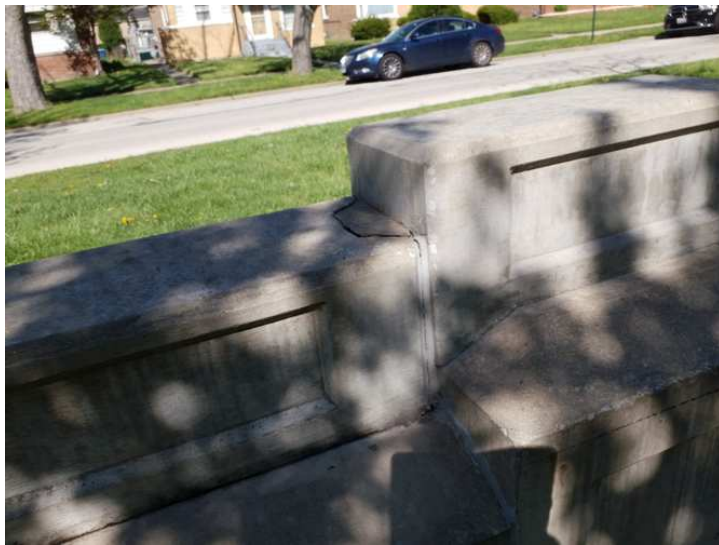
Caption: Minimally Acceptable - Cracking that is slightly larger (not typical) on the landside of the floodwall

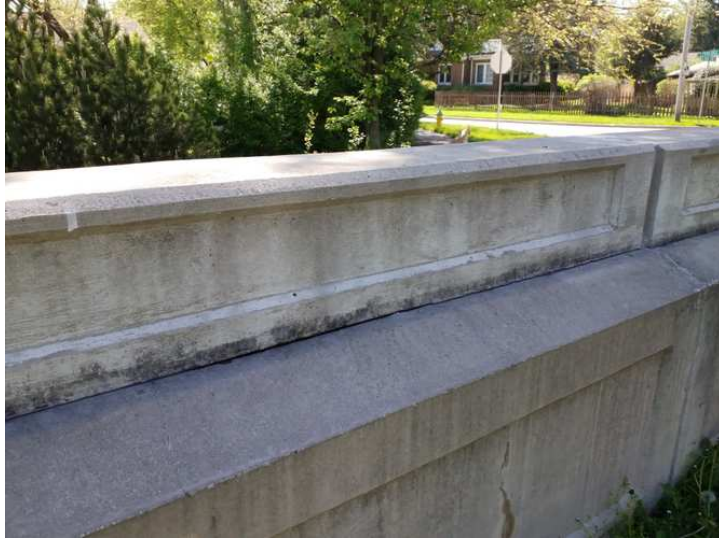
Caption: Minimally Acceptable - Broken concrete on the landside of the floodwall

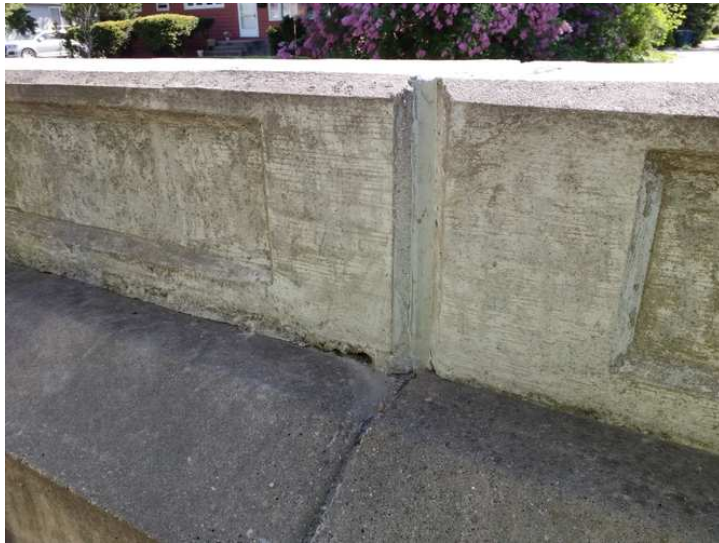
Caption: Minimally Acceptable - Separation between the top and bottom portions of the riverside of the floodwall

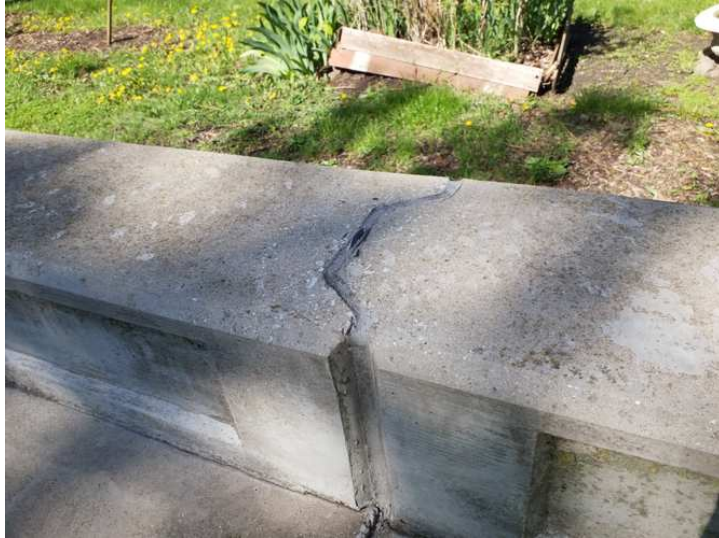
Inspect ID: 2024-0002
Feature Details: Floodwalls - Monolith Joints - Landside Joint
Station Start:
Station End:
Caption: Minimally Acceptable - Typical example of joint sealant shrinking while drying on the landside of the floodwall

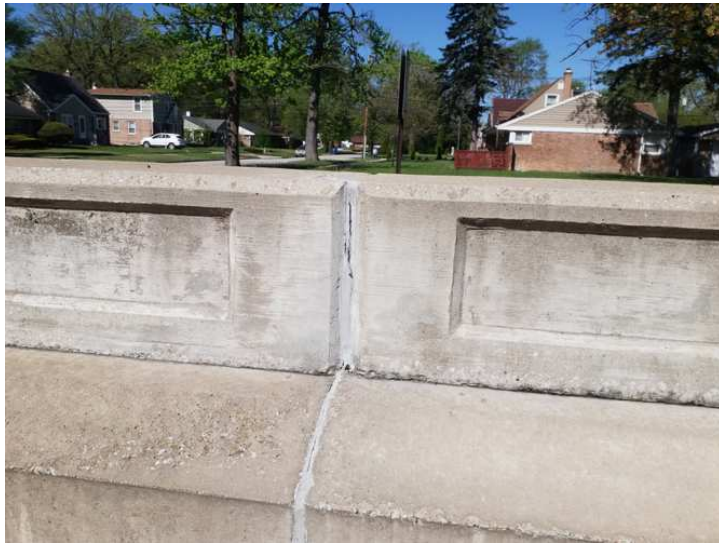
Caption: Minimally Acceptable - Typical example of the backer rod exposed at the top of the floodwall through the sealant

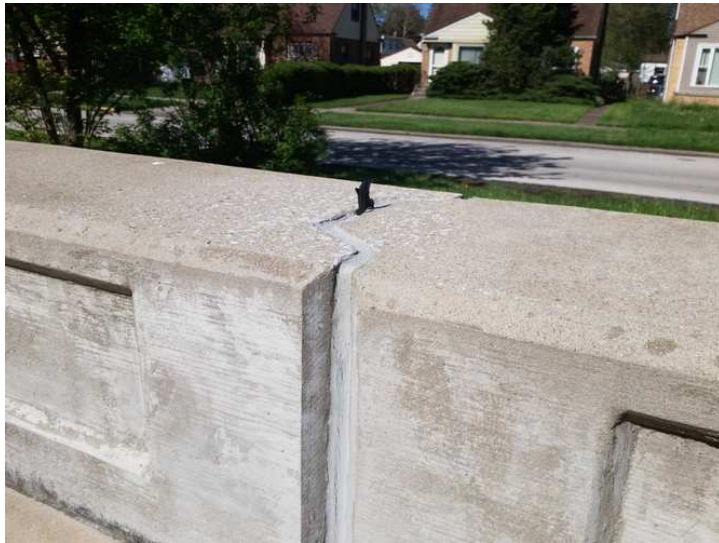
Inspect ID: 2024-0022
Feature Details: Floodwalls - Monolith Joints - Landside
Station Start:
Station End:
Caption: Minimally Acceptable - Typical exposed backer rod on the landside of the floodwall
