Levee Inspection Report

Name of System: Hammond Forest Ave
 Name of Segment: Hammond Forest Ave
 NLD System ID: 2605000010 NLD Segment ID: 2604000010

Segment Type: USACE Federally constructed, turned over to public sponsor for operations and maintenance
 Levee Sponsor (Name and Organization): Little Calumet River Basin Development Commission
 Inspection Report Prepared by: Chris Schaal Date(s) of Inspection: 04/29/2024 - 04/30/2024
 Inspection Report Prepared by: Mike Cook
 Inspection Report Prepared by: Youa Yang

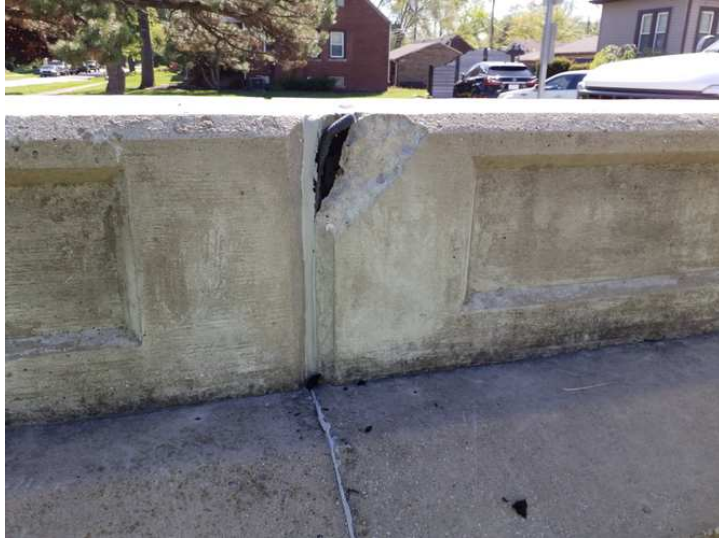
Inspect ID: 2024-0039
Feature Details: Floodwalls - Monolith Joints - Joints
Station Start:
Station End:
Caption: Minimally Acceptable - Typical sealant cracking on the riverside of the floodwall

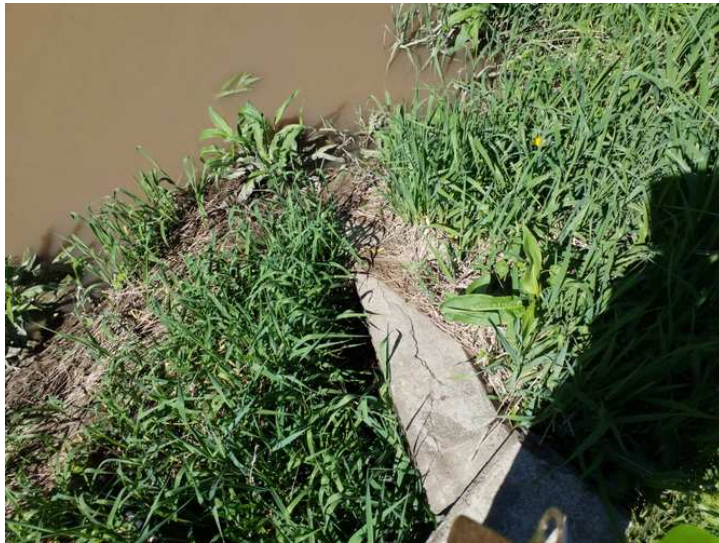
Caption: Minimally Acceptable - Sealant is saturated and deteriorating and the backer rod is exposed due to a concrete spall on the riverside of the floodwall

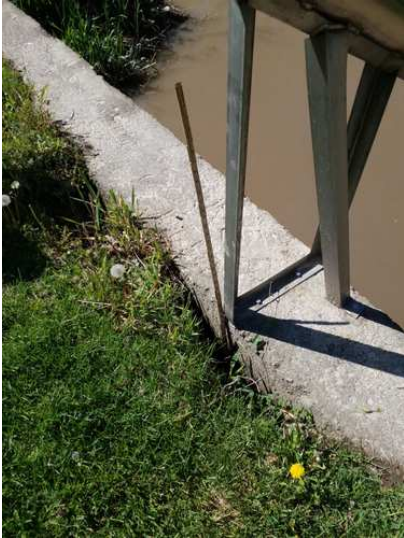
Caption: Minimally Acceptable - FA-04: Cracking at the outlet structure wingwall

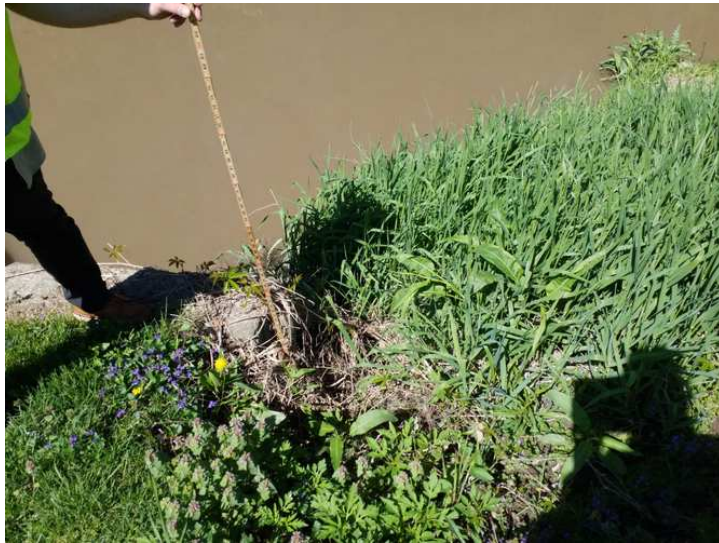
Caption: Minimally Acceptable - FA-03: Depression behind the wall, about 44 inches deep

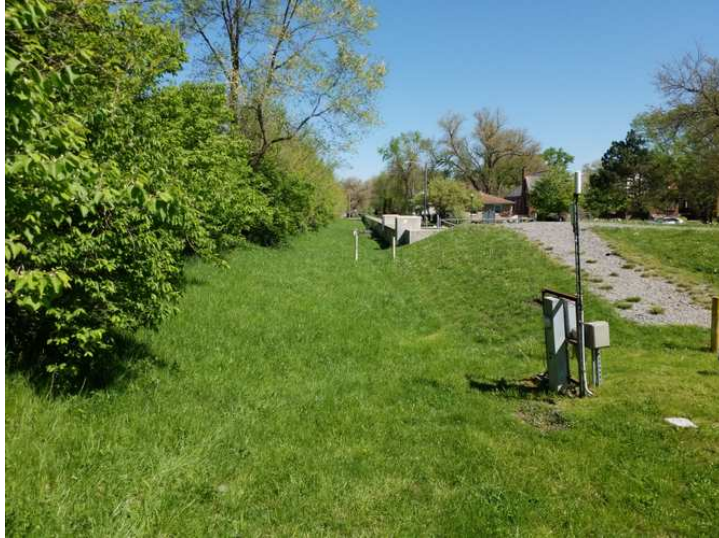
Caption: Minimally Acceptable - FA-03: Erosion near the outlet structure

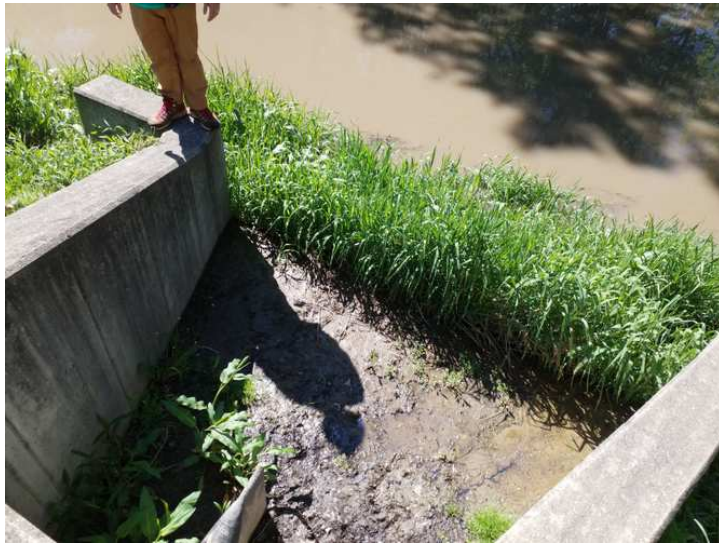
Inspect ID: 2024-0071
Feature Details: Interior Drainage System - Culverts/ Discharge Pipes - Other
Station Start:
Station End:
Caption: Acceptable - FA-06: General alignment is acceptable

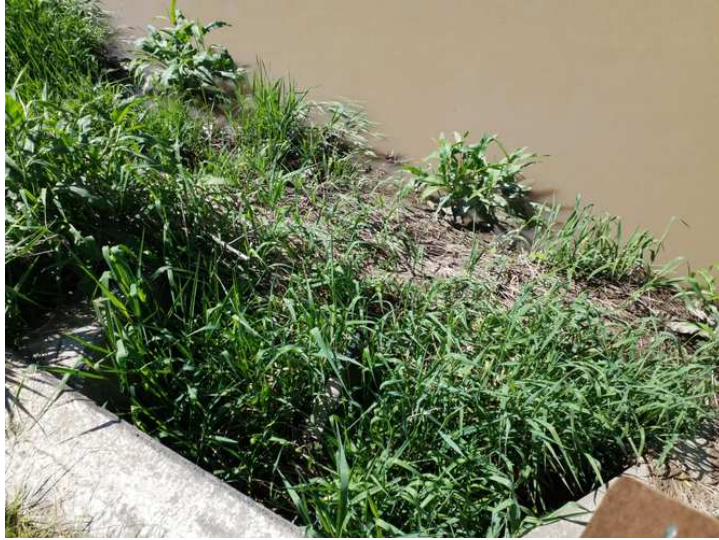
Inspect ID: 2024-0062
Feature Details: Interior Drainage System - Flap Gates/ Flap Valves/ Pinch Valves
Station Start:
Station End:
Caption: Minimally Acceptable - FA-05: Debris and vegetation are around the gate

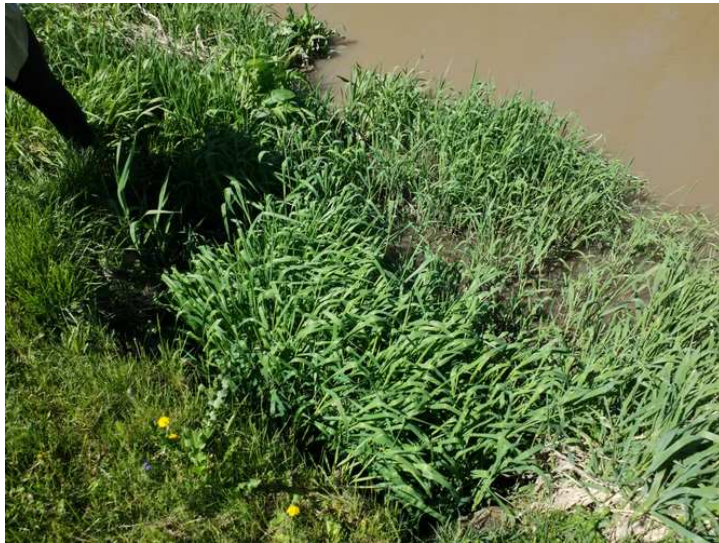
Inspect ID: 2024-0066
Feature Details: Interior Drainage System - Flap Gates/ Flap Valves/ Pinch Valves
Station Start:
Station End:
Caption: Minimally Acceptable - FA-04: Vegetation is covering the gate

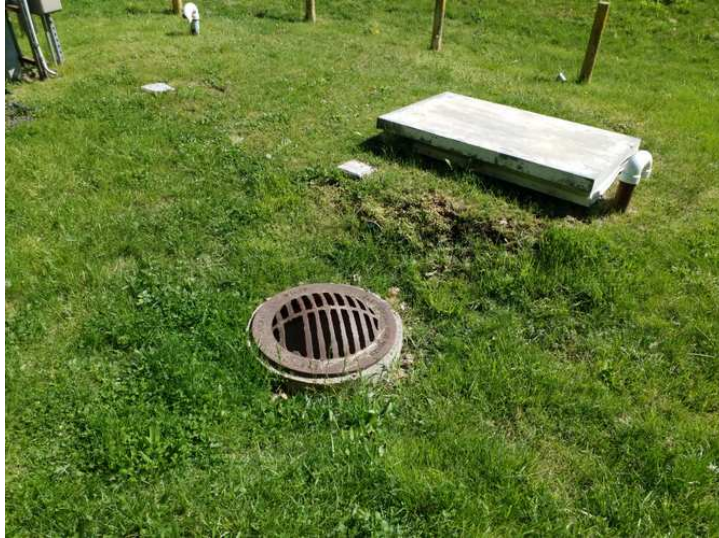
Inspect ID: 2024-0090
Feature Details: Interior Drainage System - Flap Gates/ Flap Valves/ Pinch Valves - Other
Station Start:
Station End:
Caption: Minimally Acceptable - FA-02: Vegetation is blocking the silted in gate

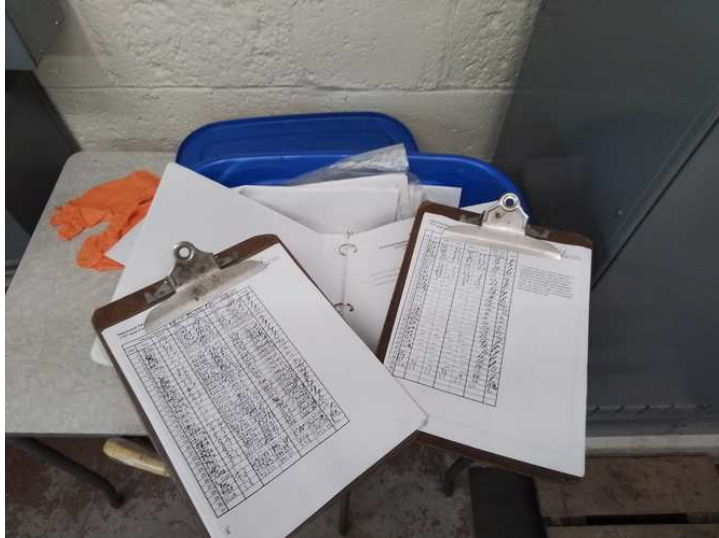
Caption: Acceptable - PS-SH: Good maintenance record keeping

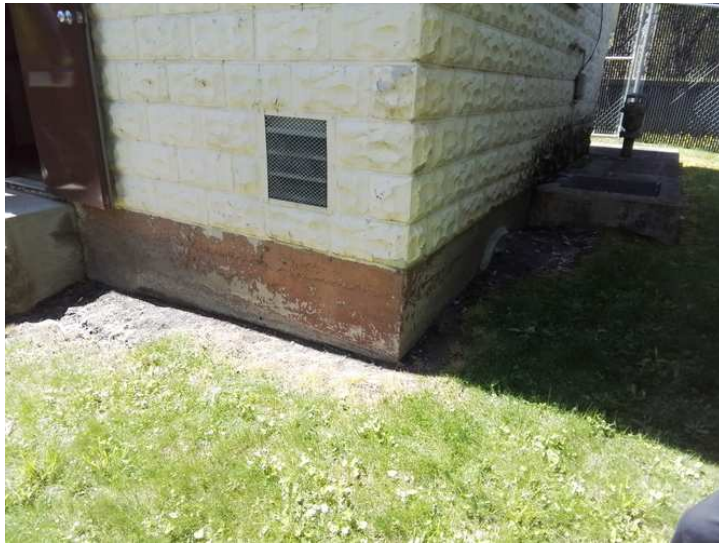
Caption: Minimally Acceptable - PS-JA: Wall crack in the building.

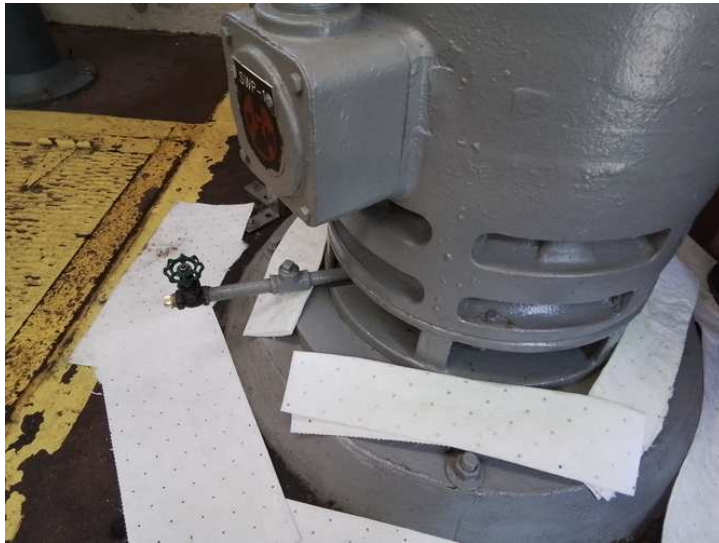
Caption: Minimally Acceptable - PS-SH: Ponding at pump 3, may be splashing up through the cover.

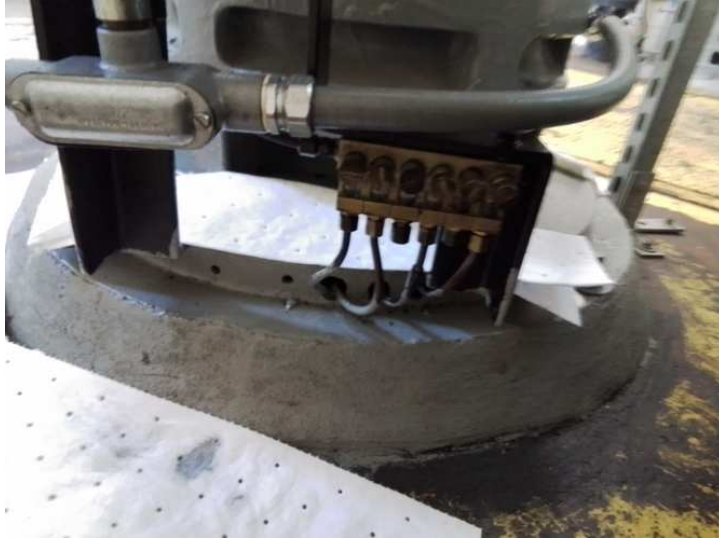
Caption: Minimally Acceptable - PS-FA: Active oil leak at SWP-1 - noted during previous inspections.

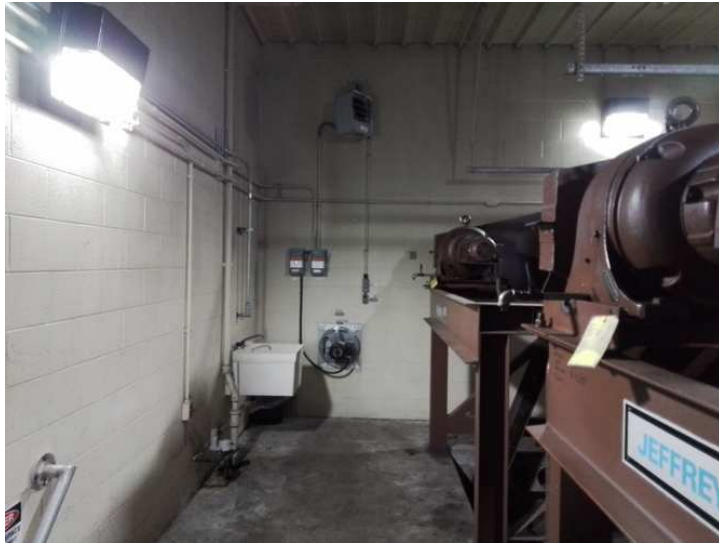
Caption: Minimally Acceptable - PS-FA: Evidence of oil leak on SWP-1 and SWP-2 supply lines (SWP-1 pictured).
