US Army Corps of Engineers ®

Levee Inspection Report

Name of System: Munster
 Name of Segment: Munster
 NLD System ID: 2605000006 NLD Segment ID: 2604000009

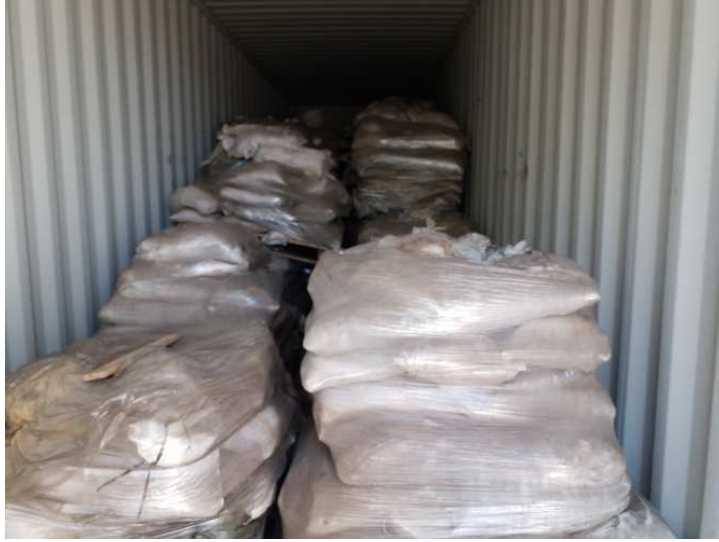
Inspect ID: 2024-0111

Caption: Acceptable - Munster sandbag supplies inside container 1. Flood fighting supplies are stored behind the Munster Public Works facility on Fisher Street.

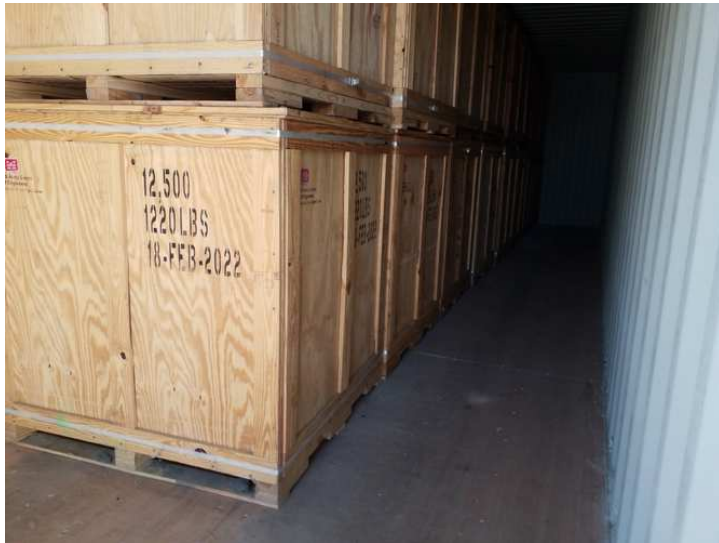
Inspect ID: 2024-0115

Caption: Acceptable - Munster flooding supplies. Over 3/4 of total supplies are in these two containers located at the Munster Public Works location on Fisher Street.

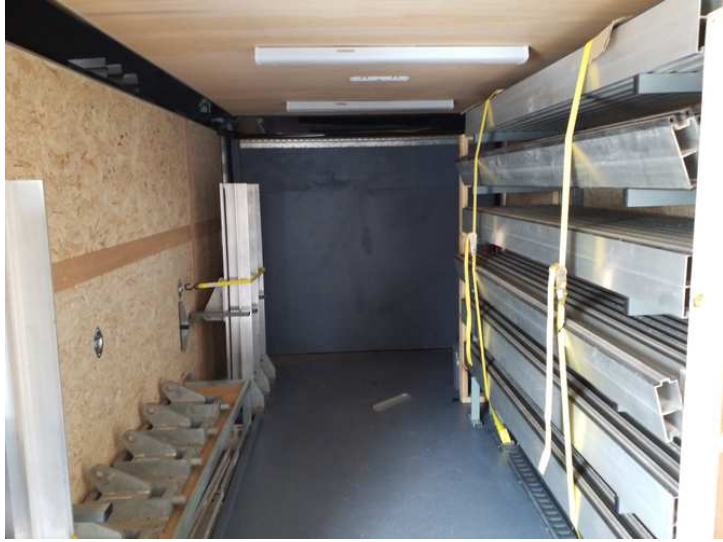
Inspect ID: 2024-0162
Feature Details: General Items - Emergency Supplies and Equipment (A or M only) - Other
Station Start:
Station End:
Caption: Acceptable - Trailer for stoplogs. All components present including spare. The trailer is located at the Munster Public Works location on Fisher Street with other flood fighting supplies.

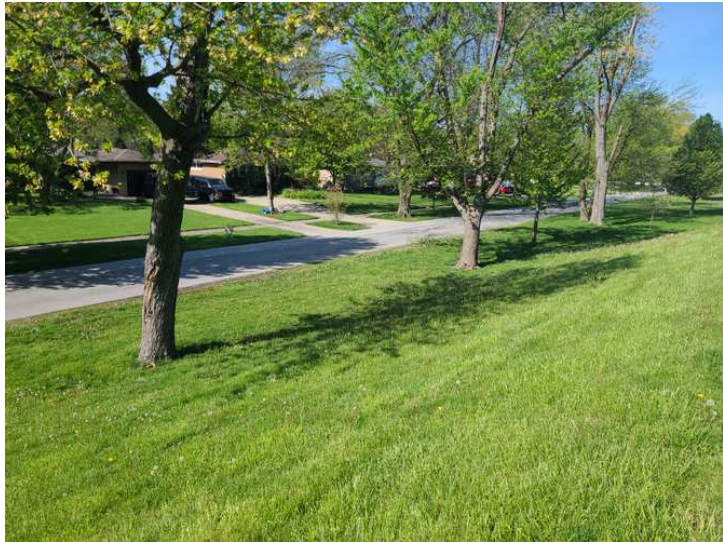
Inspect ID: 2024-0013
Feature Details: Levee Embankments - Unwanted Vegetation Growth - Landside Toe
Station Start:
Station End:
Caption: Minimally Acceptable - Trees along the landside toe.

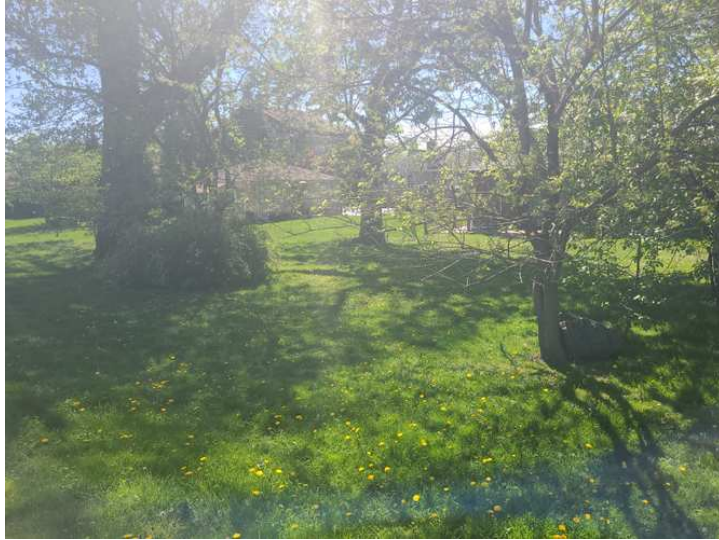
Inspect ID: 2024-0061
Feature Details: Levee Embankments - Unwanted Vegetation Growth - Landside Toe
Station Start:
Station End:
Caption: Minimally Acceptable - Trees and a bush within 15 ft of the landside toe.

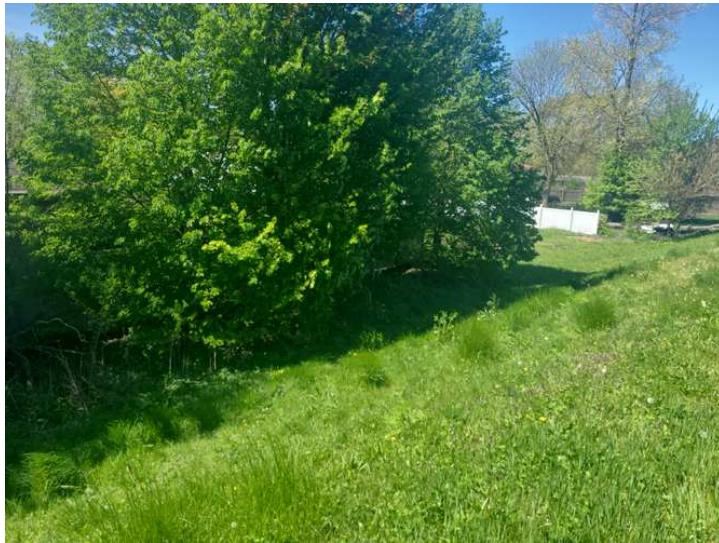
Inspect ID: 2024-0069
Feature Details: Levee Embankments - Unwanted Vegetation Growth - Landside Toe
Station Start:
Station End:
Caption: Minimally Acceptable - Trees within 15 ft of the landside toe.

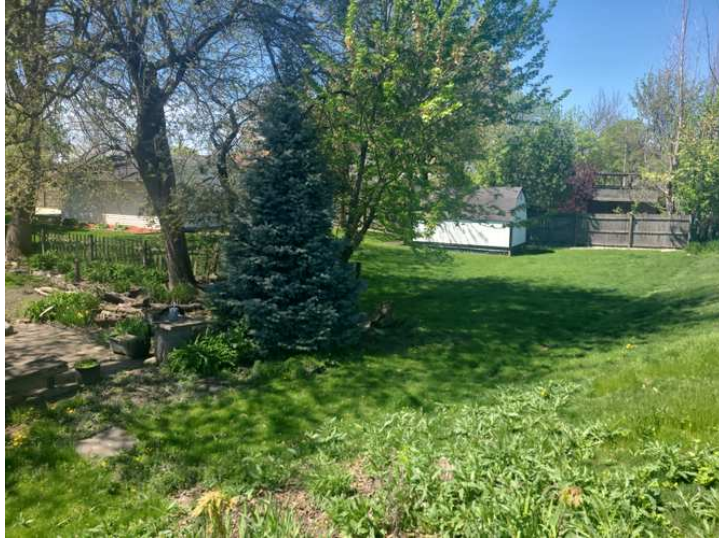
Inspect ID: 2024-0077
Feature Details: Levee Embankments - Unwanted Vegetation Growth - Landside Toe
Station Start:
Station End:
Caption: Minimally Acceptable - Tree within 15 ft of the landside toe.

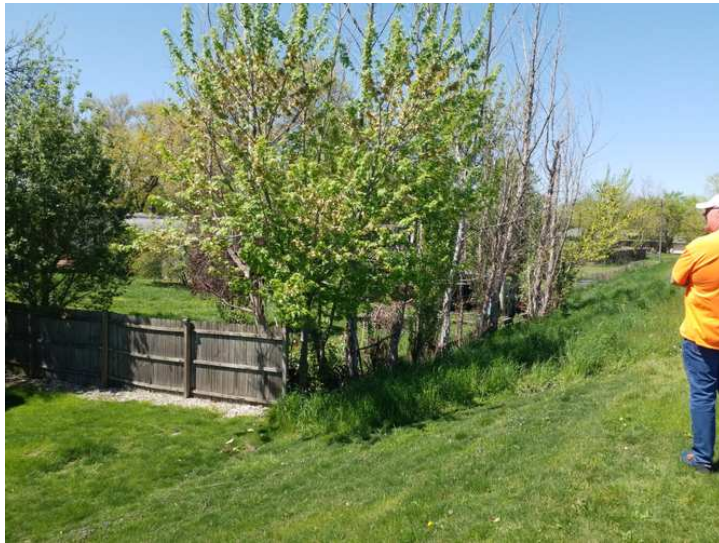
Inspect ID: 2024-0090
Feature Details: Levee Embankments - Unwanted Vegetation Growth - Landside Toe
Station Start:
Station End:
Caption: Minimally Acceptable - Vegetation along the landside toe.

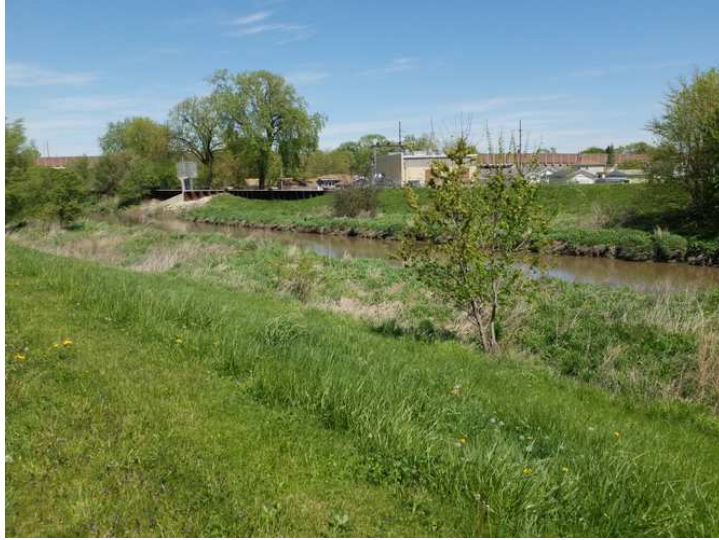
Inspect ID: 2024-0126
Feature Details: Levee Embankments - Unwanted Vegetation Growth - Waterside Toe
Station Start:
Station End:
Caption: Minimally Acceptable - Tree along the riverside toe.

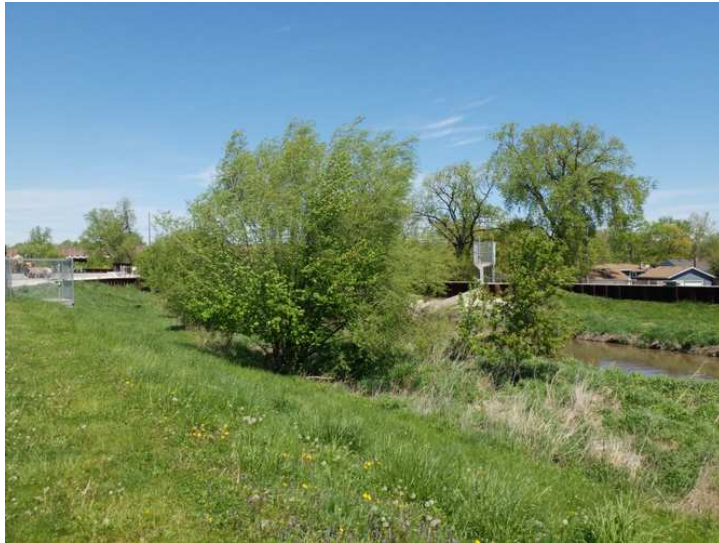
Inspect ID: 2024-0130
Feature Details: Levee Embankments - Unwanted Vegetation Growth - Waterside Toe
Station Start:
Station End:
Caption: Minimally Acceptable - Tree along the riverside toe.

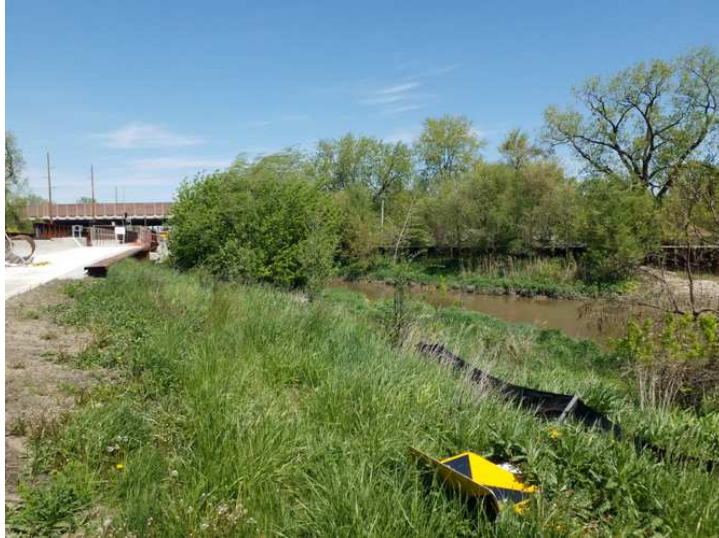
Inspect ID: 2024-0134
Feature Details: Levee Embankments - Unwanted Vegetation Growth - Waterside Slope
Station Start:
Station End:
Caption: Minimally Acceptable - Tree on the riverside slope.

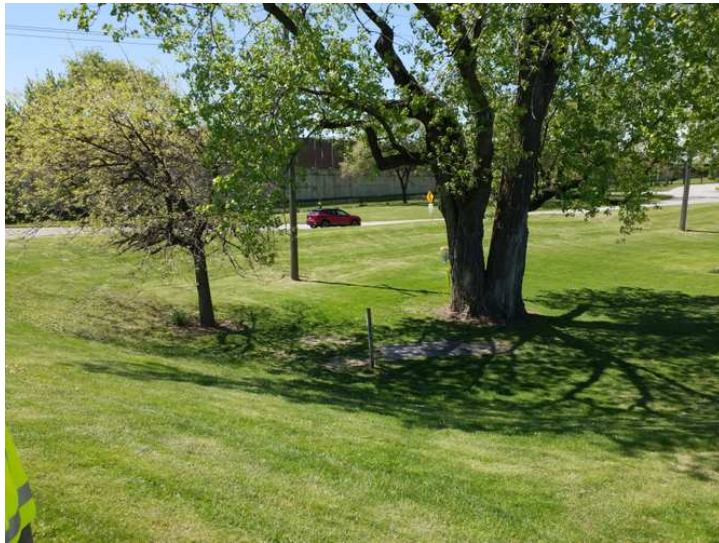
Inspect ID: 2024-0150
Feature Details: Levee Embankments - Unwanted Vegetation Growth - Waterside Slope
Station Start:
Station End:
Caption: Minimally Acceptable - Tree on the riverside slope.

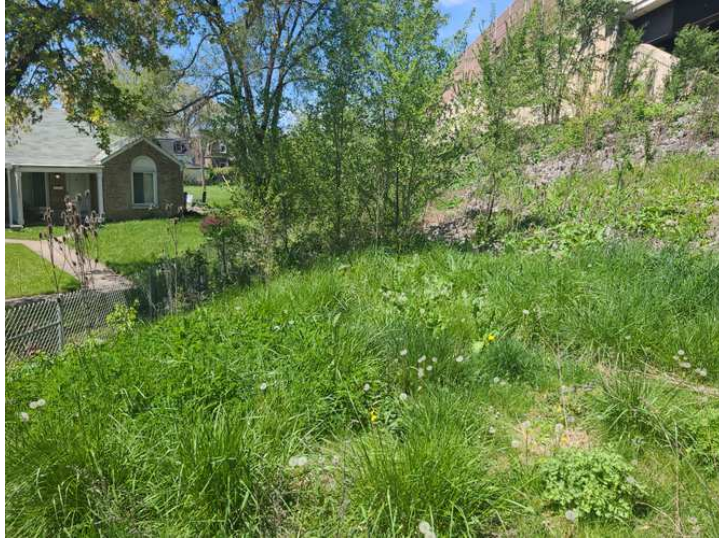
Inspect ID: 2024-0153

Caption: Minimally Acceptable - Vegetation on the crown and landside slope.

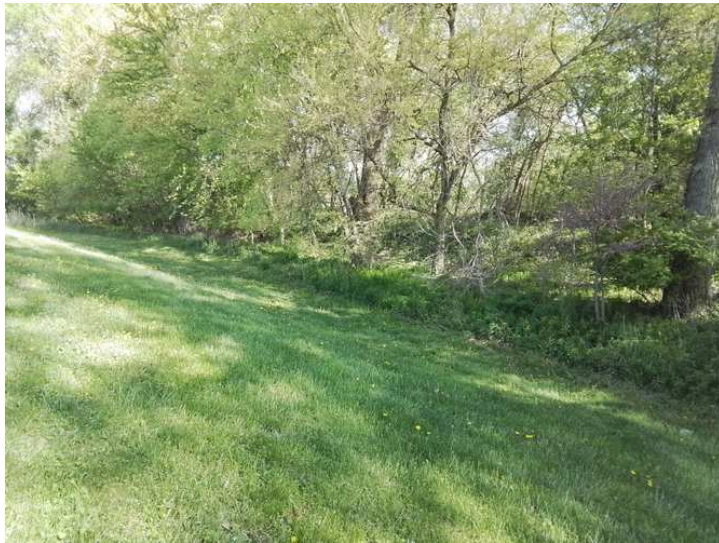
Inspect ID: 2024-0236

Caption: Minimally Acceptable - Vegetation within 15 ft of the riverside toe.

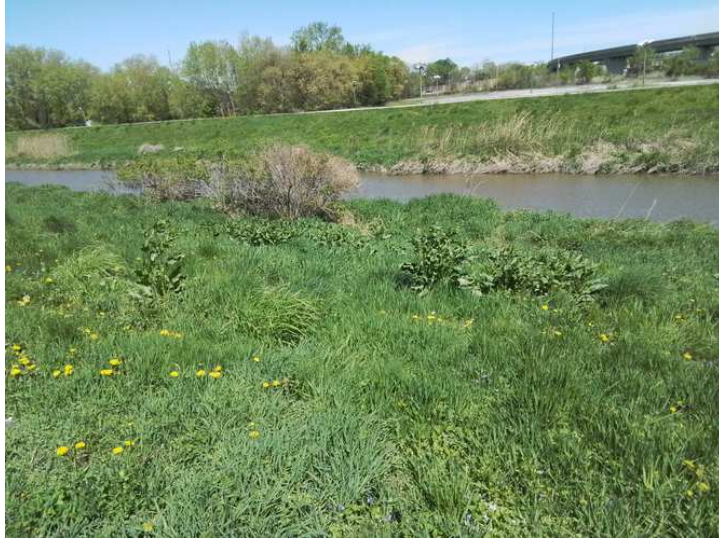
Inspect ID: 2024-0324
Feature Details: Levee Embankments - Unwanted Vegetation Growth - Waterside Toe
Station Start:
Station End:
Caption: Minimally Acceptable - Vegetation along the riverside toe.

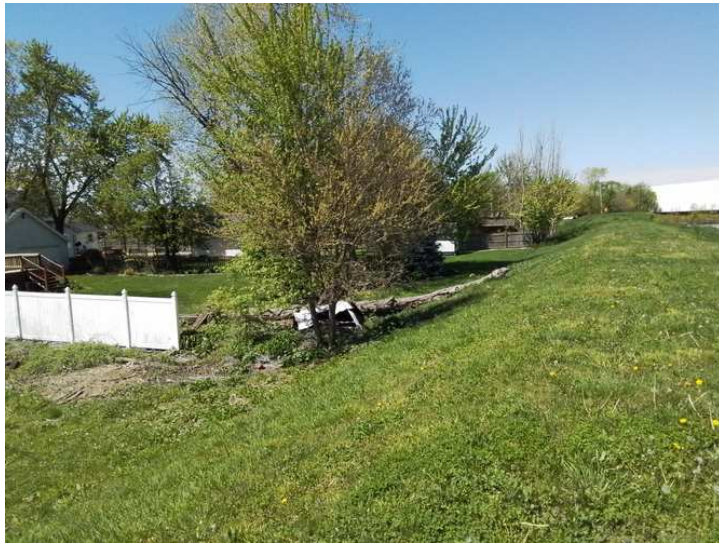
Inspect ID: 2024-0332
Feature Details: Levee Embankments - Unwanted Vegetation Growth - Landside Toe
Station Start:
Station End:
Caption: Minimally Acceptable - Trees along the landside toe.

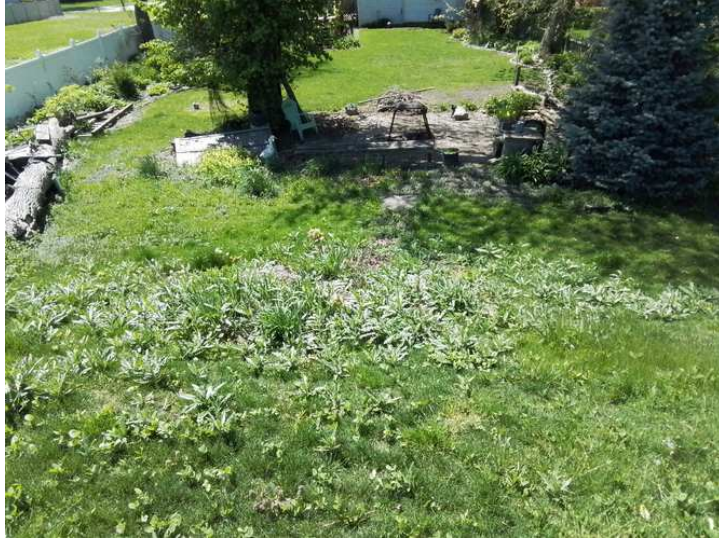
Inspect ID: 2024-0340

Caption: Minimally Acceptable - Small trees starting to grow on the landside slope.

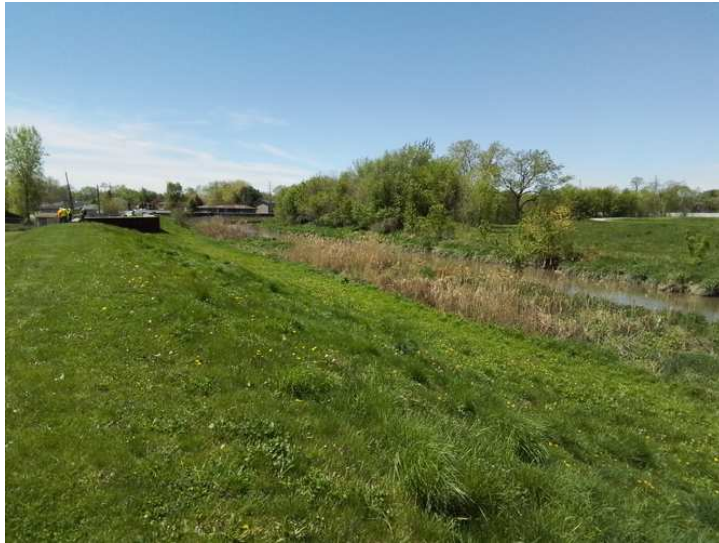
Inspect ID: 2024-0376

Caption: Minimally Acceptable - Vegetation along the riverside toe.

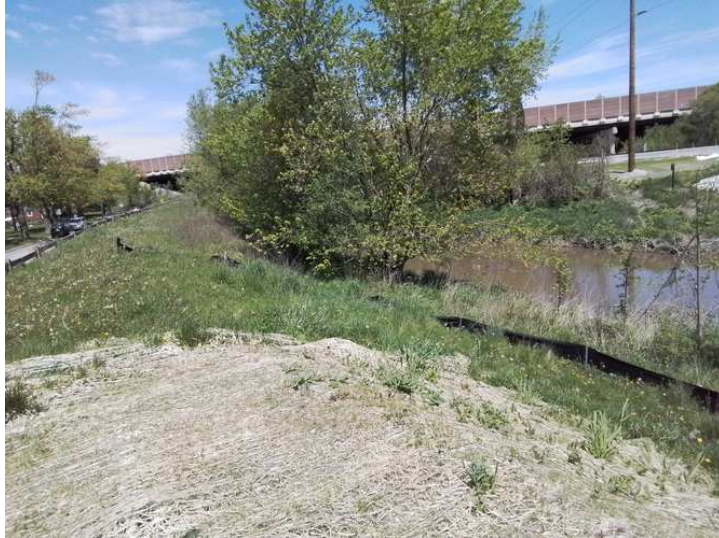
Inspect ID: 2024-0420
Feature Details: Levee Embankments - Unwanted Vegetation Growth - Waterside Toe
Station Start:
Station End:
Caption: Minimally Acceptable - Trees on the riverside toe.

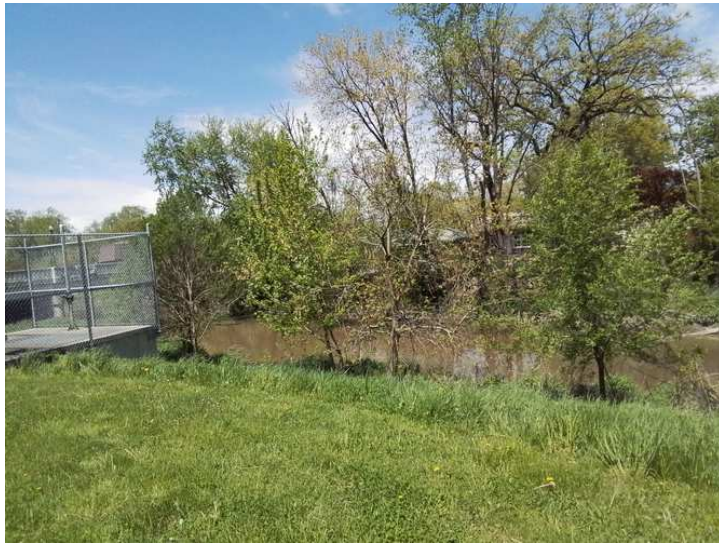
Inspect ID: 2024-0424
Feature Details: Levee Embankments - Unwanted Vegetation Growth - Waterside Toe
Station Start:
Station End:
Caption: Minimally Acceptable - Trees on the riverside toe.

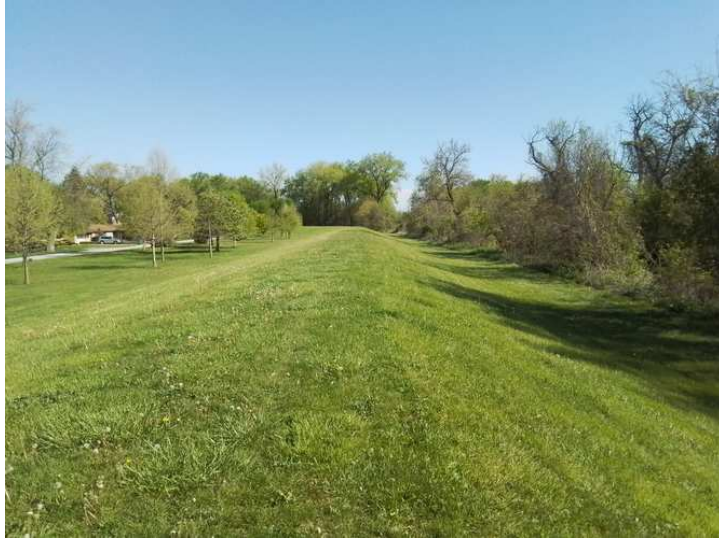
Inspect ID: 2024-0224
Feature Details: Levee Embankments - Sod Cover - Landside and Waterside
Station Start:
Station End:
Caption: Acceptable - Adequate sod cover - typical example

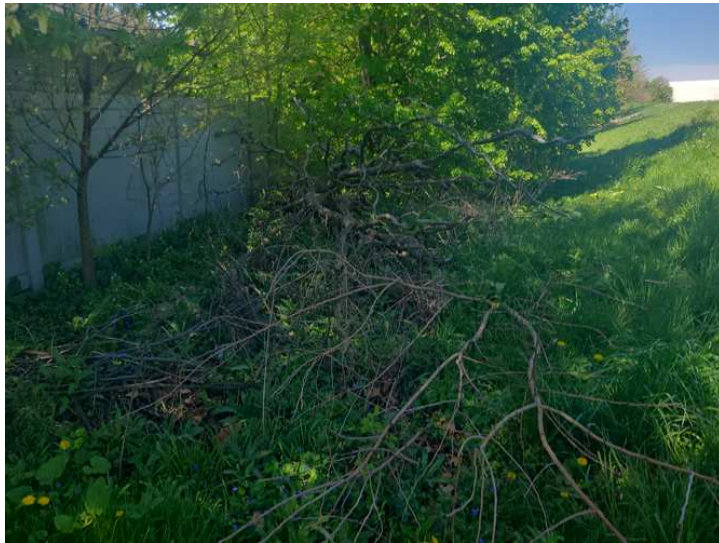
Inspect ID: 2024-0065
Feature Details: Levee Embankments - Encroachments - Landside Toe
Station Start:
Station End:
Caption: Minimally Acceptable - Downed tree on the landside toe.

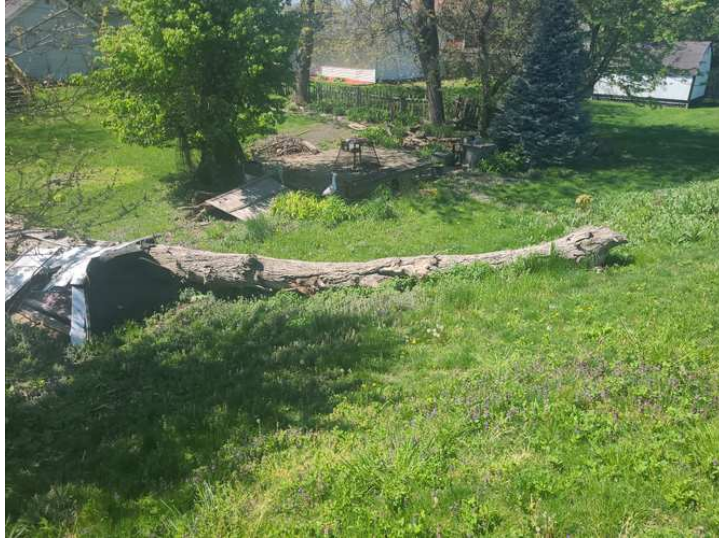
Inspect ID: 2024-0073

Caption: Minimally Acceptable - Downed tree on the landside slope. The levee profile was damaged and is healing around the tree.

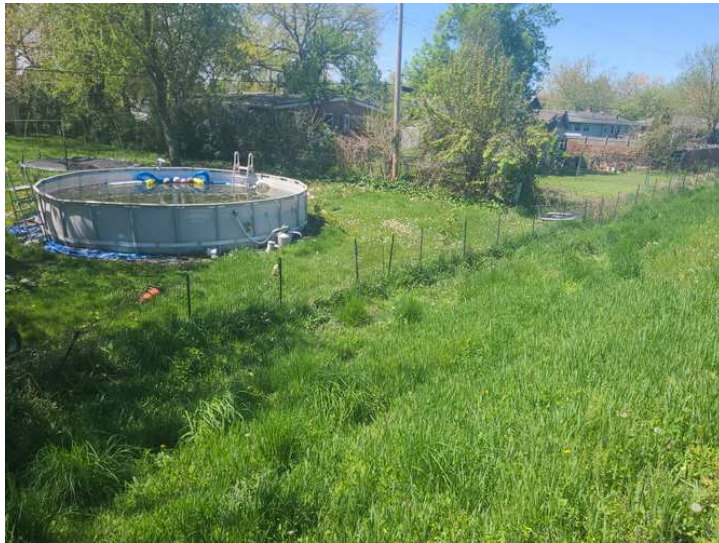
Inspect ID: 2024-0081

Caption: Minimally Acceptable - Chain-link fence along the landside toe.

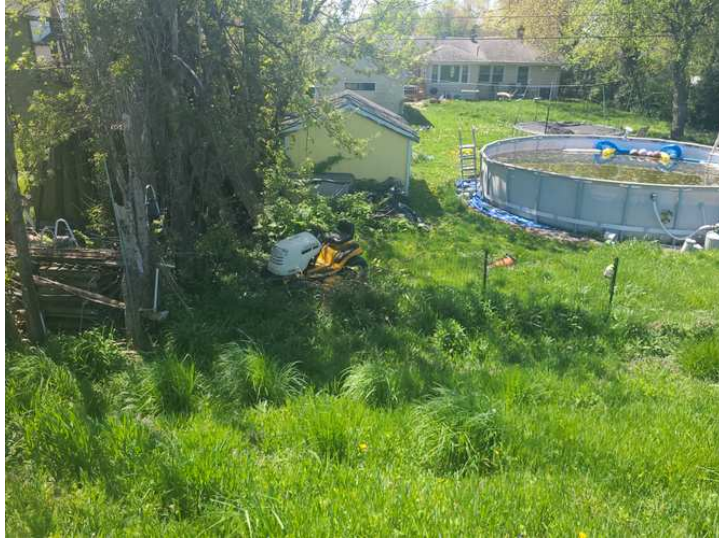
Inspect ID: 2024-0085
Feature Details: Levee Embankments - Encroachments - Landside Toe
Station Start:
Station End:
Caption: Minimally Acceptable - Lawnmower within 15 feet of the landside toe

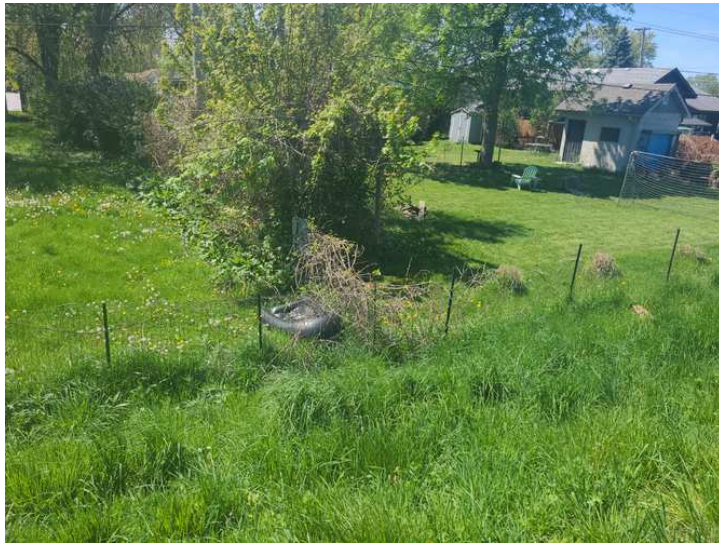
Inspect ID: 2024-0089
Feature Details: Levee Embankments - Encroachments - Landside Toe
Station Start:
Station End:
Caption: Minimally Acceptable - Watercraft within 15 feet of the landside toe.

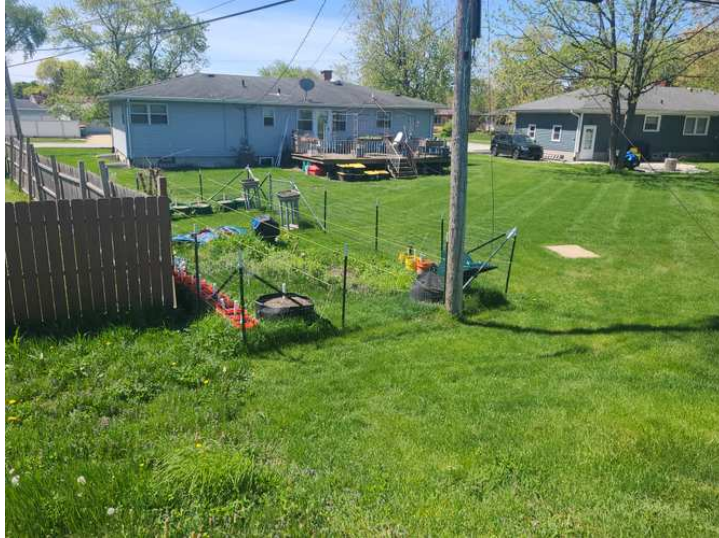
Inspect ID: 2024-0093
Feature Details: Levee Embankments - Encroachments - Landside Toe
Station Start:
Station End:
Caption: Minimally Acceptable - Garden on the landside toe.

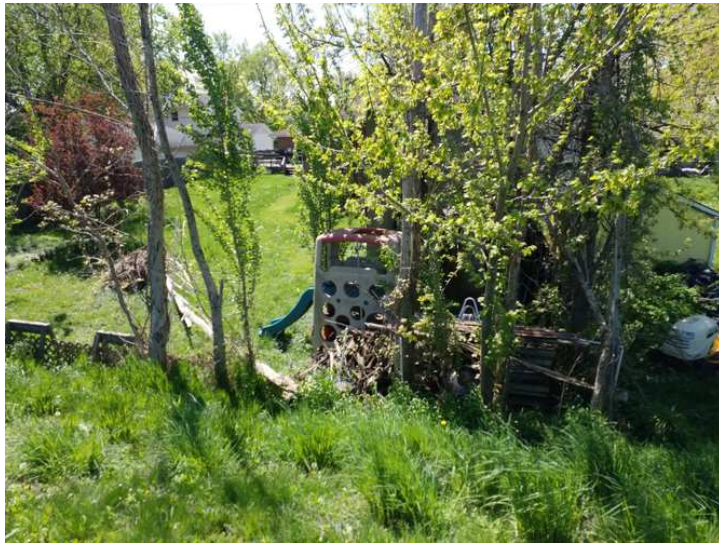
Inspect ID: 2024-0094
Feature Details: Levee Embankments - Encroachments - Landside Toe
Station Start:
Station End:
Caption: Minimally Acceptable - Playground and logs on the landside toe.

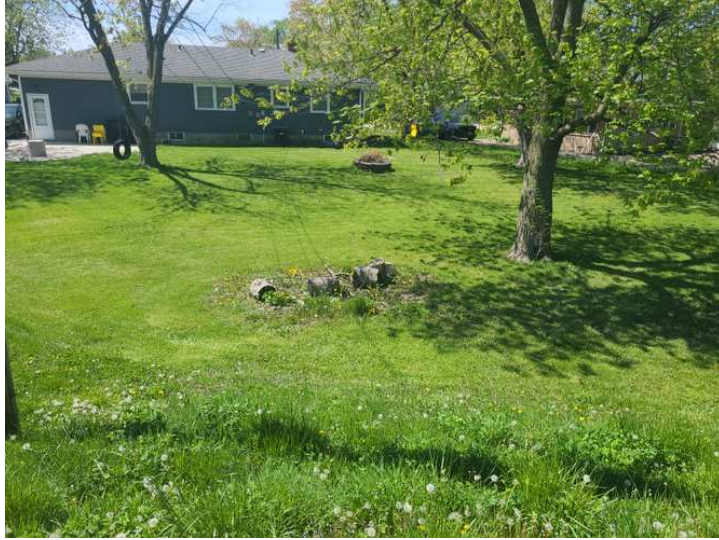
Inspect ID: 2024-0097
Feature Details: Levee Embankments - Encroachments - Landside Toe
Station Start:
Station End:
Caption: Minimally Acceptable - Debris on the landside toe.

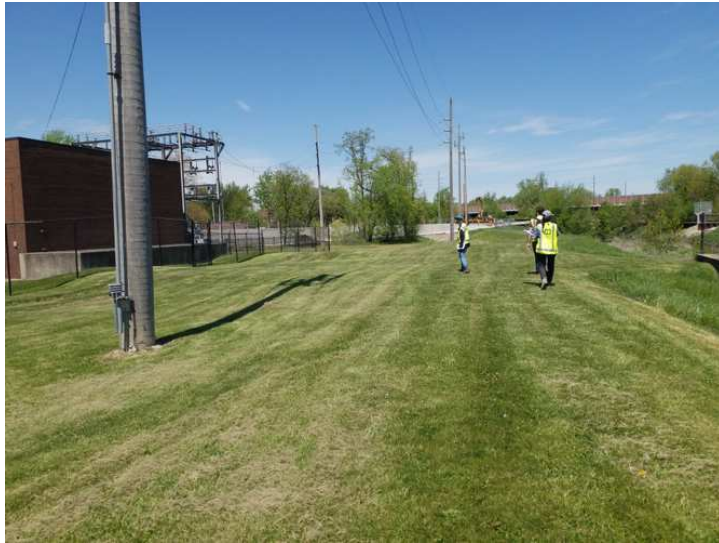
Inspect ID: 2024-0122
Feature Details: Levee Embankments - Encroachments - Landside Toe
Station Start:
Station End:
Caption: Minimally Acceptable - New electric pole on the landside toe related to the southshore train extension. A 408 permit was approved for the pole, but it is too close to the levee.

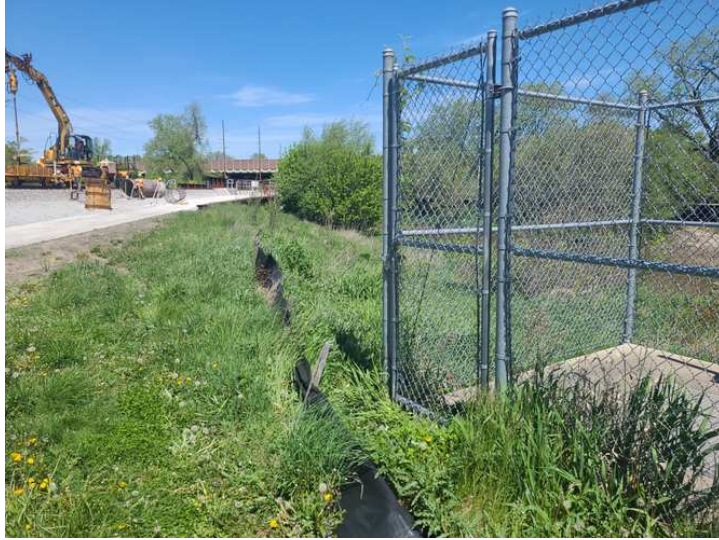
Inspect ID: 2024-0137

Caption: Acceptable - Temporary construction equipment and activity related to the southshore train extension (408 permitted).

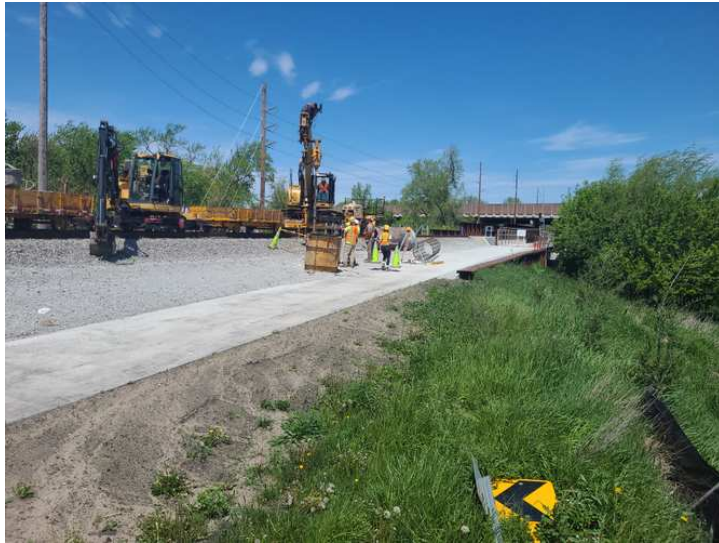
Inspect ID: 2024-0141

Caption: Acceptable - Active 408 permitted construction activities related to the southshore train extension.

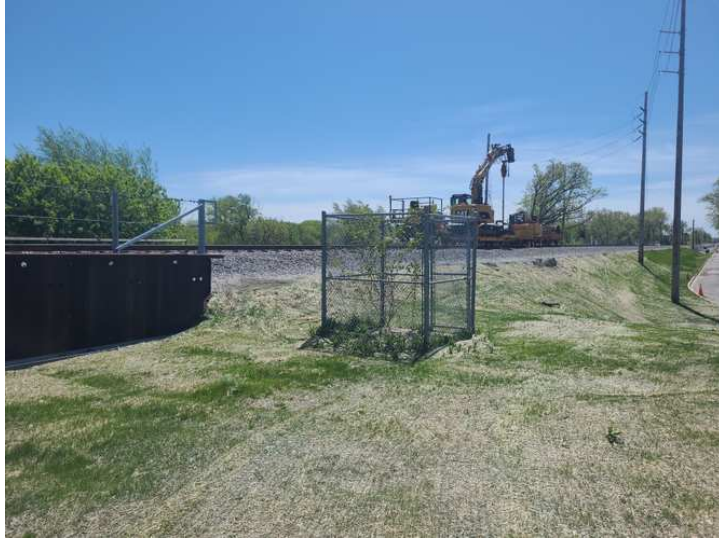
Inspect ID: 2024-0145
Feature Details: Levee Embankments - Encroachments
Station Start:
Station End:
Caption: Acceptable - Construction activity related to the southshore train extension (408 approved).

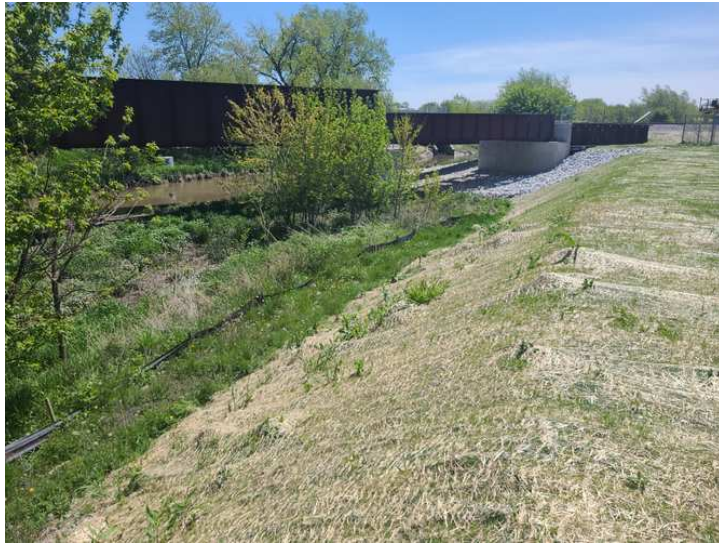
Inspect ID: 2024-0149
Feature Details: Levee Embankments - Encroachments - Waterside Toe
Station Start:
Station End:
Caption: Acceptable - Silt fence along the riverside toe - should be removed once the train track construction is complete.

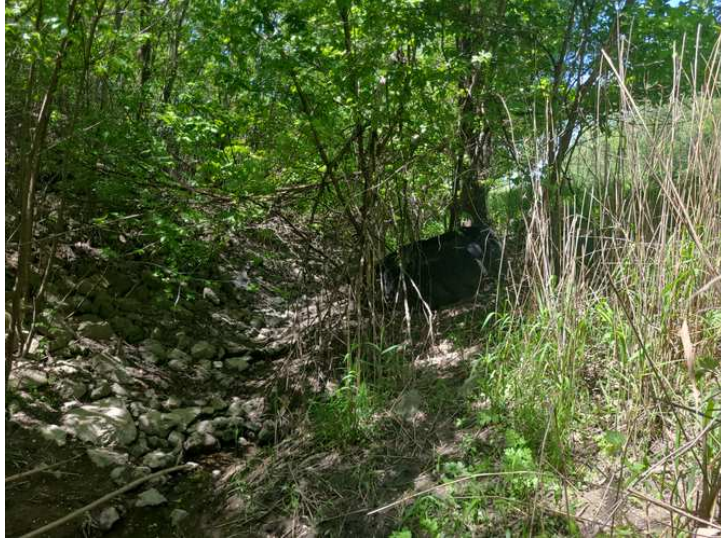
Inspect ID: 2024-0161
Feature Details: Levee Embankments - Encroachments - Waterside Toe
Station Start:
Station End:
Caption: Minimally Acceptable - Tire debris along the riverside toe.

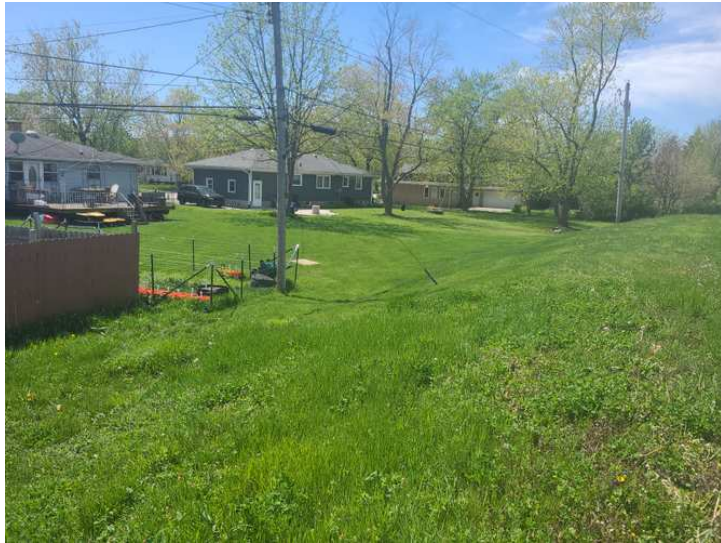
Inspect ID: 2024-0169
Feature Details: Levee Embankments - Encroachments - Landside Toe
Station Start:
Station End:
Caption: Minimally Acceptable - Pre-existing power pole on the landside toe - determine if it is Section 408 approved.

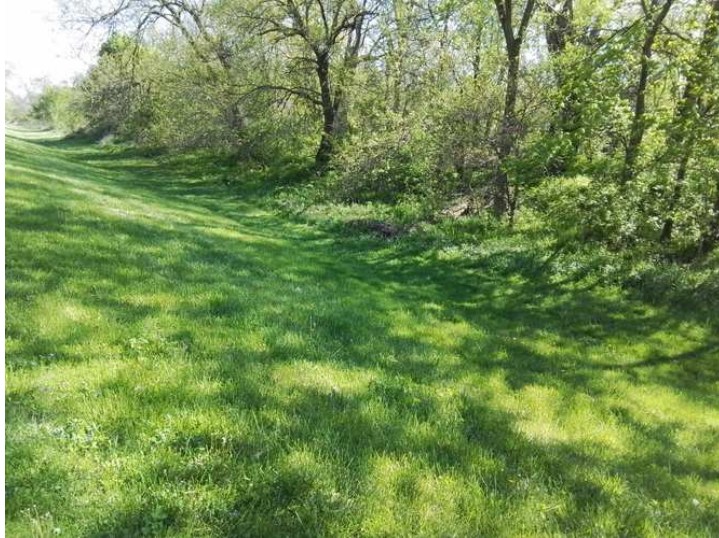
Inspect ID: 2024-0220
Feature Details: Levee Embankments - Encroachments - Waterside
Station Start:
Station End:
Caption: Minimally Acceptable - Downed tree near the riverside levee toe.

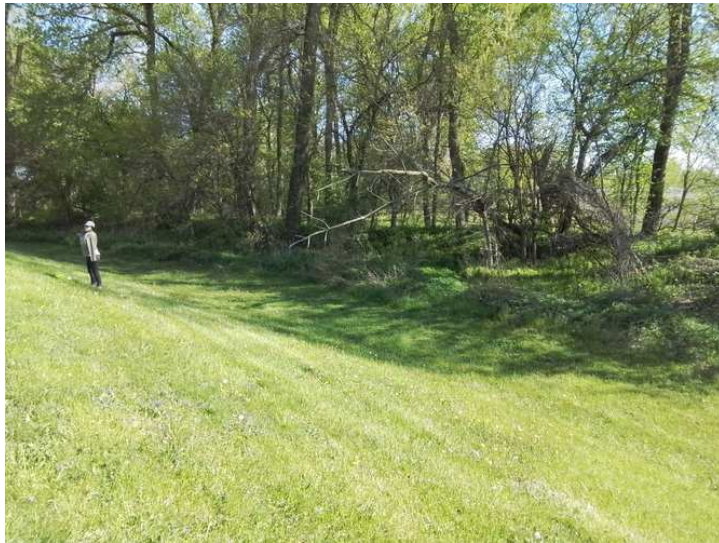
Inspect ID: 2024-0232
Feature Details: Levee Embankments - Encroachments - Waterside
Station Start:
Station End:
Caption: Minimally Acceptable - Tree leaning over on the riverside.

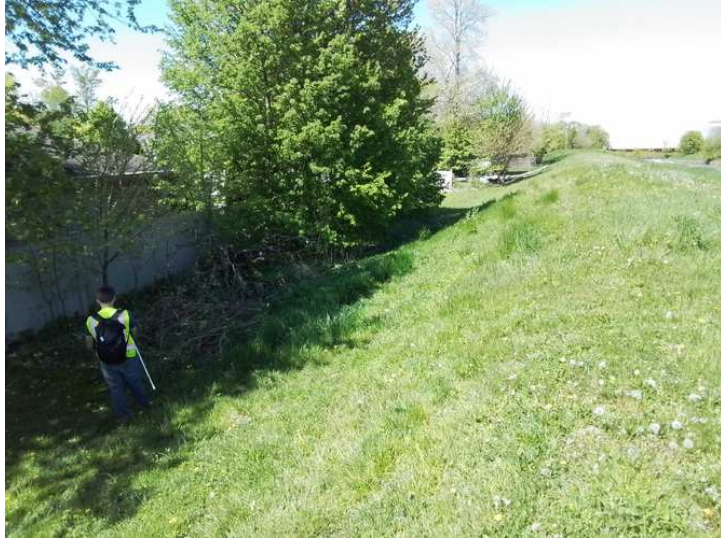
Inspect ID: 2024-0328
Feature Details: Levee Embankments - Encroachments - Landside Toe
Station Start:
Station End:
Caption: Minimally Acceptable - Fallen tree debris on landside toe.

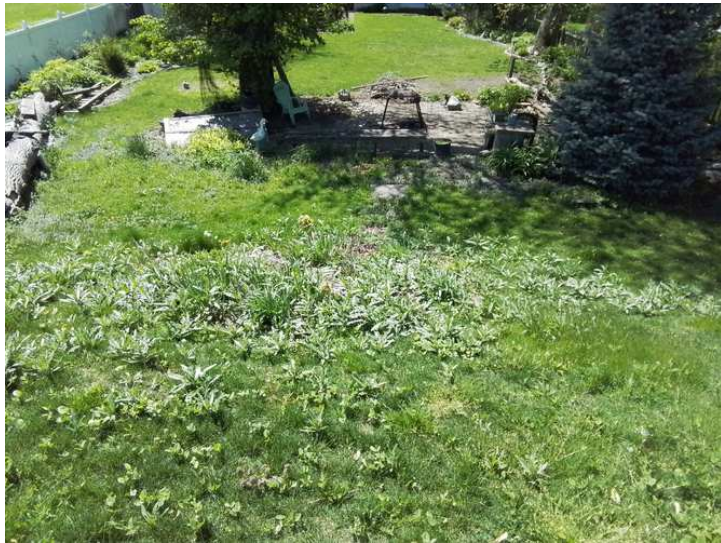
Inspect ID: 2024-0336
Feature Details: Levee Embankments - Encroachments - Landside Slope
Station Start:
Station End:
Caption: Minimally Acceptable - Garden on the landside slope.

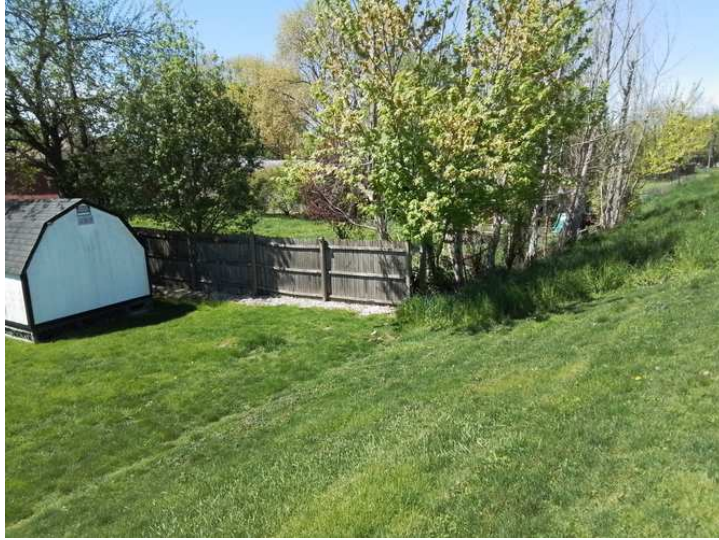
Inspect ID: 2024-0344
Feature Details: Levee Embankments - Encroachments - Landside Toe
Station Start:
Station End:
Caption: Minimally Acceptable - Wood fence perpendicular to and abutting the landside toe.

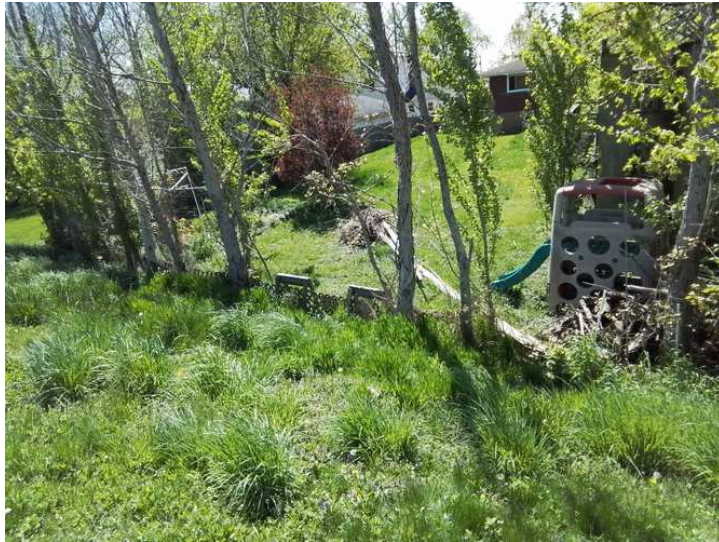
Inspect ID: 2024-0348
Feature Details: Levee Embankments - Encroachments - Landside Toe
Station Start:
Station End:
Caption: Minimally Acceptable - Decorative fence and traffic post on the landside toe.

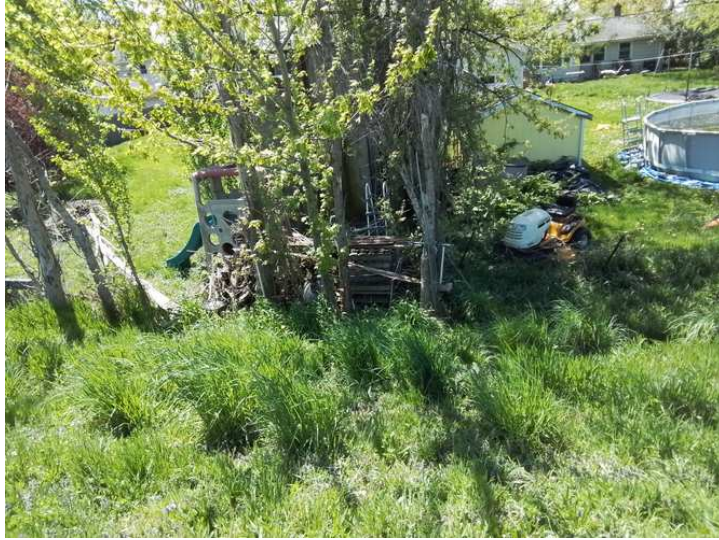
Inspect ID: 2024-0352

Caption: Minimally Acceptable - Wooden pallets stacked on the landside toe.

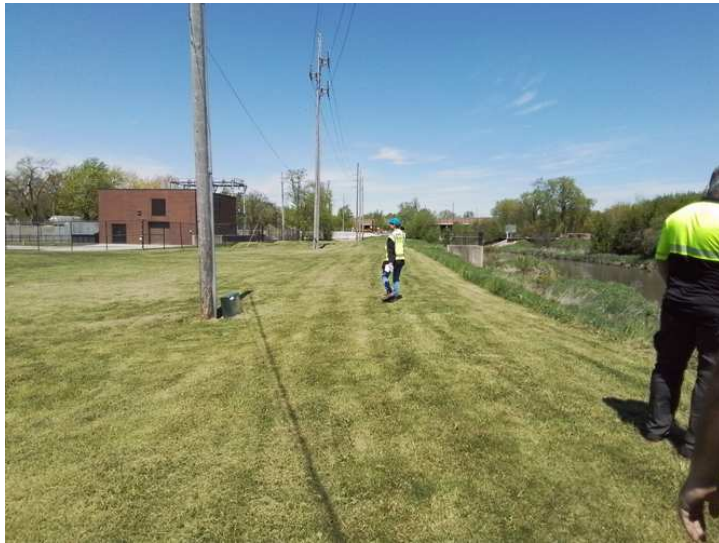
Inspect ID: 2024-0400

Caption: Minimally Acceptable - New electric poles on the landside toe related to the southshore train extension. A 408 permit was approved for the poles, but they are too close to the levee.

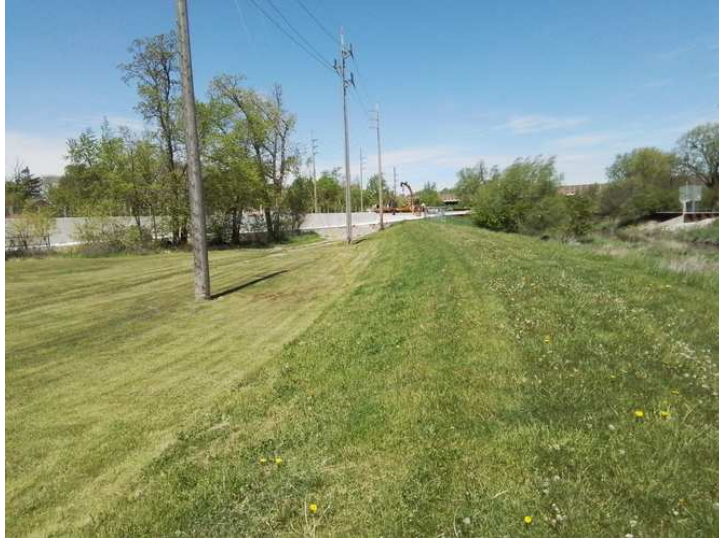
Inspect ID: 2024-0404
Feature Details: Levee Embankments - Encroachments - Landside Toe
Station Start:
Station End:
Caption: Minimally Acceptable - New electric poles on the landside toe related to the southshore train extension. A 408 permit was approved for the poles, but they are too close to the levee.

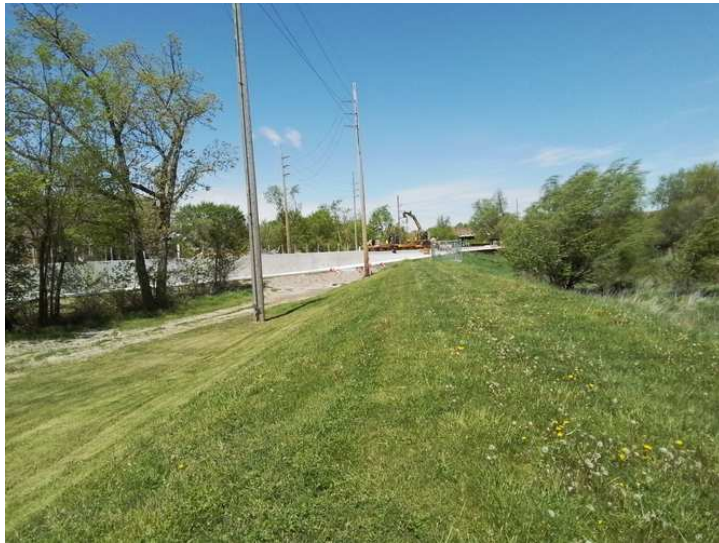
Inspect ID: 2024-0408
Feature Details: Levee Embankments - Encroachments - Landside Toe
Station Start:
Station End:
Caption: Minimally Acceptable - New electric poles on the landside toe related to the southshore train extension. A 408 permit was approved for the poles, but they are too close to the levee.

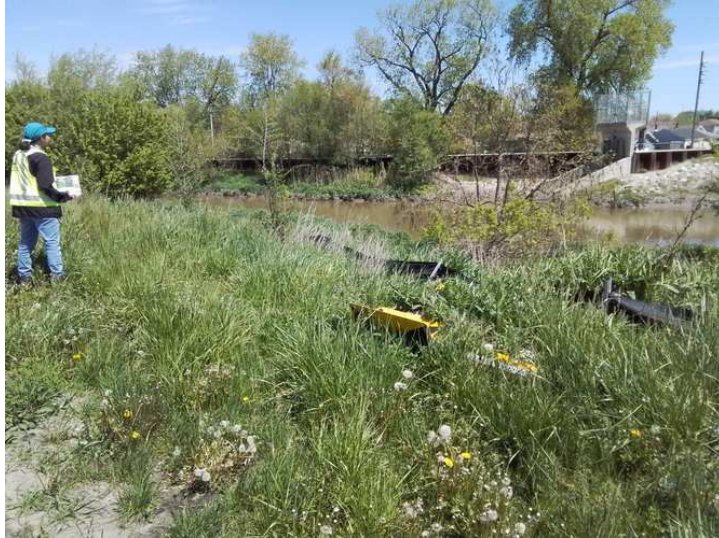
Inspect ID: 2024-0412

Caption: Minimally Acceptable - Downed signs on the riverside slope - possibly related to the train track construction.

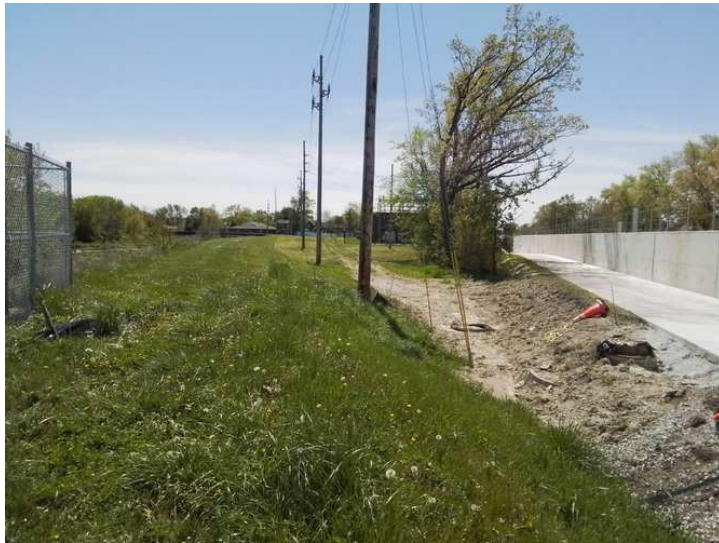
Inspect ID: 2024-0416

Caption: Minimally Acceptable - New electric poles on the landside toe related to the southshore train extension. A 408 permit was approved for the poles, but they are too close to the levee.

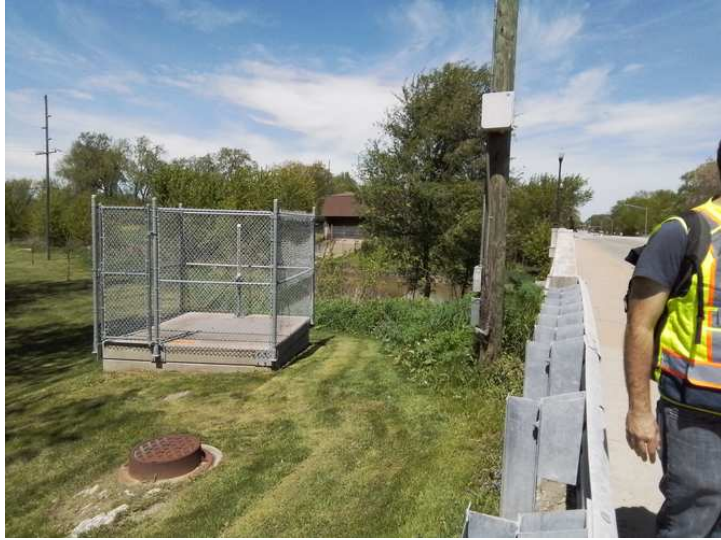
Inspect ID: 2024-0428

Caption: Minimally Acceptable - Pre-existing power pole on the riverside slope - determine if it is Section 408 approved.

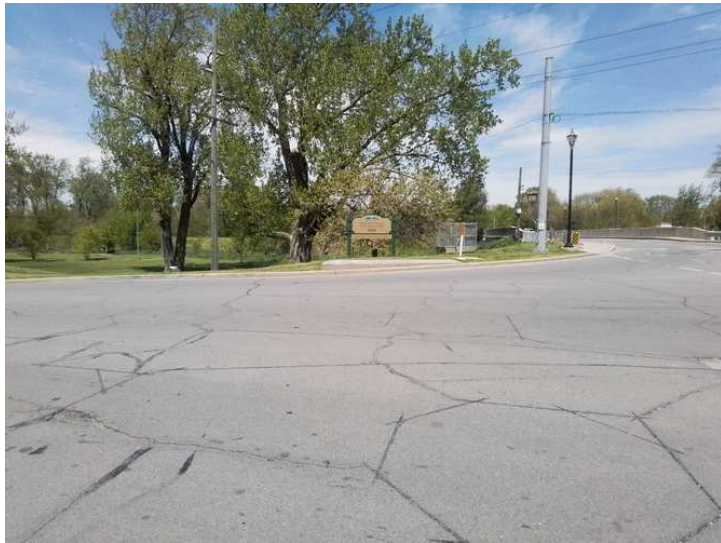
Inspect ID: 2024-0432

Caption: Minimally Acceptable - Park sign on the landside levee - determine if it is Section 408 approved.

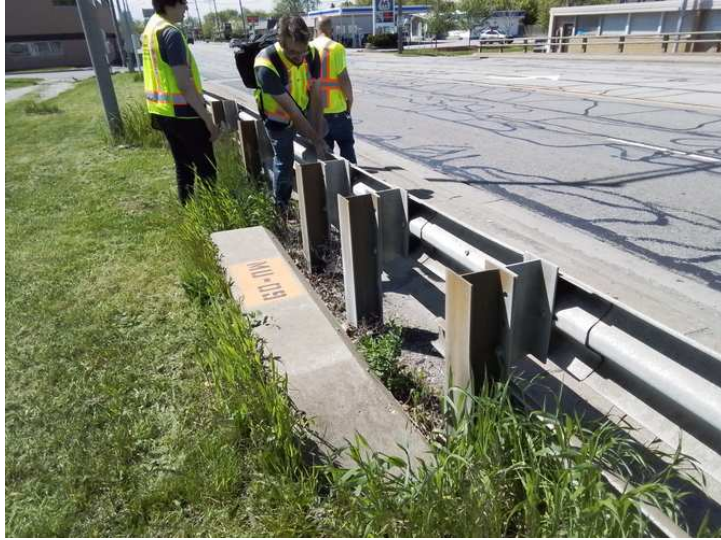
Inspect ID: 2024-0320
Feature Details: Levee Embankments - Closure Structures - Landside
Station Start:
Station End:
Caption: Minimally Acceptable - Guardrail blocking the closure as-constructed.

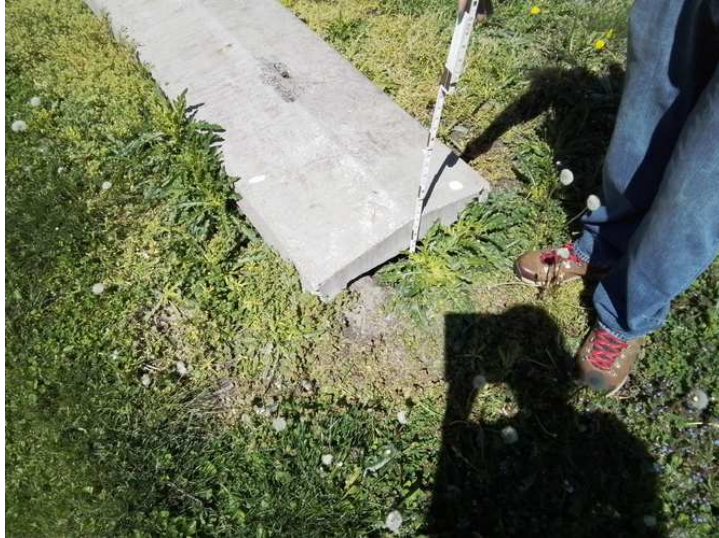
Inspect ID: 2024-0368
Feature Details: Levee Embankments - Settlement
Station Start:
Station End:
Caption: Minimally Acceptable - Hole/depression related to settlement at the floodwall tie-in.
