US Army Corps of Engineers ®

Levee Inspection Report

Name of System: Munster
 Name of Segment: Munster
 NLD System ID: 2605000006 NLD Segment ID: 2604000009

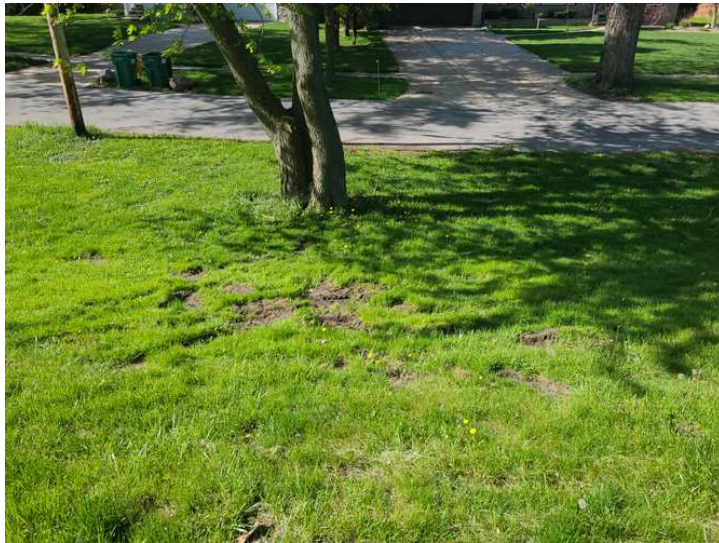
Inspect ID: 2024-0009
Feature Details: Levee Embankments - Depressions/ Rutting - Landside
Station Start:
Station End:
Caption: Minimally Acceptable - Landside slope rutting.

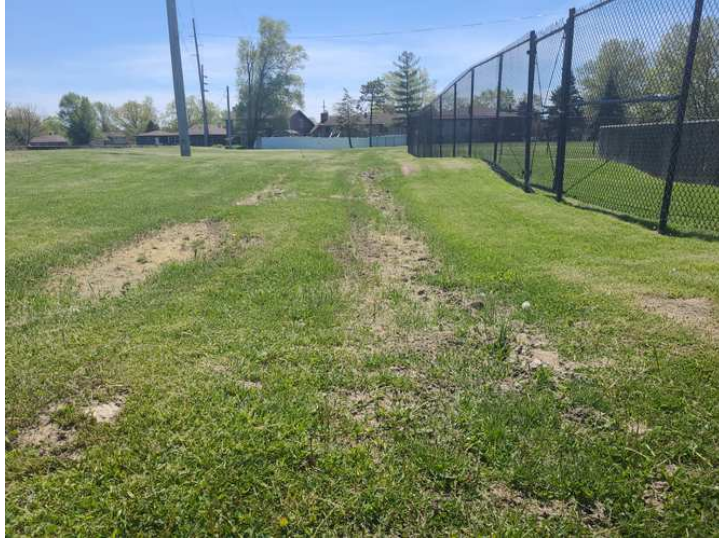
Inspect ID: 2024-0133
Feature Details: Levee Embankments - Depressions/ Rutting - Slopes and Crown
Station Start:
Station End:
Caption: Minimally Acceptable - Depression and rutting in the crown and slope

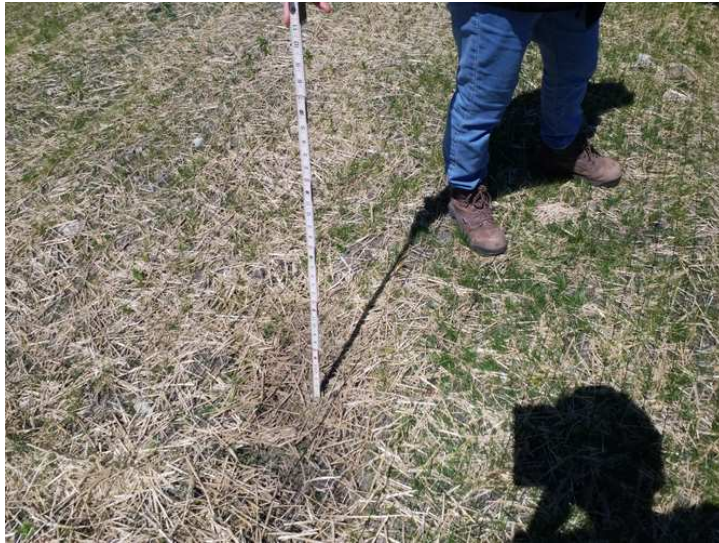
Inspect ID: 2024-0142
Feature Details: Levee Embankments - Depressions/ Rutting - Landside
Station Start:
Station End:
Caption: Minimally Acceptable - 3-inch deep rutting on the landside slope

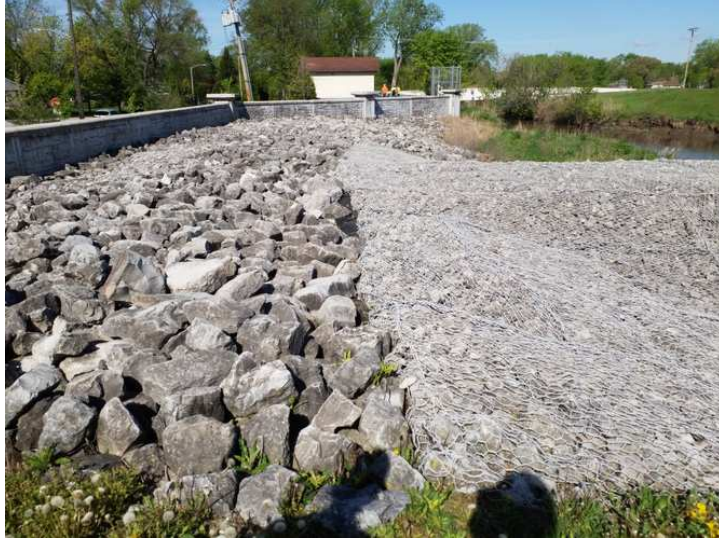
Inspect ID: 2024-0026
Feature Details: Levee Embankments - Riprap Revetments & Bank Protection - Waterside
Station Start:
Station End:
Caption: Minimally Acceptable - Exposed geotextile from displaced riprap on riverside.

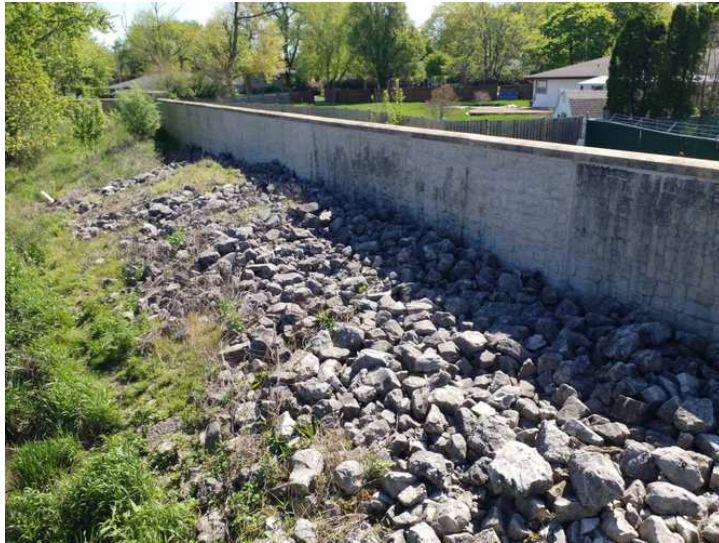
Inspect ID: 2024-0070
Feature Details: Levee Embankments - Riprap Revetments & Bank Protection - Waterside
Station Start:
Station End:
Caption: Minimally Acceptable - Displaced riprap on the riverside embankment.

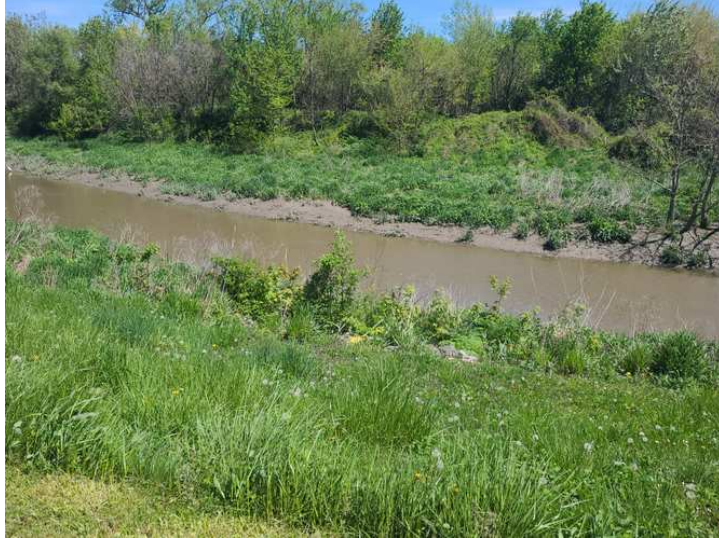
Inspect ID: 2024-0129
Feature Details: Levee Embankments - Riprap Revetments & Bank Protection - Waterside
Station Start:
Station End:
Caption: Minimally Acceptable - Vegetation in riverside riprap.

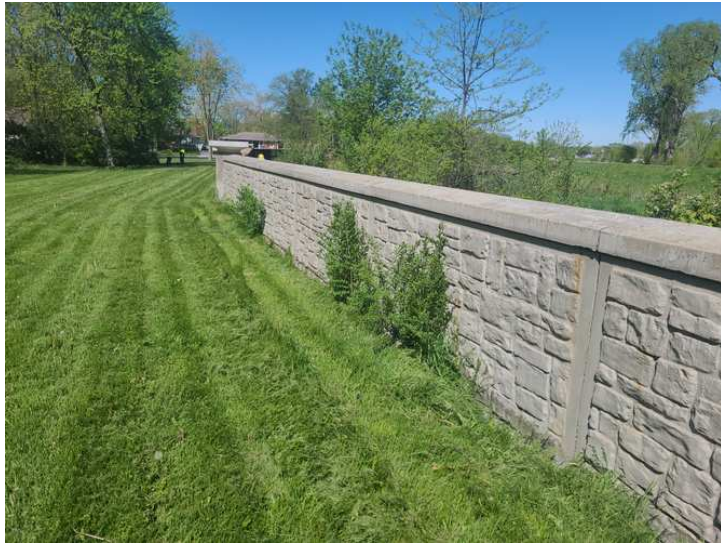
Inspect ID: 2024-0021
Feature Details: Floodwalls - Unwanted Vegetation Growth - Landside
Station Start:
Station End:
Caption: Minimally Acceptable - Vegetation against the landside floodwall.

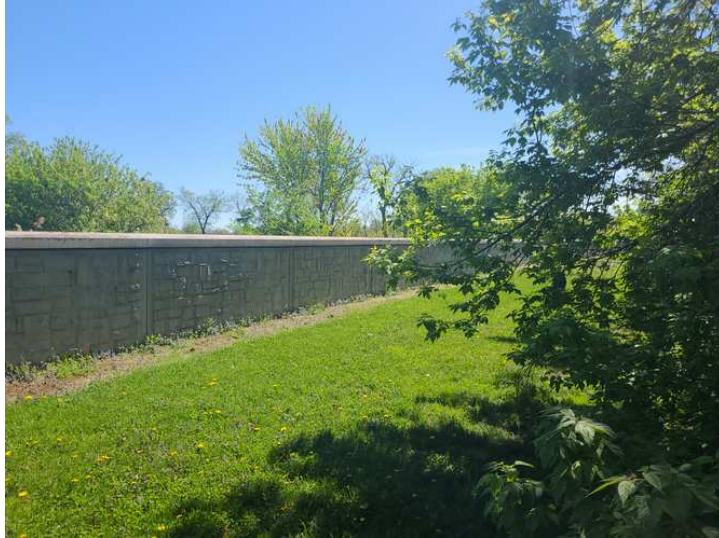
Inspect ID: 2024-0025
Feature Details: Floodwalls - Unwanted Vegetation Growth - Landside
Station Start:
Station End:
Caption: Minimally Acceptable - Vegetation against the landside floodwall.

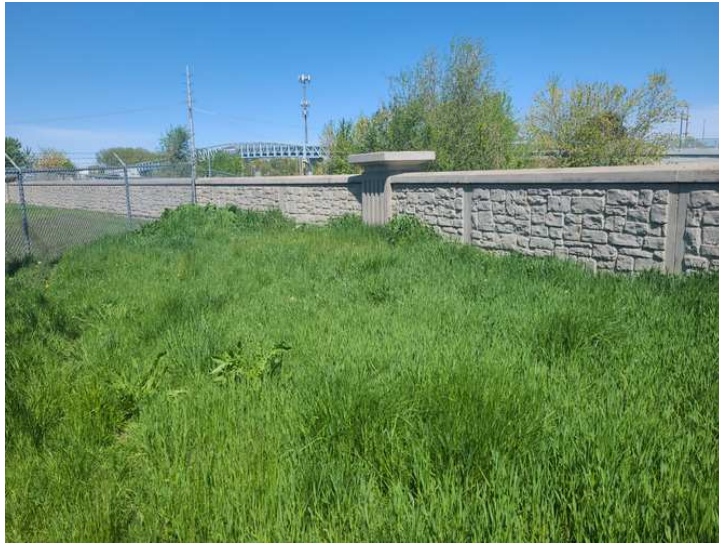
Inspect ID: 2024-0037
Feature Details: Floodwalls - Unwanted Vegetation Growth
Station Start:
Station End:
Caption: Minimally Acceptable - Vegetation against the landside floodwall.

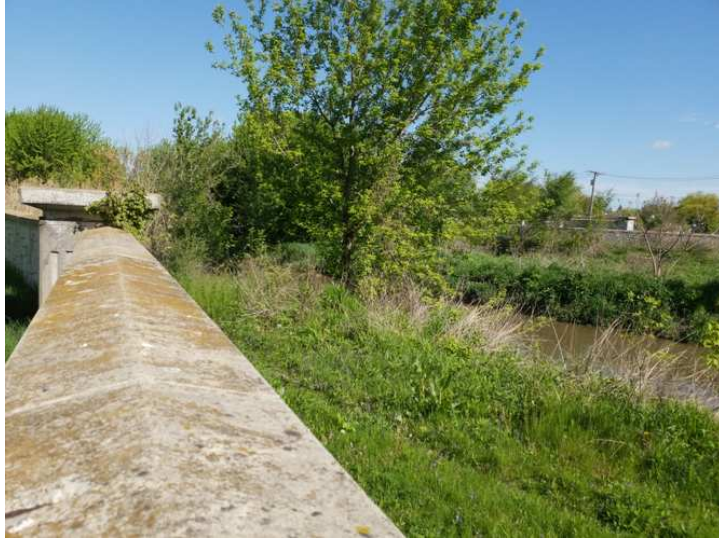
Inspect ID: 2024-0038
Feature Details: Floodwalls - Unwanted Vegetation Growth - Waterside
Station Start:
Station End:
Caption: Minimally Acceptable - Tree within 15-ft of the riverside floodwall.

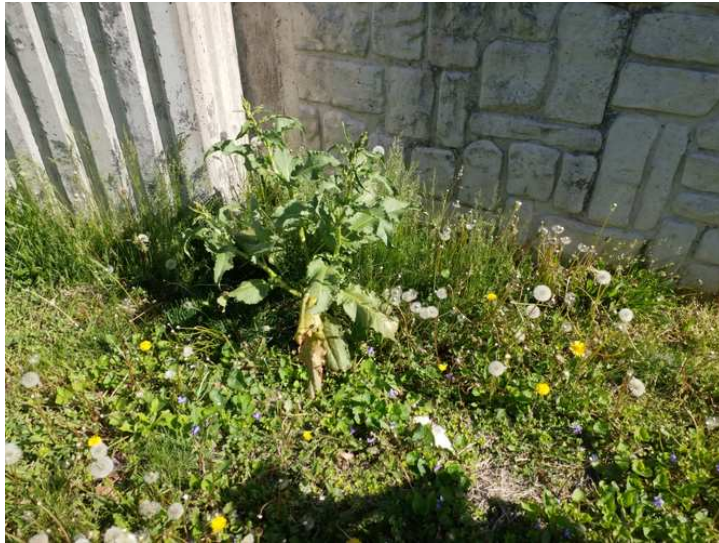
Inspect ID: 2024-0046
Feature Details: Floodwalls - Unwanted Vegetation Growth - Landside
Station Start:
Station End:
Caption: Minimally Acceptable - Vegetation against the landside floodwall.

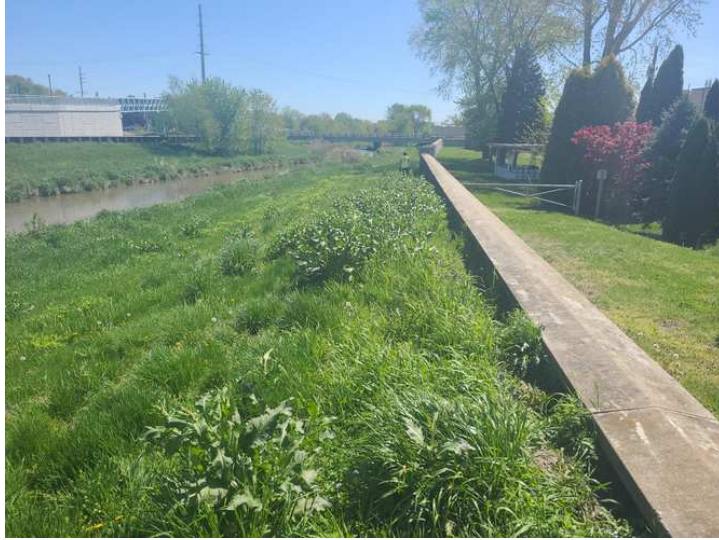
Inspect ID: 2024-0057
Feature Details: Floodwalls - Unwanted Vegetation Growth - Waterside
Station Start:
Station End:
Caption: Minimally Acceptable - Vegetation within 15-ft of the riverside floodwall.

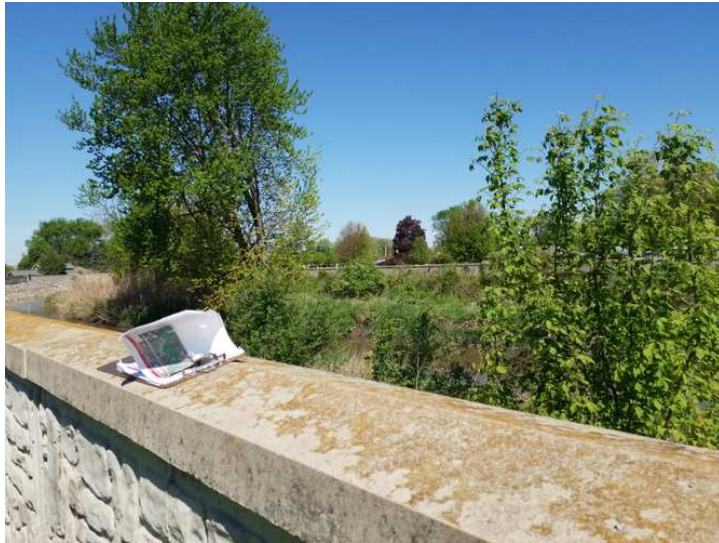
Inspect ID: 2024-0058
Feature Details: Floodwalls - Unwanted Vegetation Growth - Waterside
Station Start:
Station End:
Caption: Minimally Acceptable - Vegetation within 15-ft of the riverside floodwall.

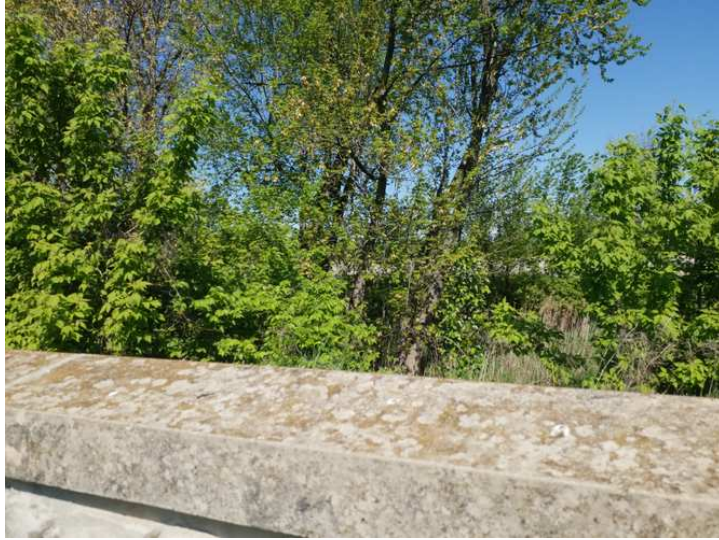
Inspect ID: 2024-0066
Feature Details: Floodwalls - Unwanted Vegetation Growth - Waterside
Station Start:
Station End:
Caption: Minimally Acceptable - Vegetation and trees within 15-ft of the riverside floodwall.

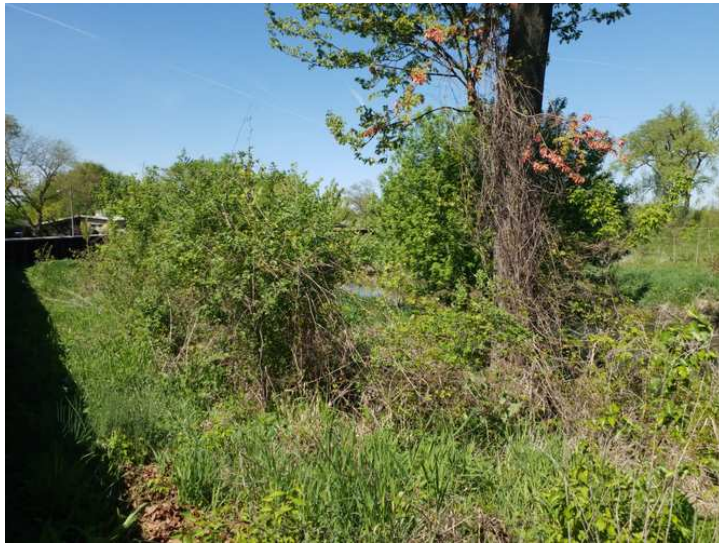
Inspect ID: 2024-0074
Feature Details: Floodwalls - Unwanted Vegetation Growth - Waterside
Station Start:
Station End:
Caption: Minimally Acceptable - Vegetation within 15-ft of the riverside floodwall.

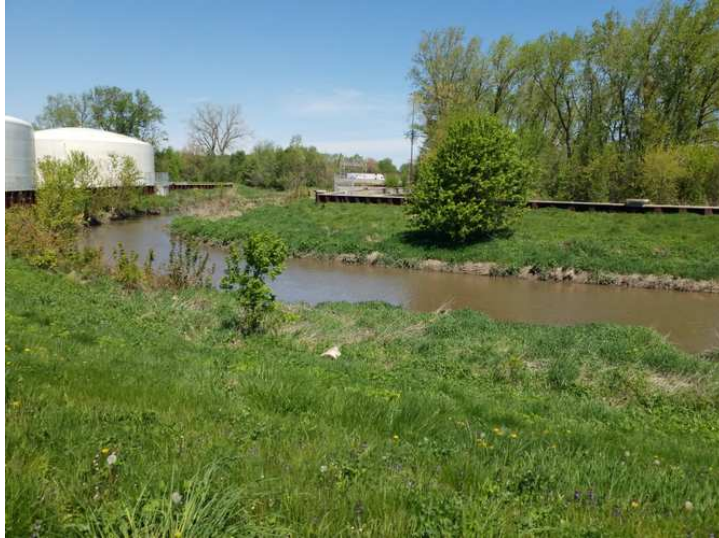
Inspect ID: 2024-0098
Feature Details: Floodwalls - Unwanted Vegetation Growth - Waterside
Station Start:
Station End:
Caption: Minimally Acceptable - Tree within 15-ft of the riverside floodwall.

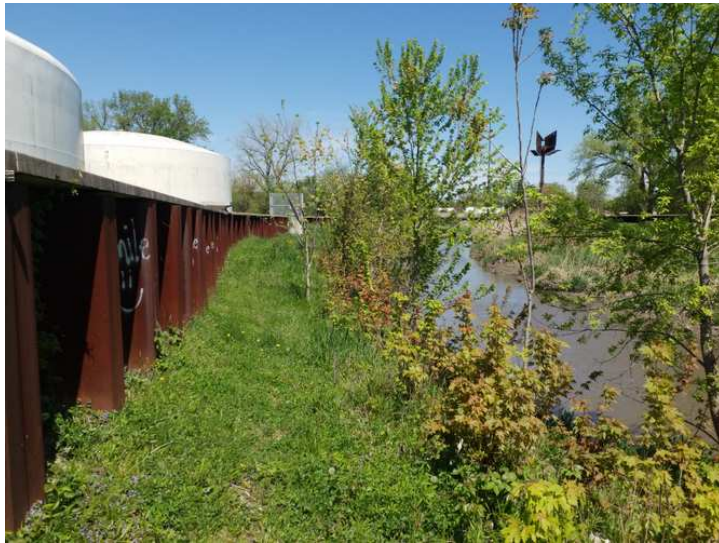
Inspect ID: 2024-0102
Feature Details: Floodwalls - Unwanted Vegetation Growth - Waterside
Station Start:
Station End:
Caption: Minimally Acceptable - Tree and vegetation within 15-ft of the riverside floodwall.

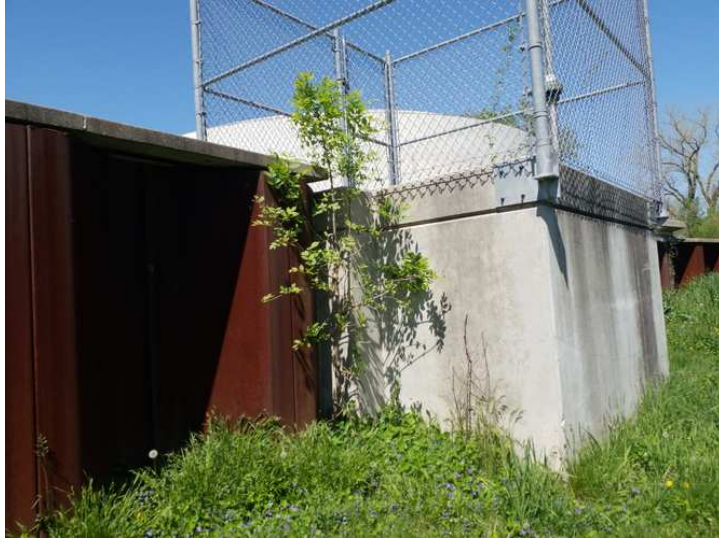
Inspect ID: 2024-0106
Feature Details: Floodwalls - Unwanted Vegetation Growth - Waterside
Station Start:
Station End:
Caption: Minimally Acceptable - Small tree against the riverside floodwall.

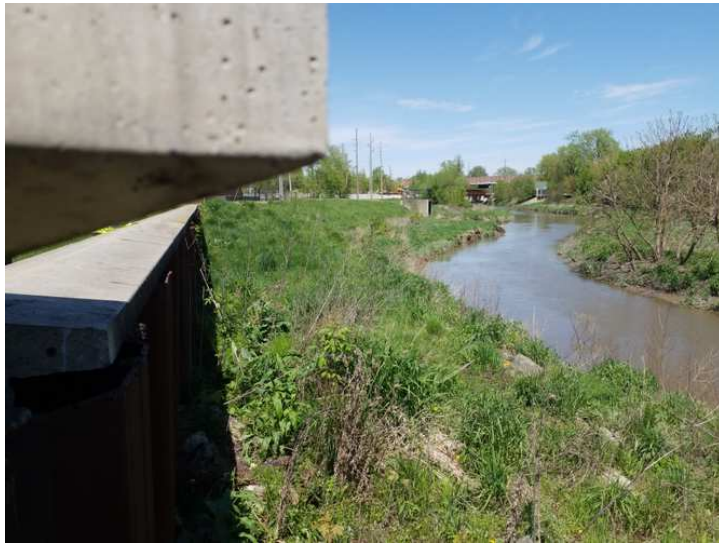
Inspect ID: 2024-0118
Feature Details: Floodwalls - Unwanted Vegetation Growth - Waterside
Station Start:
Station End:
Caption: Minimally Acceptable - Tree within 15-ft of the riverside floodwall.

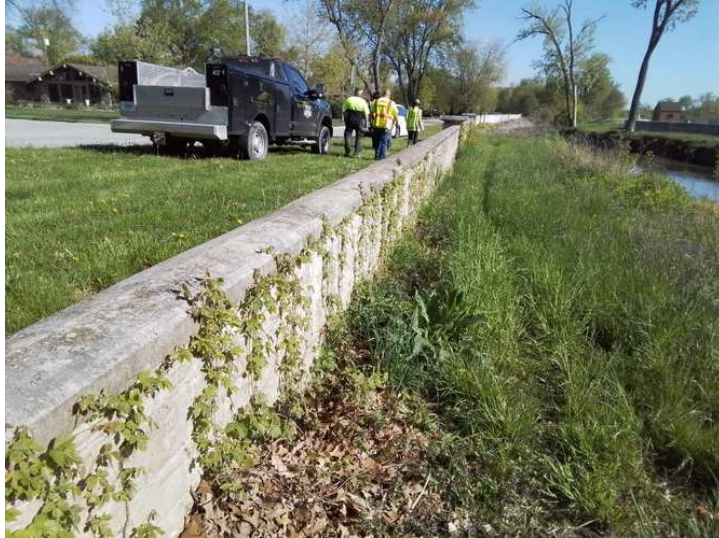
Inspect ID: 2024-0184
Feature Details: Floodwalls - Unwanted Vegetation Growth - Waterside
Station Start:
Station End:
Caption: Minimally Acceptable - Vegetation on the riverside floodwall.

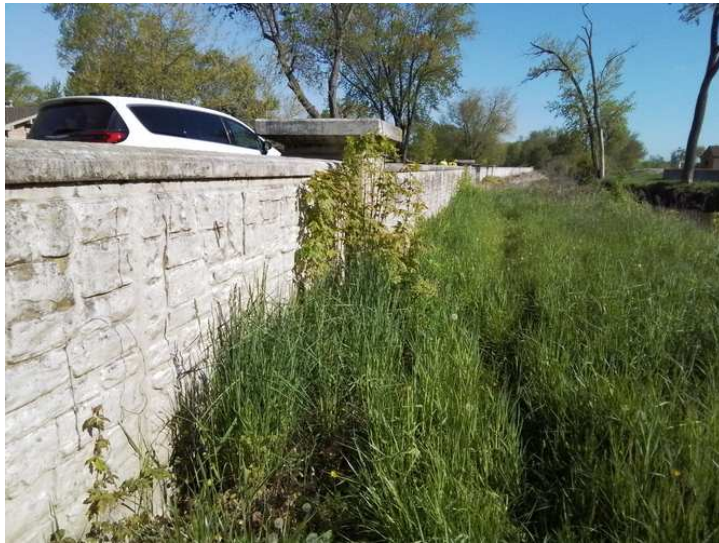
Inspect ID: 2024-0188
Feature Details: Floodwalls - Unwanted Vegetation Growth - Waterside
Station Start:
Station End:
Caption: Minimally Acceptable - Small trees within 15-ft of the riverside floodwall.

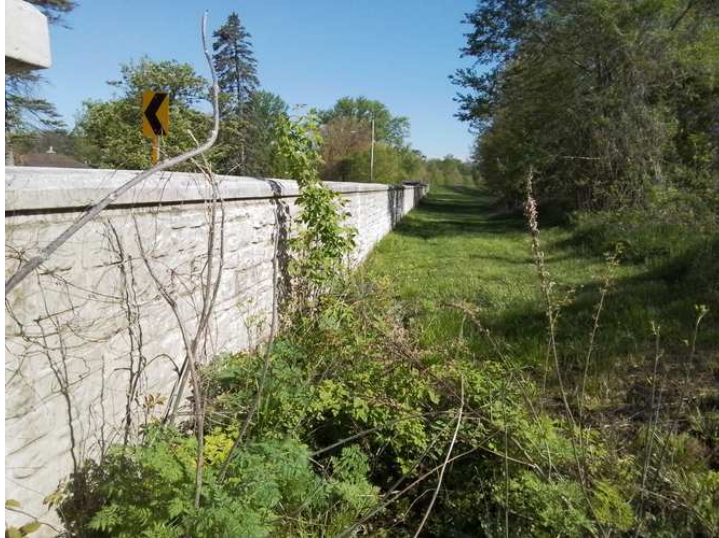
Inspect ID: 2024-0208
Feature Details: Floodwalls - Unwanted Vegetation Growth - Waterside
Station Start:
Station End:
Caption: Minimally Acceptable - Small tree within 15-ft of the riverside floodwall.

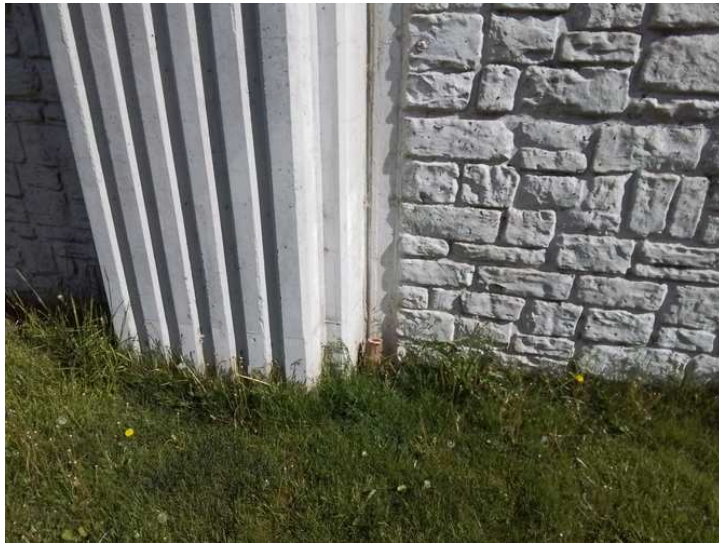
Inspect ID: 2024-0244
Feature Details: Floodwalls - Unwanted Vegetation Growth - Landside
Station Start:
Station End:
Caption: Minimally Acceptable - Tree trunk growing back against the landside floodwall.

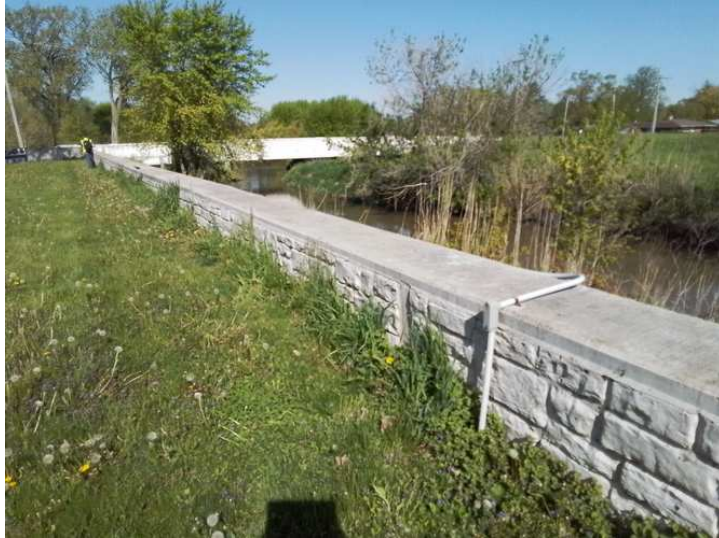
Inspect ID: 2024-0252
Feature Details: Floodwalls - Unwanted Vegetation Growth - Landside
Station Start:
Station End:
Caption: Minimally Acceptable - Vegetation along the landside floodwall (typical).

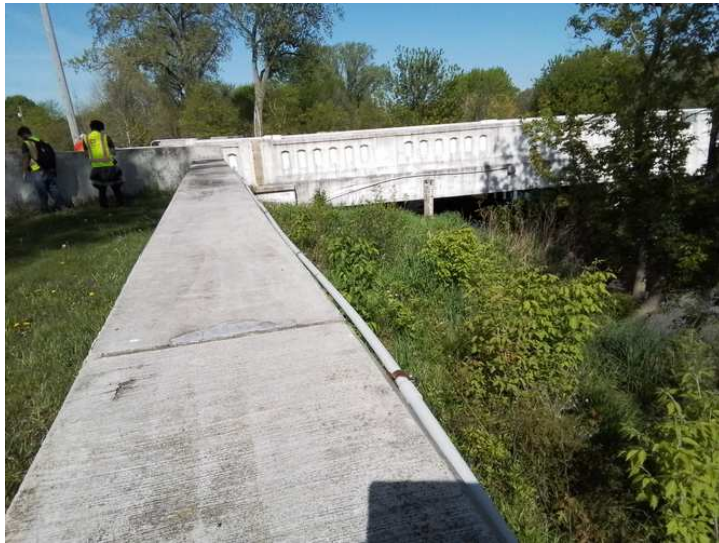
Inspect ID: 2024-0256
Feature Details: Floodwalls - Unwanted Vegetation Growth - Waterside
Station Start:
Station End:
Caption: Minimally Acceptable - Small trees within 15-ft of the riverside floodwall.

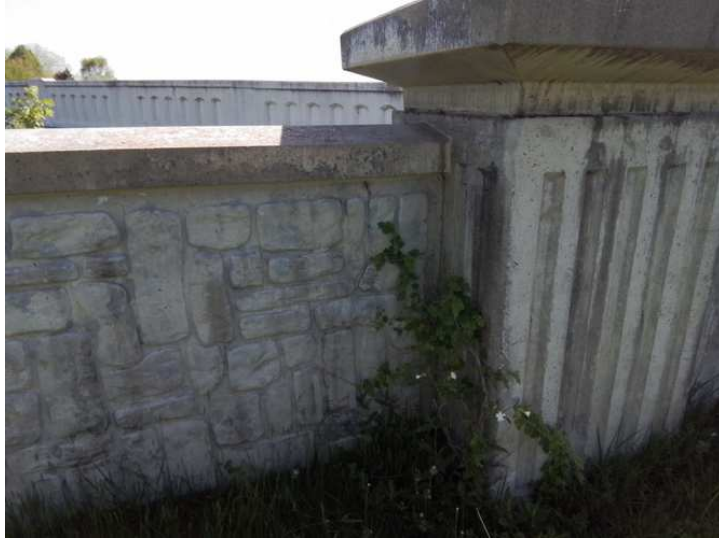
Inspect ID: 2024-0264
Feature Details: Floodwalls - Unwanted Vegetation Growth - Landside
Station Start:
Station End:
Caption: Minimally Acceptable - Small tree against the landside floodwall.

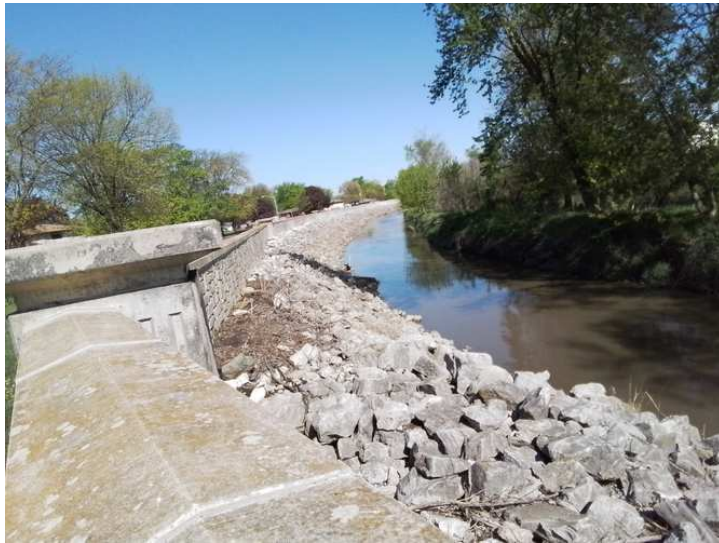
Inspect ID: 2024-0268
Feature Details: Floodwalls - Unwanted Vegetation Growth - Waterside
Station Start:
Station End:
Caption: Minimally Acceptable - Vegetation in the riprap that runs along the riverside floodwall.

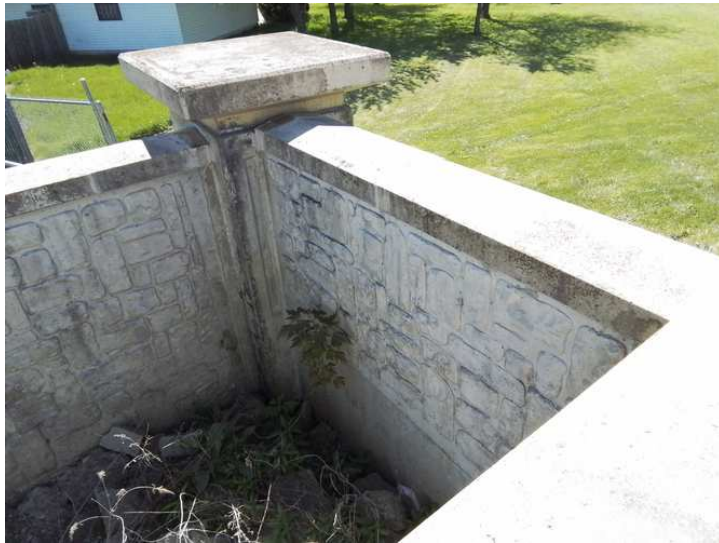
Inspect ID: 2024-0272
Feature Details: Floodwalls - Unwanted Vegetation Growth - Waterside
Station Start:
Station End:
Caption: Minimally Acceptable - Small tree against the riverside floodwall.

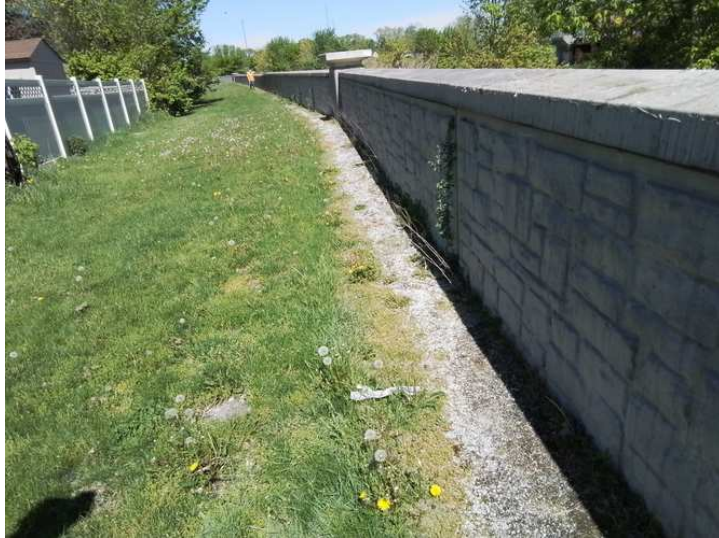
Inspect ID: 2024-0292
Feature Details: Floodwalls - Unwanted Vegetation Growth - Waterside
Station Start:
Station End:
Caption: Minimally Acceptable - Small tree against the riverside floodwall.

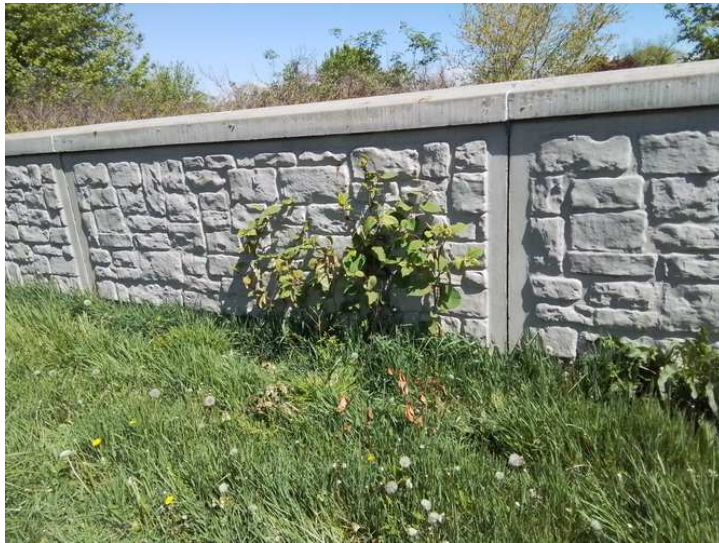
Inspect ID: 2024-0308
Feature Details: Floodwalls - Unwanted Vegetation Growth - Landside
Station Start:
Station End:
Caption: Minimally Acceptable - Vegetation within 15-ft of the landside floodwall.

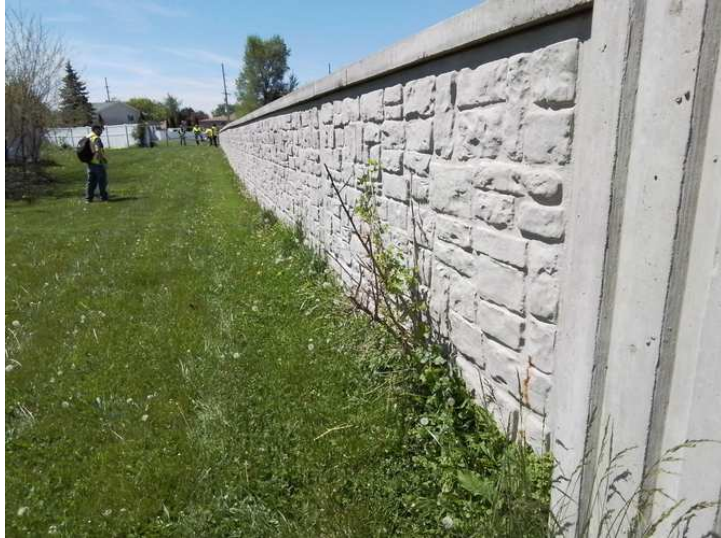
Inspect ID: 2024-0312
Feature Details: Floodwalls - Unwanted Vegetation Growth - Landside
Station Start:
Station End:
Caption: Minimally Acceptable - Small trees against the landside floodwall.

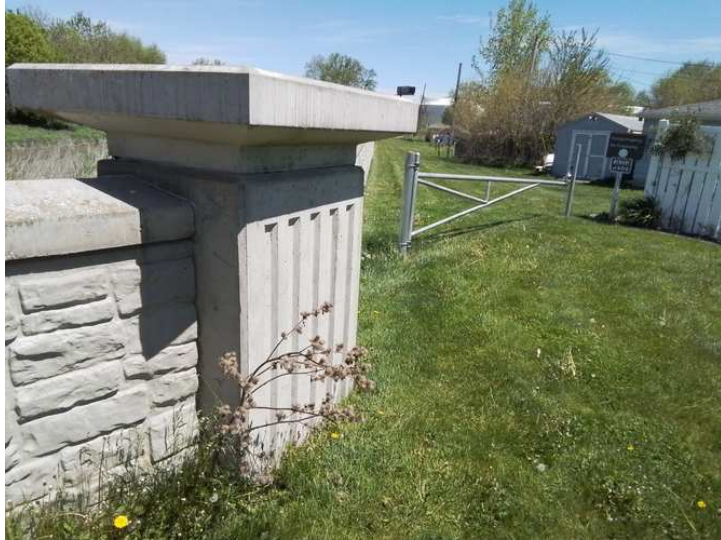
Inspect ID: 2024-0388
Feature Details: Floodwalls - Unwanted Vegetation Growth - Landside
Station Start:
Station End:
Caption: Minimally Acceptable - Small tree against the landside floodwall.

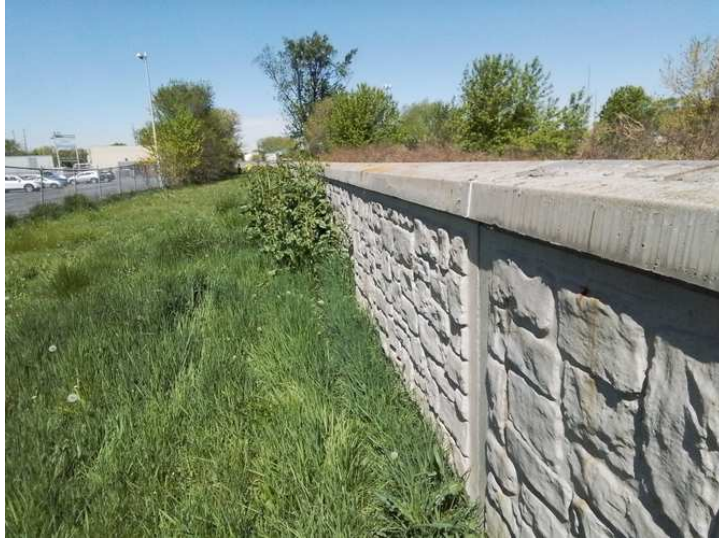
Inspect ID: 2024-0392
Feature Details: Floodwalls - Unwanted Vegetation Growth - Landside
Station Start:
Station End:
Caption: Minimally Acceptable - Small tree against the landside floodwall.

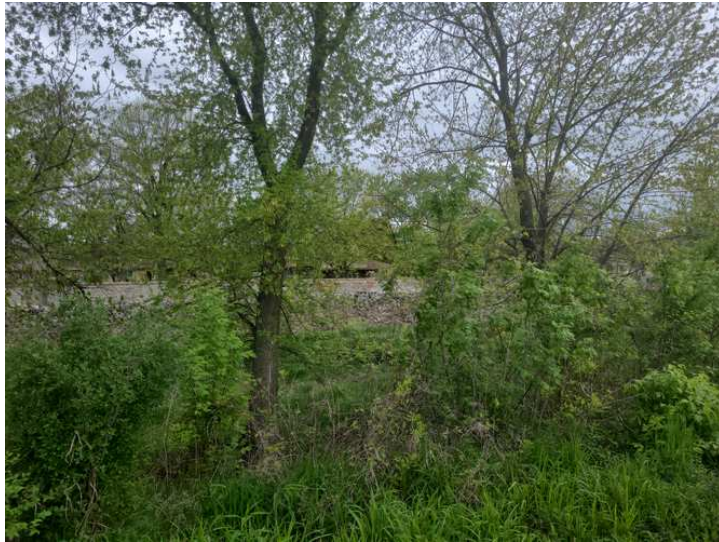
Inspect ID: 2024-0441
Feature Details: Floodwalls - Unwanted Vegetation Growth - Landside
Station Start:
Station End:
Caption: Minimally Acceptable - Small trees against the landside floodwall.

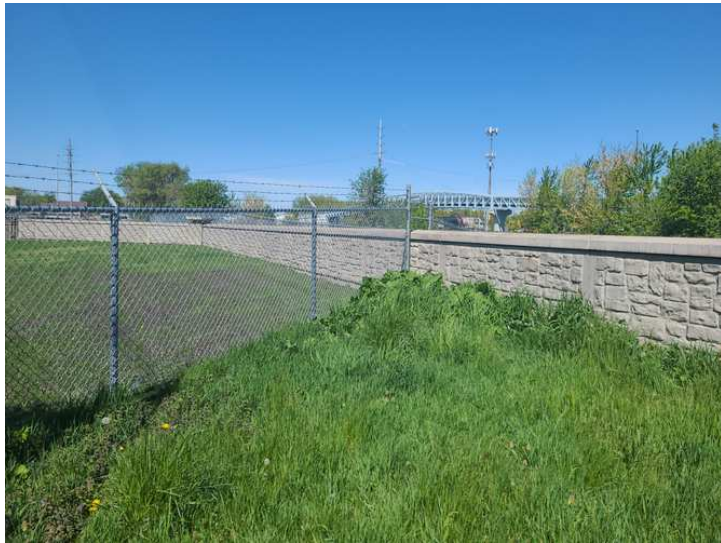
Inspect ID: 2024-0005
Feature Details: Floodwalls - Encroachments - Landside
Station Start:
Station End:
Caption: Minimally Acceptable - Debris on the landside floodwall.

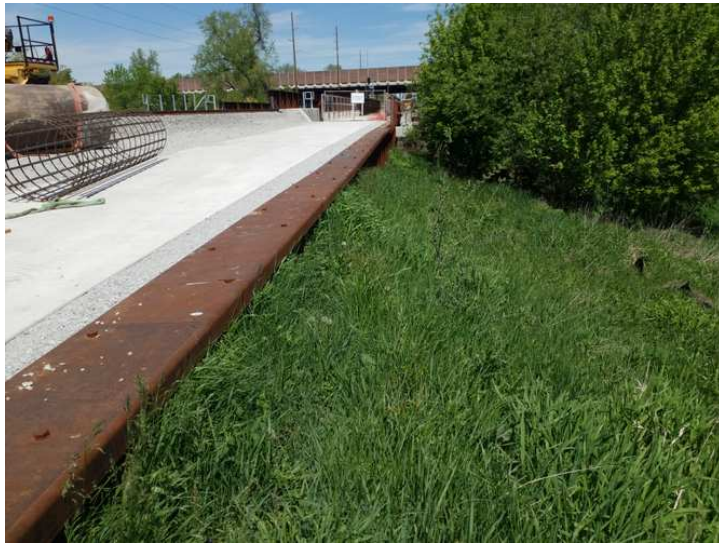
Inspect ID: 2024-0125

Caption: Minimally Acceptable - Guide wire within 15-ft of the landside floodwall.

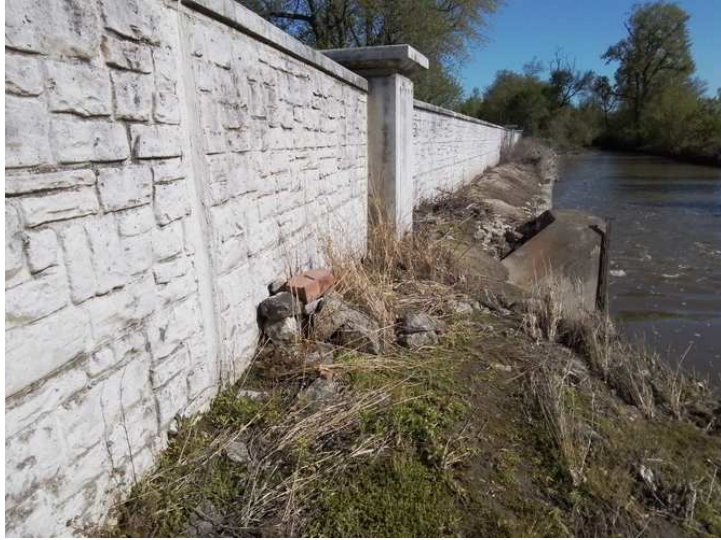
Inspect ID: 2024-0158
Feature Details: Floodwalls - Encroachments - Landside
Station Start:
Station End:
Caption: Minimally Acceptable - Guardrail within 15-ft of the landside wall. Signs, tower, and other visible objects within 15-ft of the wall are 408 approved.

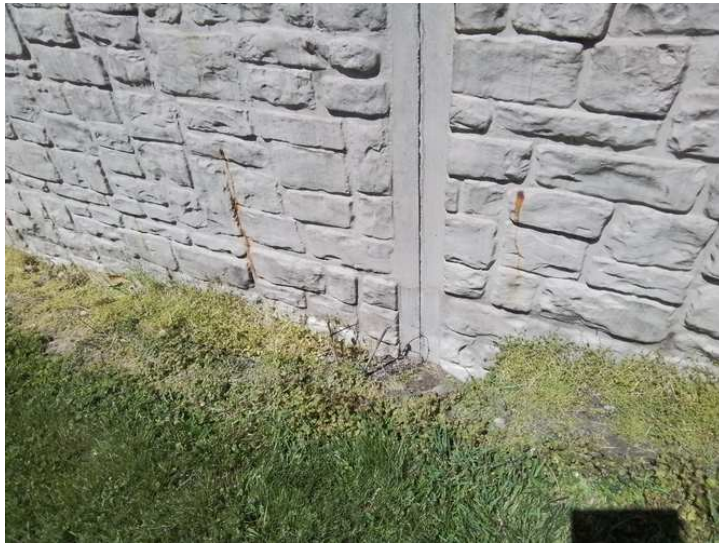
Inspect ID: 2024-0356
Feature Details: Floodwalls - Encroachments - Waterside
Station Start:
Station End:
Caption: Minimally Acceptable - Graffiti on the riverside floodwall.

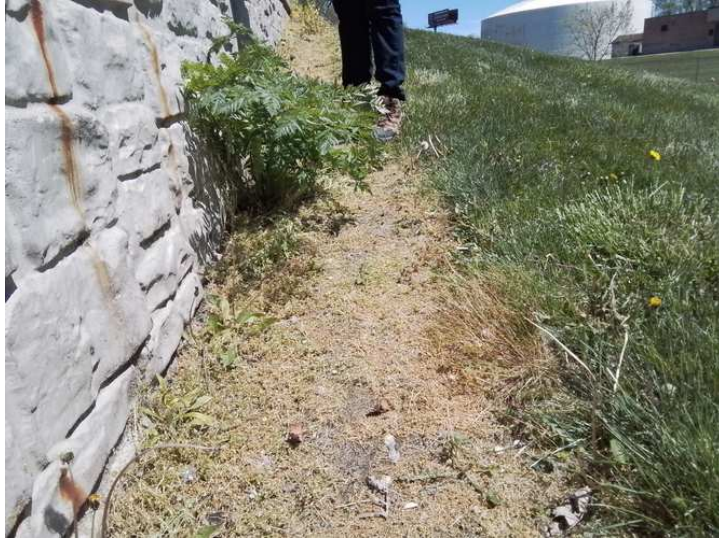
Inspect ID: 2024-0372
Feature Details: Floodwalls - Encroachments - Landside
Station Start:
Station End:
Caption: Minimally Acceptable - Rebar and barbed wire running along the base of the landside floodwall.

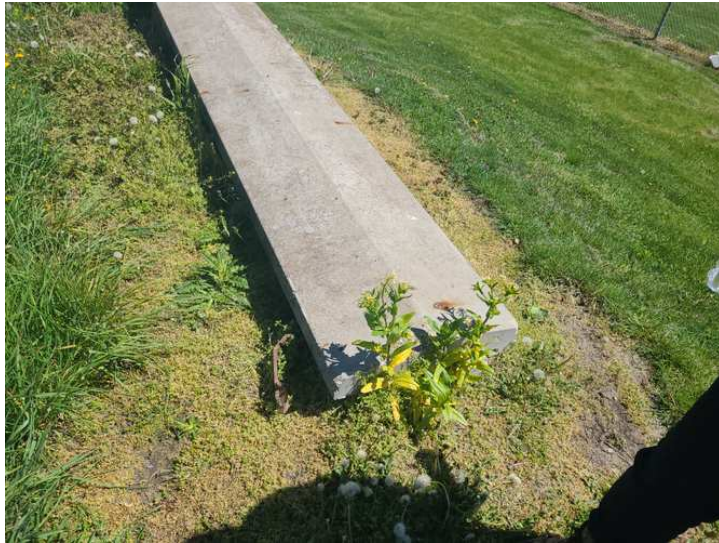
Inspect ID: 2024-0105
Feature Details: Floodwalls - Tilting, Sliding or Settlement of Concrete Structures
Station Start:
Station End:
Caption: Minimally Acceptable - Cap has shifted at tie-in.

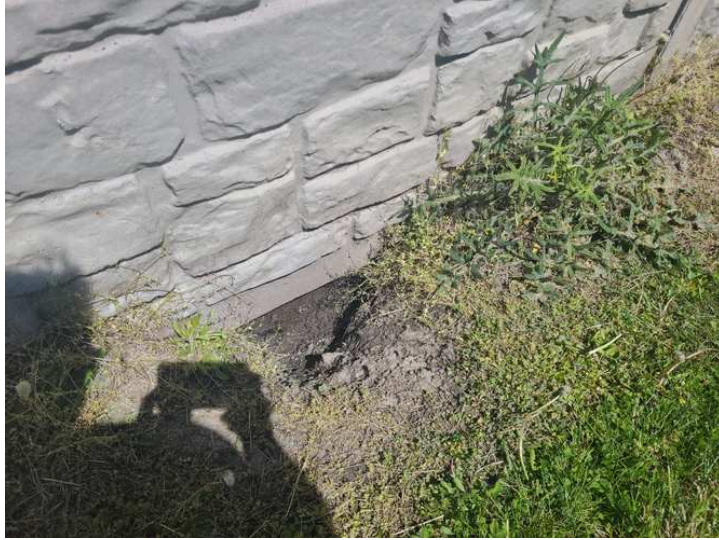
Inspect ID: 2024-0109
Feature Details: Floodwalls - Foundation of Concrete Structures - Landside
Station Start:
Station End:
Caption: Minimally Acceptable - Animal burrow on the landside of the wall.

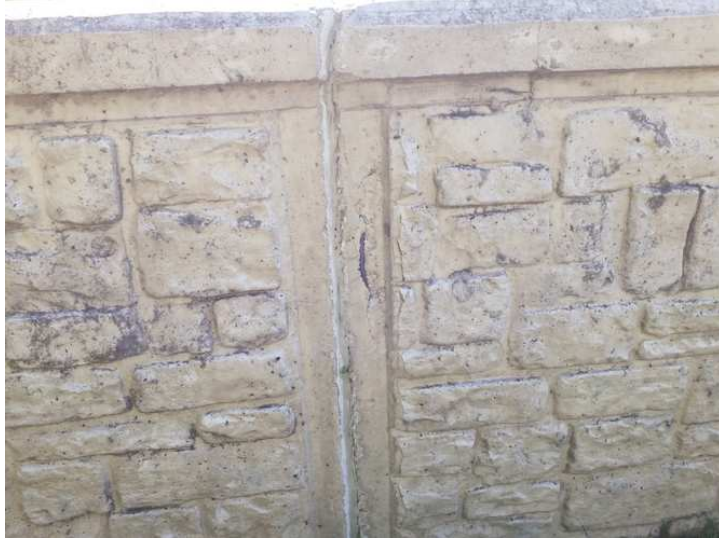
Inspect ID: 2024-0006
Feature Details: Floodwalls - Monolith Joints - Landside Joint
Station Start:
Station End:
Caption: Minimally Acceptable - Cracking in joint sealant.

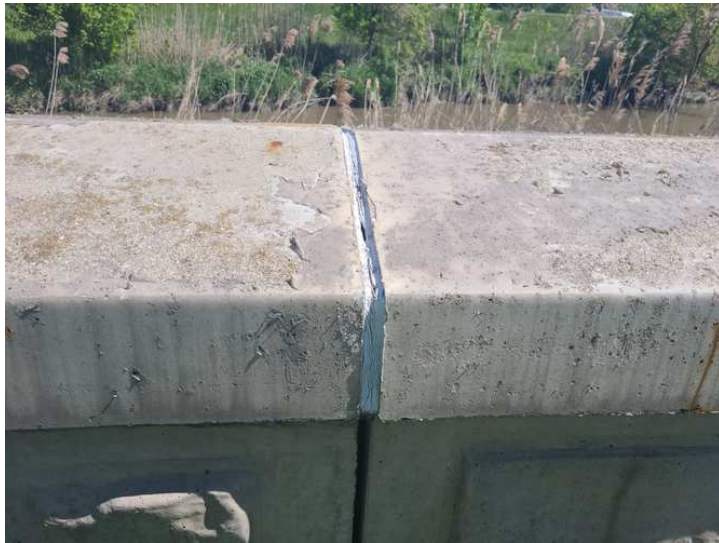
Inspect ID: 2024-0018

Caption: Minimally Acceptable - Cracking in joint sealant.

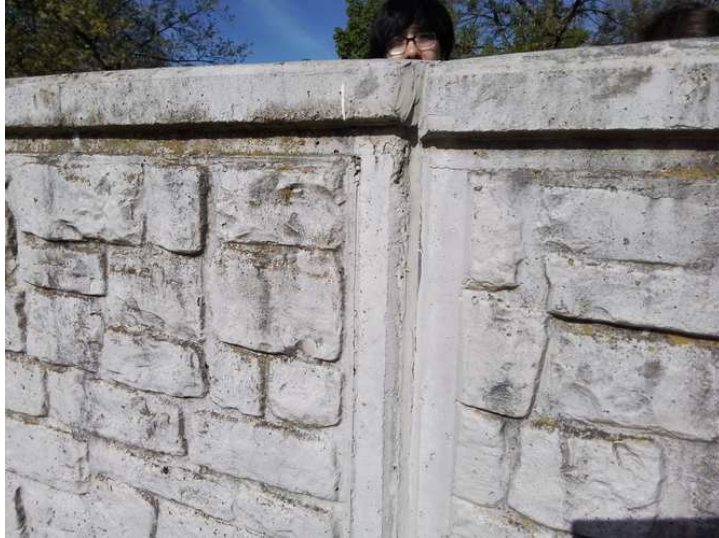
Inspect ID: 2024-0110
Feature Details: Floodwalls - Monolith Joints - Top of Floodwall
Station Start:
Station End:
Caption: Minimally Acceptable - Degraded expansion foam in joint.

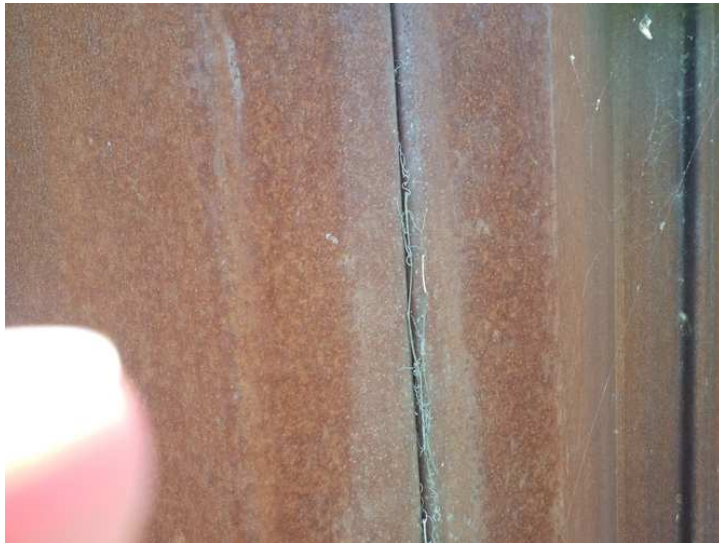
Inspect ID: 2024-0204

Caption: Acceptable - Joint sealant is typically in good condition on riverside.

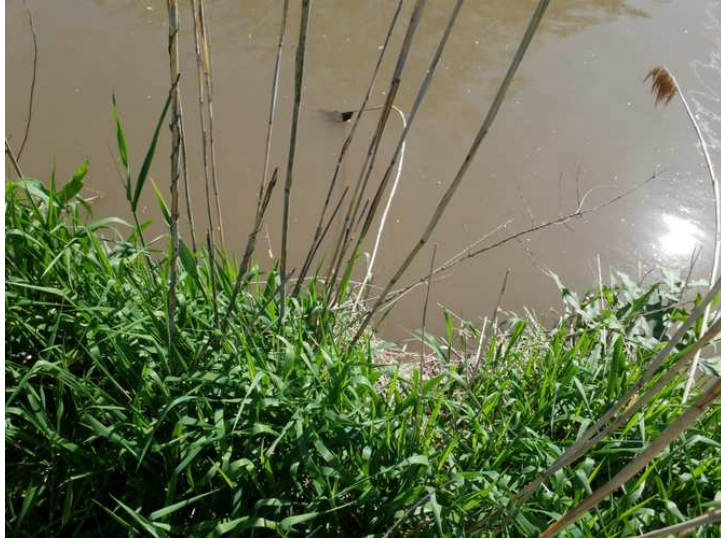
Inspect ID: 2024-0086

Caption: Minimally Acceptable - Possible seepage at sheetpile joint.

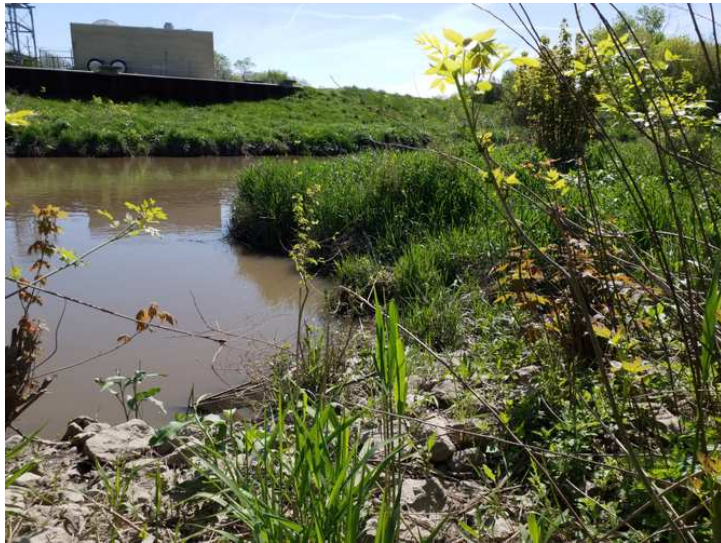
Inspect ID: 2024-0027

Caption: Minimally Acceptable - MU-08: Vegetation around the outlet structure. Wingwalls were underwater and could not be inspected.

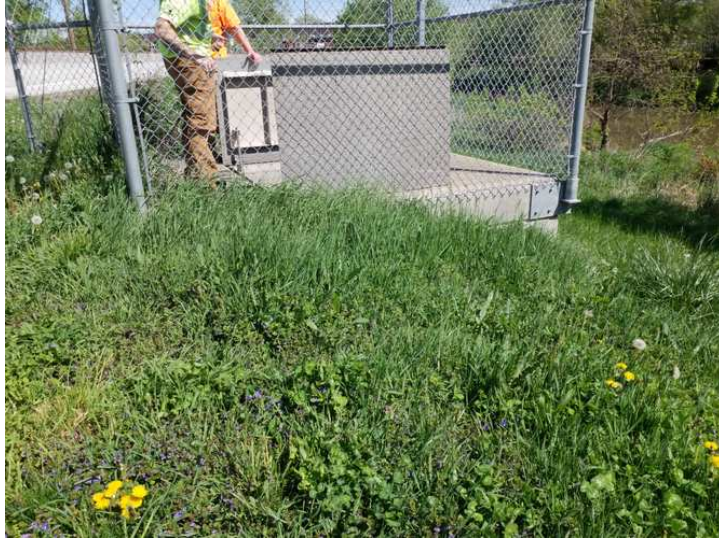
Inspect ID: 2024-0039
Feature Details: Interior Drainage System - Vegetation and Obstructions - Gatewell
Station Start:
Station End:
Caption: Minimally Acceptable - MU-06: Vegetation around the gatewell structure

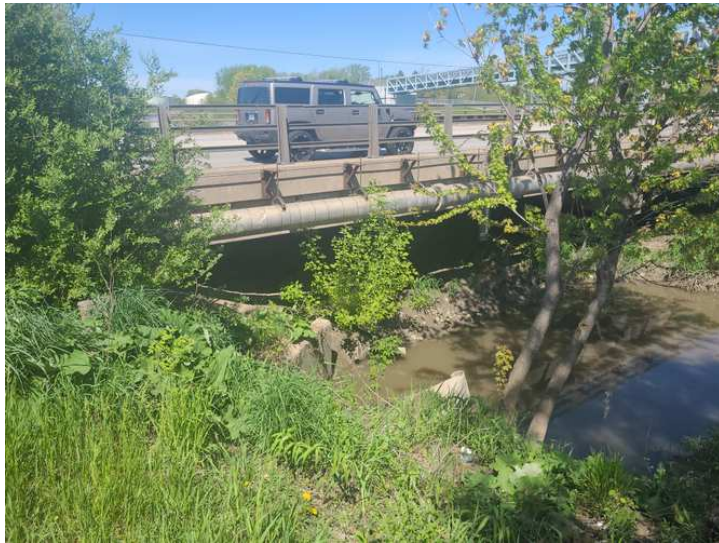
Inspect ID: 2024-0045
Feature Details: Interior Drainage System - Vegetation and Obstructions - Outlet Structure
Station Start:
Station End:
Caption: Minimally Acceptable - MU-09: Vegetation around the outlet structure.

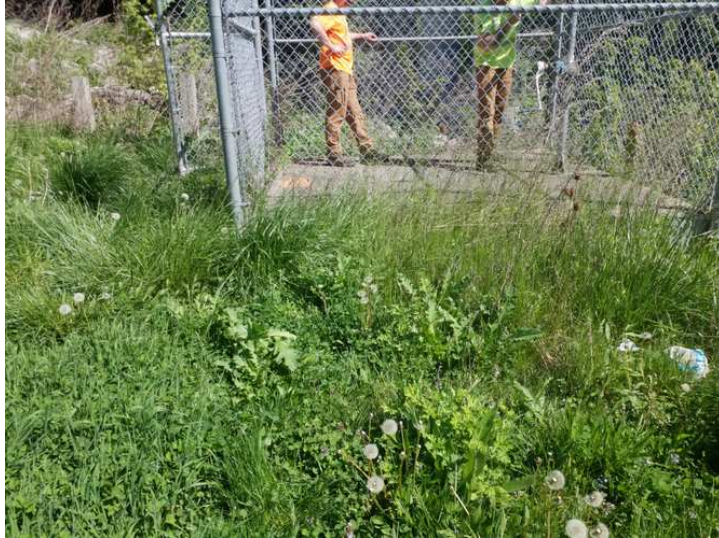
Inspect ID: 2024-0055

Caption: Minimally Acceptable - MU-04: Vegetation around the gatewell structure.

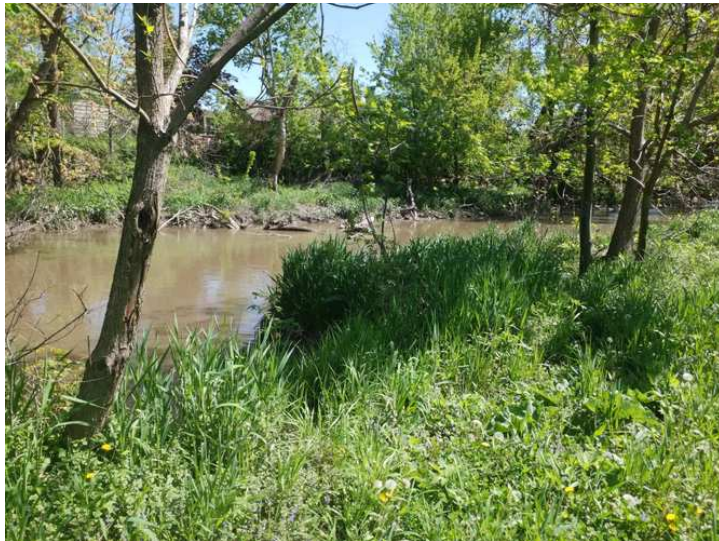
Inspect ID: 2024-0075

Caption: Minimally Acceptable - MU-02: Vegetation and tree around the outlet structure.

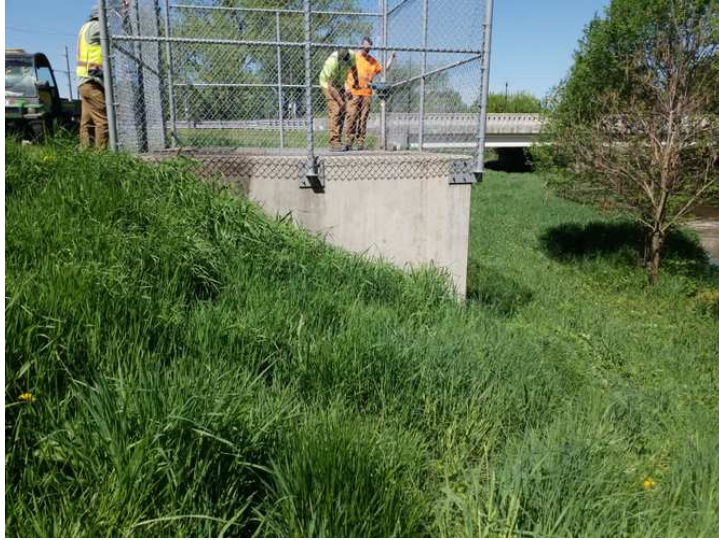
Inspect ID: 2024-0083
Feature Details: Interior Drainage System - Vegetation and Obstructions - Gatewell
Station Start:
Station End:
Caption: Minimally Acceptable - MU-02: Vegetation around the gatewell structure.
