US Army Corps of Engineers ®

Levee Inspection Report

Name of System: Munster
 Name of Segment: Munster
 NLD System ID: 2605000006 NLD Segment ID: 2604000009

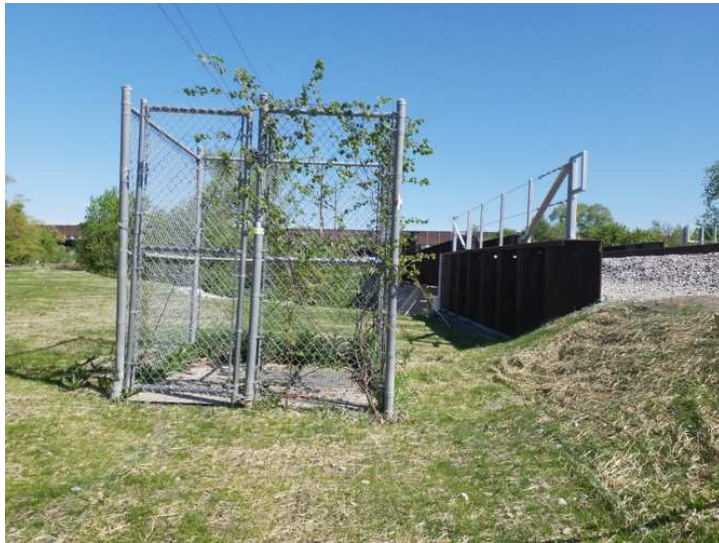
Inspect ID: 2024-0442
Feature Details: Interior Drainage System - Vegetation and Obstructions
Station Start:
Station End:
Caption: Minimally Acceptable - MU-05: Vegetation around the chain link fence enclosure.

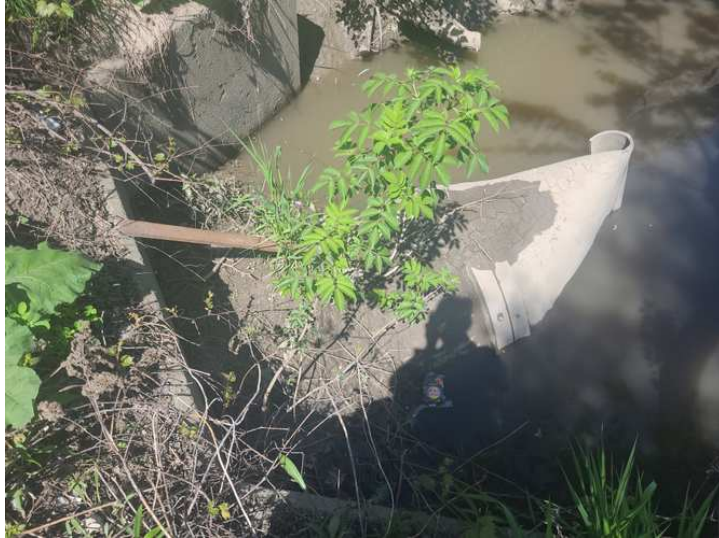
Inspect ID: 2024-0053

Caption: Minimally Acceptable - MU-09: Debris and soil on the duckbill valve.

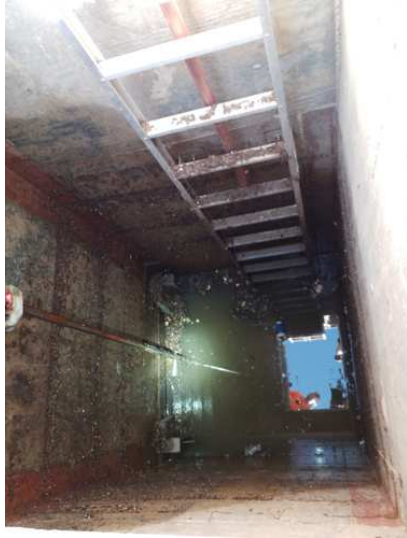
Inspect ID: 2024-0007
Feature Details: Interior Drainage System - Sluice / Slide Gates - Gatewell
Station Start:
Station End:
Caption: Minimally Acceptable - MU-11: Gate fully closed - the gate was a bit noisy while closing.

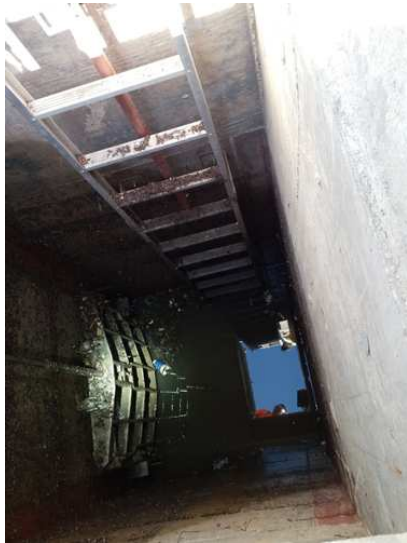
Inspect ID: 2024-0011
Feature Details: Interior Drainage System - Sluice / Slide Gates - Gatewell
Station Start:
Station End:
Caption: Minimally Acceptable - MU-11: Some debris is inside the gatewell chamber.

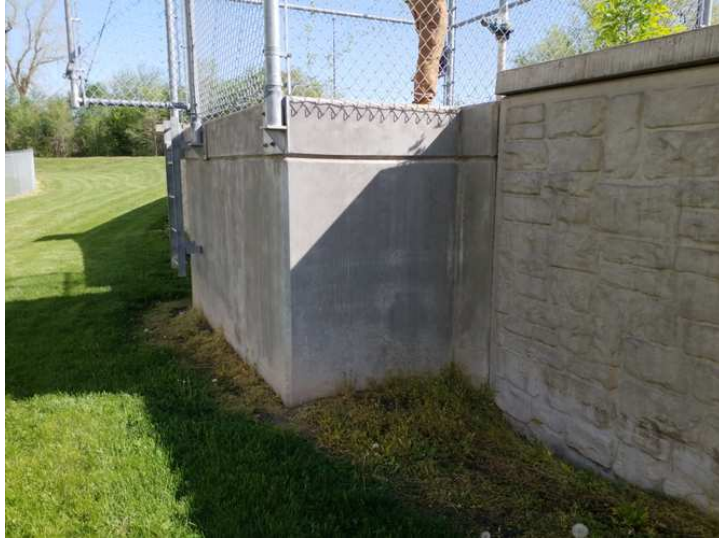
Inspect ID: 2024-0015

Caption: Acceptable - MU-08: The gatewell structure is well mowed and in good condition.

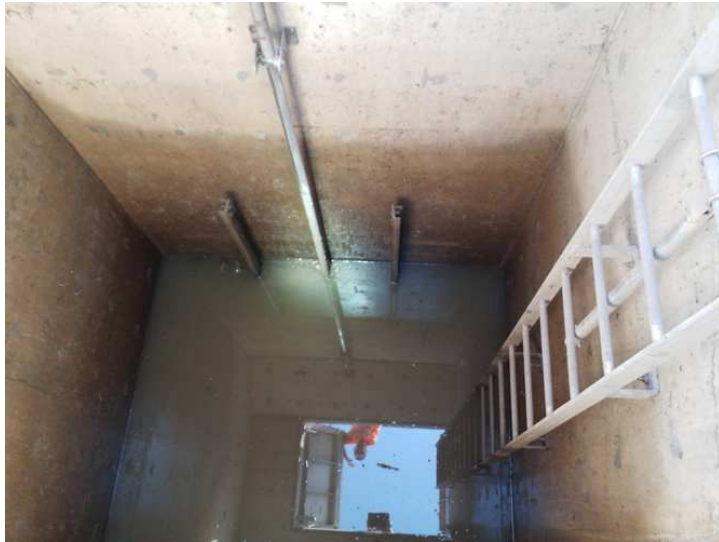
Inspect ID: 2024-0023

Caption: Acceptable - MU-08: Gate fully closed - no issues.

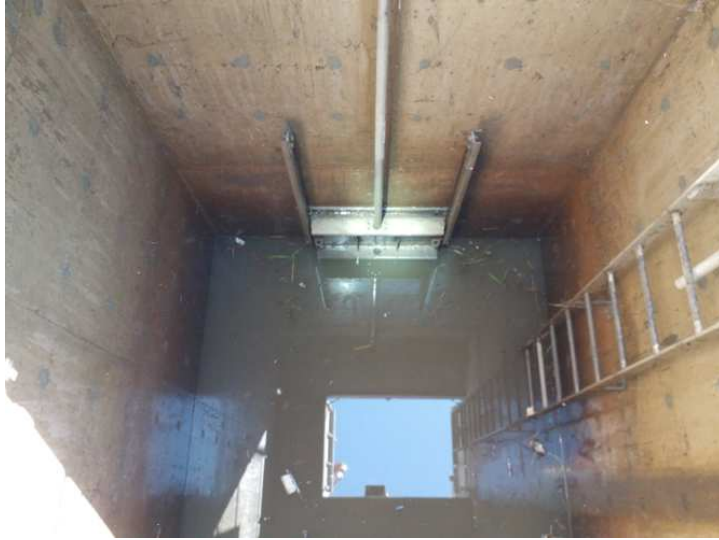
Inspect ID: 2024-0043
Feature Details: Interior Drainage System - Sluice / Slide Gates - Gatewell
Station Start:
Station End:
Caption: Acceptable - MU-06: Gate fully closed - no issues.

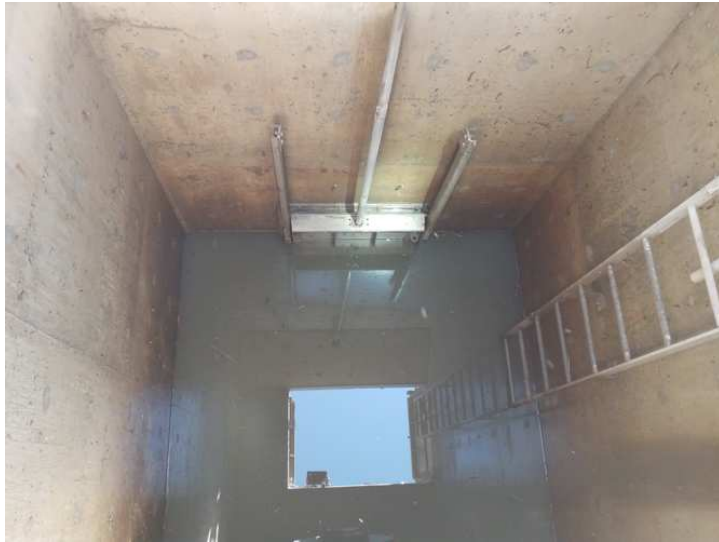
Inspect ID: 2024-0063
Feature Details: Interior Drainage System - Sluice / Slide Gates - Gatewell
Station Start:
Station End:
Caption: Acceptable - MU-04: Gate fully closed - no issues.

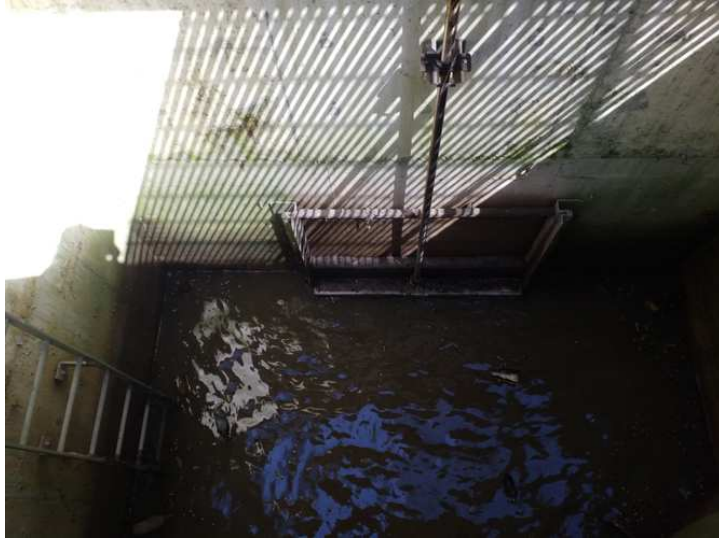
Inspect ID: 2024-0071
Feature Details: Interior Drainage System - Sluice / Slide Gates - Gatewell
Station Start:
Station End:
Caption: Acceptable - MU-02: Gate fully closed - no issues.

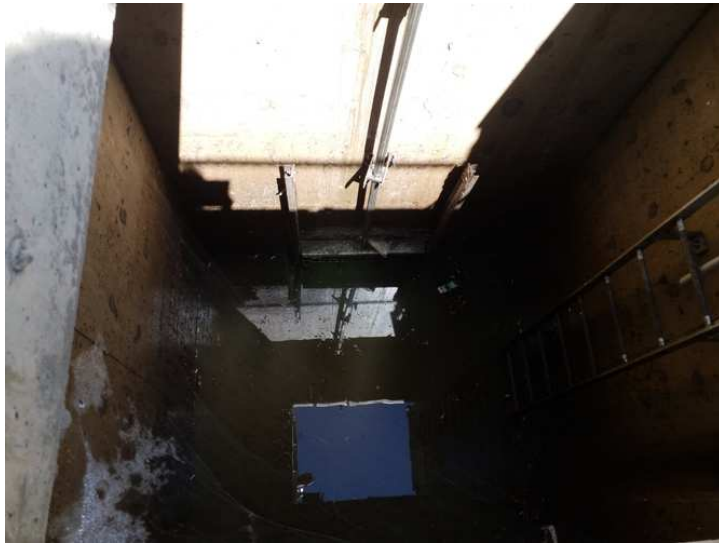
Inspect ID: 2024-0103
Feature Details: Interior Drainage System - Sluice / Slide Gates - Gatewell
Station Start:
Station End:
Caption: Acceptable - MU-01: Gate fully closed - no issues.

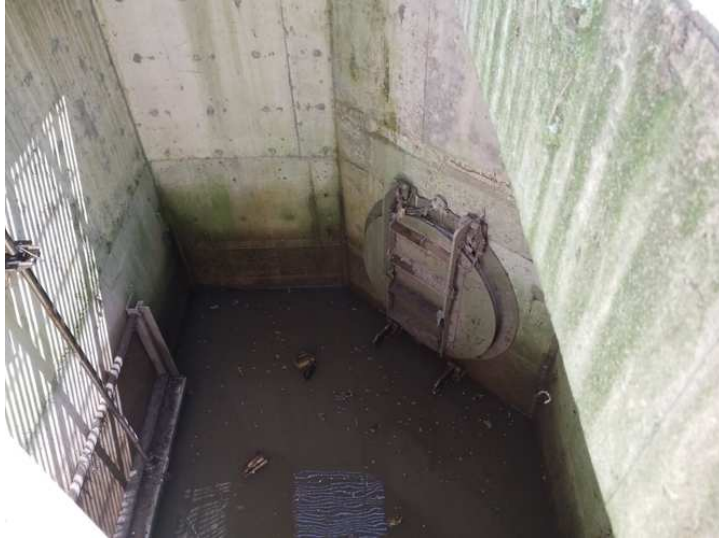
Inspect ID: 2024-0087

Caption: Acceptable - MU-02: Inlet flap gate into the sluice gate chamber.

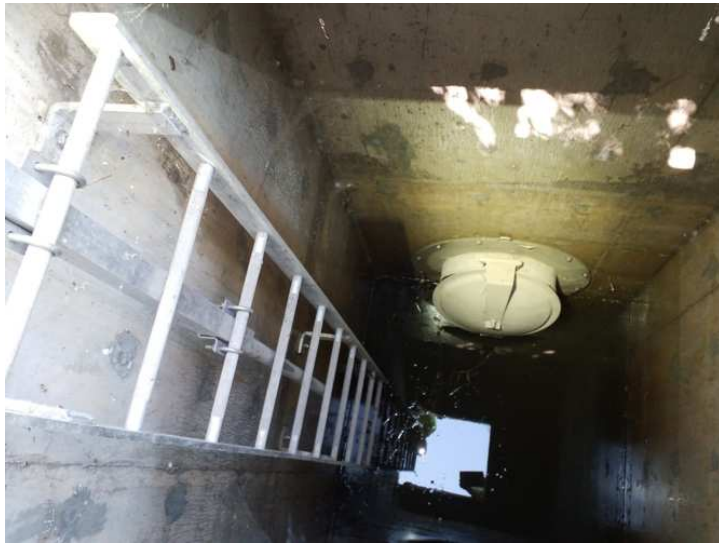
Inspect ID: 2024-0095

Caption: Acceptable - MU-03: The flap gate is in good condition, slightly ajar.

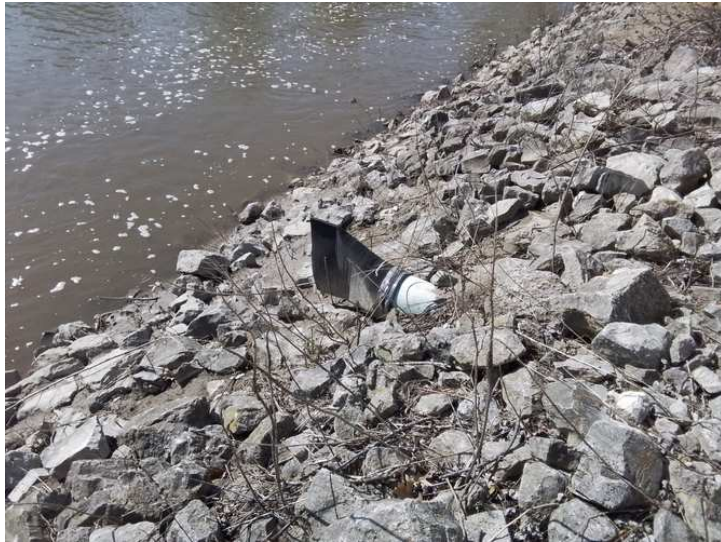
Inspect ID: 2024-0200
Feature Details: Interior Drainage System - Flap Gates/ Flap Valves/ Pinch Valves - Outlet Structure
Station Start:
Station End:
Caption: Minimally Acceptable - MU-12: A stick is stuck in the duckbill valve.

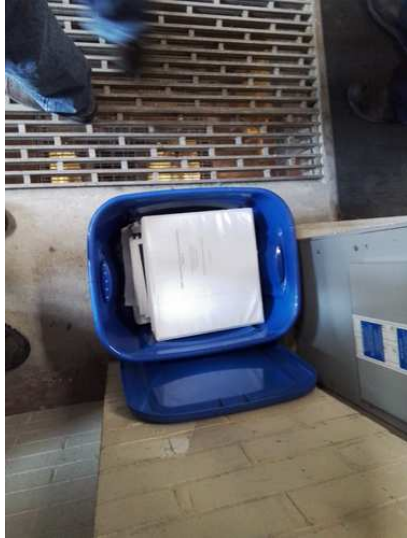
Inspect ID: 2024-0012
Feature Details: Pump Stations - Pump Station Operations and Maintenance Equipment Manuals
Station Start:
Station End:
Caption: Acceptable - PS-BA: Manuals are kept onsite.

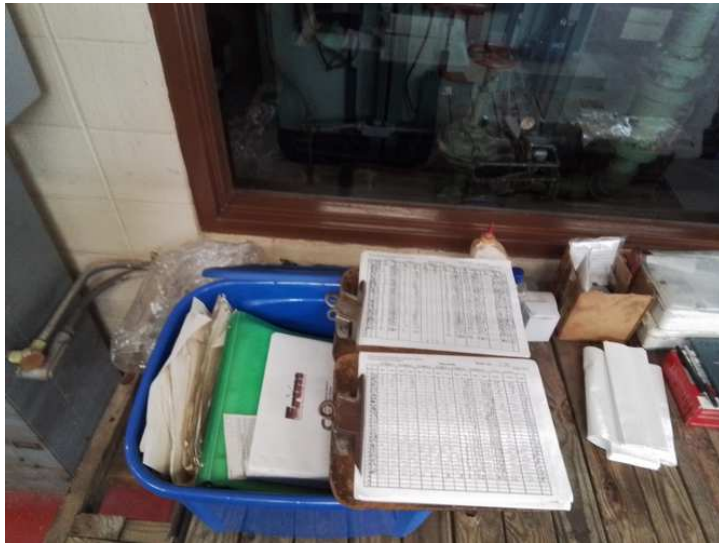
Inspect ID: 2024-0060
Feature Details: Pump Stations - Pump Station Operations and Maintenance Equipment Manuals - Interior
Station Start:
Station End:
Caption: Acceptable - PS-CA: Manuals and maintenance records are kept onsite.

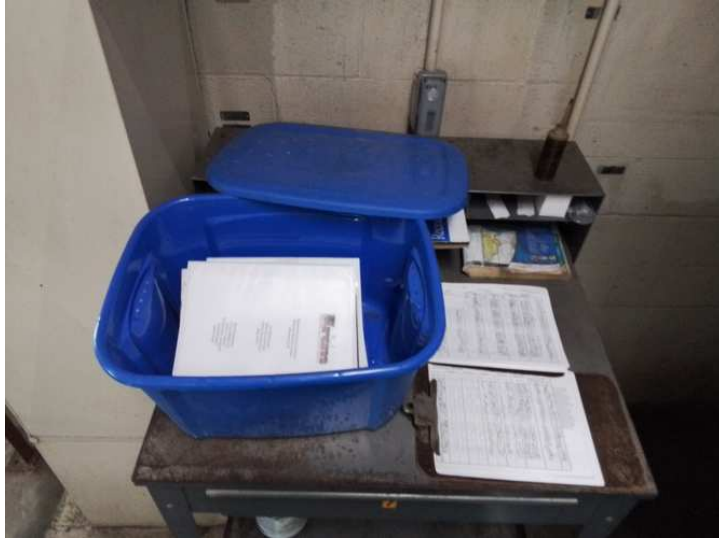
Inspect ID: 2024-0160
Feature Details: Pump Stations - Pump Station Operations and Maintenance Equipment Manuals - Interior
Station Start:
Station End:
Caption: Acceptable - PS-HM: Manuals and maintenance records are kept onsite.

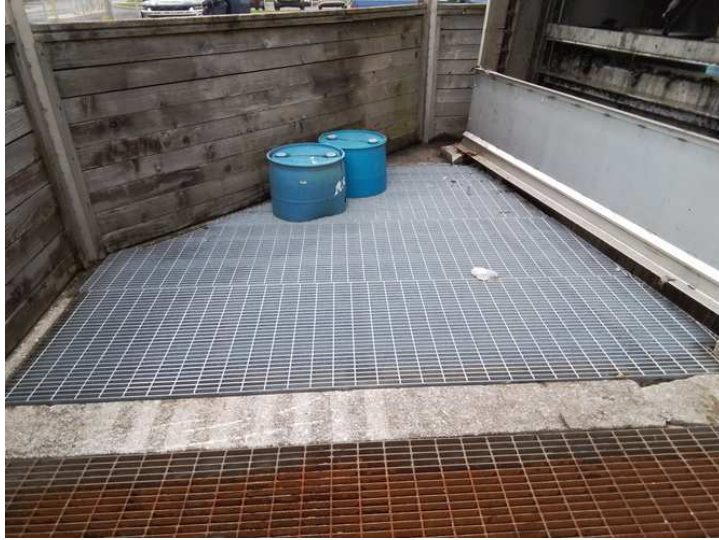
Inspect ID: 2024-0056

Caption: Minimally Acceptable - PS-CA: Missing clips on grates near trash rakes - unchanged from previous inspections. Recommend adding missing clips for safety.

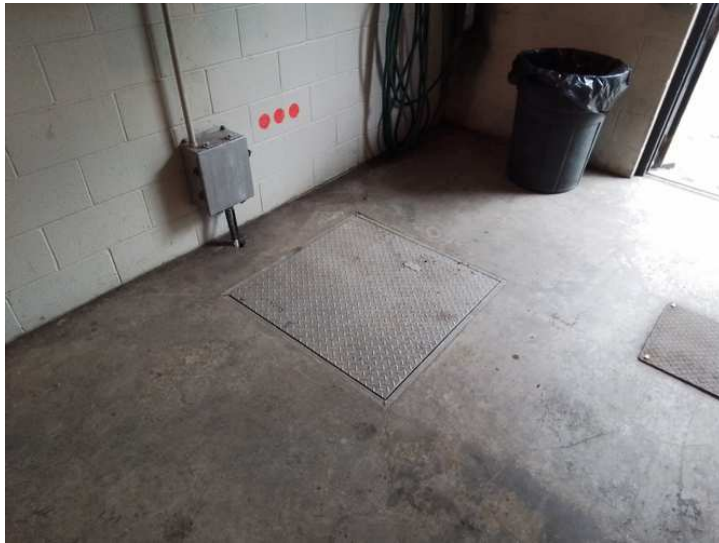
Inspect ID: 2024-0108

Caption: Minimally Acceptable - PS-OA: Typical example of missing confined space labels throughout the building. Recommend adding missing confined space labels.

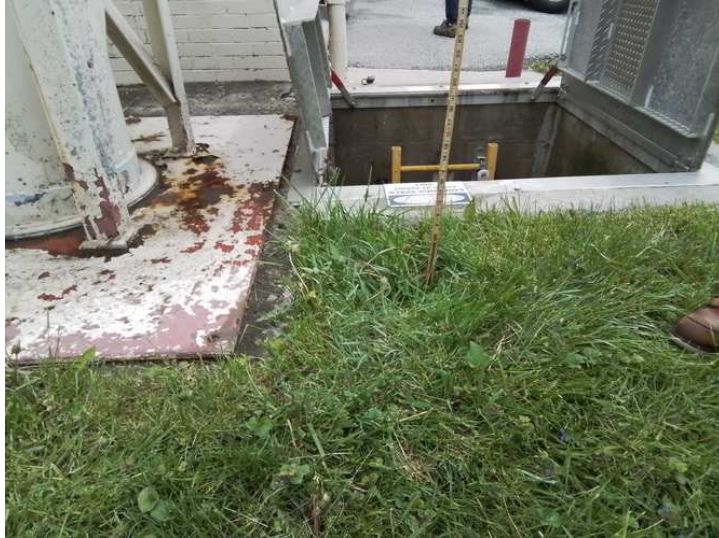
Inspect ID: 2024-0008

Caption: Acceptable - PS-BA: Minor depression near EF-02 - Appears unchanged since last inspection. Recommend continuing to monitor the depression.

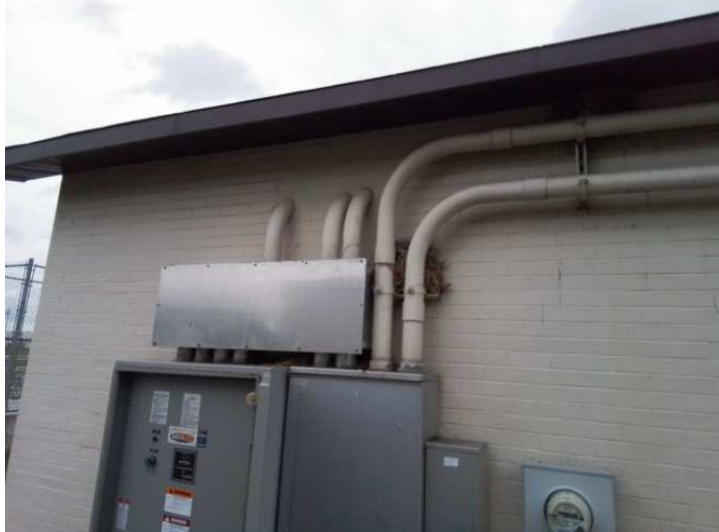
Inspect ID: 2024-0024

Caption: Acceptable - PS-BA: Bird nests on building. Nests do not appear to be affecting building operation, recommend that they can be left in place.

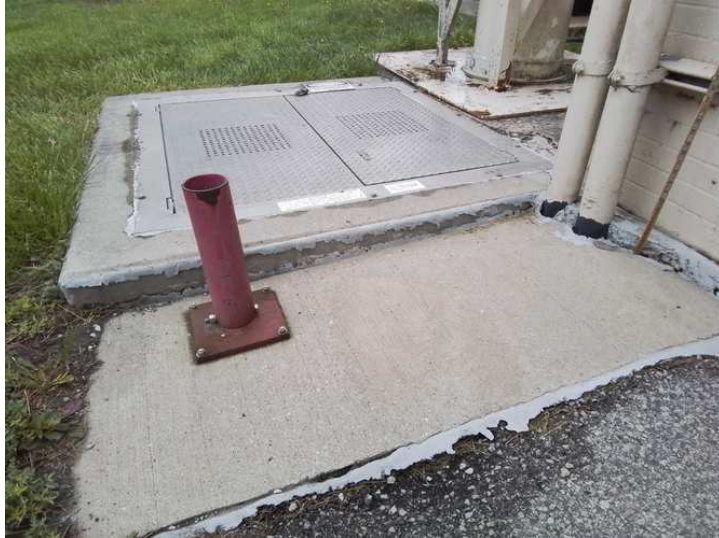
Inspect ID: 2024-0028
Feature Details: Pump Stations - Plant Building - Exterior
Station Start:
Station End:
Caption: Minimally Acceptable - PS-BA: Ground subsiding below concrete - appears similar to last inspection. Recommend monitoring the distance between the concrete pads to determine if the subsidence is continuing to occur.

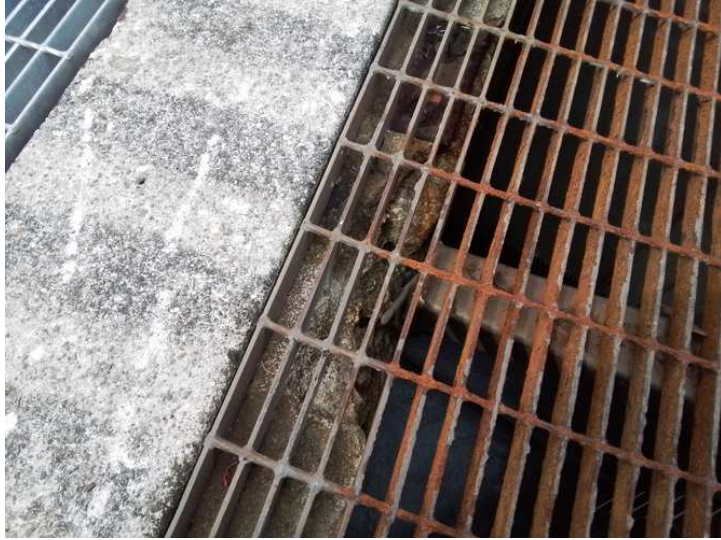
Inspect ID: 2024-0052

Caption: Minimally Acceptable - PS-CA: Concrete spalling near trash rakes - Danger of possible beam failure under the grate. Recommend repairing the concrete to prevent beam failure.

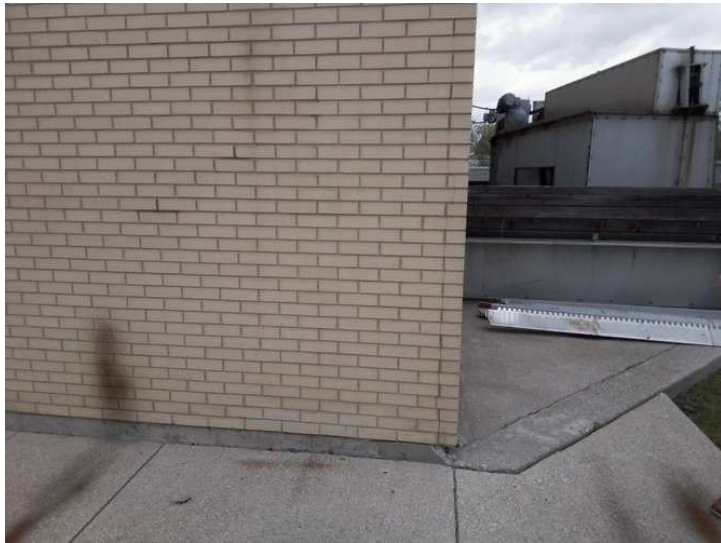
Inspect ID: 2024-0084

Caption: Minimally Acceptable - PS-CA: Typical example of wall cracks in the building. Recommend continuing to monitor minor cracks and filling in/sealing more significant ones.

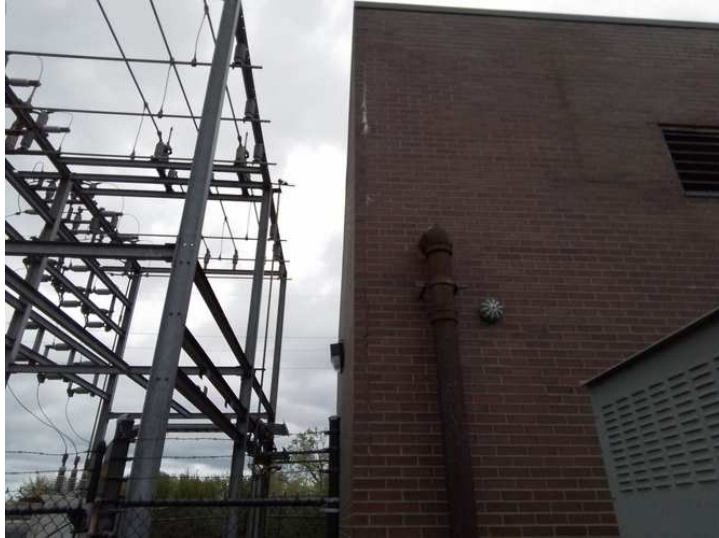
Inspect ID: 2024-0136
Feature Details: Pump Stations - Plant Building - Exterior
Station Start:
Station End:
Caption: Minimally Acceptable - PS-OA: Cracks on corner of building. Recommend monitoring for worsening behavior.

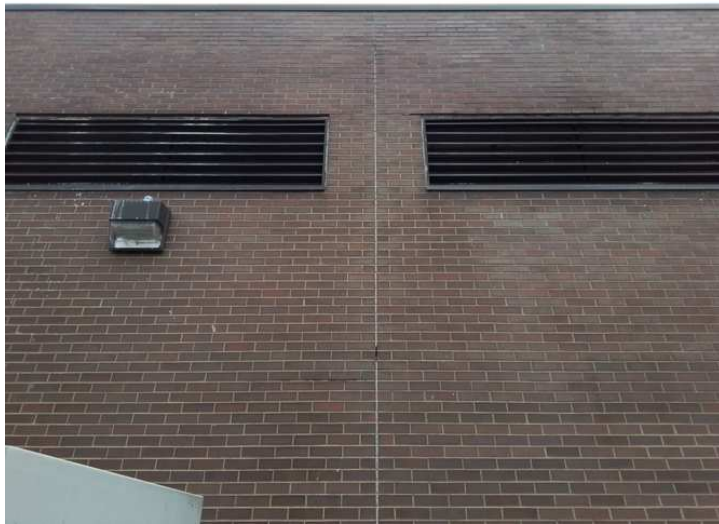
Inspect ID: 2024-0144
Feature Details: Pump Stations - Plant Building - Exterior
Station Start:
Station End:
Caption: Minimally Acceptable - PS-OA: Missing filler at expansion joint - noted during previous inspections. Recommend replacing missing filler to prevent building leaks.

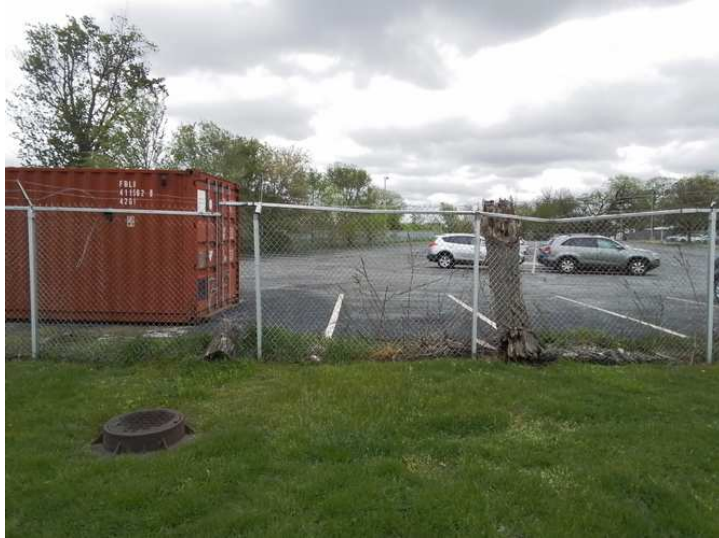
Inspect ID: 2024-0088

Caption: Minimally Acceptable - PS-CA: Broken security fencing - noted during previous inspections. Recommend repair.

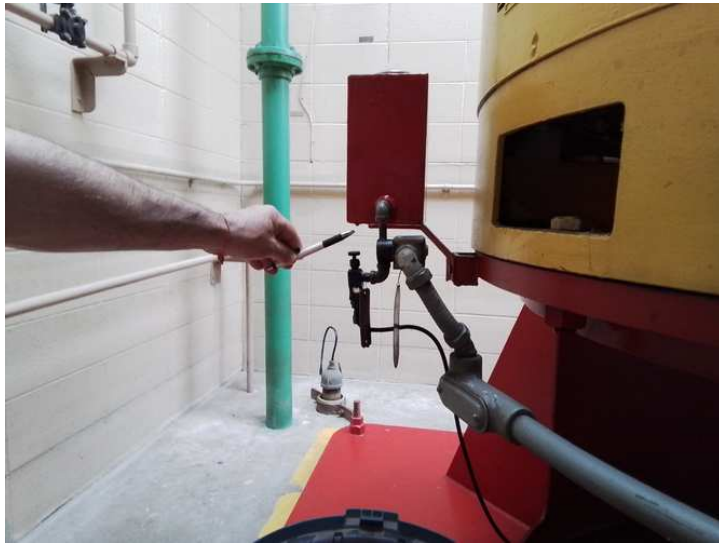
Inspect ID: 2024-0064

Caption: Minimally Acceptable - PS-CA: Active leak on the bottom of the pump 4 lubricating reservoir. Recommend repairing the leak.

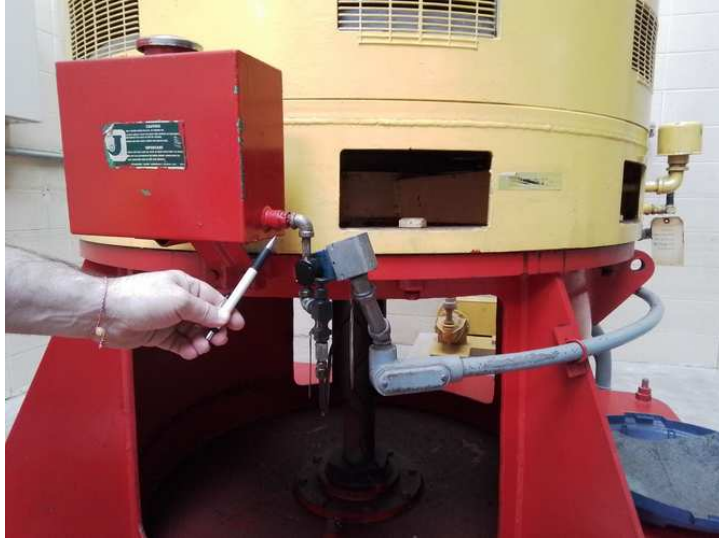
Inspect ID: 2024-0076
Feature Details: Pump Stations - Pumps - Interior
Station Start:
Station End:
Caption: Minimally Acceptable - PS-CA: Active leak at the pump 1 lubricating supply line. Recommend repairing the leak.

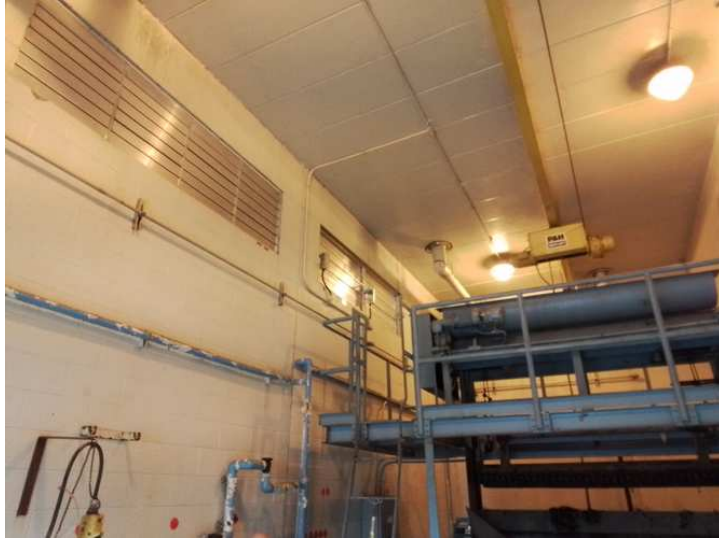
Inspect ID: 2024-0132

Caption: Unacceptable - PS-OA: Louver didn't open while sump exhaust fan was running. May be acceptable if louver was not designed to open while sump is operating.

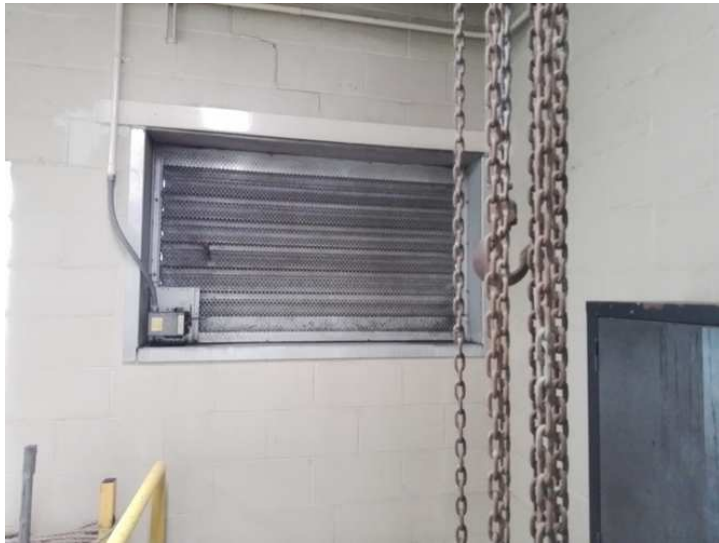
Inspect ID: 2024-0152

Caption: Unacceptable - PS-HM: Louver didn't open while sump exhaust fan was running. May be acceptable if louver was not designed to open while sump is operating.

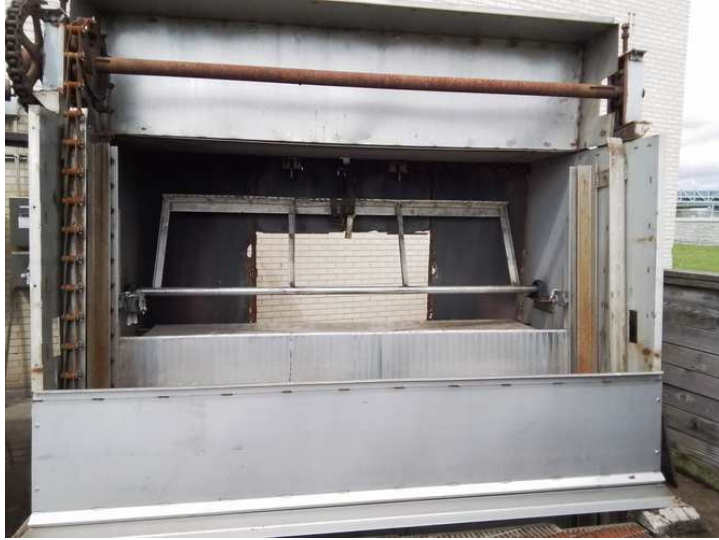
Inspect ID: 2024-0048

Caption: Minimally Acceptable - PS-CA: The north trash rake is still out of service from last year. No ETA on repair time - difficultly finding parts. This is Minimally Acceptable instead of Unacceptable because the other trash rake is operational. Recommend installing a new system if the old parts are no longer manufactured.

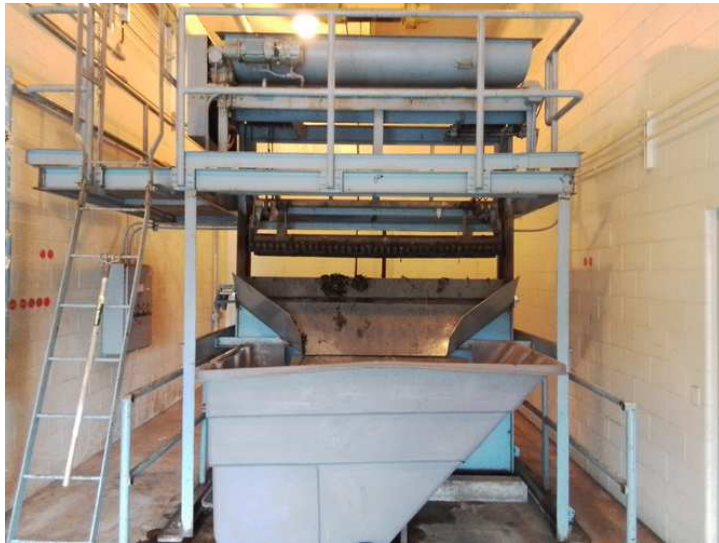
Inspect ID: 2024-0140

Caption: Minimally Acceptable - PS-OA: Unusual squealing noise while operating the trash rake. Recommend investigating the noise and repairing/lubricating the system as needed.

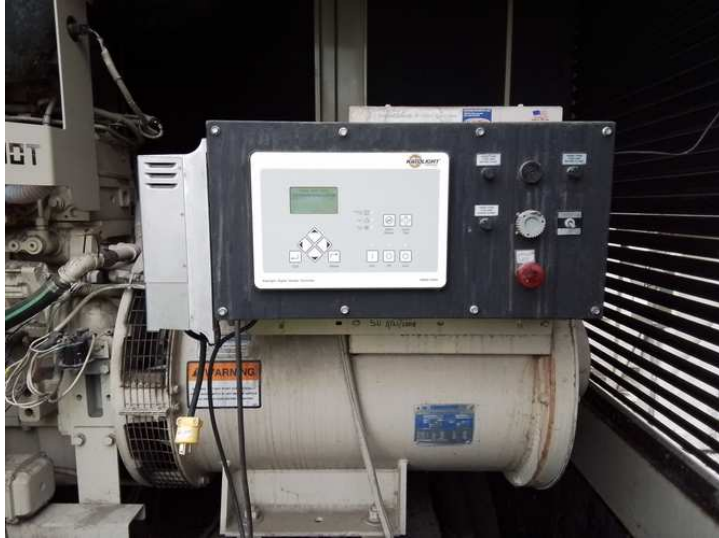
Inspect ID: 2024-0020
Feature Details: Pump Stations - Power Source - Exterior
Station Start:
Station End:
Caption: Acceptable - PS-BA: Generator runtime hours are 325 hrs 27 mins (hours during last inspection were 291 hrs 21 mins).

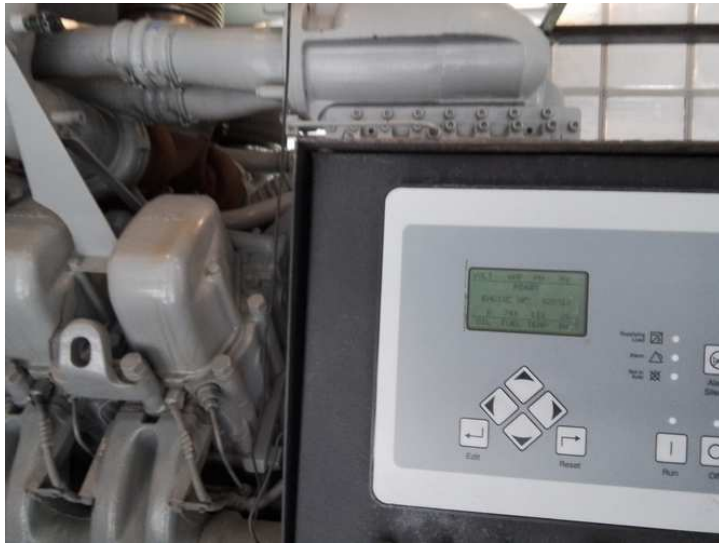
Inspect ID: 2024-0096
Feature Details: Pump Stations - Power Source - Exterior
Station Start:
Station End:
Caption: Acceptable - PS-CA: Generator hours are 420 hrs 10 mins (hrs during last inspection were 398).

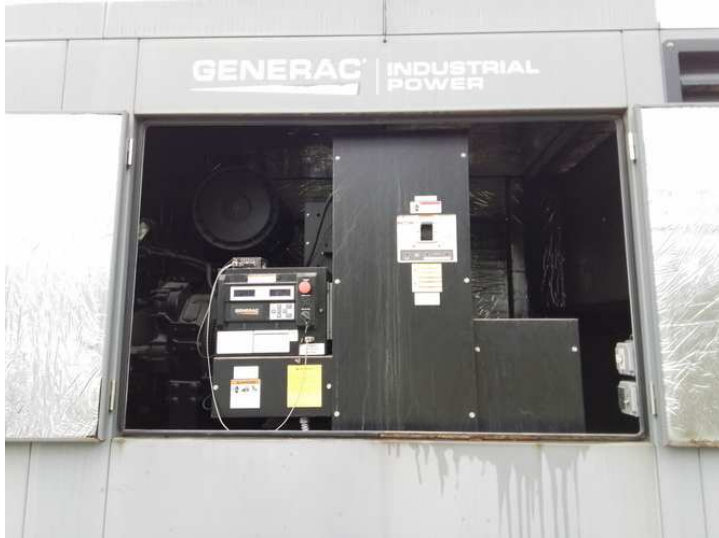
Inspect ID: 2024-0128
Feature Details: Pump Stations - Power Source - Exterior
Station Start:
Station End:
Caption: Acceptable - PS-OA: Generator hours: North - 183.3 (167.4 hrs during last inspection). Center - 188.5 (172 hrs during last inspection). South - 157.6 (141.1 hrs during last inspection).

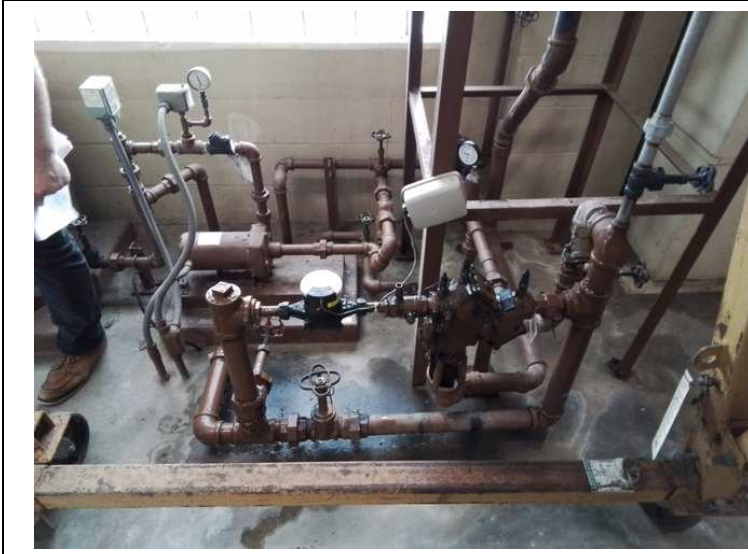
Caption: Minimally Acceptable - PS-CA: Severe corrosion on the sewage pump discharge line. Recommend removing the corrosion.
