Site Visit Summary

Name of System: Gary

Name of Segment: Gary Burr St

Field Trip Report Prepared by: Chris Schaal Date of Site Visit: 04/08/2024 - 04/10/2024

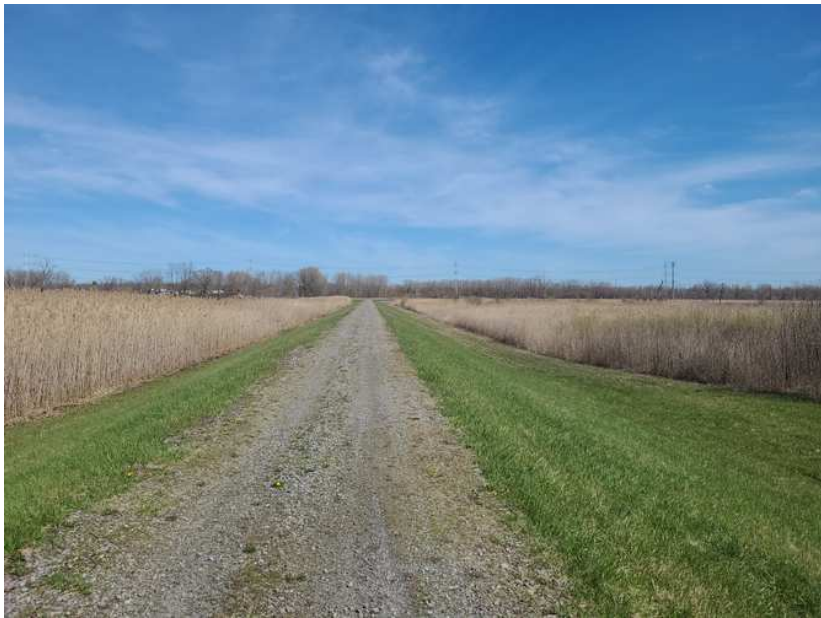
No User Rating (Site Visit) - Tires, debris observed on landside toe..

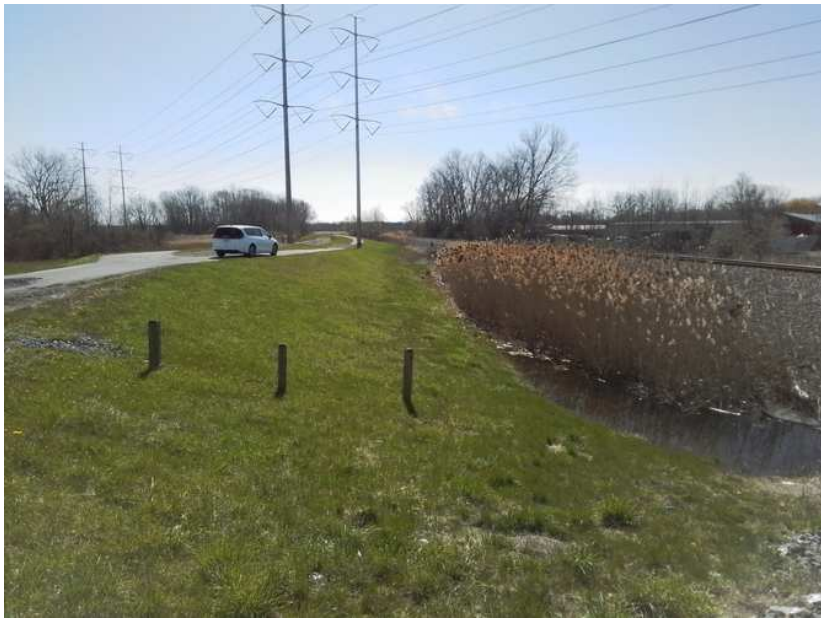
No User Rating (Site Visit) - GB-02: Sedimentation and vegetation near flap gate.
