**US Army Corps
of Engineers ®**

Site Visit Summary

Name of System: Gary

Name of Segment: Gary North

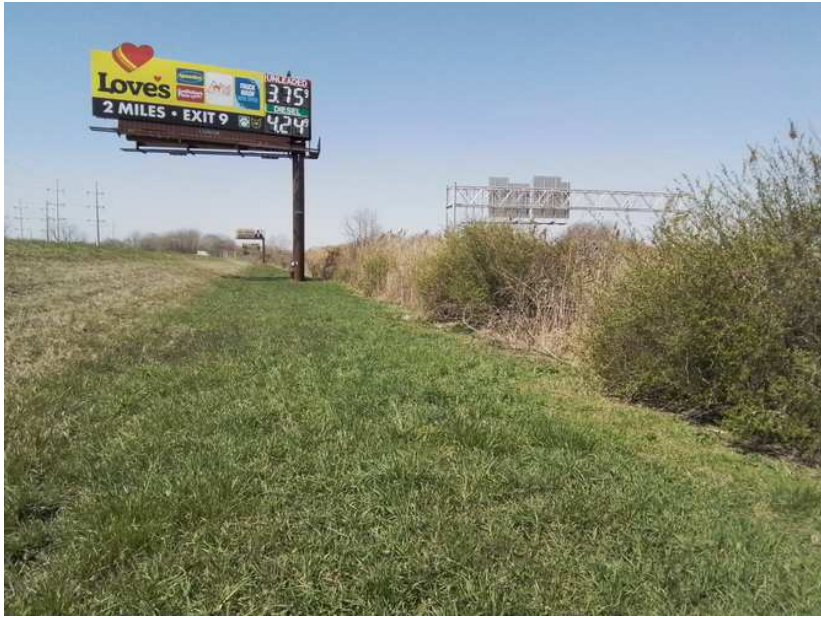
Inspect ID: 2024-0004

No User Rating (Site Visit) - Vegetation growth on landside toe and slope beyond barrier fence

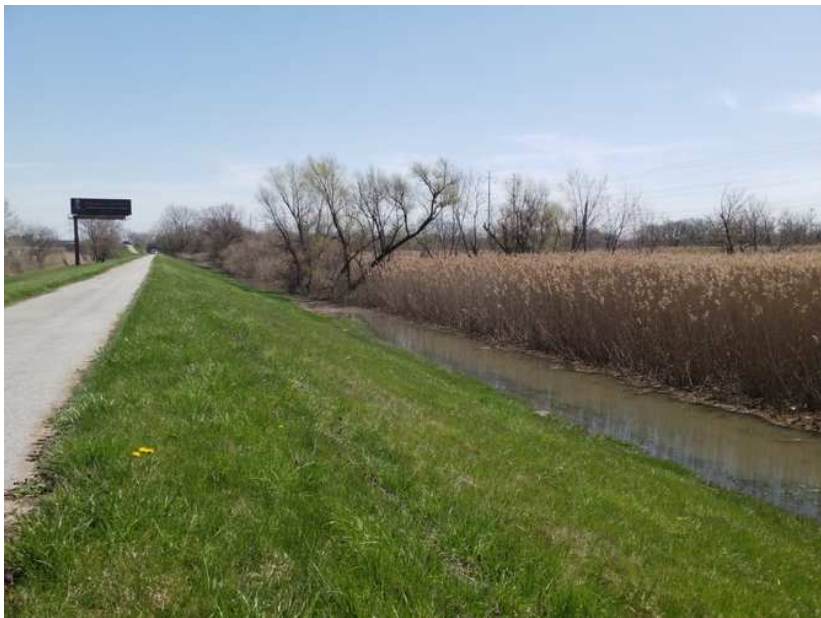
Inspect ID: 2024-0027

No User Rating (Site Visit) - Trees on riverside toe

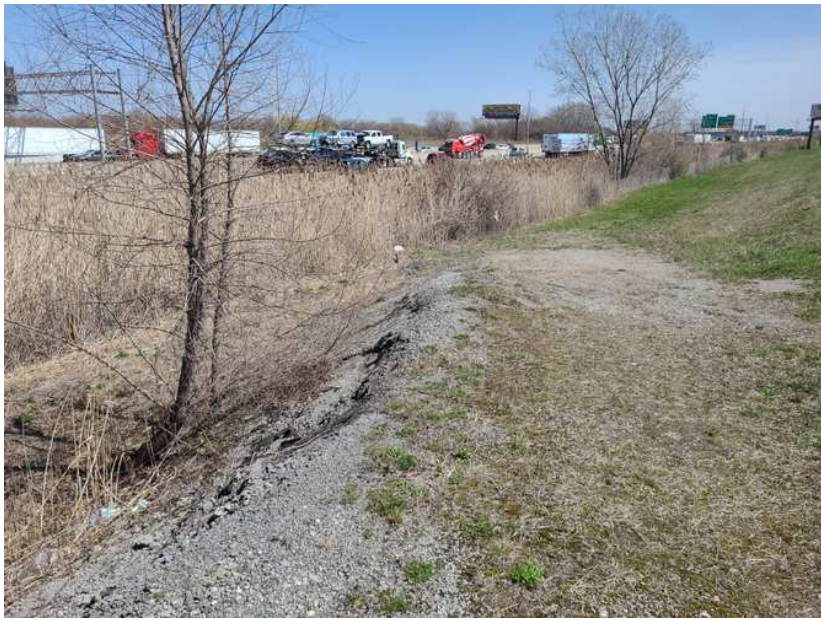
Inspect ID: 2024-0029

No User Rating (Site Visit) - Trees near access ramp on landslide slope

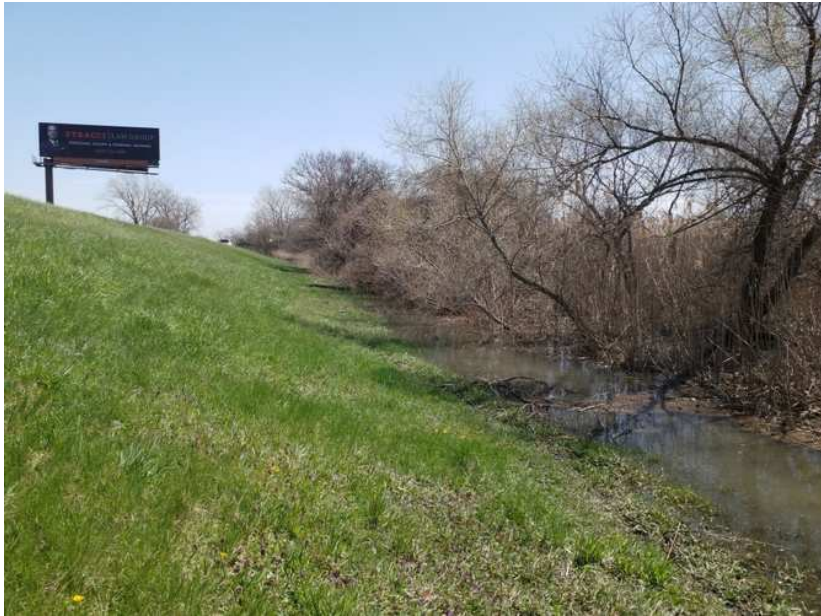
Inspect ID: 2024-0031

No User Rating (Site Visit) - Trees and brushes in the riverside toe extending about 100 ft east

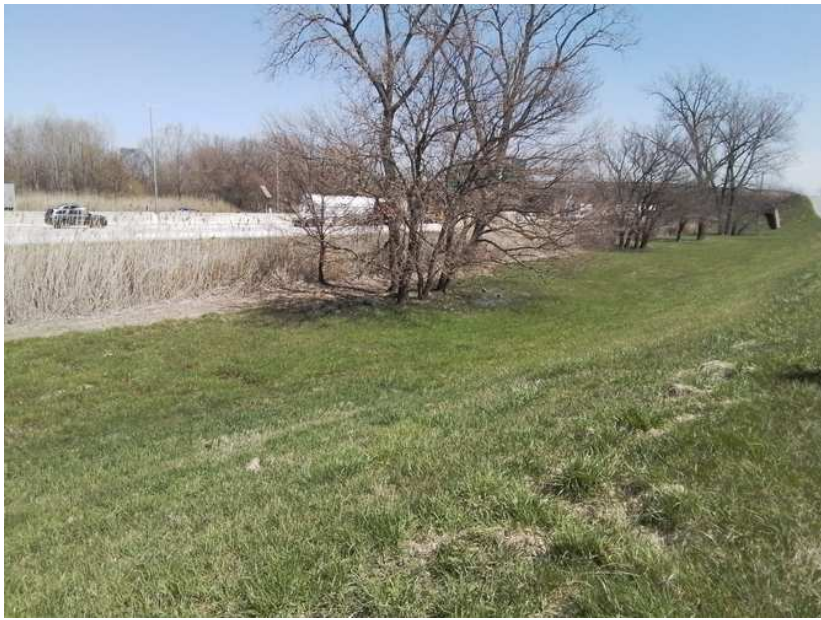
Inspect ID: 2024-0040

No User Rating (Site Visit) - Cluster of trees within the 15 feet vegetation free zone on the roadside toe

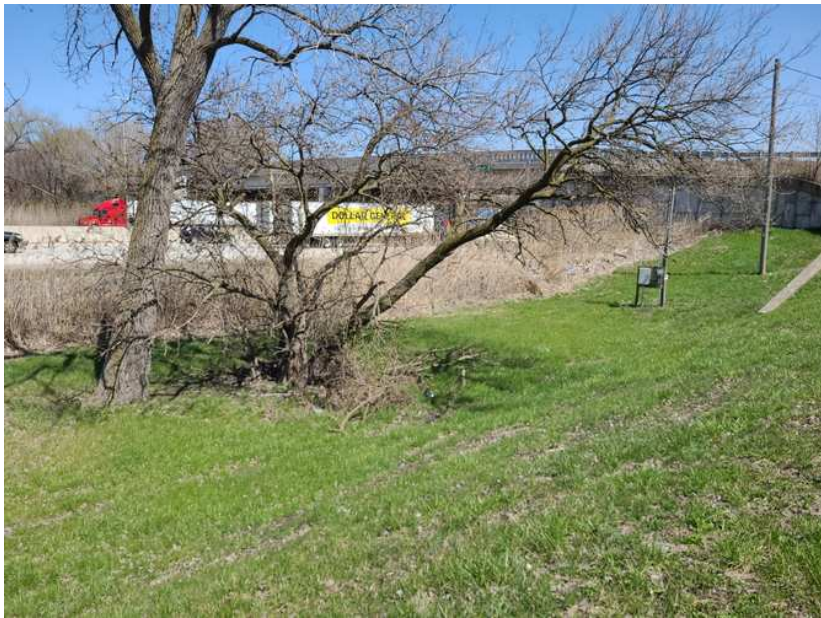
Inspect ID: 2024-0049

No User Rating (Site Visit) - Leaning tree and dead brush on roadside toe

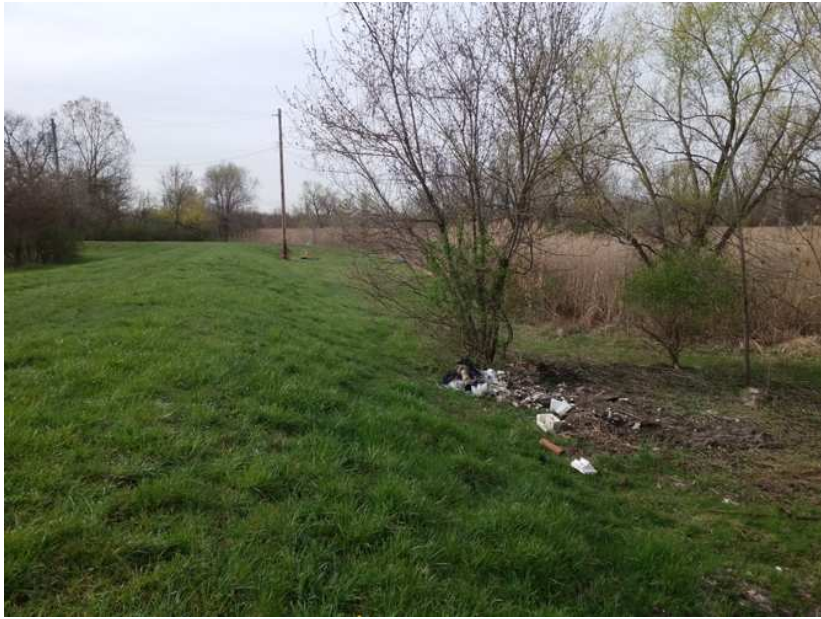
Inspect ID: 2024-0059

No User Rating (Site Visit) - Tree on riverside slope

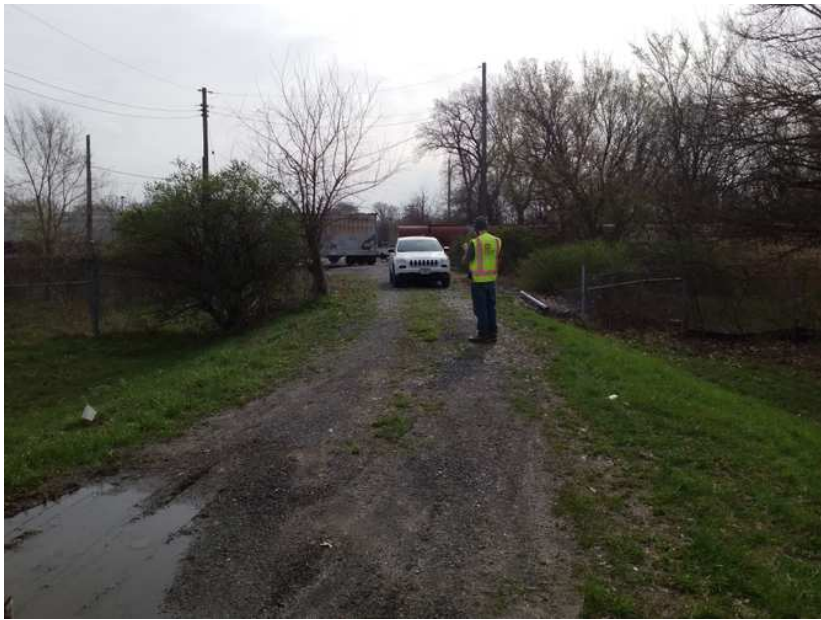
Inspect ID: 2024-0075

No User Rating (Site Visit) - Trees on both sides of levee slope

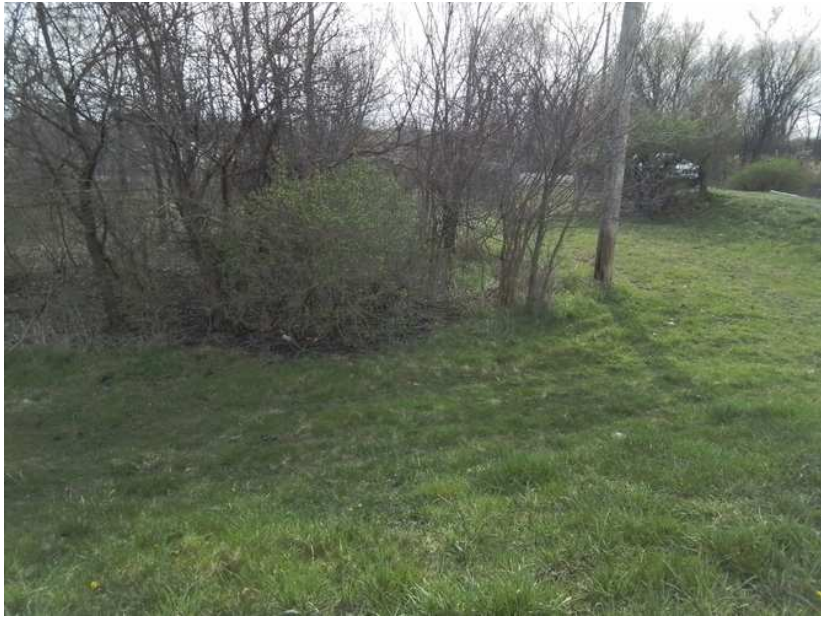
Inspect ID: 2024-0076

No User Rating (Site Visit) - Vegetation on landside toe

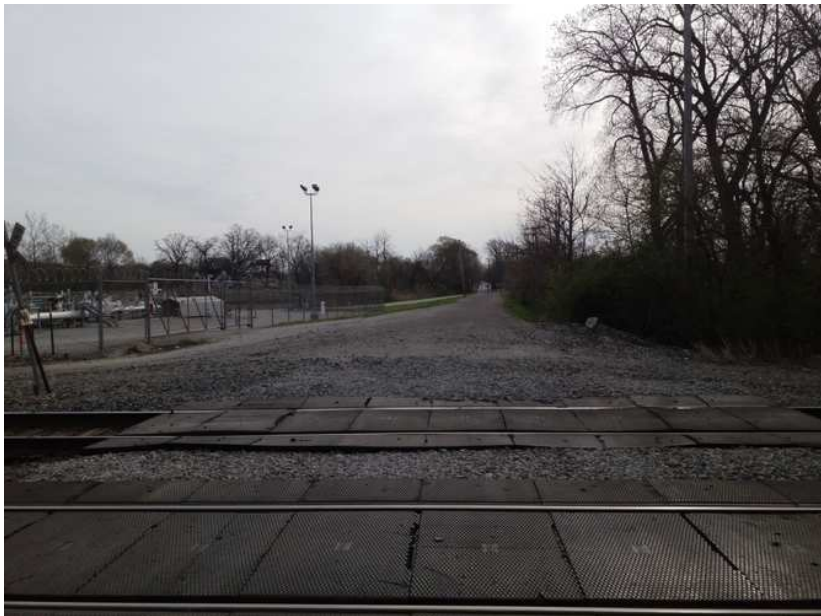
Inspect ID: 2024-0079

No User Rating (Site Visit) - Tree and vegetation growth on riverside slope and toe

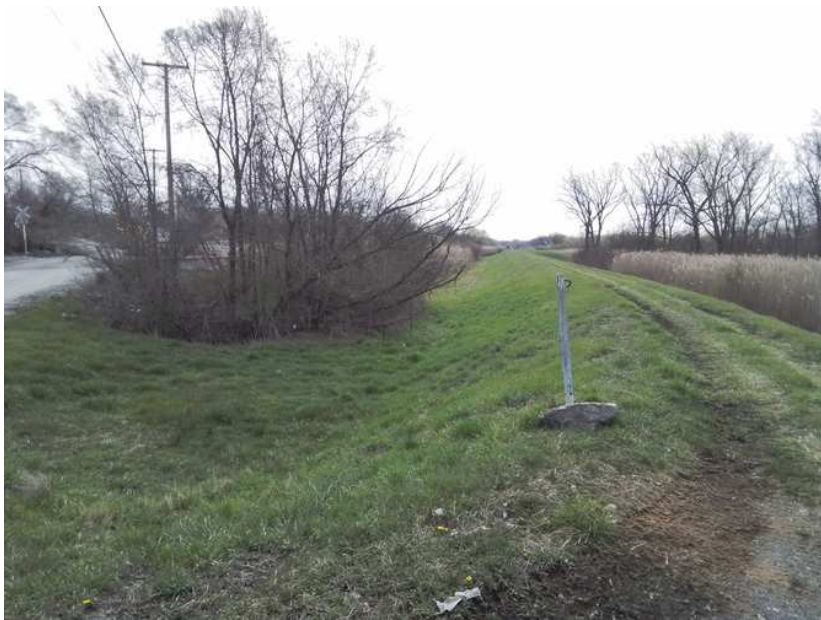
Inspect ID: 2024-0104

No User Rating (Site Visit) - Typical vegetation on landside toe

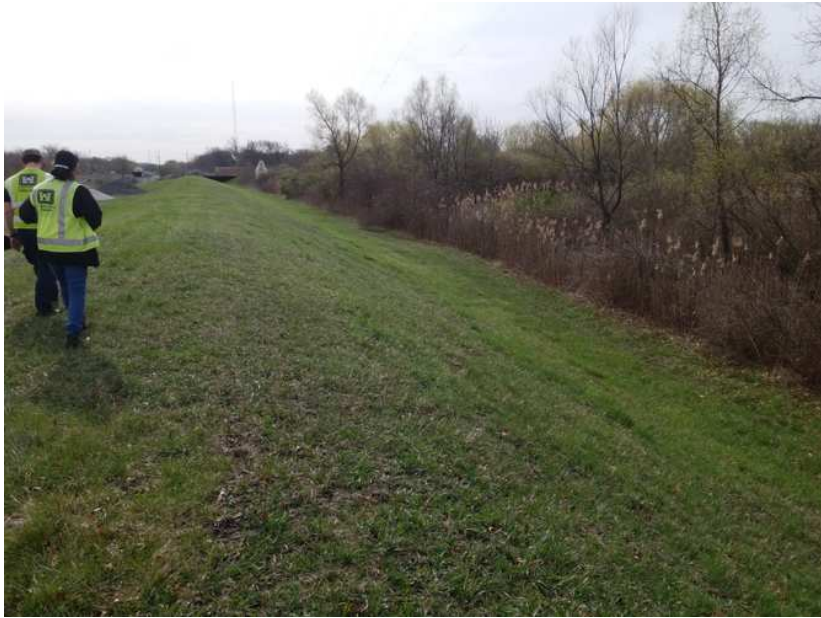
Inspect ID: 2024-0127

No User Rating (Site Visit) - Vegetation on riverside toe

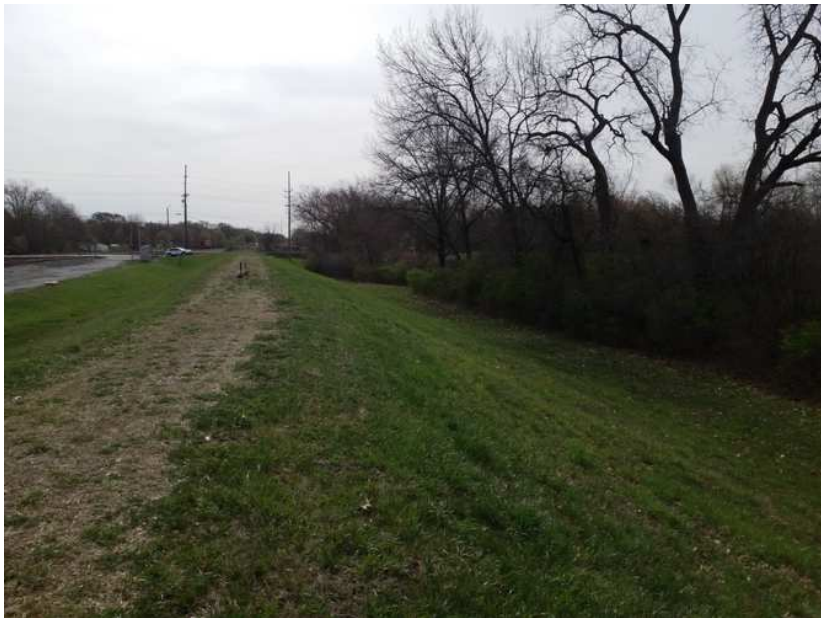
Inspect ID: 2024-0147

No User Rating (Site Visit) - Vegetation growth on riverside toe

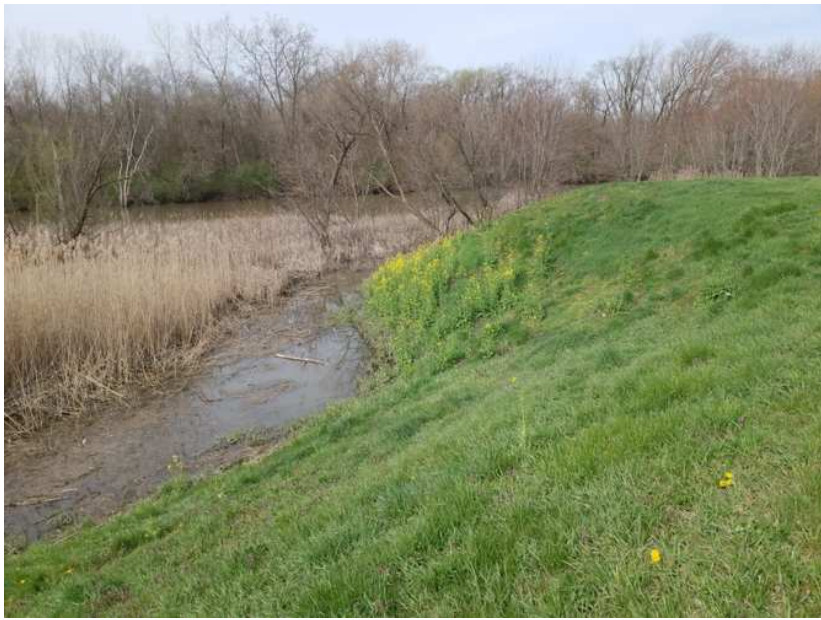
Inspect ID: 2024-0179

No User Rating (Site Visit) - Tall vegetation on riverside slope

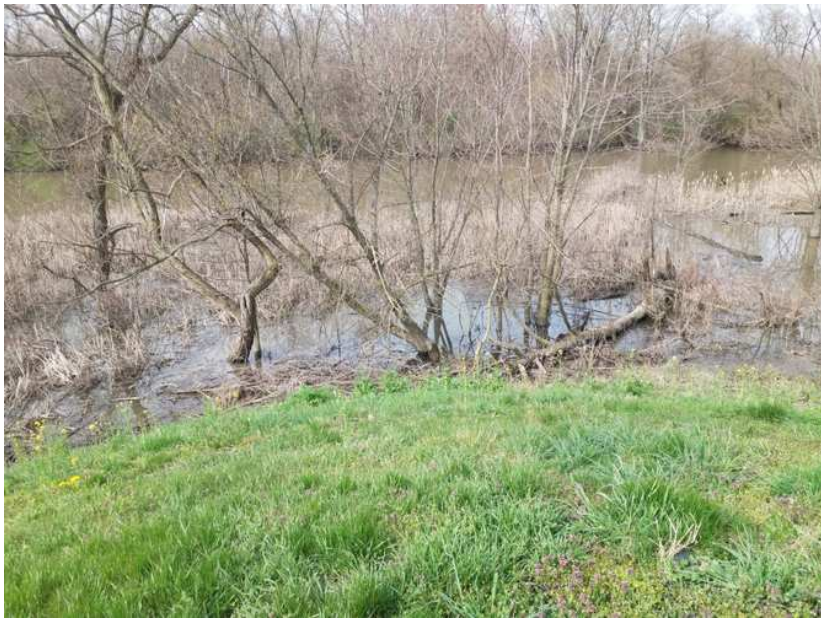
Inspect ID: 2024-0183

No User Rating (Site Visit) - Trees on riverside toe

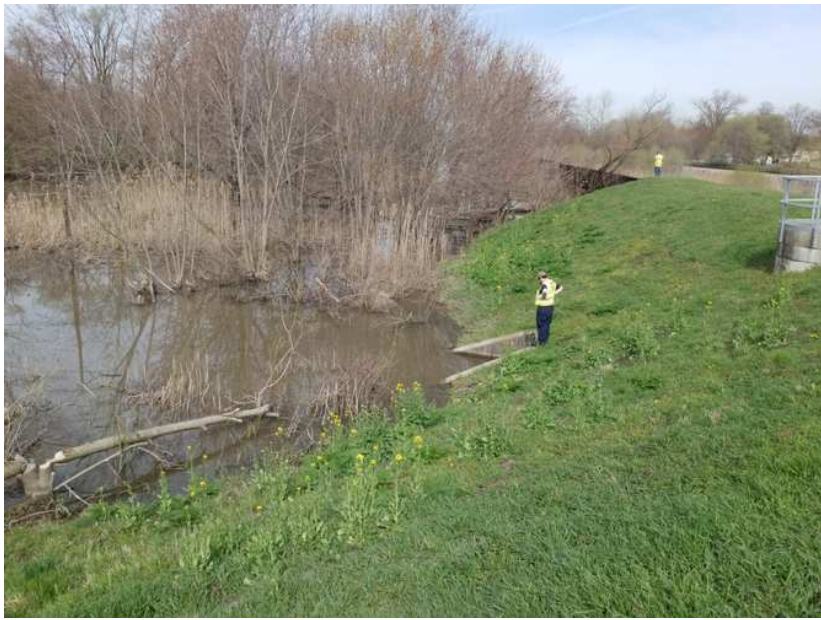
Inspect ID: 2024-0187

No User Rating (Site Visit) - Tall vegetation along riverside slope

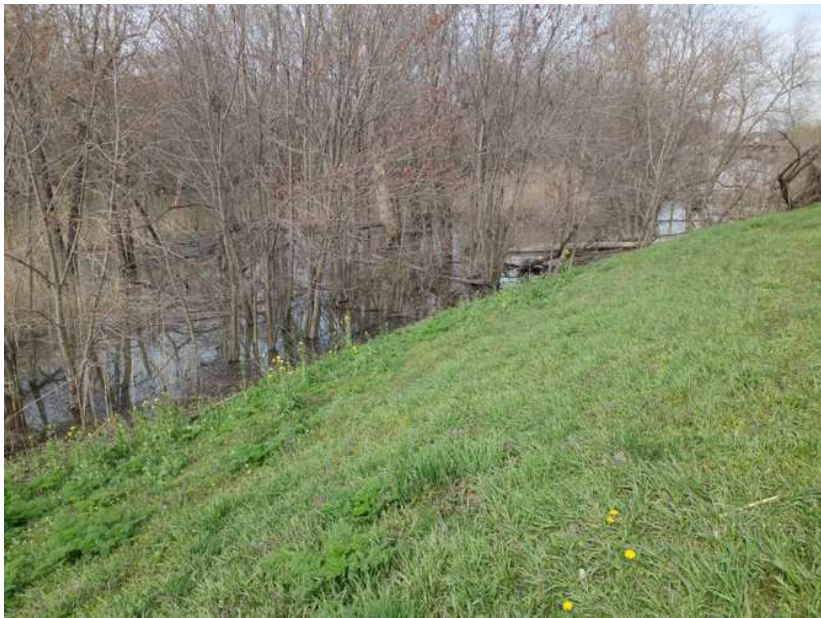
Inspect ID: 2024-0191

No User Rating (Site Visit) - Trees along riverside toe

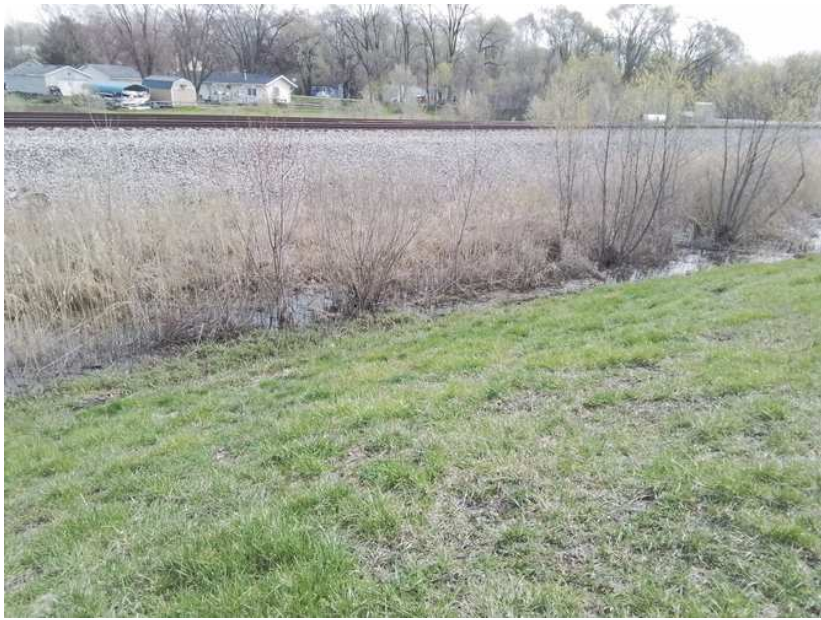
Inspect ID: 2024-0192

No User Rating (Site Visit) - Vegetation on landside toe

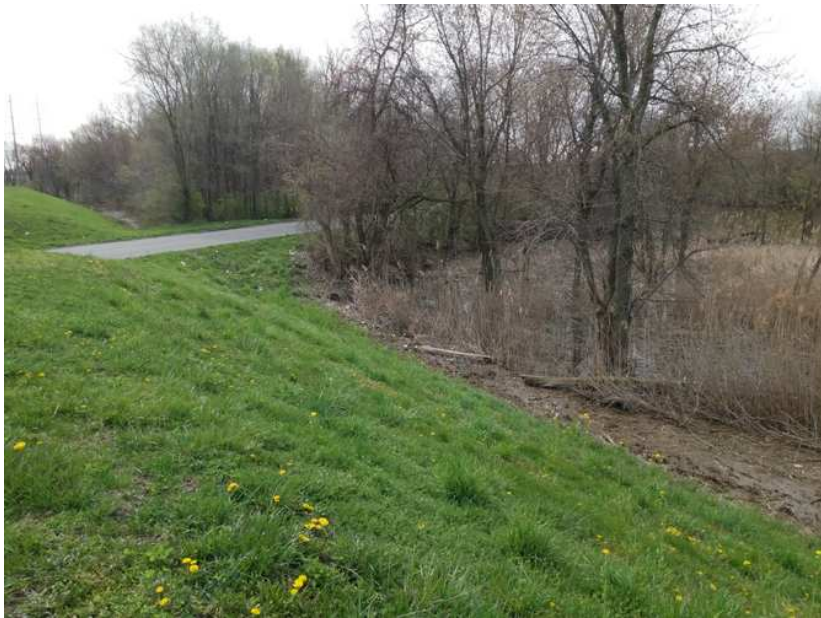
Inspect ID: 2024-0199

No User Rating (Site Visit) - Trees along riverside toe

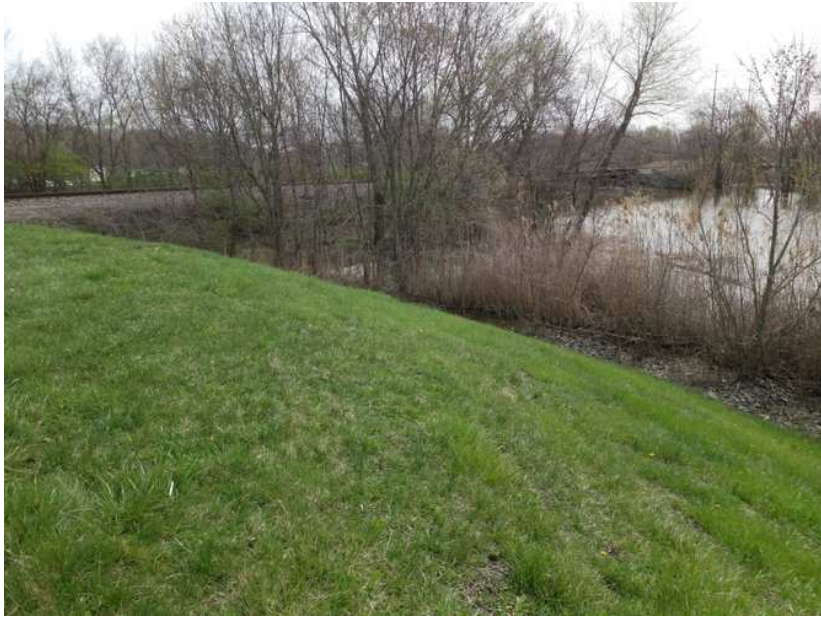
Inspect ID: 2024-0207

No User Rating (Site Visit) - Trees on riverside toe

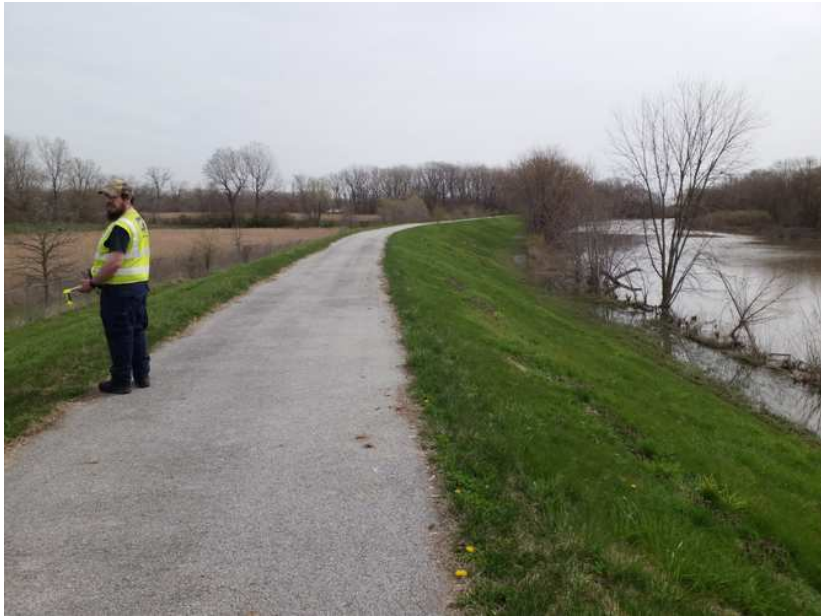
Inspect ID: 2024-0235

No User Rating (Site Visit) - Trees on riverside toe

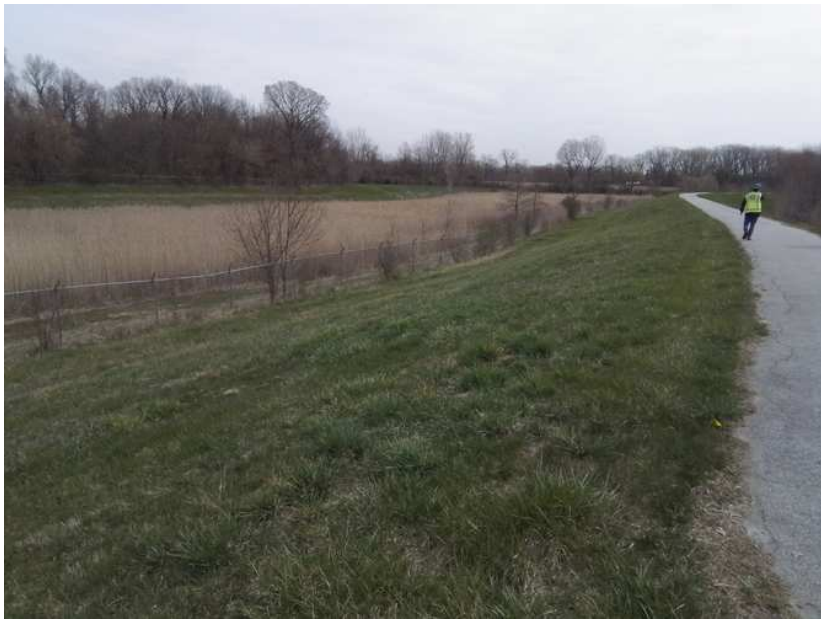
Inspect ID: 2024-0244

No User Rating (Site Visit) - Typical trees along fence on landside toe

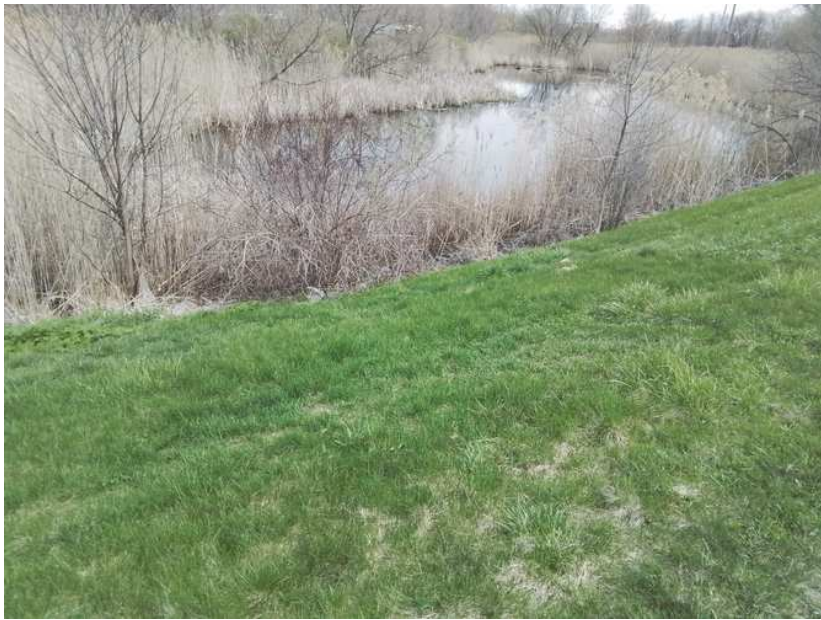
Inspect ID: 2024-0288

No User Rating (Site Visit) - Vegetation in riprap on riverside toe

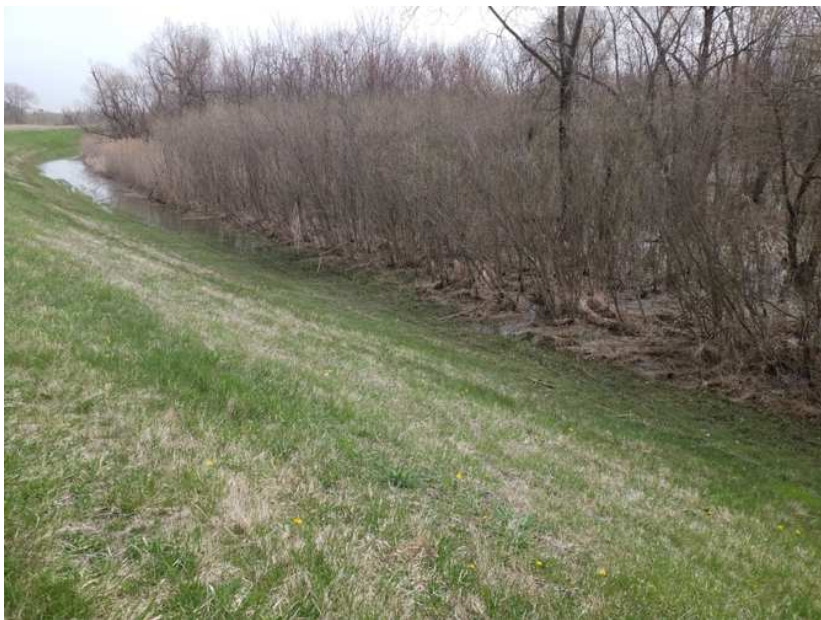
Inspect ID: 2024-0291

No User Rating (Site Visit) - Vegetation along riverside toe

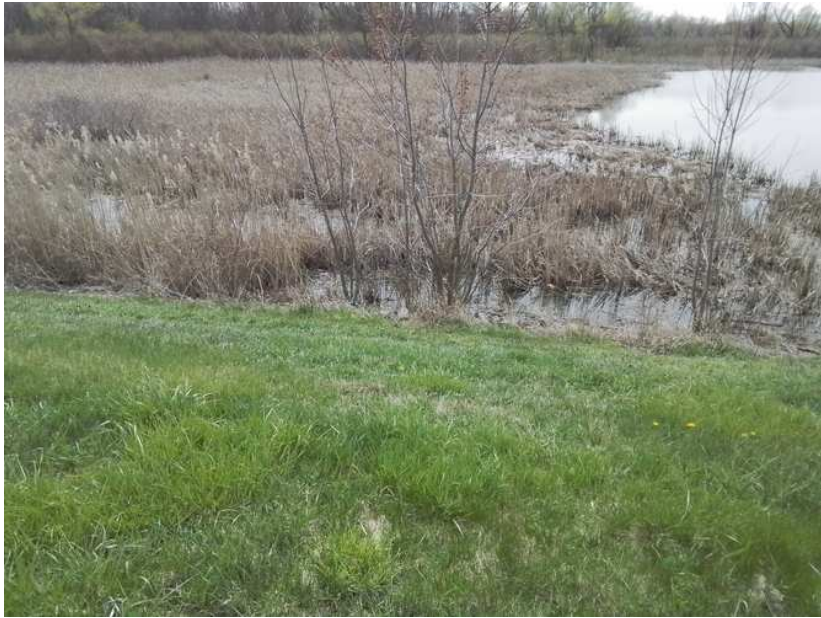
Inspect ID: 2024-0292

No User Rating (Site Visit) - Vegetation in riprap on riverside

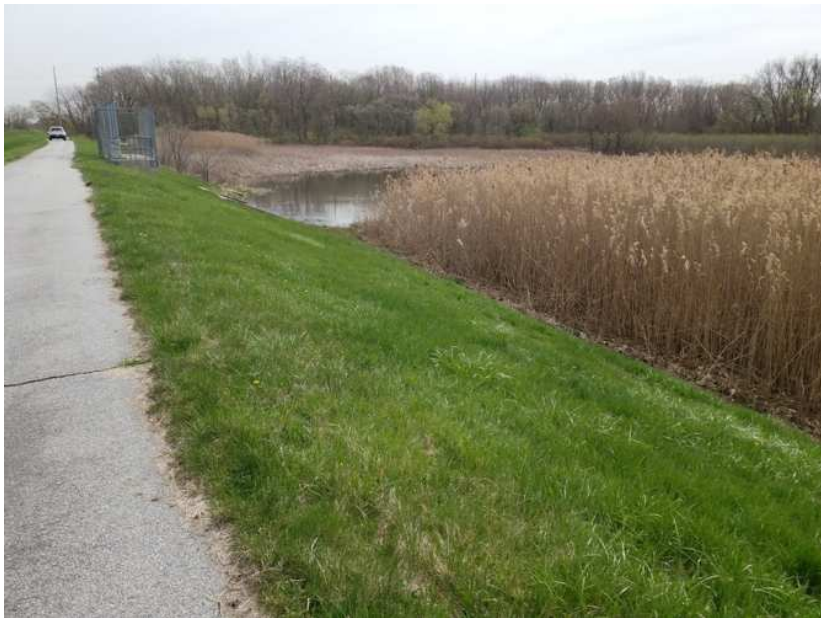
Inspect ID: 2024-0303

No User Rating (Site Visit) - Vegetation on riverside toe

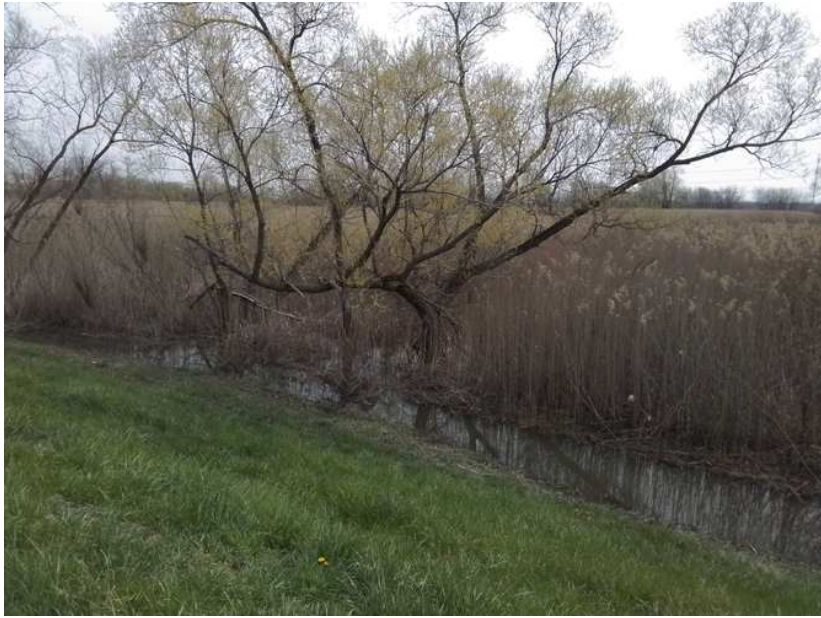
Inspect ID: 2024-0304

No User Rating (Site Visit) - Tree overhanging on riverside slope

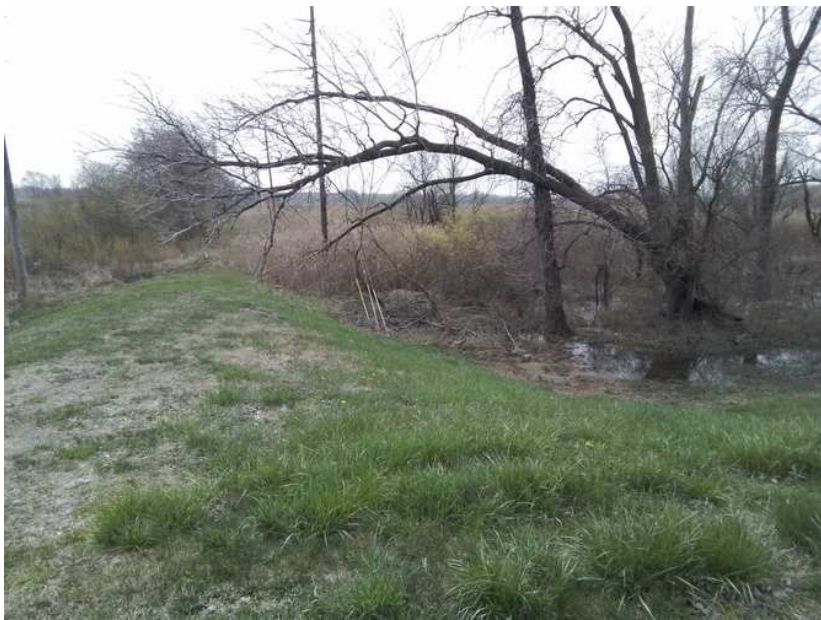
Inspect ID: 2024-0312

No User Rating (Site Visit) - Tree overhanging on riverside slope

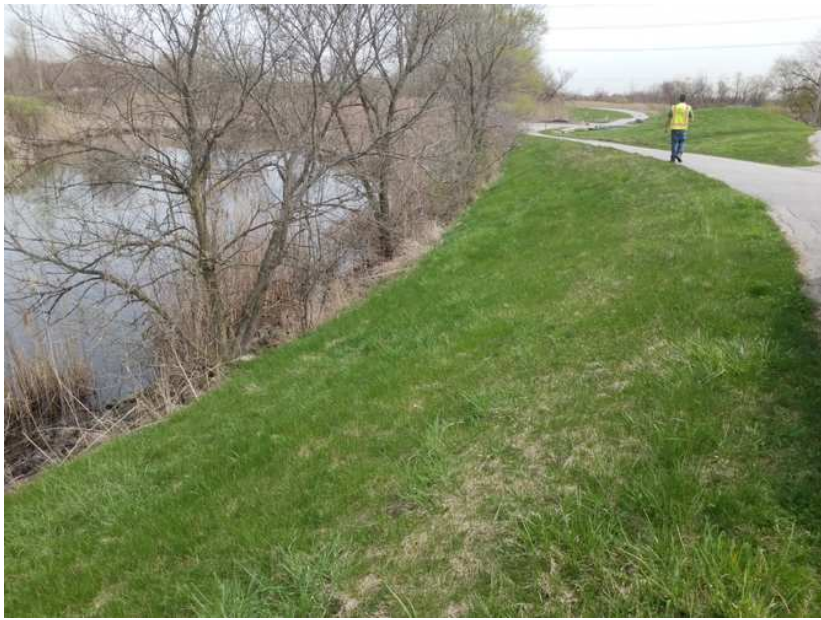
Inspect ID: 2024-0315

No User Rating (Site Visit) - Trees along landside toe

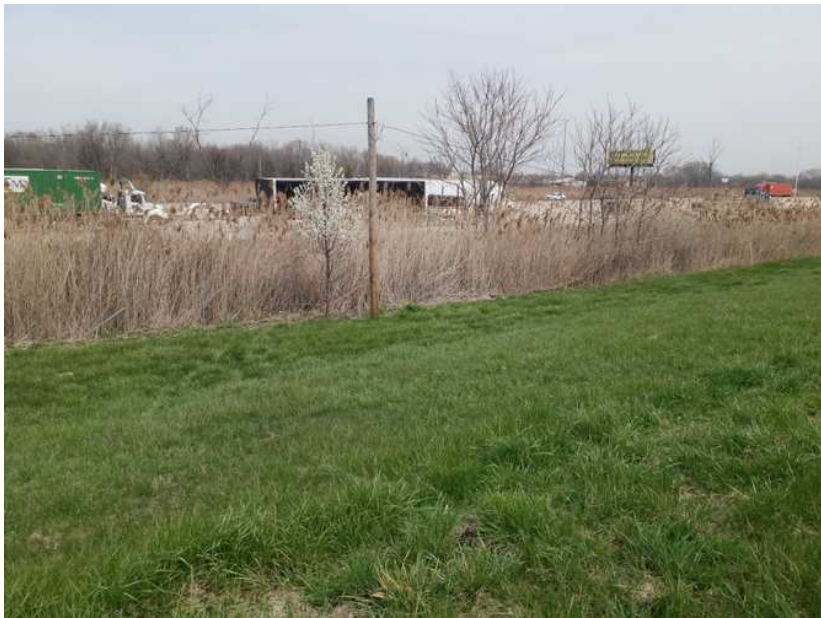
Inspect ID: 2024-0335

No User Rating (Site Visit) - Tree on landside toe

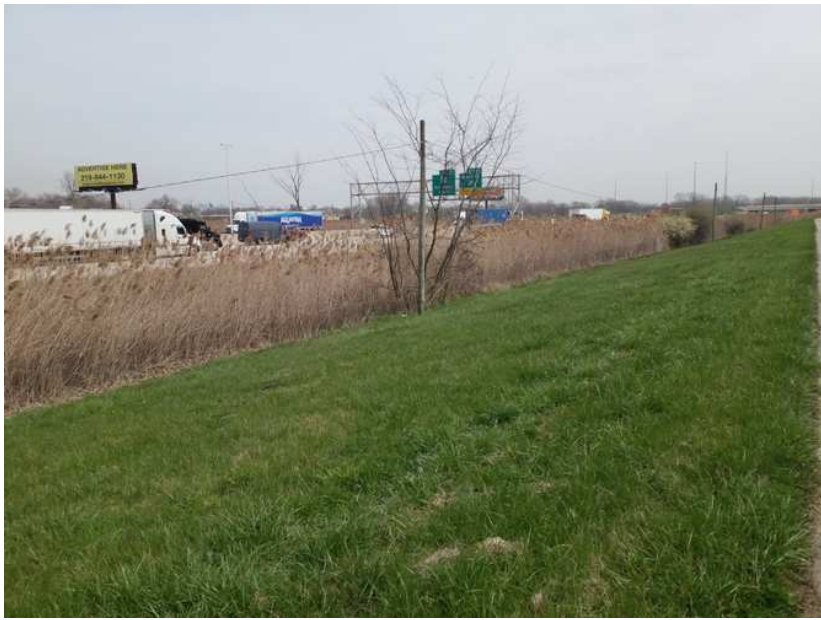
Inspect ID: 2024-0343

No User Rating (Site Visit) - Tree on landside toe

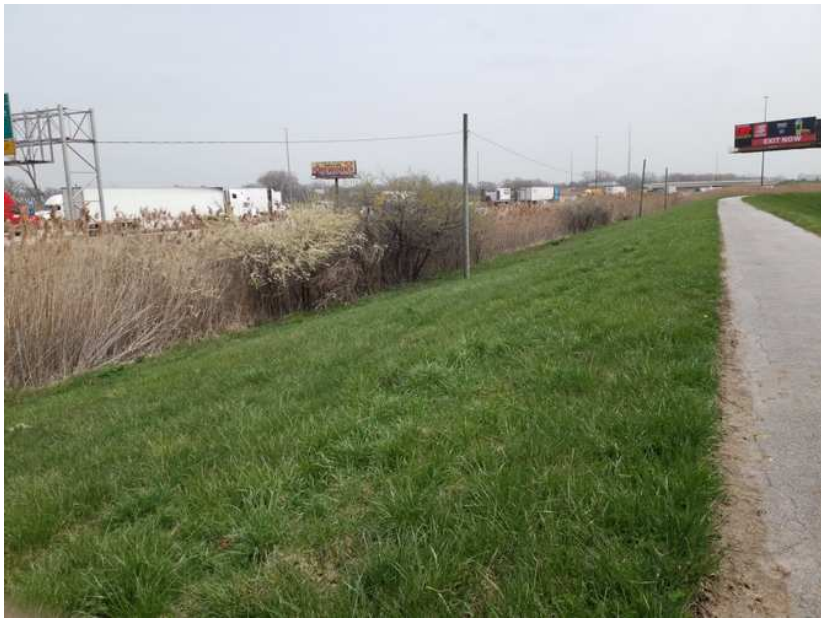
Inspect ID: 2024-0347

No User Rating (Site Visit) - Trees and vegetation along landside toe

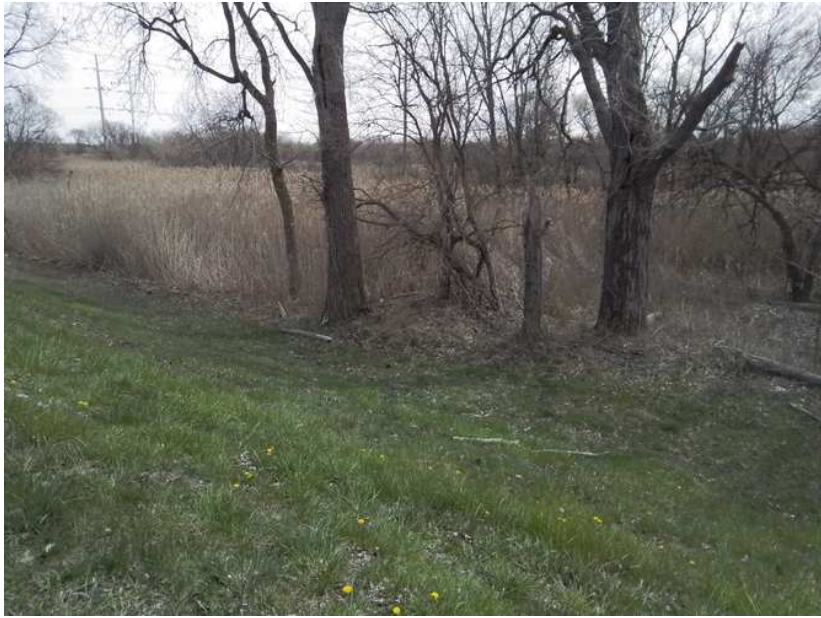
Inspect ID: 2024-0364

No User Rating (Site Visit) - Vegetation on riverside toe

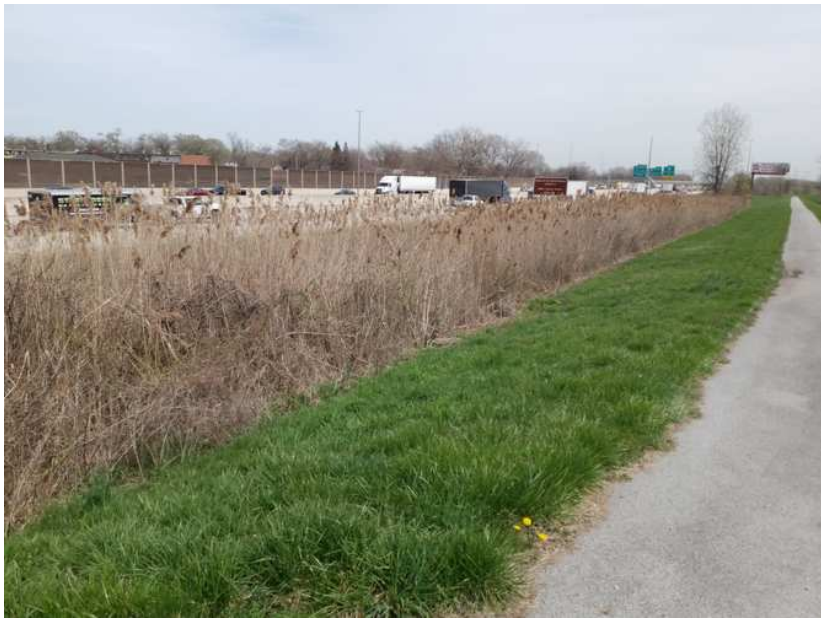
Inspect ID: 2024-0375

No User Rating (Site Visit) - Vegetation along landside toe

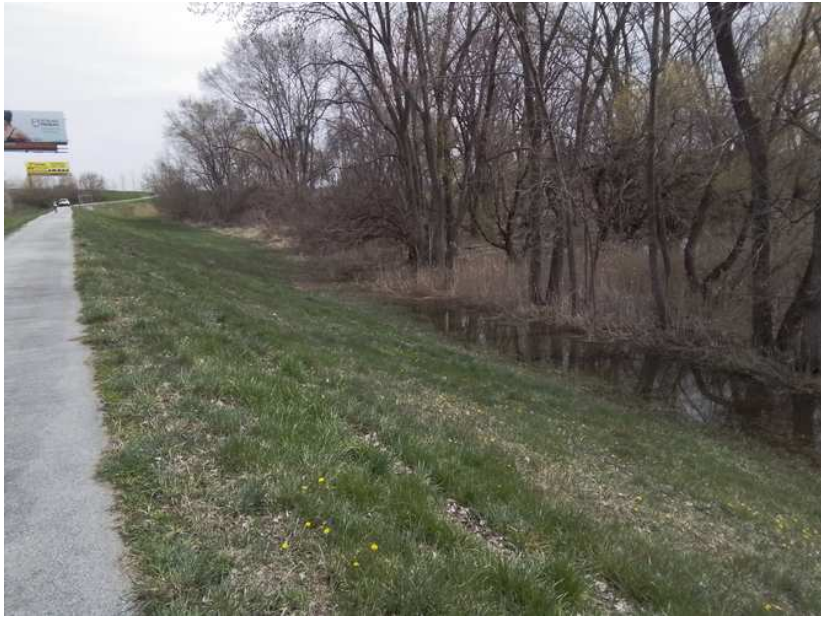
Inspect ID: 2024-0376

No User Rating (Site Visit) - Tree on riverside toe

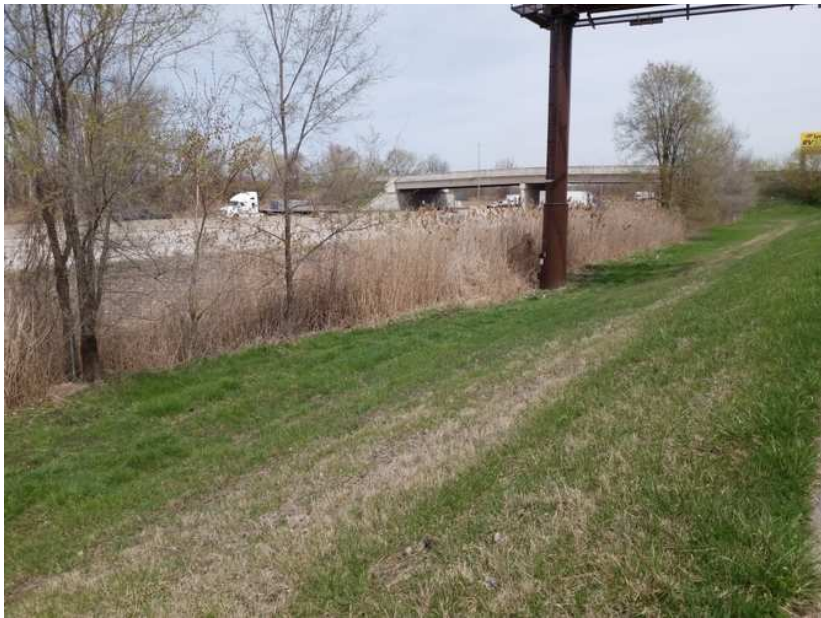
Inspect ID: 2024-0407

No User Rating (Site Visit) - Trees on landside toe

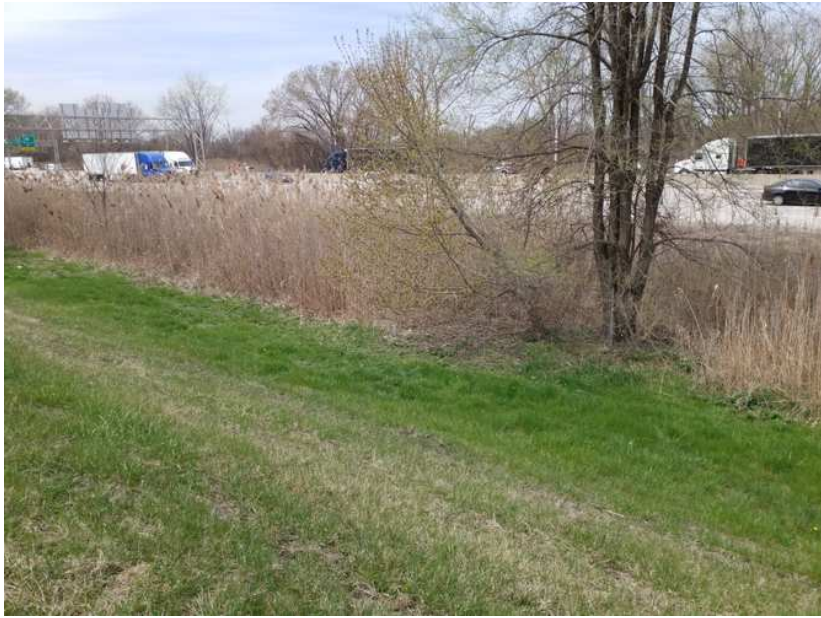
Inspect ID: 2024-0411

No User Rating (Site Visit) - Tree on landside toe

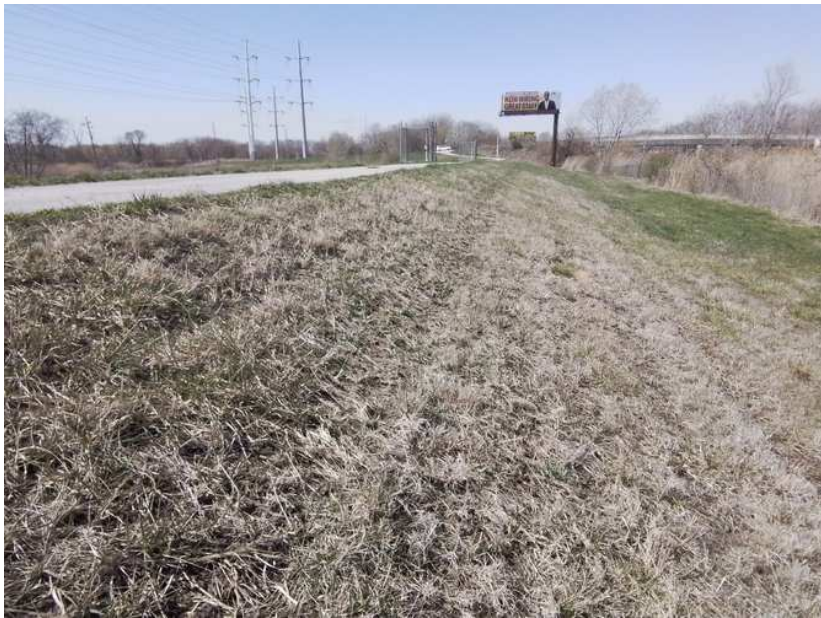
Inspect ID: 2024-0008

No User Rating (Site Visit) - Poor grass cover along landside slope

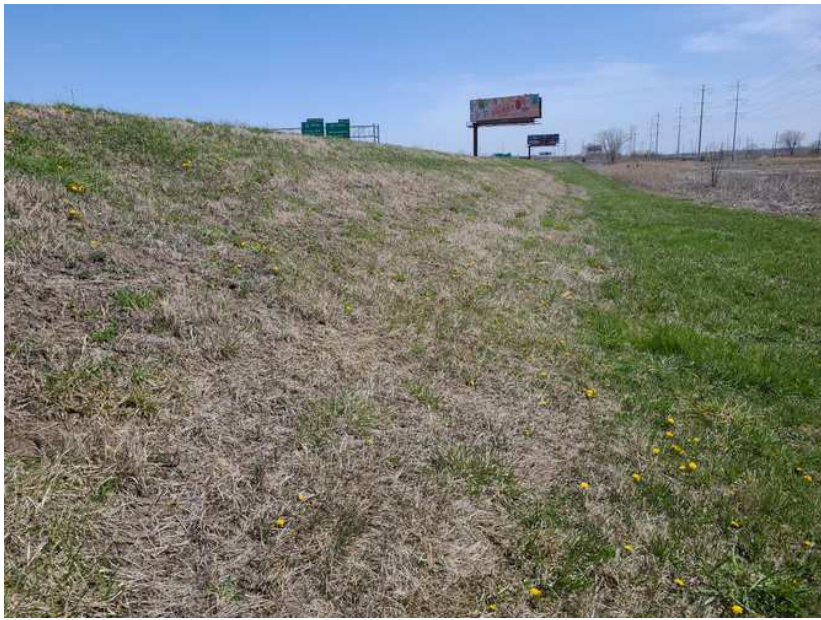
Inspect ID: 2024-0017
Rated Item: 2. Sod Cover
Lat/Long: 41.56680/-87.32473
Caption:

No User Rating (Site Visit) - Poor sod cover along riverside slope

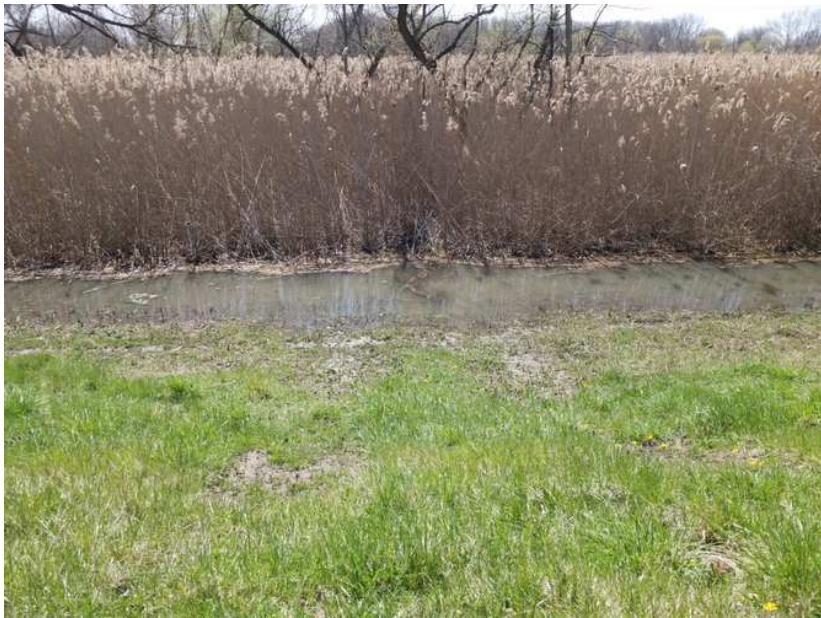
Inspect ID: 2024-0035
Rated Item: 2. Sod Cover
Lat/Long: 41.56712/-87.34766
Caption:

No User Rating (Site Visit) - Minor loss of sod cover on riverside toe and slope

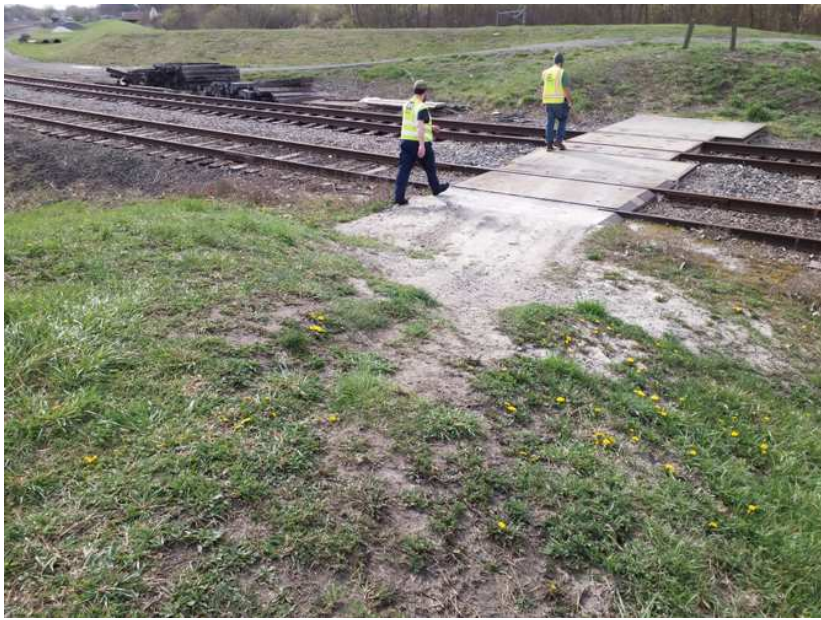
Inspect ID: 2024-0111

No User Rating (Site Visit) - Poor sod cover at railroad closure

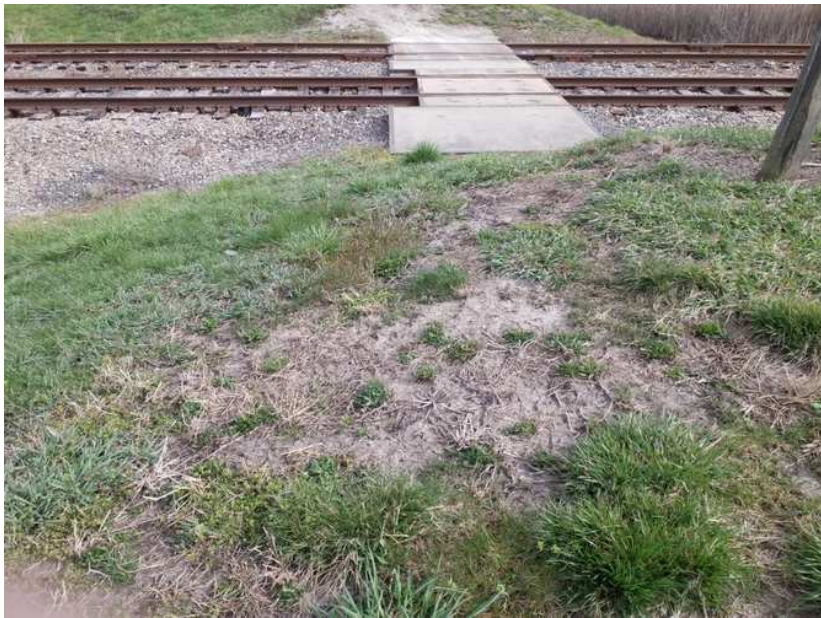
Inspect ID: 2024-0115

No User Rating (Site Visit) - Poor sod cover at railroad closure

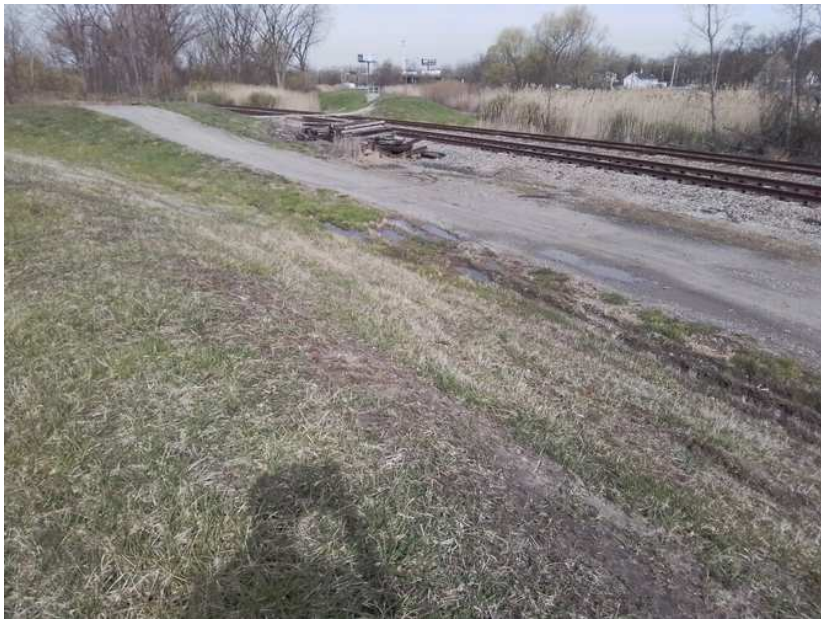
Inspect ID: 2024-0128

No User Rating (Site Visit) - Poor sod cover on crown
