**US Army Corps
of Engineers ®**

Site Visit Summary

Name of System: Gary

Name of Segment: Gary North

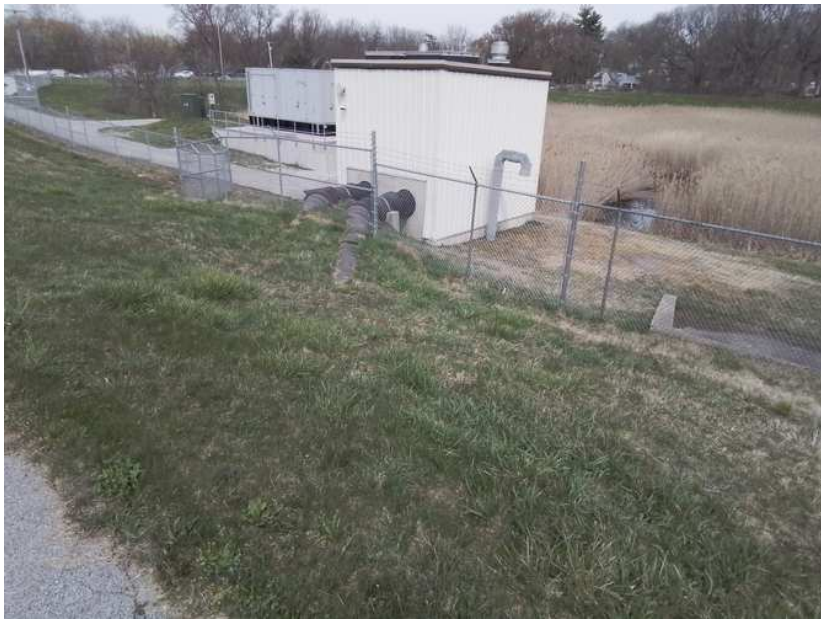
Inspect ID: 2024-0240

No User Rating (Site Visit) - GN-07: Poor sod cover over pipes on landside

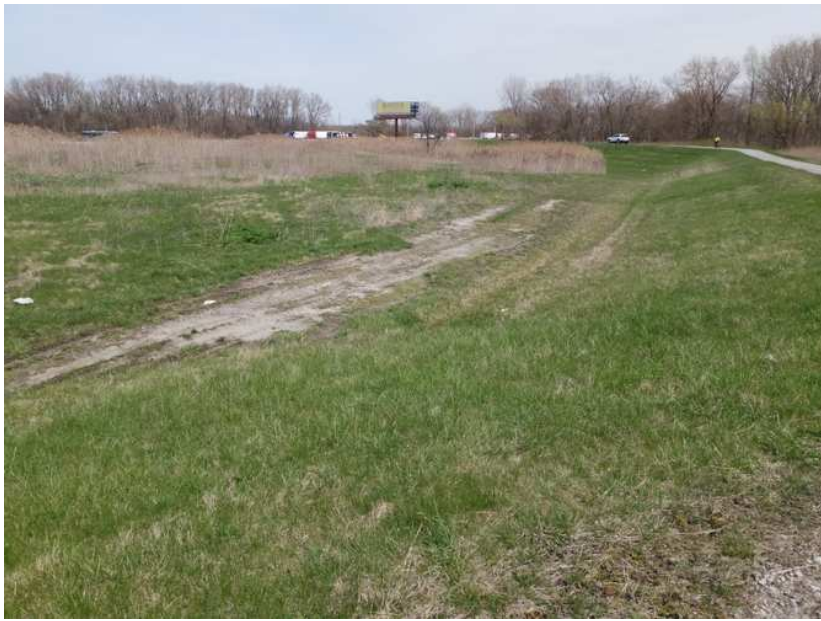
Inspect ID: 2024-0395

No User Rating (Site Visit) - Poor grass cover on landside toe

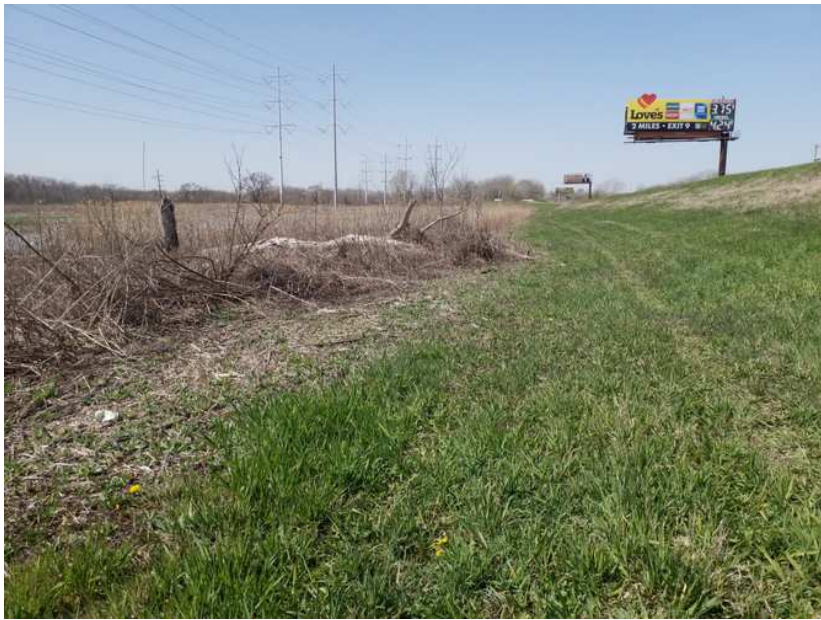
Inspect ID: 2024-0003

No User Rating (Site Visit) - Dead tree branches on the riverside toe

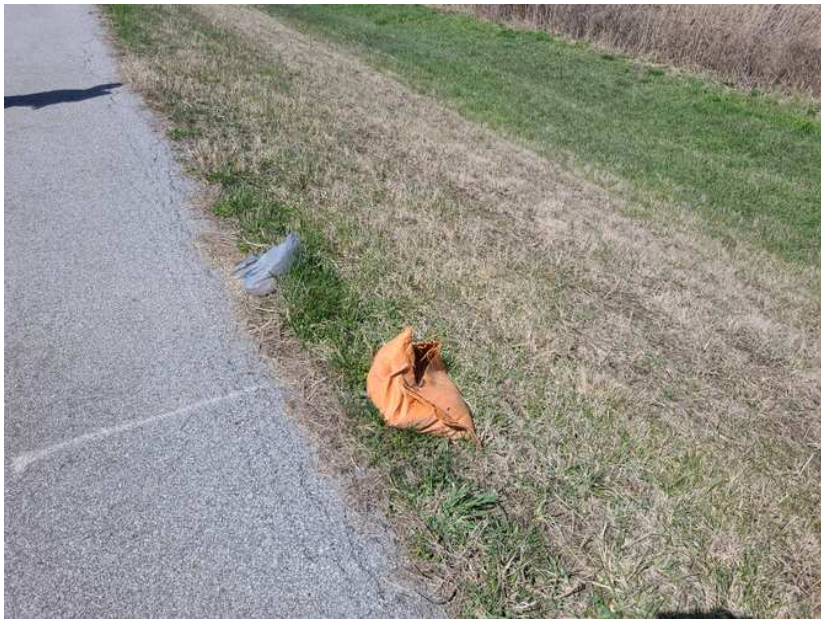
Inspect ID: 2024-0005

No User Rating (Site Visit) - Debris on crest

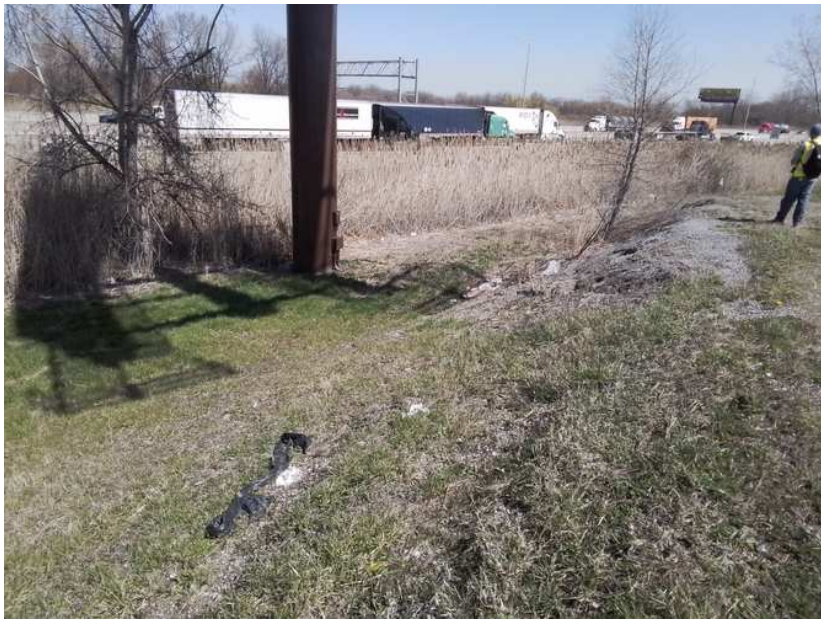
Inspect ID: 2024-0016

No User Rating (Site Visit) - Debris and sediment pile along landside toe and slope

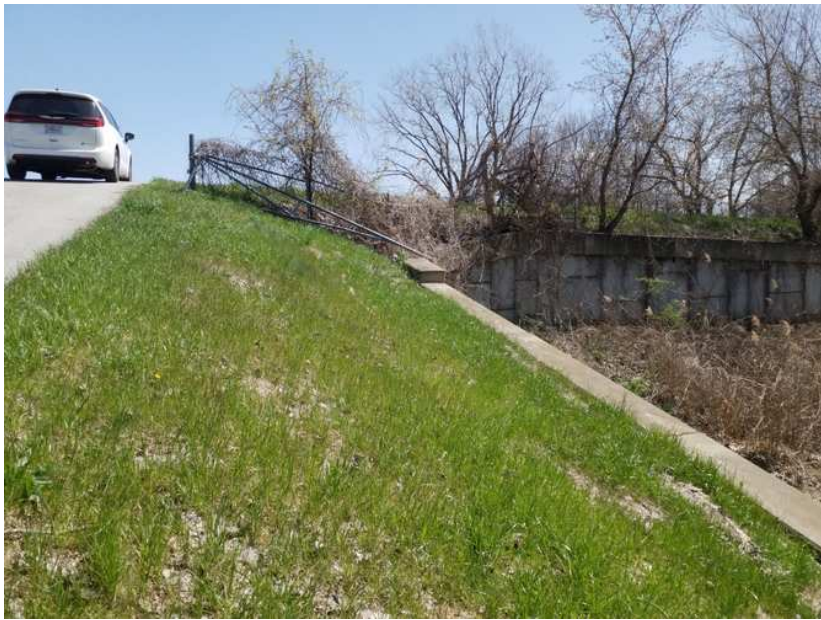
Inspect ID: 2024-0039

No User Rating (Site Visit) - Broken gate on riverside slope

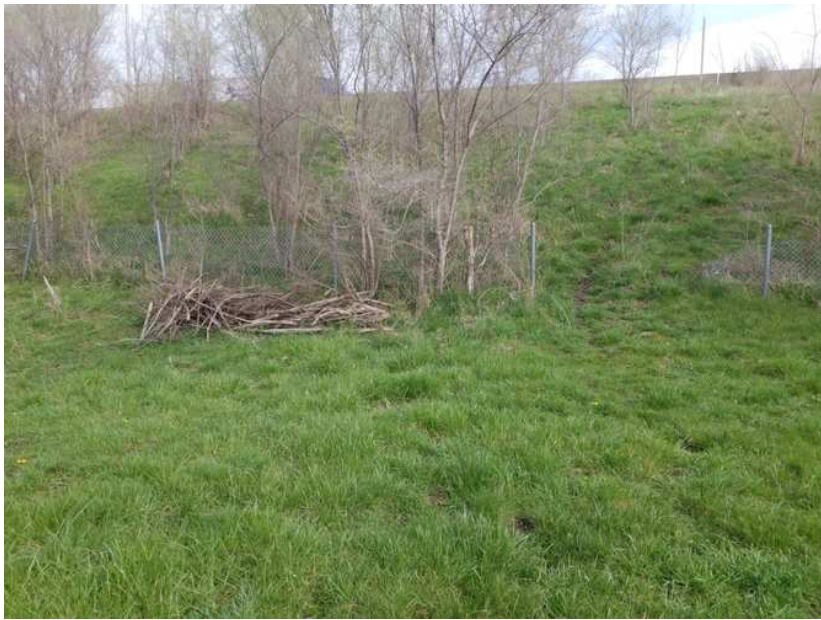
Inspect ID: 2024-0051

No User Rating (Site Visit) - Debris on riverside crown/slope. Broken fence on crown.

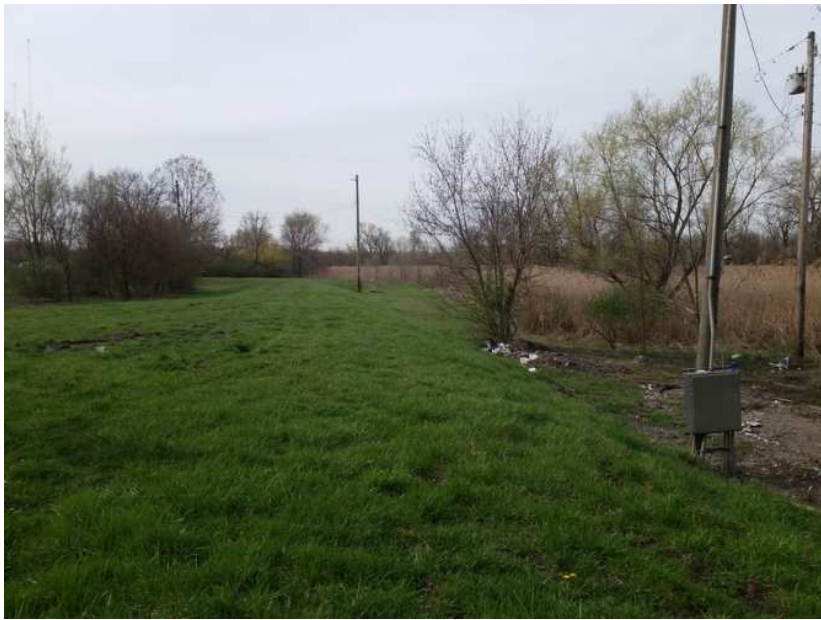
Inspect ID: 2024-0055

No User Rating (Site Visit) - Electric poles encroaching on riverside slope

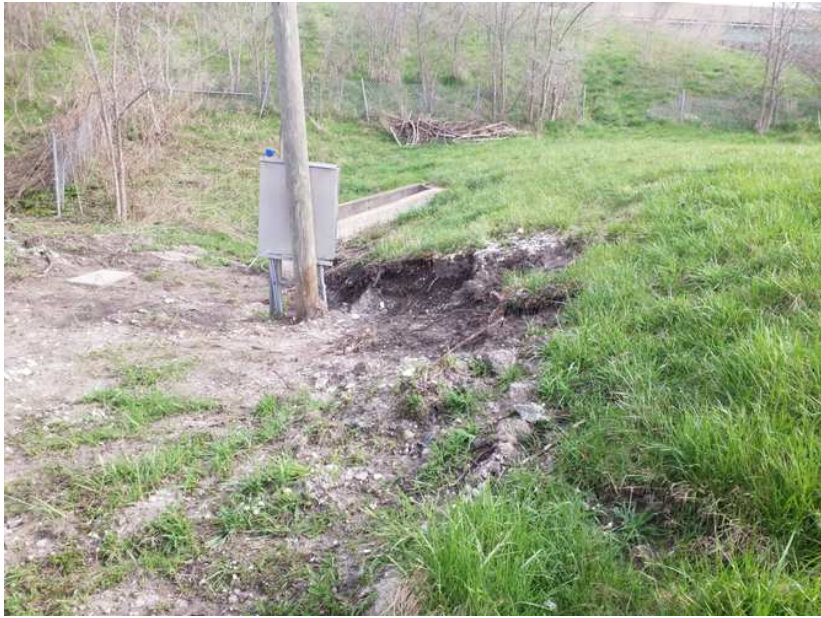
Inspect ID: 2024-0063

No User Rating (Site Visit) - Erosion and digging activity on riverside slope

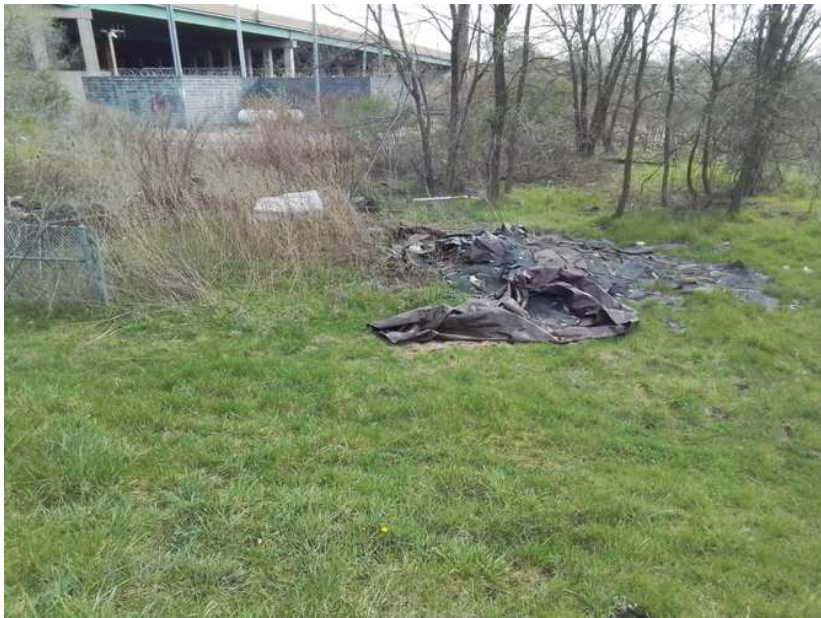
Inspect ID: 2024-0064

No User Rating (Site Visit) - Trash on landside toe

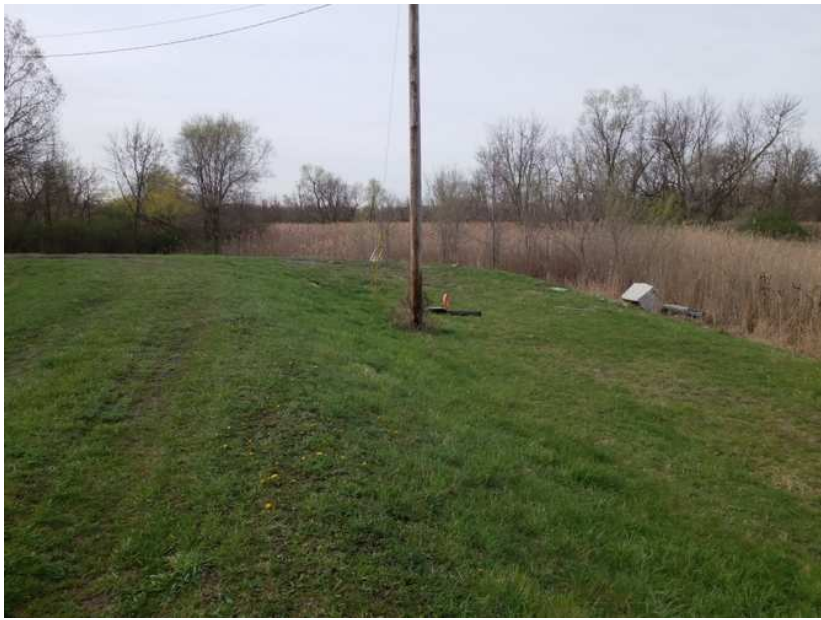
Inspect ID: 2024-0067

No User Rating (Site Visit) - Trash and debris on riverside toe and slope

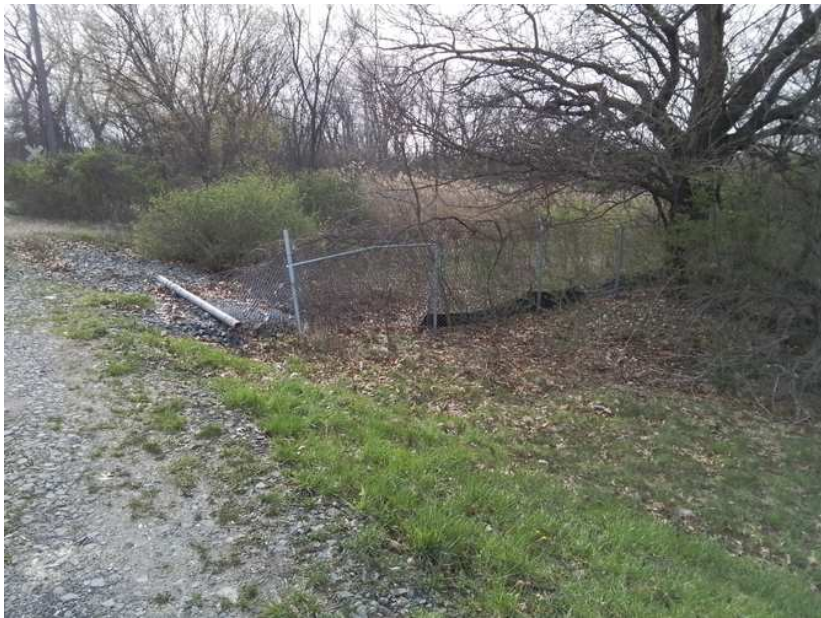
Inspect ID: 2024-0080

No User Rating (Site Visit) - Broken fence on riverside toe

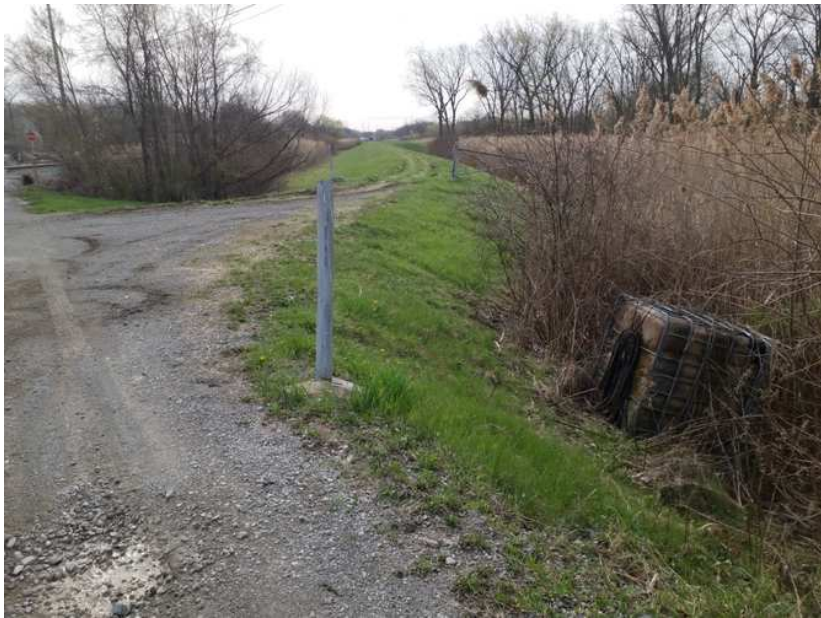
Inspect ID: 2024-0091

No User Rating (Site Visit) - Debris on riverside slope

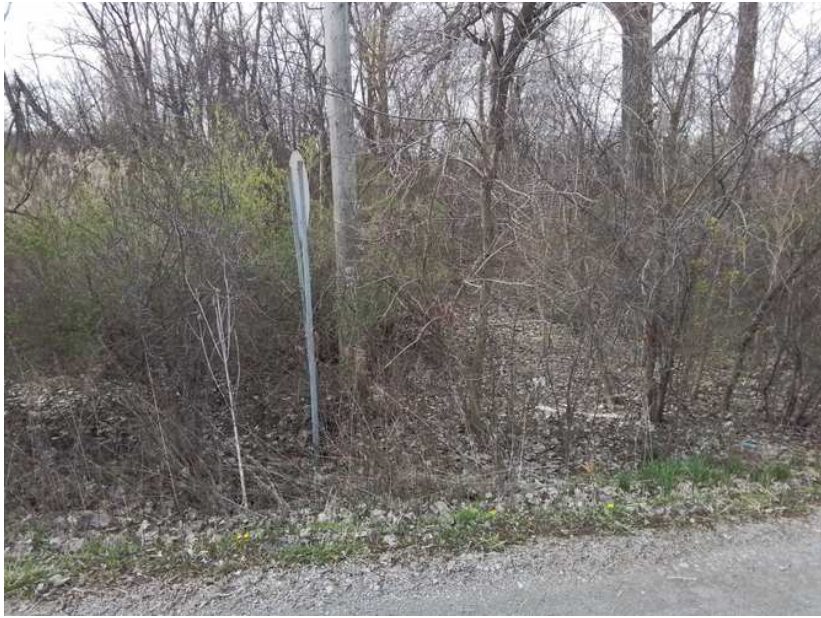
Inspect ID: 2024-0092

No User Rating (Site Visit) - Sign and pole on riverside toe

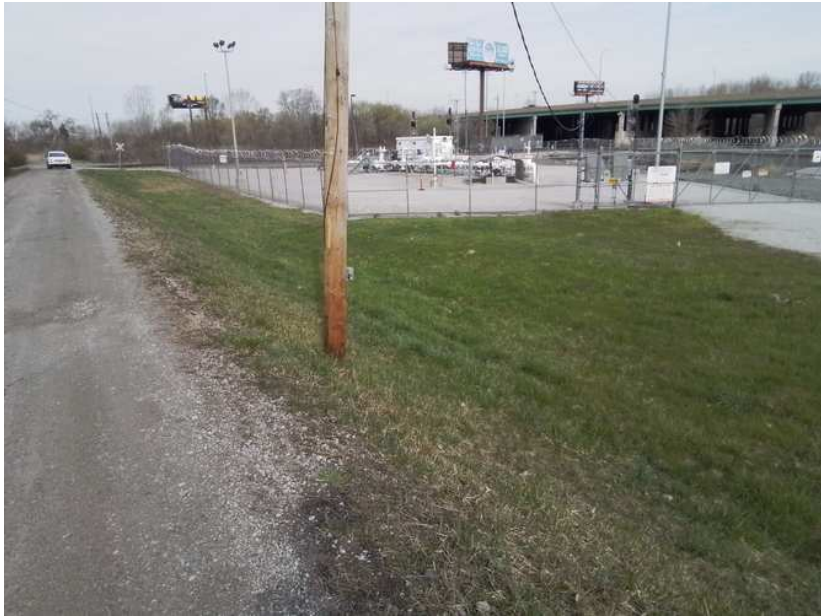
Inspect ID: 2024-0096

No User Rating (Site Visit) - Electrical pole on landside slope

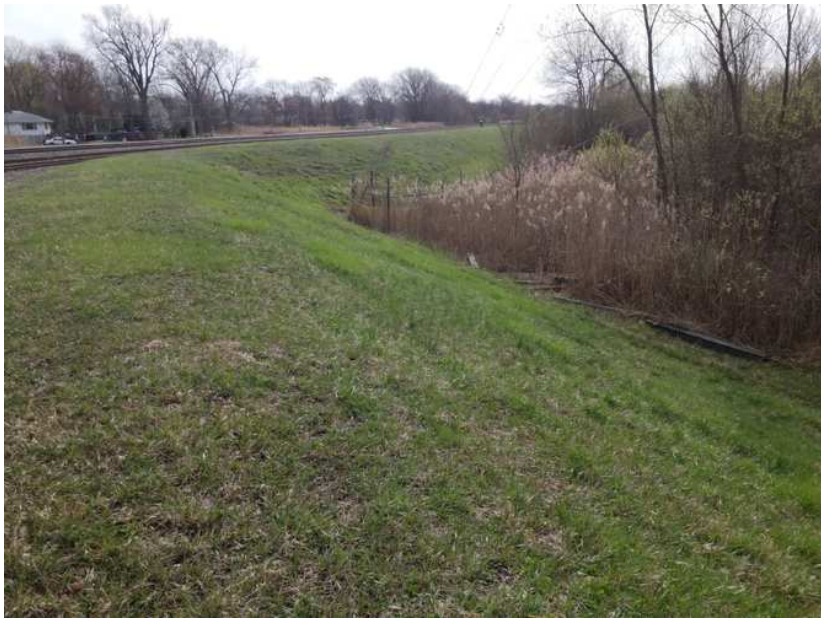
Inspect ID: 2024-0119

No User Rating (Site Visit) - Debris on riverside toe

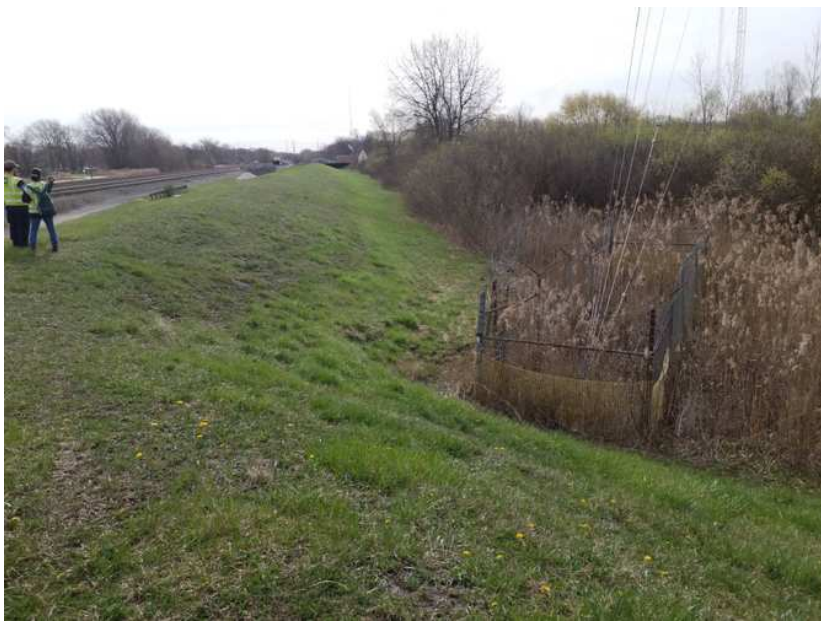
Inspect ID: 2024-0123

No User Rating (Site Visit) - Electrical wire and fence on riverside toe

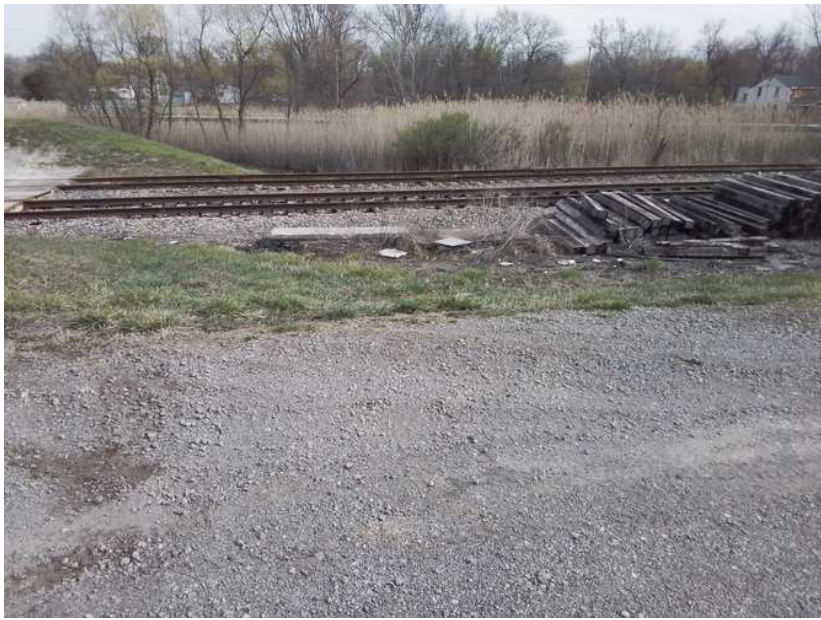
Inspect ID: 2024-0124

No User Rating (Site Visit) - Encroachment near closure

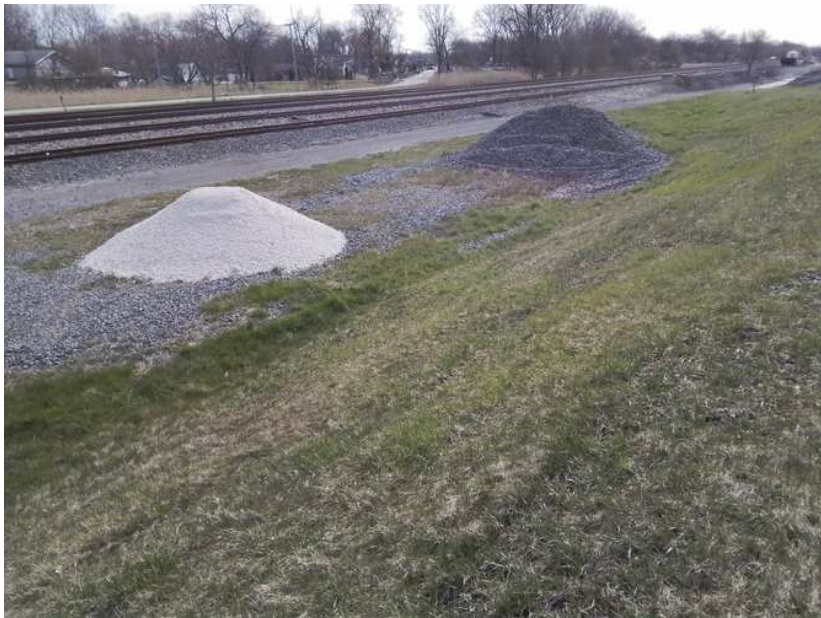
Inspect ID: 2024-0132

No User Rating (Site Visit) - Ballast encroaching on landside toe

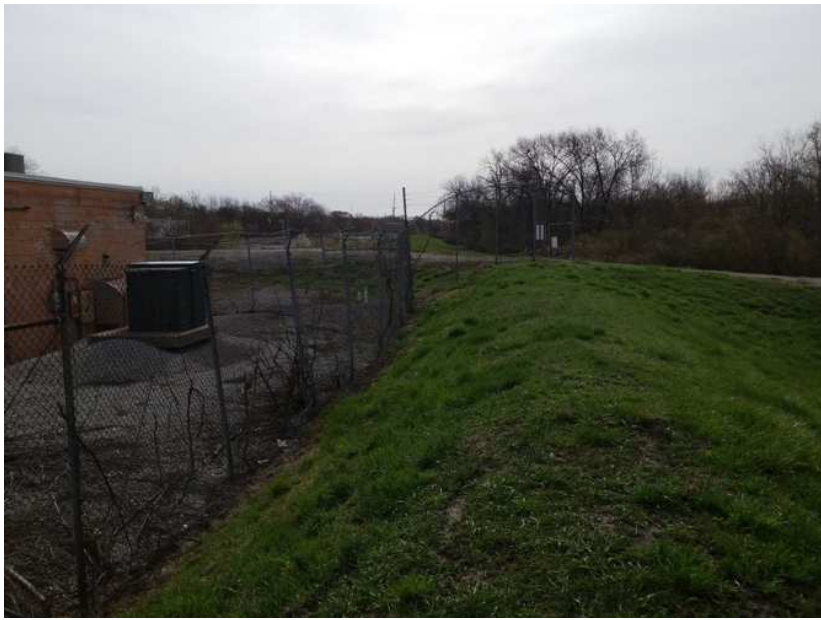
Inspect ID: 2024-0135

No User Rating (Site Visit) - Fence on landside slope and crown of tieback levee

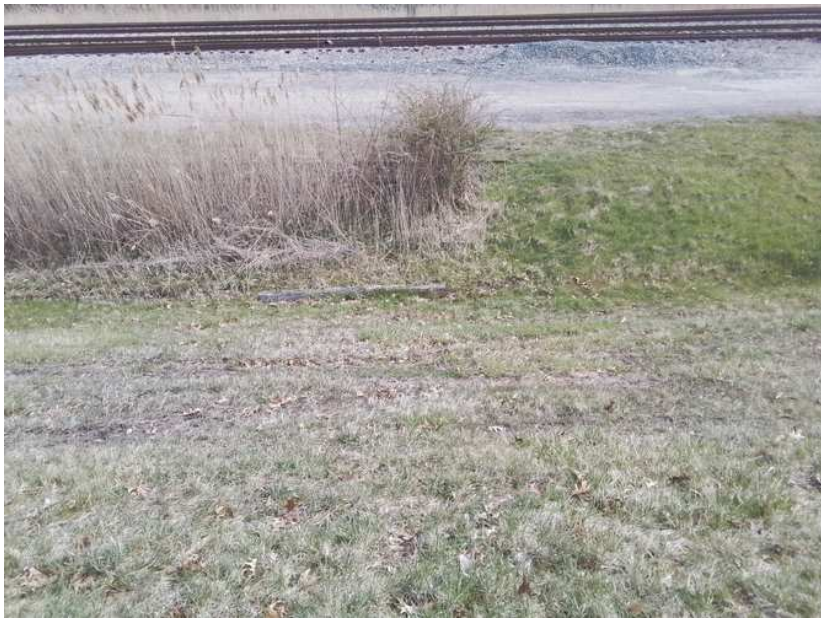
Inspect ID: 2024-0164

No User Rating (Site Visit) - Wooden beam on landside toe

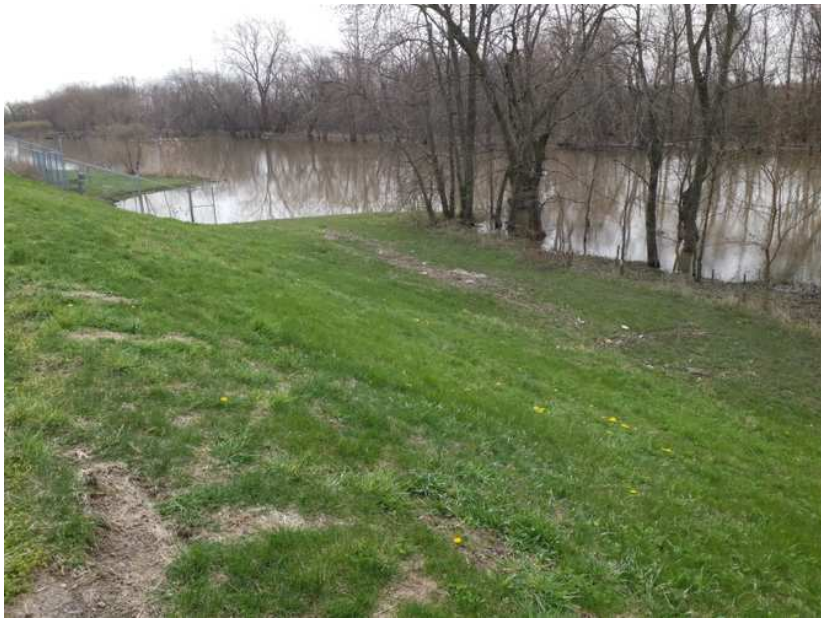
Inspect ID: 2024-0231

No User Rating (Site Visit) - Debris on riverside toe

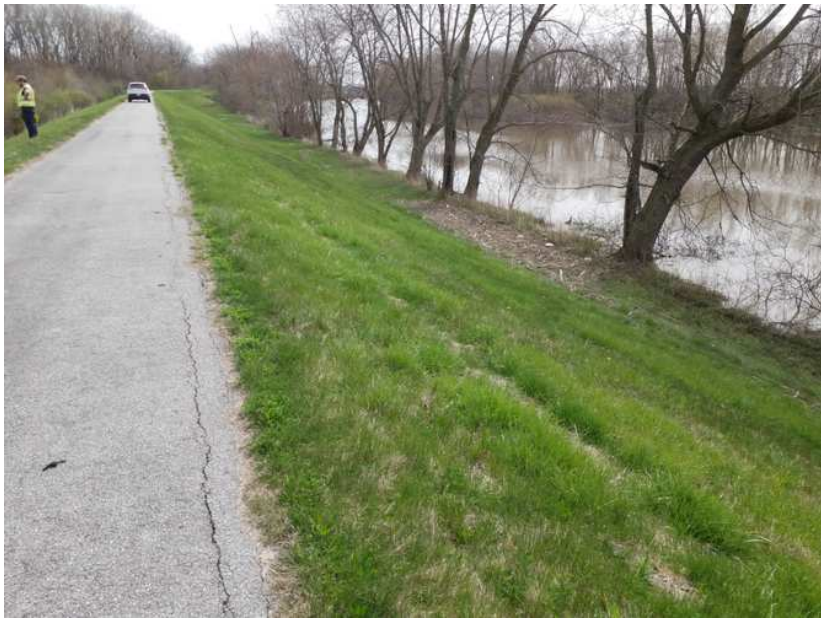
Inspect ID: 2024-0247

No User Rating (Site Visit) - Debris on riverside toe

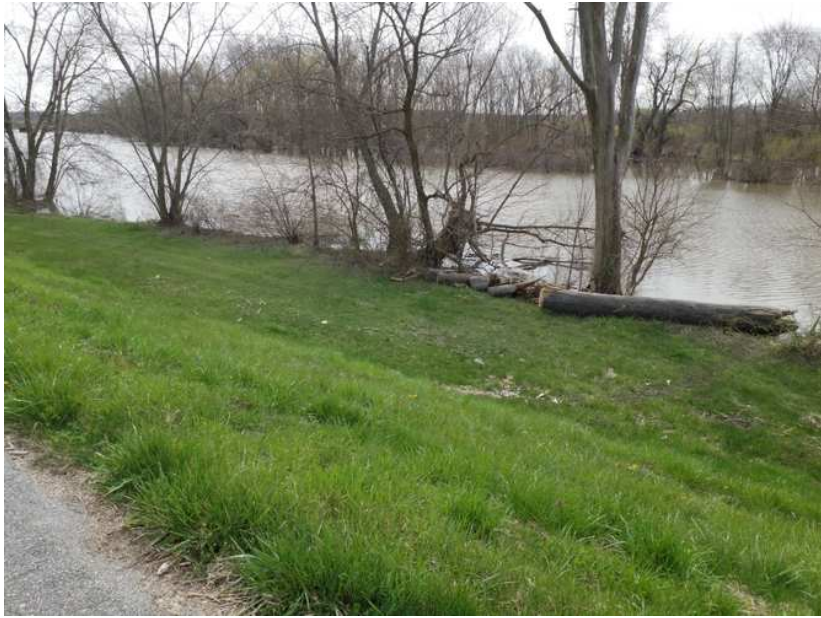
Inspect ID: 2024-0251

No User Rating (Site Visit) - Fallen tree near riverside toe

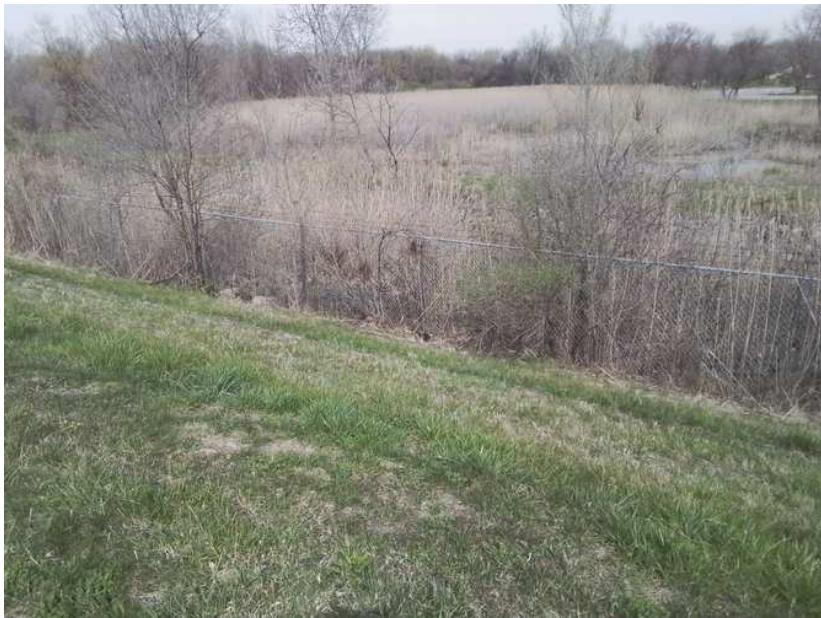
Inspect ID: 2024-0256

No User Rating (Site Visit) - Fencing along landside toe

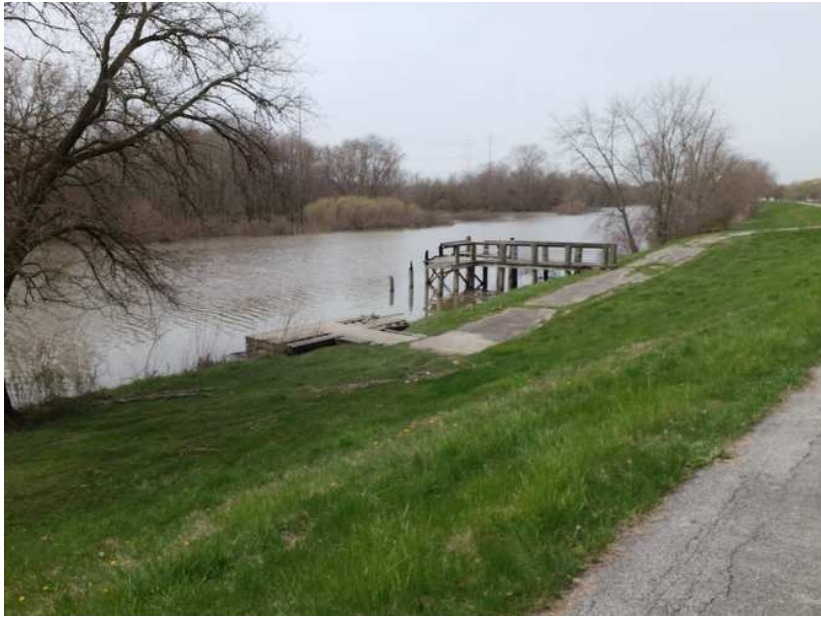
Inspect ID: 2024-0259

No User Rating (Site Visit) - Abandoned burned dock within riverside toe buffer area

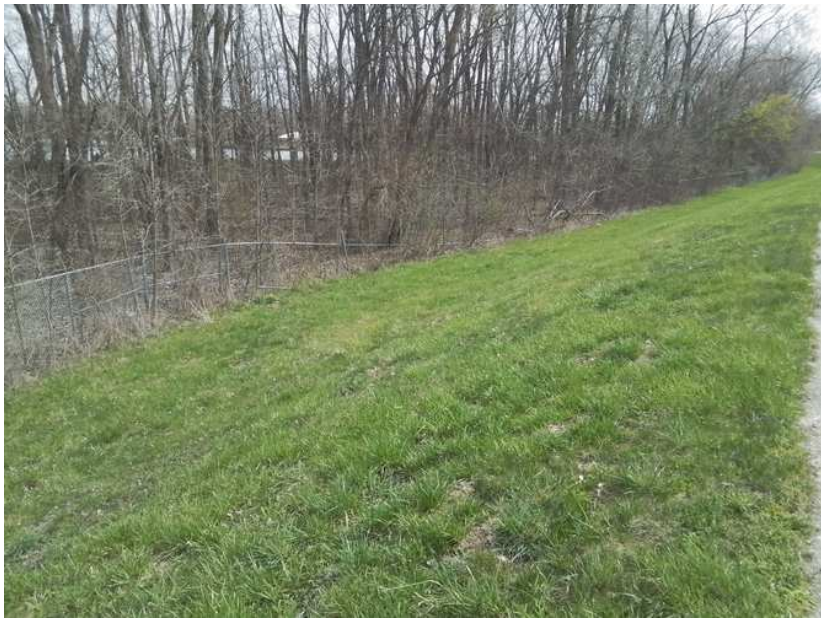
Inspect ID: 2024-0260

No User Rating (Site Visit) - Fencing down on landside toe

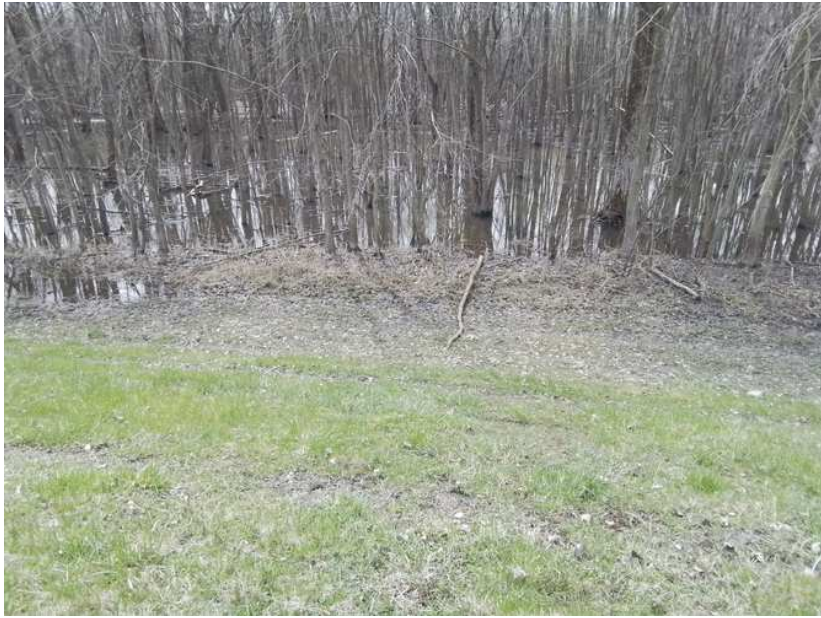
Inspect ID: 2024-0276

No User Rating (Site Visit) - Fallen tree branches on riverside toe

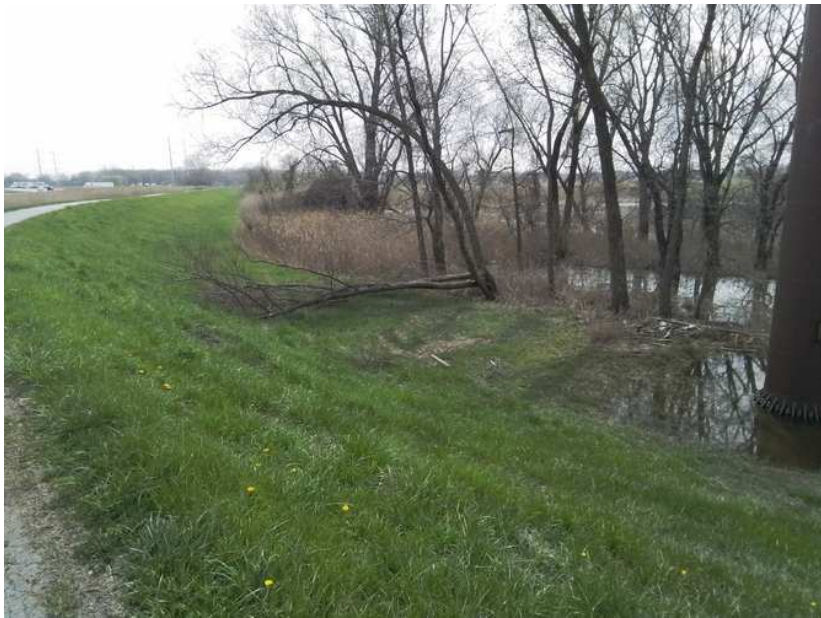
Inspect ID: 2024-0320

No User Rating (Site Visit) - Downed tree on riverside toe

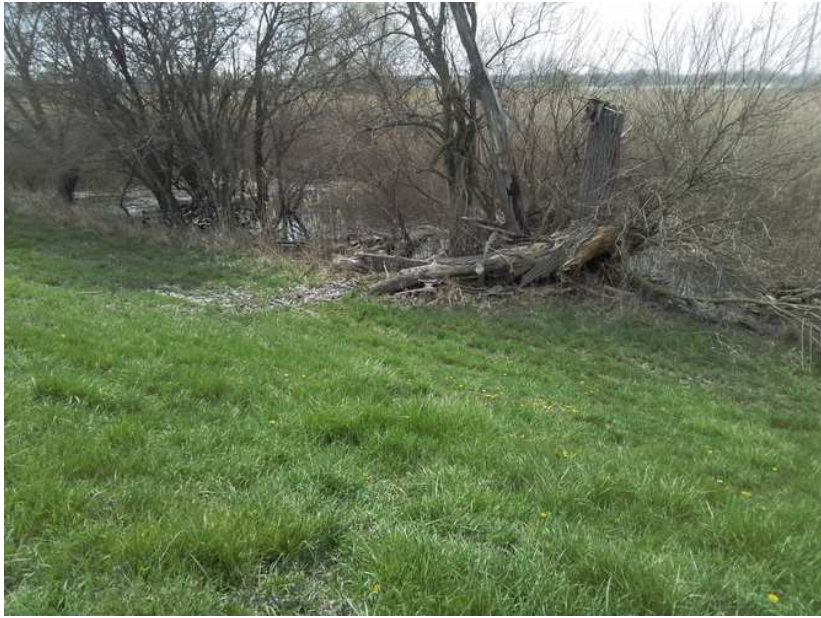
Inspect ID: 2024-0328

No User Rating (Site Visit) - Fallen tree on riverside toe and slope

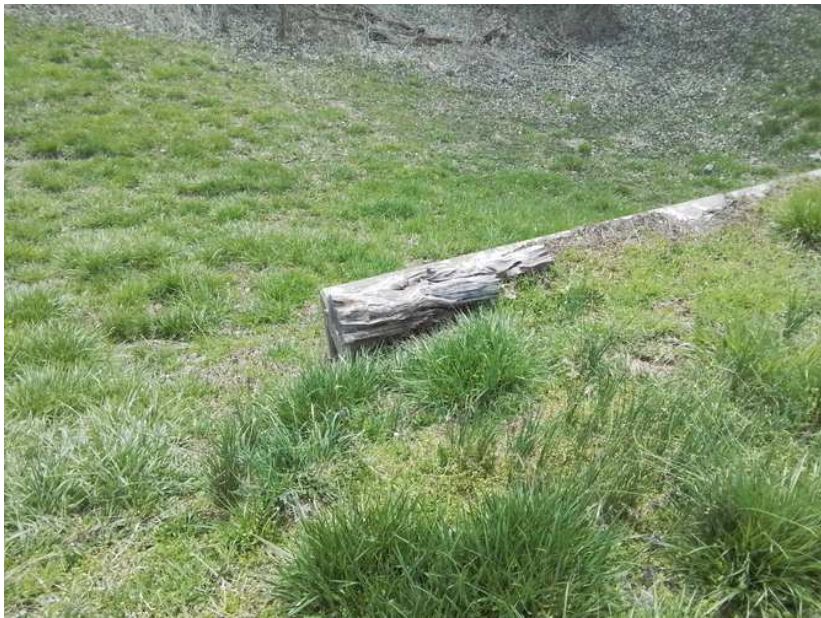
Inspect ID: 2024-0332

No User Rating (Site Visit) - Log on riverside access ramp

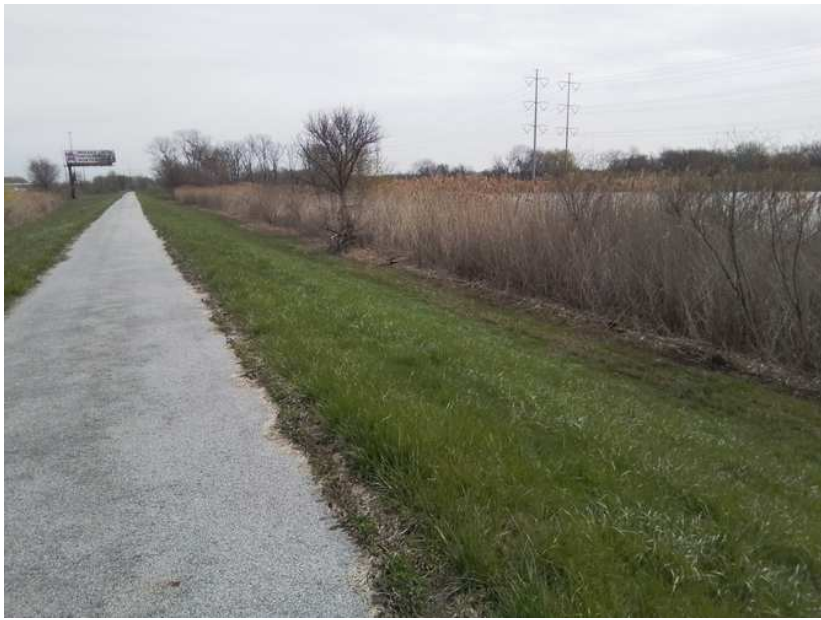
Inspect ID: 2024-0336

No User Rating (Site Visit) - Typical vegetation along riverside toe

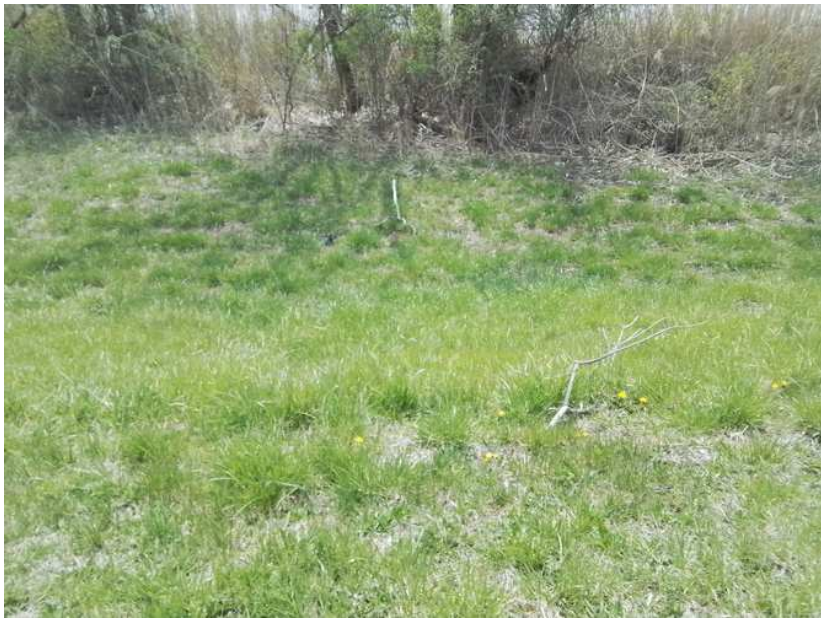
Inspect ID: 2024-0340

No User Rating (Site Visit) - Downed tree branches on riverside slope

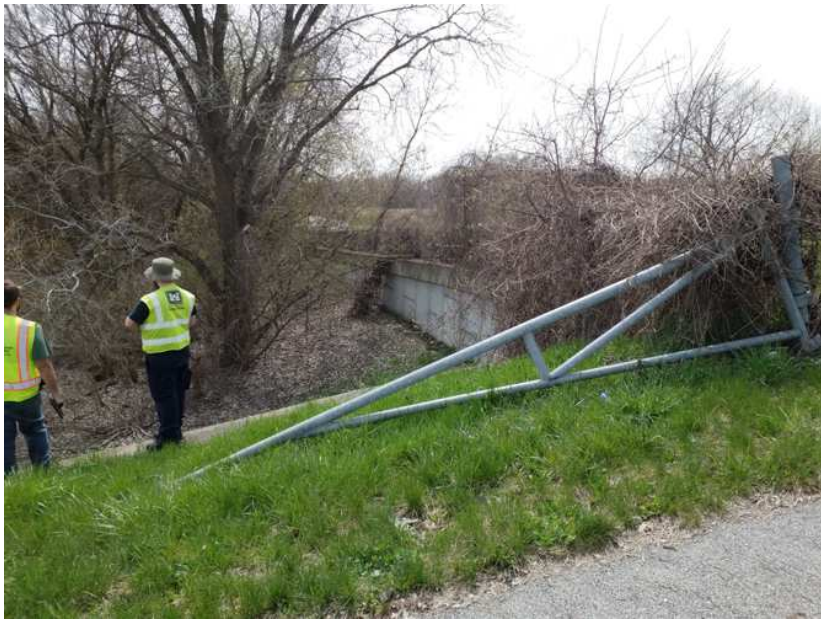
Inspect ID: 2024-0368

No User Rating (Site Visit) - Post encroaching on riverside toe

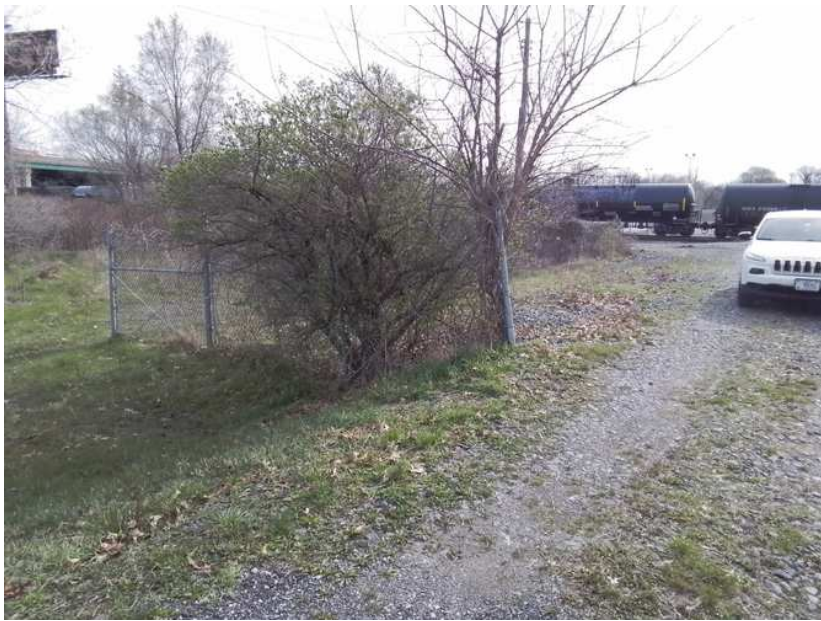
Inspect ID: 2024-0391

No User Rating (Site Visit) - Fence encroaching on crown and landside slope and toe

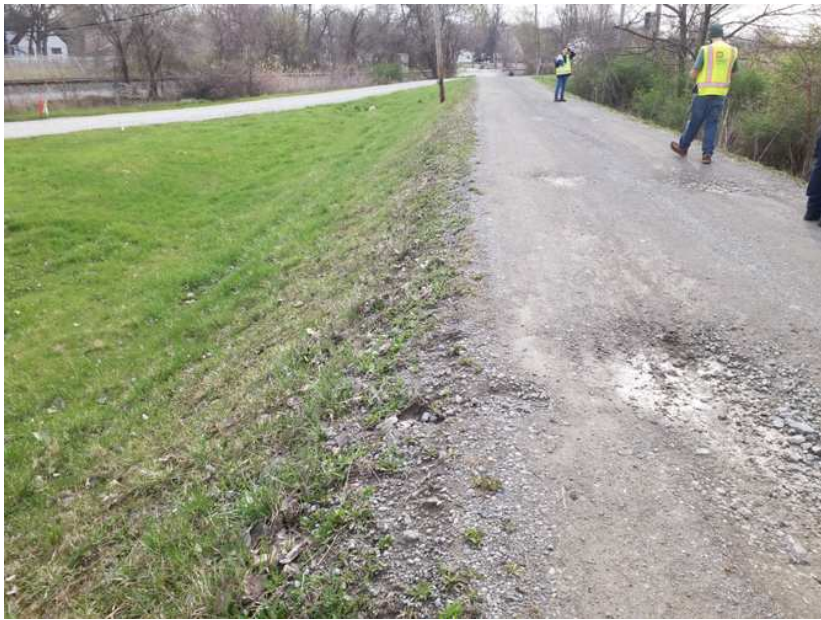
Inspect ID: 2024-0033

No User Rating (Site Visit) - Slope erosion on landside access ramp

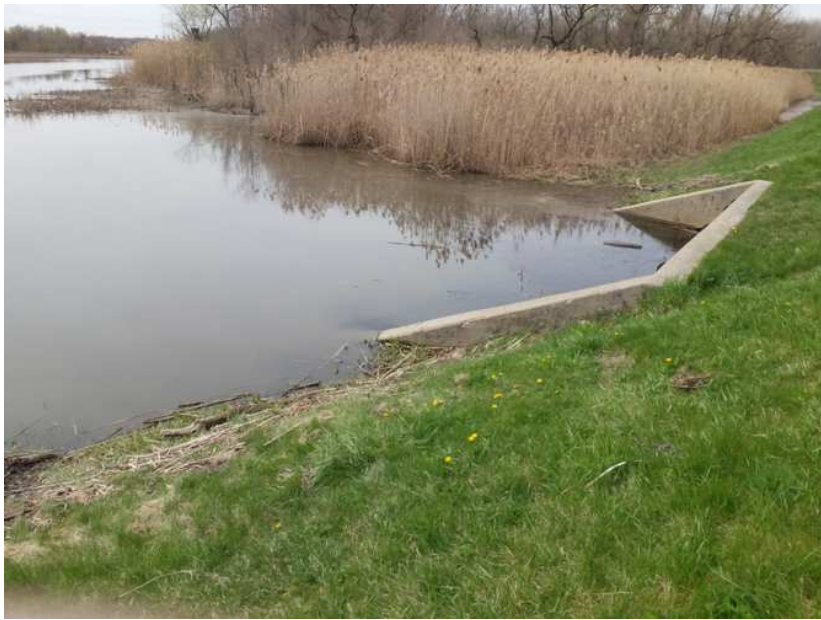
Inspect ID: 2024-0228

No User Rating (Site Visit) - Riverside slope erosion due to poor sod cover

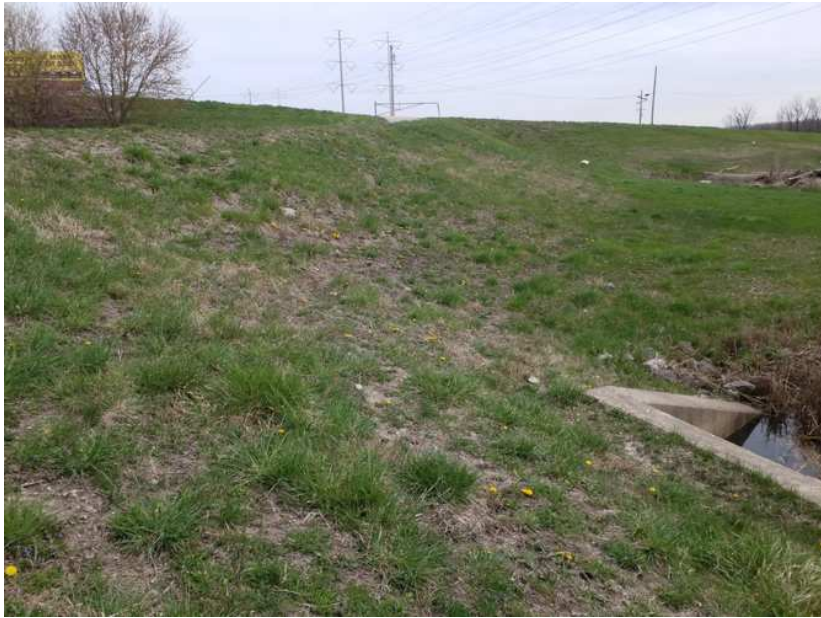
Inspect ID: 2024-0352

No User Rating (Site Visit) - Erosion along riverside toe

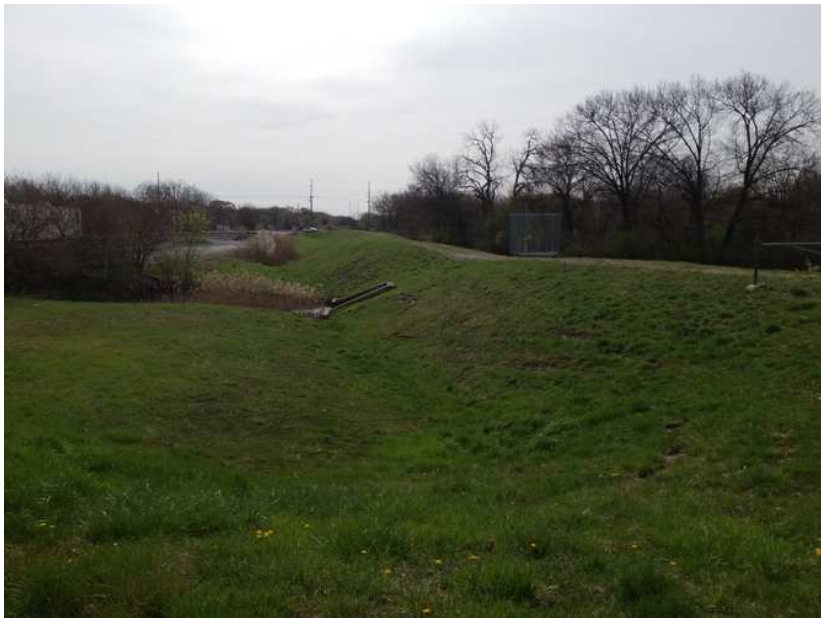
Inspect ID: 2024-0415

No User Rating (Site Visit) - Erosion along riverside slope

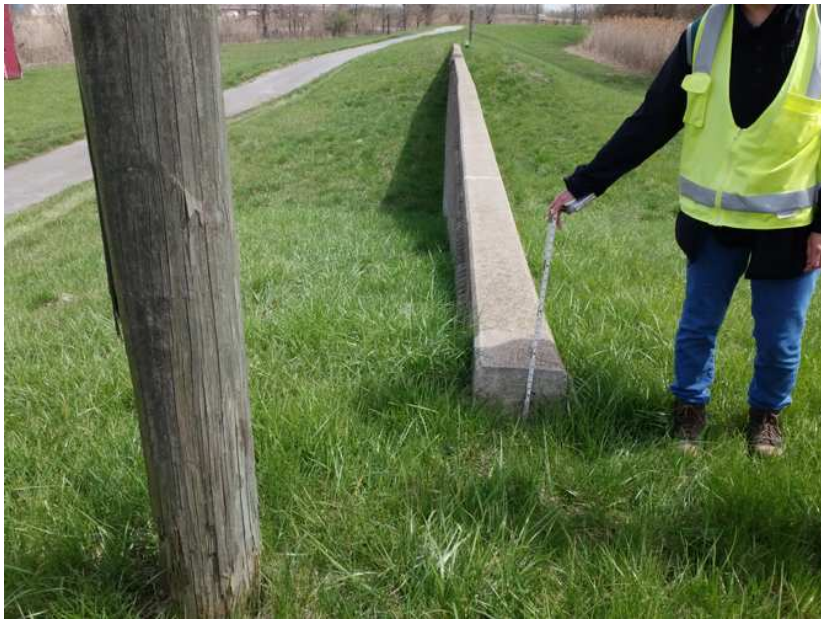
Inspect ID: 2024-0139

No User Rating (Site Visit) - Settlement in crest and slope near GN-03

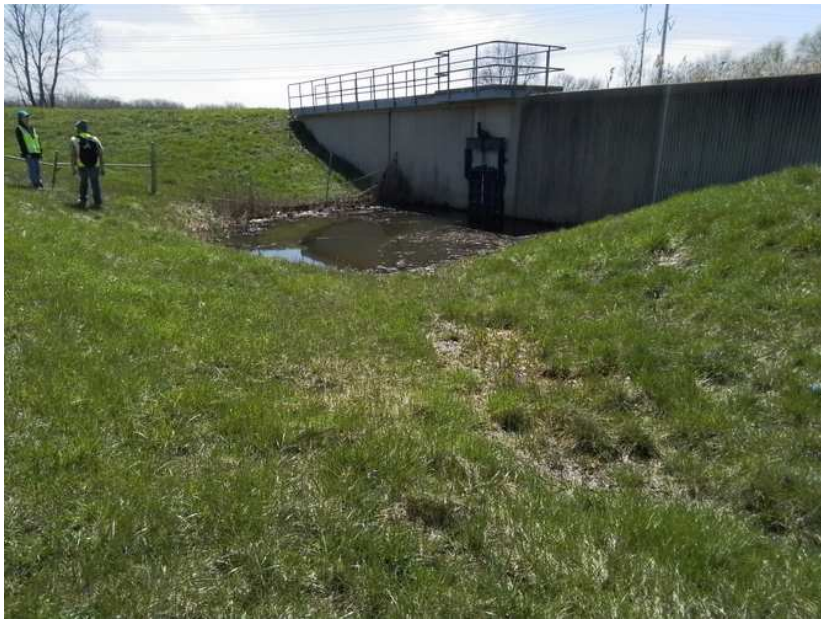
Inspect ID: 2024-0007

No User Rating (Site Visit) - Rutting from vehicle tires along riverside toe

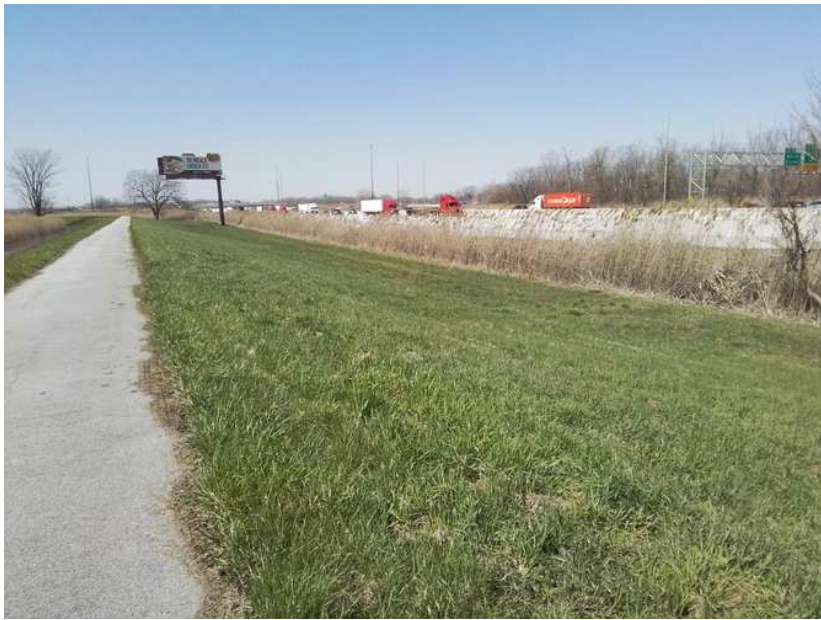
Inspect ID: 2024-0025

No User Rating (Site Visit) - Depression in crest

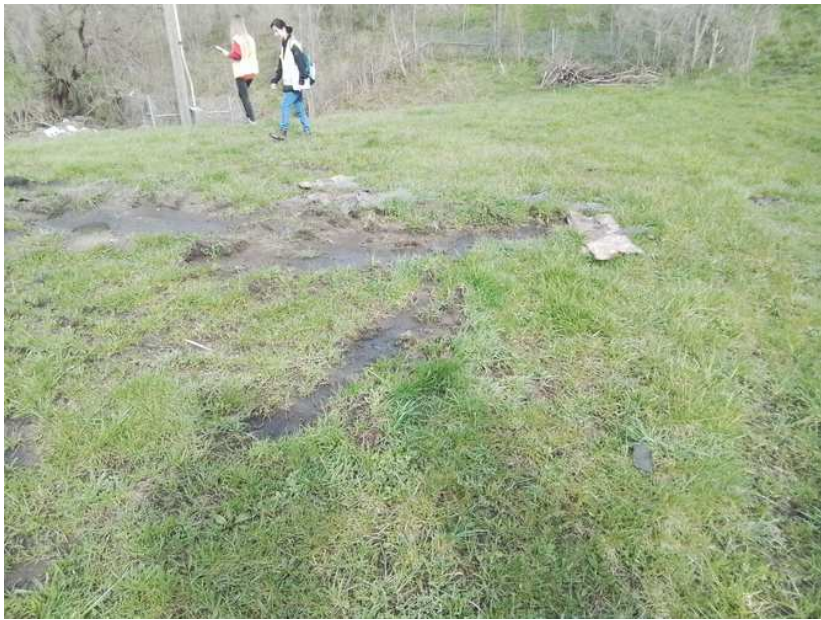
Inspect ID: 2024-0036

No User Rating (Site Visit) - Depression in landside slope
