**US Army Corps
of Engineers ®**

Site Visit Summary

Name of System: Gary

Name of Segment: Gary North

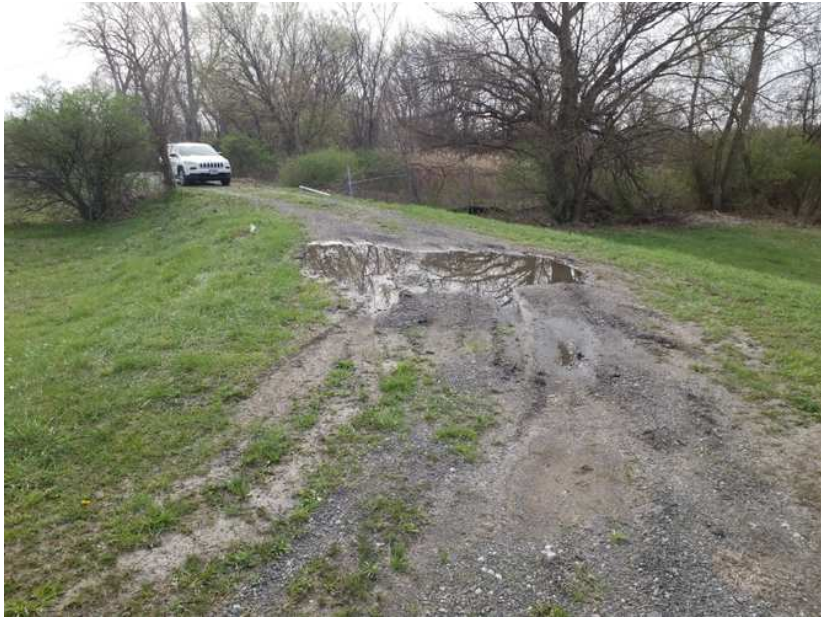
Inspect ID: 2024-0068

No User Rating (Site Visit) - Rutting on crest

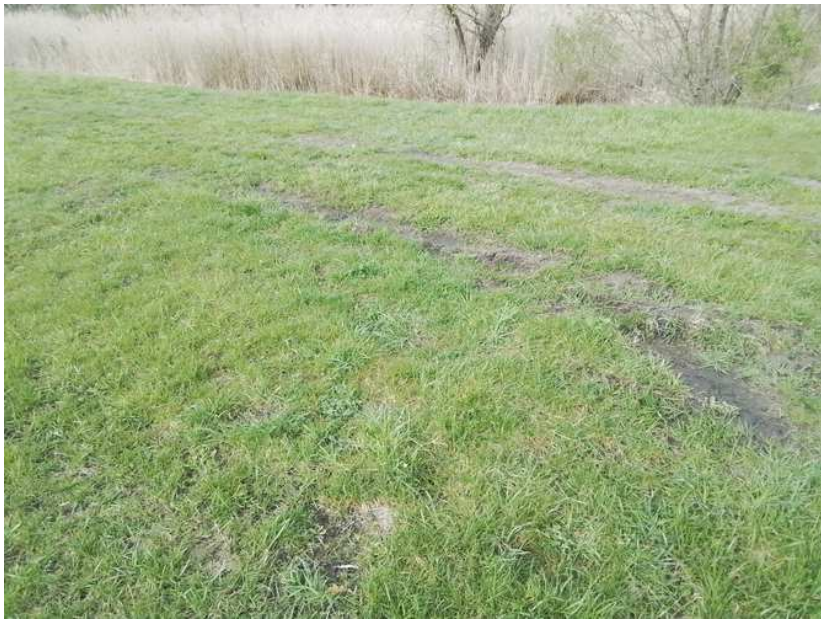
Inspect ID: 2024-0071

No User Rating (Site Visit) - Rutting and ponding on crown of levee

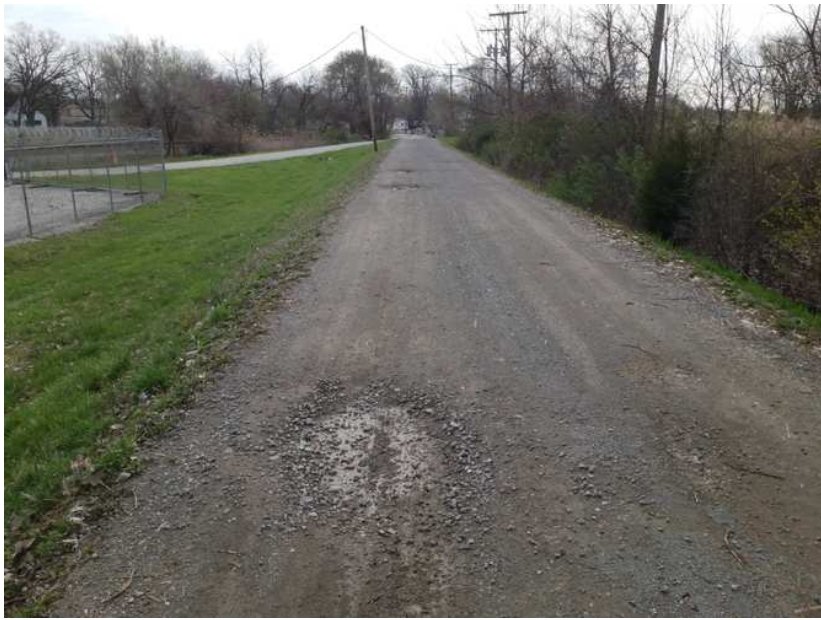
Inspect ID: 2024-0072

No User Rating (Site Visit) - Depression on crown

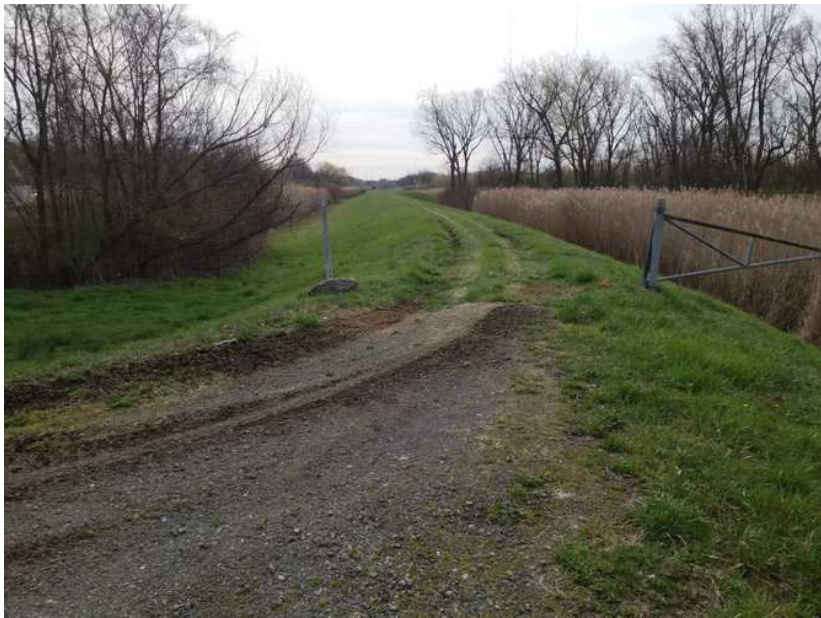
Inspect ID: 2024-0083

No User Rating (Site Visit) - Rutting along levee crown

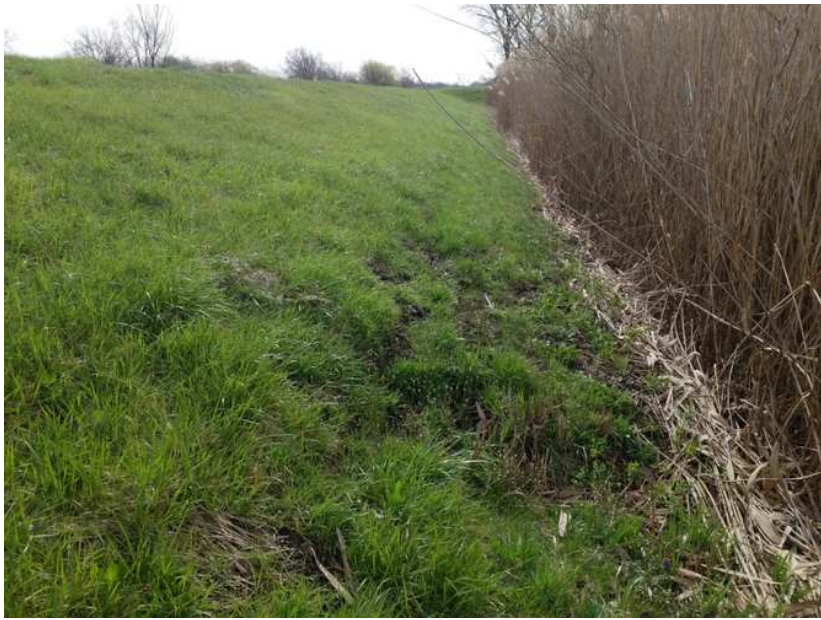
Inspect ID: 2024-0095

No User Rating (Site Visit) - Rutting along levee crown

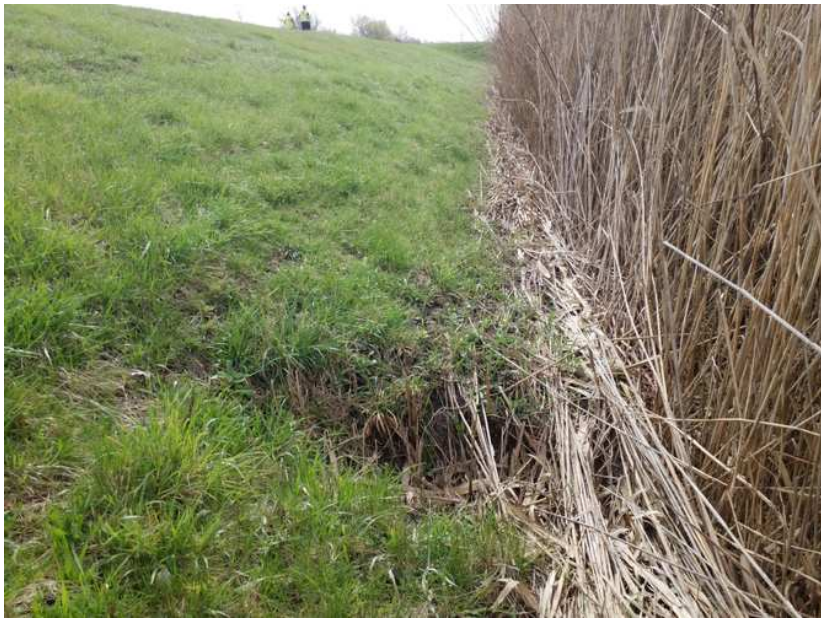
Inspect ID: 2024-0099

No User Rating (Site Visit) - Depression on riverside toe

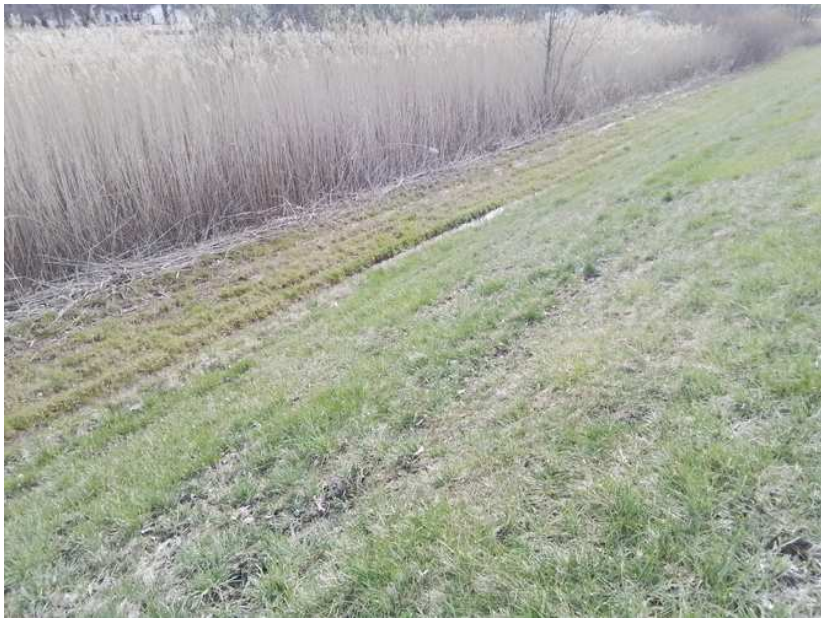
Inspect ID: 2024-0103

No User Rating (Site Visit) - Large depression in riverside toe

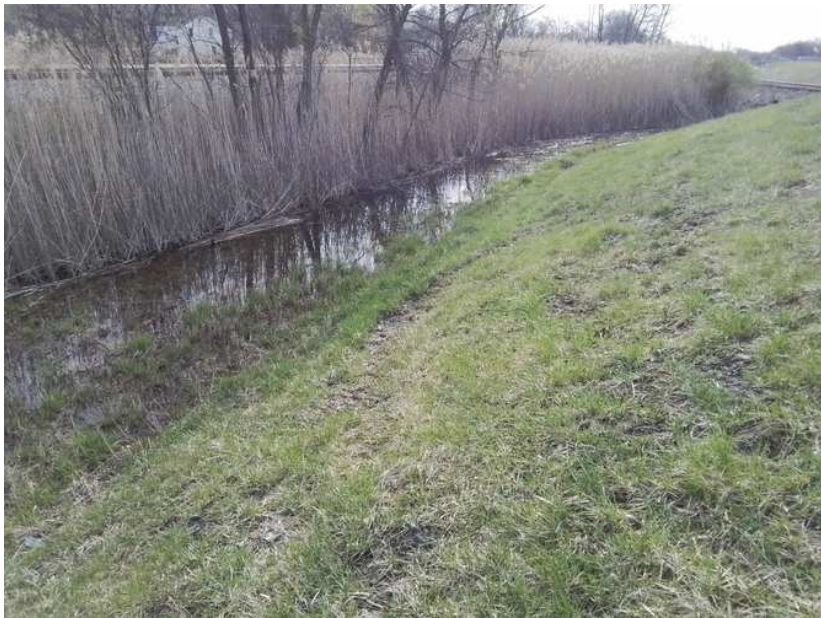
Inspect ID: 2024-0108

No User Rating (Site Visit) - Rutting on landside toe

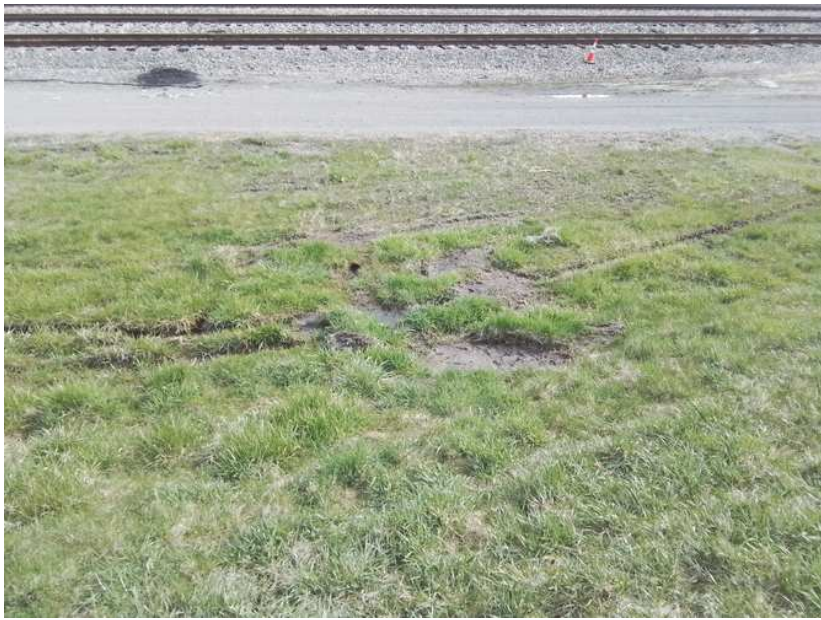
Inspect ID: 2024-0120

No User Rating (Site Visit) - Rutting on landside slope

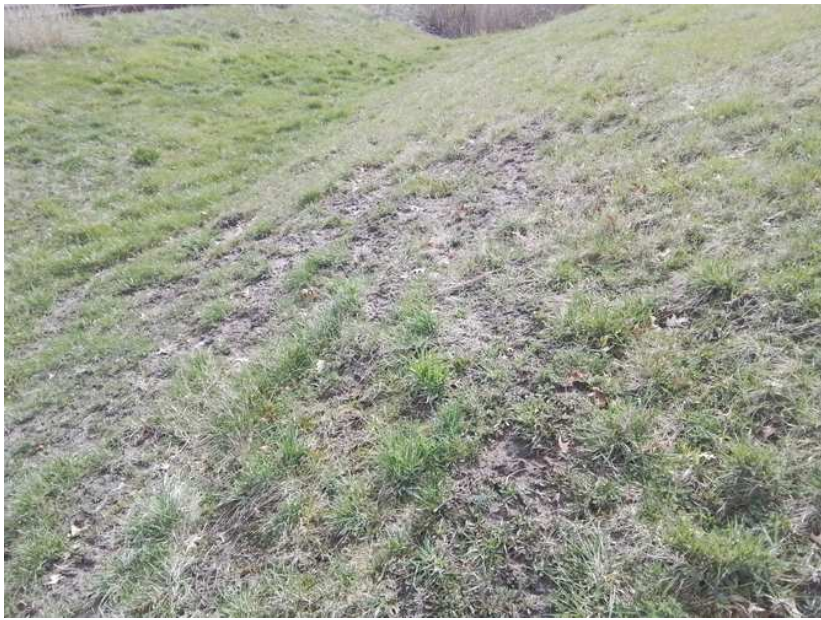
Inspect ID: 2024-0136

No User Rating (Site Visit) - Rutting on landside toe

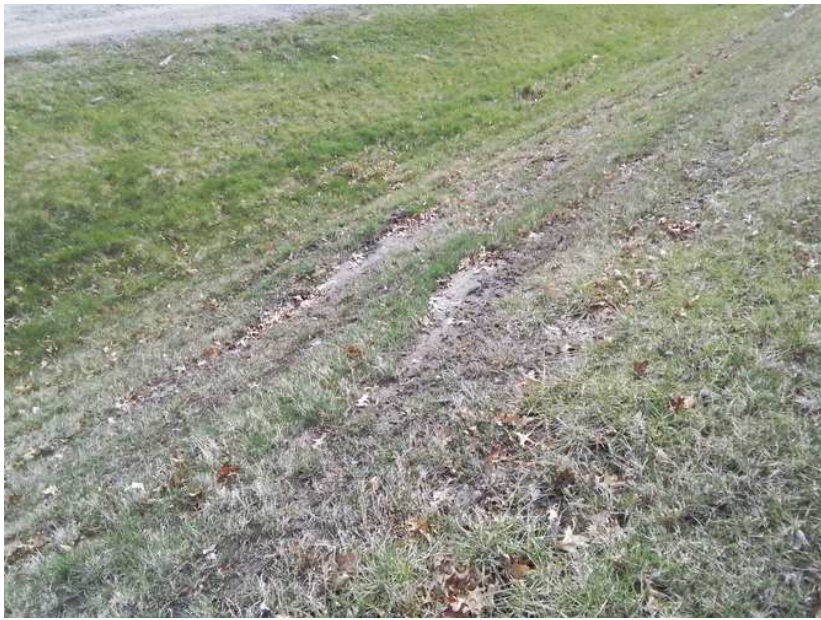
Inspect ID: 2024-0156

No User Rating (Site Visit) - Rutting on landside slope

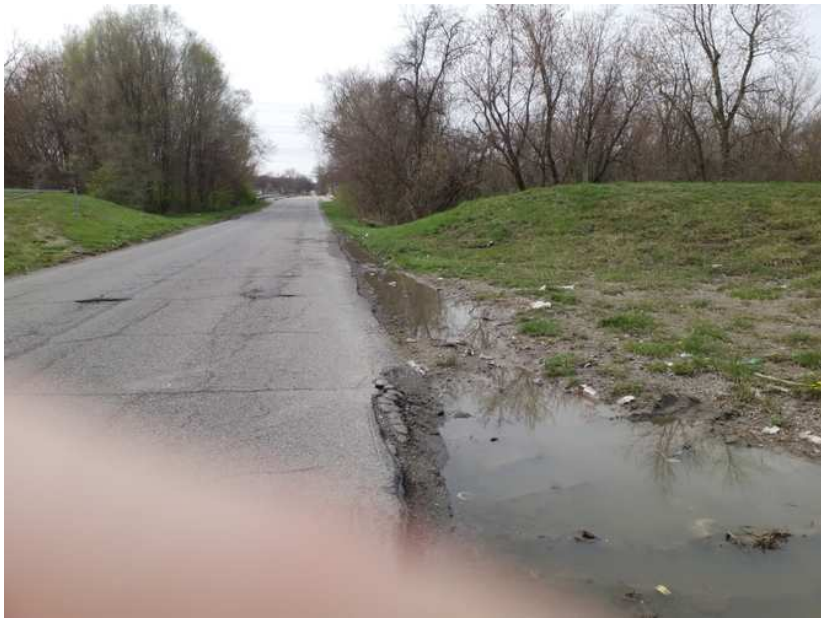
Inspect ID: 2024-0168

No User Rating (Site Visit) - Deep rutting on landside slope

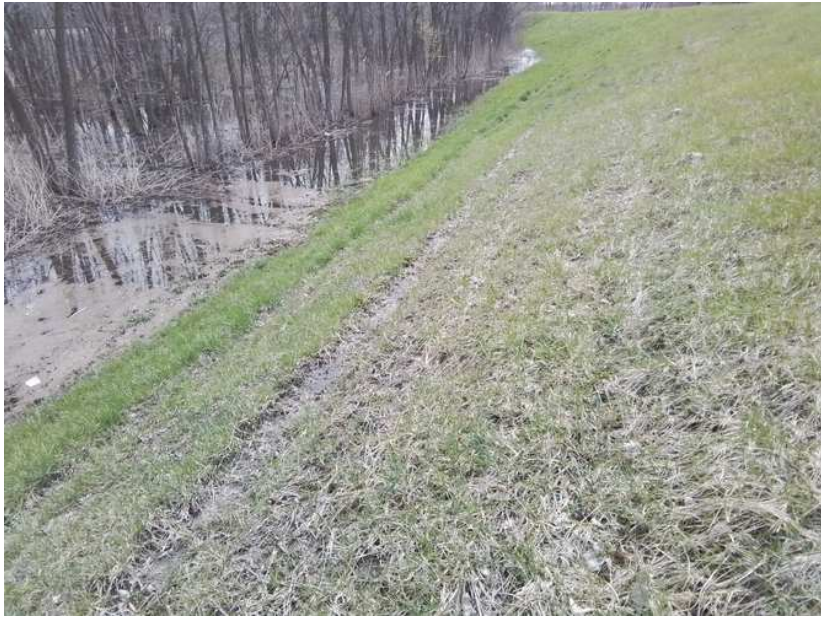
Inspect ID: 2024-0203

No User Rating (Site Visit) - Rutting and ponding water along road at levee road closure at Calhoun

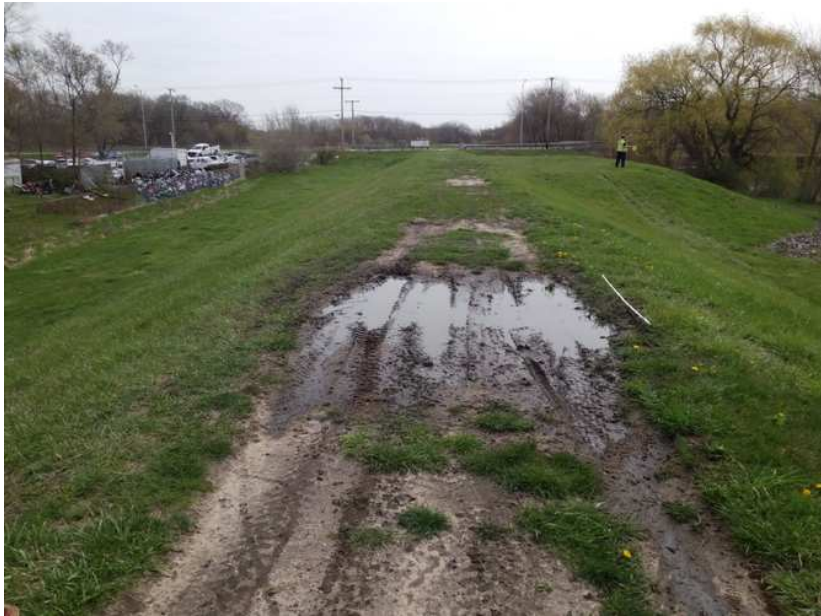
Inspect ID: 2024-0208

No User Rating (Site Visit) - Rutting on landside slope

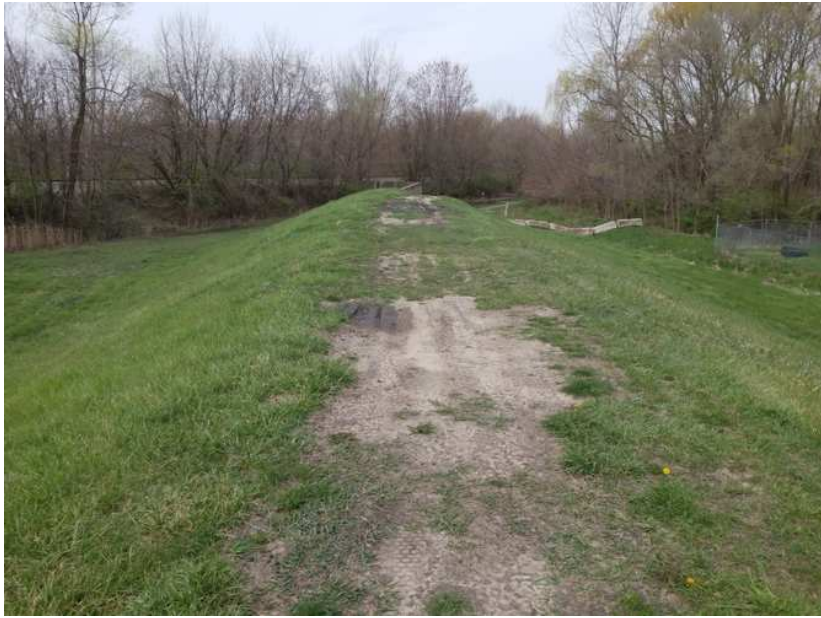
Inspect ID: 2024-0219

No User Rating (Site Visit) - Depressions (up to 5-ft long) and ponding on levee crown

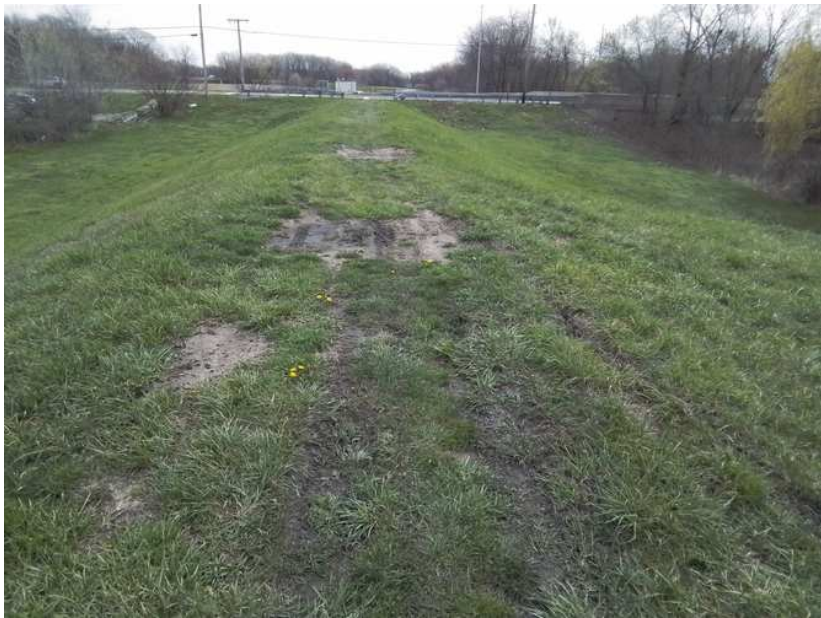
Inspect ID: 2024-0223

No User Rating (Site Visit) - Depressions and rutting on crown

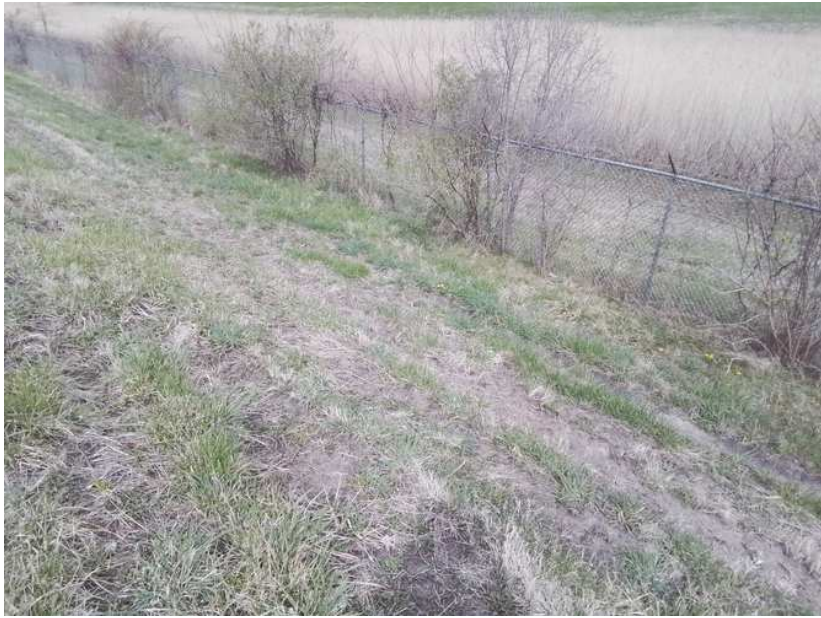
Inspect ID: 2024-0232

No User Rating (Site Visit) - Rutting and depression on crown

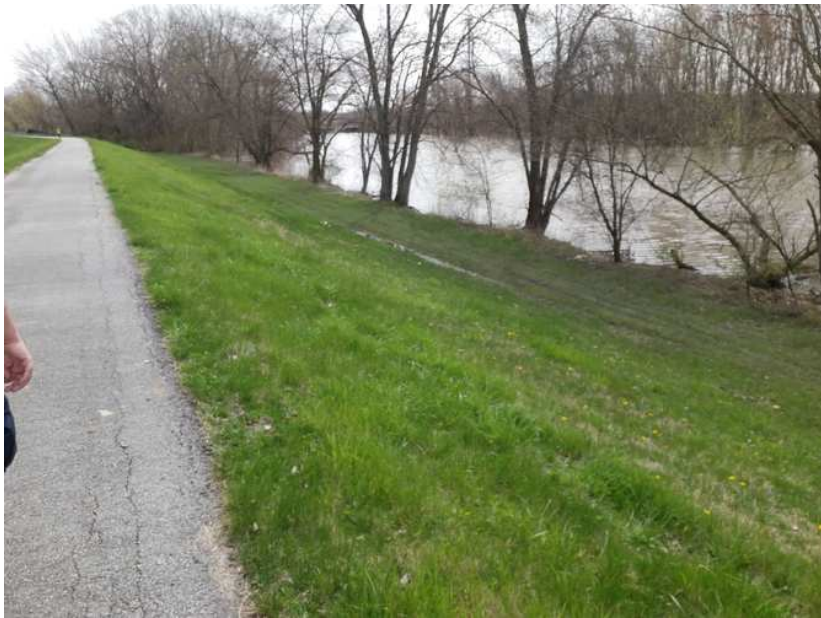
Inspect ID: 2024-0248

No User Rating (Site Visit) - Depression on landside slope

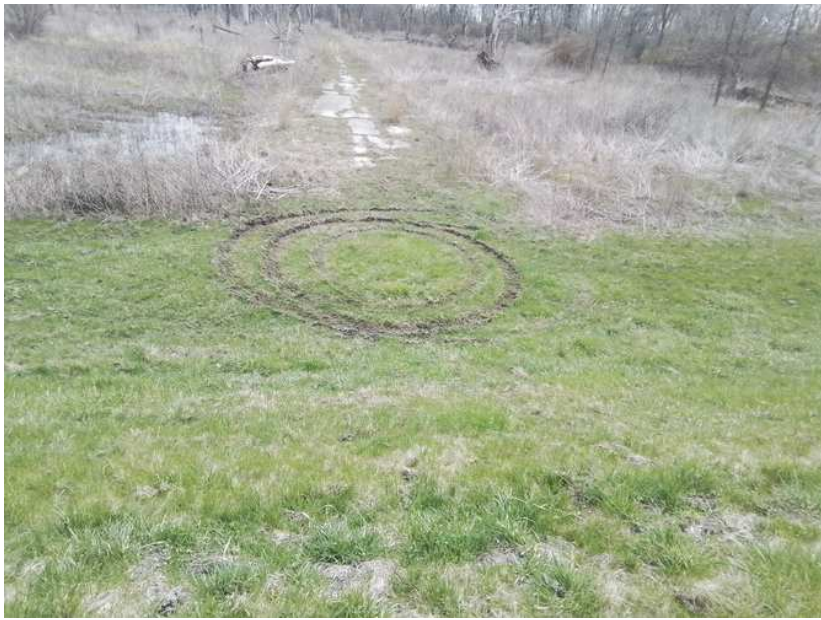
Inspect ID: 2024-0255

No User Rating (Site Visit) - Rutting and ponding on riverside toe

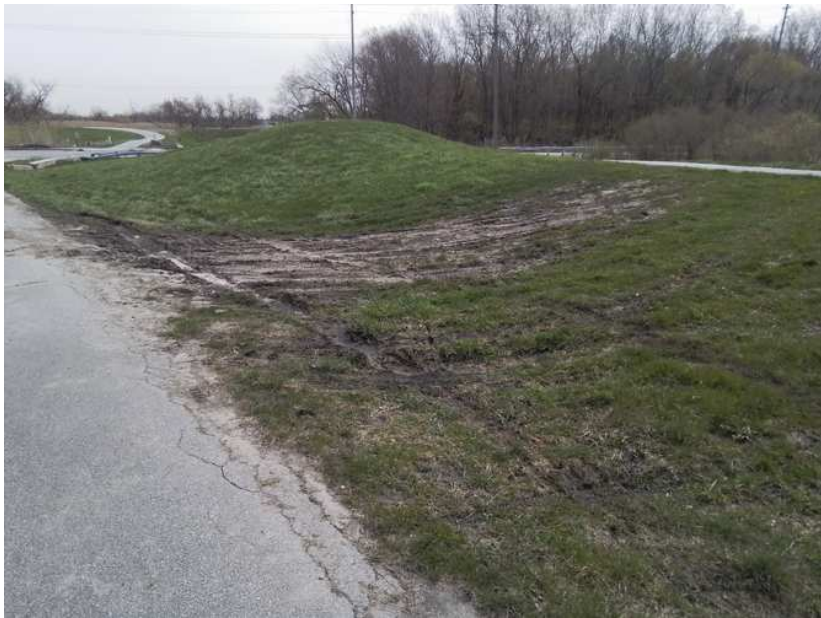
Inspect ID: 2024-0268

No User Rating (Site Visit) - Rutting on riverside toe from vehicle activity

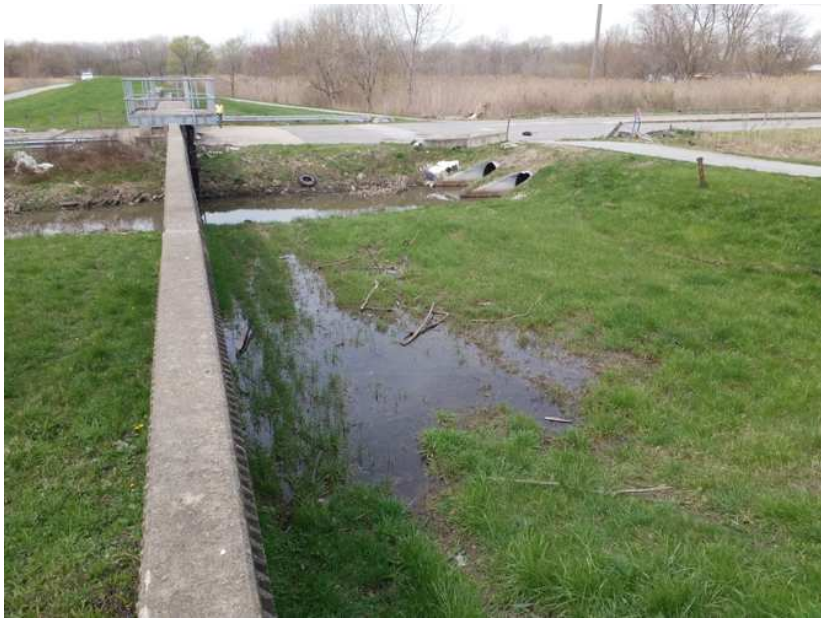
Inspect ID: 2024-0296

No User Rating (Site Visit) - Rutting on landside slope

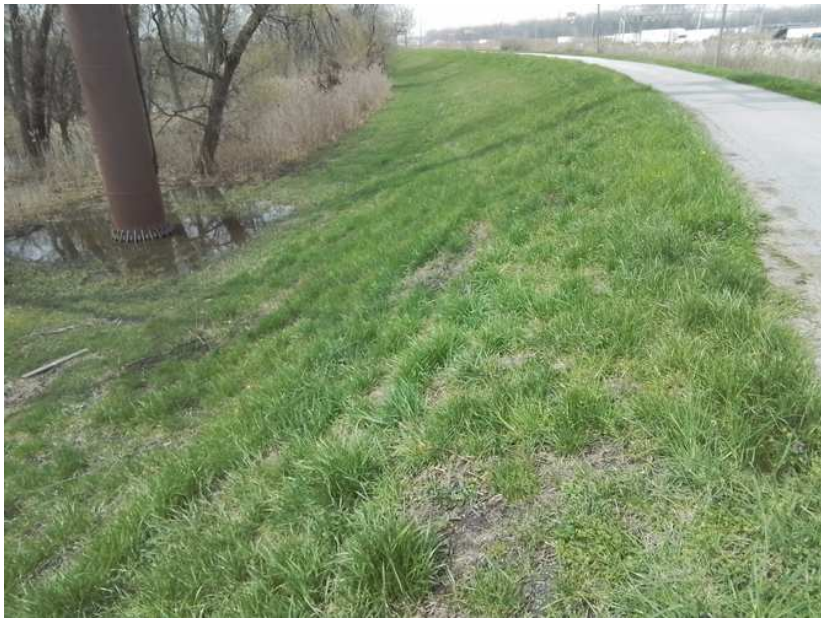
Inspect ID: 2024-0323

No User Rating (Site Visit) - Rutting and depression along landside

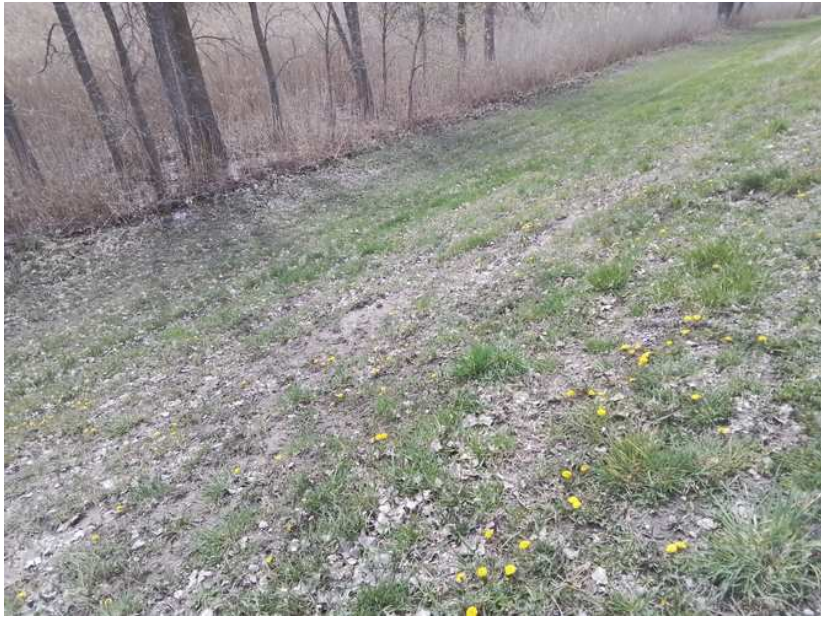
No User Rating (Site Visit) - Rutting on riverside slope

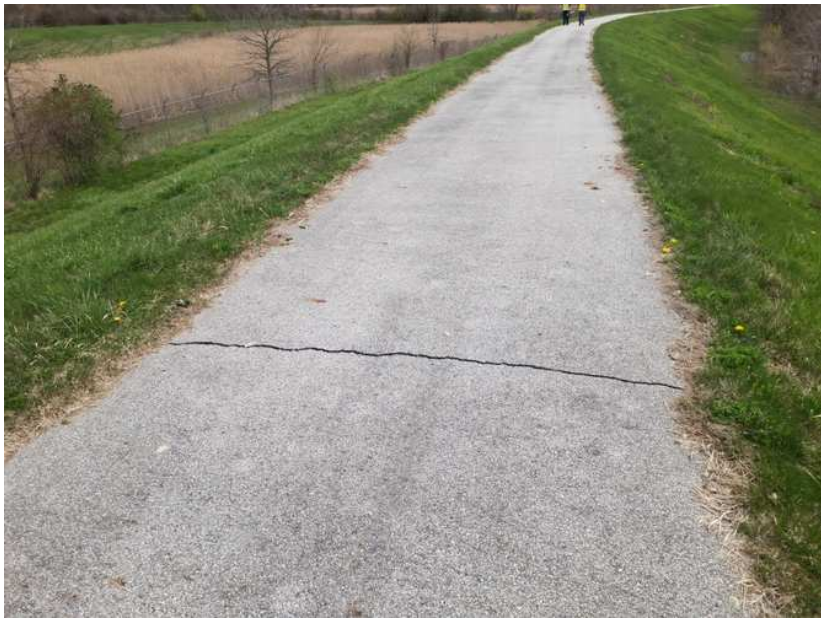
Inspect ID: 2024-0037

Rated Item: 9. Cracking

No User Rating (Site Visit) - Asphalt cracking on dipping portion of crest

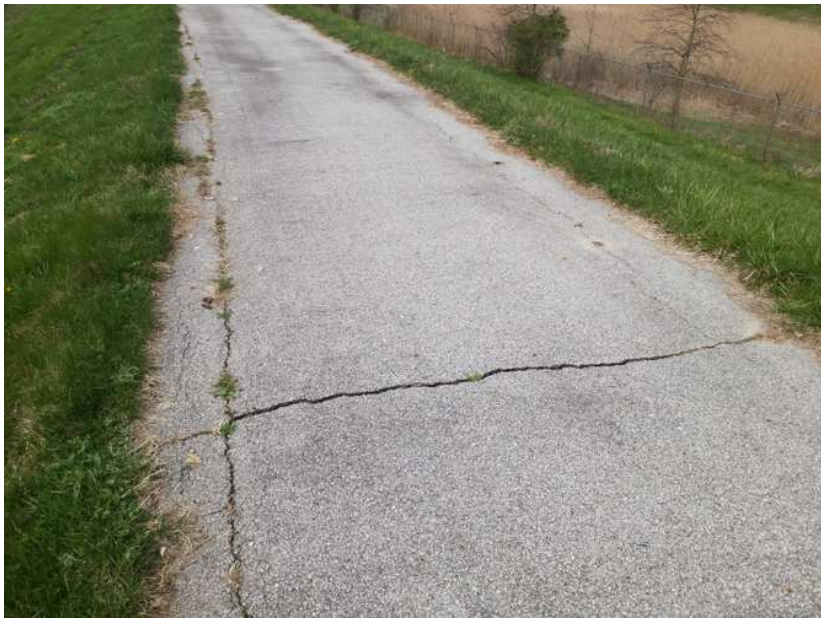
Inspect ID: 2024-0239

Rated Item: 9. Cracking

No User Rating (Site Visit) - Asphalt cracking on levee crown

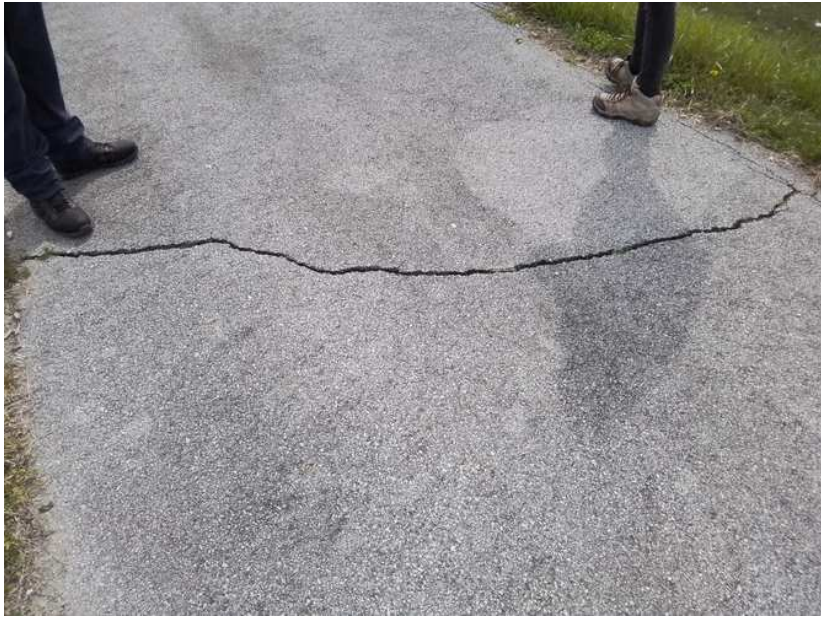
Inspect ID: 2024-0243

Rated Item: 9. Cracking

No User Rating (Site Visit) - Asphalt cracking on levee crown

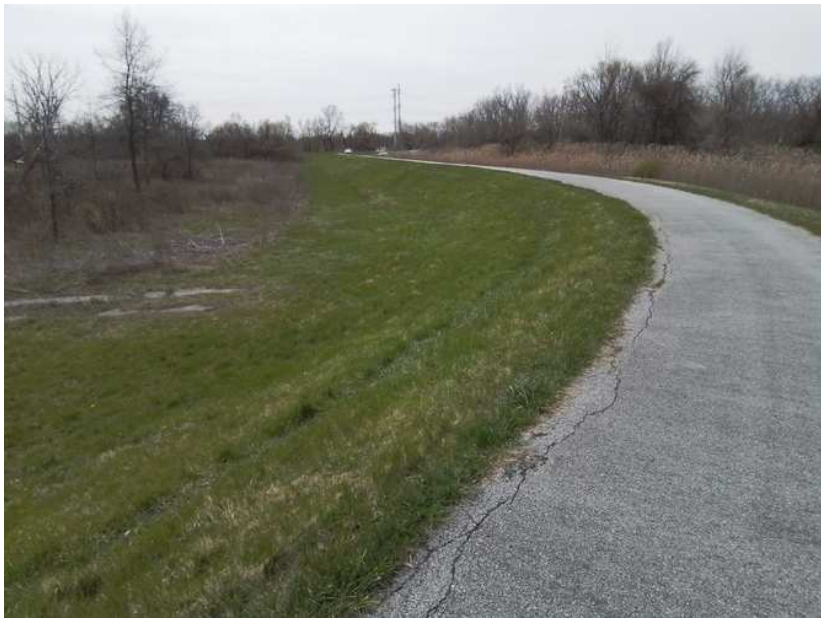
Inspect ID: 2024-0252

Rated Item: 9. Cracking

No User Rating (Site Visit) - Asphalt crack on crest

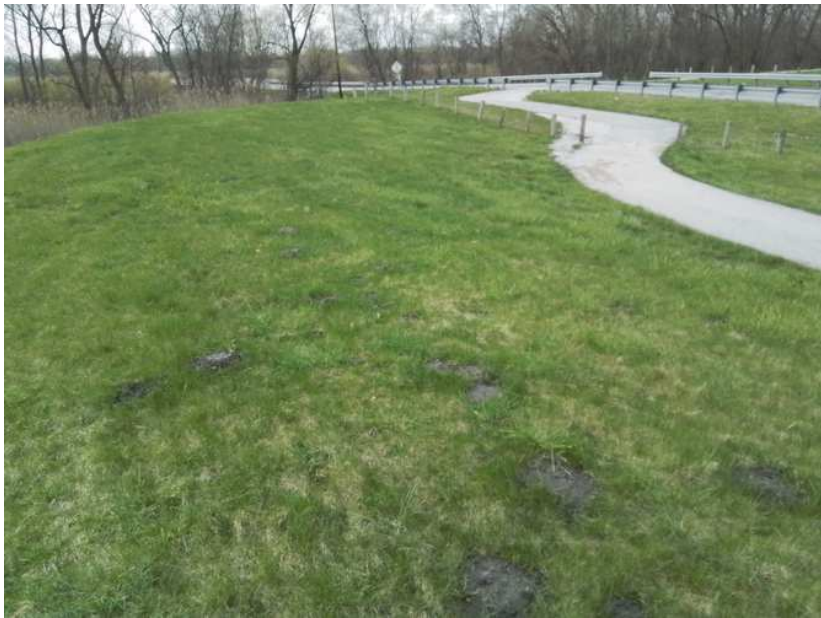
Inspect ID: 2024-0100

Rated Item: 10. Animal Control

No User Rating (Site Visit) - Active animal burrow in riverside slope

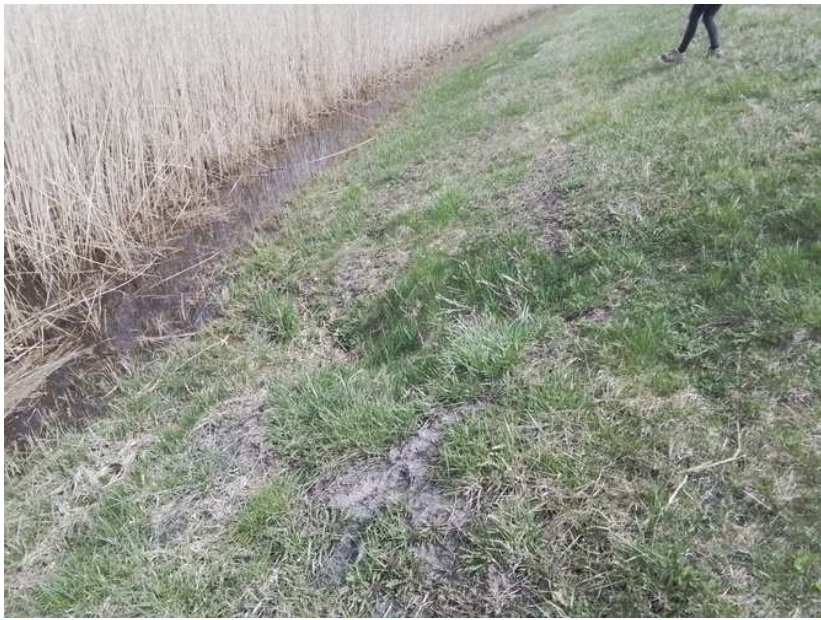
Inspect ID: 2024-0264

Rated Item: 10. Animal Control

No User Rating (Site Visit) - Large number of animal burrows on riverside

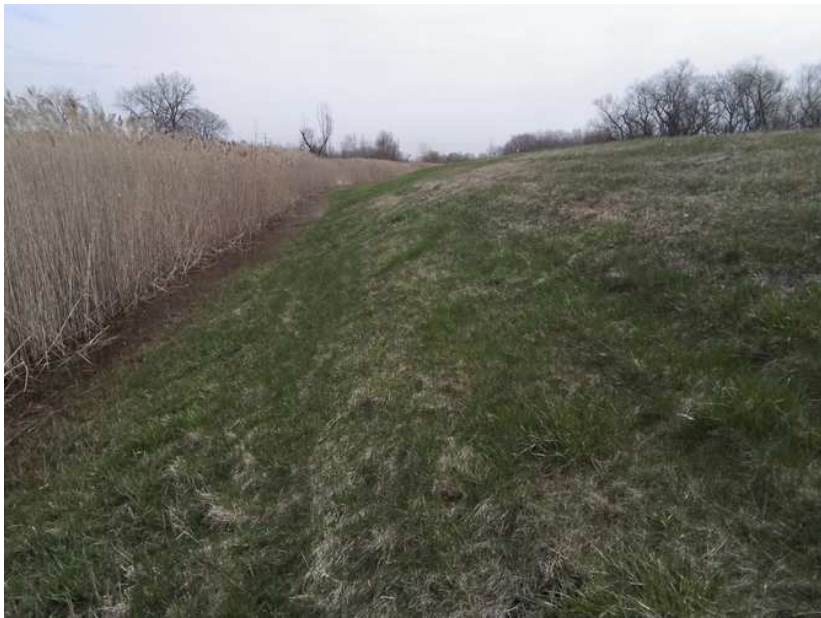
Inspect ID: 2024-0280

Rated Item: 10. Animal Control

No User Rating (Site Visit) - Animal burrow on landside slope

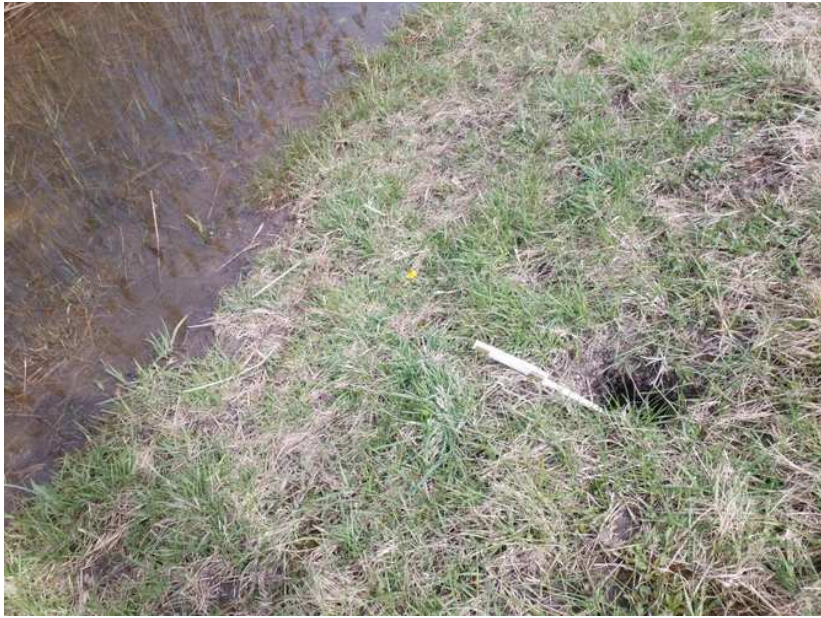
Inspect ID: 2024-0284

Rated Item: 10. Animal Control

No User Rating (Site Visit) - Collapsed animal burrow on landside toe

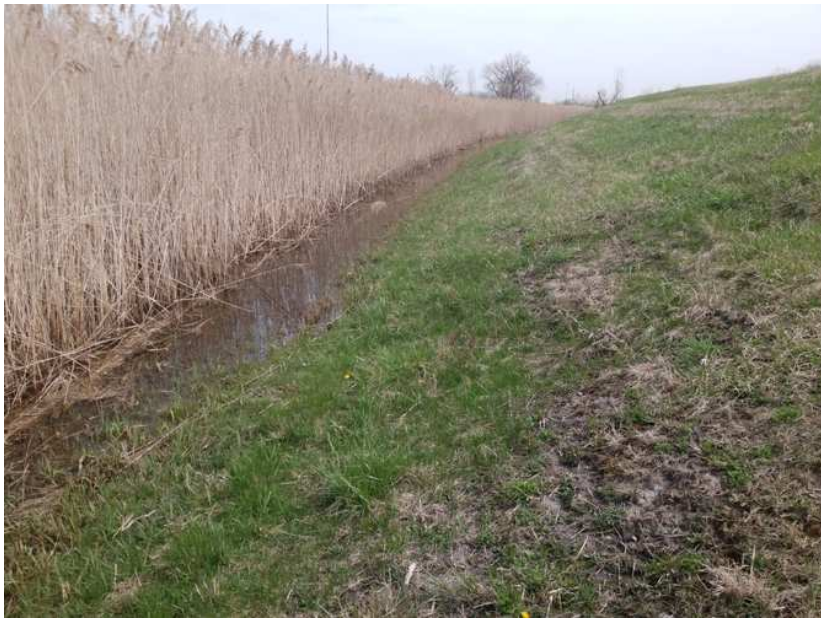
Inspect ID: 2024-0287

Rated Item: 10. Animal Control

No User Rating (Site Visit) - 18 inch deep animal burrow at landside levee toe

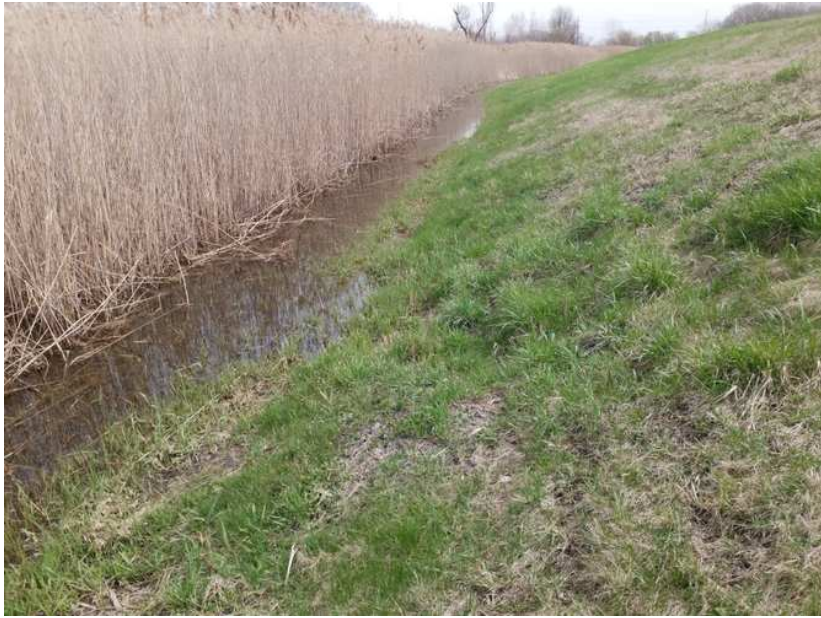
Inspect ID: 2024-0295

Rated Item: 10. Animal Control

No User Rating (Site Visit) - Collapsed animal burrow in landside toe

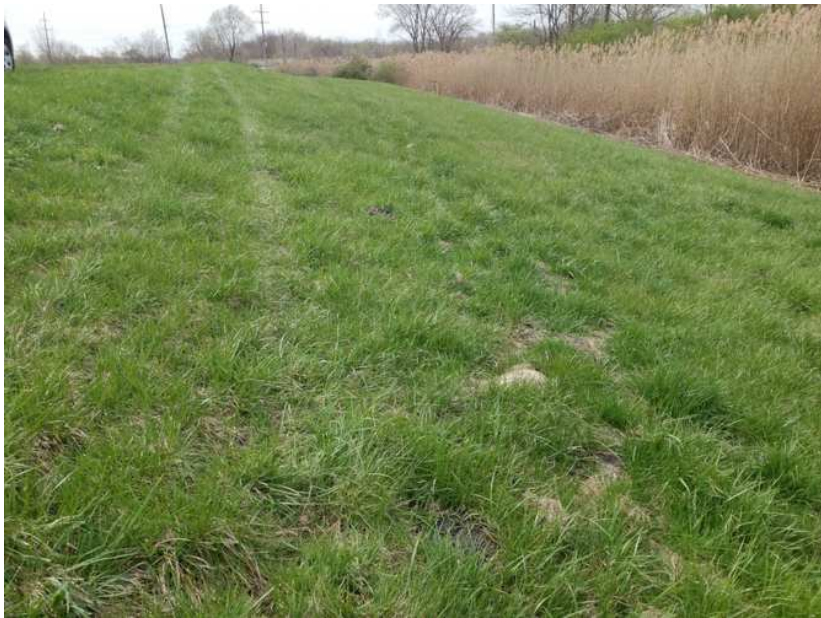
Inspect ID: 2024-0299

Rated Item: 10. Animal Control

No User Rating (Site Visit) - Collapsed animal burrow in landside toe

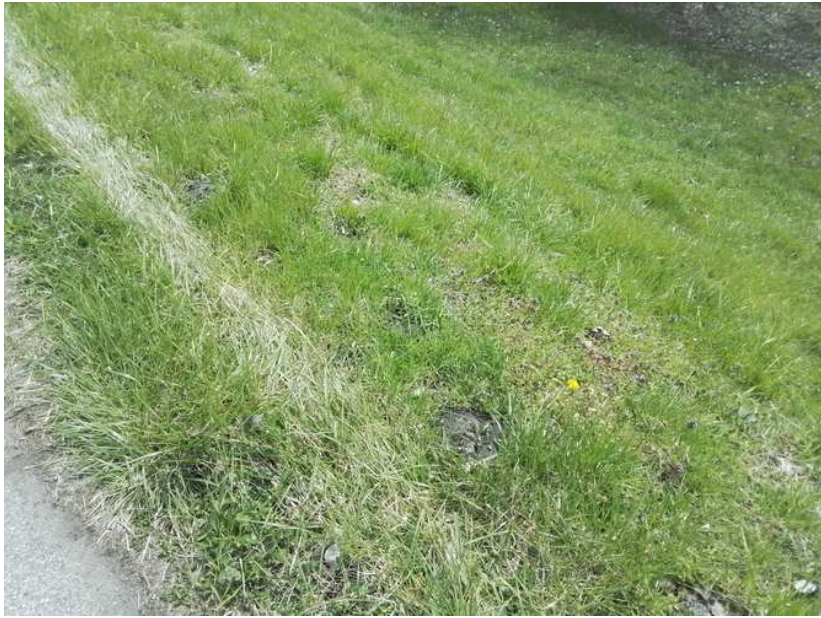
Inspect ID: 2024-0331

Rated Item: 10. Animal Control

No User Rating (Site Visit) - Animal burrows on landside slope

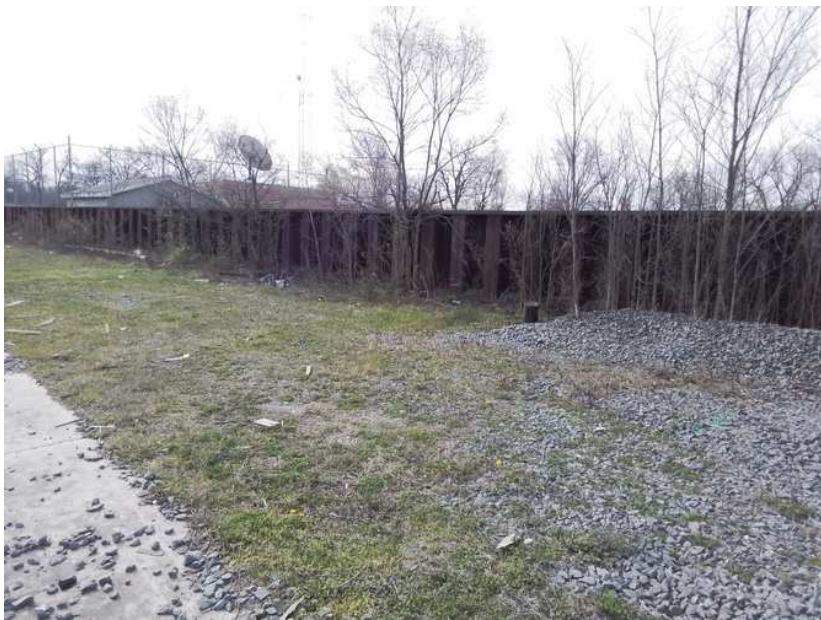
Inspect ID: 2024-0344

Rated Item: 10. Animal Control

No User Rating (Site Visit) - Animal burrows on riverside slope

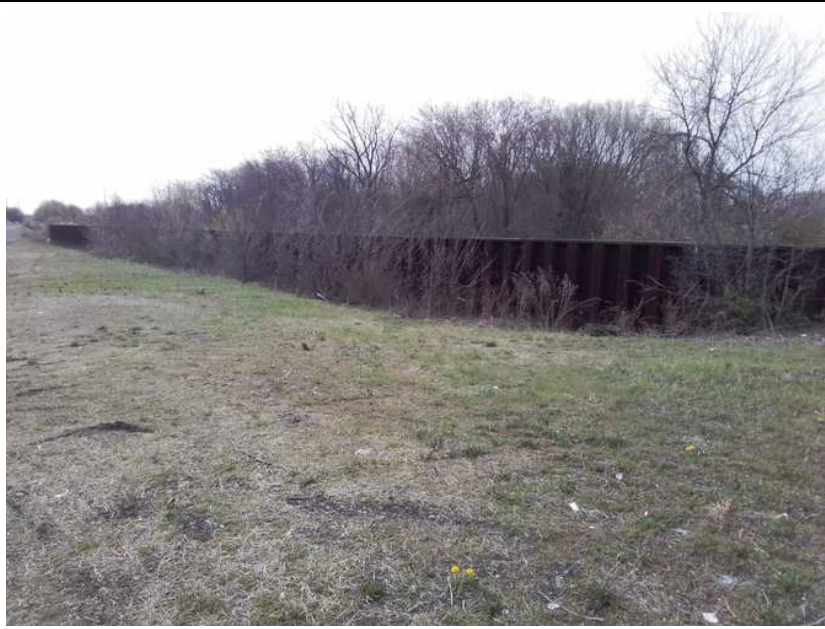
Inspect ID: 2024-0144

Rated Item: 1. Unwanted Vegetation Growth

No User Rating (Site Visit) - Trees on landside

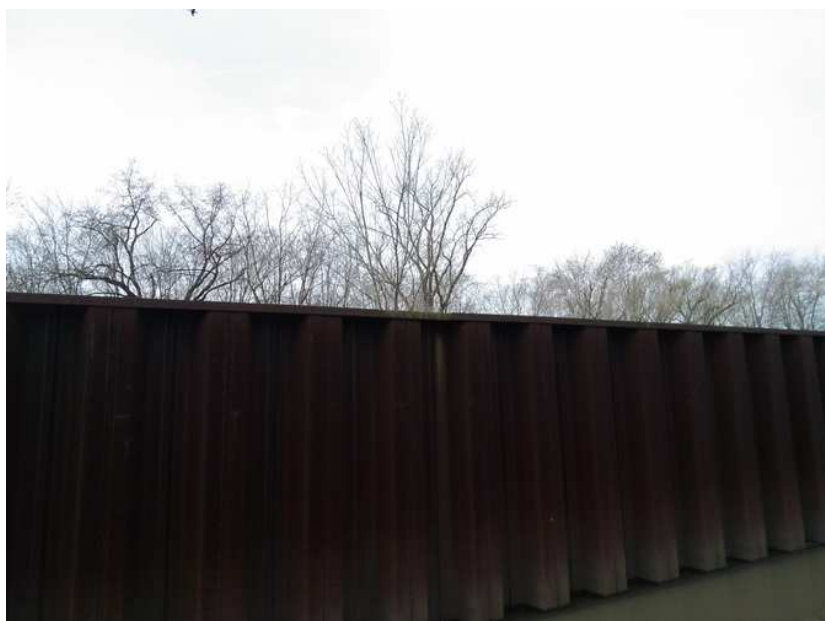
Inspect ID: 2024-0172

Rated Item: 1. Unwanted Vegetation Growth

No User Rating (Site Visit) - Trees in landside near floodwall

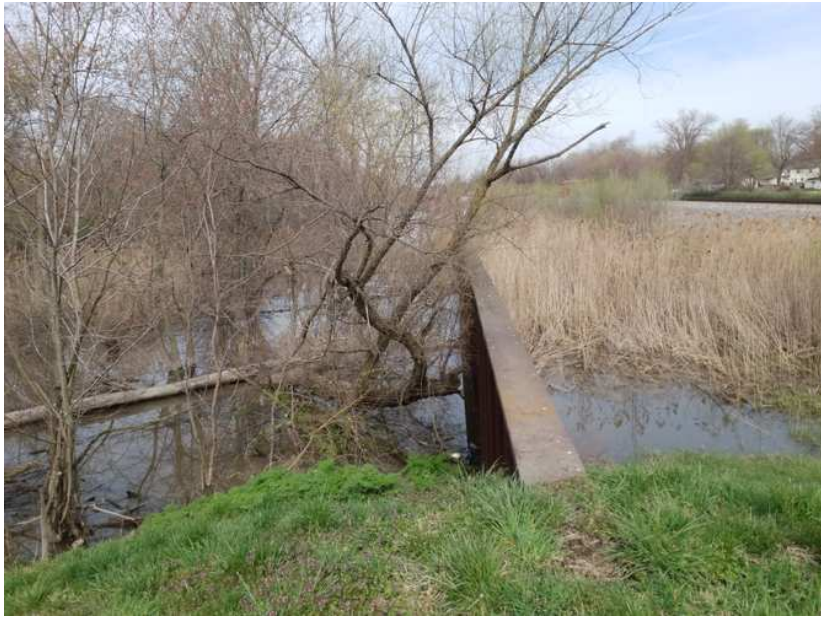
Inspect ID: 2024-0180

Rated Item: 1. Unwanted Vegetation Growth

No User Rating (Site Visit) - Tree on riverside of floodwall

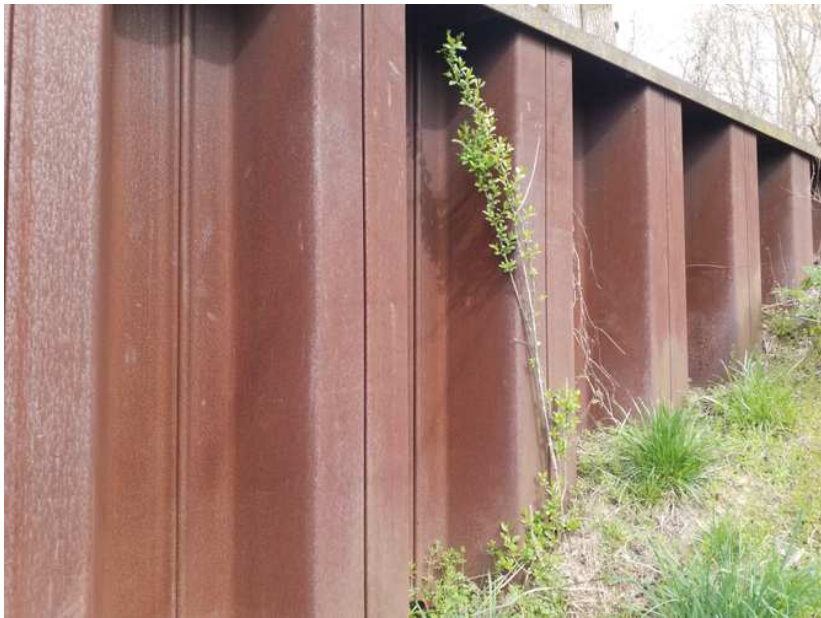
Inspect ID: 2024-0195

Rated Item: 1. Unwanted Vegetation Growth

No User Rating (Site Visit) - Fallen tree overhanging floodwall on riverside

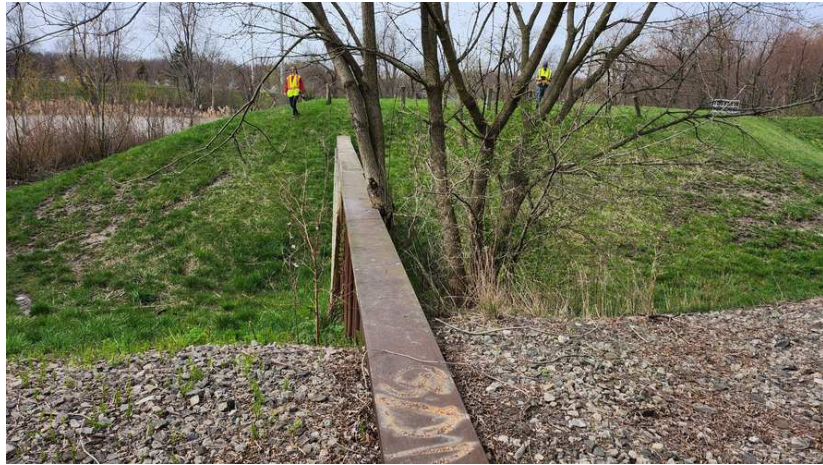
Inspect ID: 2024-0215

Rated Item: 1. Unwanted Vegetation Growth

No User Rating (Site Visit) - New tree growth on riverside of floodwall

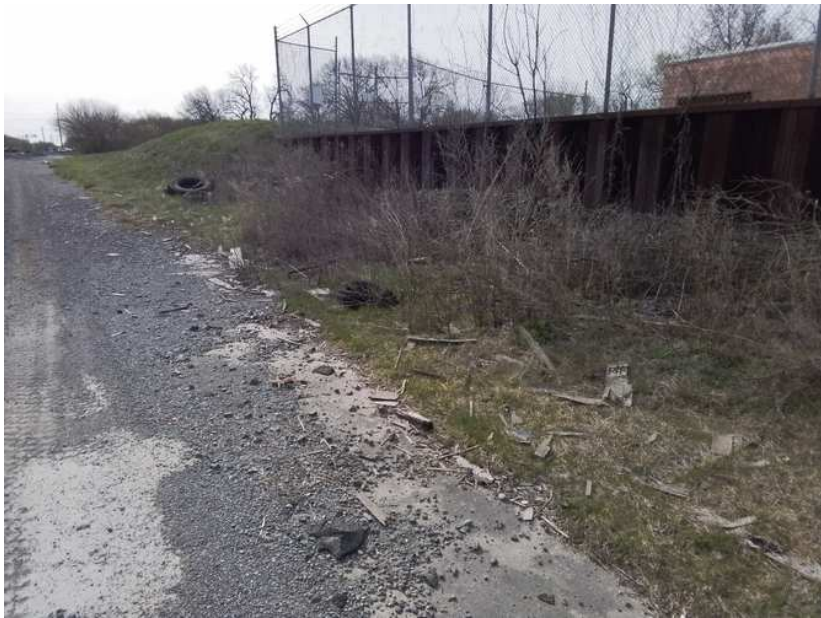
Inspect ID: 2024-0140

Rated Item: 2. Encroachments

No User Rating (Site Visit) - Ballast on landside.

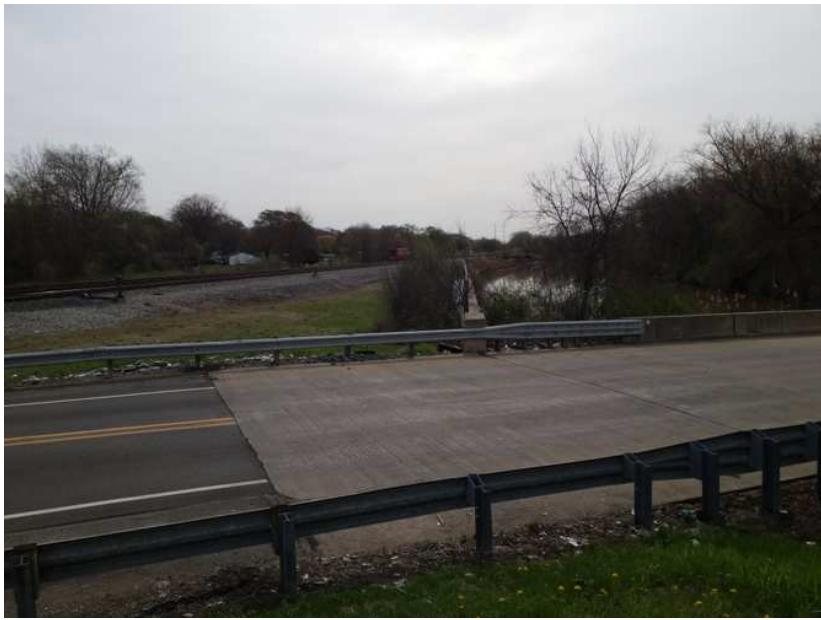
Inspect ID: 2024-0148

Rated Item: 2. Encroachments

No User Rating (Site Visit) - Debris on landside
