**US Army Corps
of Engineers ®**

Site Visit Summary

Name of System: Gary

Name of Segment: Gary North

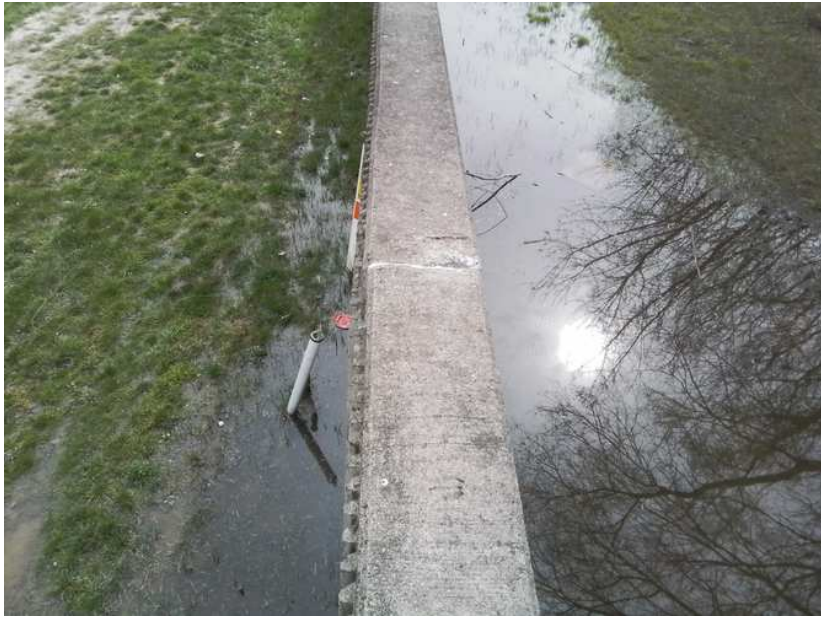
Inspect ID: 2024-0211

Rated Item: 4. Concrete Surfaces

No User Rating (Site Visit) - Gap between concrete and metal at top of floodwall.

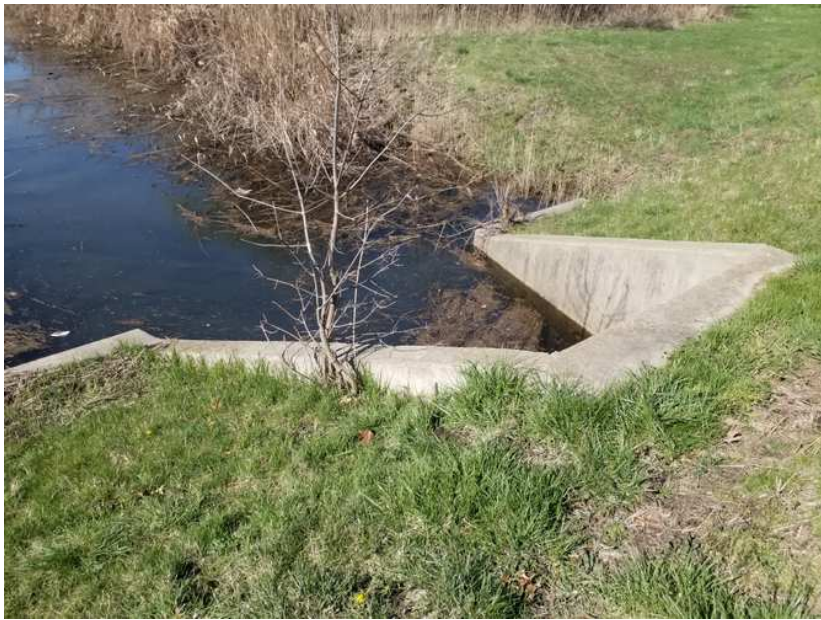
Inspect ID: 2024-0184

Rated Item: 7. Monolith Joints

No User Rating (Site Visit) - Landside interlock is wet, suggesting seepage.

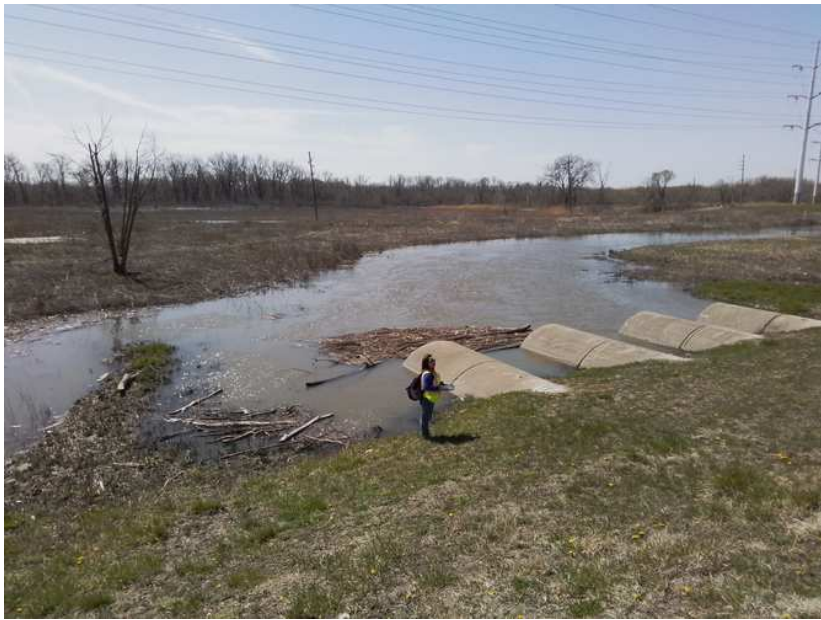
Inspect ID: 2024-0006

Rated Item: 1. Vegetation and Obstructions

No User Rating (Site Visit) - Small tree at outlet structure

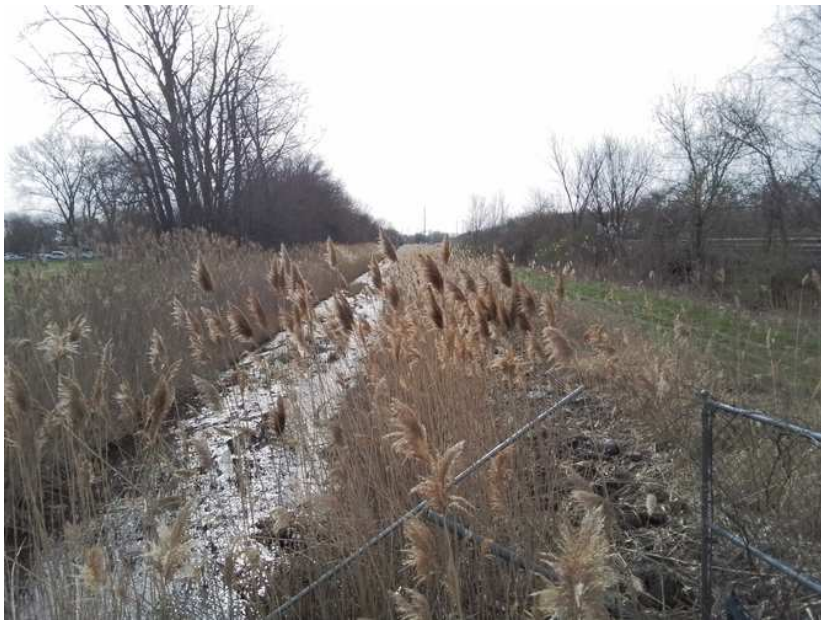
Inspect ID: 2024-0032

Rated Item: 1. Vegetation and Obstructions

No User Rating (Site Visit) - Small trees in landside drainage ditch.

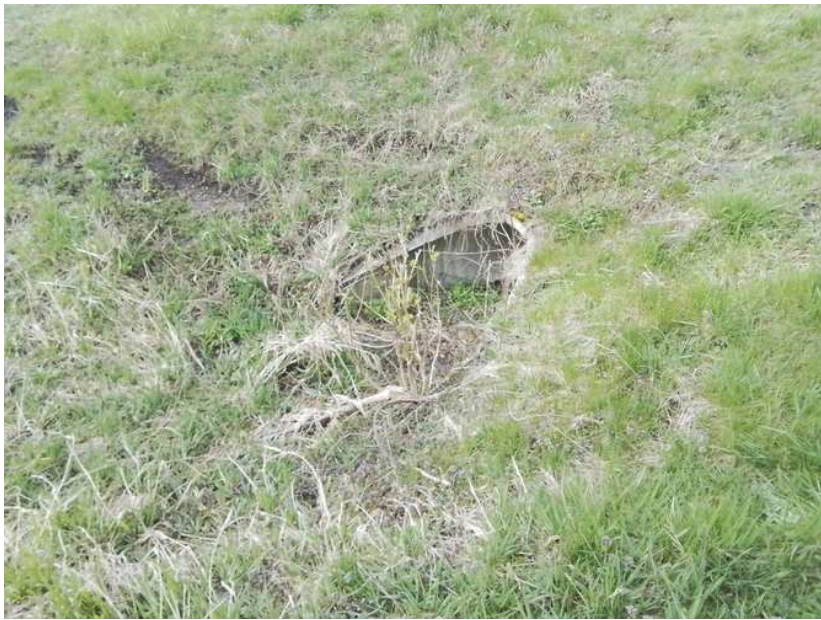
Inspect ID: 2024-0052

Rated Item: 1. Vegetation and Obstructions

No User Rating (Site Visit) - Landside drainage ditch - typical conditions

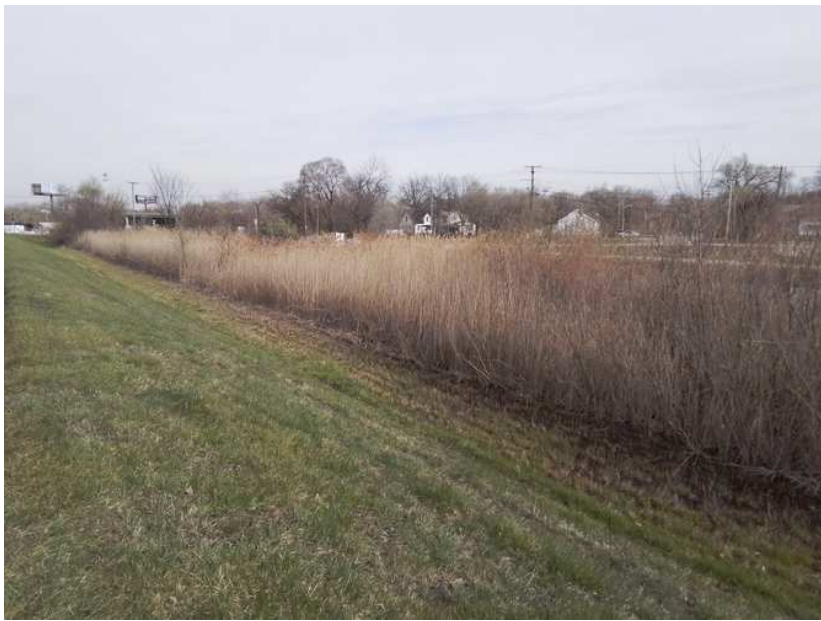
Inspect ID: 2024-0112

No User Rating (Site Visit) - Drainage ditch vegetation on landside

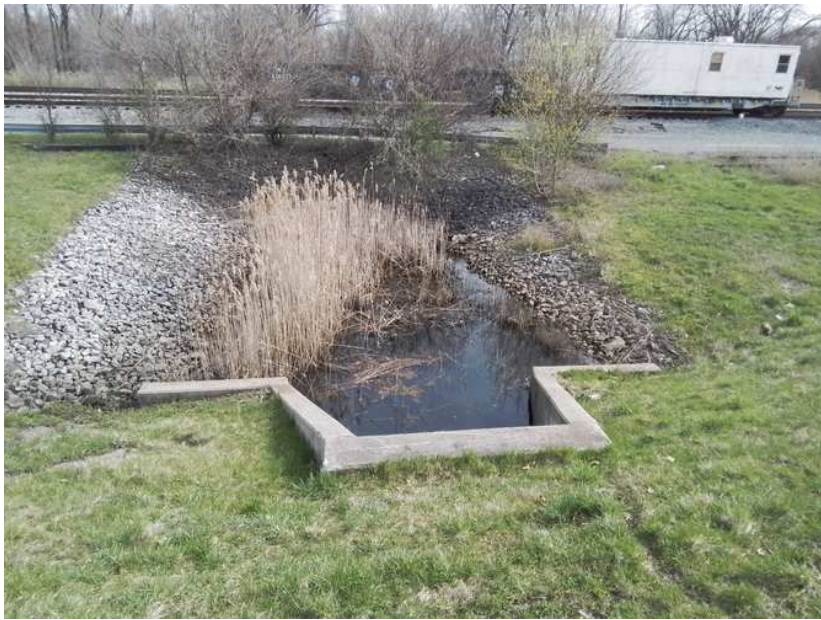
Inspect ID: 2024-0152

No User Rating (Site Visit) - Drainage ditch vegetation on landside

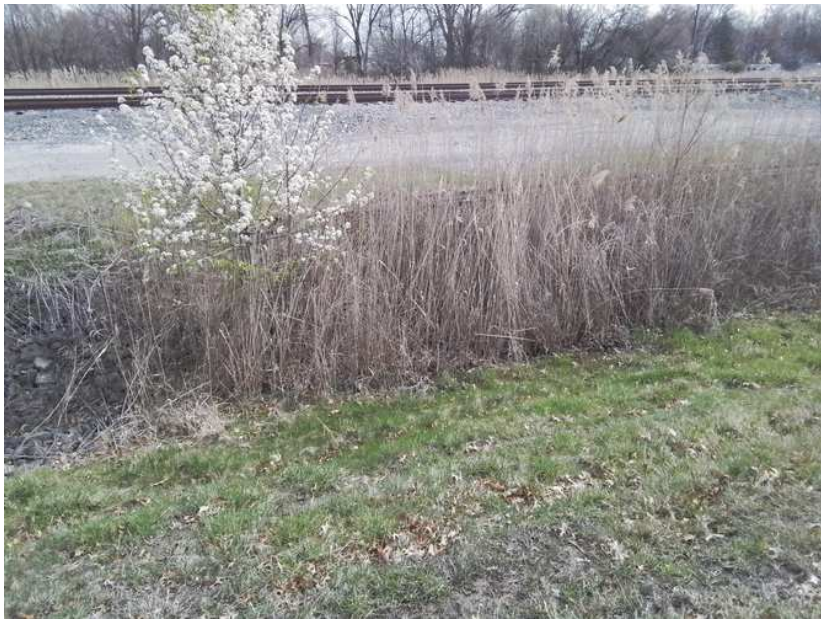
Inspect ID: 2024-0160

No User Rating (Site Visit) - Landside ditch vegetation

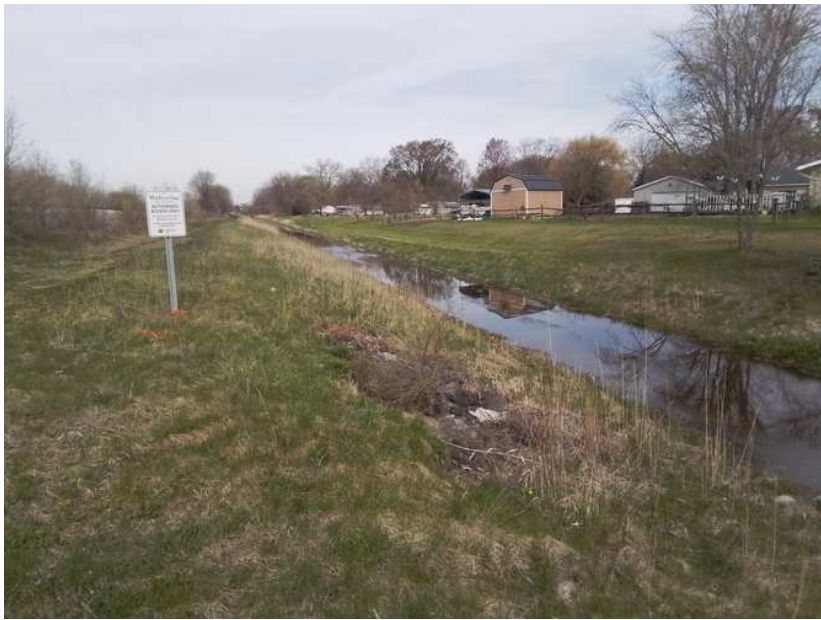
Inspect ID: 2024-0200

No User Rating (Site Visit) - Typical drainage ditch Typical drainage ditch on landside

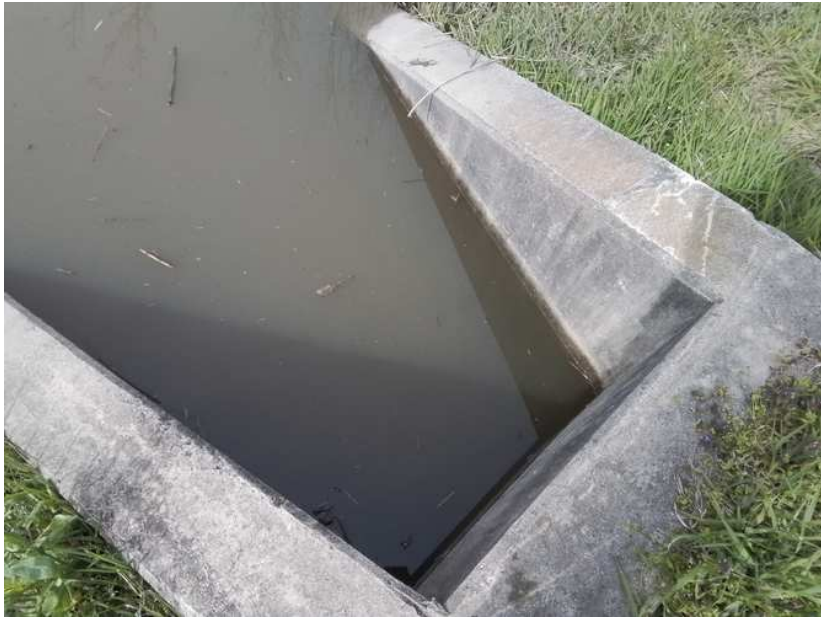
Inspect ID: 2024-0204

No User Rating (Site Visit) - GN-04: No issues with conduit, water is flowing properly

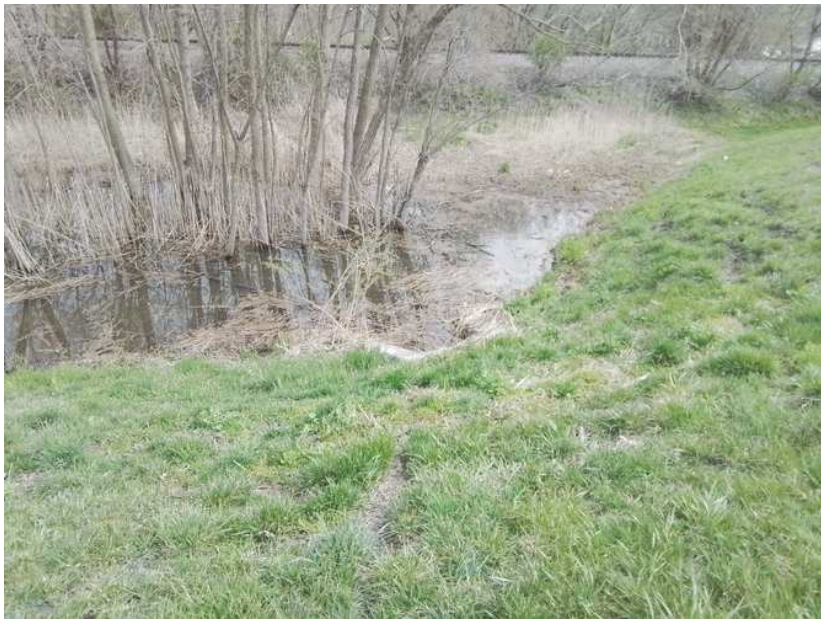
Inspect ID: 2024-0212

No User Rating (Site Visit) - GN-05: Vegetation on landside wing wall

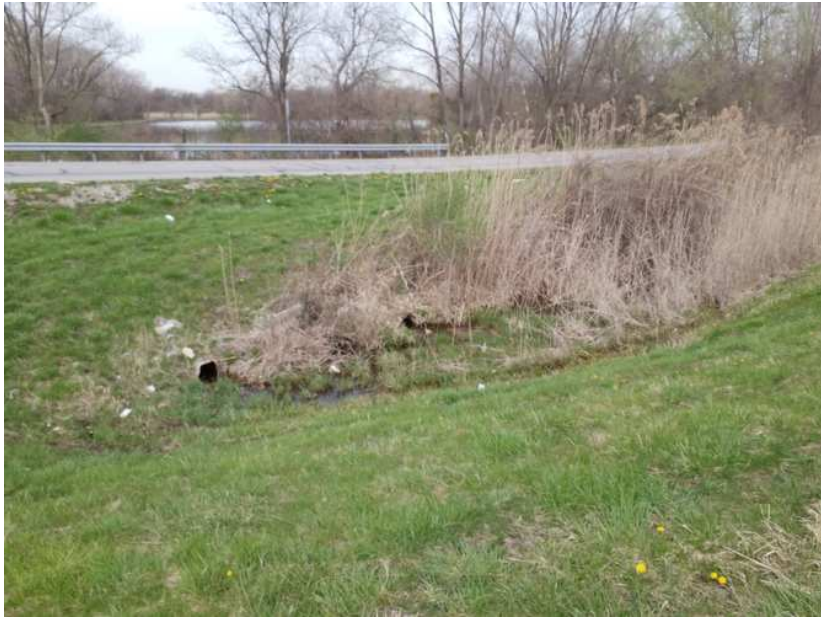
Inspect ID: 2024-0267

No User Rating (Site Visit) - Debris in ditch and around culverts on landside

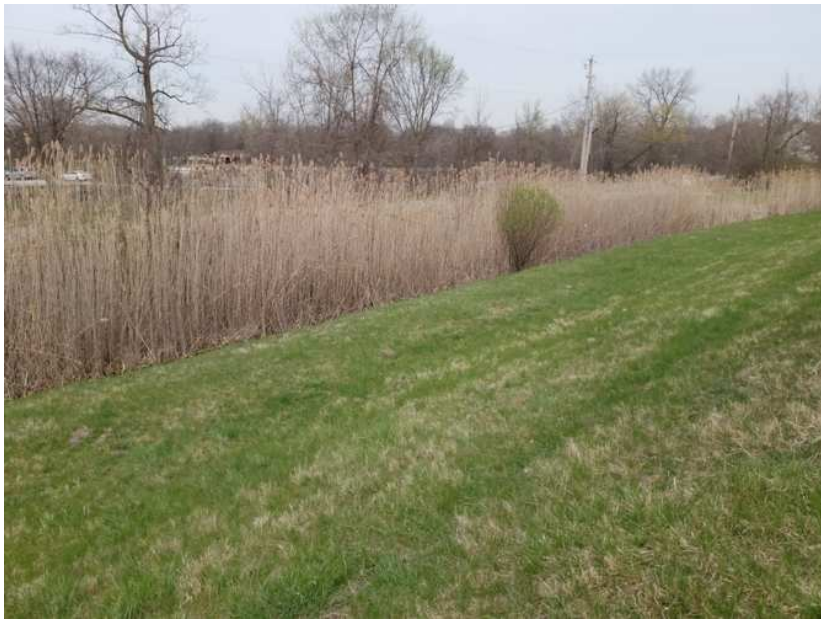
Inspect ID: 2024-0271

No User Rating (Site Visit) - Small tree in landside ditch

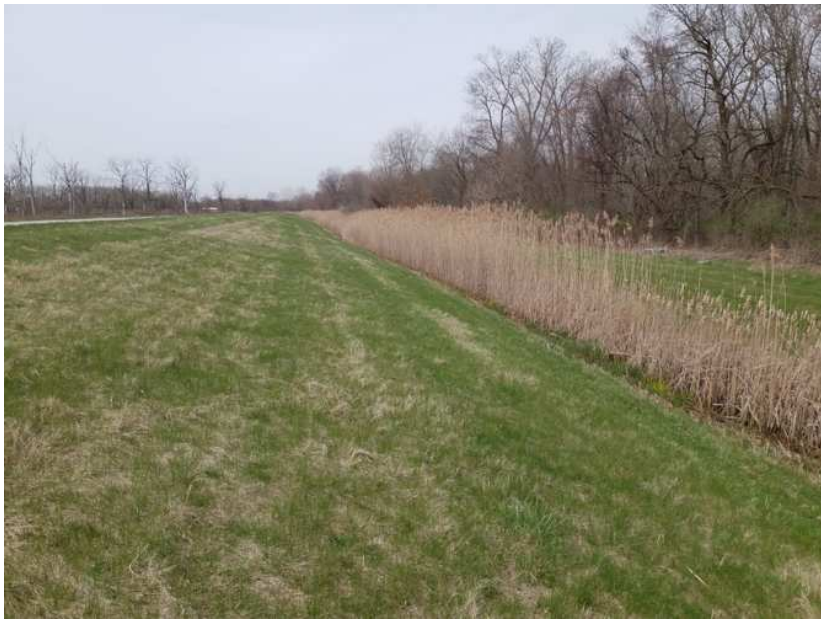
Inspect ID: 2024-0279

No User Rating (Site Visit) - Typical landside ditch vegetation

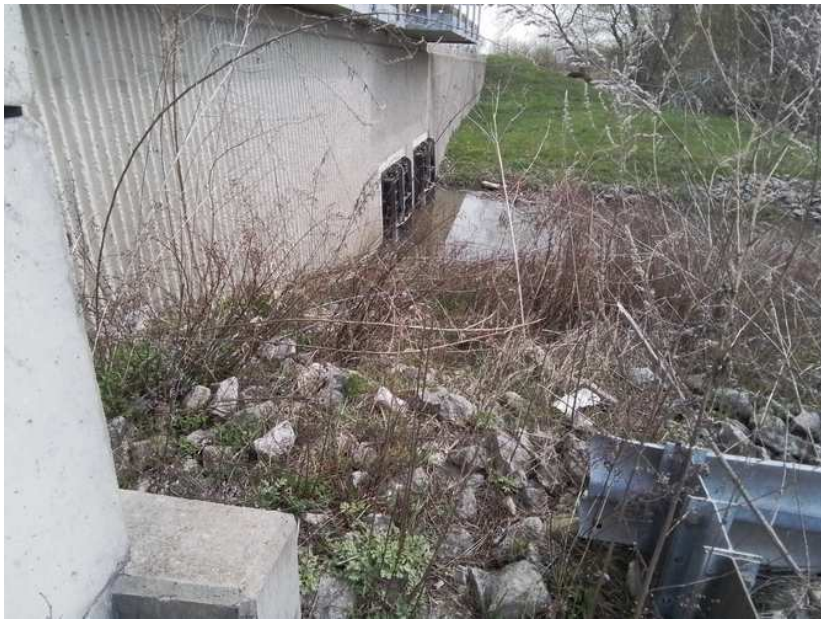
Inspect ID: 2024-0300

No User Rating (Site Visit) - GN-07: Vegetation in riprap on riverside toe

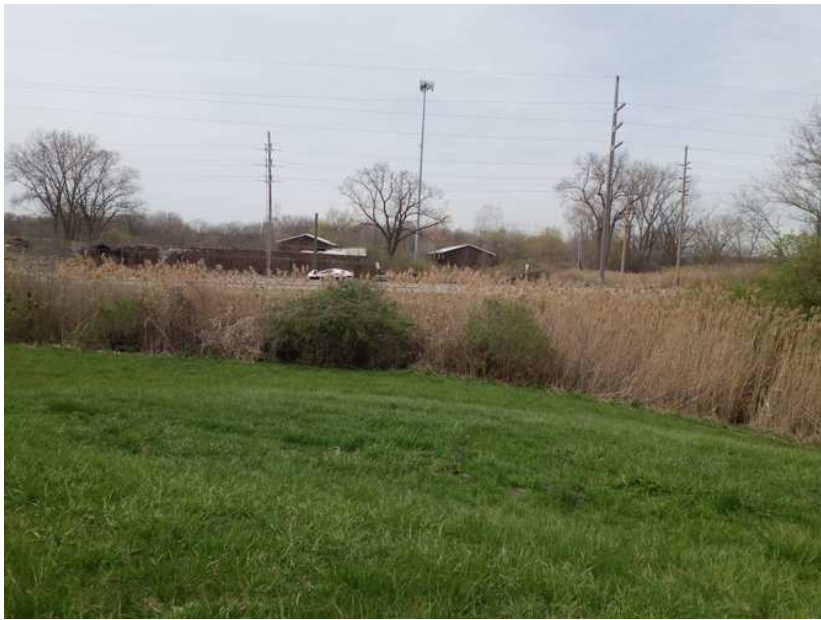
Inspect ID: 2024-0327

No User Rating (Site Visit) - Trees in landside ditch

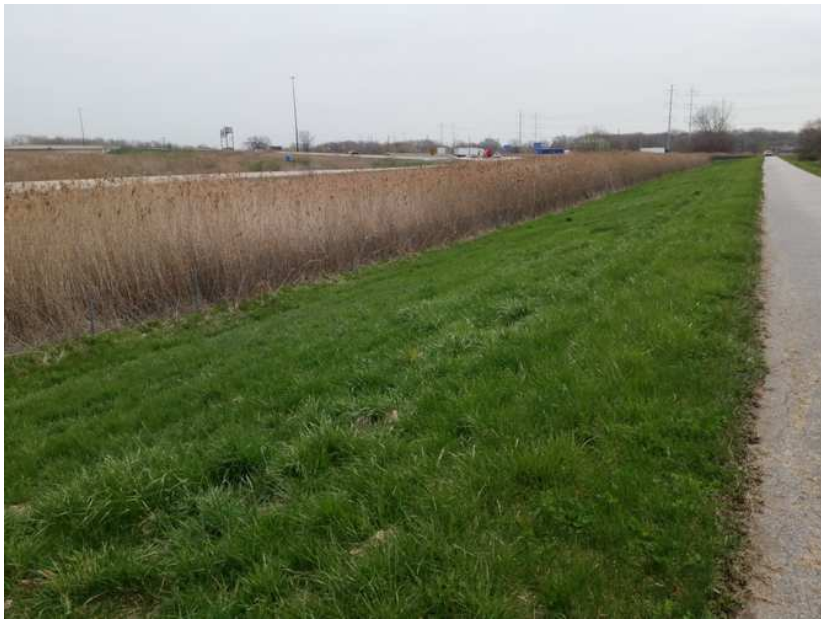
Inspect ID: 2024-0355

No User Rating (Site Visit) - Typical INDOT ditch

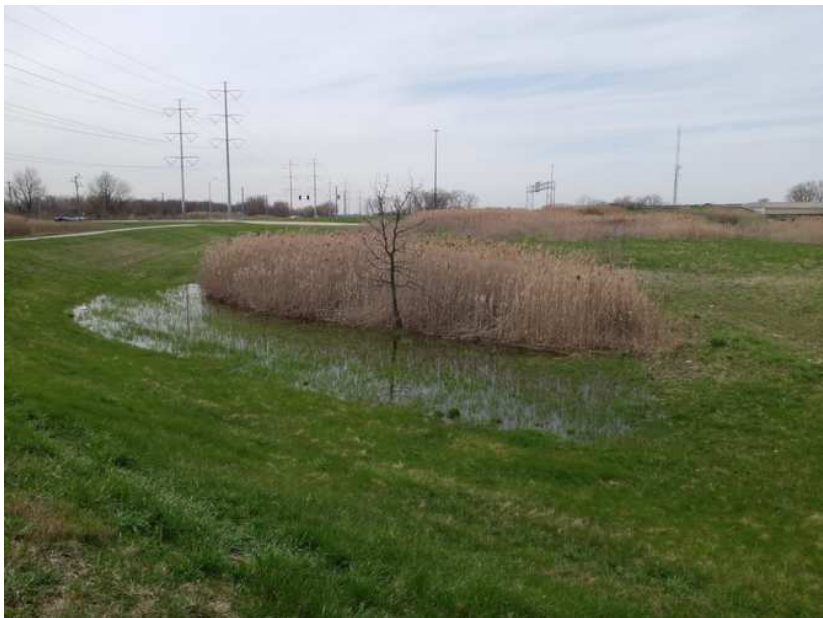
Inspect ID: 2024-0403

No User Rating (Site Visit) - Tree in landside ditch

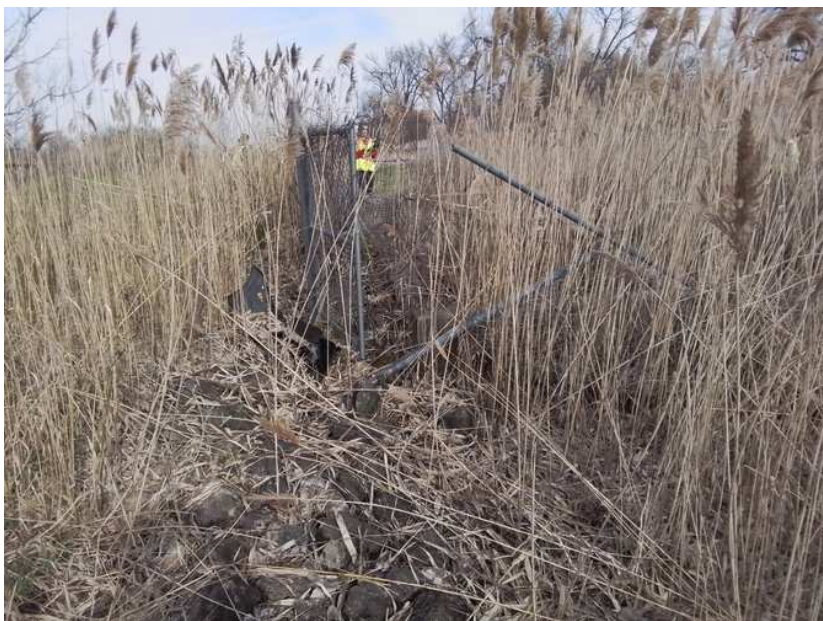
Inspect ID: 2024-0048

No User Rating (Site Visit) - Debris against fence

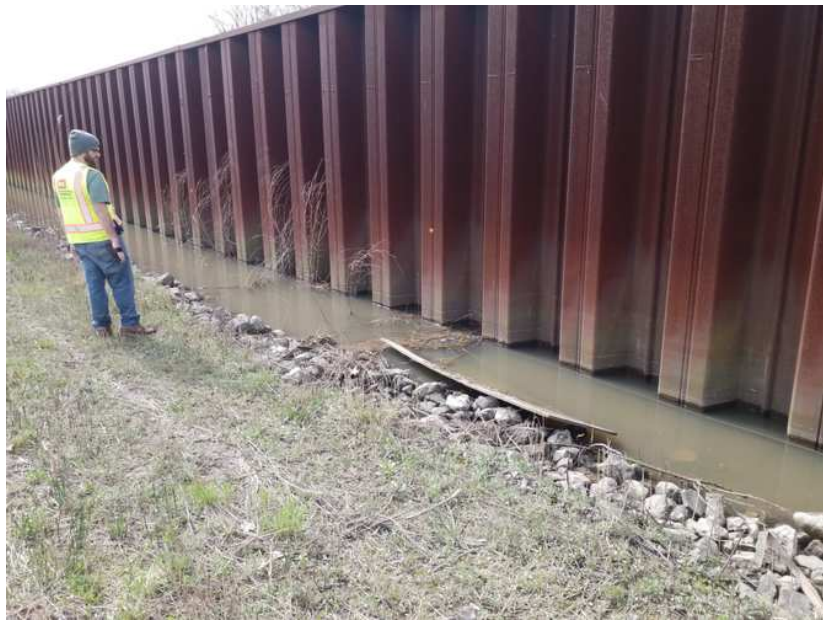
Inspect ID: 2024-0175

No User Rating (Site Visit) - Debris in landside ditch along floodwall

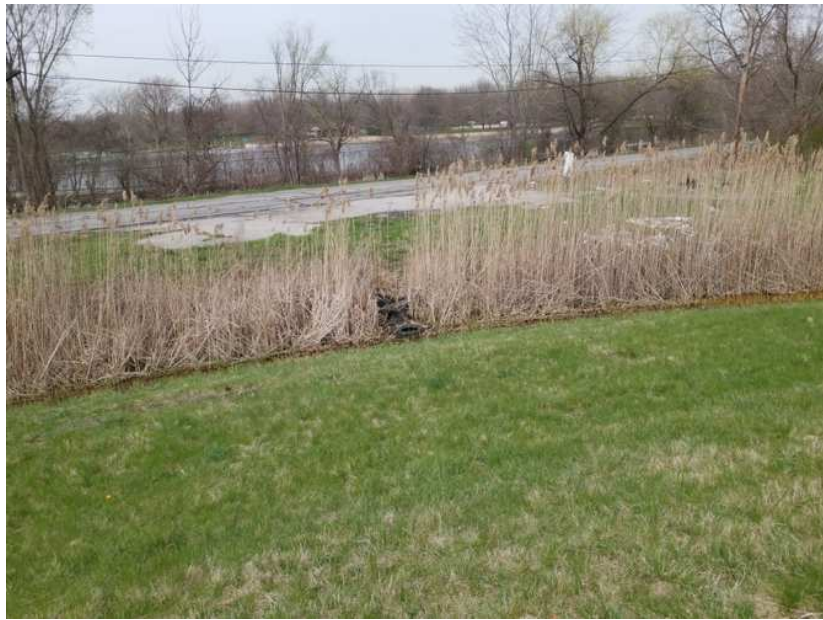
Inspect ID: 2024-0275

No User Rating (Site Visit) - Tires in landside ditch

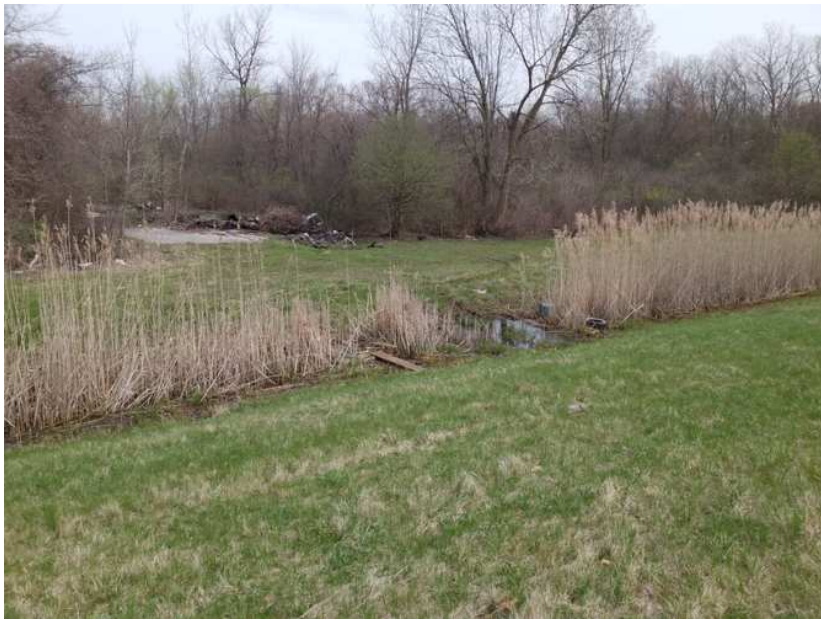
Inspect ID: 2024-0283

No User Rating (Site Visit) - Debris in landside ditch

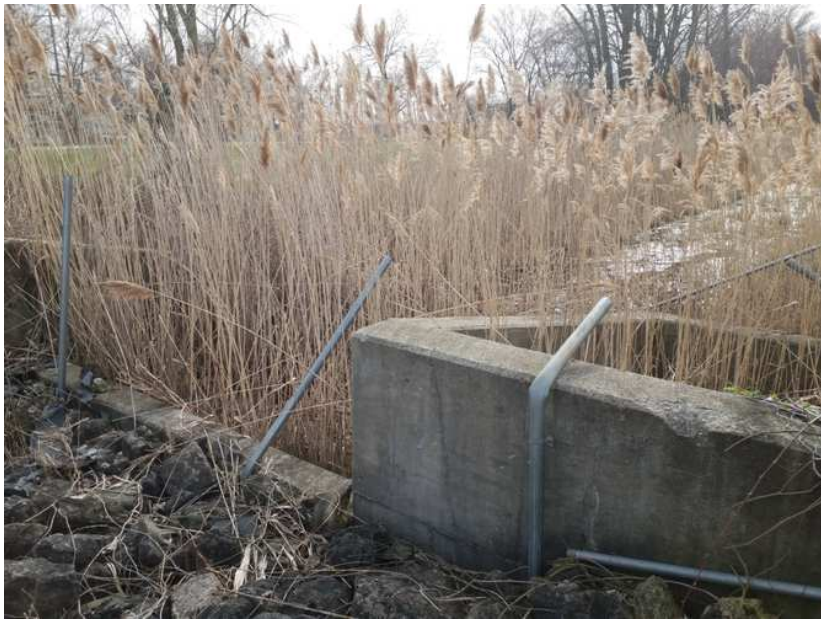
Inspect ID: 2024-0043

No User Rating (Site Visit) - Fencing along structure missing/destroyed

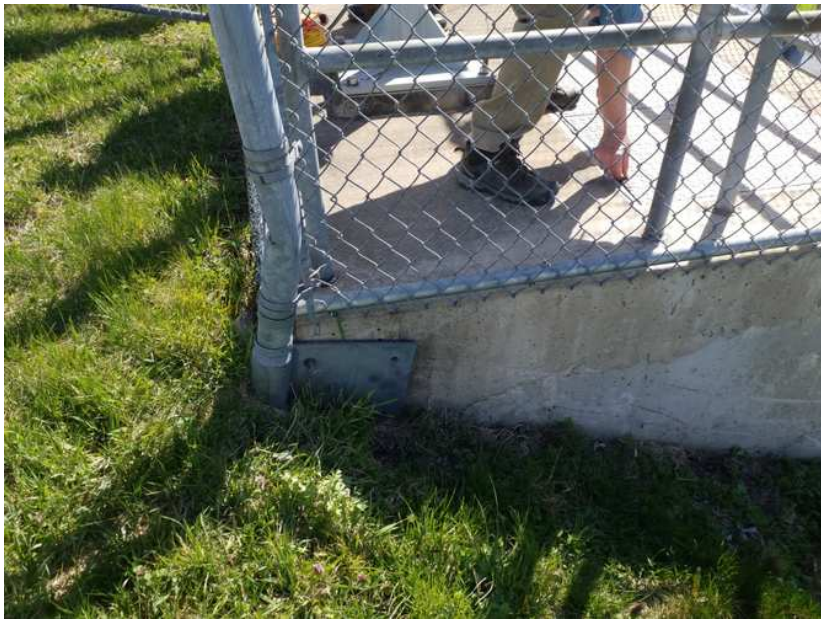
Inspect ID: 2024-0018

No User Rating (Site Visit) - GN-08: Fence mounting plate is missing screws

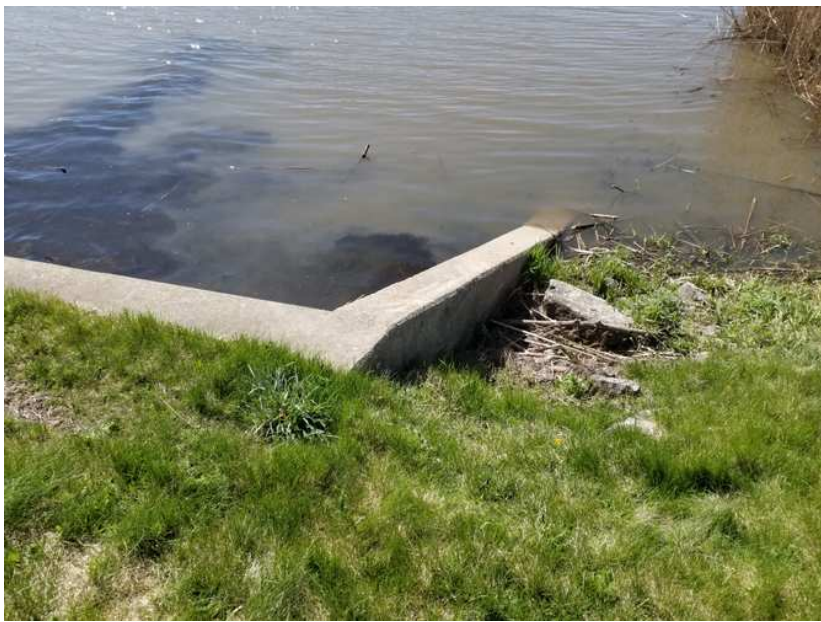
Inspect ID: 2024-0034

No User Rating (Site Visit) - GN-08: Erosion on both sides of outfall

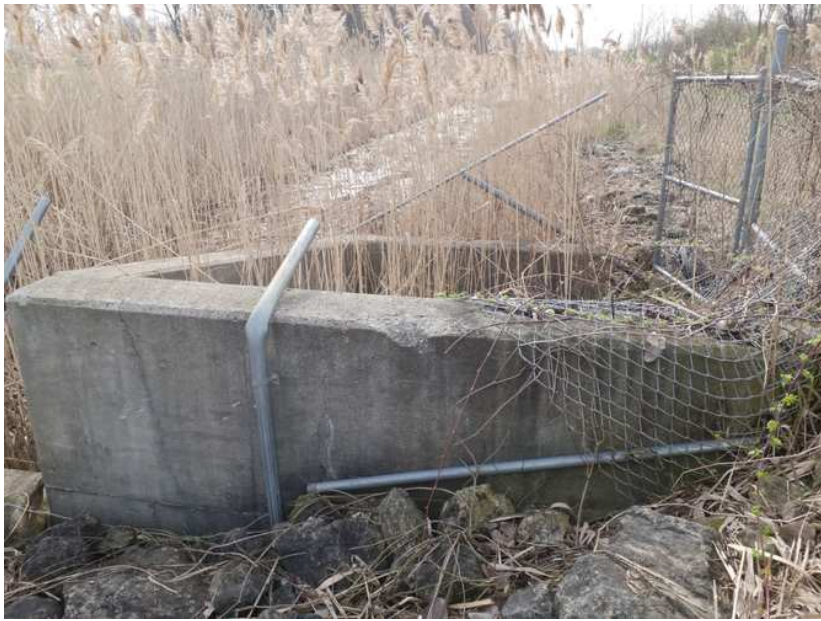
Inspect ID: 2024-0047

No User Rating (Site Visit) - Crack in concrete and missing chunk of concrete in headwall

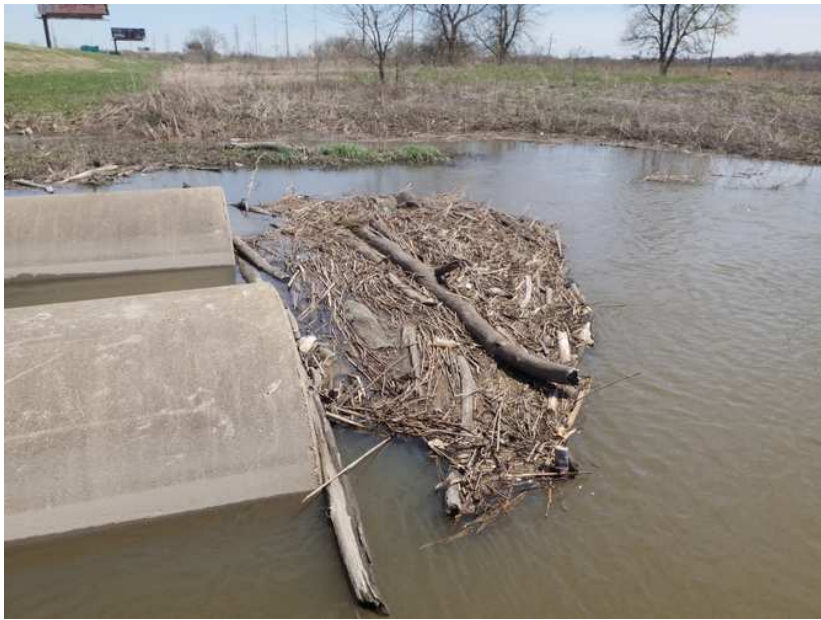
Inspect ID: 2024-0102

No User Rating (Site Visit) - Culverts between GN-13 and 14 are partially blocked by debris

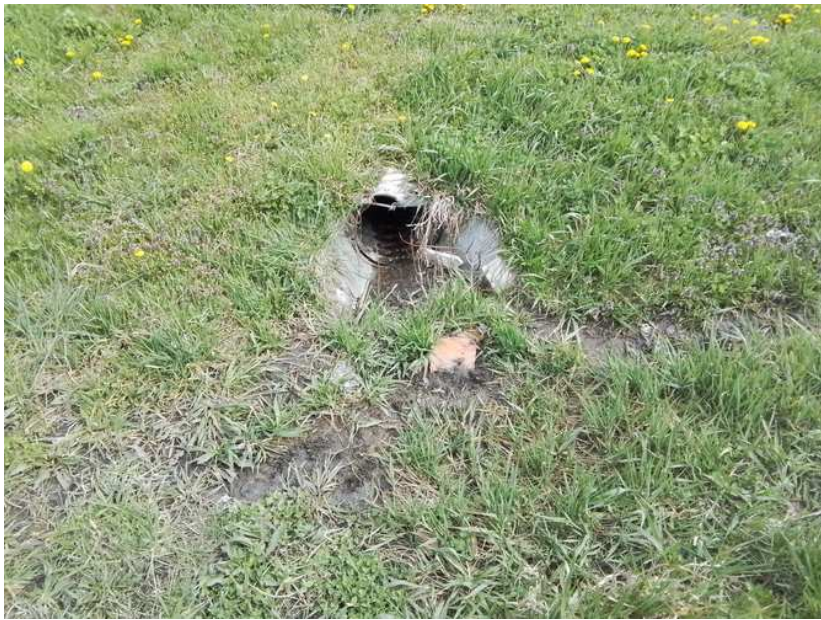
Inspect ID: 2024-0236

No User Rating (Site Visit) - Damaged corrugated culvert

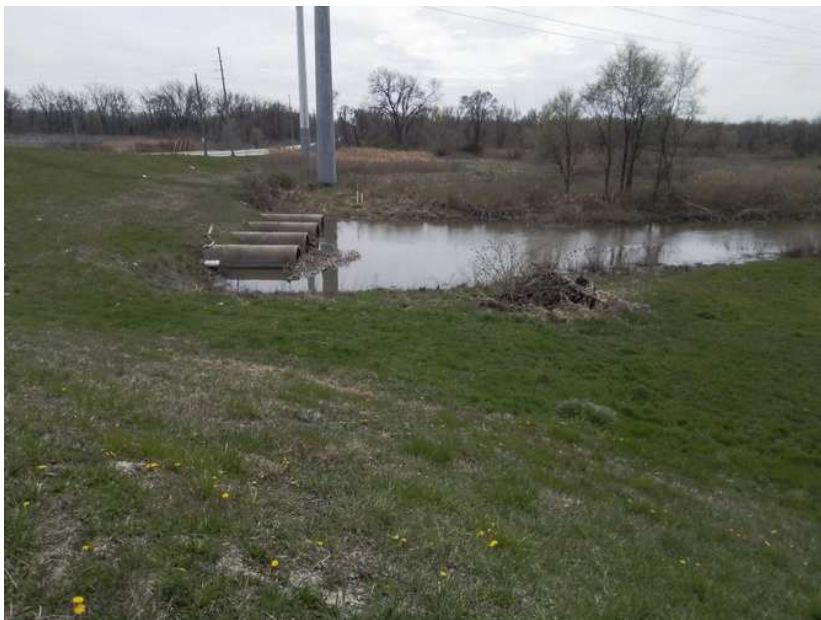
Inspect ID: 2024-0380

No User Rating (Site Visit) - Culvert by GN-12 is blocked with debris

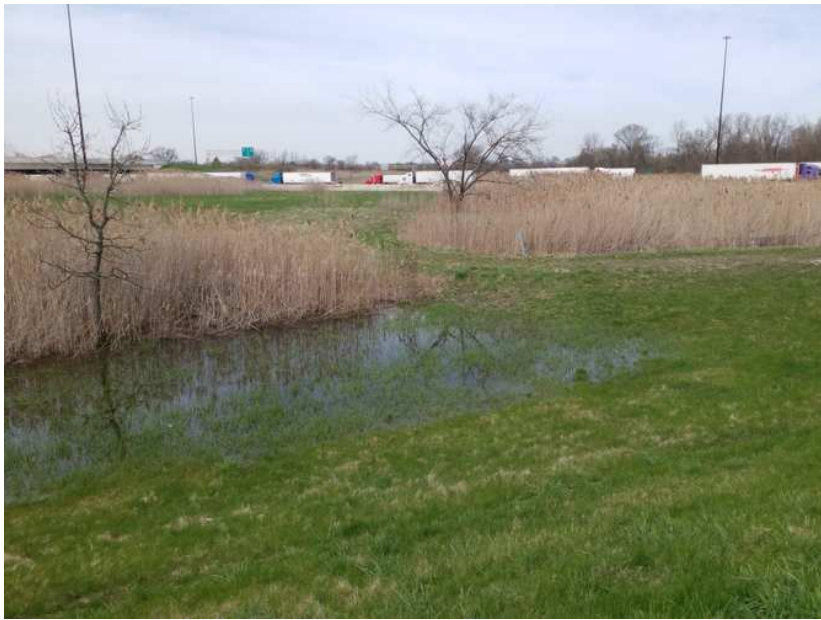
Inspect ID: 2024-0399

No User Rating (Site Visit) - Culvert under ramp connecting the ditch is not visible

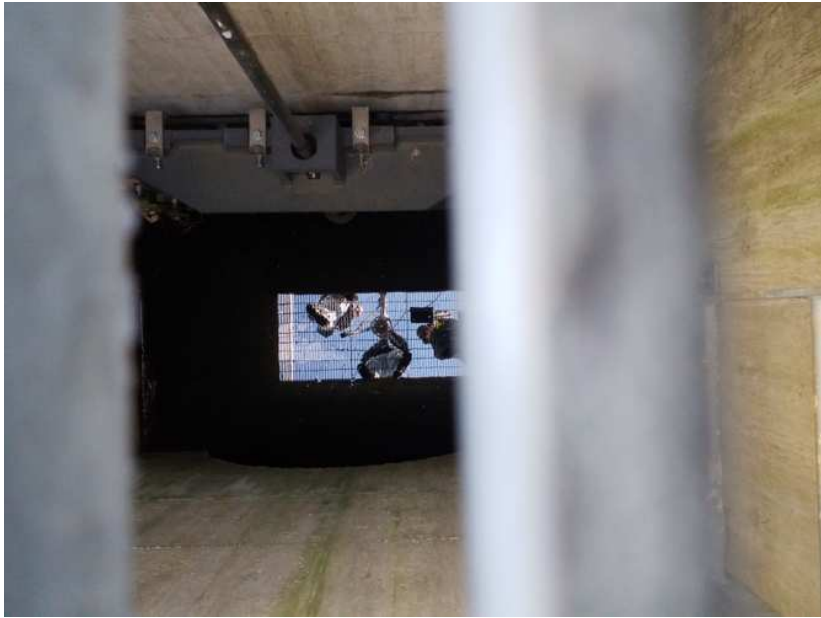
Inspect ID: 2024-0002

No User Rating (Site Visit) - GN-03: Fully closed - squeaking reduced since last inspection

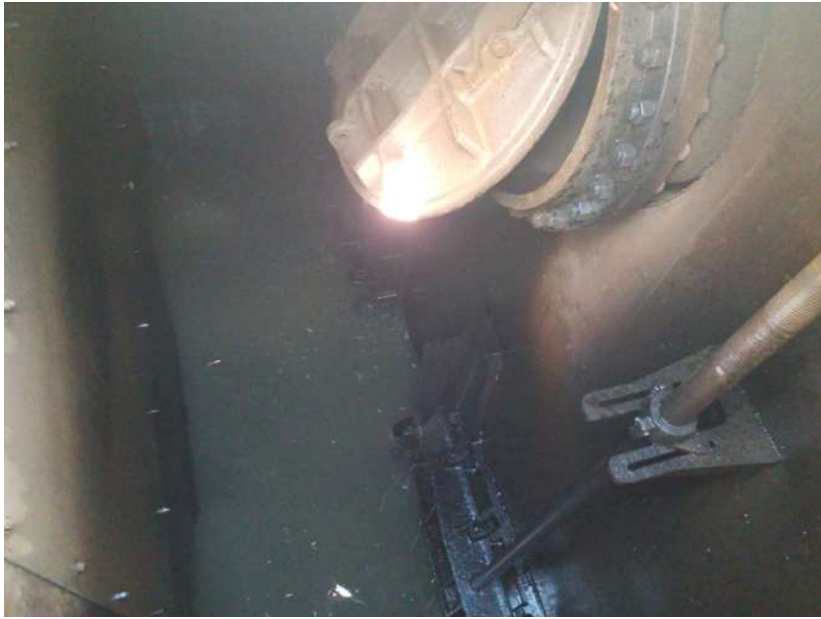
Inspect ID: 2024-0014

No User Rating (Site Visit) - GN-07: Not typically operated due to high river levels

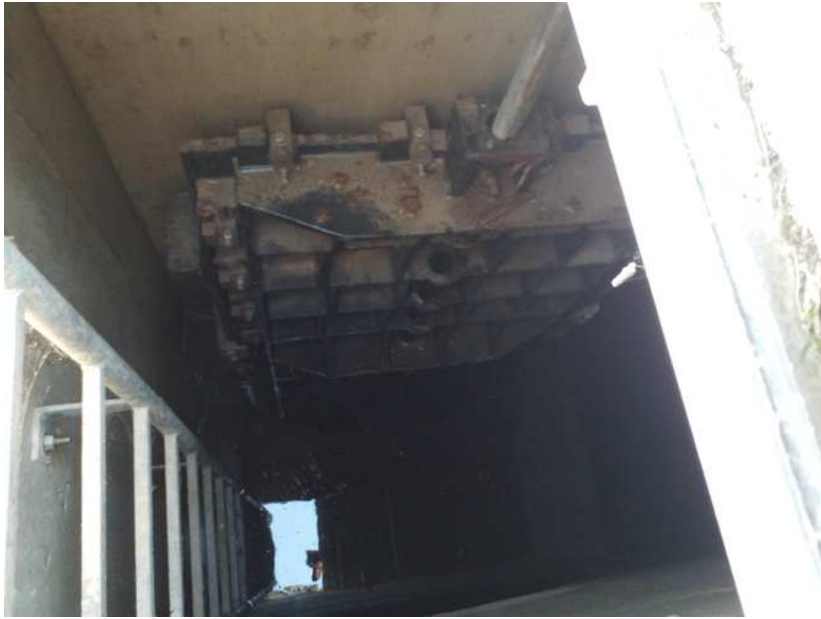
Inspect ID: 2024-0022

No User Rating (Site Visit) - GN-08A: Gate closed. A, B, and C gates operated smoothly

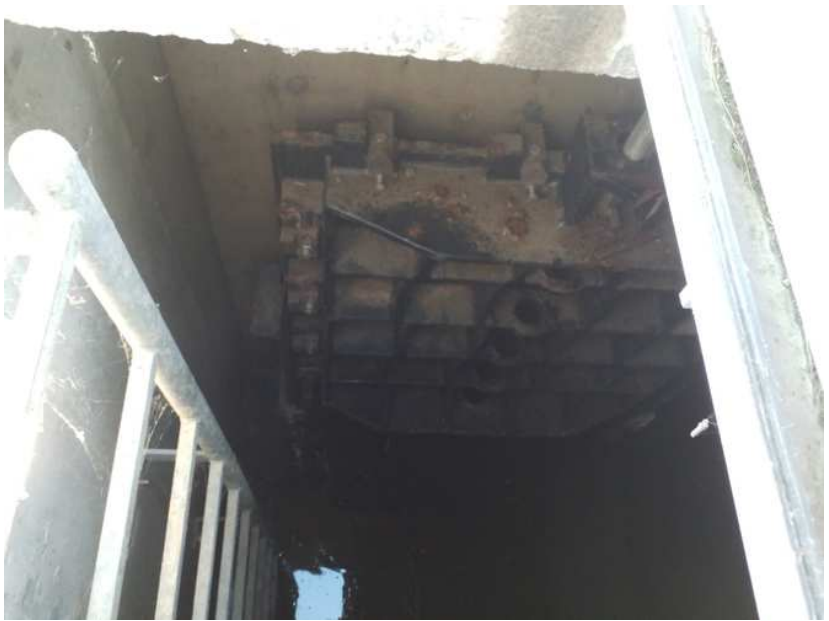
Inspect ID: 2024-0026

No User Rating (Site Visit) - GN-08A: Gate open. A, B, and C gates operated smoothly

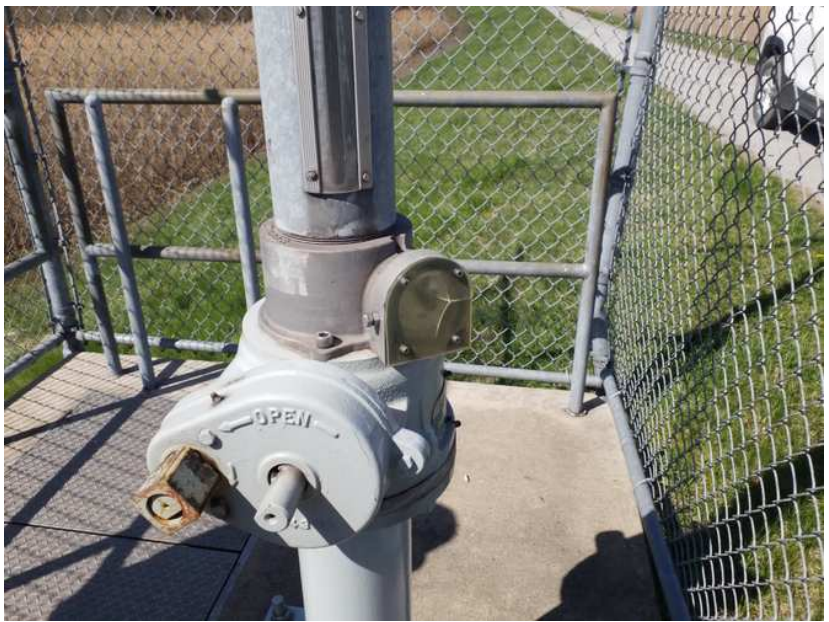
Inspect ID: 2024-0046

No User Rating (Site Visit) - GN-08: All gauges (A, B, and C) were not working - unchanged since last inspection. Closure was verified using screw shaft

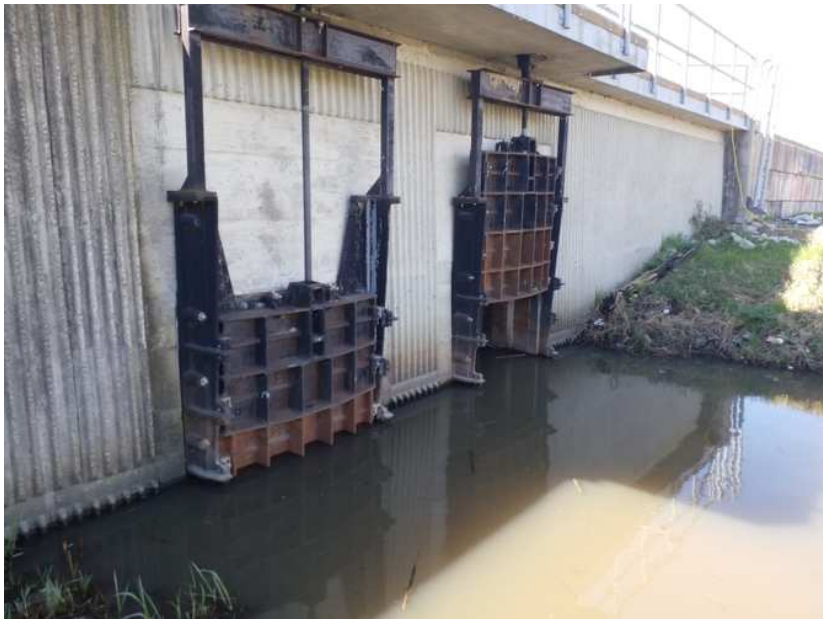
Inspect ID: 2024-0058

No User Rating (Site Visit) - GN-09B: Gate closed. Gate operated smoothly

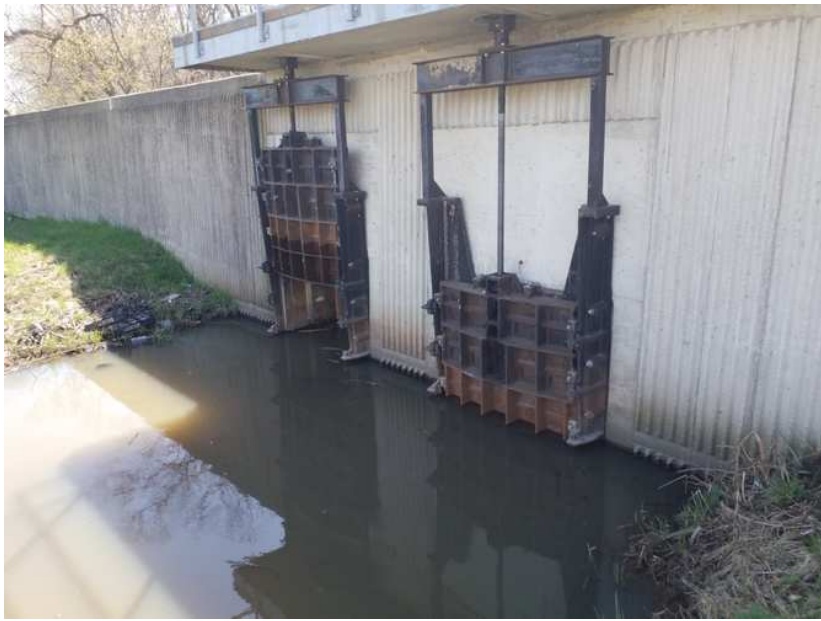
Inspect ID: 2024-0062

No User Rating (Site Visit) - GN-09A: Gate closed. Gate operated smoothly

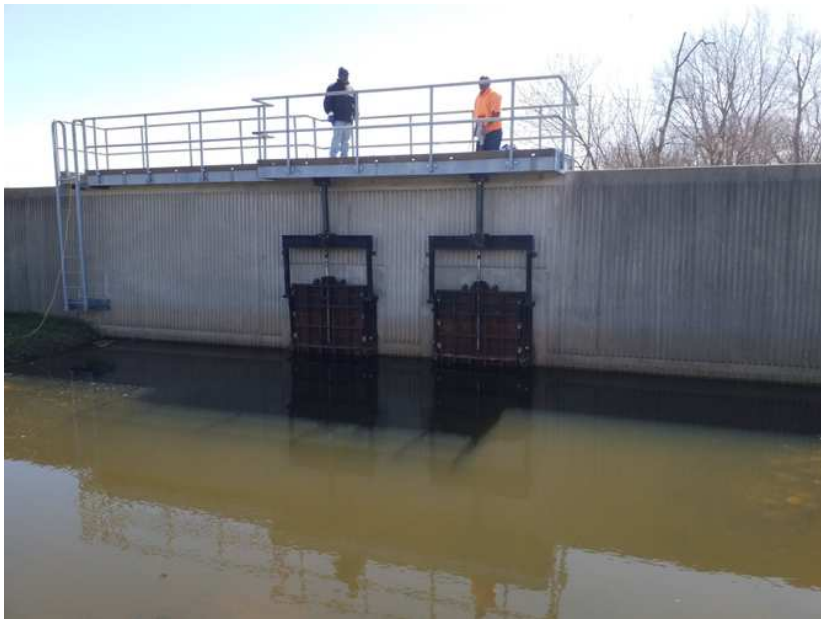
Inspect ID: 2024-0066

No User Rating (Site Visit) - GN-10: Gates A,B open - squeaking noted during last inspection is no longer present

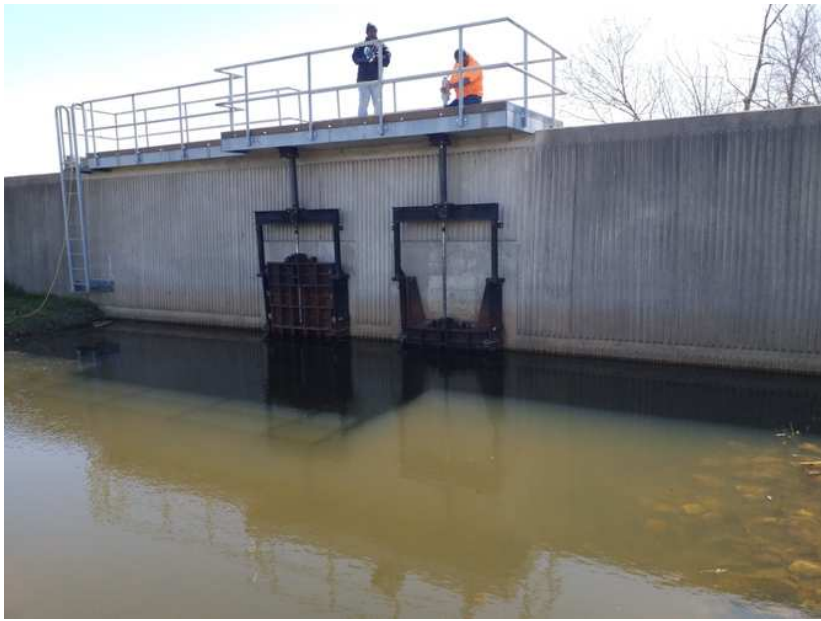
Inspect ID: 2024-0070

No User Rating (Site Visit) - GN-10A: Gate closed. Gate operated smoothly

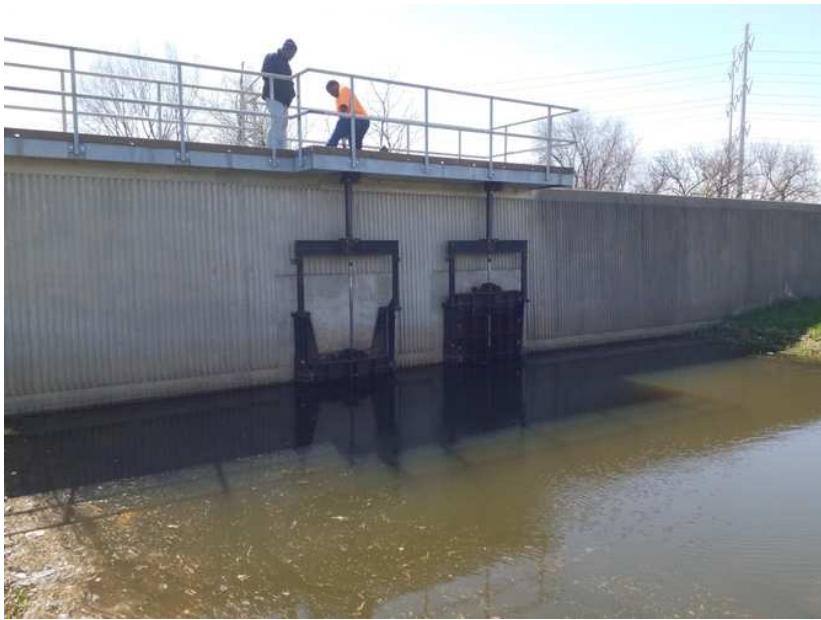
Inspect ID: 2024-0074

No User Rating (Site Visit) - GN-10B: Gate closed. Gate operated smoothly

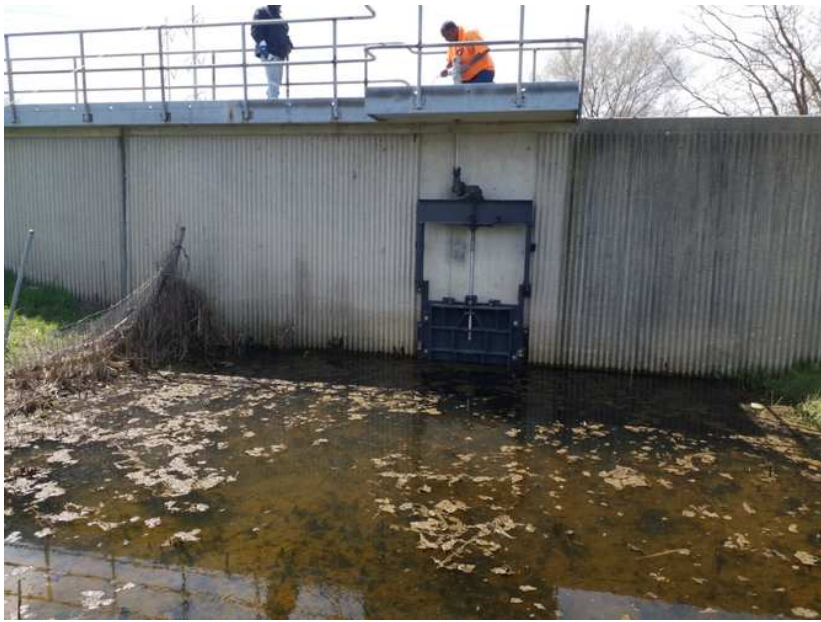
Inspect ID: 2024-0082

No User Rating (Site Visit) - GN-11: Gate closed. Gate operated smoothly

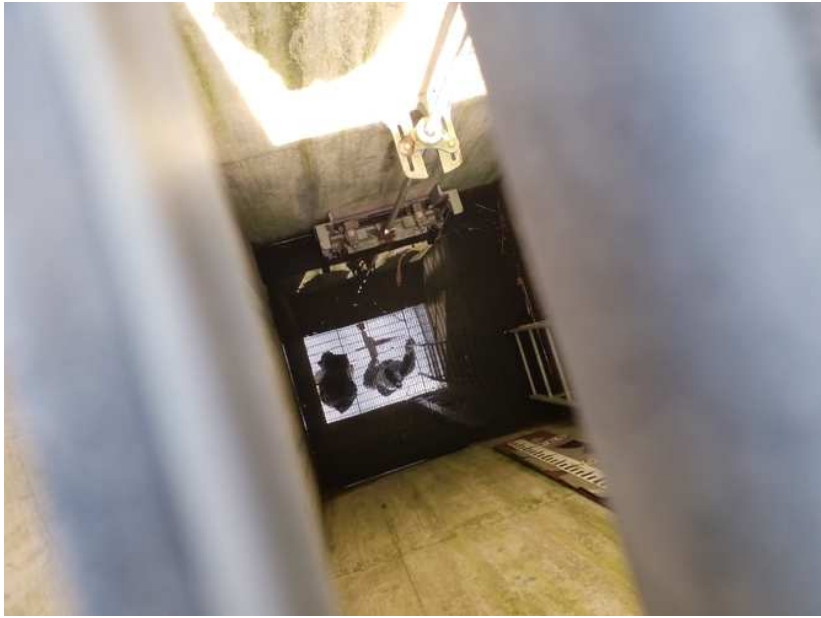
Inspect ID: 2024-0098

No User Rating (Site Visit) - GN-13: Gate closed. Gate operated smoothly

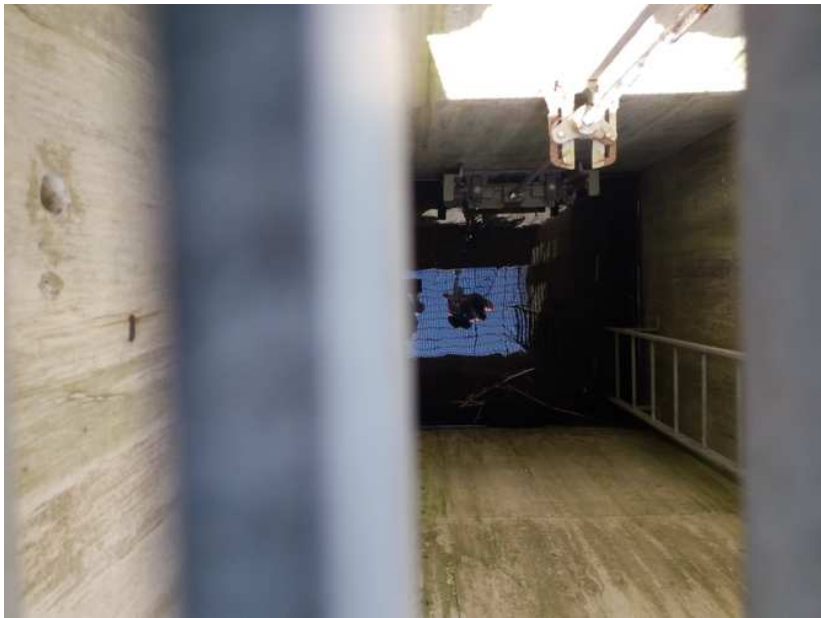
Inspect ID: 2024-0106

No User Rating (Site Visit) - GN-14: Gate closed. Gate operated smoothly
