**US Army Corps
of Engineers ®**

Site Visit Summary

Name of System: Gary

Name of Segment: Gary North

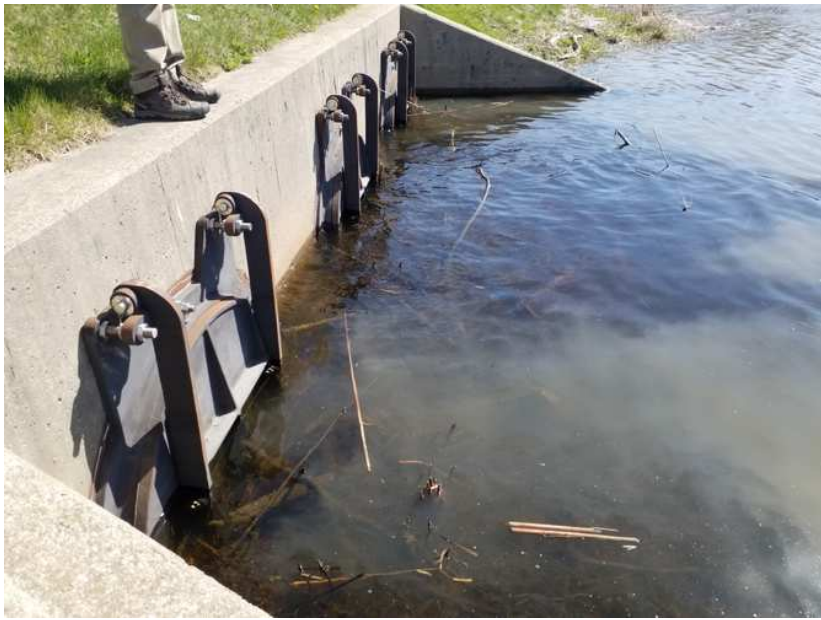
No User Rating (Site Visit) - GN-03: Flap gate not fully sealed

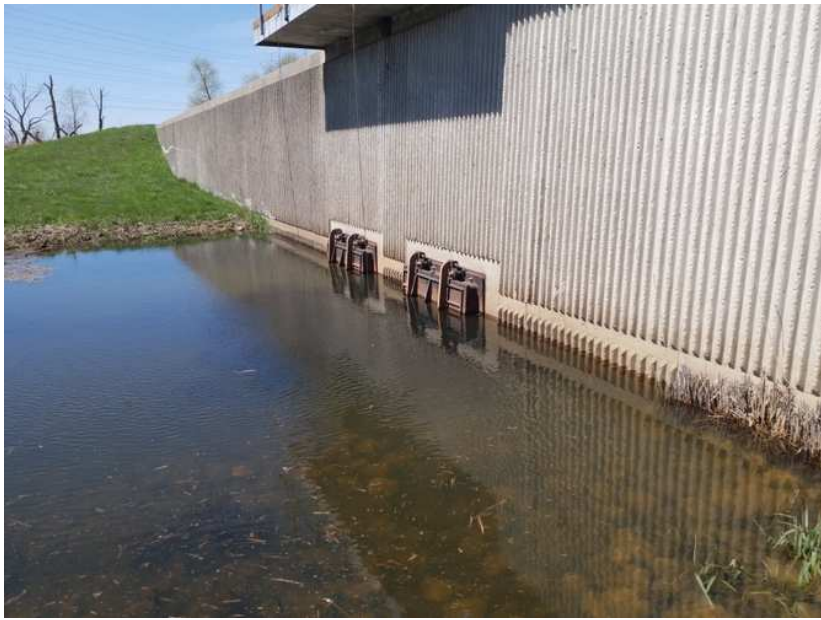
No User Rating (Site Visit) - GN-08: Vegetation/debris at flap gates is much improved since last inspection. 3 flap gates aren't fully sealed

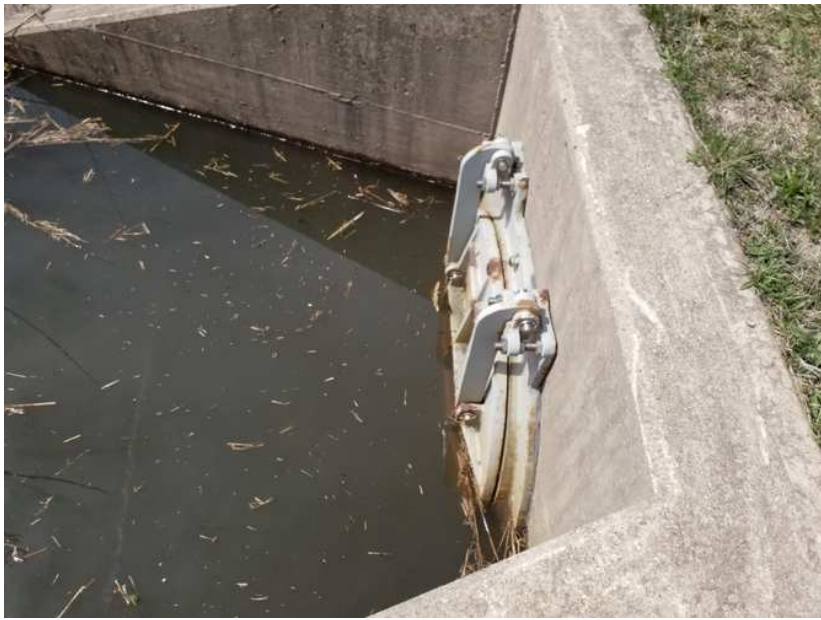
No User Rating (Site Visit) - GN-10: flap gates (A,B) not fully sealed

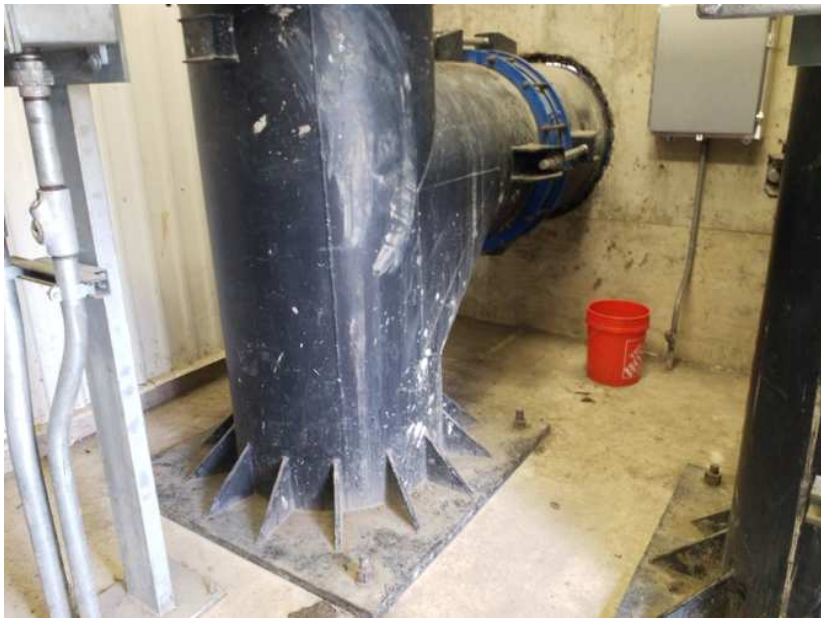
No User Rating (Site Visit) - PS-BR: No change in settlement

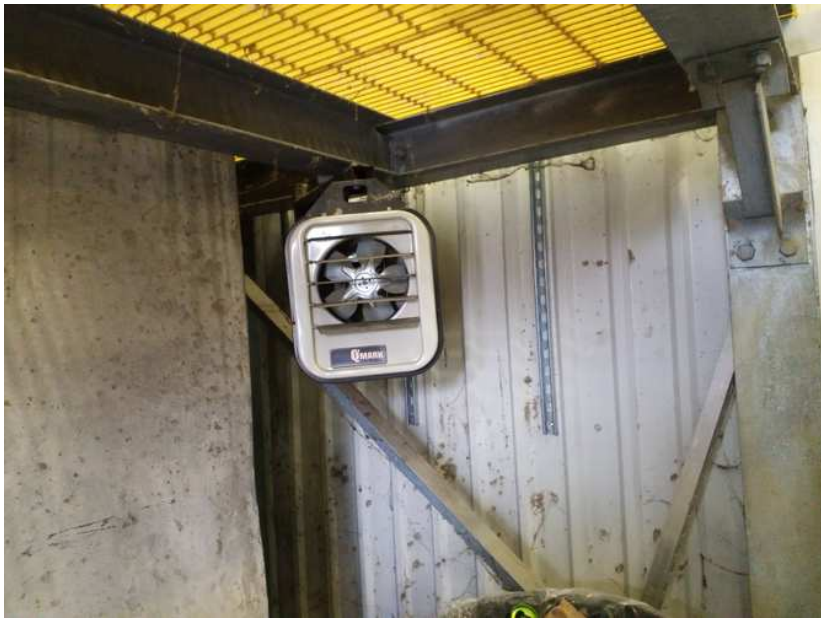
No User Rating (Site Visit) - PS-BR: Pump station exhaust fan not operated
