US Army Corps
of Engineers ®

Site Visit Summary

Name of System: Gary

Name of Segment: Gary South

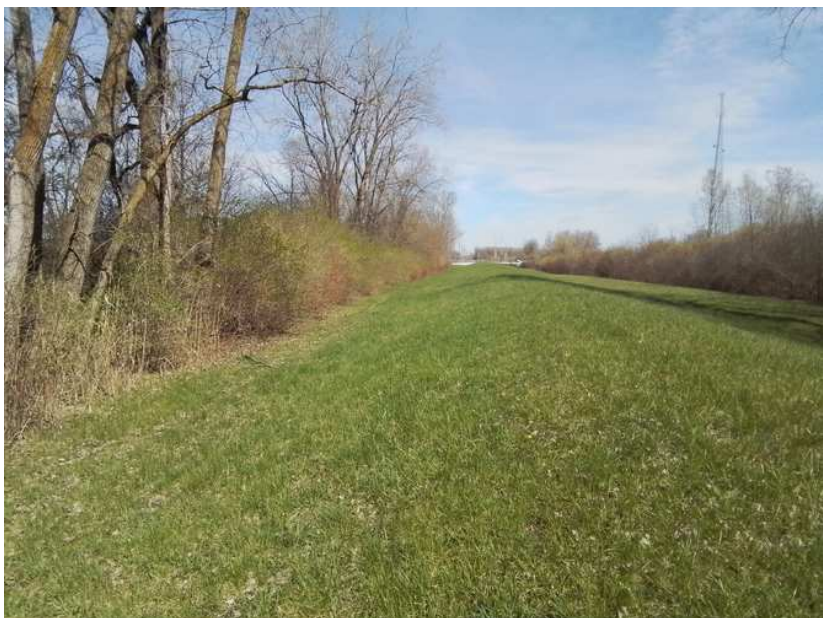
Inspect ID: 2024-0008

No User Rating (Site Visit) - Trees and vegetation within 15 feet of landside toe.

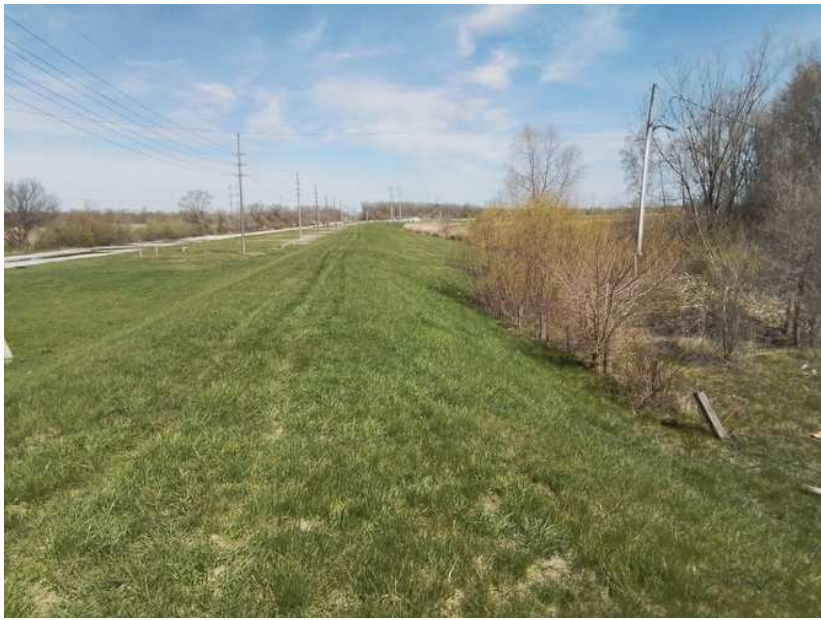
Inspect ID: 2024-0020

No User Rating (Site Visit) - Trees and vegetation on riverside toe.

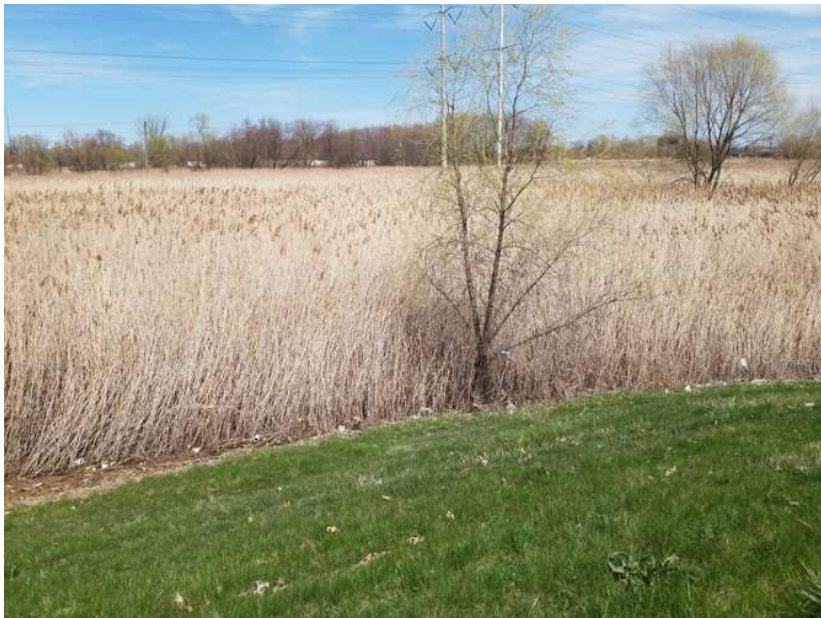
Inspect ID: 2024-0043

No User Rating (Site Visit) - Small trees and vegetation on landside toe.

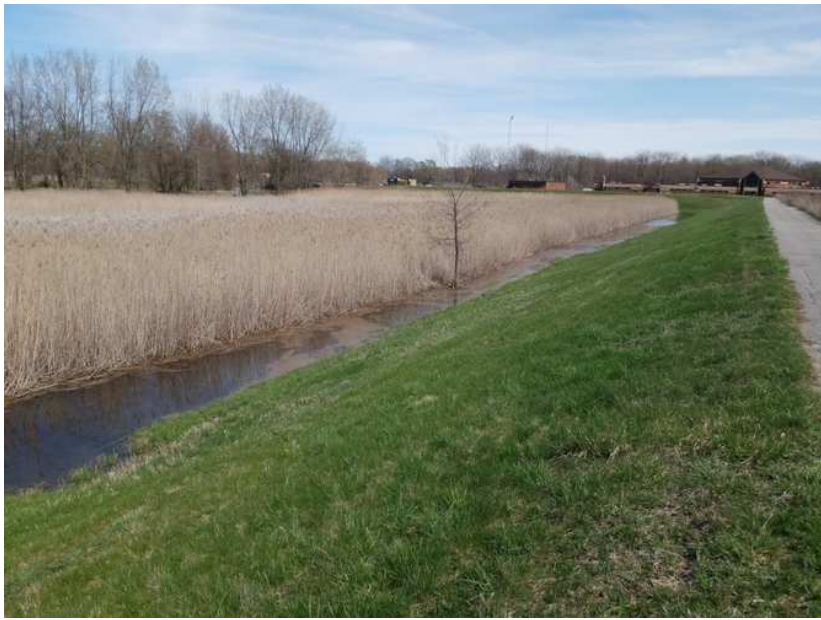
Inspect ID: 2024-0063

No User Rating (Site Visit) - Tree on riverside toe.

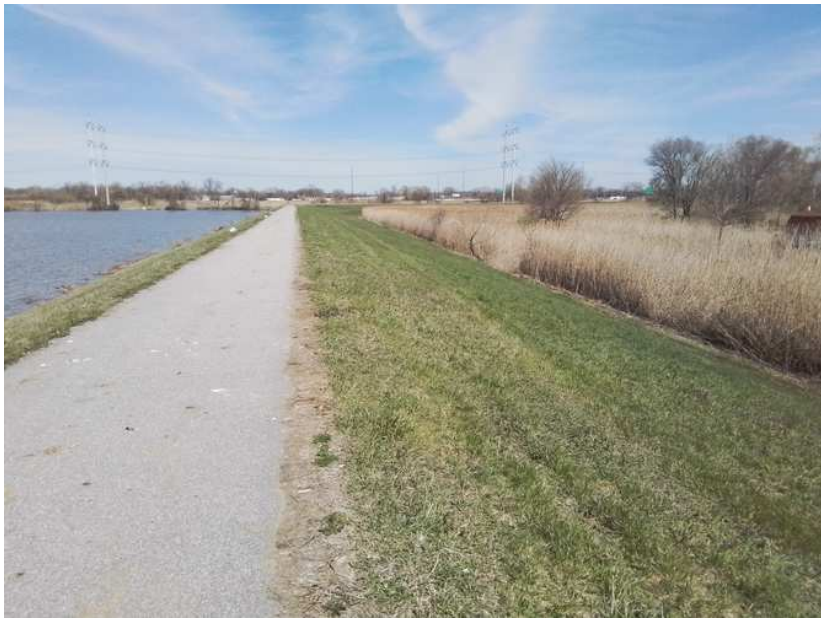
Inspect ID: 2024-0072

No User Rating (Site Visit) - Tree near riverside toe.

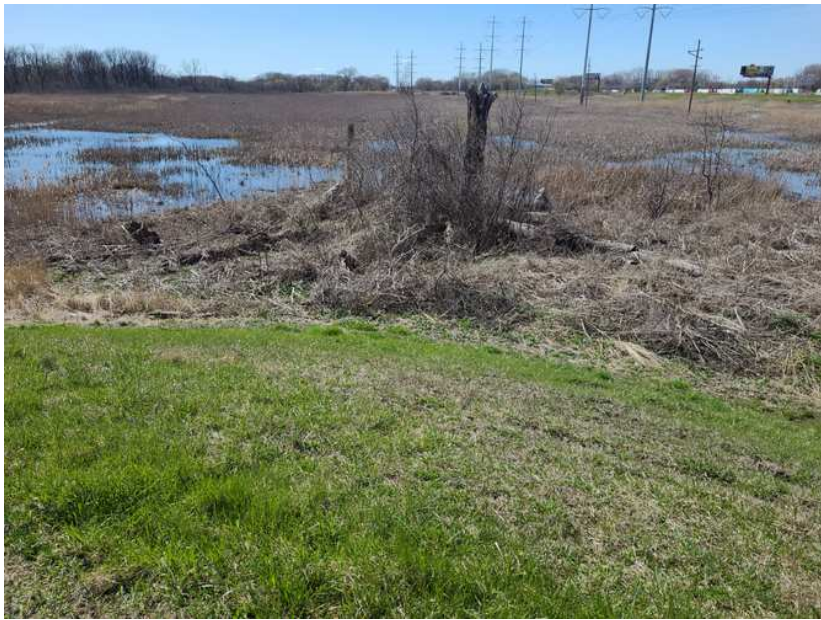
Inspect ID: 2024-0153

No User Rating (Site Visit) - Several dead trees near riverside toe and one downed tree on the riverside toe.

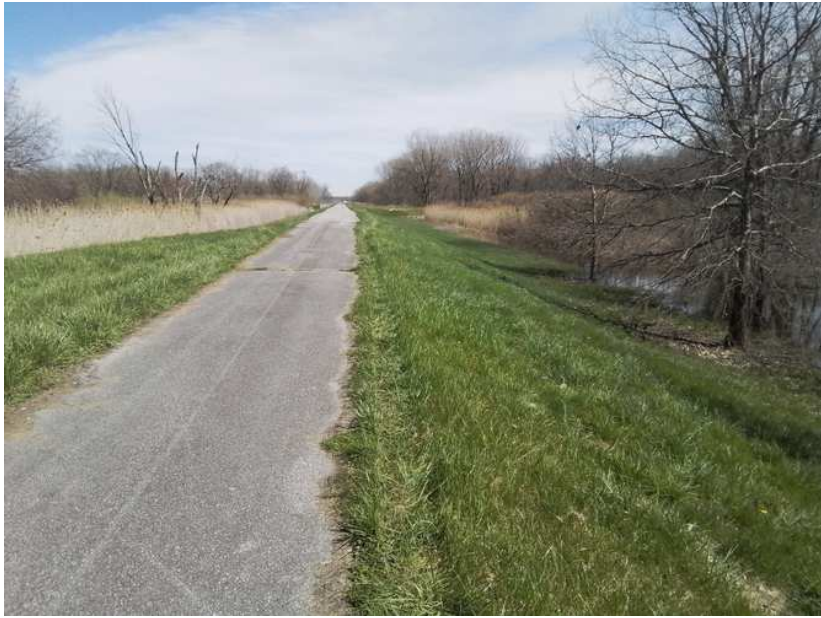
Inspect ID: 2024-0172

No User Rating (Site Visit) - Dead trees, brush and debris on riverside toe.

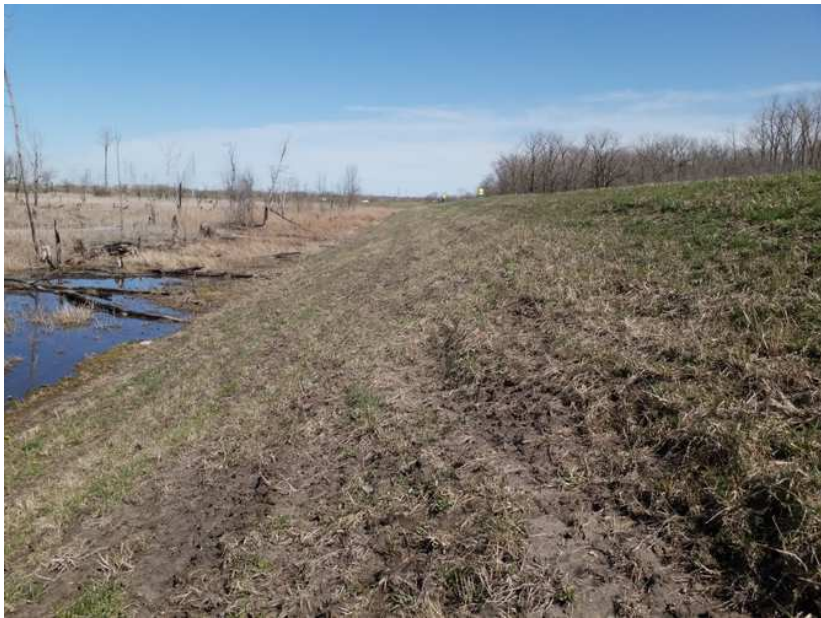
Inspect ID: 2024-0079

No User Rating (Site Visit) - Tree on landside levee toe.

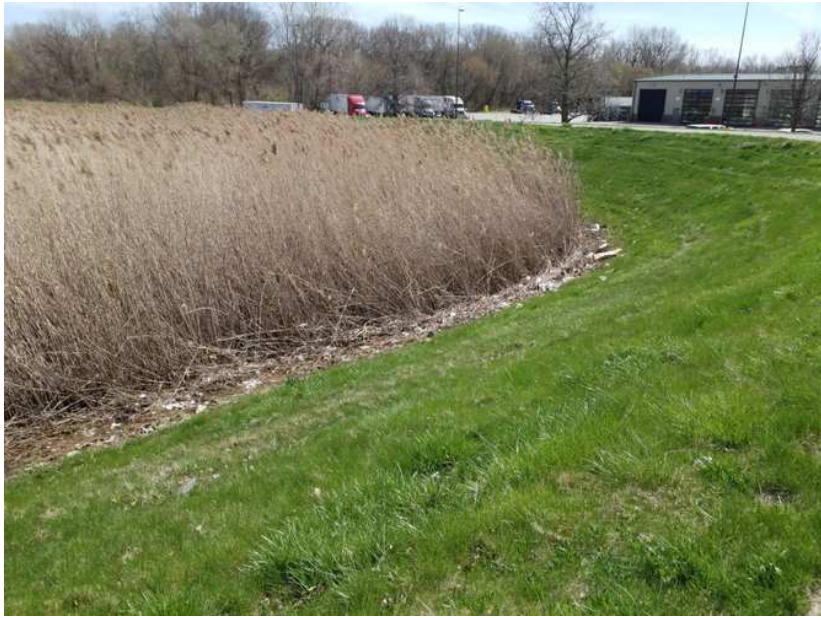
Inspect ID: 2024-0047

No User Rating (Site Visit) - Fallen logs washed up on riverside toe.

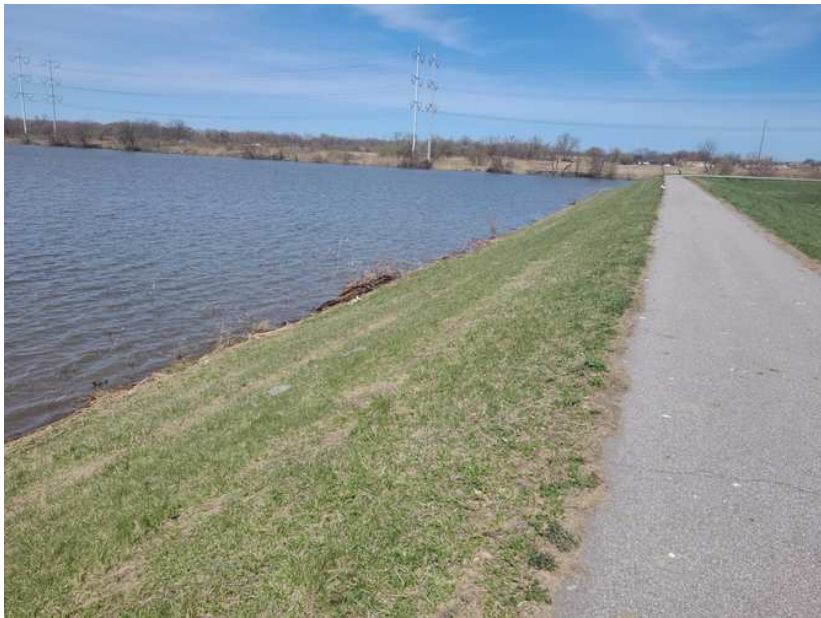
Inspect ID: 2024-0049

No User Rating (Site Visit) - Riverside debris accumulation

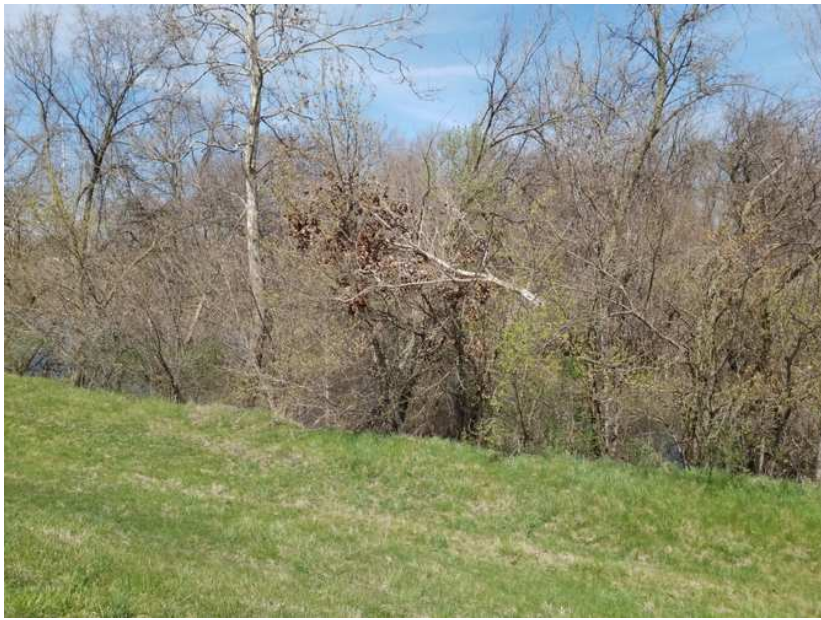
Inspect ID: 2024-0059

No User Rating (Site Visit) - Debris on riverside toe

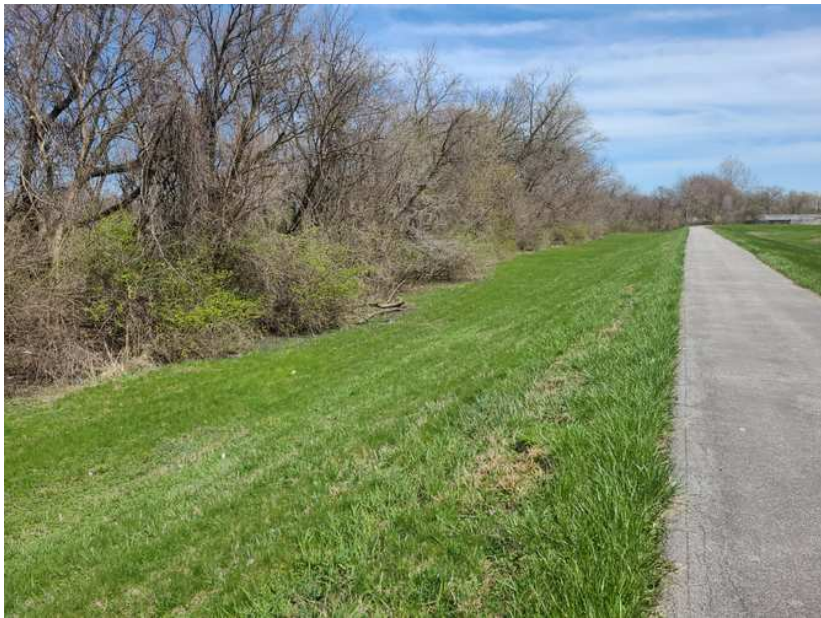
Inspect ID: 2024-0097

No User Rating (Site Visit) - Dead tree overhanging riverside toe

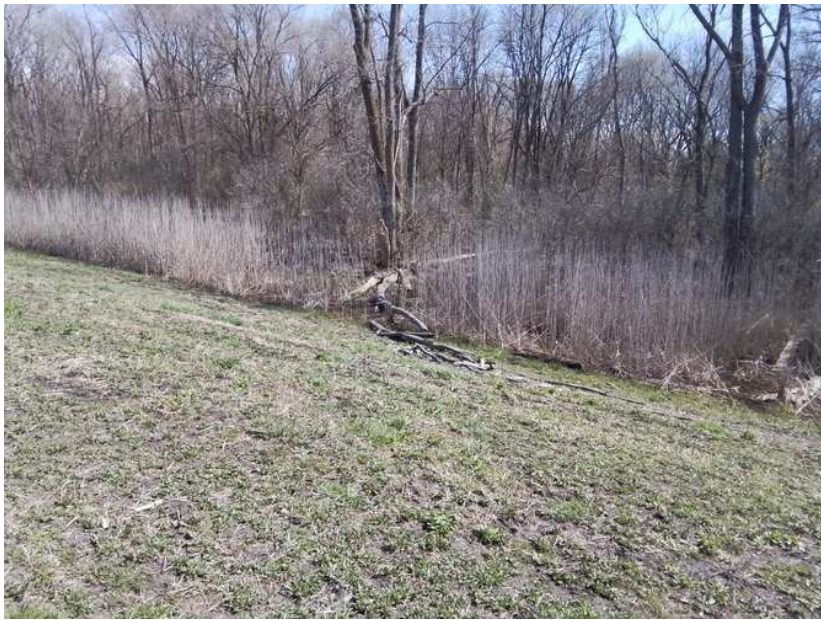
Inspect ID: 2024-0204

No User Rating (Site Visit) - Tree and debris on landside toe

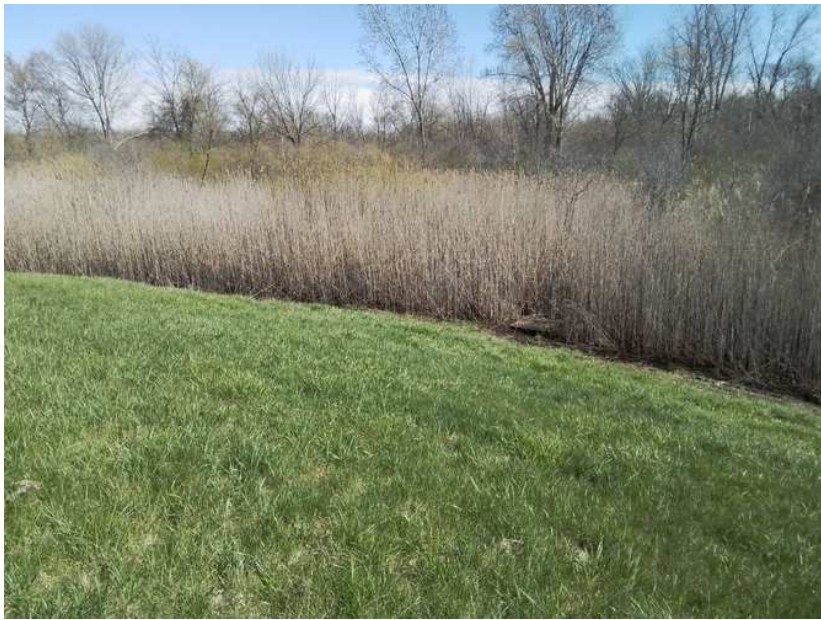
Inspect ID: 2024-0216

No User Rating (Site Visit) - Downed tree on landside toe

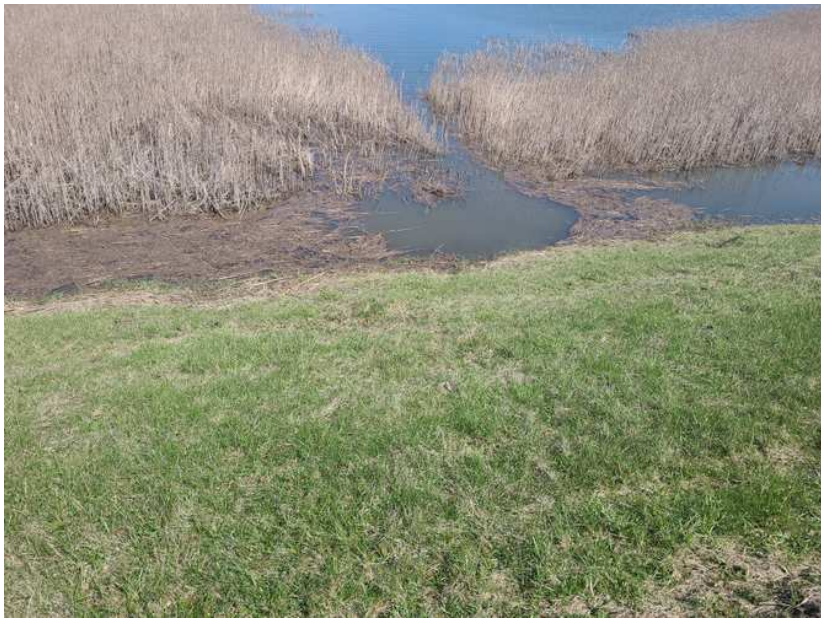
Inspect ID: 2024-0041

No User Rating (Site Visit) - Erosion and bank caving on the riverside toe

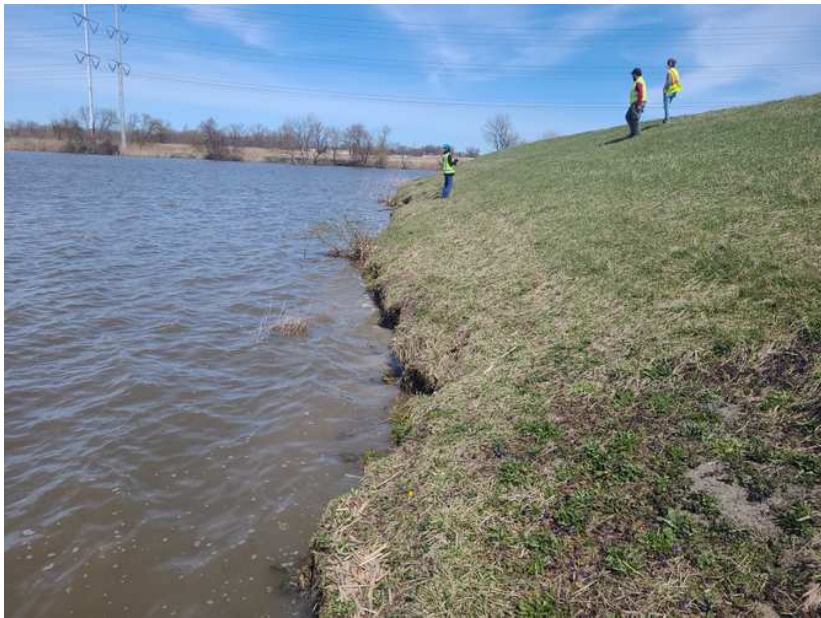
Inspect ID: 2024-0053

No User Rating (Site Visit) - Typical erosion and bank caving. Wave action causing bank caving line on riverside slope

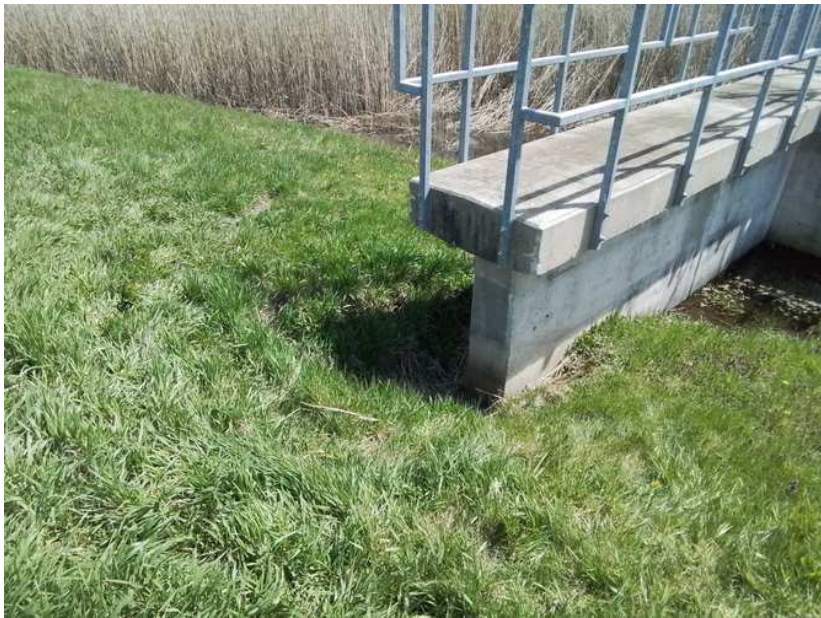
Inspect ID: 2024-0060

No User Rating (Site Visit) - Active bank caving on riverside toe

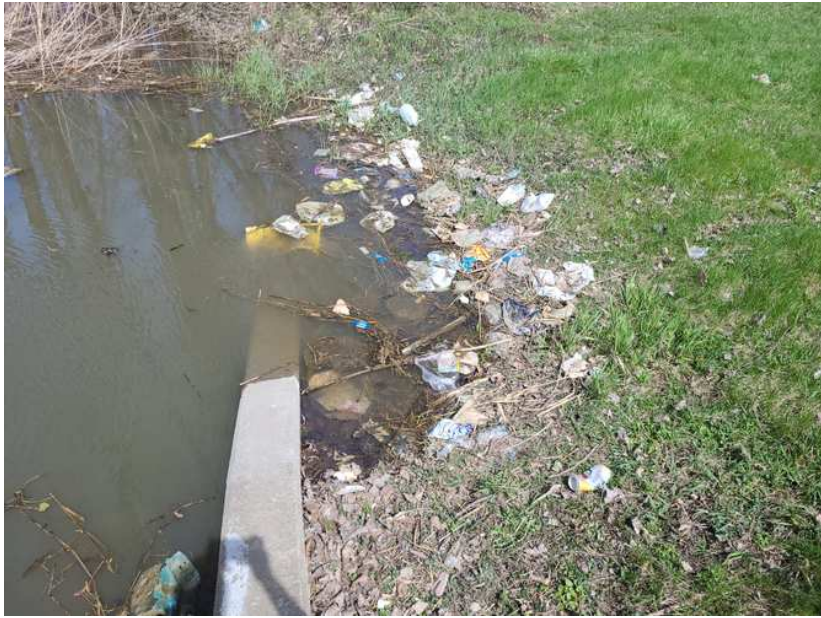
Inspect ID: 2024-0093

No User Rating (Site Visit) - Erosion around gate structure on landside slope

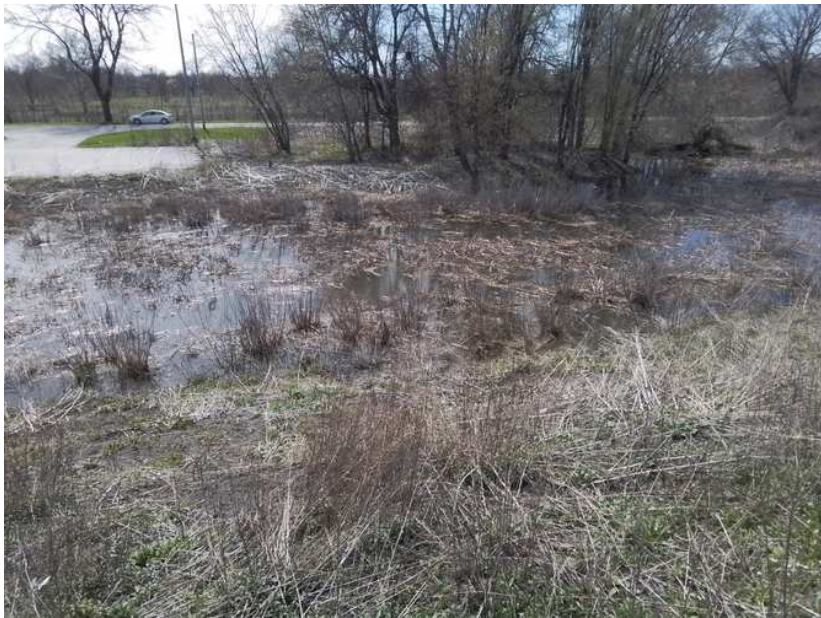
Inspect ID: 2024-0136

No User Rating (Site Visit) - GS-09: Erosion around the riverside wingwall

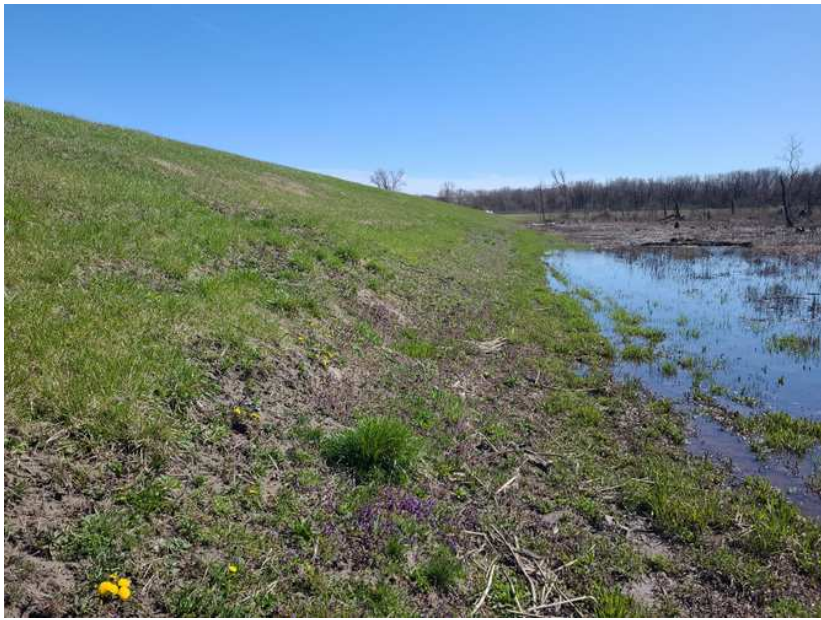
Inspect ID: 2024-0145

No User Rating (Site Visit) - Collapsed/eroded area on landside toe

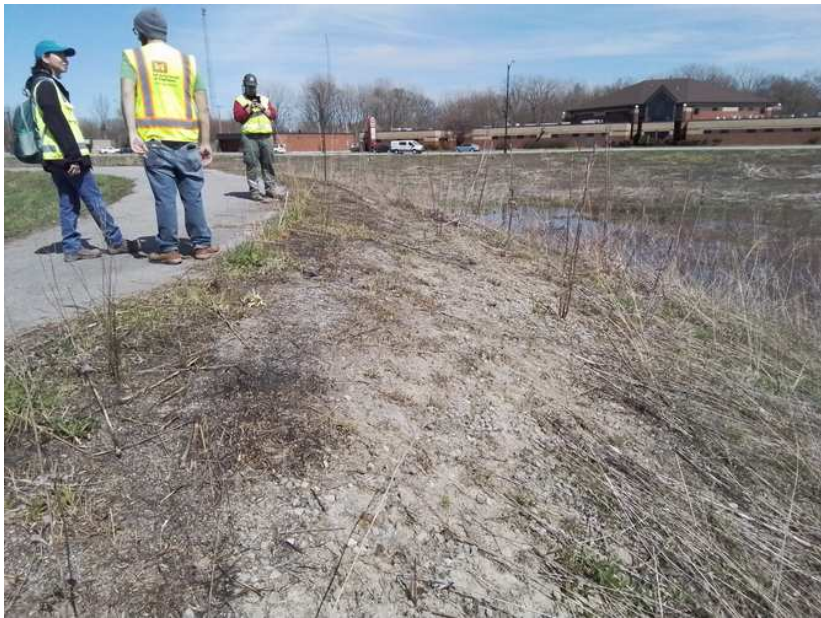
Inspect ID: 2024-0148

No User Rating (Site Visit) - Bank caving and erosion on riverside levee toe

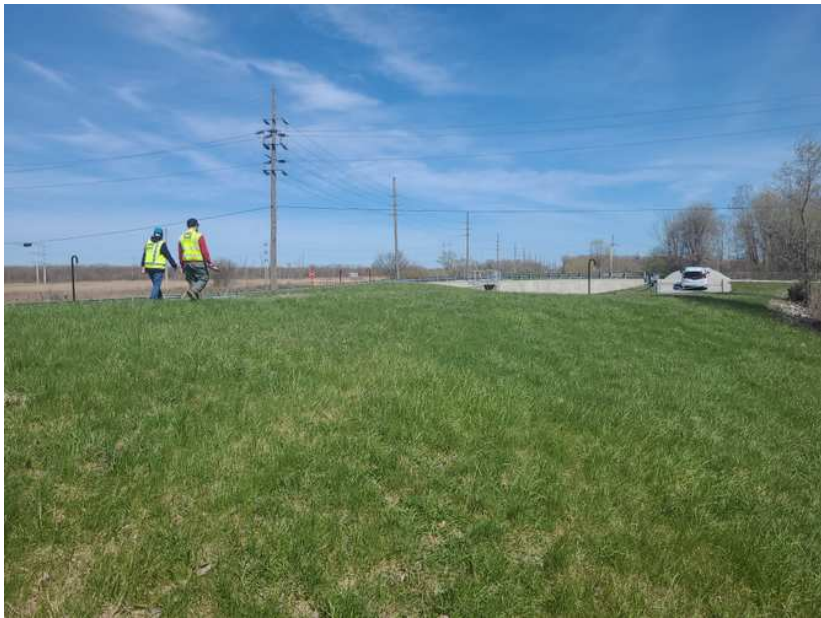
Inspect ID: 2024-0013

0221 - No User Rating (Site Visit) - Bank caving on riverside toe

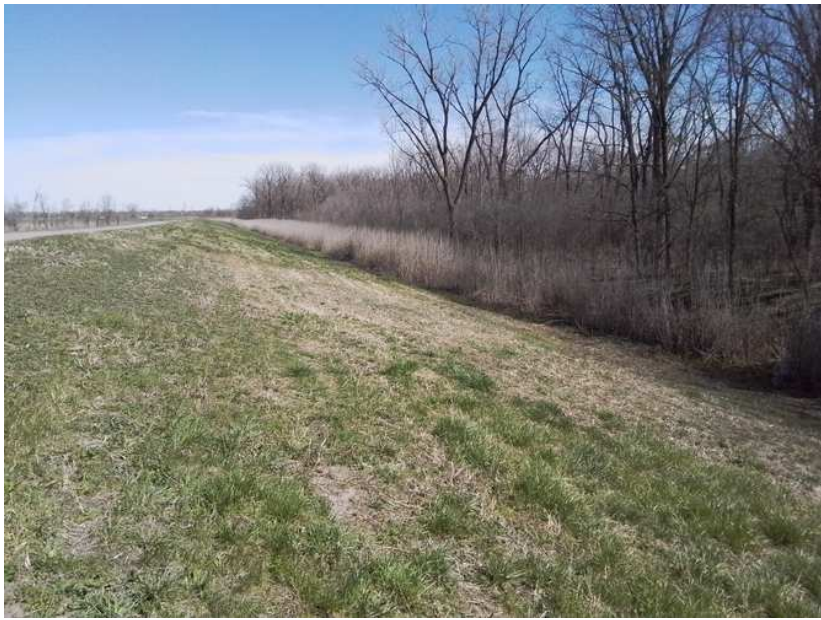
Inspect ID: 2024-0196

No User Rating (Site Visit) - Dip in levee crest at access road intersection with levee crown.

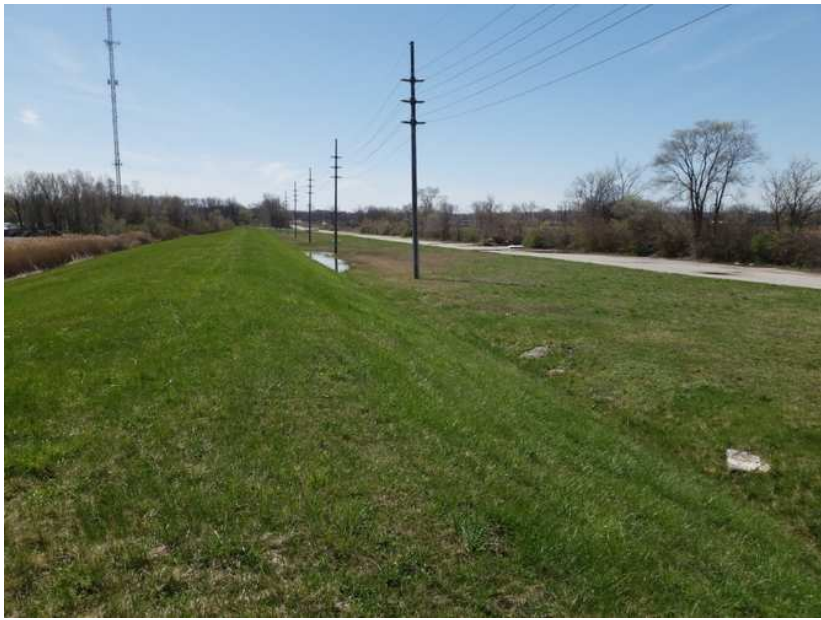
Inspect ID: 2024-0007

No User Rating (Site Visit) - Depression on landside toe.

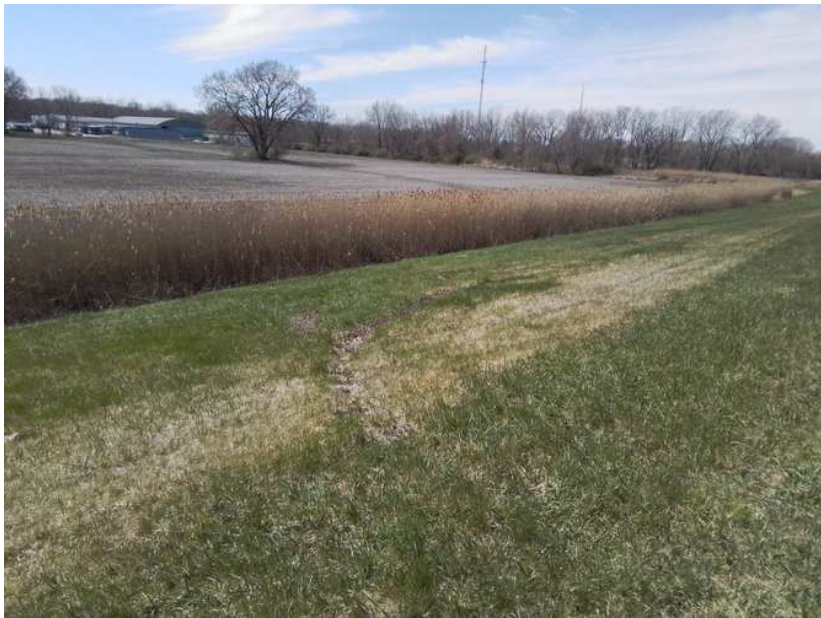
Inspect ID: 2024-0052

No User Rating (Site Visit) - Depressions in landside toe are retaining water

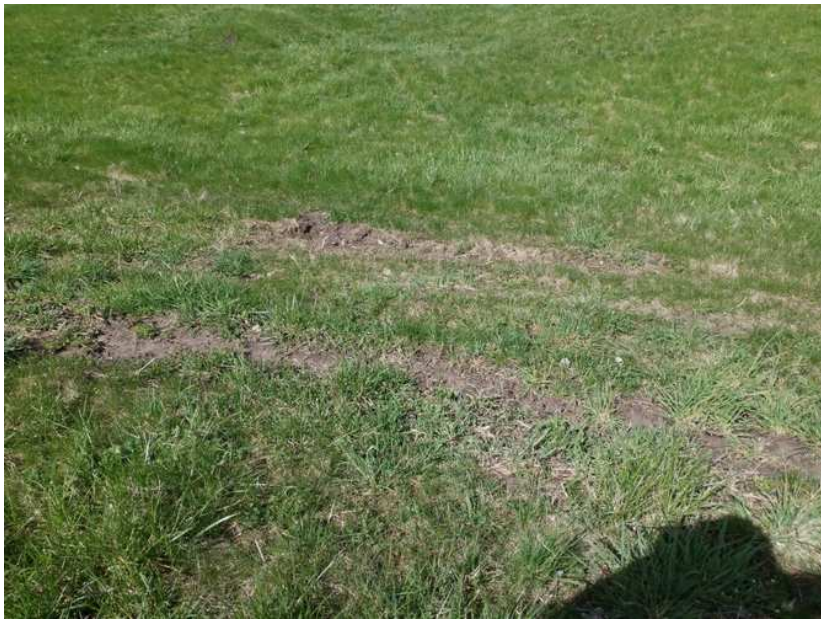
Inspect ID: 2024-0055

No User Rating (Site Visit) - Rutting along landside slope

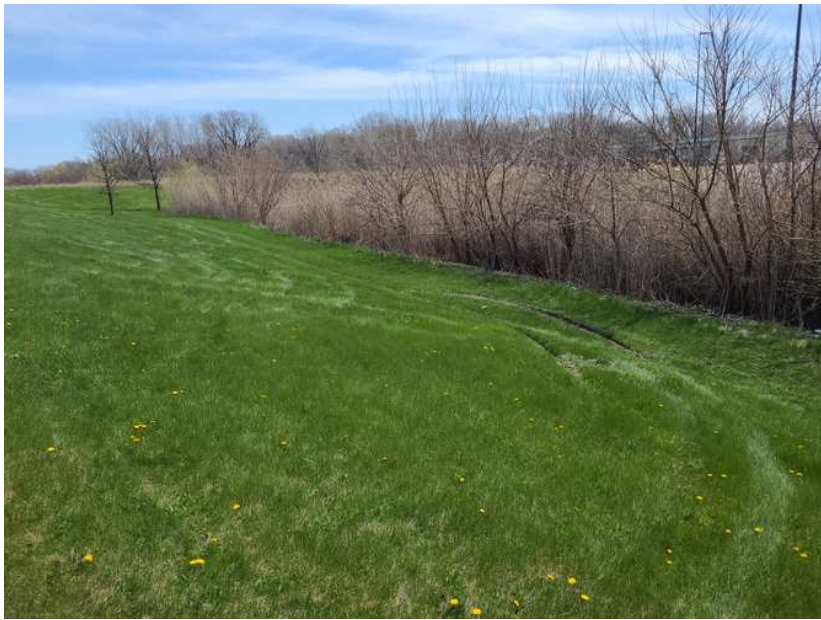
Inspect ID: 2024-0077

No User Rating (Site Visit) - Rutting along riverside slope

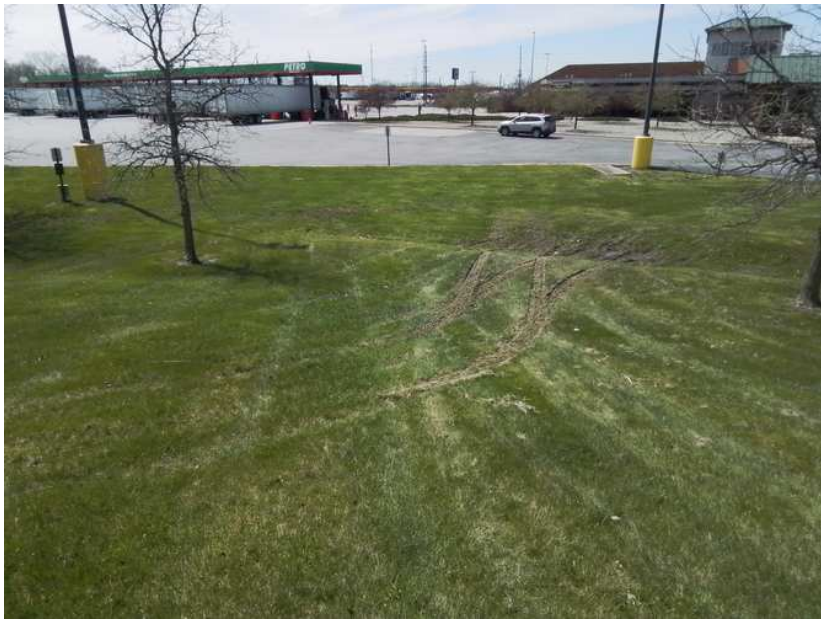
Inspect ID: 2024-0112

No User Rating (Site Visit) - Tire tracks creating ruts along landside toe

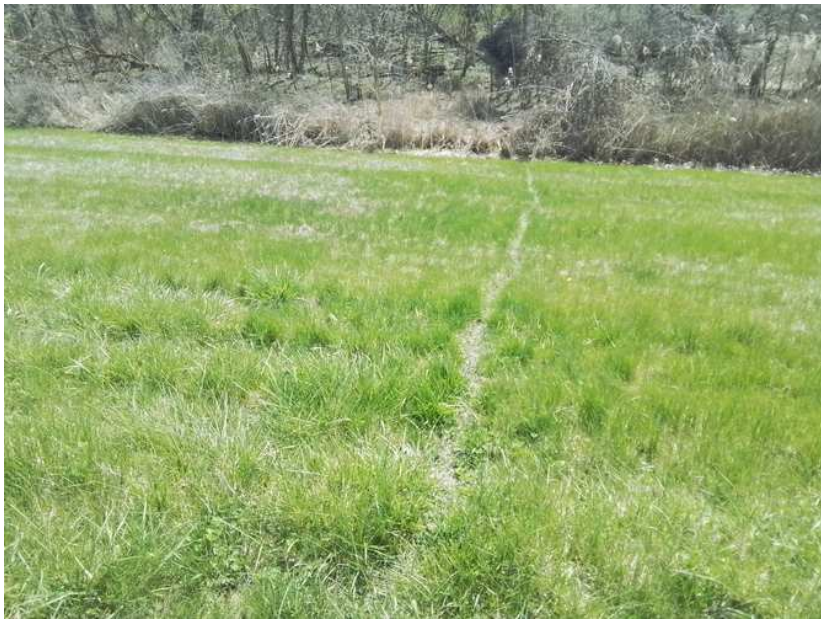
Inspect ID: 2024-0120

No User Rating (Site Visit) - Rutting and ponding on landside slope and toe

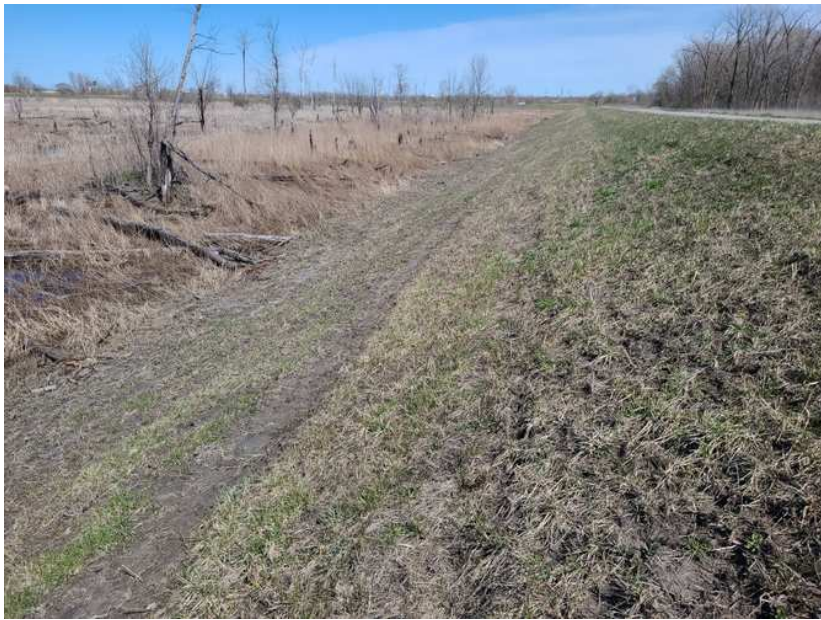
Inspect ID: 2024-0133

No User Rating (Site Visit) - Animal trail is creating rutting along landside slope

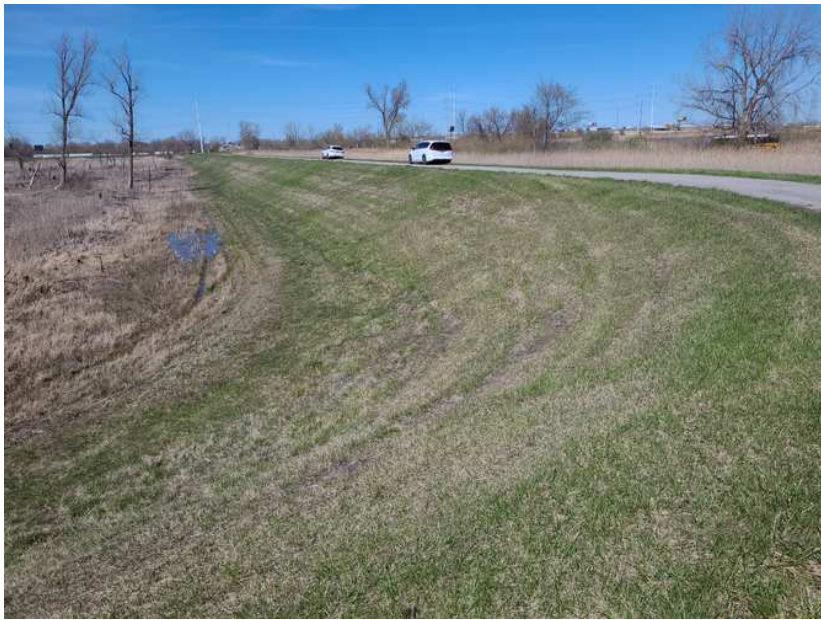
Inspect ID: 2024-0137

No User Rating (Site Visit) - Deep rutting on riverside slope

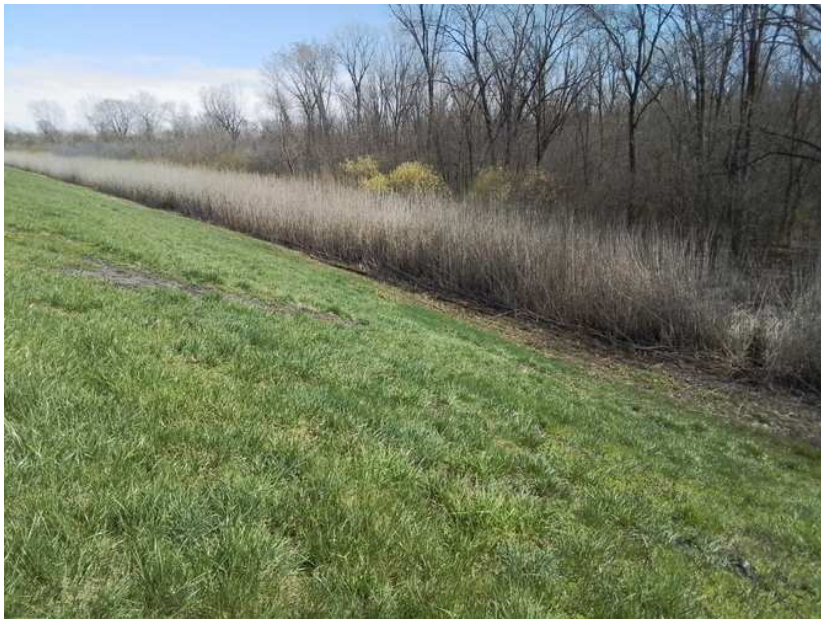
Inspect ID: 2024-0208

No User Rating (Site Visit) - Small depressions on inside corner of riverside slope

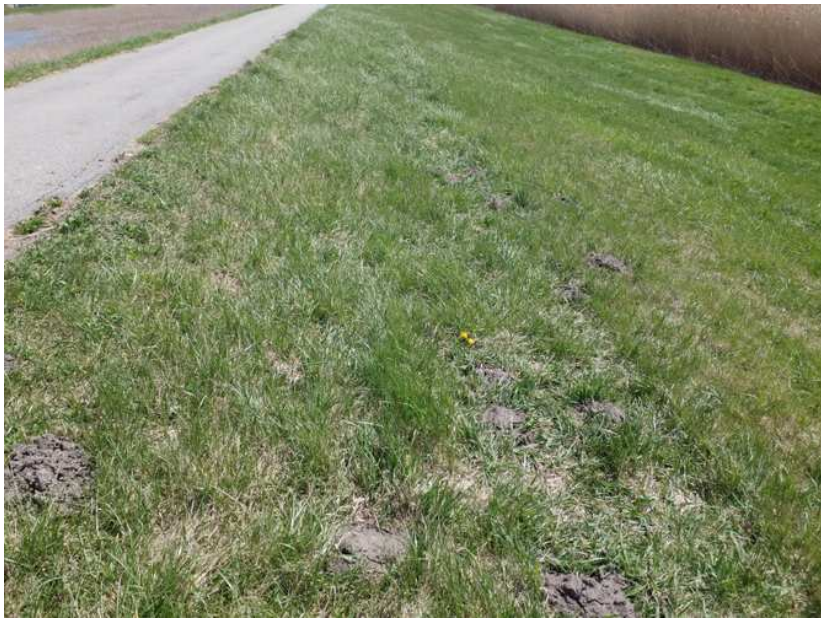
Inspect ID: 2024-0015

No User Rating (Site Visit) - Animal burrows are typical along landside toe

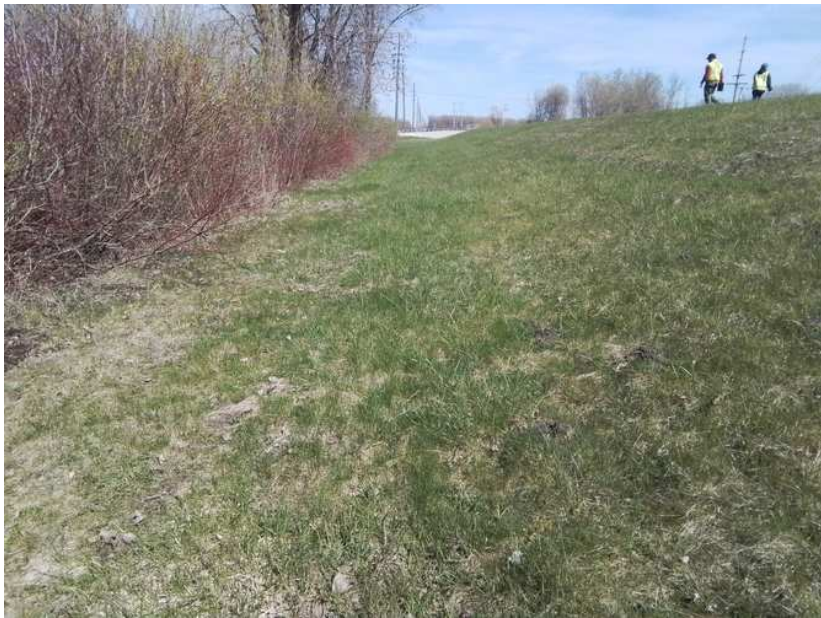
Inspect ID: 2024-0016

No User Rating (Site Visit) - Cluster of animal burrows on landside slope

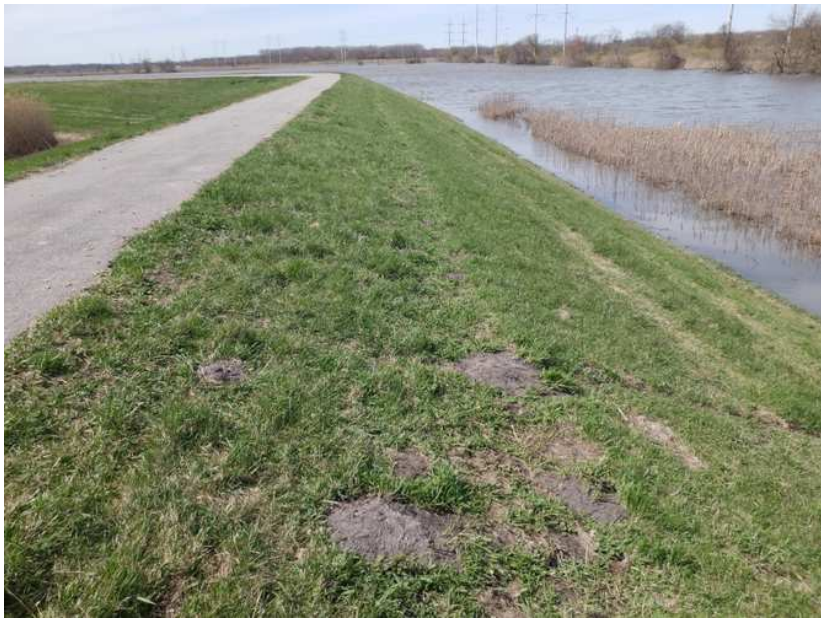
Inspect ID: 2024-0023

No User Rating (Site Visit) - Animal burrows on riverside toe and slope.

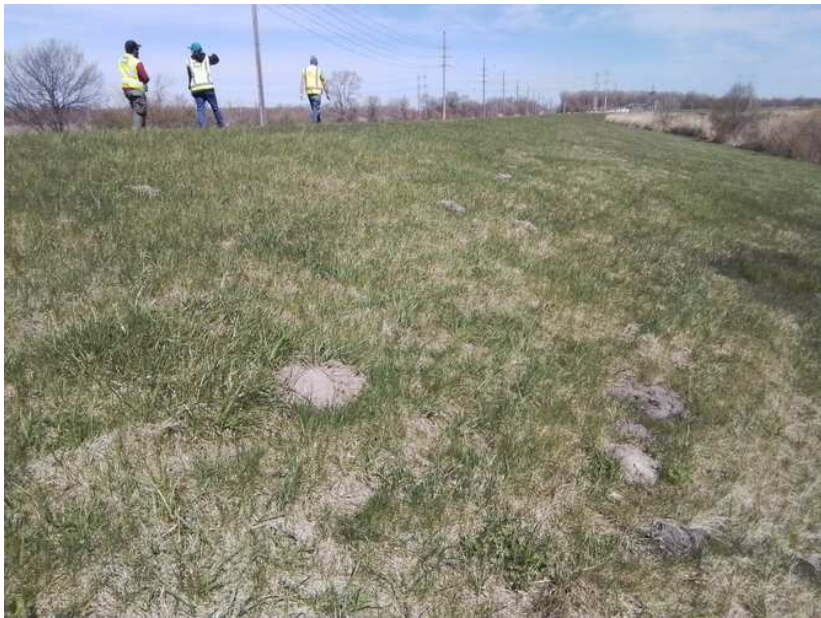
Inspect ID: 2024-0024

No User Rating (Site Visit) - Animal burrows on riverside slope

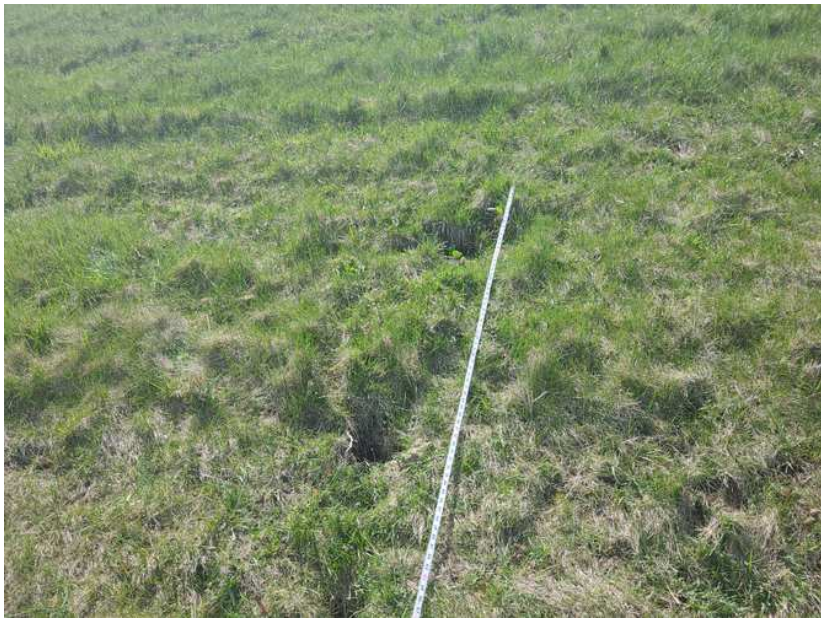
No User Rating (Site Visit) - Animal burrows on landside slope

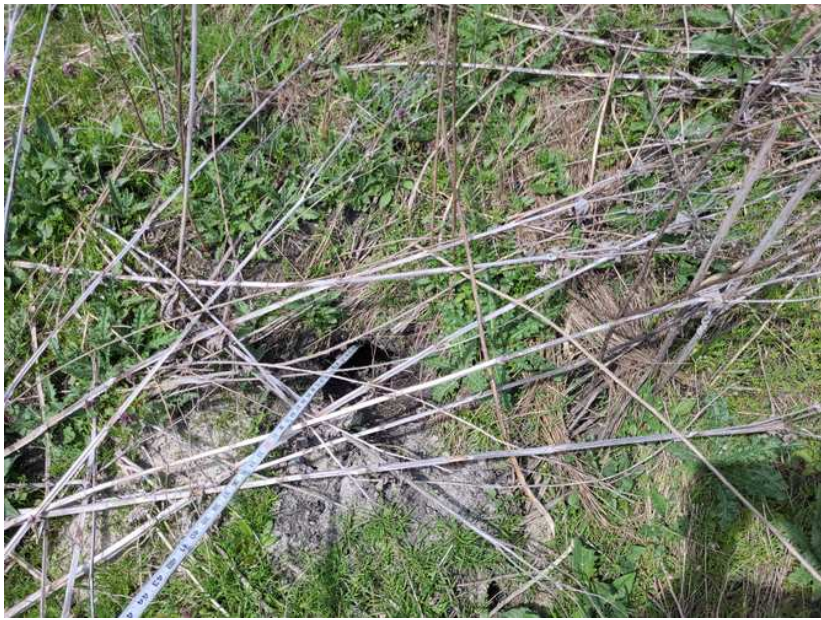
Inspect ID: 2024-0029

No User Rating (Site Visit) - Typical animal burrow on riverside slope

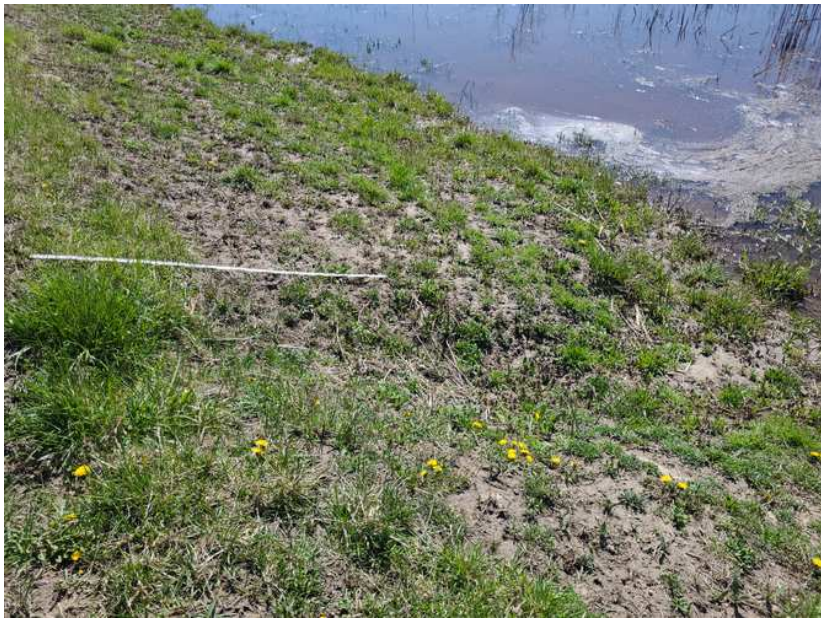
Inspect ID: 2024-0109

No User Rating (Site Visit) - 16-inch deep animal burrow in landside slope

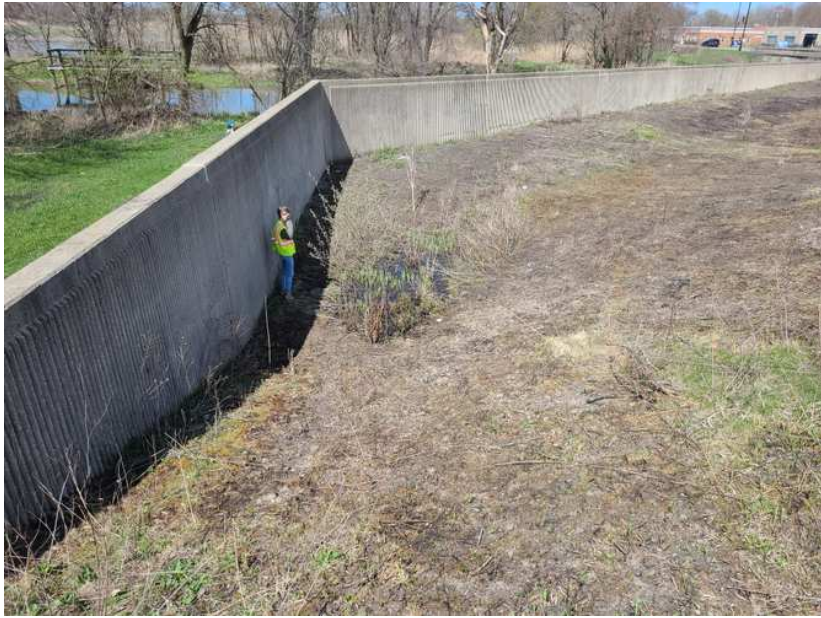
Inspect ID: 2024-0017

No User Rating (Site Visit) - Tree growth on riverside base of floodwall

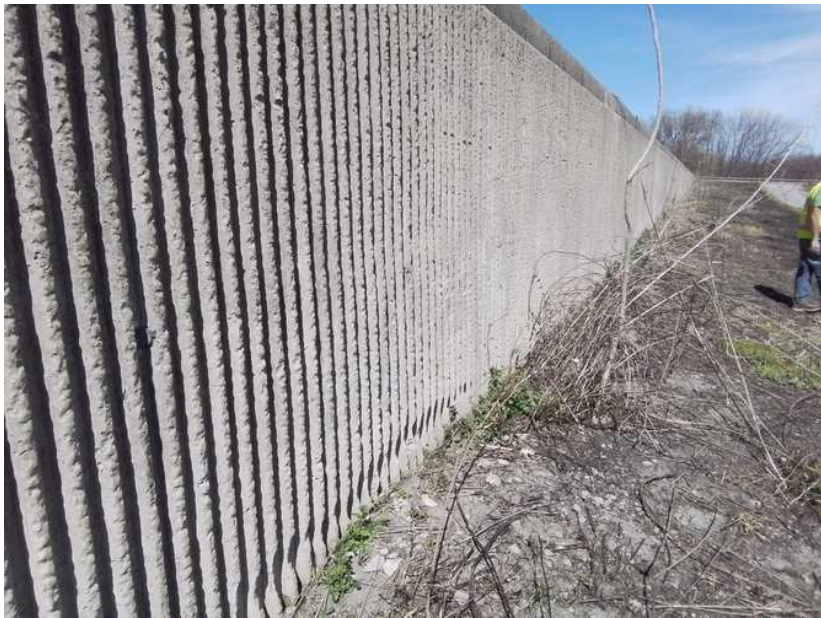
Inspect ID: 2024-0113

No User Rating (Site Visit) - Large tree near landside wall

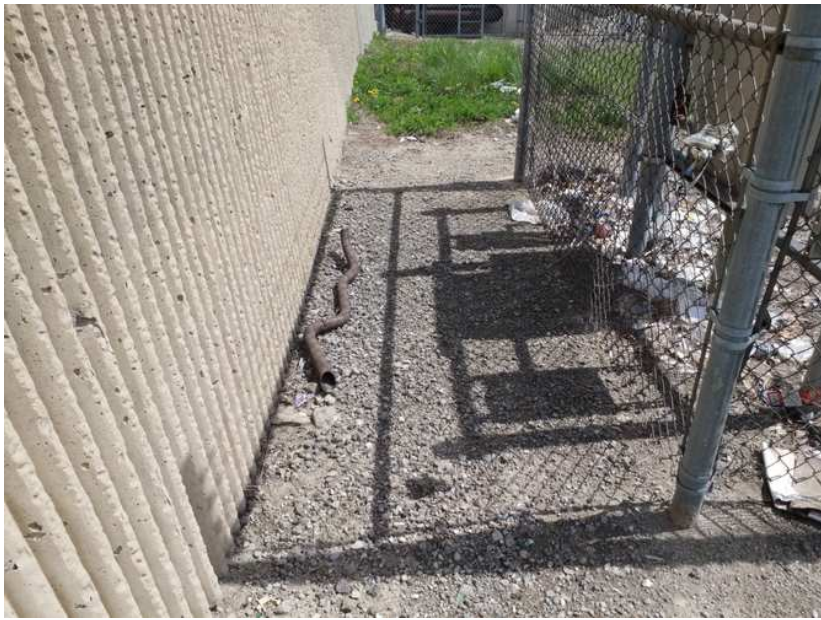
Inspect ID: 2024-0156

No User Rating (Site Visit) - Woody vegetation along landside face of floodwall

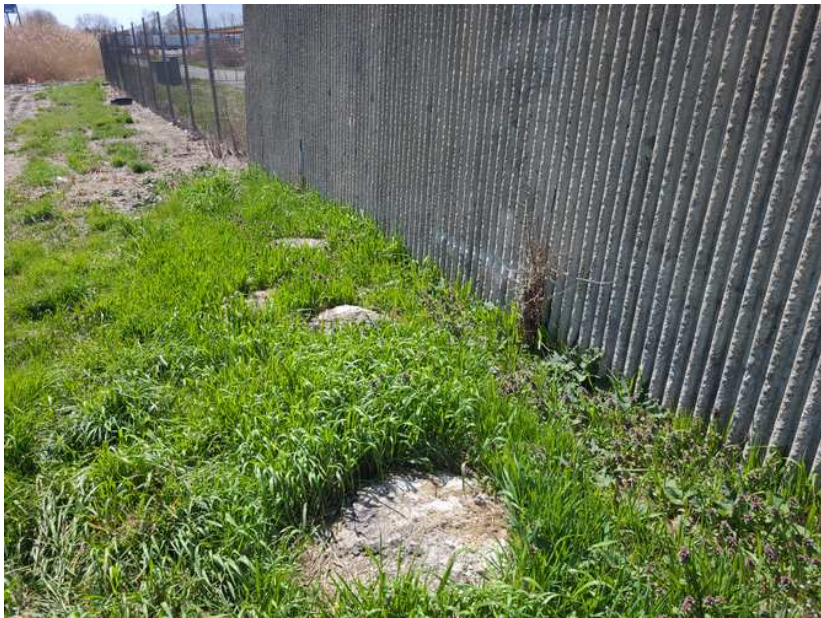
Inspect ID: 2024-0039

No User Rating (Site Visit) - Debris near landside base of floodwall
