US Army Corps
of Engineers ®

Site Visit Summary

Name of System: Gary

Name of Segment: Gary South

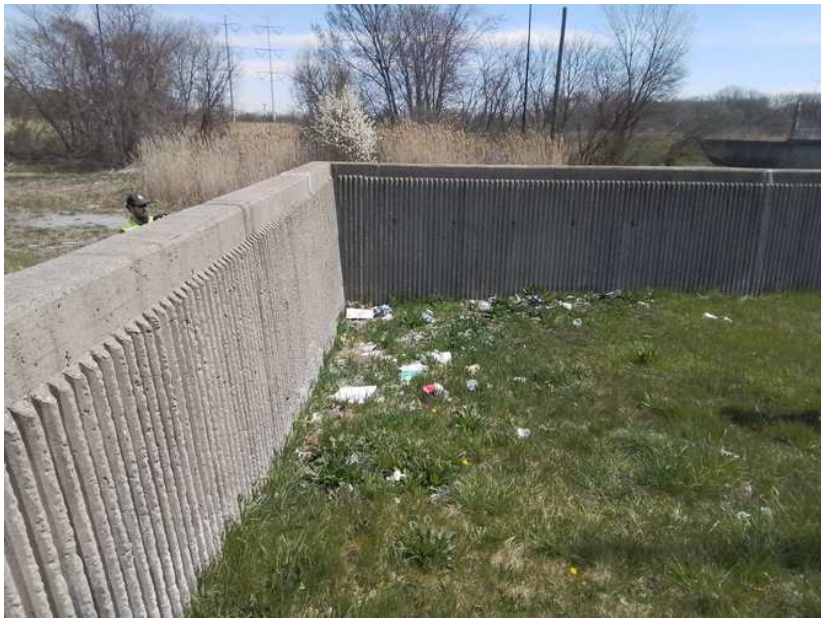
Inspect ID: 2024-0069

No User Rating (Site Visit) - Debris near riverside flood wall

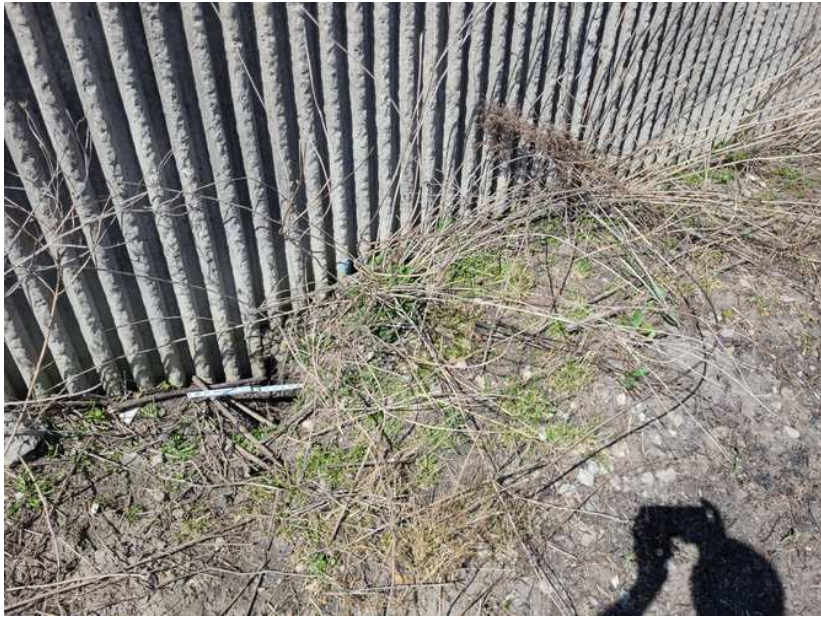
No User Rating (Site Visit) - Animal burrow (approximately 8 inch) along landside of floodwall

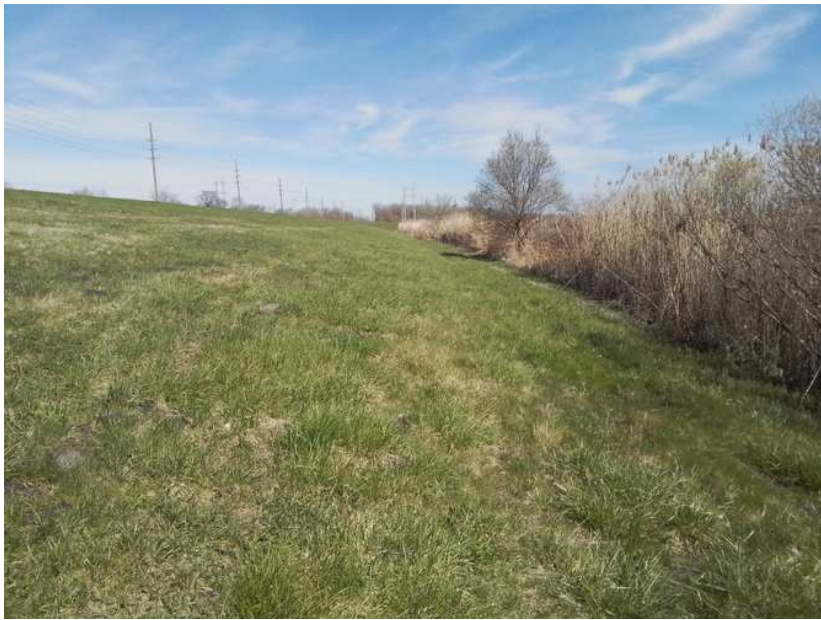
Inspect ID: 2024-0012

No User Rating (Site Visit) - Trees in landside ditch.

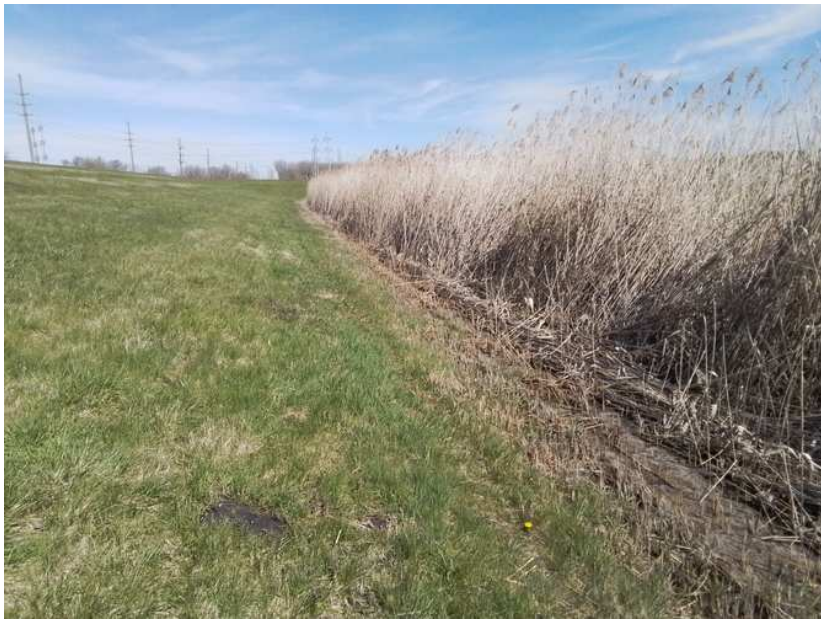
Inspect ID: 2024-0028

No User Rating (Site Visit) - Vegetation in landside ditch

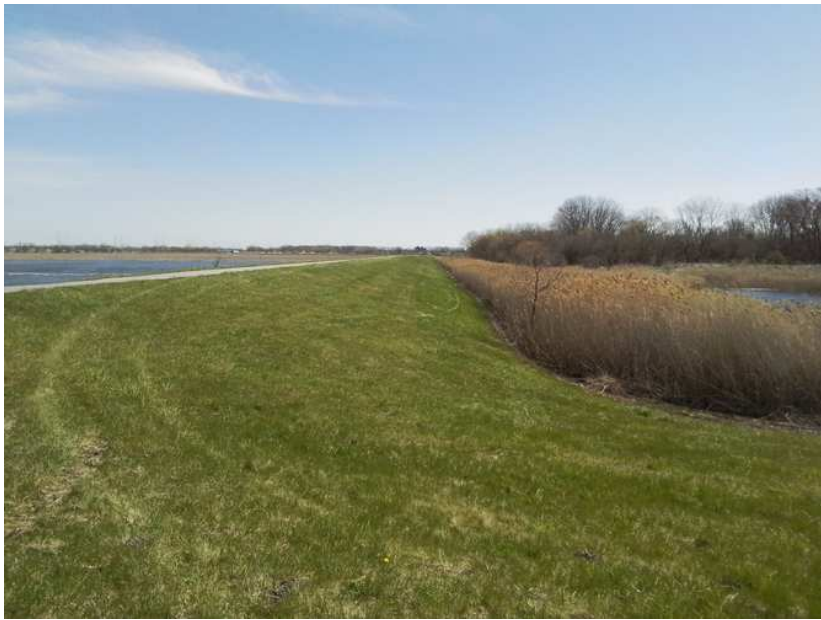
Inspect ID: 2024-0036

No User Rating (Site Visit) - Vegetation in landside ditch. Typical.

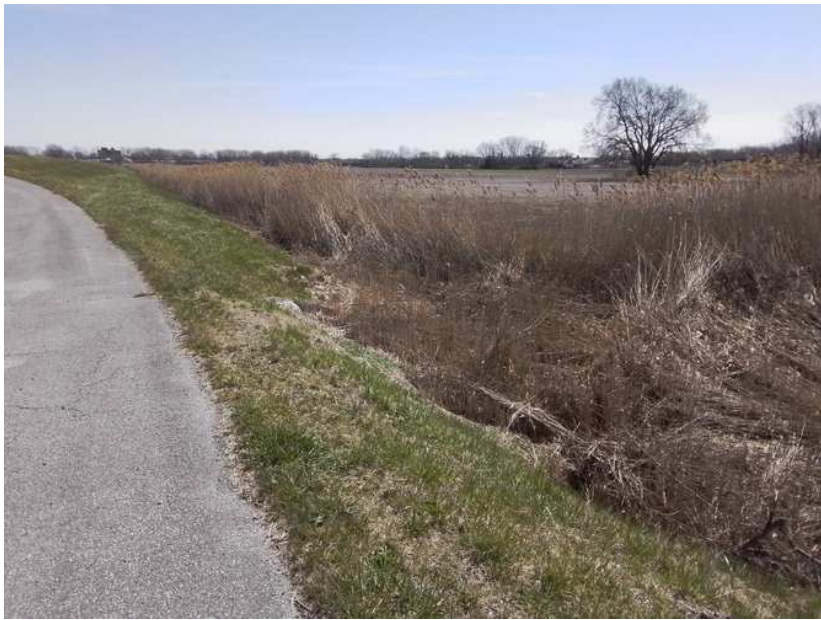
Inspect ID: 2024-0040

No User Rating (Site Visit) - Vegetation in landside ditch. (looking east)

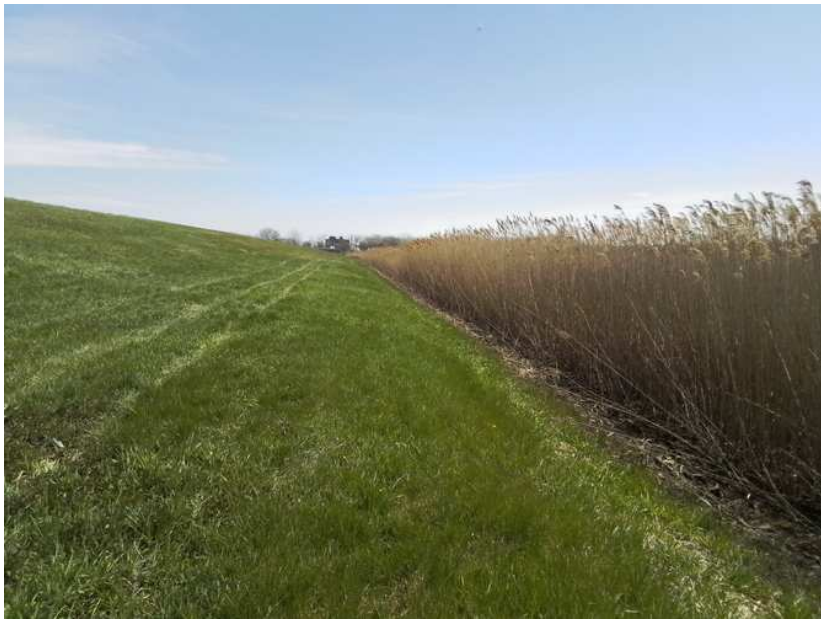
Inspect ID: 2024-0048

No User Rating (Site Visit) - Excessive vegetation in ditch and around culverts on landside

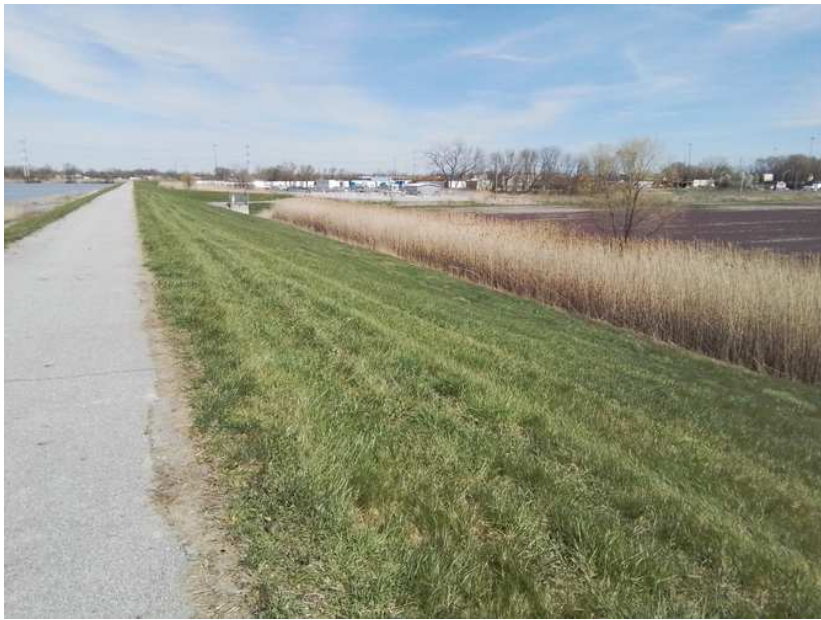
Inspect ID: 2024-0056

No User Rating (Site Visit) - Vegetation in ditch on landside

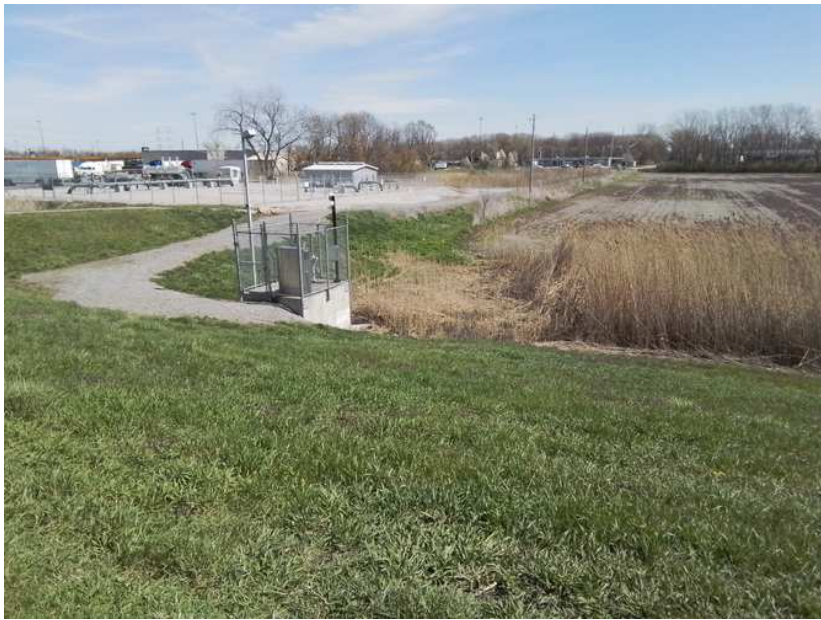
Inspect ID: 2024-0064

No User Rating (Site Visit) - Vegetation in landside ditch

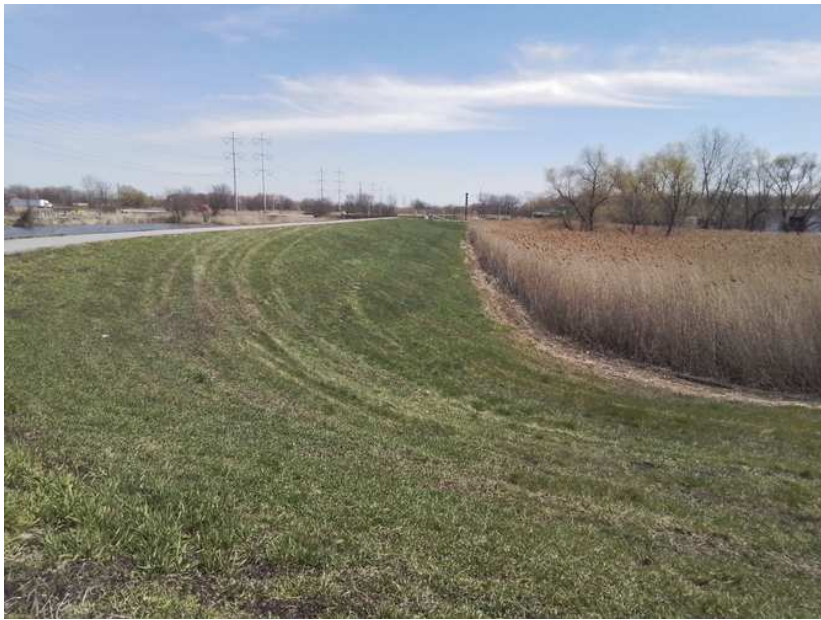
Inspect ID: 2024-0068

No User Rating (Site Visit) - Vegetation in landside ditch and around culverts

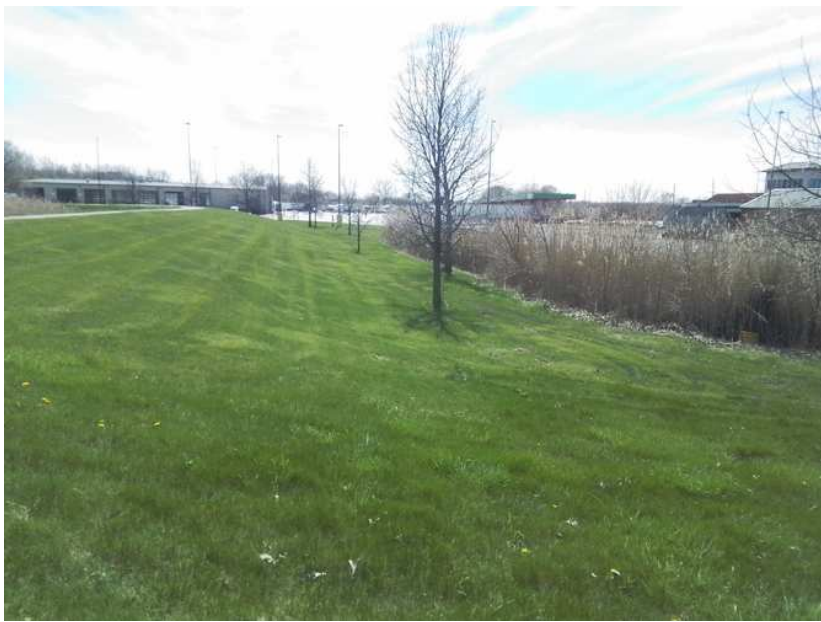
Inspect ID: 2024-0076

No User Rating (Site Visit) - Vegetation in landside ditch

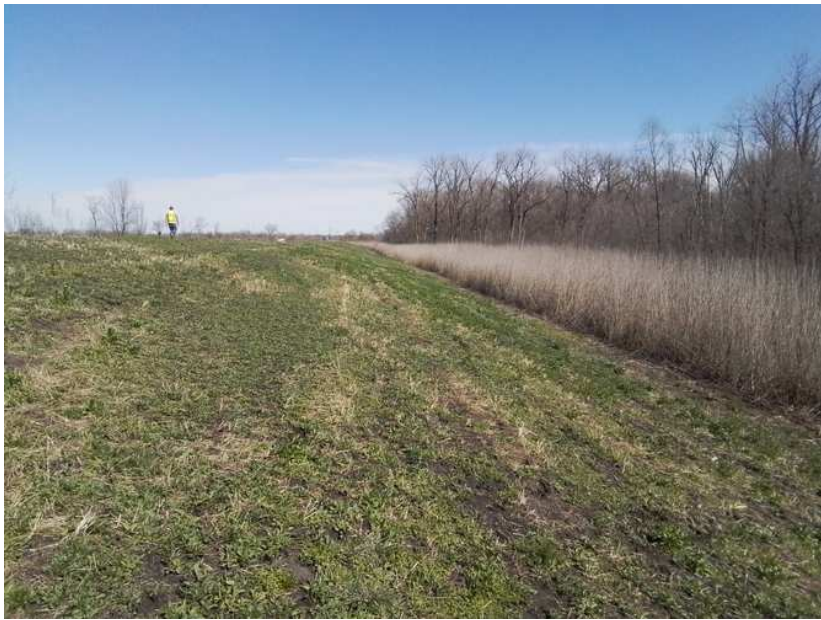
Inspect ID: 2024-0108

No User Rating (Site Visit) - Vegetation in ditch along landside

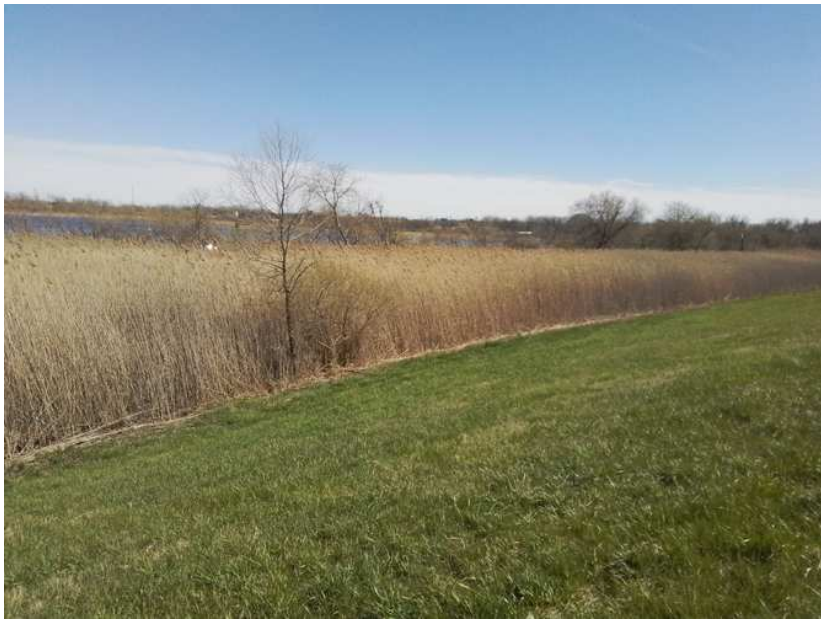
Inspect ID: 2024-0200

No User Rating (Site Visit) - Vegetation in landside ditch (typical)

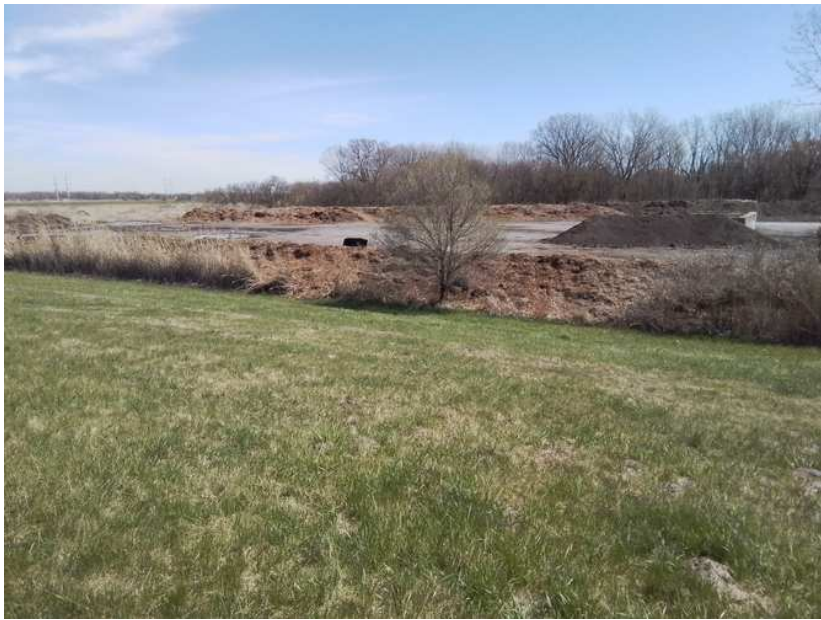
Inspect ID: 2024-0220

No User Rating (Site Visit) - Tree in landside ditch

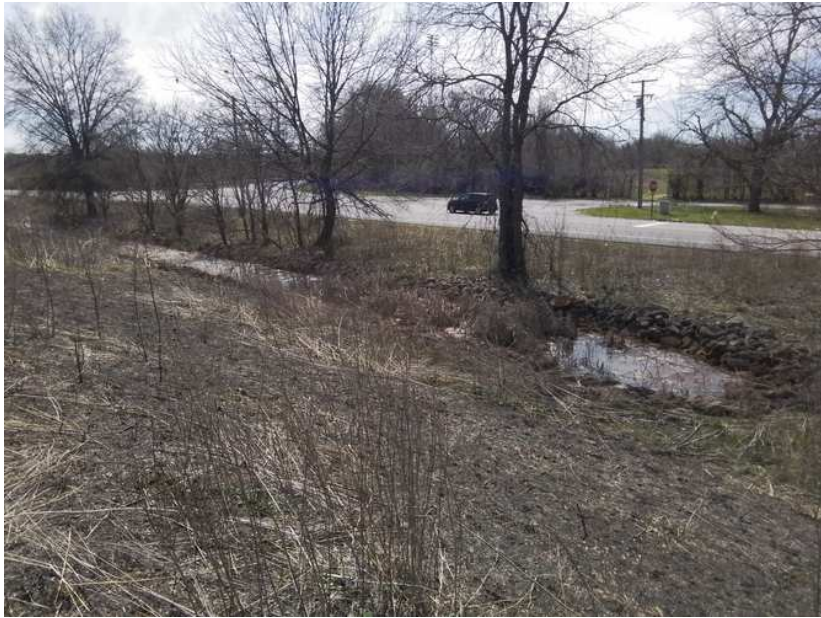
Inspect ID: 2024-0116

No User Rating (Site Visit) - Debris in landside ditch

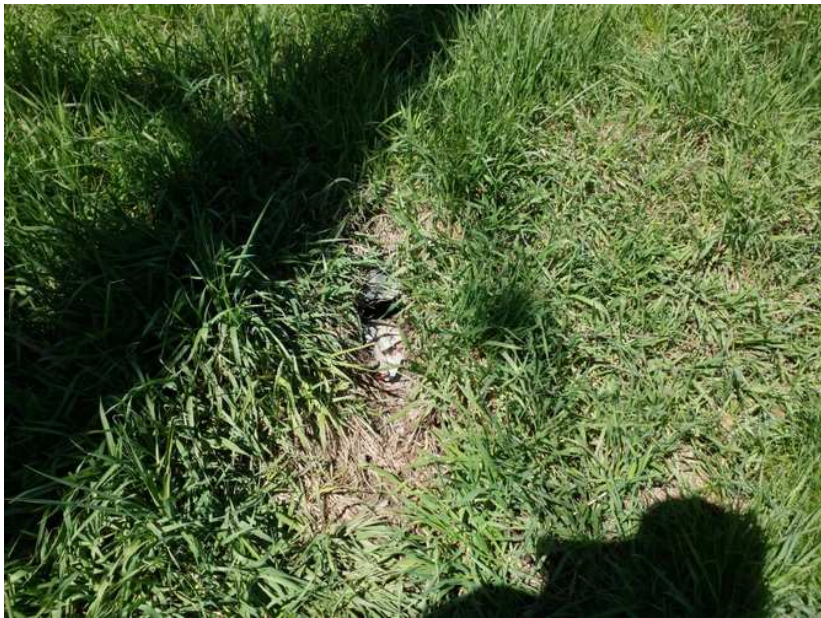
No User Rating (Site Visit) - GS-09: Spalling on concrete at outfall riverside

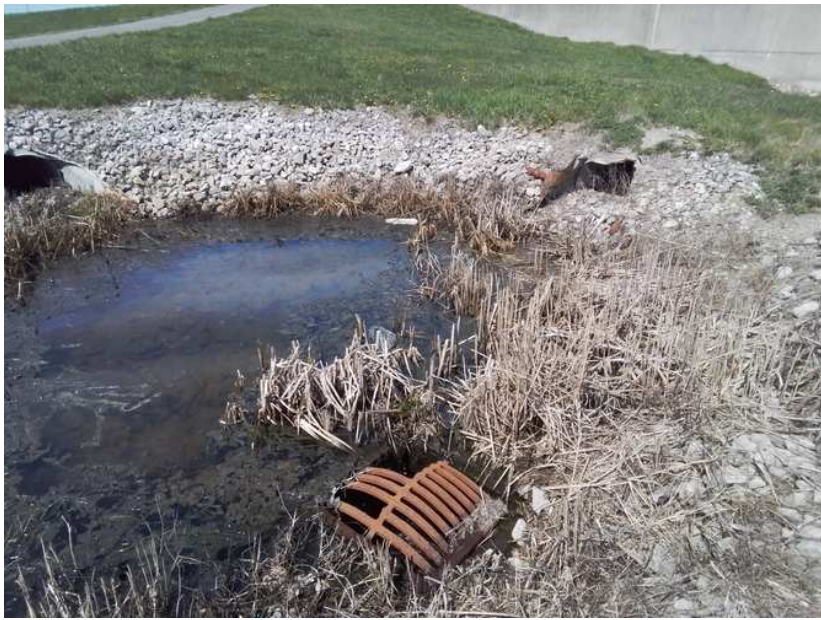
Inspect ID: 2024-0075

No User Rating (Site Visit) - Land side interior drainage culvert outlet overgrown

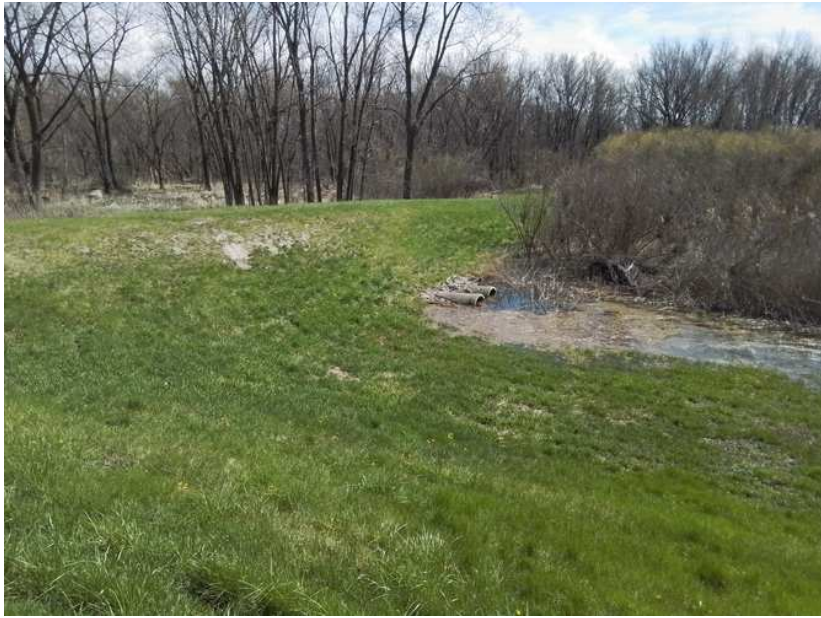
Inspect ID: 2024-0170

No User Rating (Site Visit) - PS-GW: Scour hole from last year not visible due to high water level

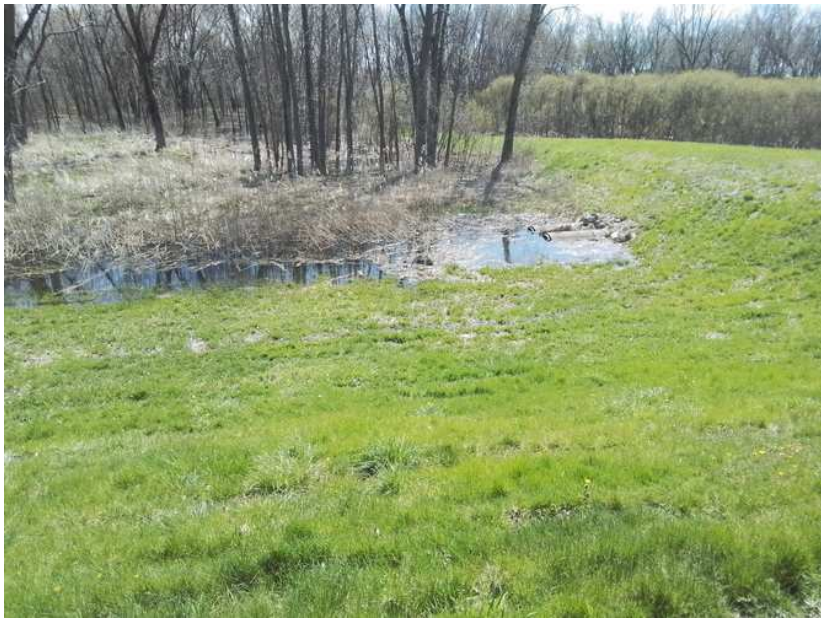
Inspect ID: 2024-0176

No User Rating (Site Visit) - Culverts in landside ditch in good condition

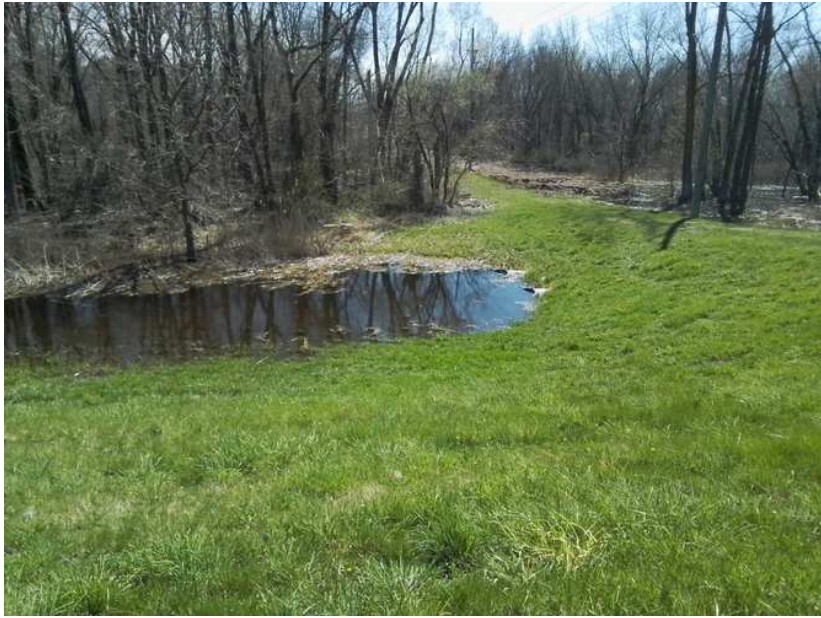
Inspect ID: 2024-0180

No User Rating (Site Visit) - Culverts in good condition on landside

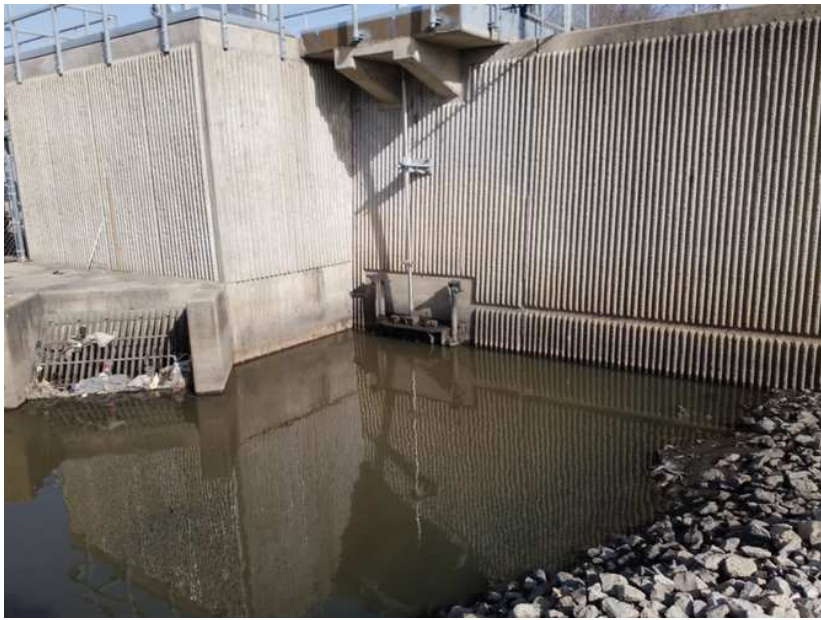
Inspect ID: 2024-0002

No User Rating (Site Visit) - GS-8B: A and B both operated smoothly. C not operated because of high river levels

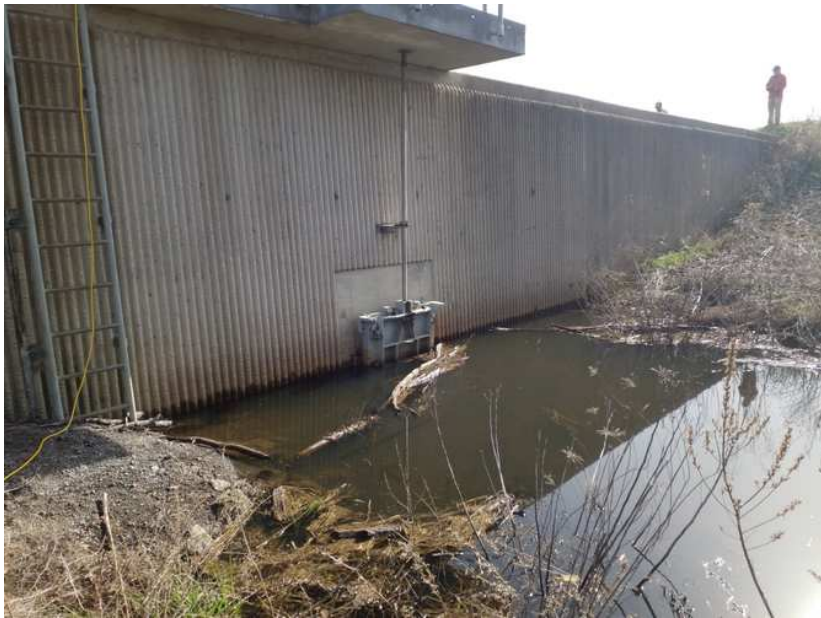
No User Rating (Site Visit) - GS-8C: Closed. Not operated due to high water levels

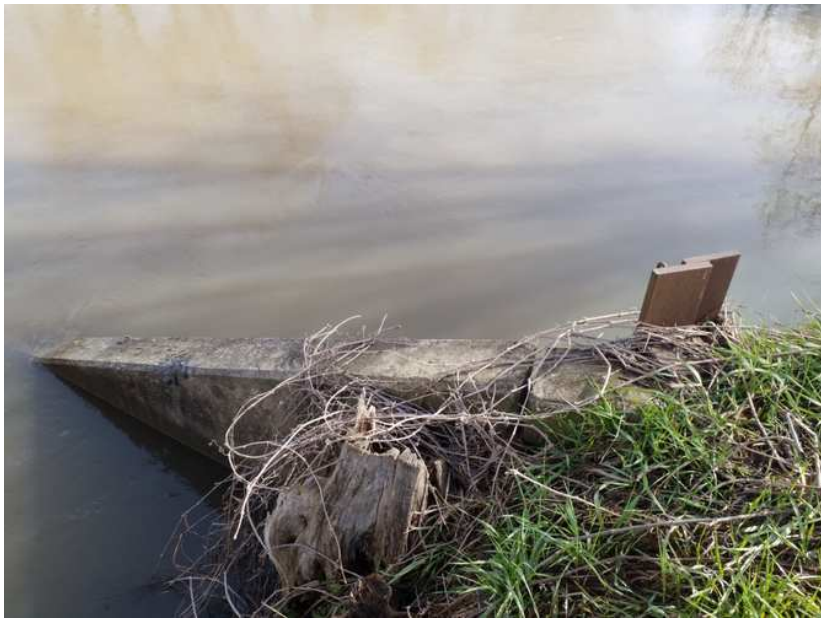
No User Rating (Site Visit) - GS-10: Closed. Some debris obstructing outlet

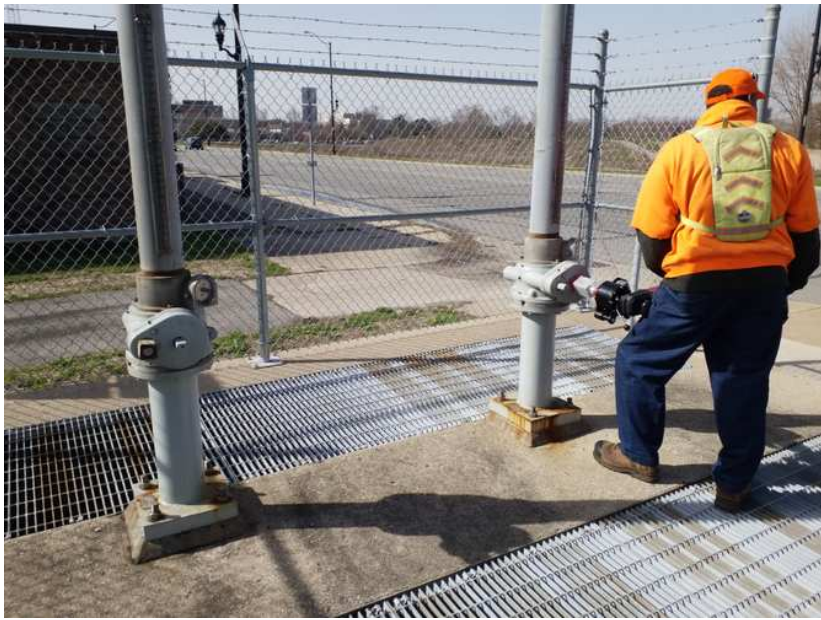
No User Rating (Site Visit) - GS-11: Wingwall has shifted

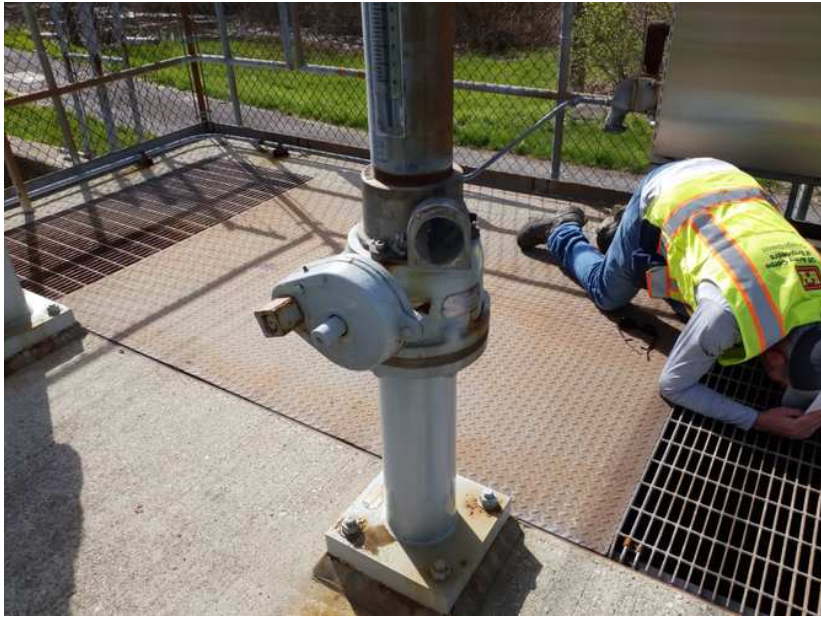
No User Rating (Site Visit) - GS-11: Operated successfully

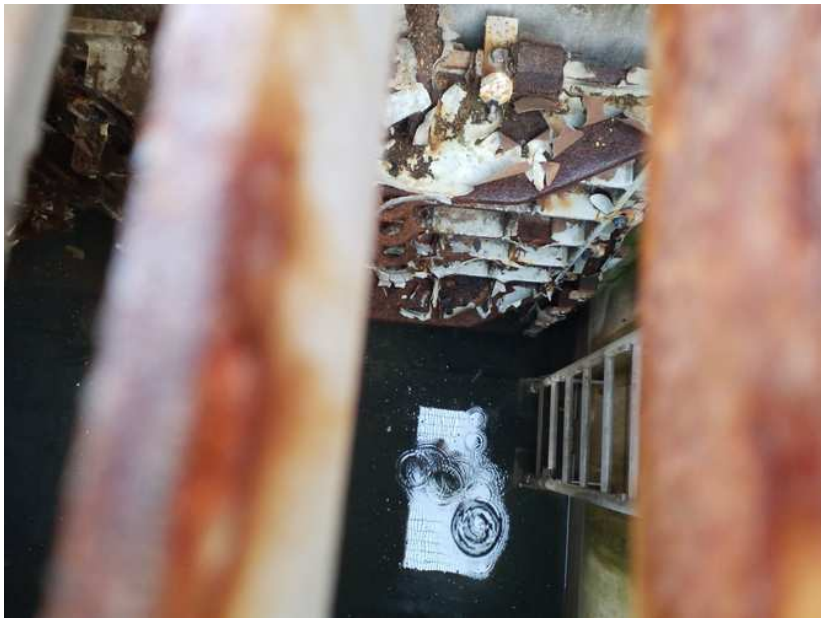
No User Rating (Site Visit) - GS-12A: Operated successfully. Can't tell if gate is leaking still. Paint peeling on gate.

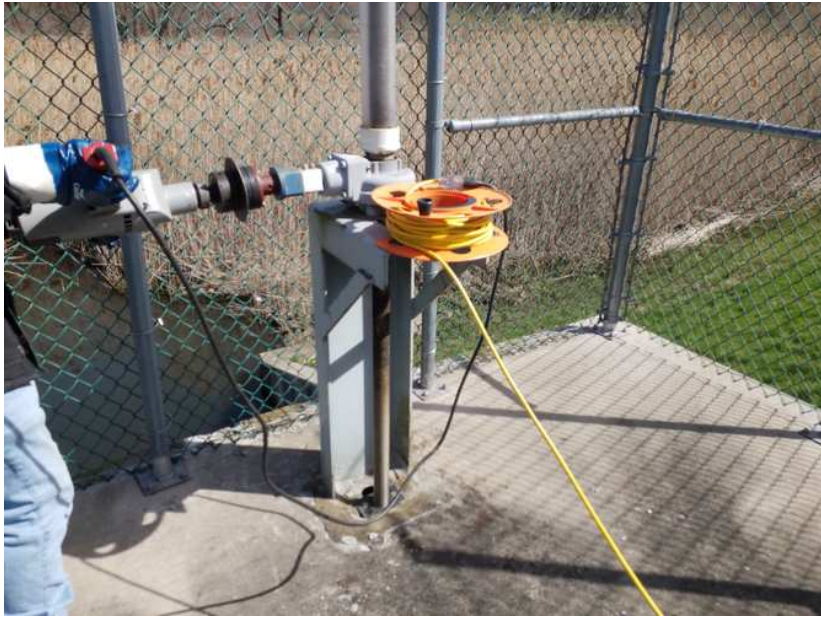
No User Rating (Site Visit) - GS-12B: Operated successfully. Paint peeling on gate

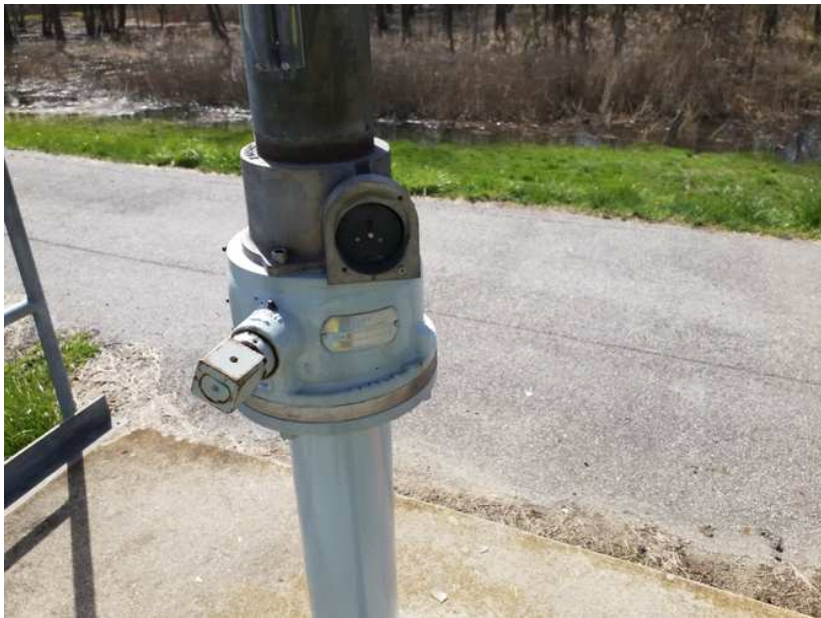
No User Rating (Site Visit) - GS-14: Operated successfully

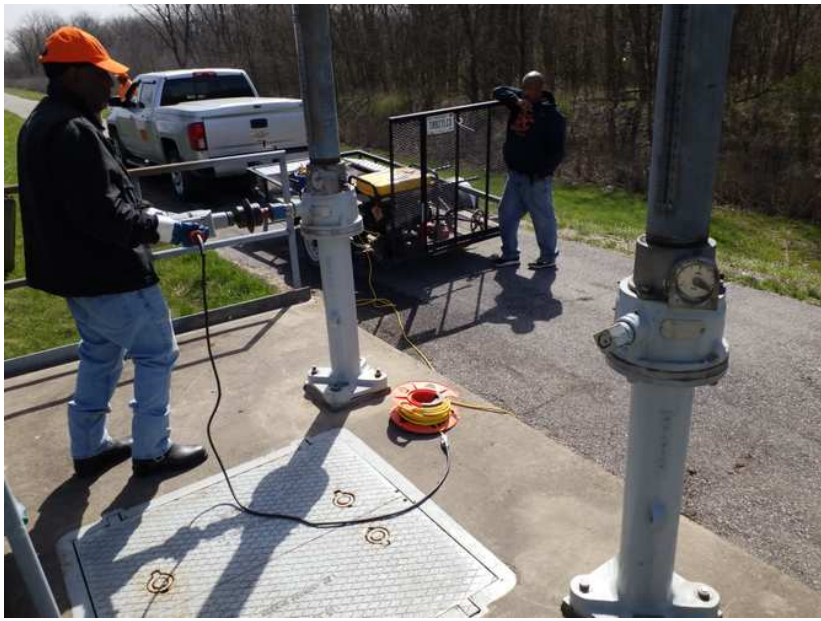
No User Rating (Site Visit) - GS-15: Gate operated successfully. Could not verify seal due to missing gauge. Gate goes up and down smoothly

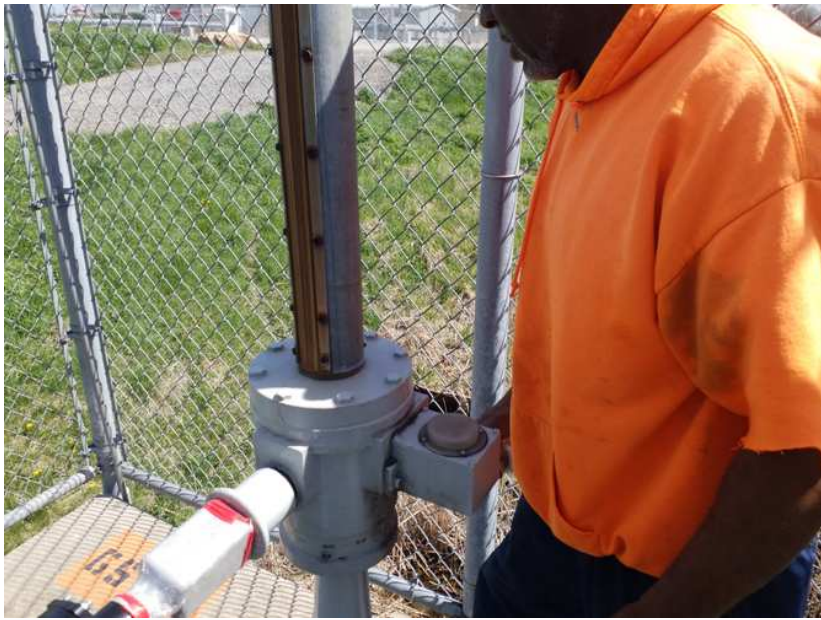
No User Rating (Site Visit) - GS-16: Operated successfully

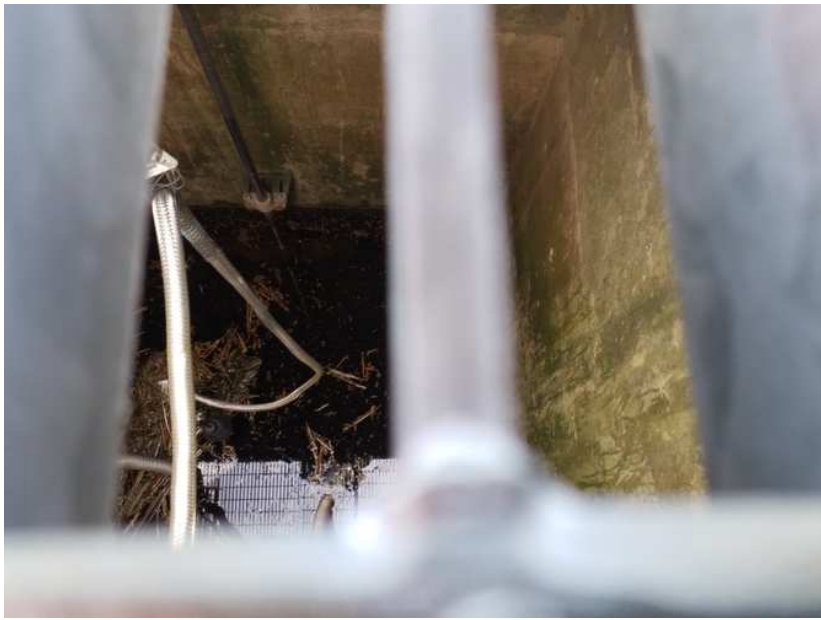
No User Rating (Site Visit) - GS-04: Gauge and screw shaft can't be seen

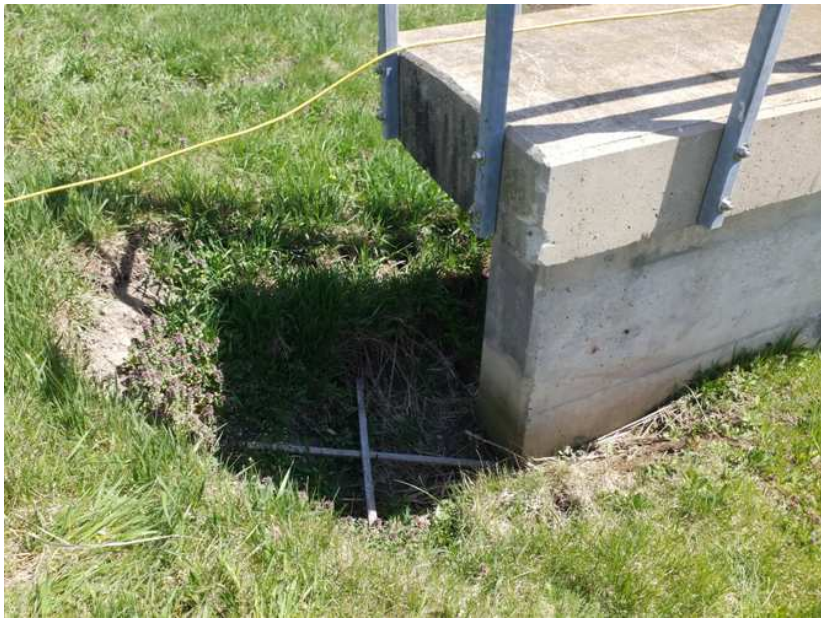
No User Rating (Site Visit) - GS-04: Closed. Operates smoothly

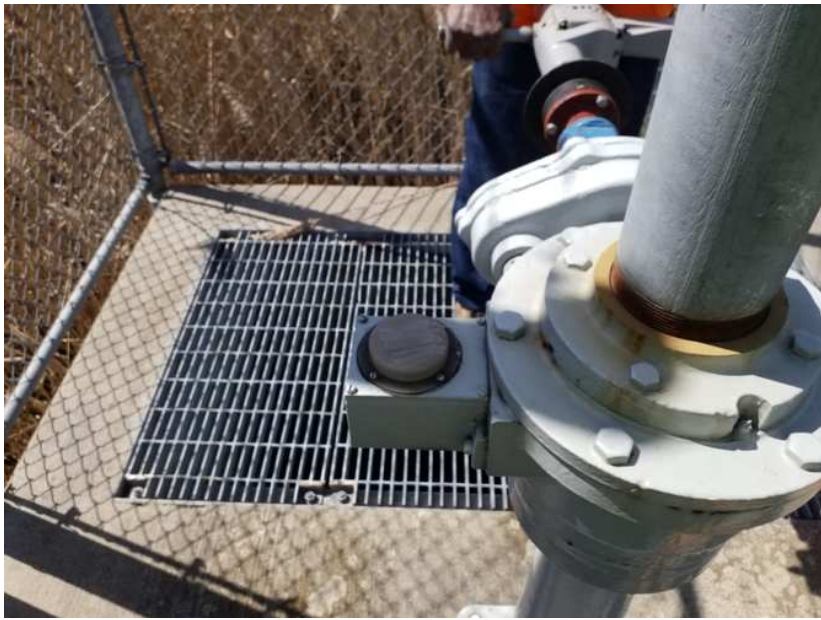
No User Rating (Site Visit) - GS-03: Erosion making access to gate difficult

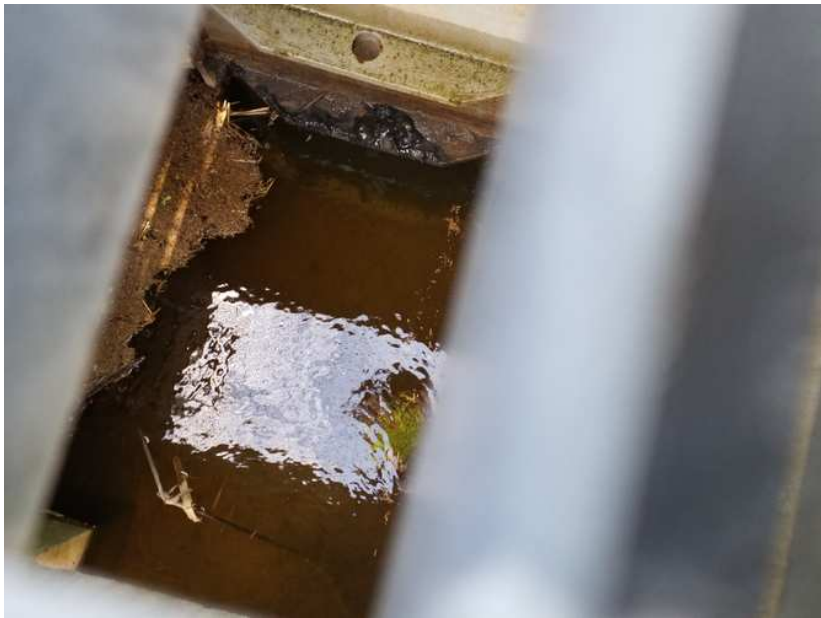
No User Rating (Site Visit) - GS-03: Gauge works at sluice gate but is difficult to read

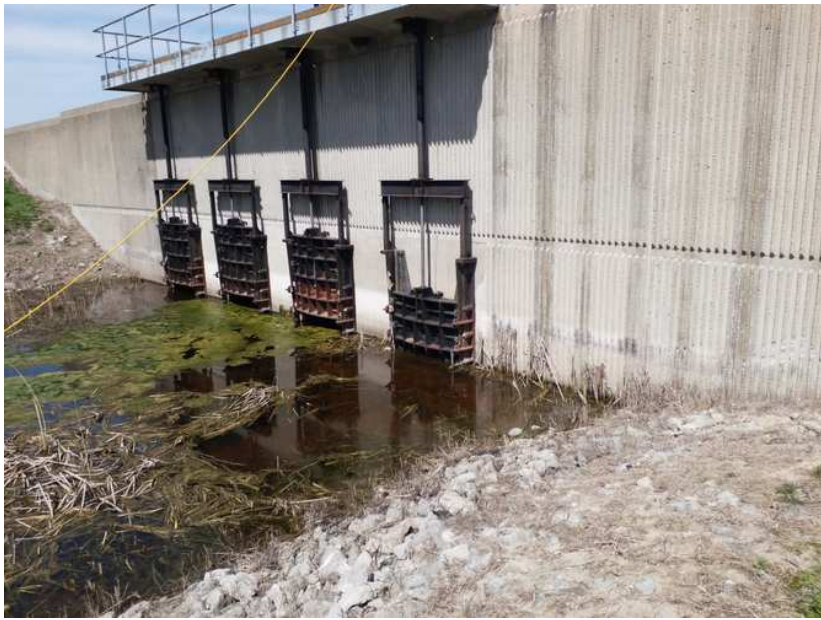
No User Rating (Site Visit) - GS-03: Gate open - no issues with operation but some silting on gate

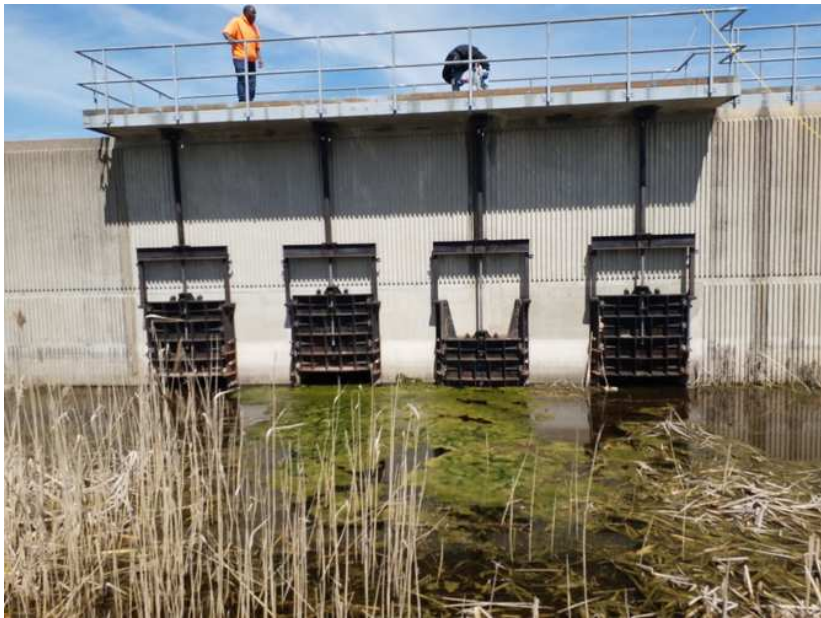
No User Rating (Site Visit) - GS-02D: Closed. Some squeaking

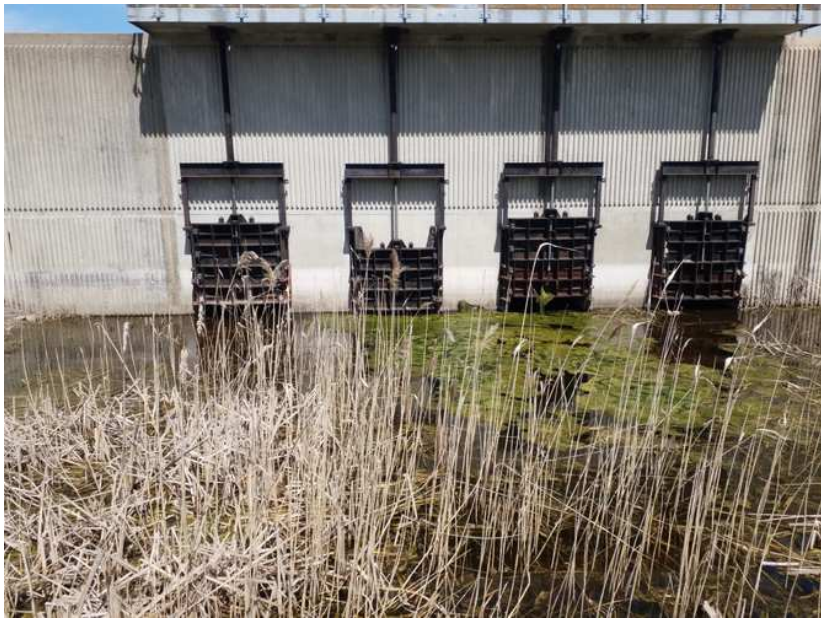
No User Rating (Site Visit) - GS-02C: Closed. Operates well

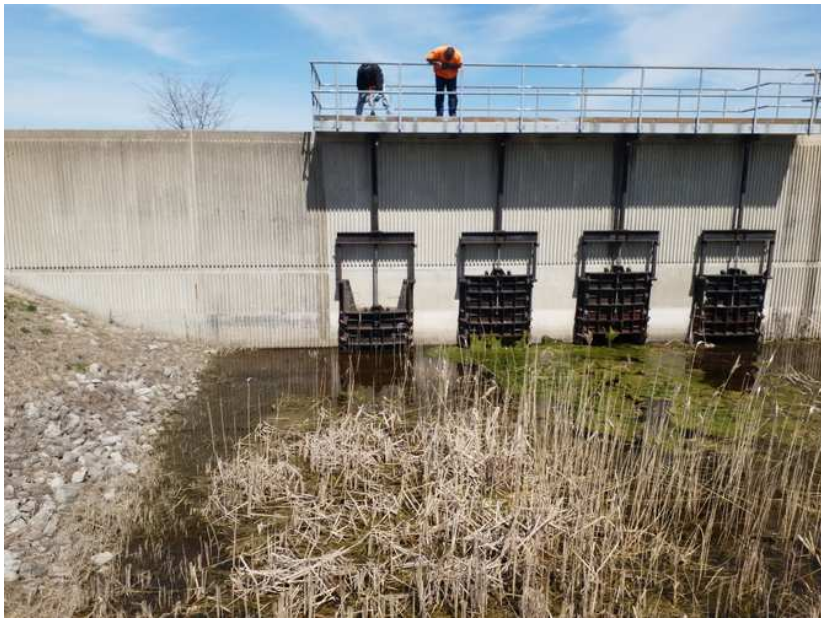
No User Rating (Site Visit) - GS-02B: Closed. Squeaks during operation

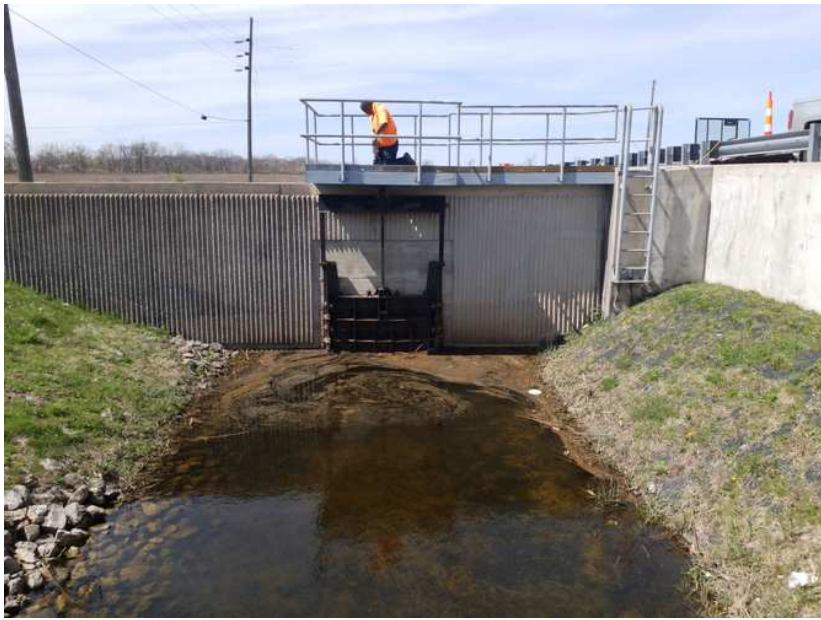
No User Rating (Site Visit) - GS-02A: Closed. Some squeaking during operation

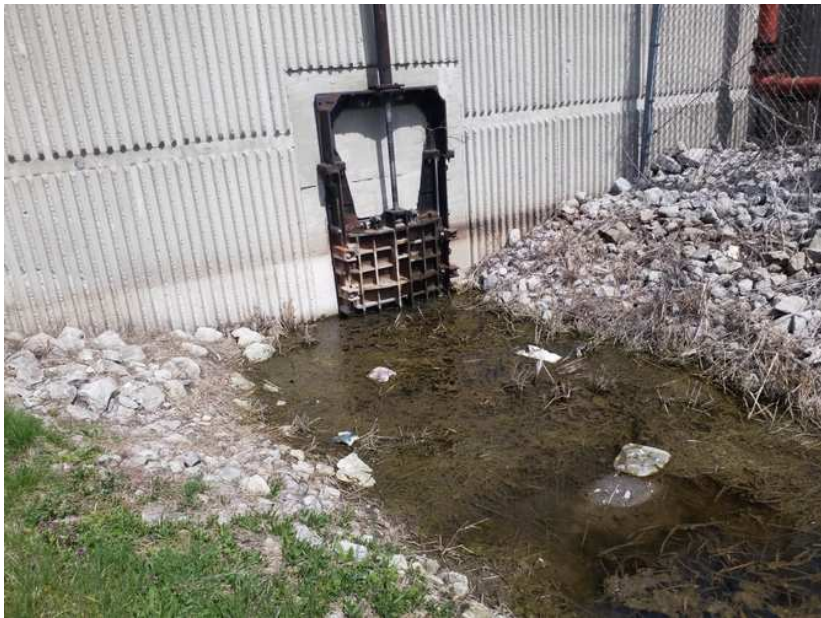
No User Rating (Site Visit) - GS-01: Closed. Operates well with some squeaking

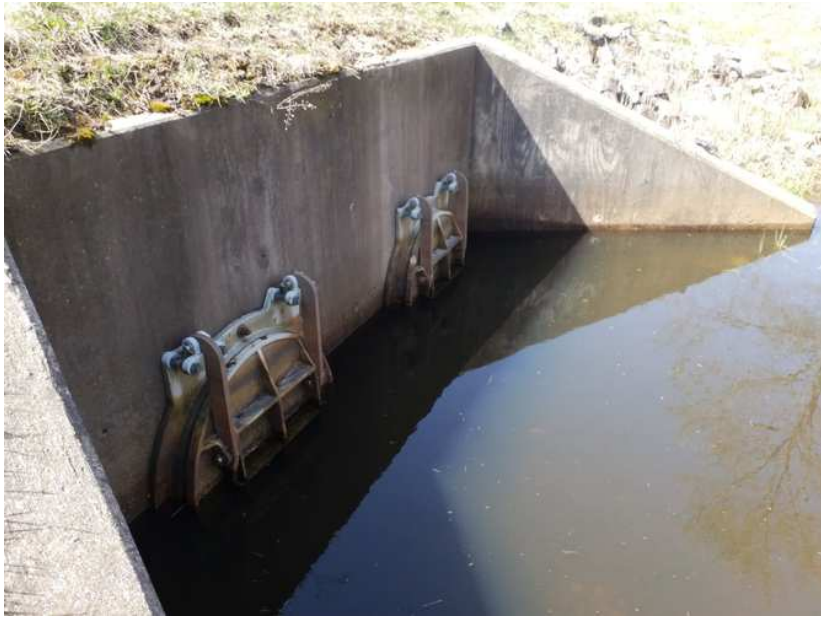
No User Rating (Site Visit) - GS-05: Slight leakage. Not operated because it will backflow to pump station

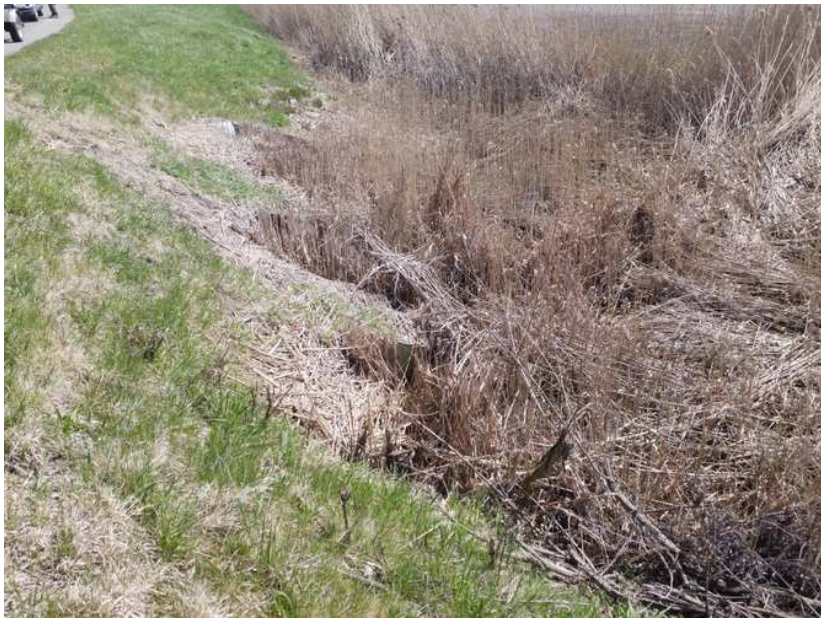
No User Rating (Site Visit) - GS-16: Flap gates not sealing completely. Debris blocking seal

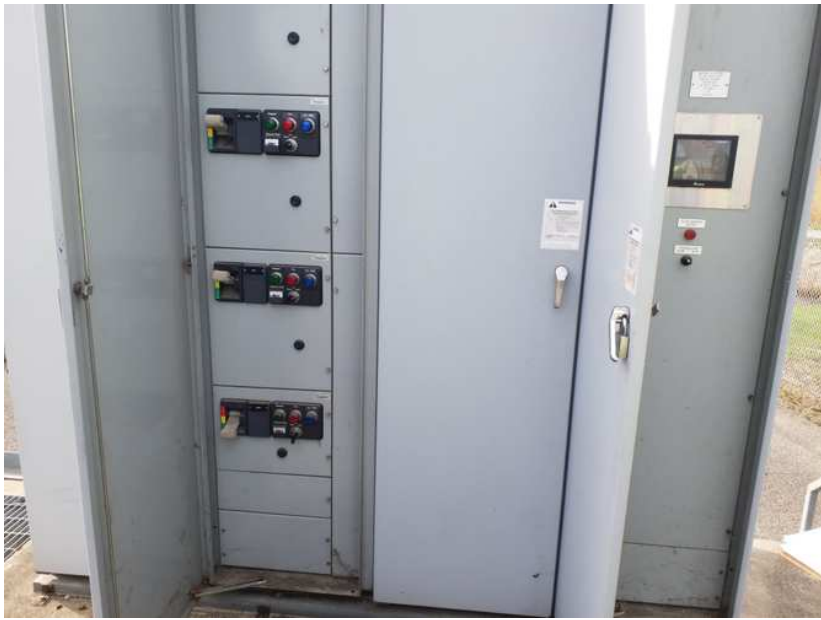
No User Rating (Site Visit) - PS-GE: No manuals on site. Manuals in central office
