US Army Corps
of Engineers ®

Site Visit Summary

Name of System: Gary

Name of Segment: Gary South

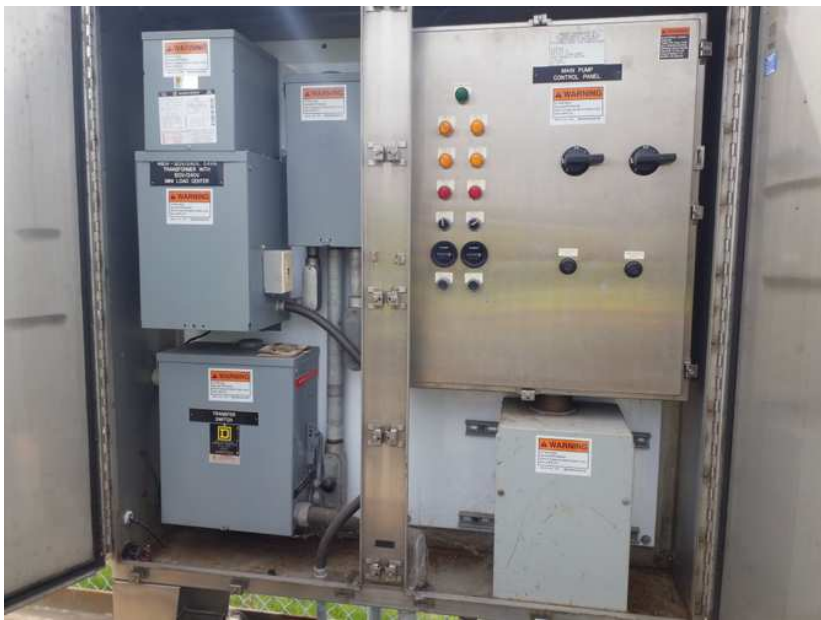
No User Rating (Site Visit) - PS-GW: Operations manual not on site but is in main office

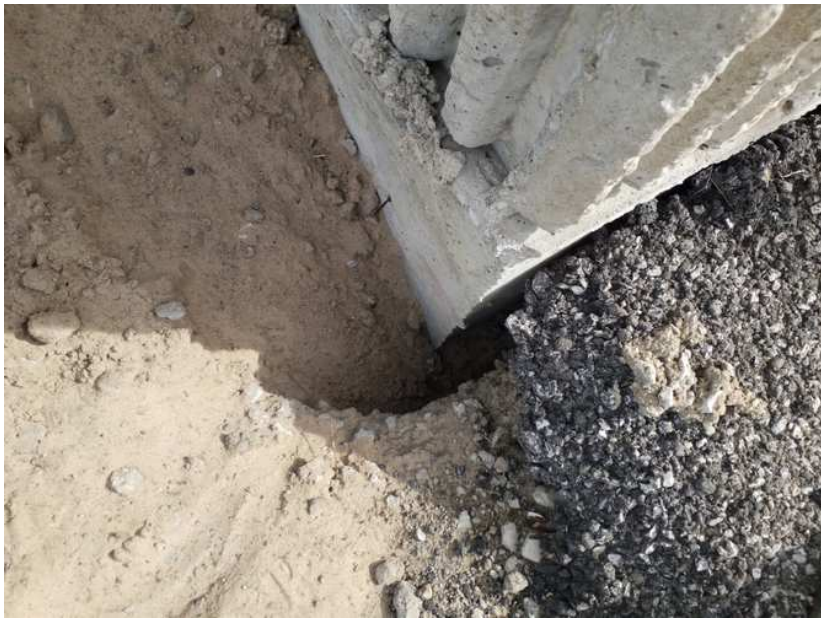
No User Rating (Site Visit) - PS-GW: Undermining of asphalt road to pump station.

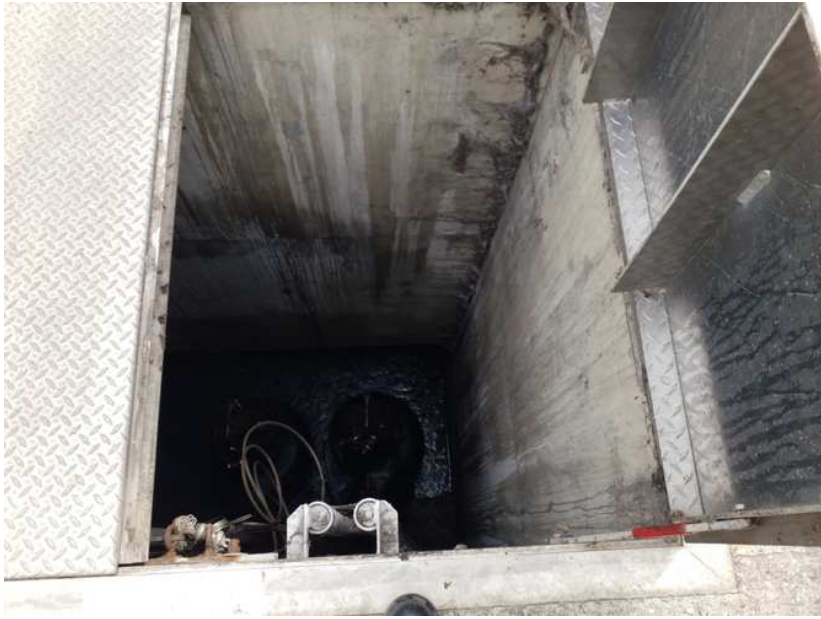
No User Rating (Site Visit) - PS-GW: Trash in sump
