US Army Corps of Engineers ®

## Site Visit Summary

Name of System: Highland

NLD System ID: 2605000005 NLD Segment ID: 2604000007

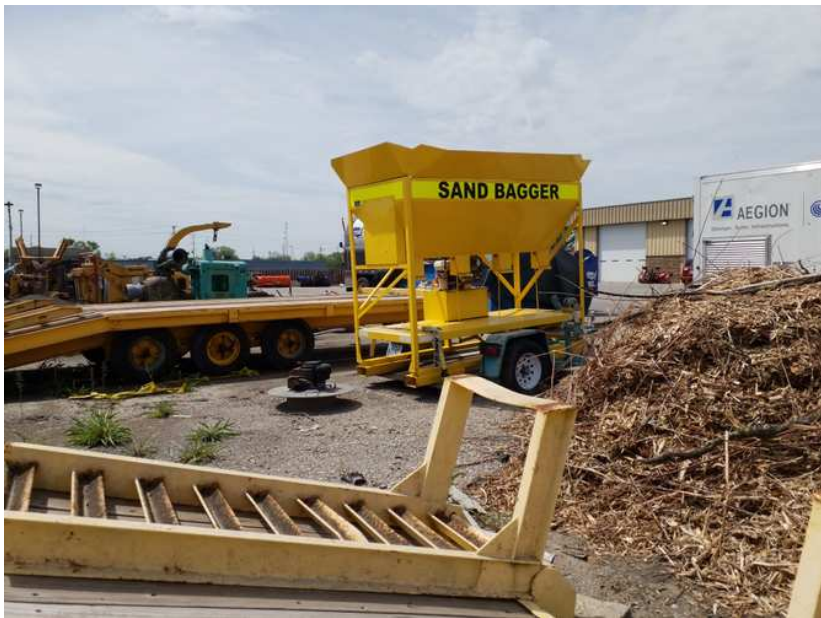
**Inspect ID:** 2024-0110

No User Rating (Site Visit) - Flood fighting supplies at the Public Works Facility at 8001 Kennedy Avenue. Highland Public Works has 14-16 pellets of sandbags, approximately 1000 pieces of sandbags.

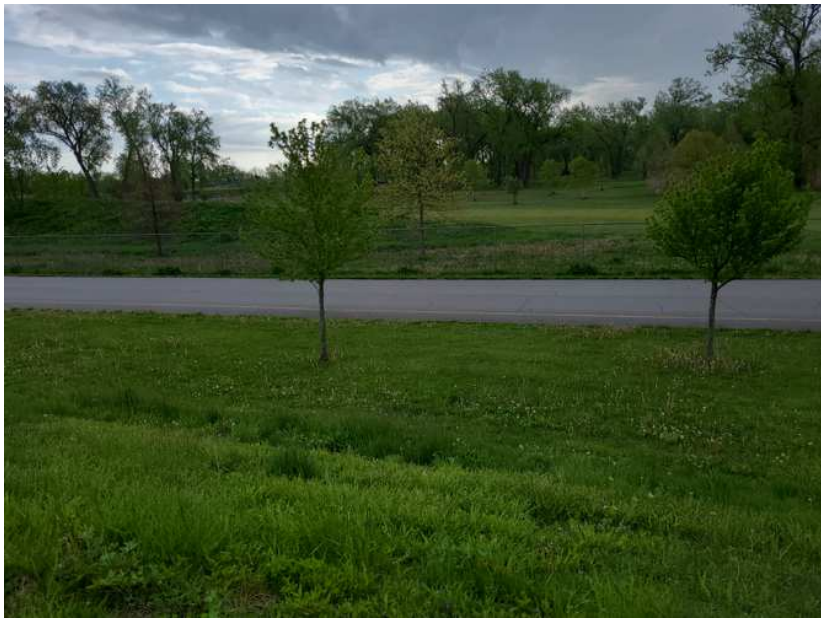
**Inspect ID:** 2024-0013

No User Rating (Site Visit) - Tree on landside toe

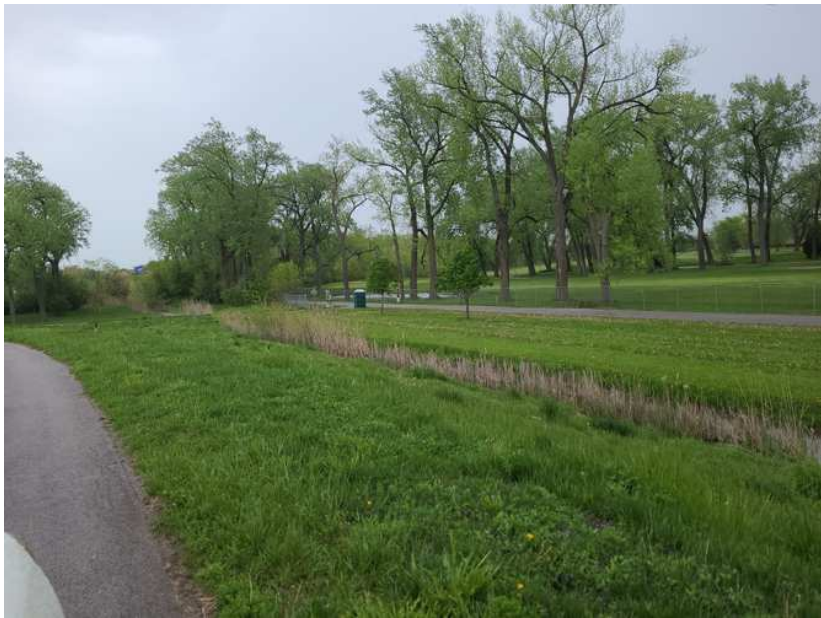
**Inspect ID:** 2024-0017

No User Rating (Site Visit) - Tree on landside toe

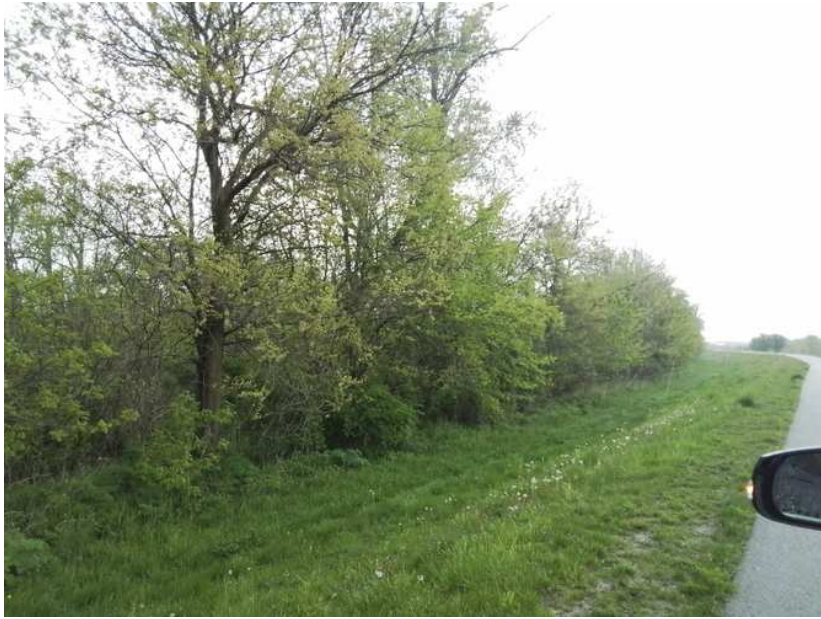
**Inspect ID:** 2024-0025

No User Rating (Site Visit) - Vegetation in landside ditch. - improved since last year

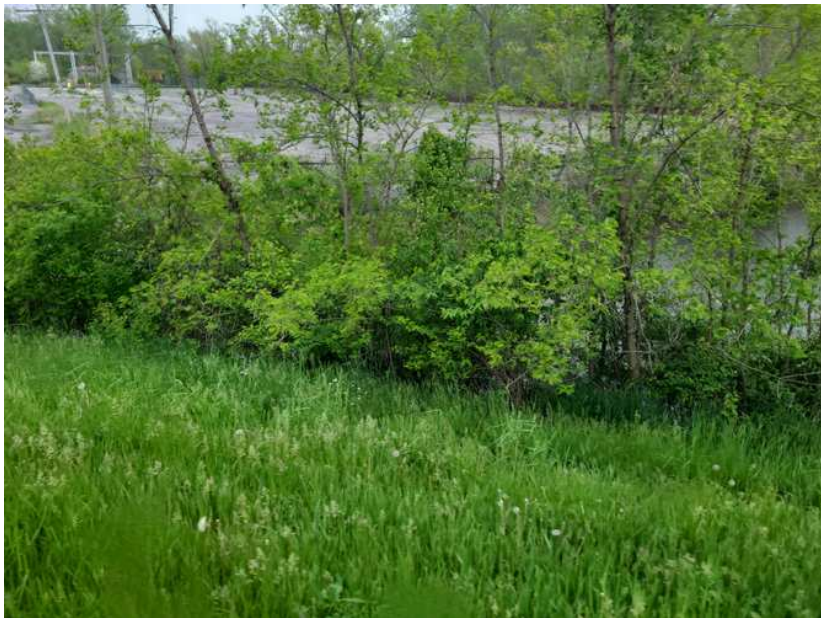
**Inspect ID:** 2024-0028

No User Rating (Site Visit) - Vegetation on riverside

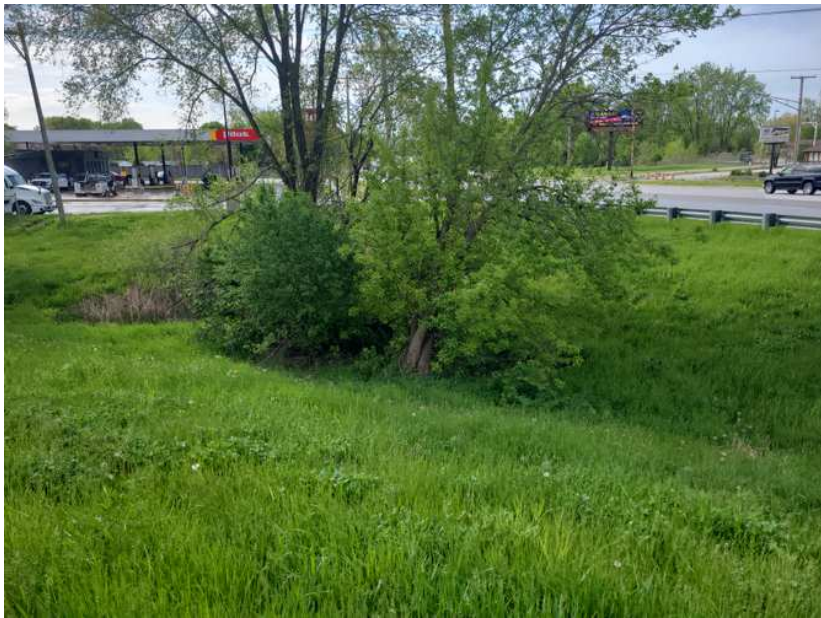
**Inspect ID:** 2024-0034

No User Rating (Site Visit) - HI-05: High vegetation around gate well

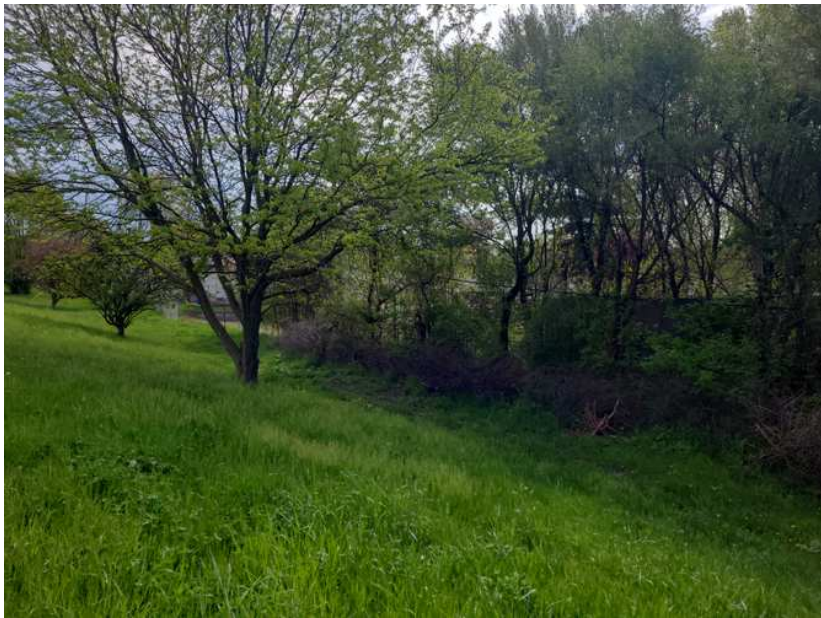
**Inspect ID:** 2024-0045

No User Rating (Site Visit) - Vegetation on riverside toe

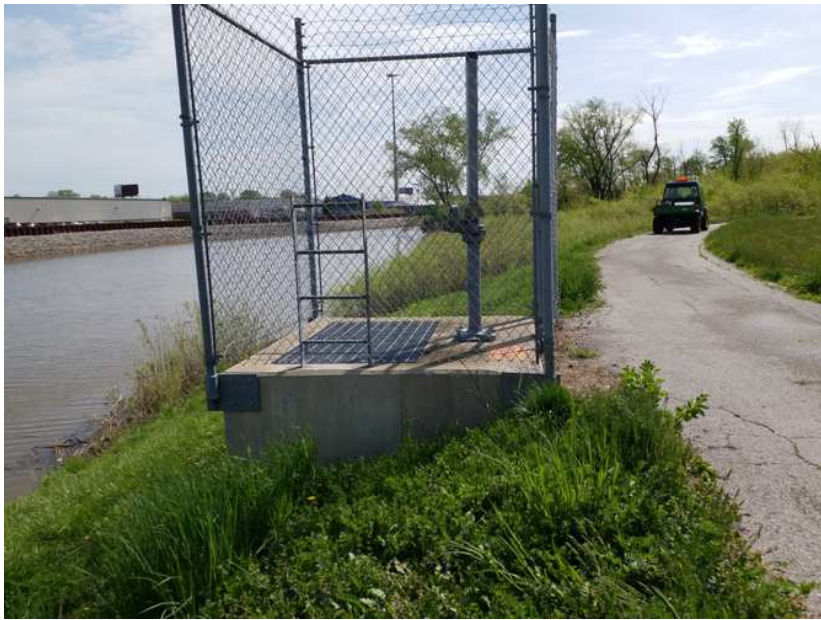
**Inspect ID:** 2024-0049

No User Rating (Site Visit) - Vegetation on riverside slope

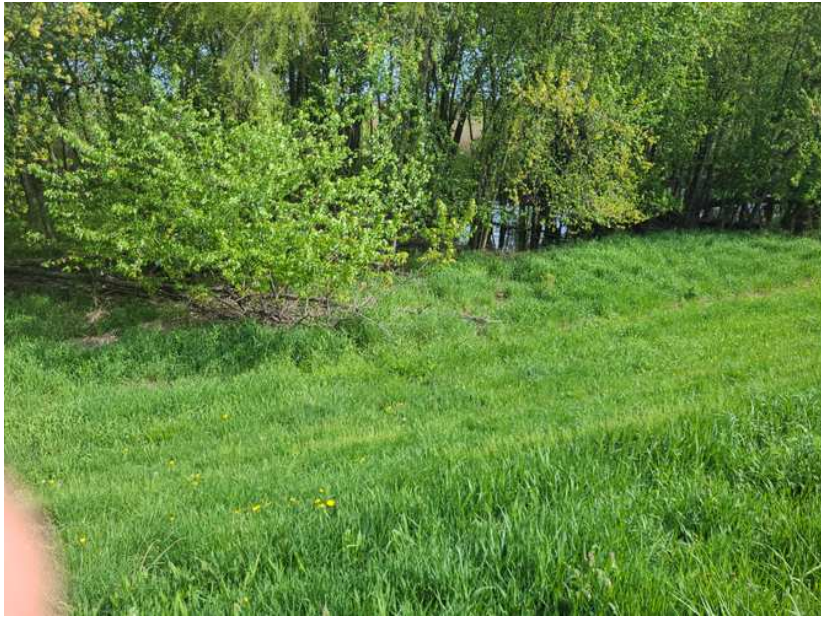
**Inspect ID:** 2024-0062

No User Rating (Site Visit) - HI-10: Vegetation around gate well

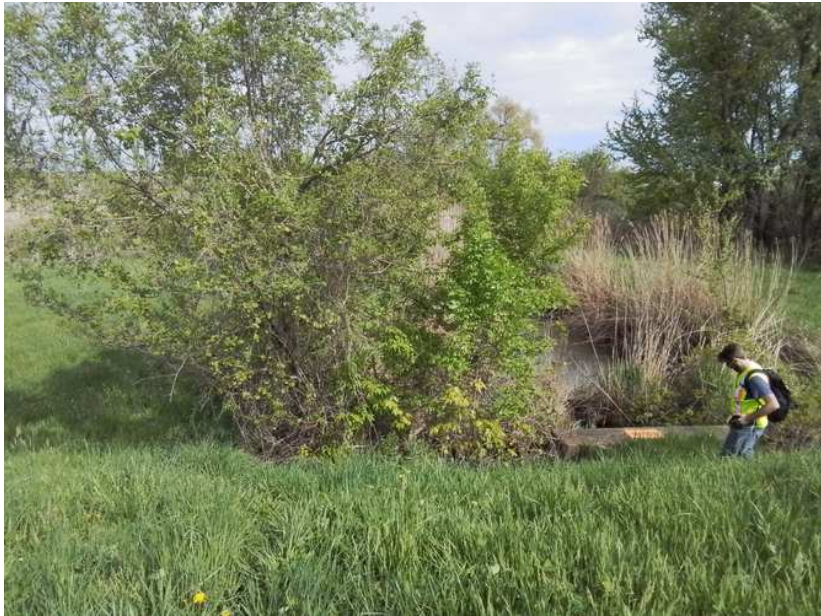
**Inspect ID:** 2024-0065

No User Rating (Site Visit) - Riverside vegetation along toe

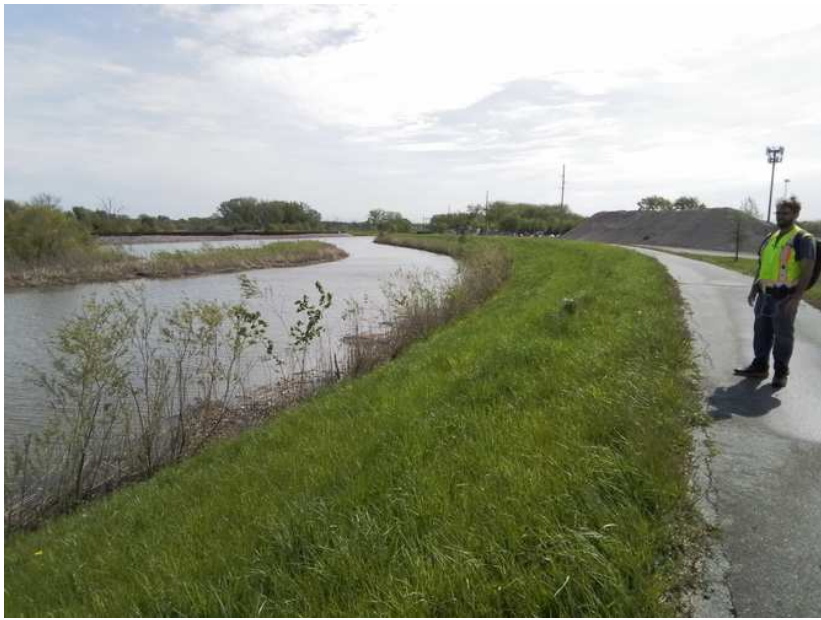
**Inspect ID:** 2024-0068

No User Rating (Site Visit) - Vegetation on riverside toe

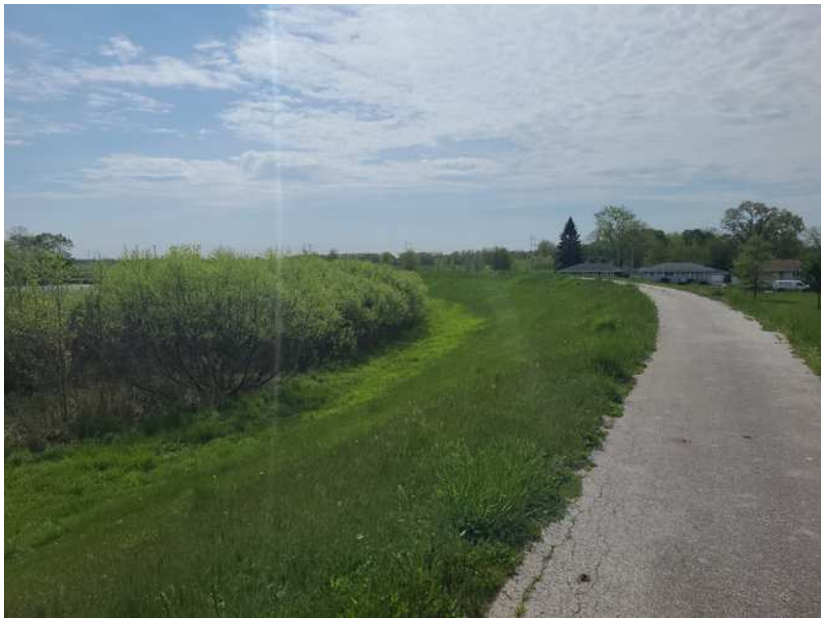
**Inspect ID:** 2024-0128

No User Rating (Site Visit) - Typical riverside vegetation.

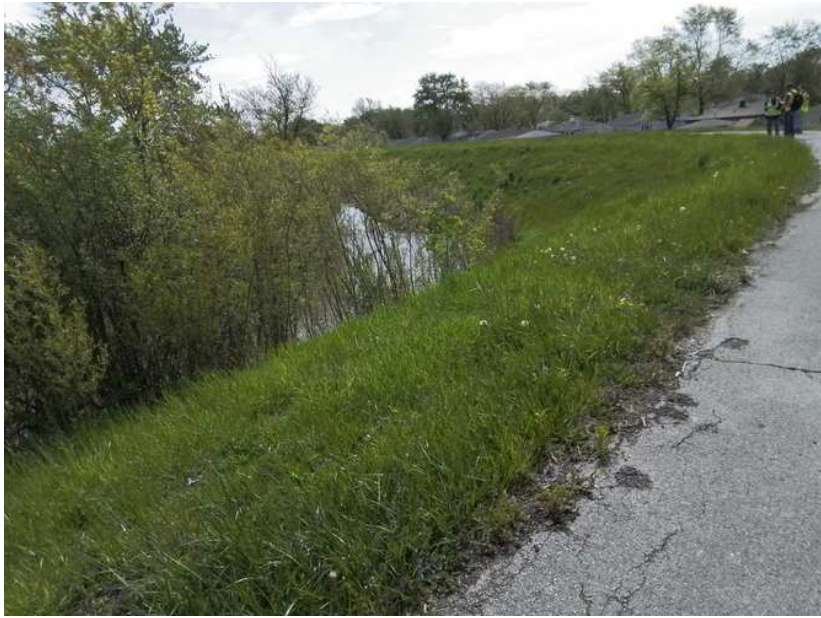
**Inspect ID:** 2024-0161

No User Rating (Site Visit) - Vegetation along riverside toe

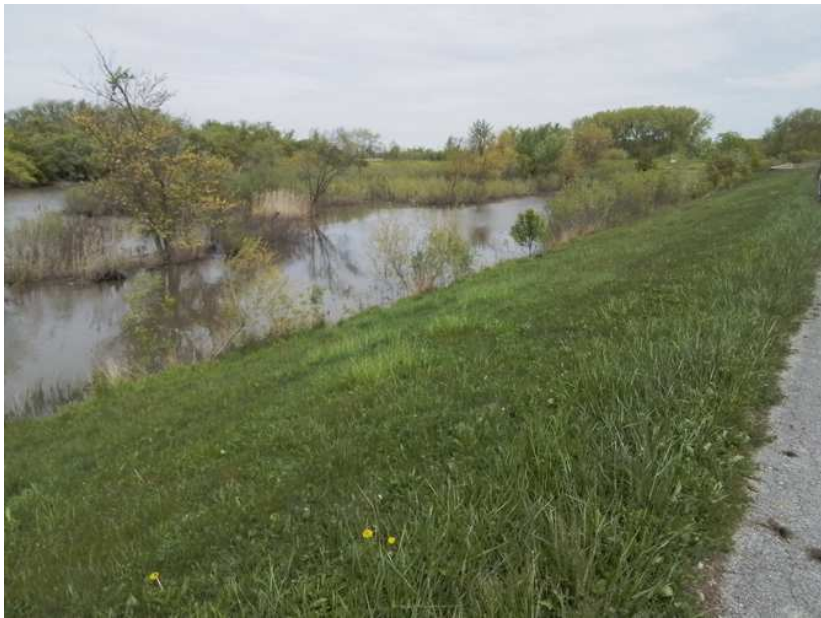
**Inspect ID:** 2024-0168

No User Rating (Site Visit) - Trees on riverside toe

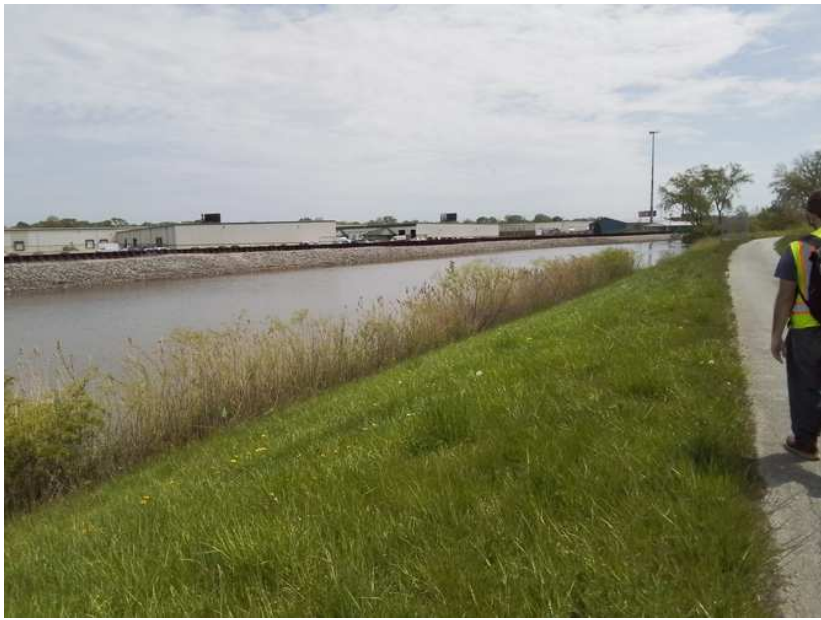
**Inspect ID:** 2024-0180

No User Rating (Site Visit) - Vegetation on riverside toe

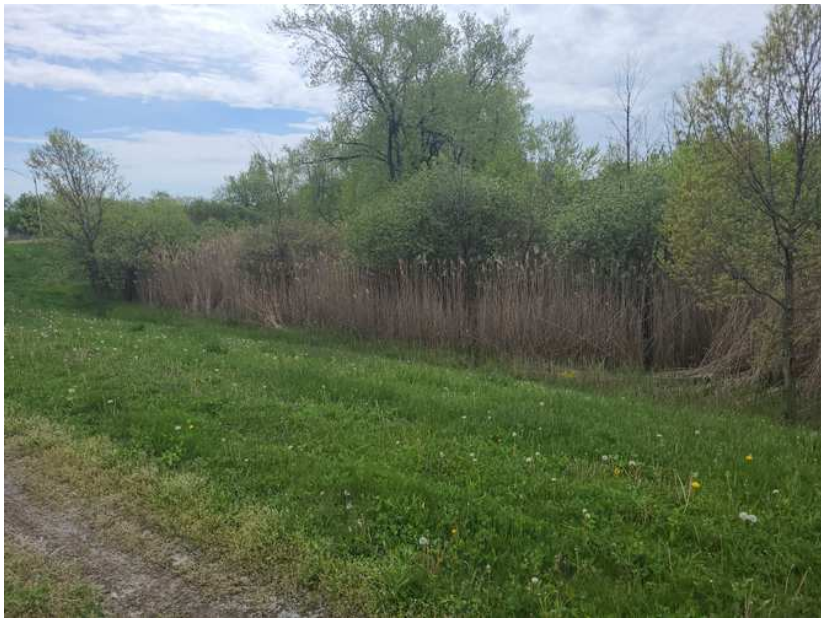
**Inspect ID:** 2024-0204

No User Rating (Site Visit) - Vegetation at riverside levee toe.

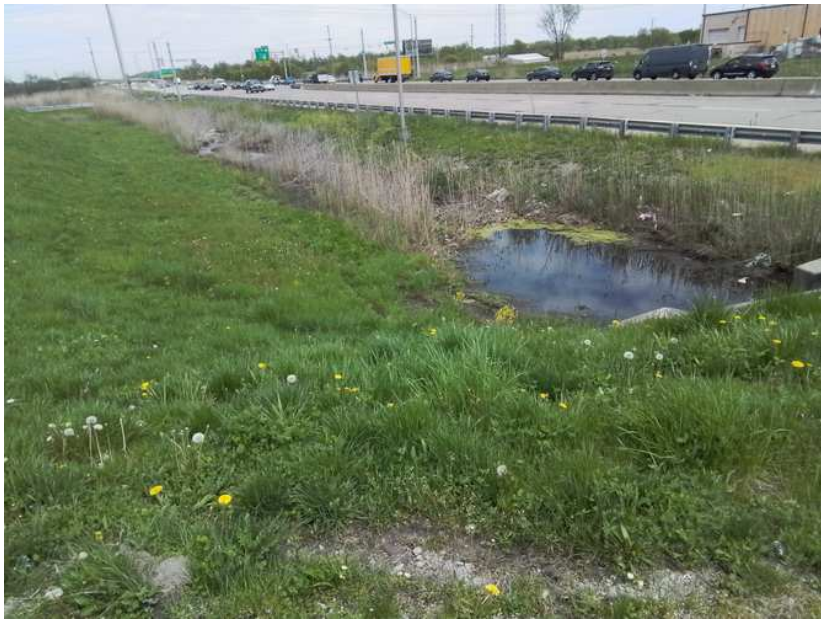
**Inspect ID:** 2024-0252

No User Rating (Site Visit) - Vegetation on landside toe.

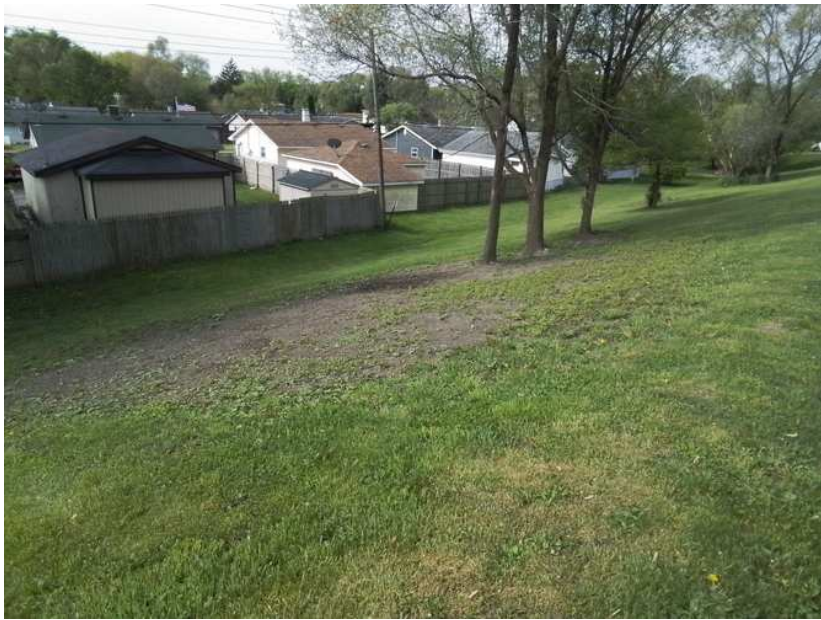
**Inspect ID:** 2024-0268

No User Rating (Site Visit) - Vegetation at ditch on riverside.

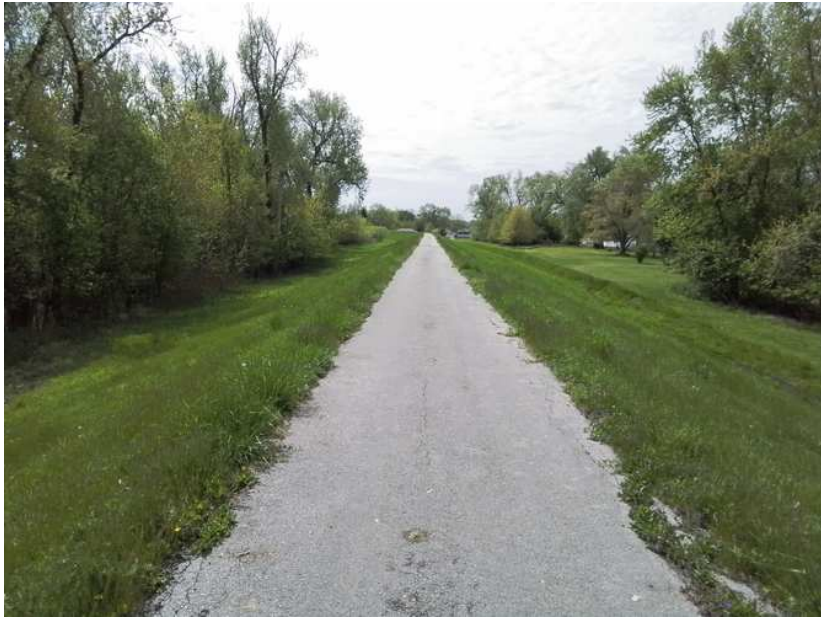
**Inspect ID:** 2024-0080

No User Rating (Site Visit) - Poor sod cover on landside slope.

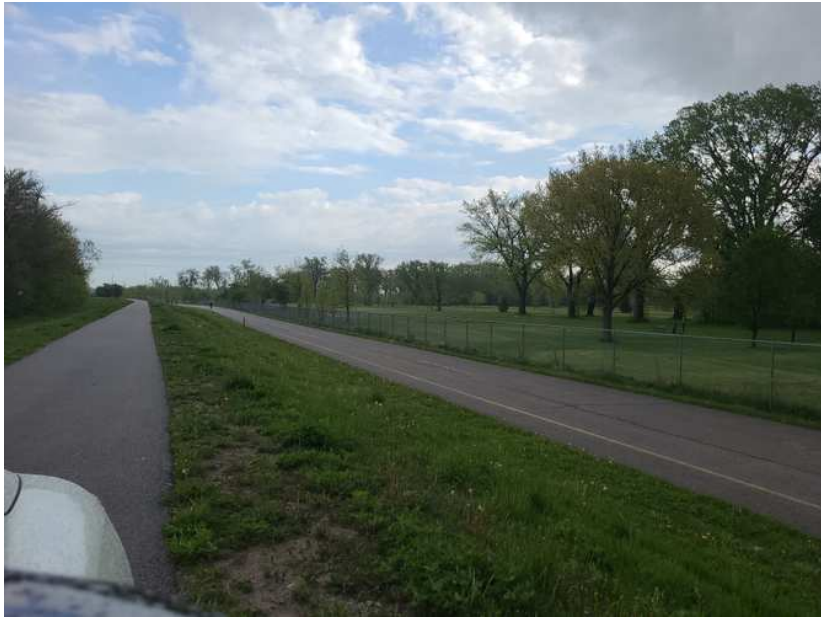
**Inspect ID:** 2024-0216

No User Rating (Site Visit) - Typical excellent sod cover on both landside and waterside.

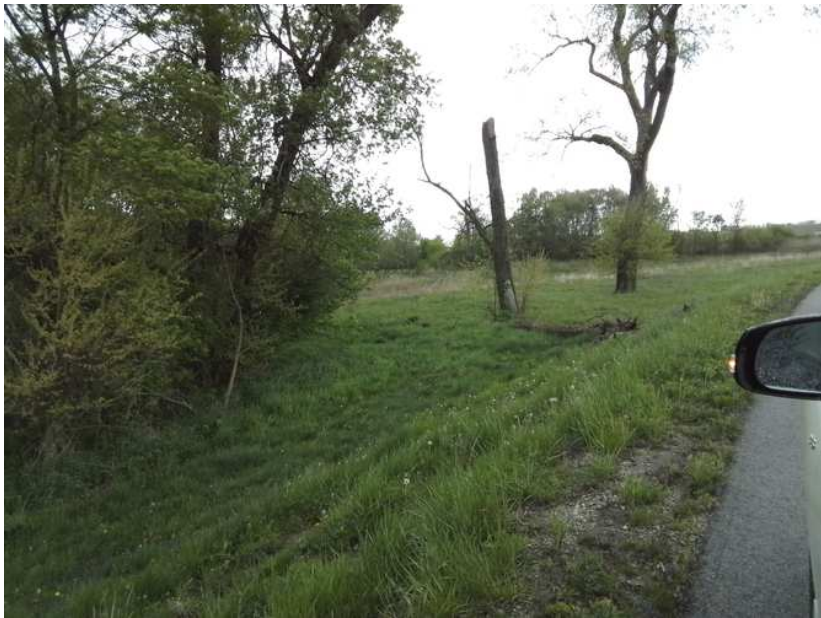
**Inspect ID:** 2024-0021

No User Rating (Site Visit) - Access ramp blocks landside ditch.

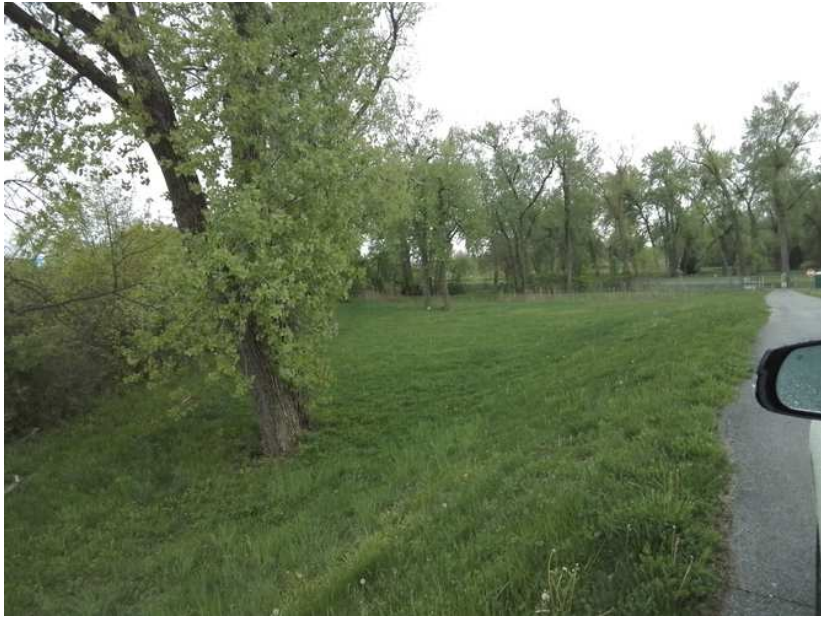
**Inspect ID:** 2024-0032

No User Rating (Site Visit) - Downed tree on riverside toe

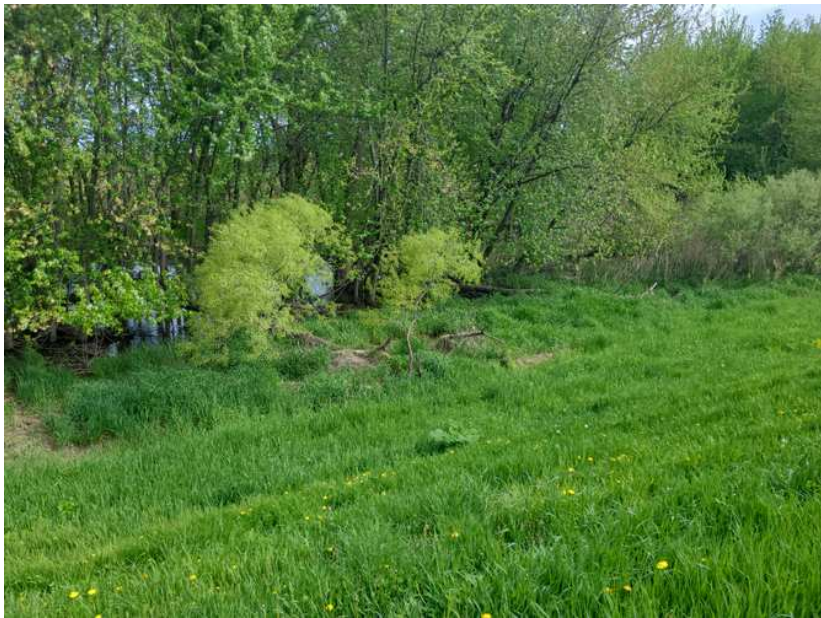
**Inspect ID:** 2024-0056

No User Rating (Site Visit) - Tree on riverside toe area.

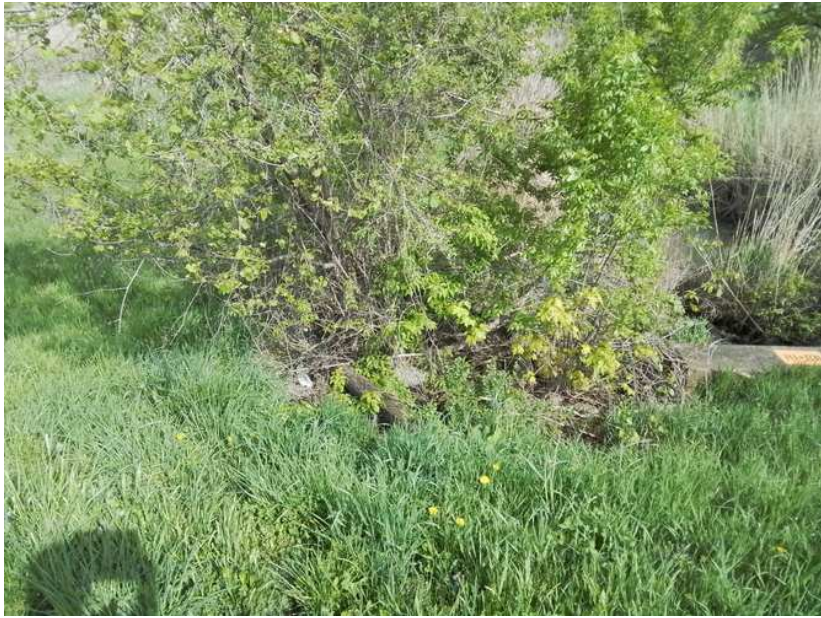
**Inspect ID:** 2024-0069

No User Rating (Site Visit) - Downed tree on riverside toe

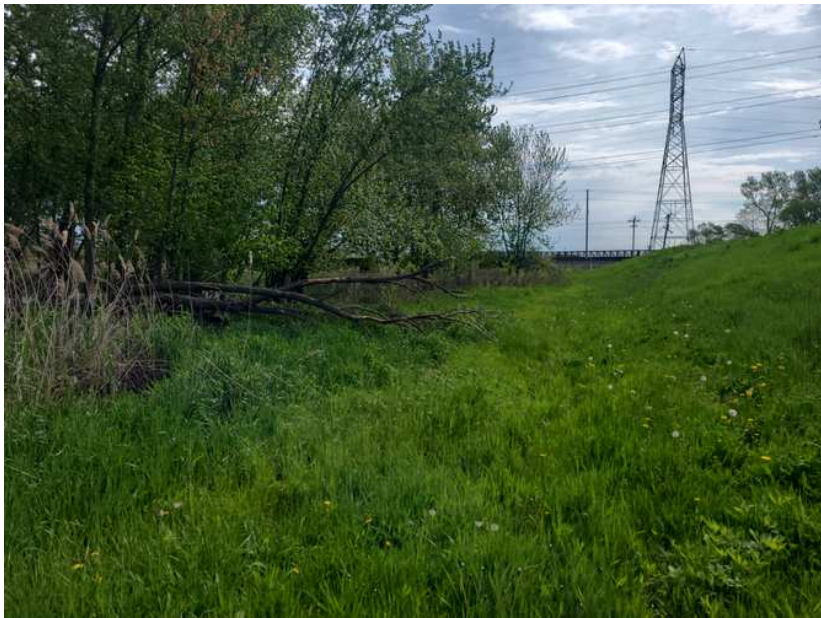
**Inspect ID:** 2024-0072

No User Rating (Site Visit) - Logs on riverside toe

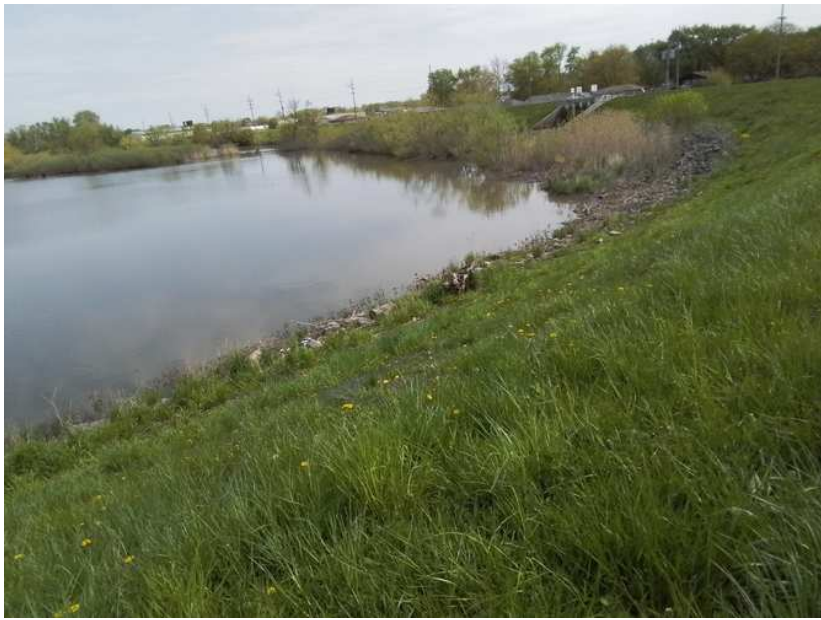
**Inspect ID:** 2024-0153

No User Rating (Site Visit) - Minor debris on riverside toe

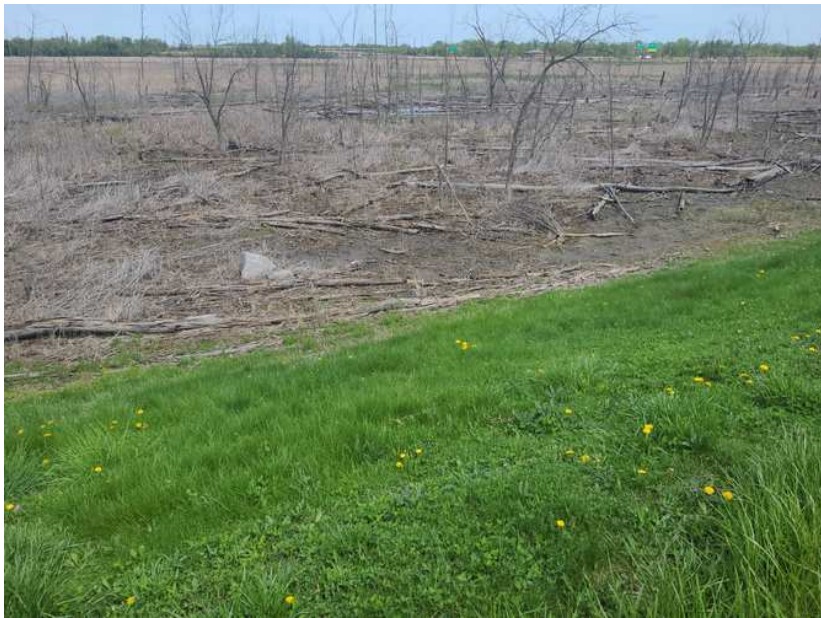
**Inspect ID:** 2024-0193

No User Rating (Site Visit) - Debris on riverside toe

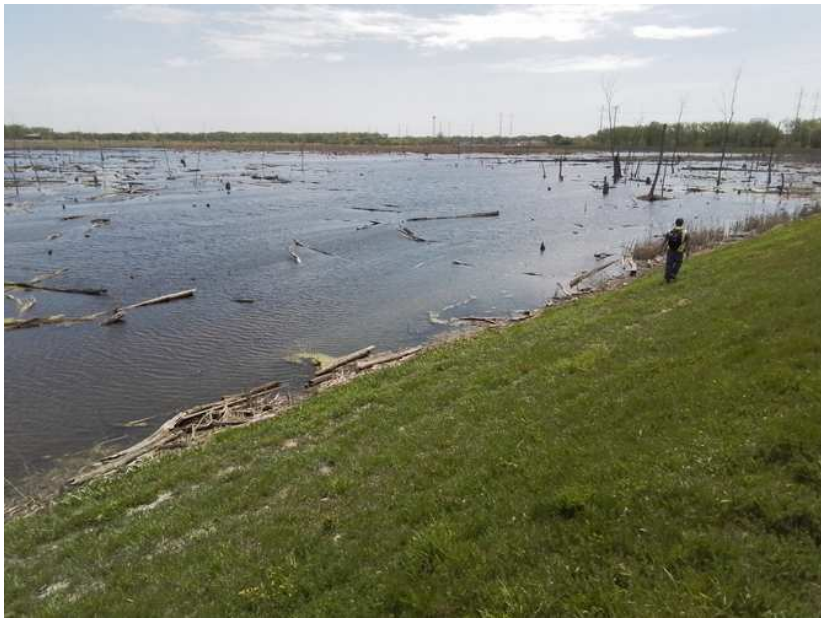
**Inspect ID:** 2024-0224

No User Rating (Site Visit) - Debris on crown and riverside slope

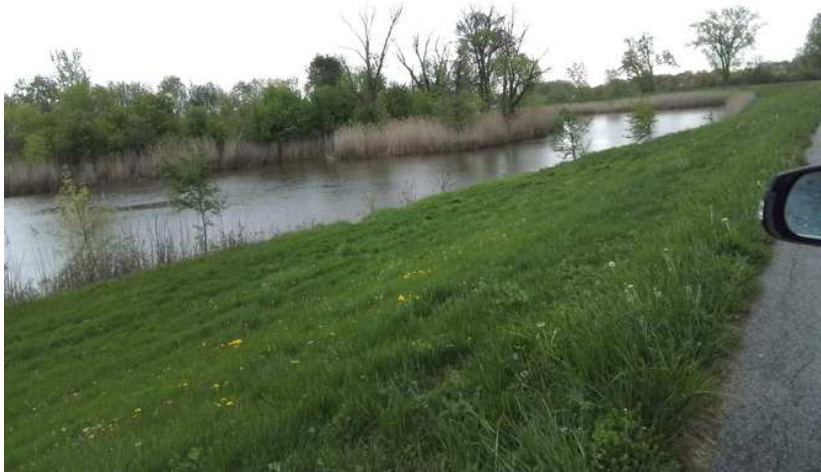
**Inspect ID:** 2024-0248

No User Rating (Site Visit) - Debris at landside levee toe.

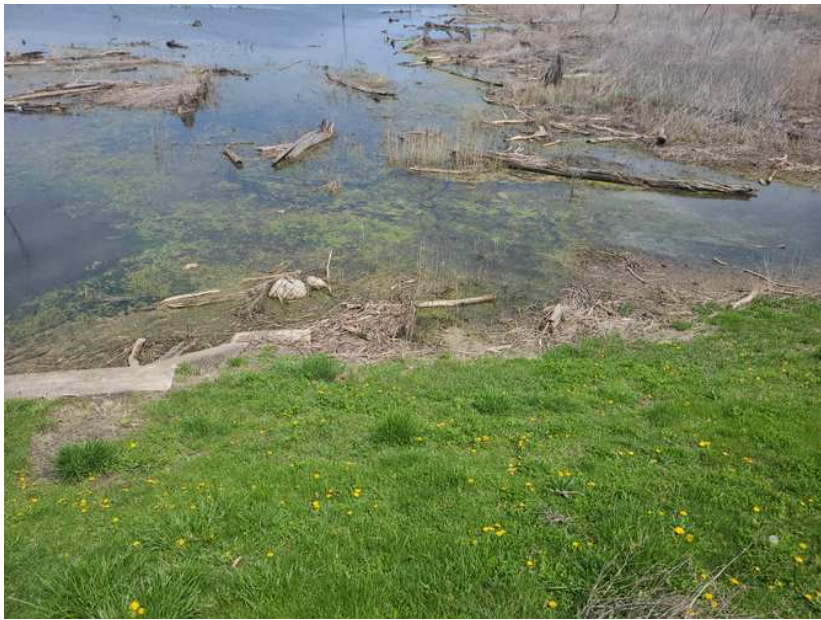
**Inspect ID:** 2024-0205

**Rated Item:** 6. Erosion/ Bank Caving

No User Rating (Site Visit) - Erosion near wingwall on riverside slope.

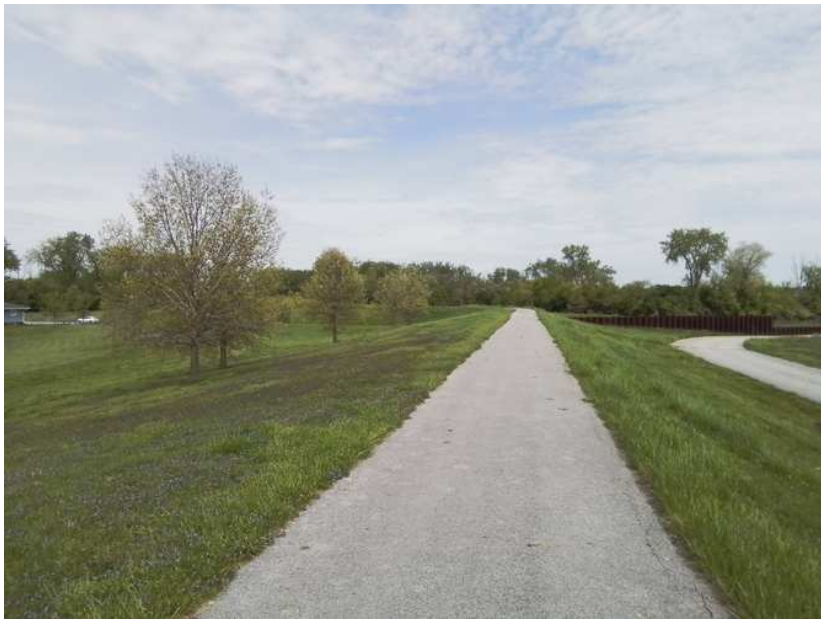
**Inspect ID:** 2024-0244  
**Rated Item:** 7. Settlement  
**Lat/Long:** 41.56401/-87.44224  
**Caption:**

No User Rating (Site Visit) - Depression in crown of levee around the bend.

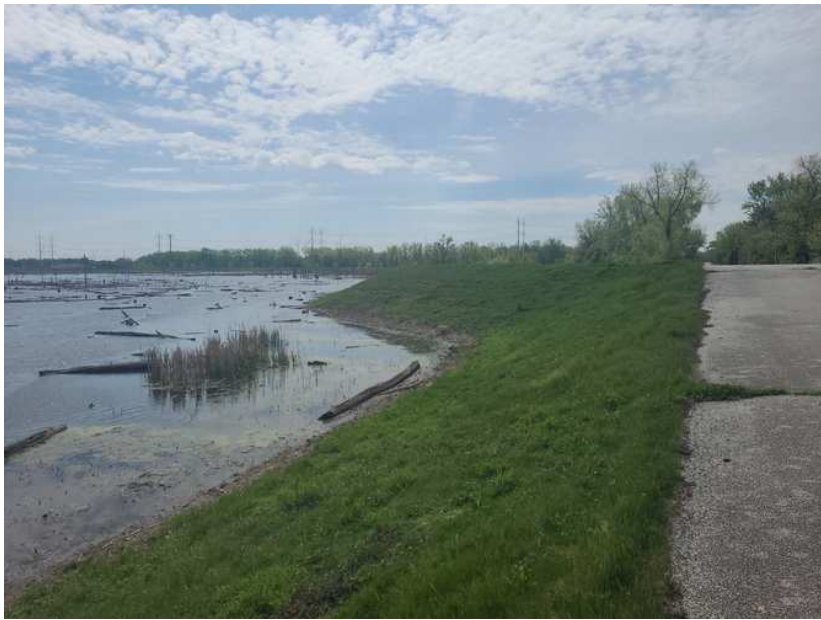
**Inspect ID:** 2024-0177

**Rated Item:** 8. Depressions/ Rutting

No User Rating (Site Visit) - Erosion and rutting on riverside slope

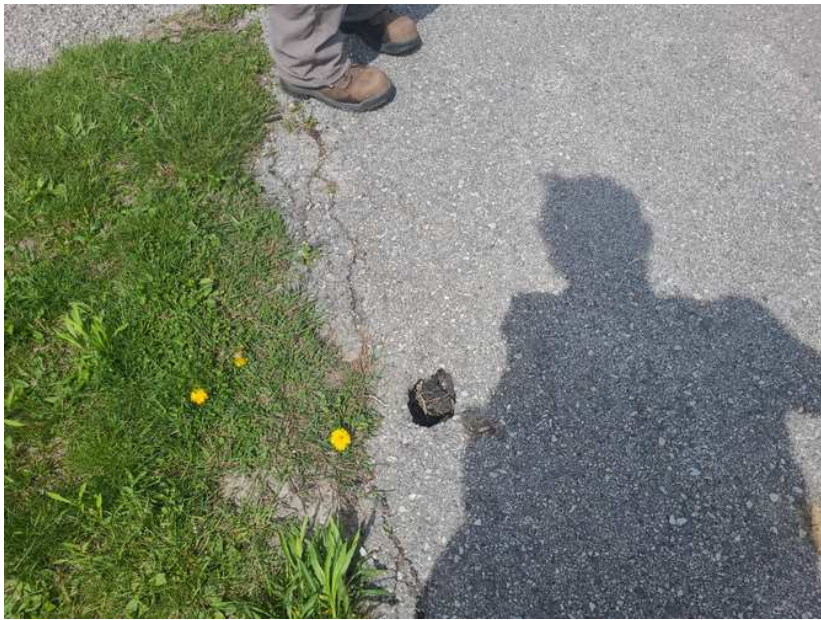
**Inspect ID:** 2024-0181

**Rated Item:** 8. Depressions/ Rutting

No User Rating (Site Visit) - Pothole in asphalt on landside crest.

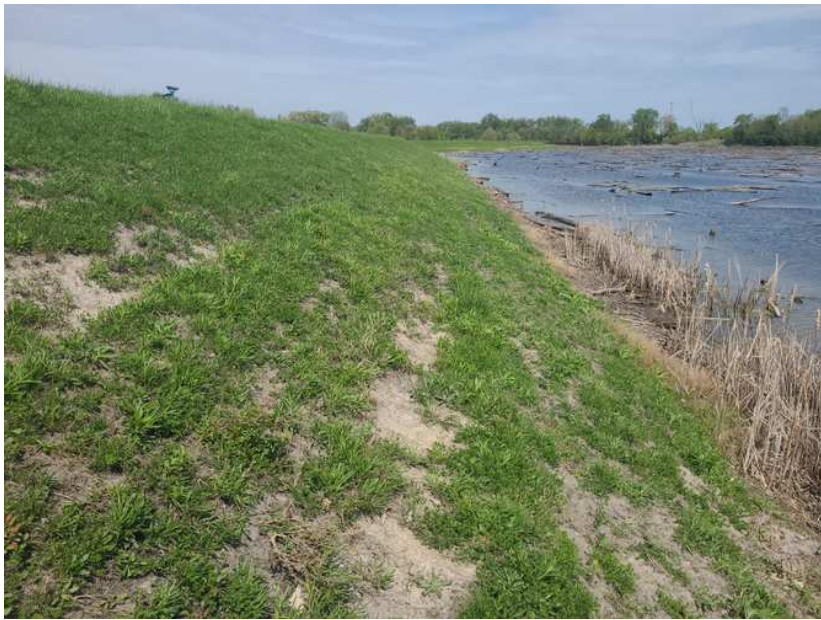
**Inspect ID:** 2024-0189

**Rated Item:** 8. Depressions/ Rutting

No User Rating (Site Visit) - Old riverside slope rutting

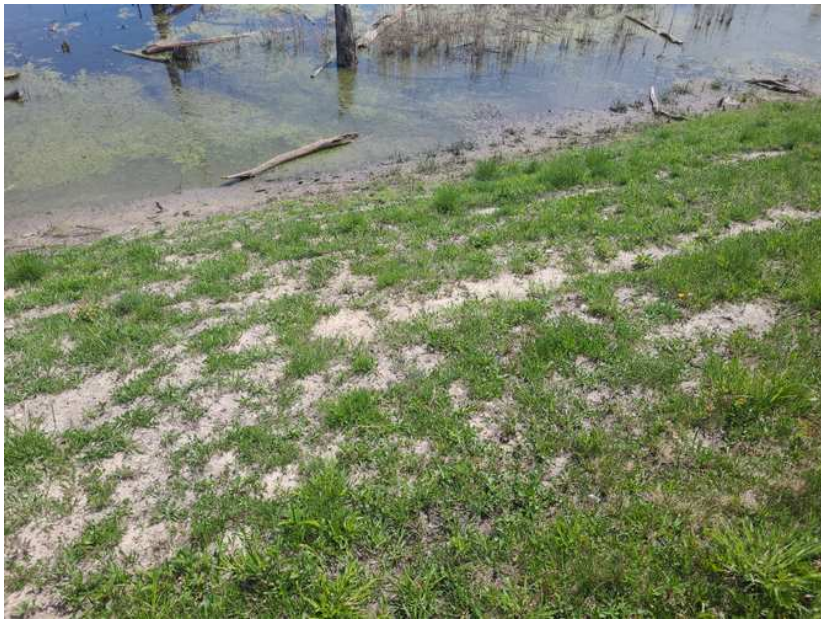
**Inspect ID:** 2024-0197

**Rated Item:** 8. Depressions/ Rutting

No User Rating (Site Visit) - Old rutting and poor sod cover on riverside slope.

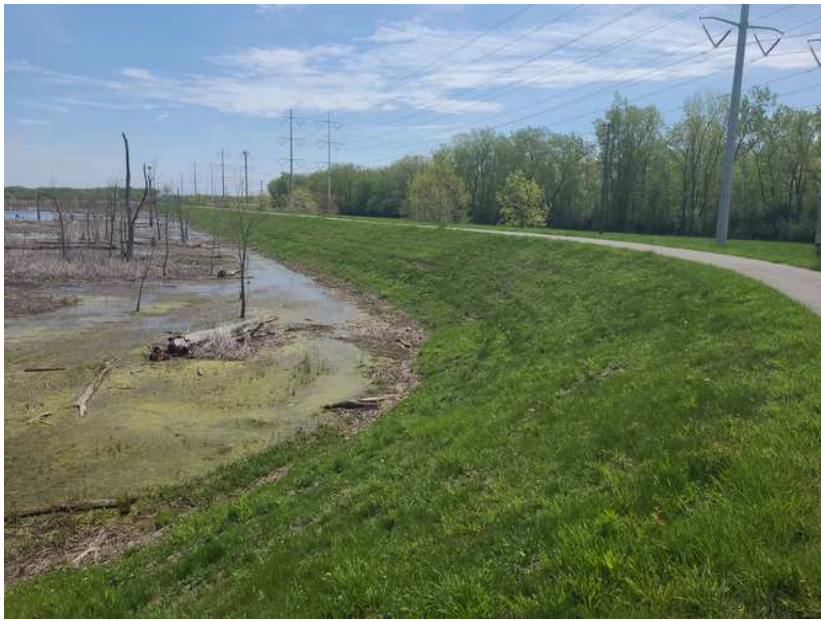
**Inspect ID:** 2024-0201

**Rated Item:** 8. Depressions/ Rutting

No User Rating (Site Visit) - Rutting in riverside slope

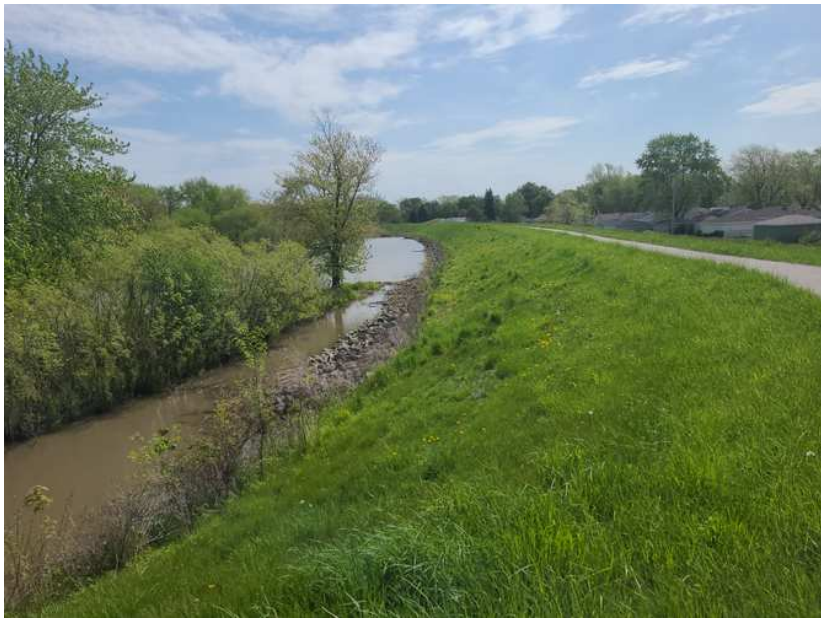
**Inspect ID:** 2024-0129

**Rated Item:** 12. Riprap Revetments & Bank Protection

No User Rating (Site Visit) - Riprap was sprayed with herbicide in mid-April. Typical result of spraying.

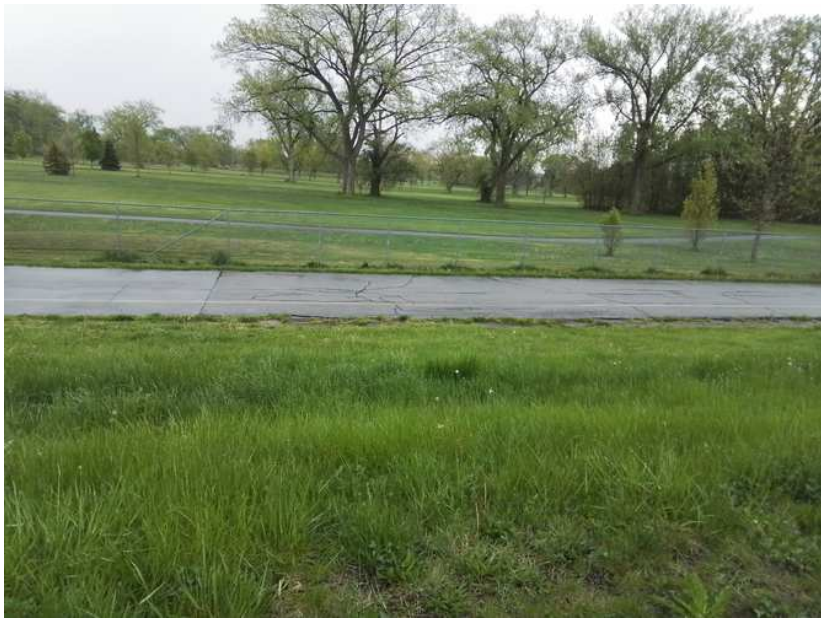
**Inspect ID:** 2024-0060

**Rated Item:** 15. Seepage

No User Rating (Site Visit) - Prior area of pinhole seeps

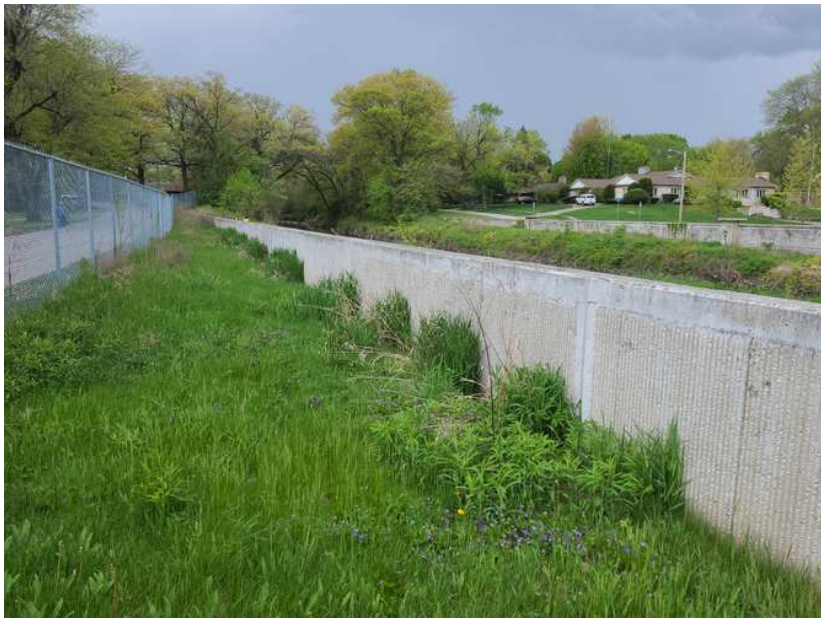
**Inspect ID:** 2024-0001

**Rated Item:** 1. Unwanted Vegetation Growth

No User Rating (Site Visit) - Tall vegetation along landside wall.

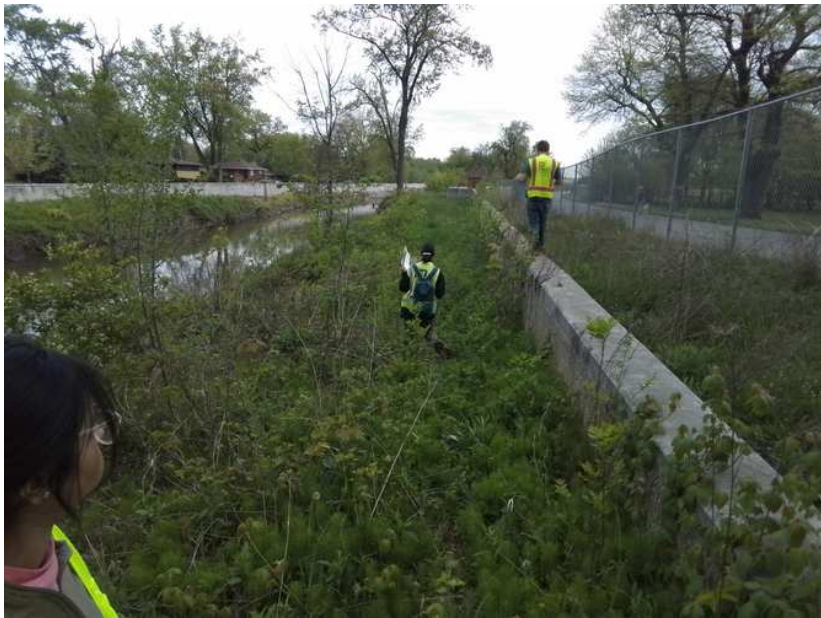
**Inspect ID:** 2024-0004

**Rated Item:** 1. Unwanted Vegetation Growth

No User Rating (Site Visit) - Typical vegetation on riverside of floodwall.

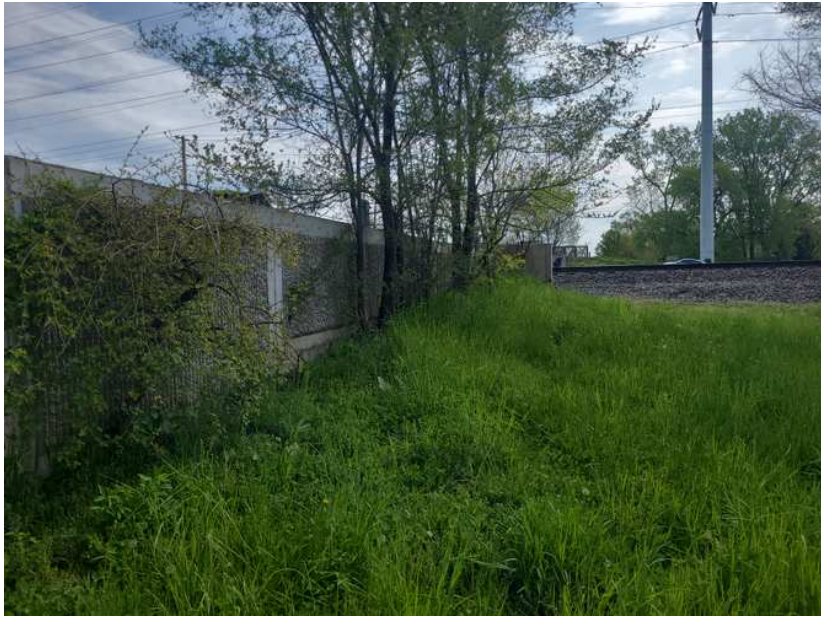
**Inspect ID:** 2024-0081

**Rated Item:** 1. Unwanted Vegetation Growth

No User Rating (Site Visit) - Tree on landside of floodwall

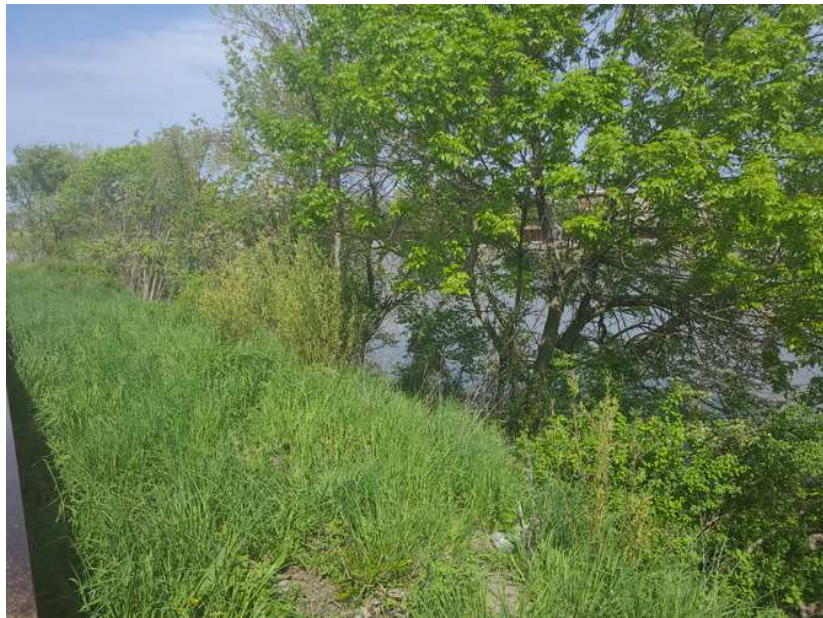
**Inspect ID:** 2024-0113

**Rated Item:** 1. Unwanted Vegetation Growth

No User Rating (Site Visit) - Trees on riverside

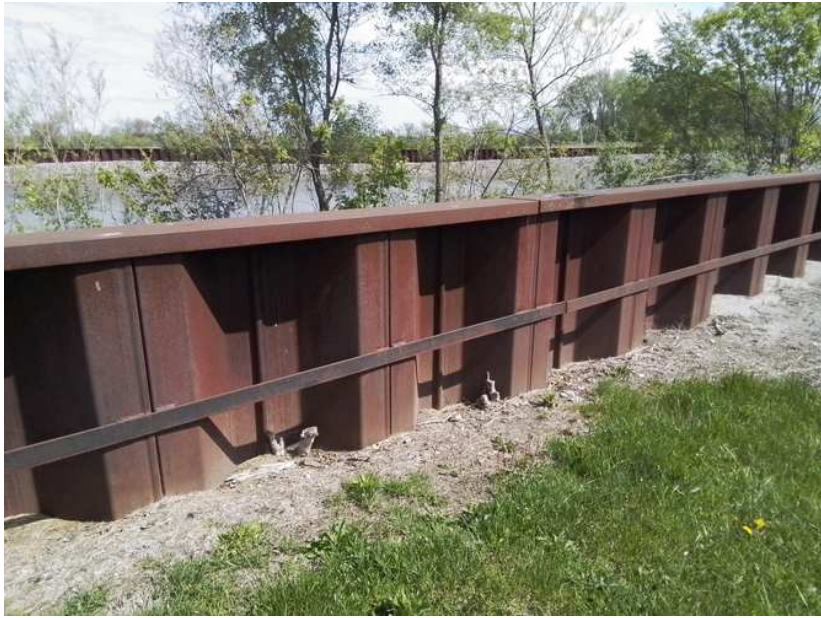
**Inspect ID:** 2024-0132

**Rated Item:** 1. Unwanted Vegetation Growth

No User Rating (Site Visit) - Tree trunks cut but still growing on landside.
