US Army Corps of Engineers ®

## Site Visit Summary

Name of System: Highland

NLD System ID: 2605000005 NLD Segment ID: 2604000007

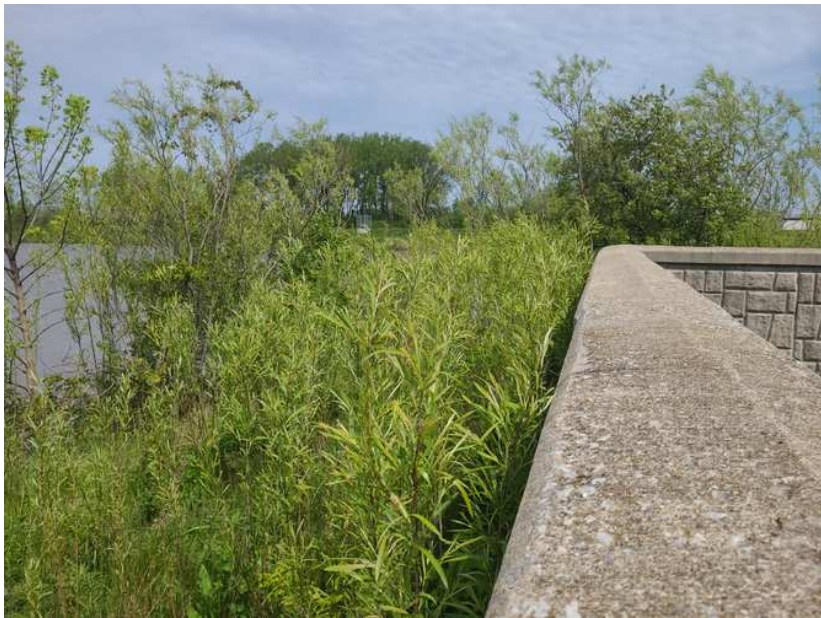
**Inspect ID:** 2024-0145

**Rated Item:** 1. Unwanted Vegetation Growth

No User Rating (Site Visit) - Tall vegetation on riverside line from here to the east.

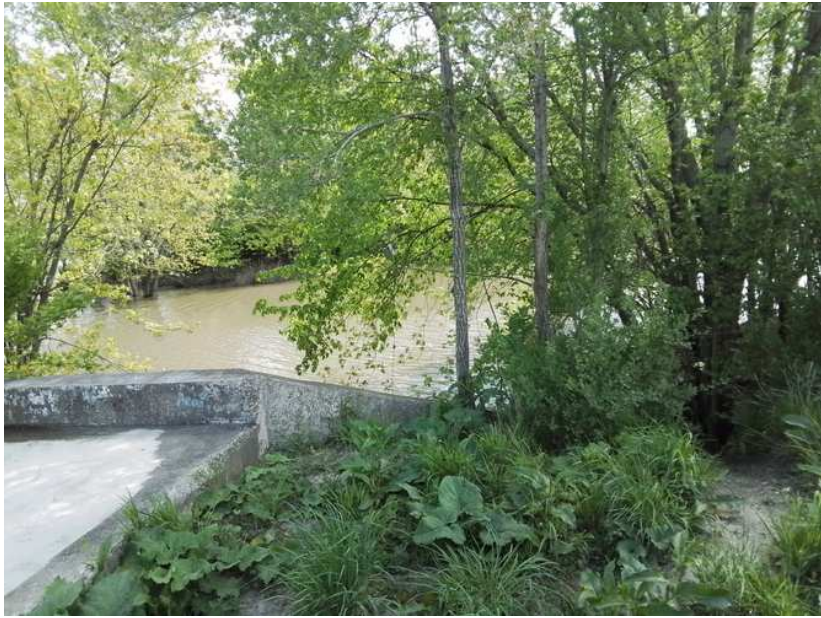
**Inspect ID:** 2024-0148

**Rated Item:** 1. Unwanted Vegetation Growth

No User Rating (Site Visit) - HI-08: Trees around gate headwall.

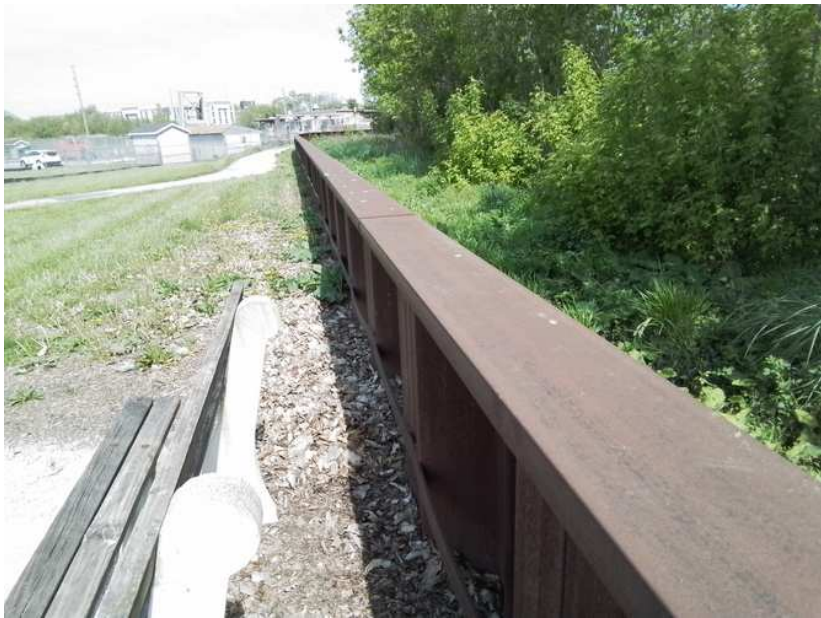
**Inspect ID:** 2024-0156

**Rated Item:** 1. Unwanted Vegetation Growth

No User Rating (Site Visit) - Vegetation and debris typical

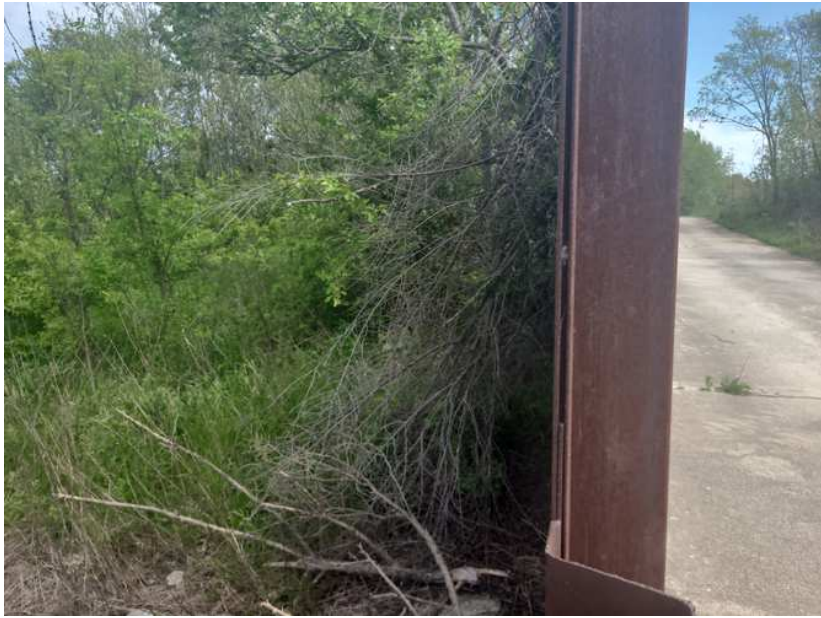
**Inspect ID:** 2024-0165

**Rated Item:** 1. Unwanted Vegetation Growth

No User Rating (Site Visit) - Vegetation along the weir at the rookery

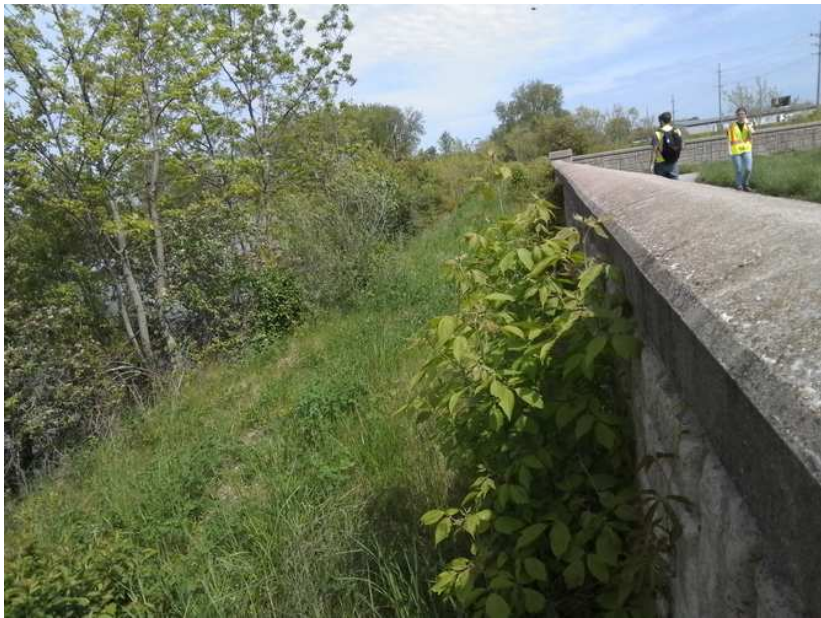
**Inspect ID:** 2024-0192

**Rated Item:** 1. Unwanted Vegetation Growth

No User Rating (Site Visit) - Small trees on the riverside

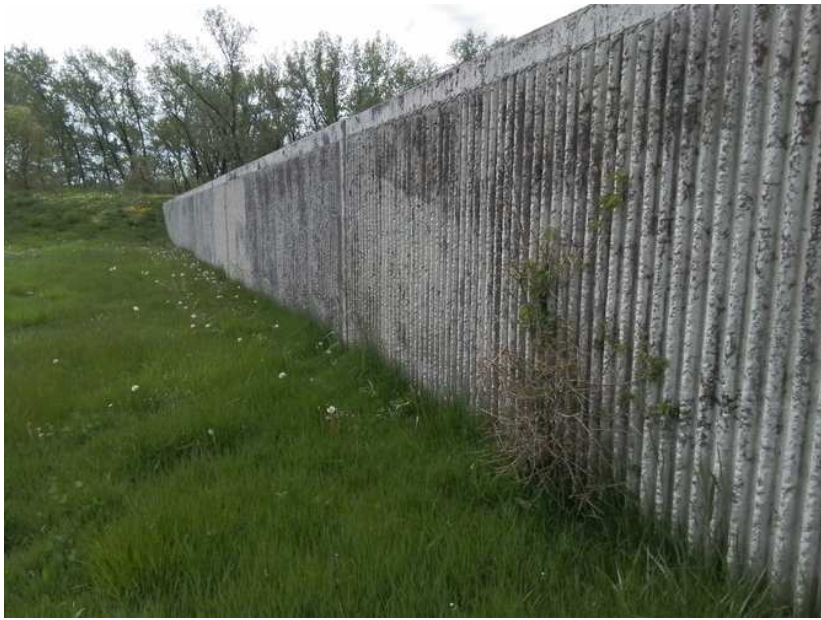
**Inspect ID:** 2024-0256

**Rated Item:** 1. Unwanted Vegetation Growth

No User Rating (Site Visit) - Small tree on riverside.

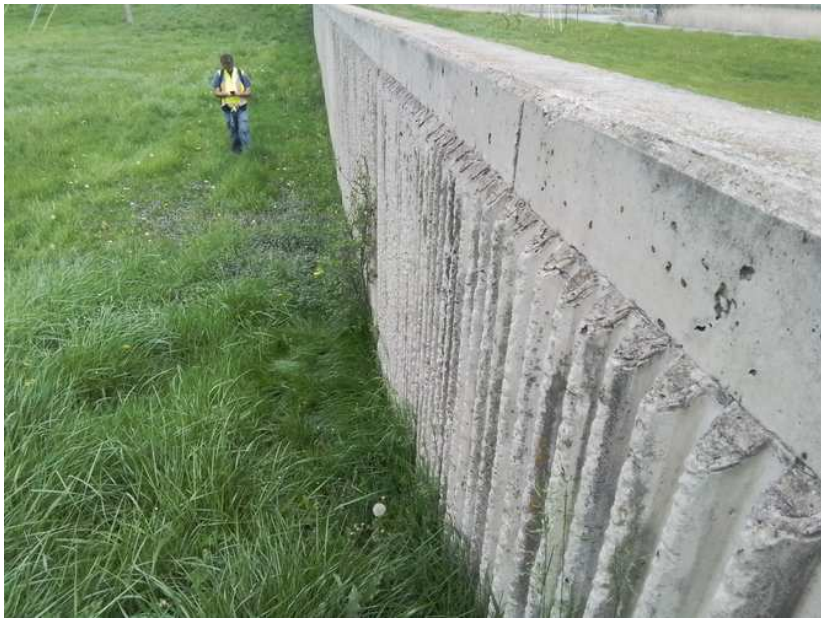
**Inspect ID:** 2024-0260

**Rated Item:** 1. Unwanted Vegetation Growth

No User Rating (Site Visit) - Small tree landside

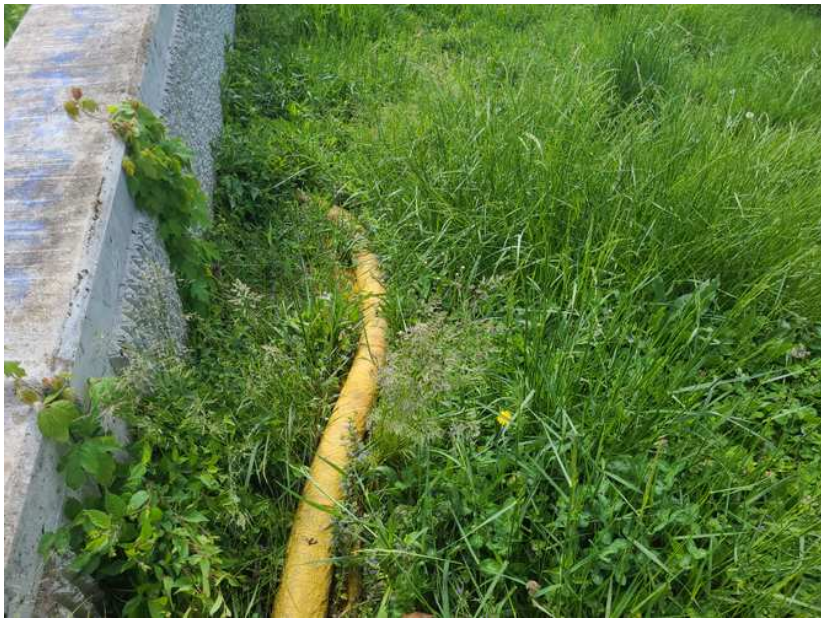
**Inspect ID:** 2024-0077

**Rated Item:** 2. Encroachments

No User Rating (Site Visit) - Debris on landside of the floodwall.

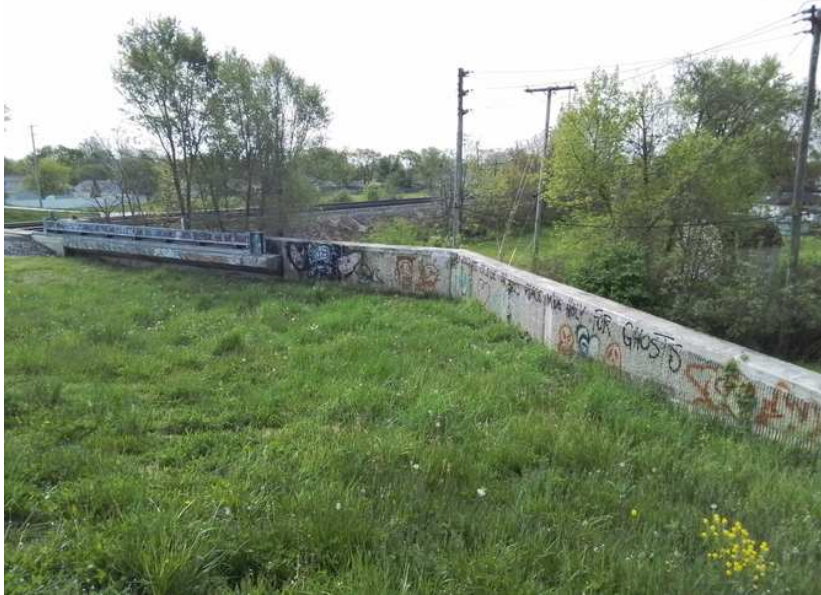
**Inspect ID:** 2024-0096

**Rated Item:** 2. Encroachments

No User Rating (Site Visit) - Graffiti on riverside of railroad closure gate and floodwall.

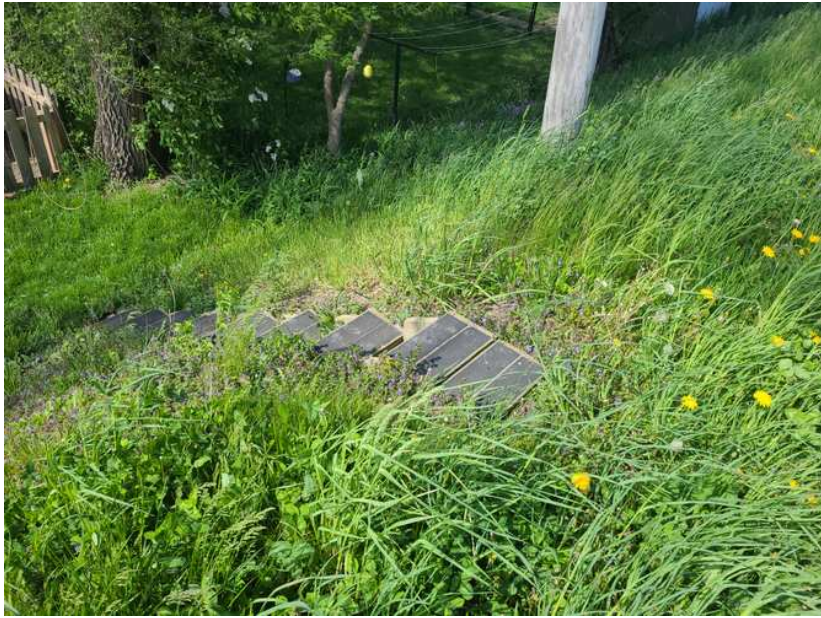
**Inspect ID:** 2024-0097

**Rated Item:** 2. Encroachments

No User Rating (Site Visit) - Stairs in berm on landside by the floodwall

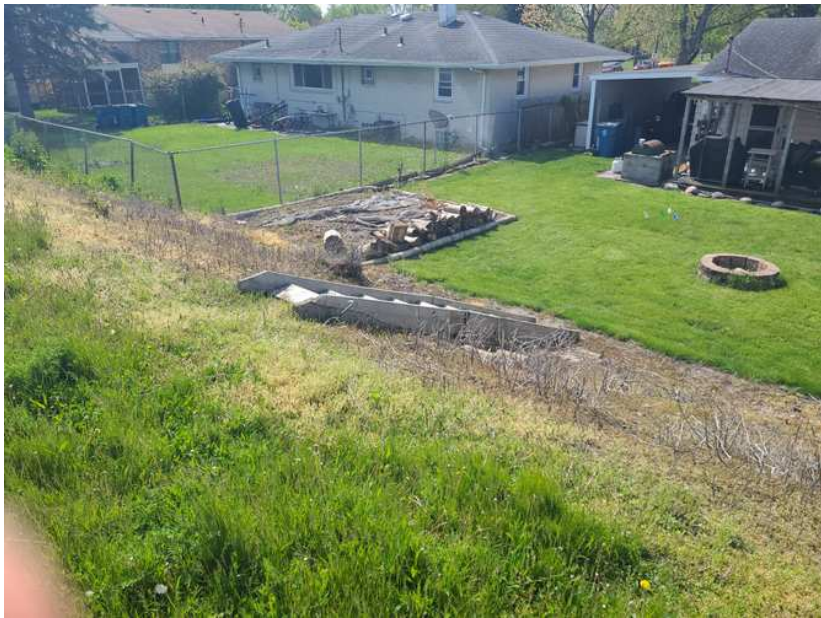
**Inspect ID:** 2024-0101

**Rated Item:** 2. Encroachments

No User Rating (Site Visit) - Stairs on landside berm by the floodwall

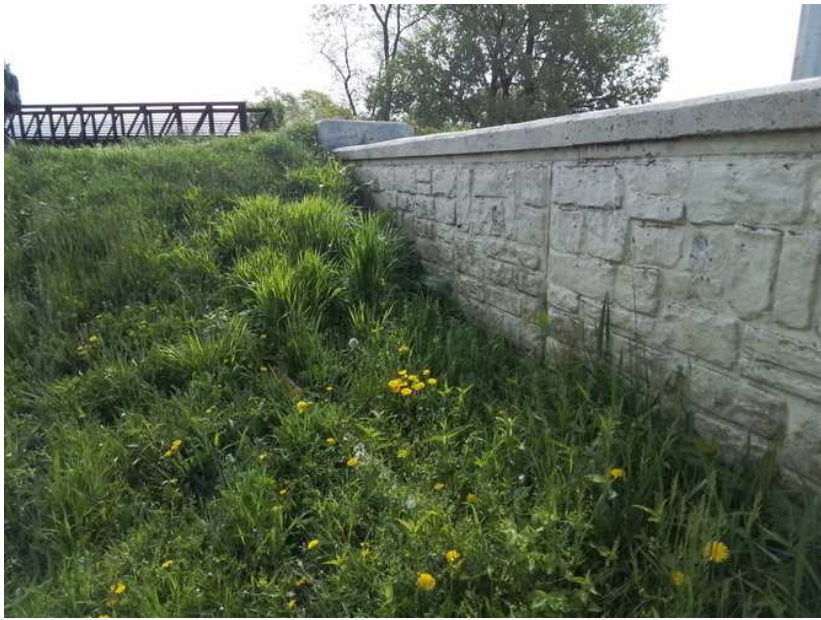
**Inspect ID:** 2024-0116

**Rated Item:** 2. Encroachments

No User Rating (Site Visit) - Sign encroachment on riverside of floodwall.

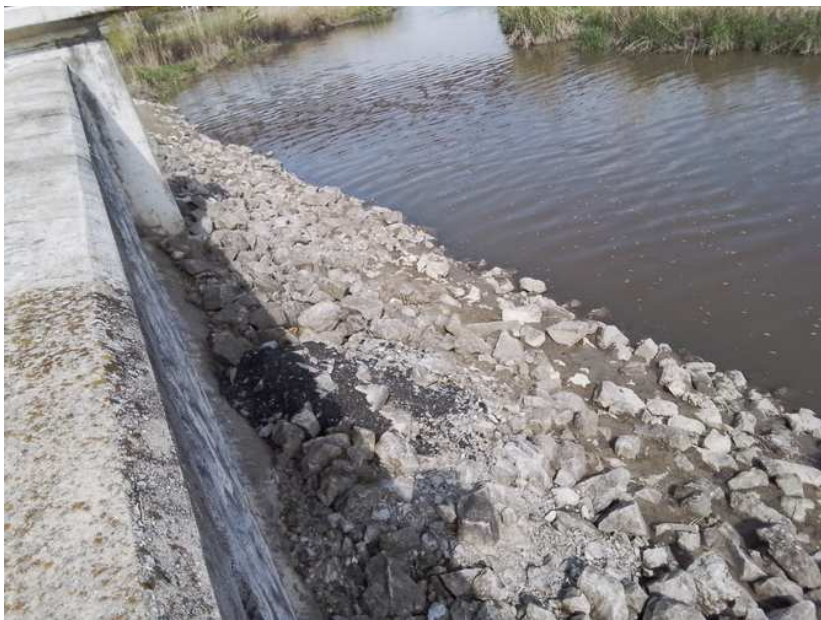
**Inspect ID:** 2024-0120

**Rated Item:** 2. Encroachments

No User Rating (Site Visit) - Firepit debris on riverside of the floodwall.

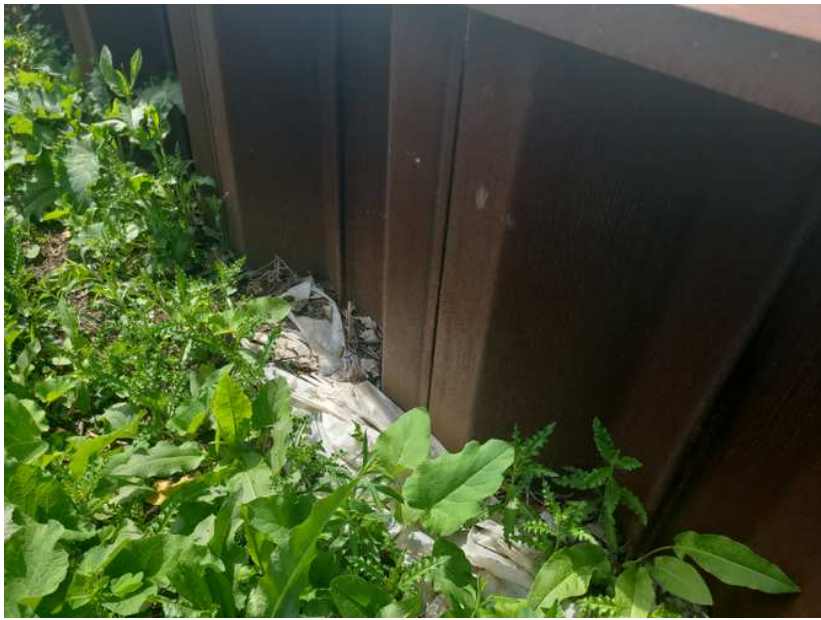
**Inspect ID:** 2024-0121

**Rated Item:** 2. Encroachments

No User Rating (Site Visit) - Debris on the riverside

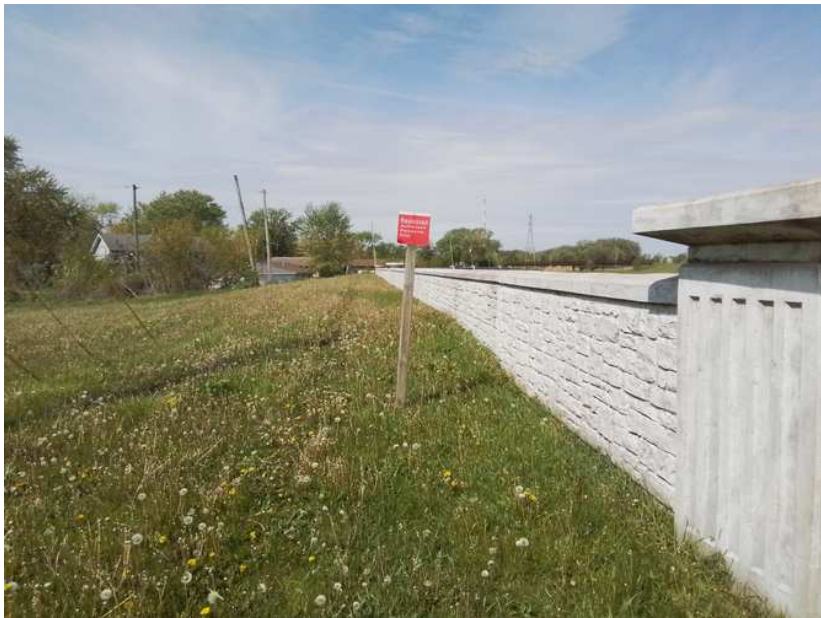
**Inspect ID:** 2024-0124

**Rated Item:** 2. Encroachments

No User Rating (Site Visit) - Sign on the landside of the floodwall.

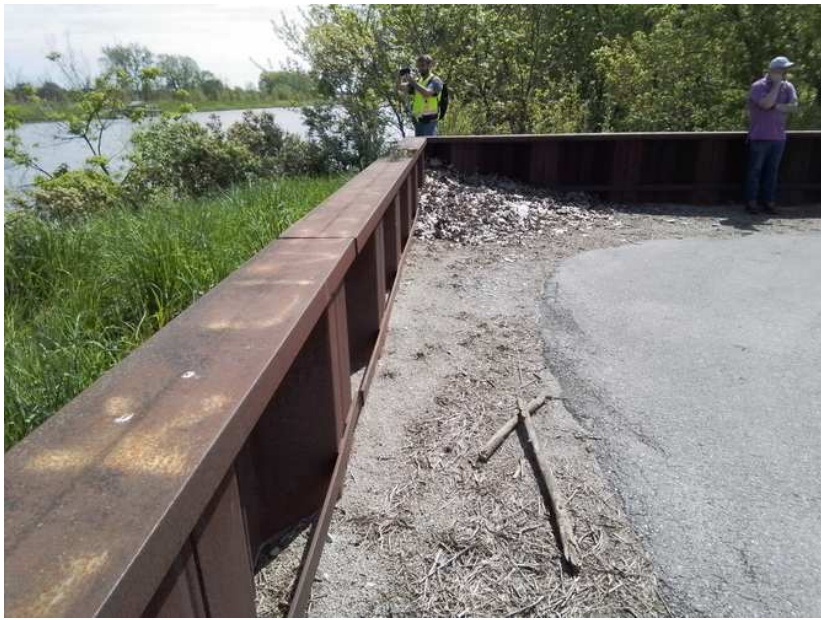
**Inspect ID:** 2024-0136

**Rated Item:** 2. Encroachments

No User Rating (Site Visit) - Leaf pile on landside.

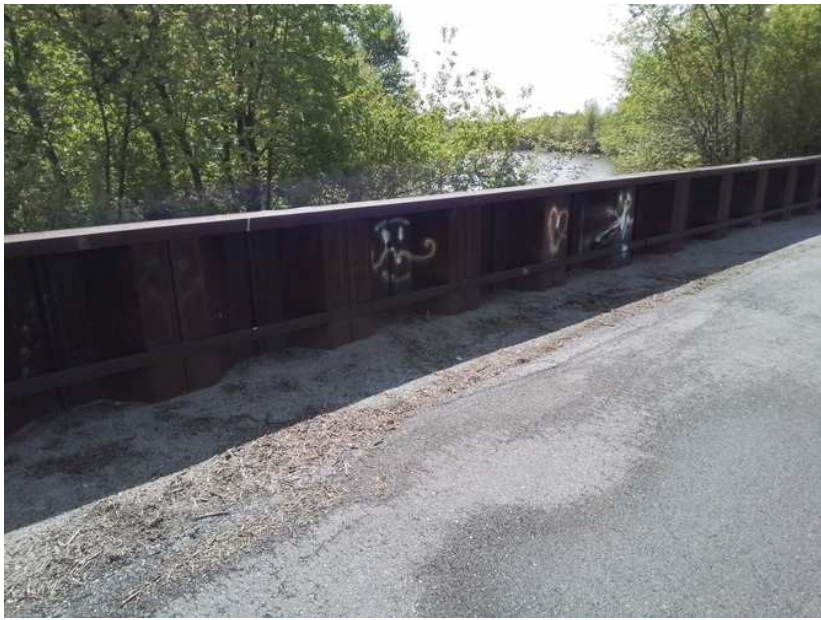
**Inspect ID:** 2024-0140

**Rated Item:** 2. Encroachments

No User Rating (Site Visit) - Graffiti on the floodwall on landside.

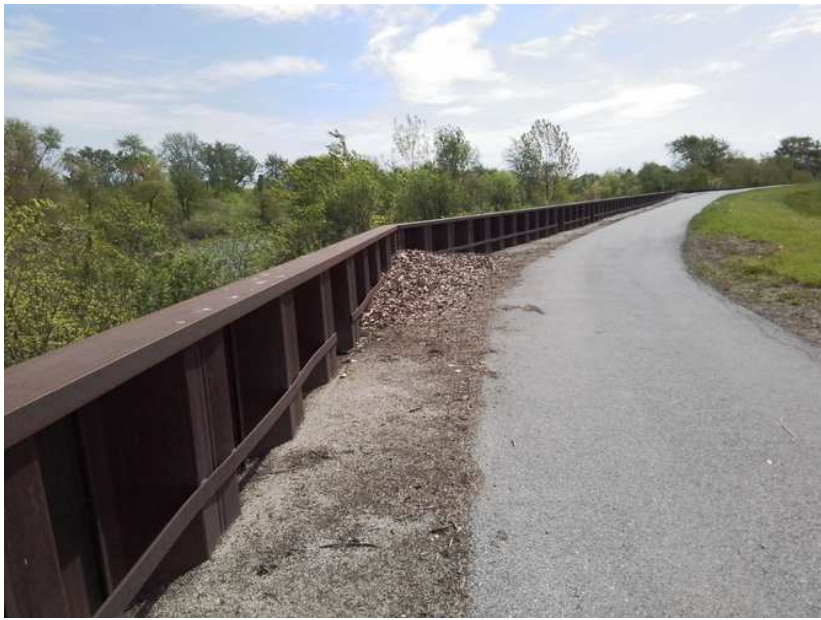
**Inspect ID:** 2024-0160

**Rated Item:** 2. Encroachments

No User Rating (Site Visit) - Pile of leaves on landside.

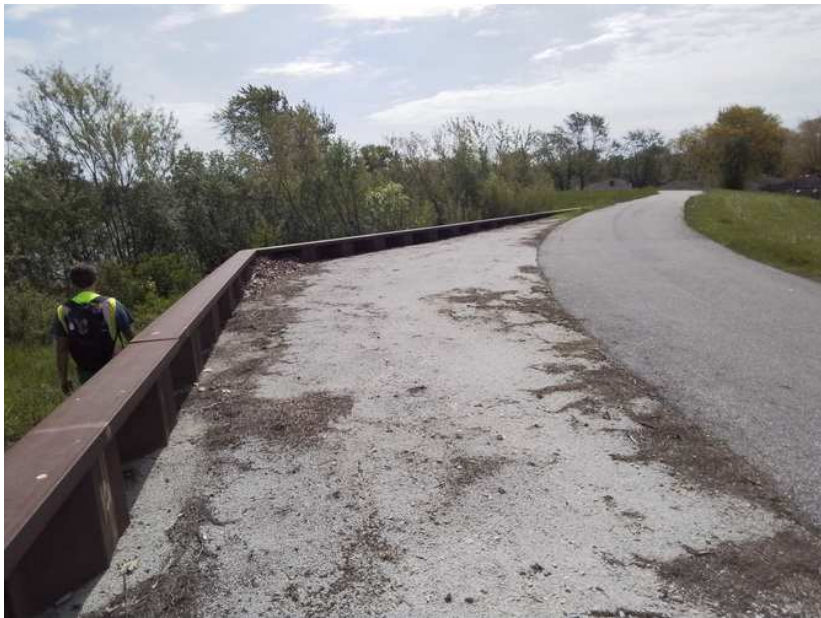
**Inspect ID:** 2024-0164

**Rated Item:** 2. Encroachments

No User Rating (Site Visit) - Pile of leaves on landside.

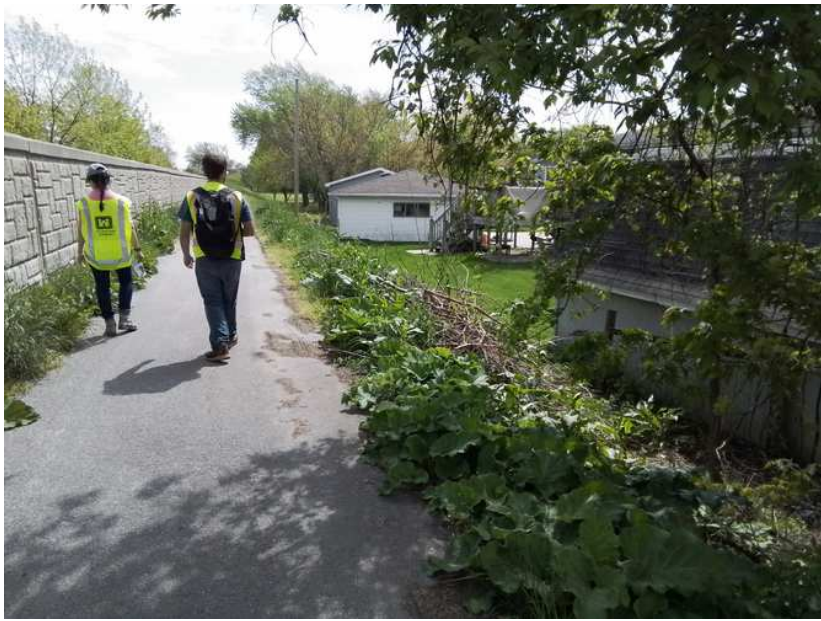
**Inspect ID:** 2024-0196

**Rated Item:** 2. Encroachments

No User Rating (Site Visit) - Debris pile on landside of floodwall.

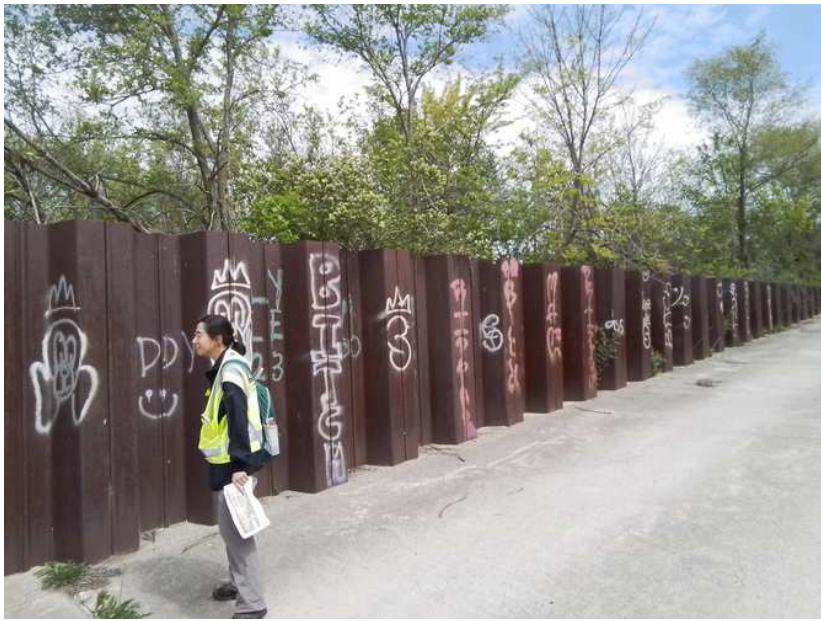
**Inspect ID:** 2024-0228

**Rated Item:** 2. Encroachments

No User Rating (Site Visit) - Graffiti on sheet piling by weir on the landside face.

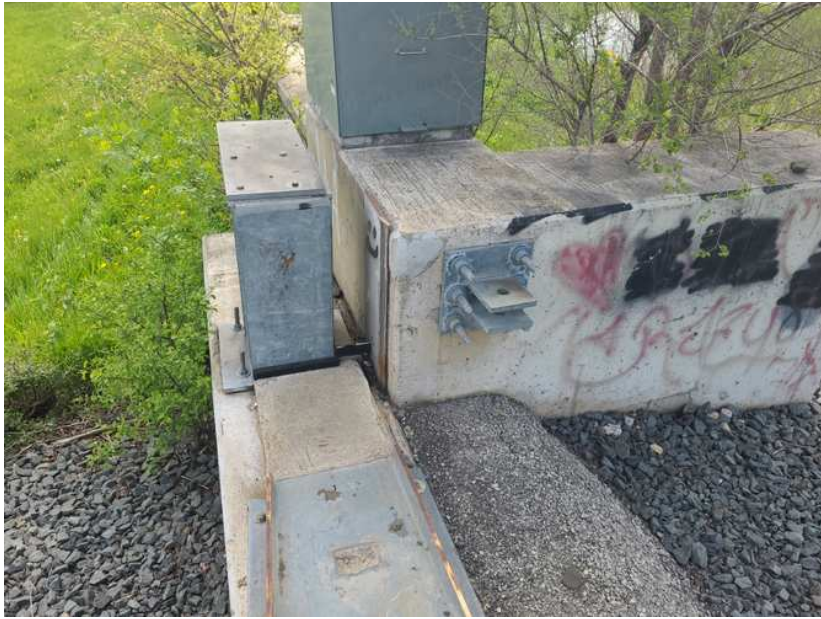
**Inspect ID:** 2024-0085

**Rated Item:** 3. Closure Structures (Stop Log Closures and Gates) (A or U only)

No User Rating (Site Visit) - Missing seal on railroad closure.

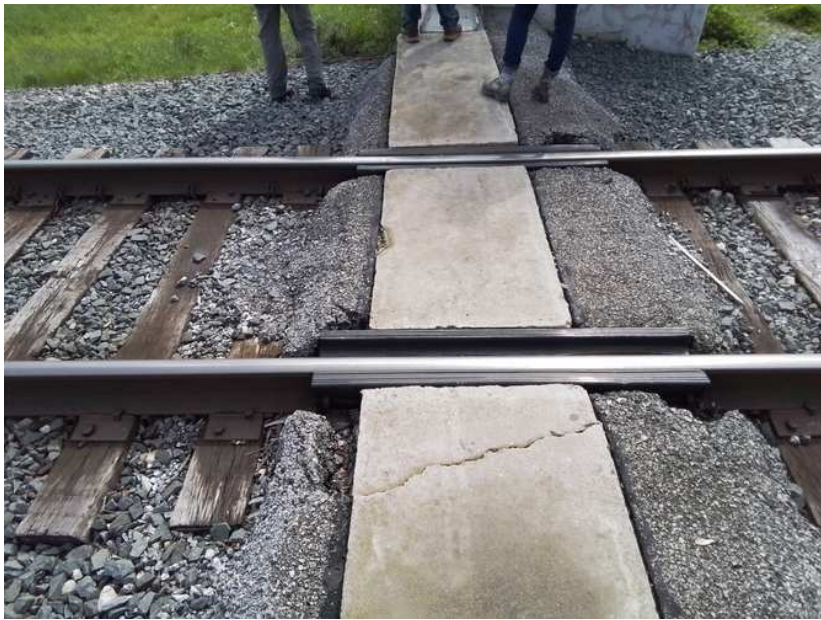
**Inspect ID:** 2024-0104

**Rated Item:** 3. Closure Structures (Stop Log Closures and Gates) (A or U only)

No User Rating (Site Visit) - Crack in concrete and asphalt at closure structure on the top of the floodwall.

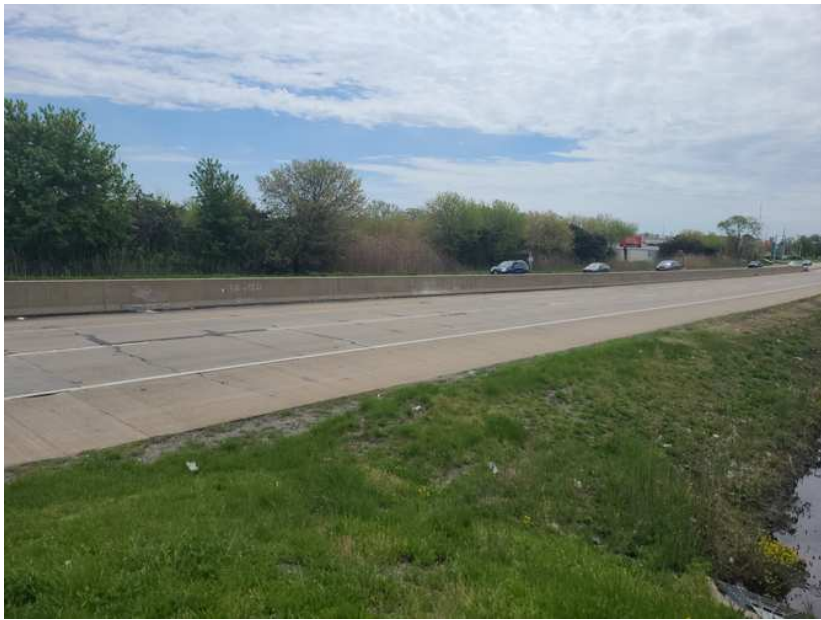
**Inspect ID:** 2024-0229

**Rated Item:** 3. Closure Structures (Stop Log Closures and Gates) (A or U only)

No User Rating (Site Visit) - No issues observed with median wall sandbag abutment

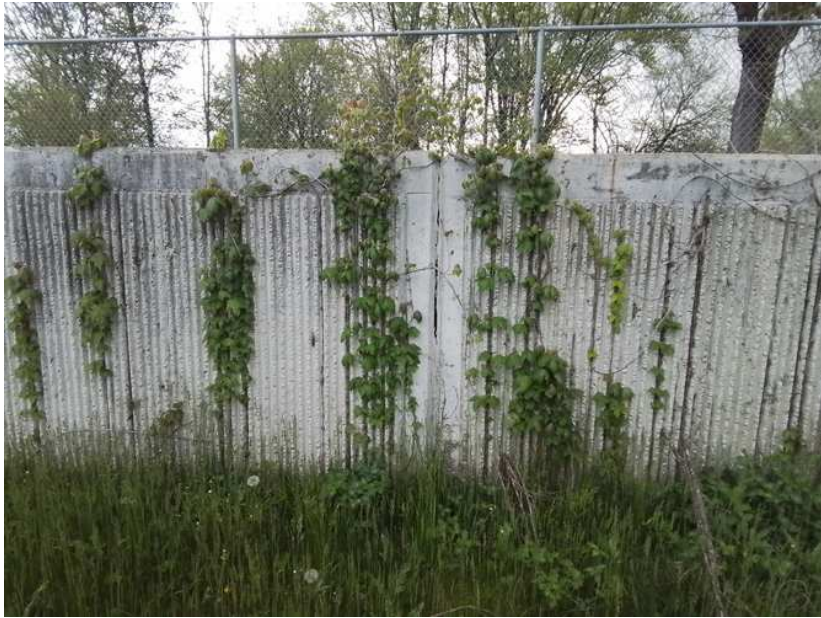
**Inspect ID:** 2024-0016

**Rated Item:** 4. Concrete Surfaces

No User Rating (Site Visit) - Typical joint deterioration on floodwall on riverside.

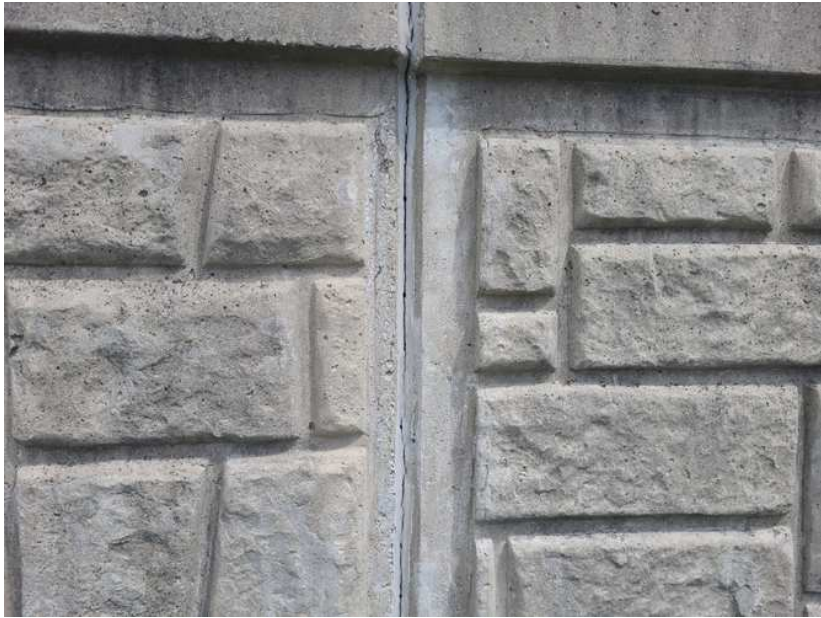
**Inspect ID:** 2024-0125

No User Rating (Site Visit) - Typical silt infill in joints on the landside.

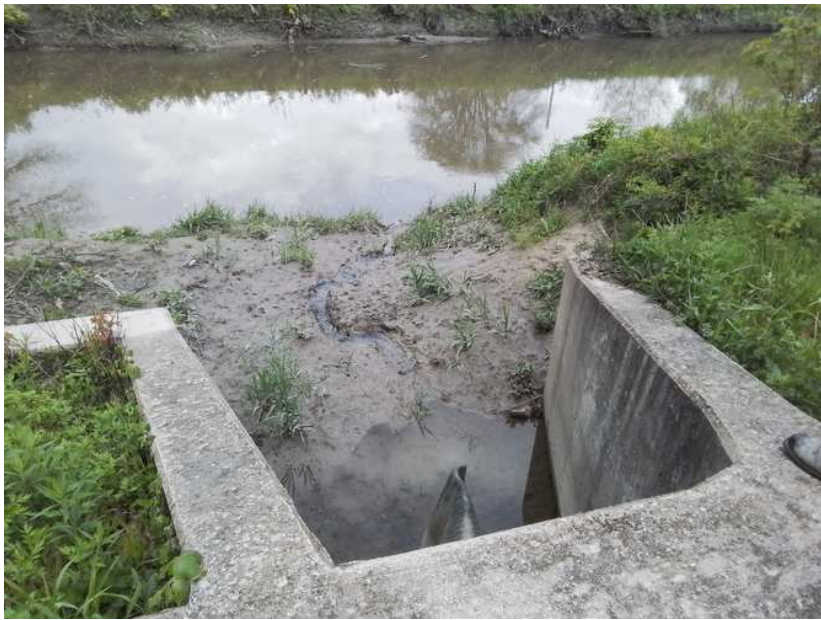
No User Rating (Site Visit) - At weir on landside, potential seepage at joint interlock.

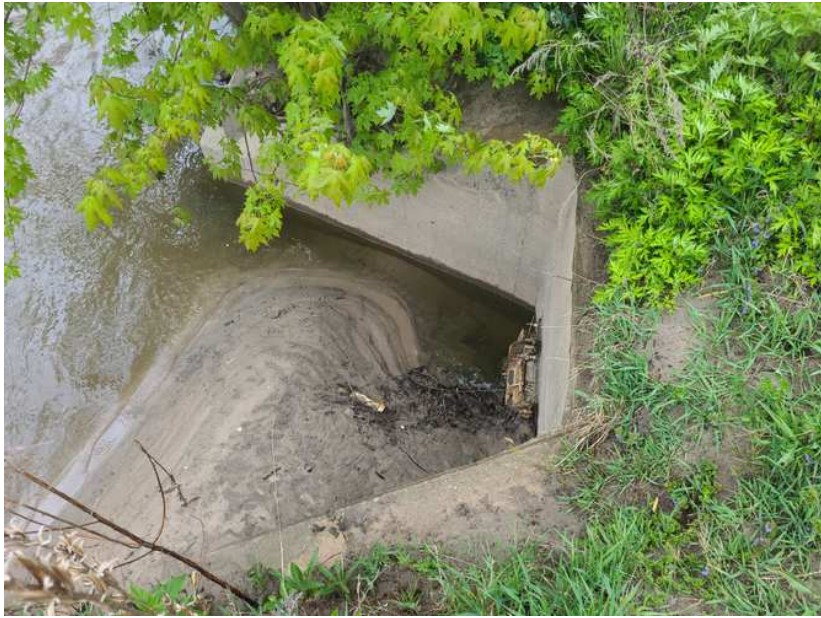
**Inspect ID:** 2024-0008

No User Rating (Site Visit) - HI-01: Silting and vegetation around headwall.

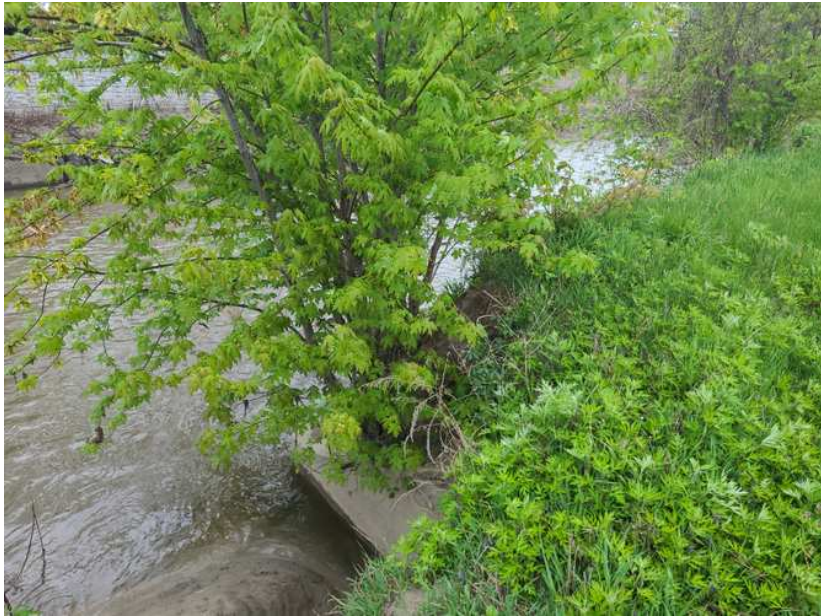
**Inspect ID:** 2024-0037

No User Rating (Site Visit) -HI-02: Silt covering flap gate

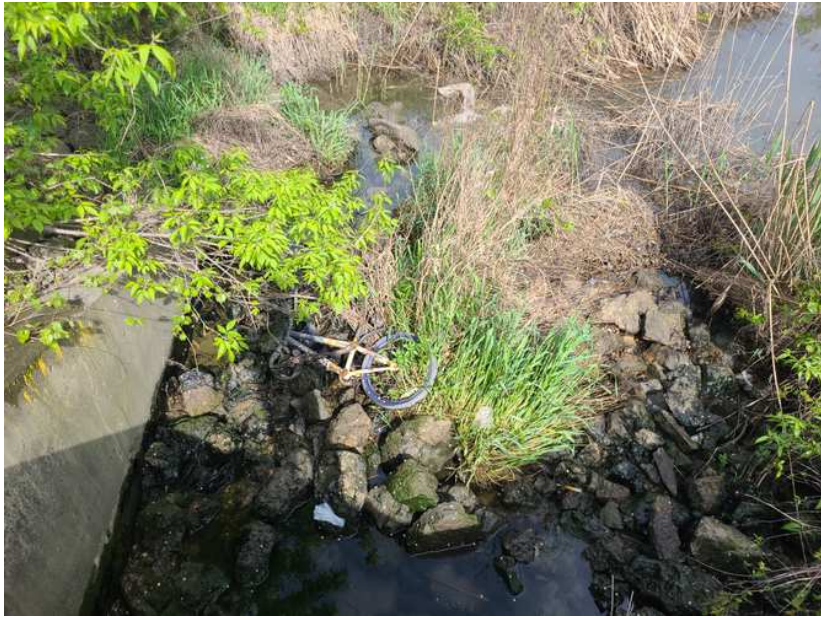
**Inspect ID:** 2024-0041

No User Rating (Site Visit) - HI-02: Tree on wingwall on outlet structure.

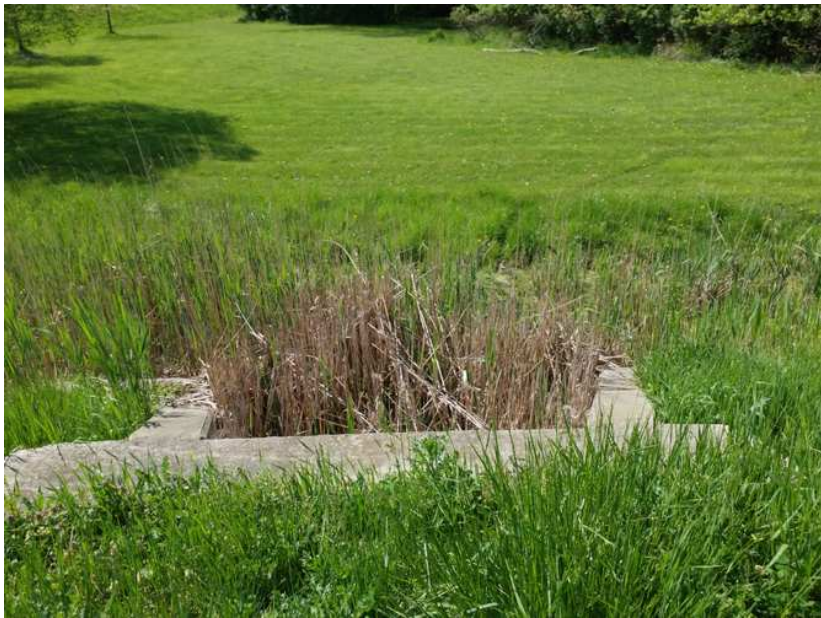
**Inspect ID:** 2024-0057

No User Rating (Site Visit) -HI-06: Debris at outlet structure

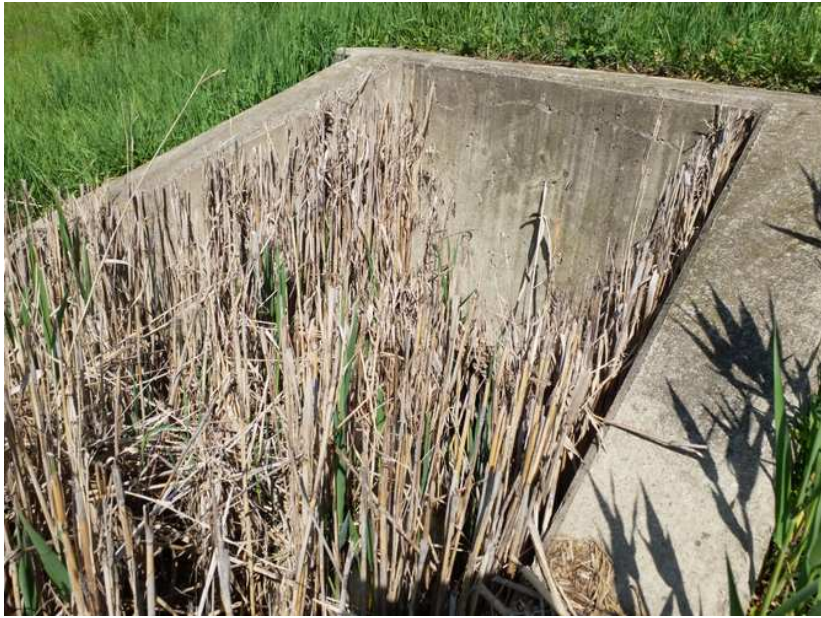
**Inspect ID:** 2024-0058

No User Rating (Site Visit) - HI-10: Vegetation around inlet structure

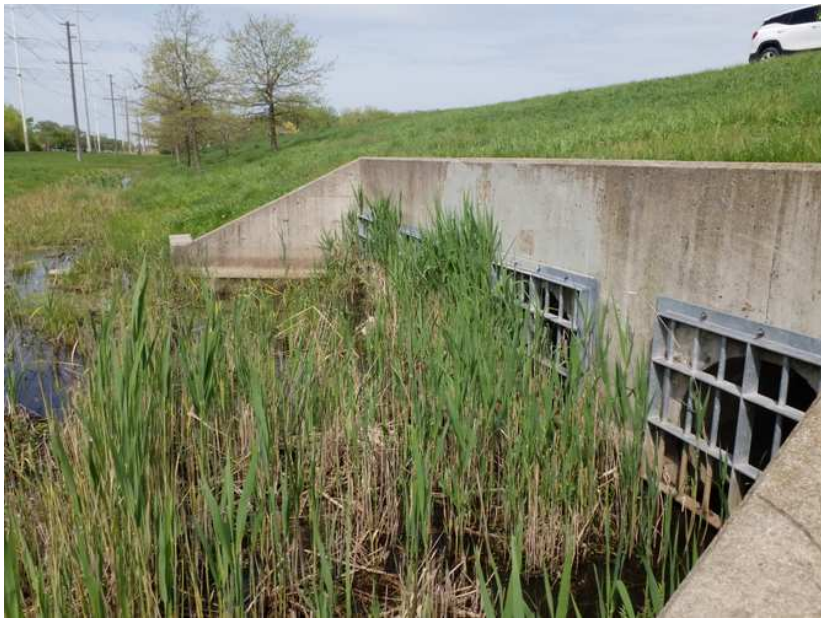
**Inspect ID:** 2024-0058

No User Rating (Site Visit) - HI-10: Vegetation around inlet structure

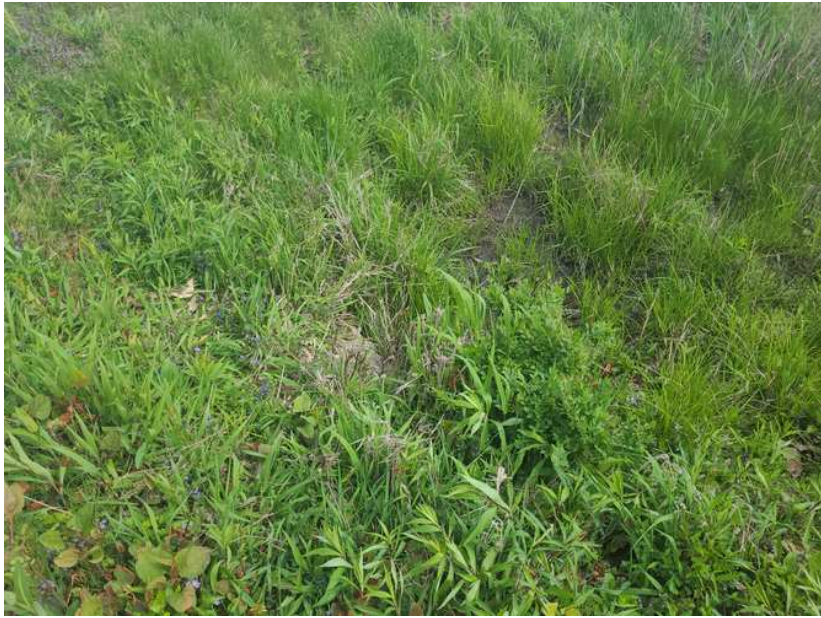
**Inspect ID:** 2024-0078

No User Rating (Site Visit) - HI-11 a-d: Vegetation around inlet structure

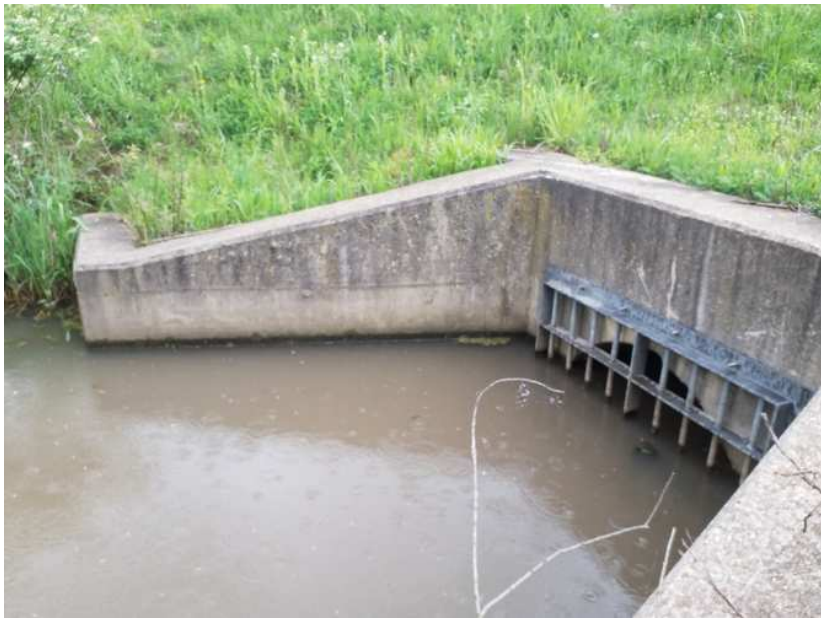
**Inspect ID:** 2024-0212

No User Rating (Site Visit) - Vegetation in landside ditch.

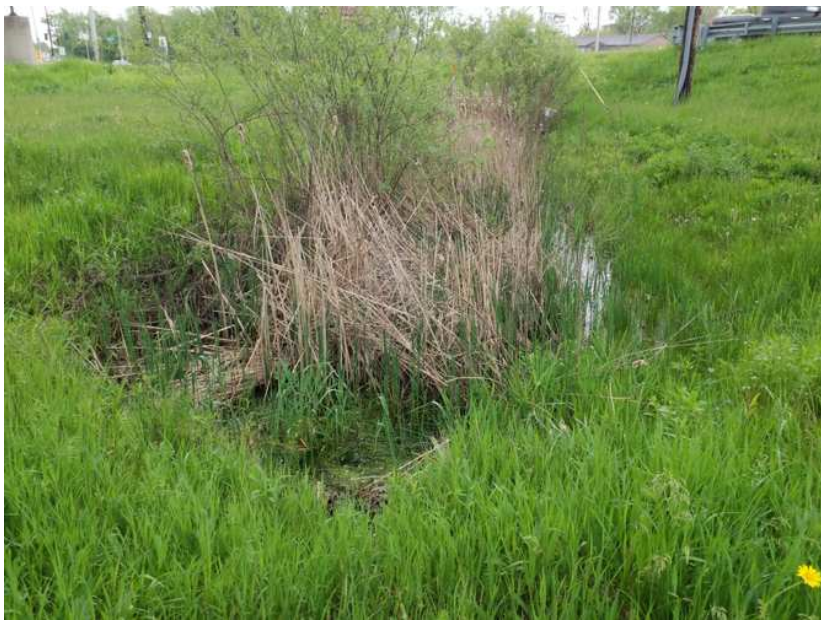
**Inspect ID:** 2024-0022

No User Rating (Site Visit) - HI-03: Wood debris at inlet structure

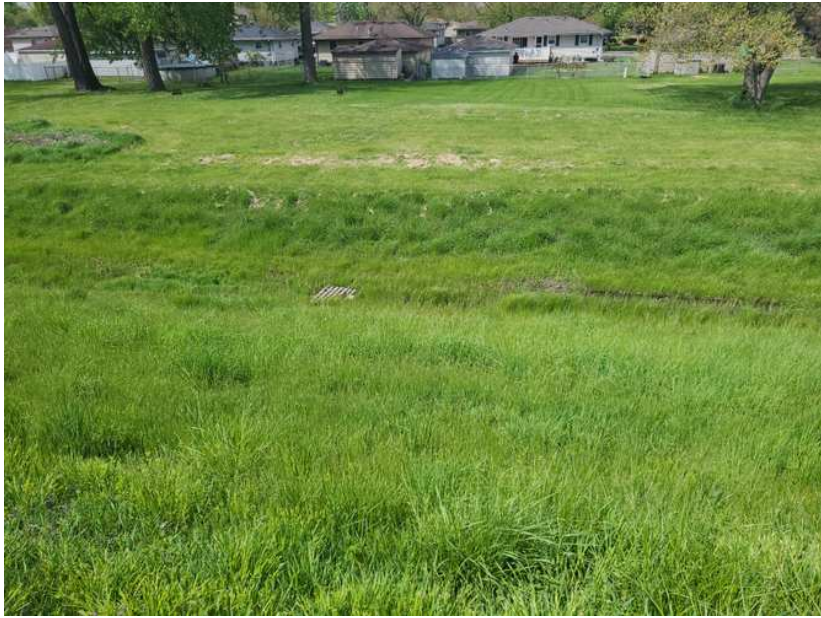
**Inspect ID:** 2024-0038

No User Rating (Site Visit) - HI-05: Vegetation around the inlet structure

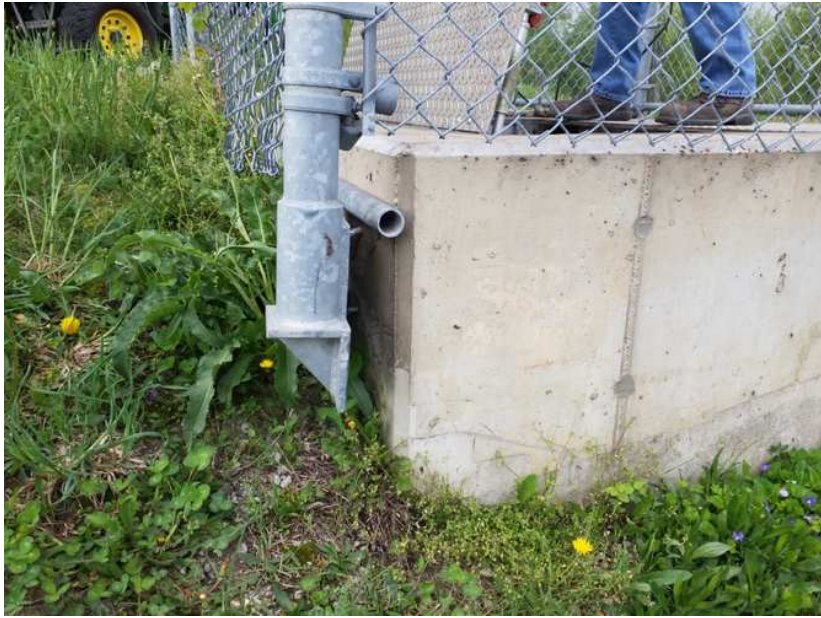
No User Rating (Site Visit) - HI-11: Erosion around the gate well structure

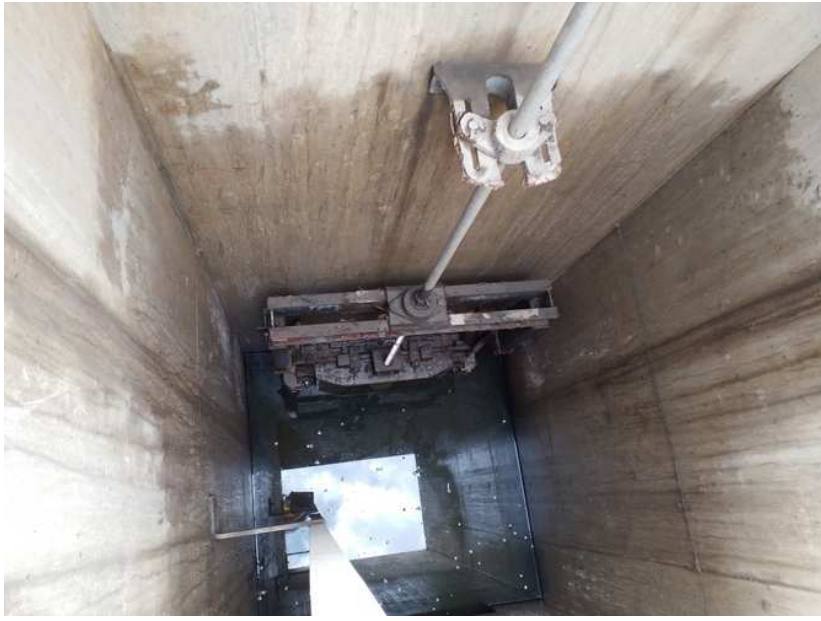
No User Rating (Site Visit) - HI-03: Gate fully closed, no issues

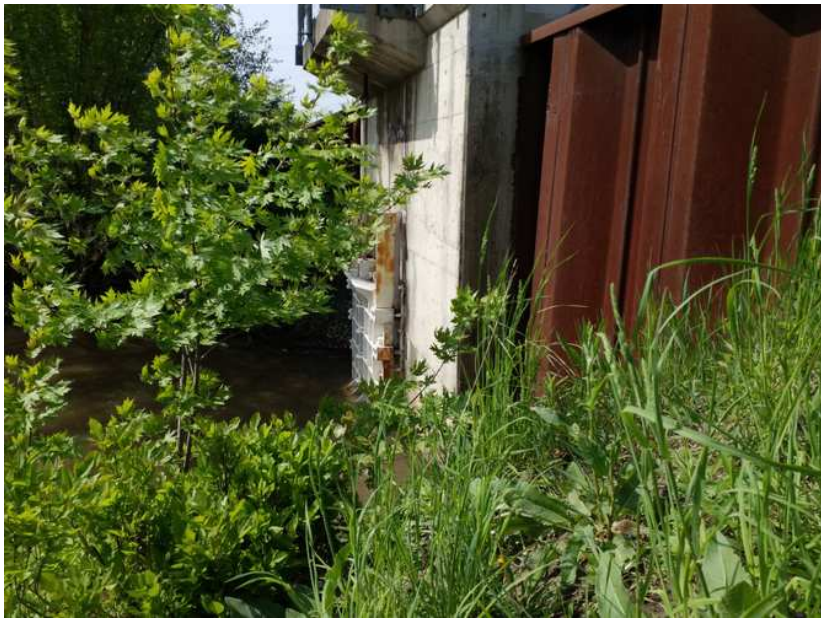
**Inspect ID:** 2024-0026

No User Rating (Site Visit) - HI-05: Fully closed, no issues

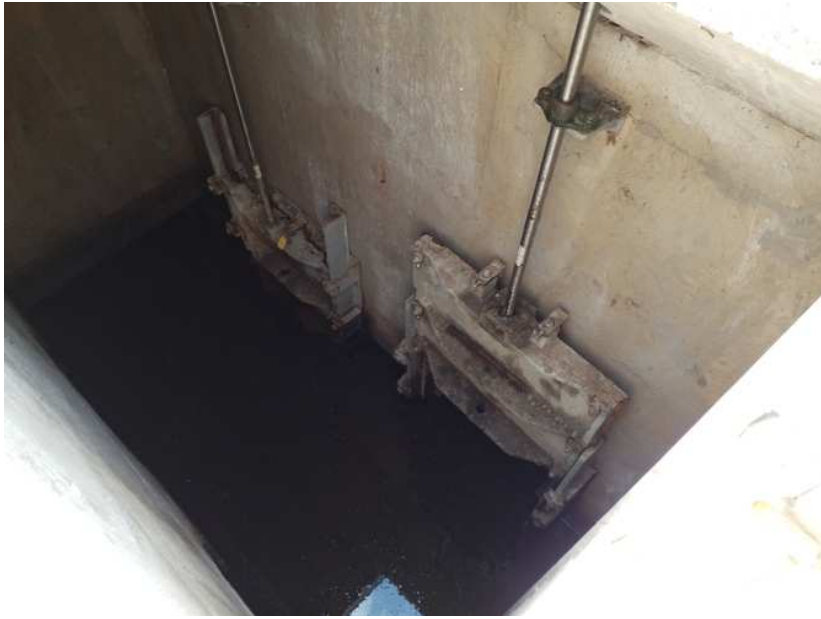
No User Rating (Site Visit) - HI-10: Gate fully closed, no issues

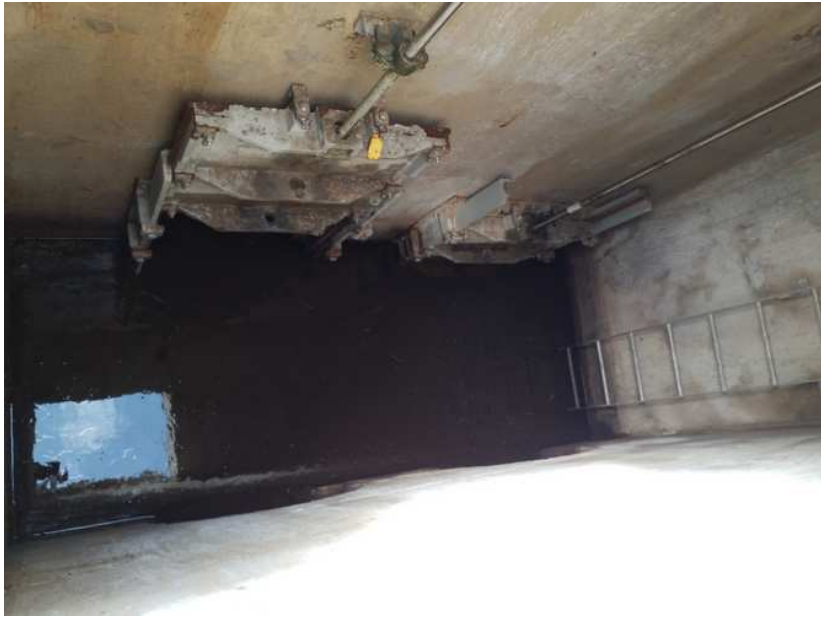
**Inspect ID:** 2024-0070

No User Rating (Site Visit) - HI-11a: (Left) fully closed, some noise when closing

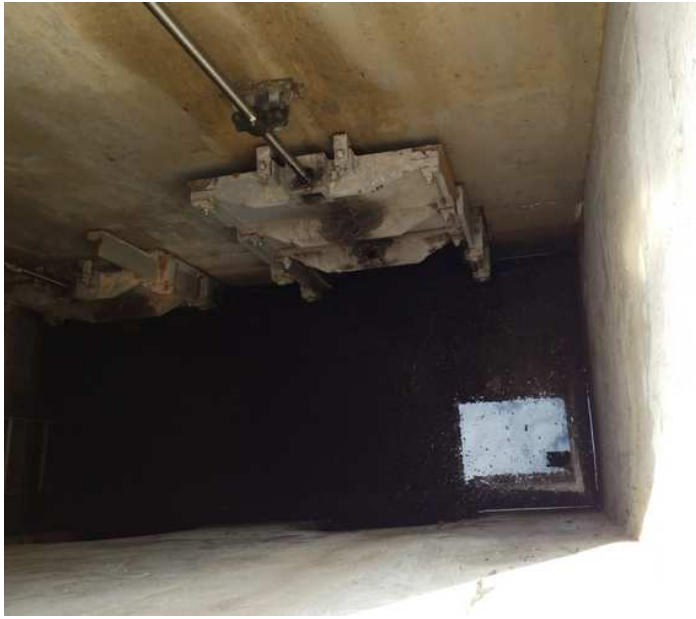
**Inspect ID:** 2024-0086

No User Rating (Site Visit) - HI-11b: (Right) fully closed, no issues.
