US Army Corps of Engineers ®

## Site Visit Summary

Name of System: Highland

NLD System ID: 2605000005 NLD Segment ID: 2604000007

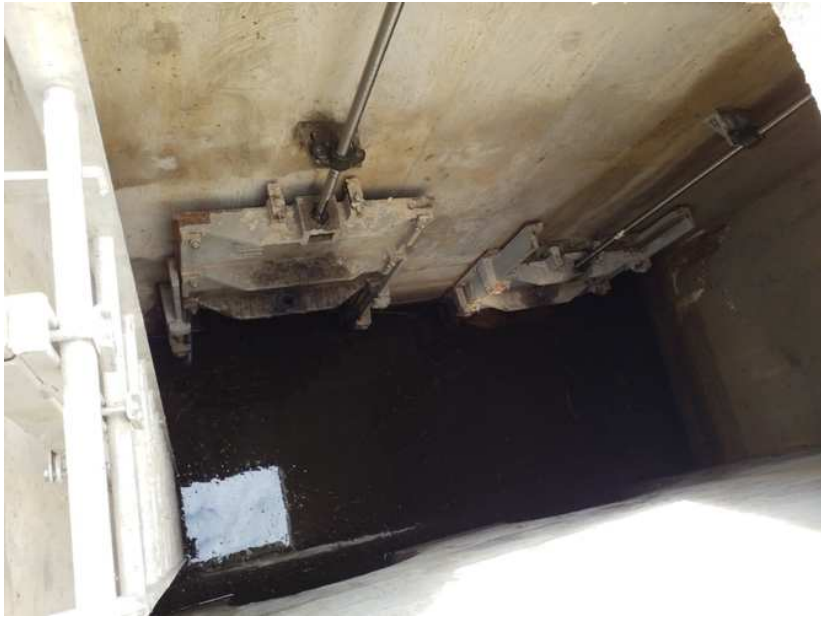
**Inspect ID:** 2024-0090

No User Rating (Site Visit) - HI-11c: (Left) gate fully closed with no issues.

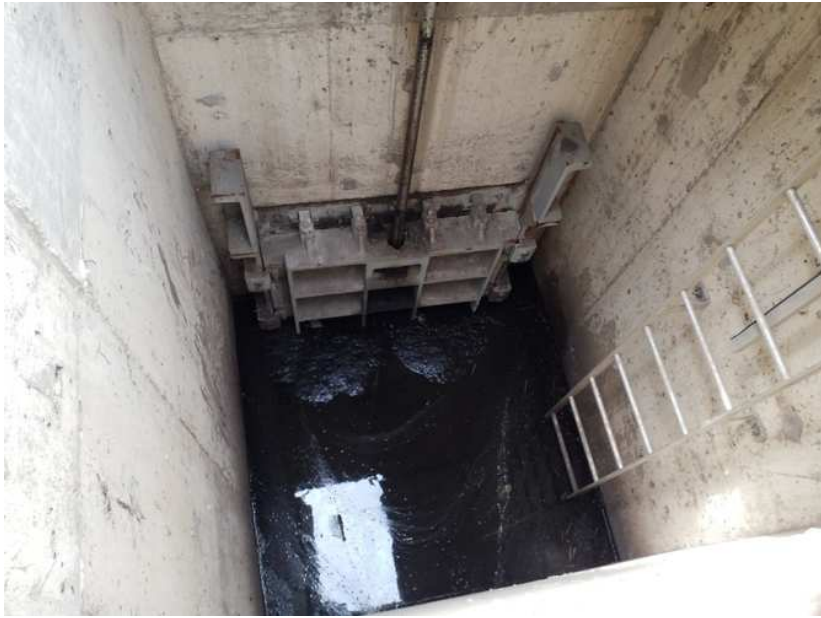
No User Rating (Site Visit) - HI-11d: (Right) gate fully closed with no issues.

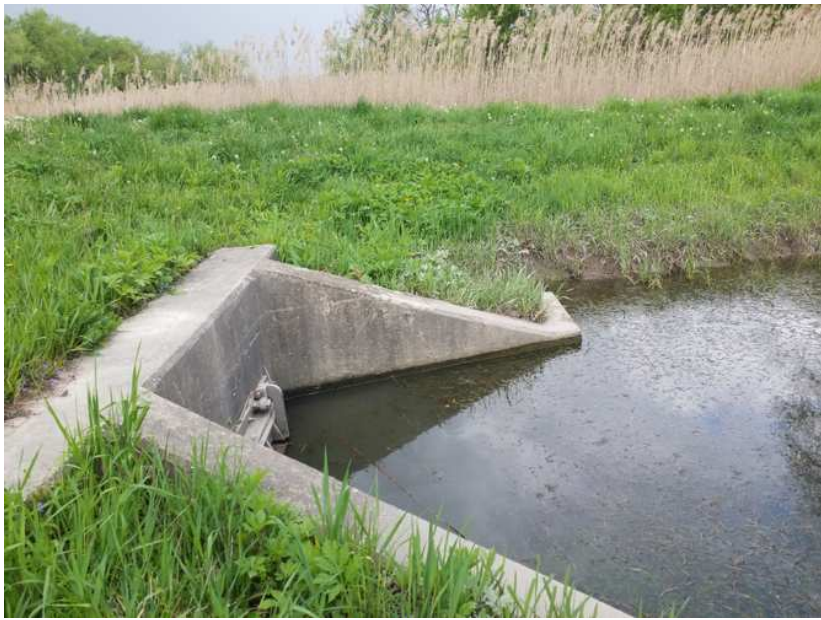
No User Rating (Site Visit) - HI-12: Gate fully closed, no issues

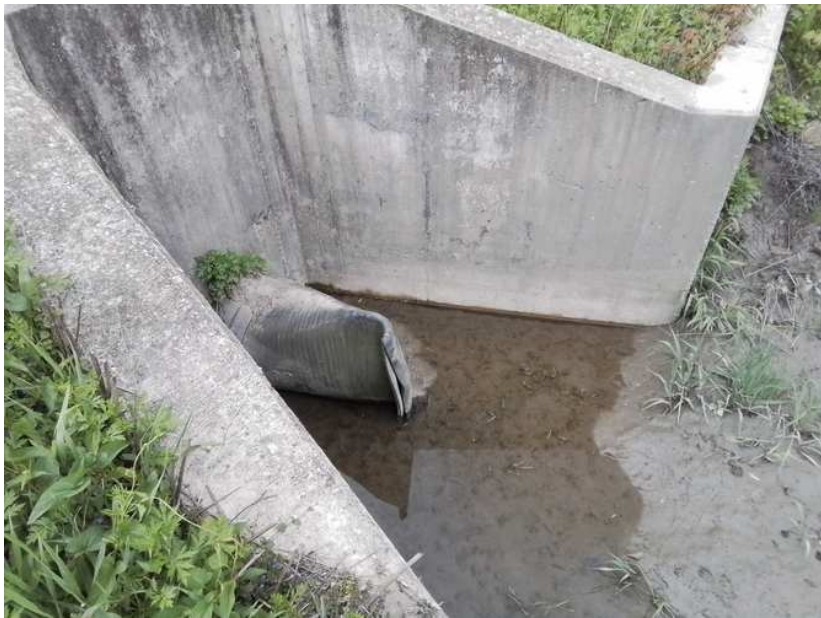
**Inspect ID:** 2024-0006

No User Rating (Site Visit) - HI-03: Water level high thus flap is mostly in the water, looks to be in closed position

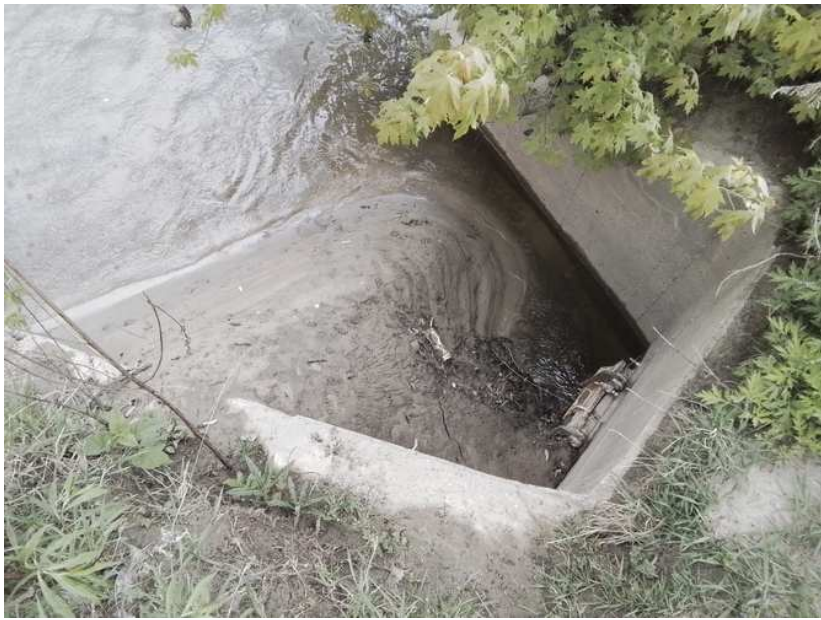
**Inspect ID:** 2024-0012

No User Rating (Site Visit) - HI-1: Flap gate deformed.

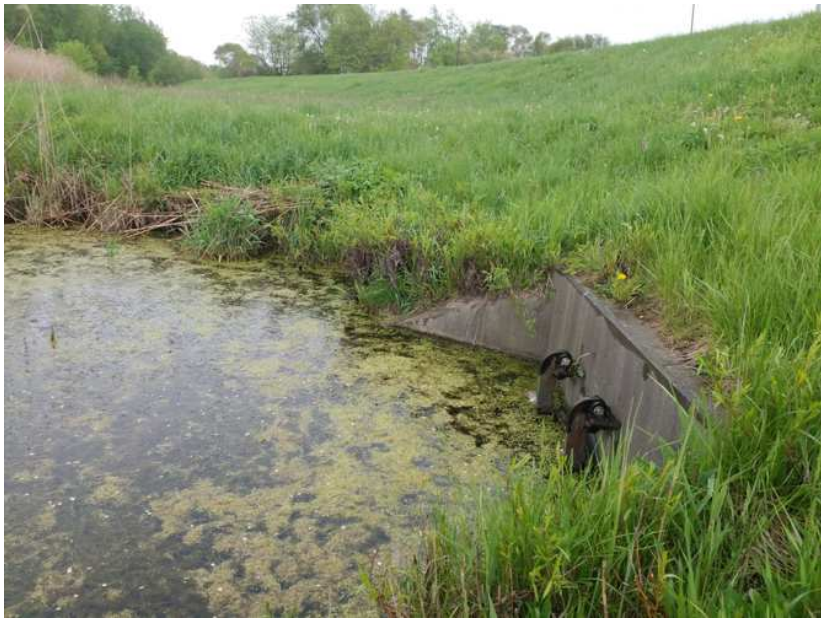
**Inspect ID:** 2024-0024

No User Rating (Site Visit) - HI-02: Flap gate.

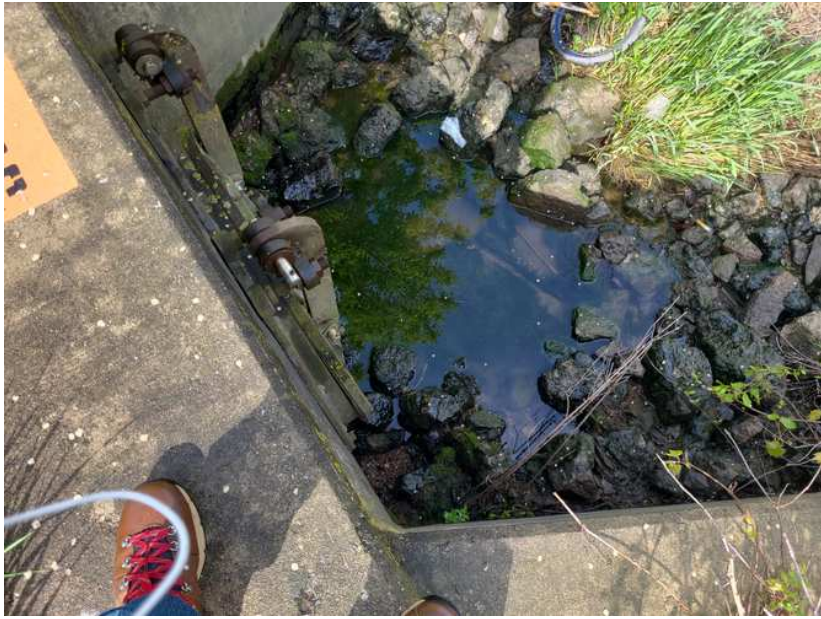
**Inspect ID:** 2024-0030

No User Rating (Site Visit) - HI-05: High water level cover gate flap, looks to be closed

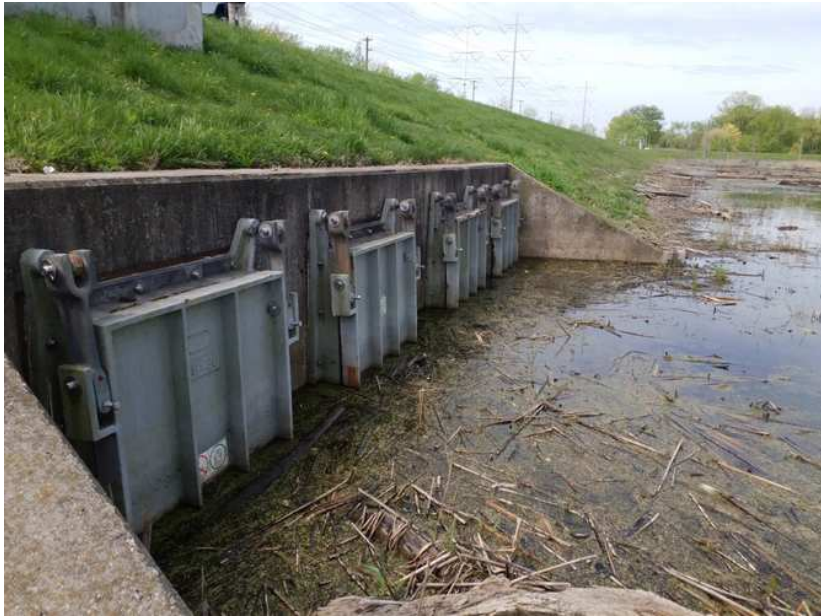
**Inspect ID:** 2024-0061

No User Rating (Site Visit) - HI-06: Flap gate slightly ajar.

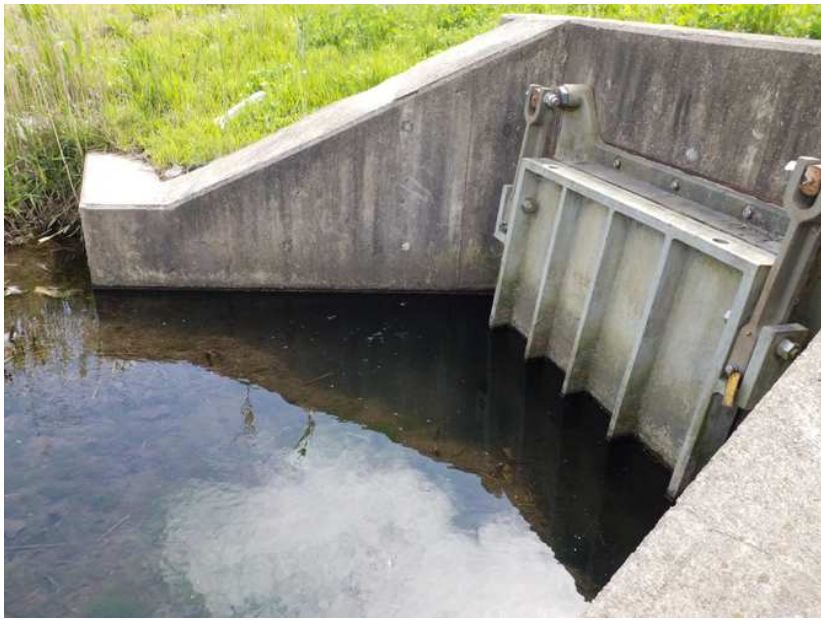
**Inspect ID:** 2024-0074

No User Rating (Site Visit) - HI-11a-d: Debris around the gates

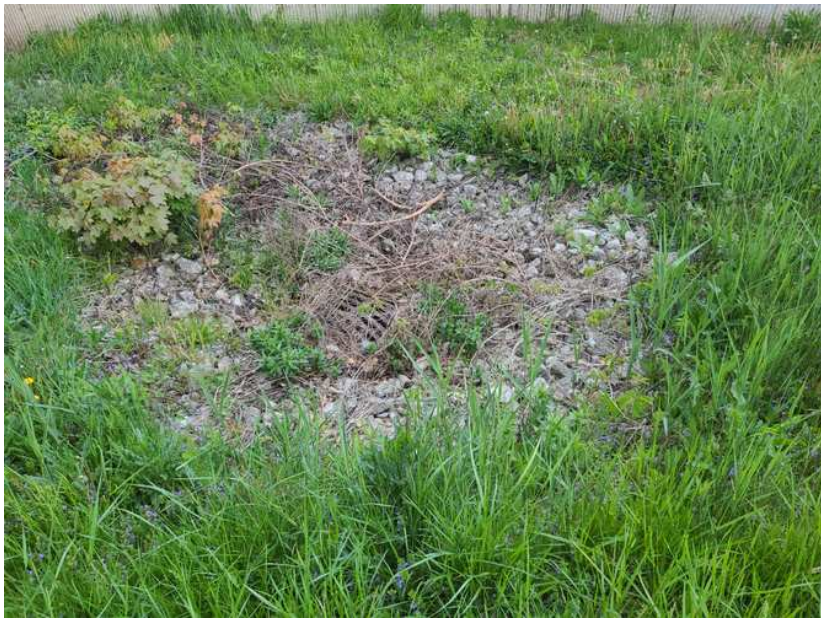
**Inspect ID:** 2024-0098

No User Rating (Site Visit) - HI-12: Inlet gate silted in

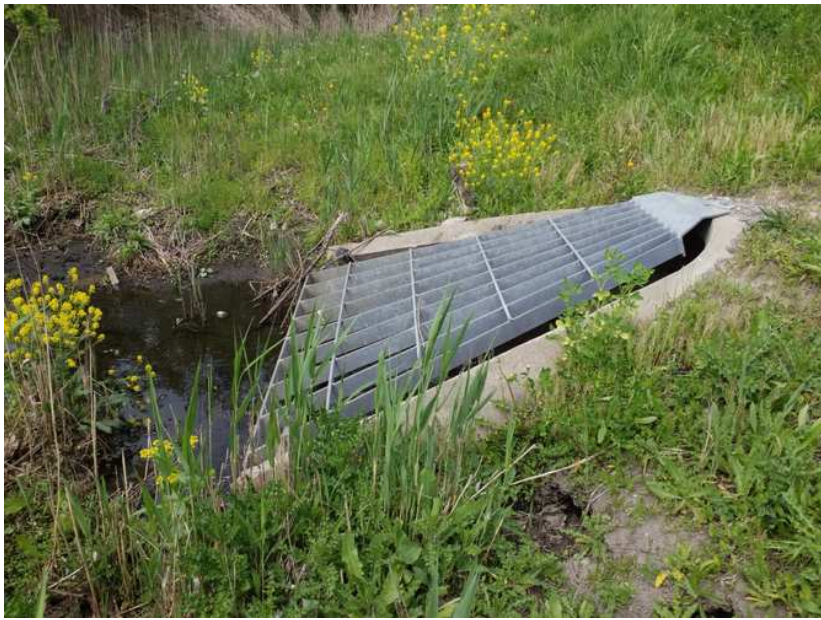
**Inspect ID:** 2024-0005

No User Rating (Site Visit) - HI-02: Inlet clogged with debris

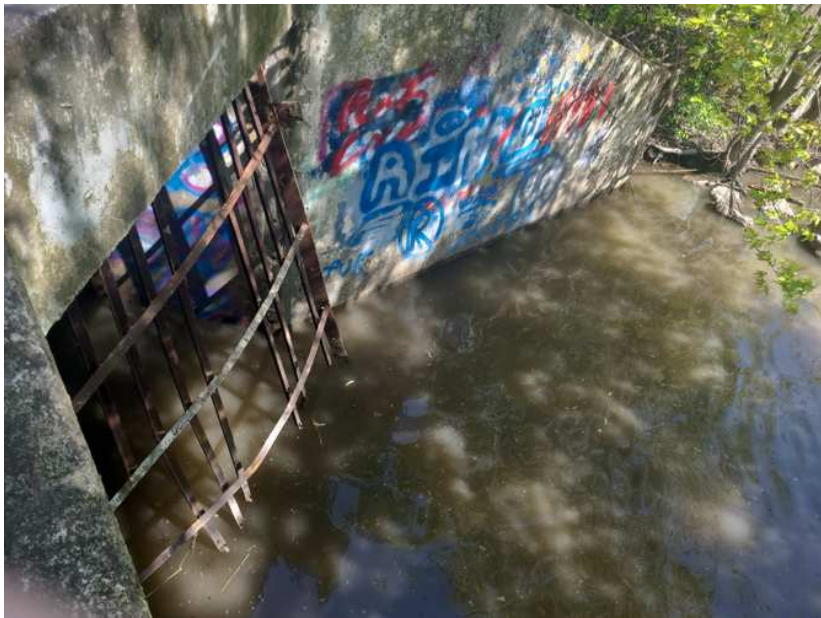
**Inspect ID:** 2024-0102

No User Rating (Site Visit) - HI-12: Trash rack in good condition

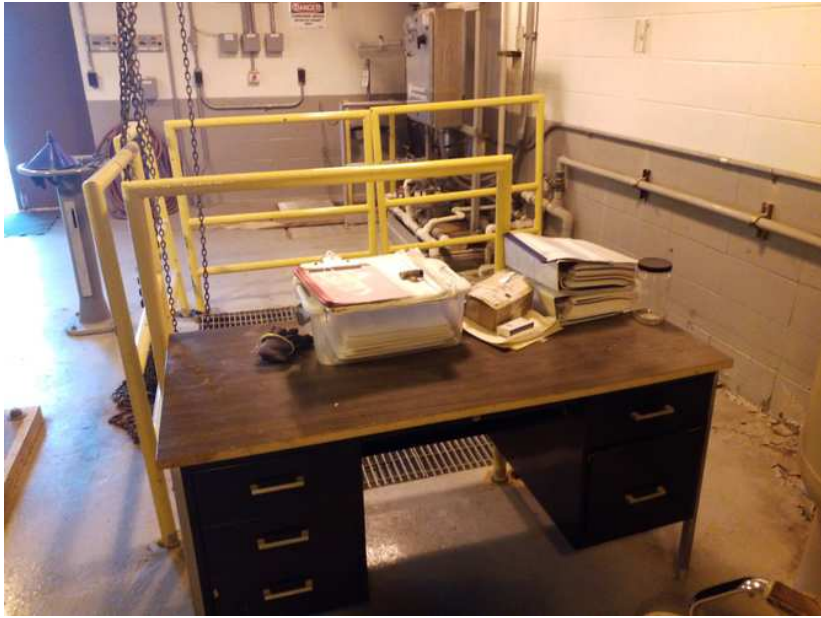
No User Rating (Site Visit) - PS-81: Manuals onsite

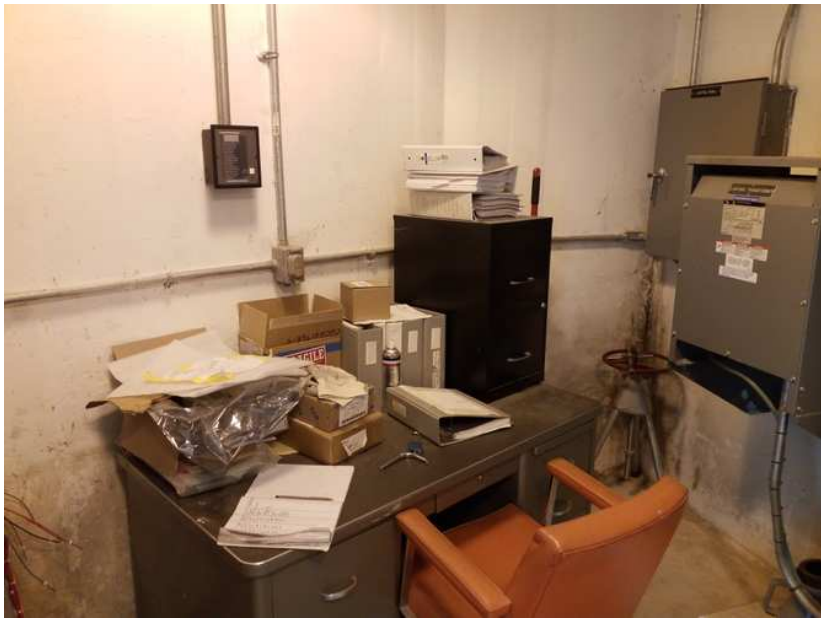
**Inspect ID:** 2024-0059

No User Rating (Site Visit) - PS-N5: Manuals onsite

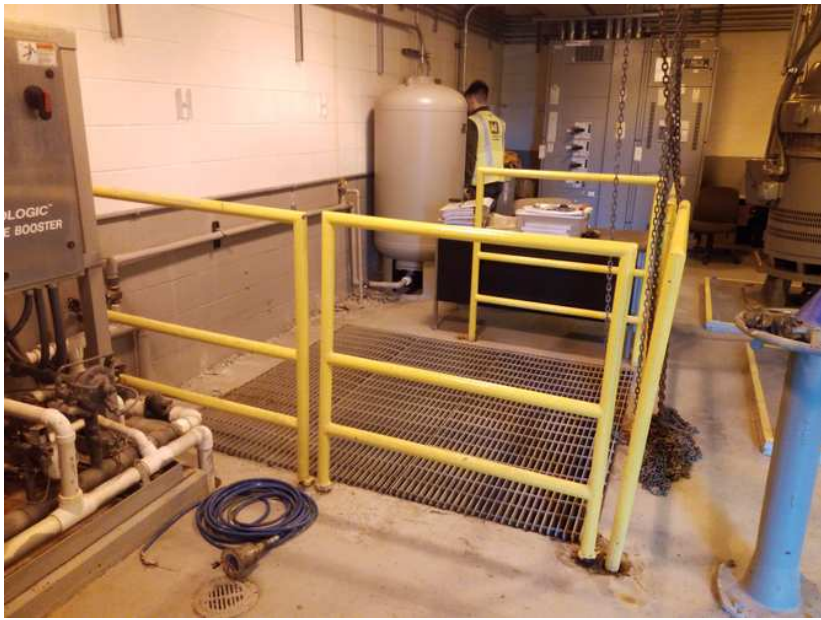
**Inspect ID:** 2024-0091

No User Rating (Site Visit) - PS-ND: Manuals onsite

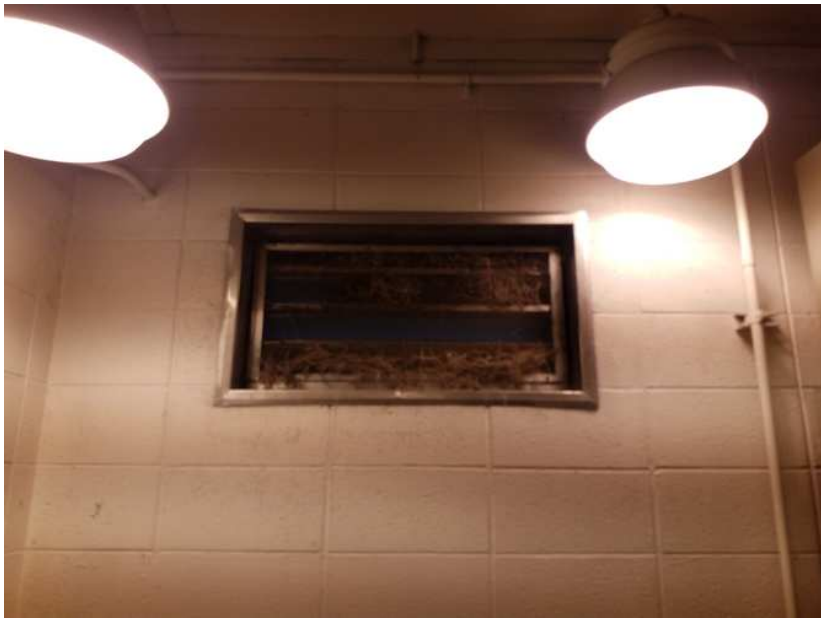
No User Rating (Site Visit) - PS-81: Bird nests in louver

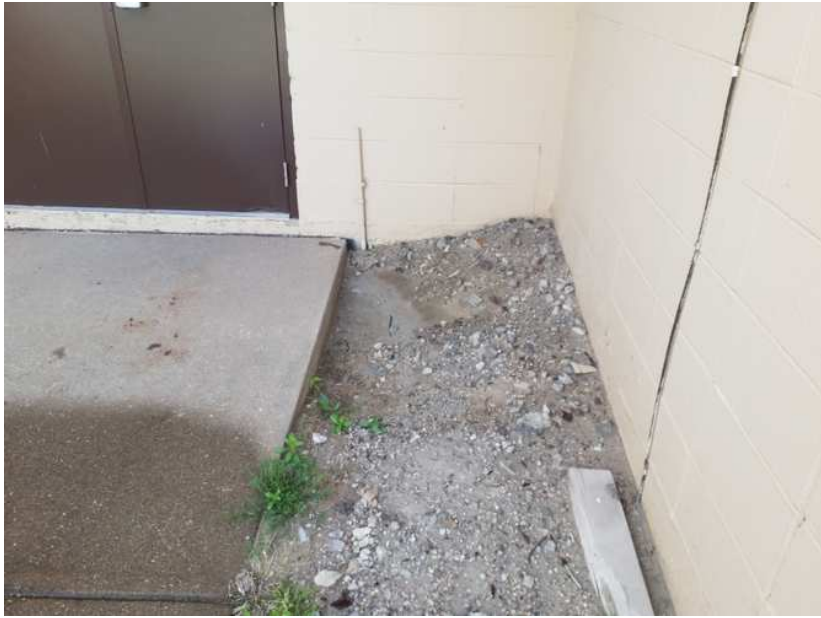
No User Rating (Site Visit) - PS-N5: Doors were recently repainted - exterior will also be repainted soon

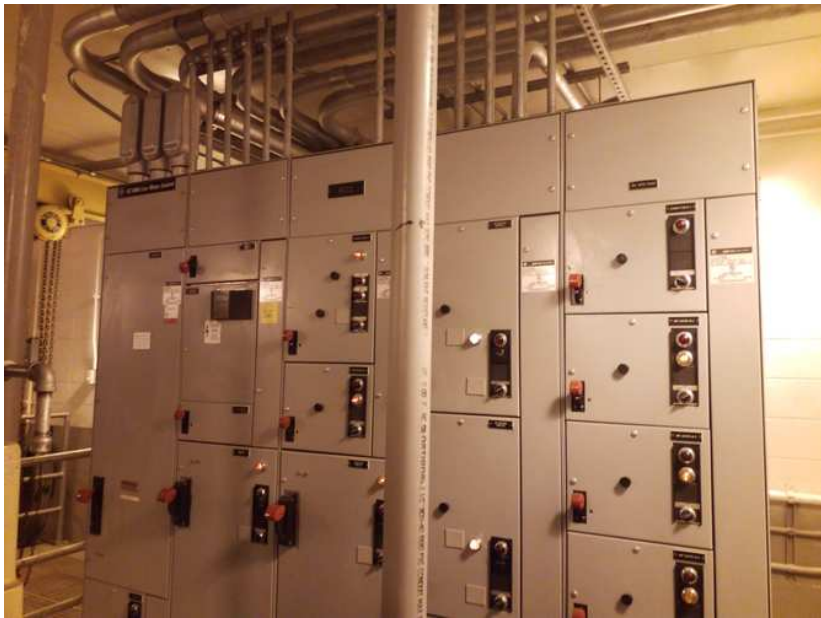
No User Rating (Site Visit) - PS-ND: Generator has 573.9 hrs - there were 551.8 hrs during the last inspection
